## Seskin Renewables Wind Farm

## Factual Ground Investigation Report

### January 2025

Project Title	Seskin Renewables Wind Farm
Client	MKO Ireland
Engineer	Hydro-Environmental Services
Project No	14166-09-24
Document Title	Factual Ground Investigation Report

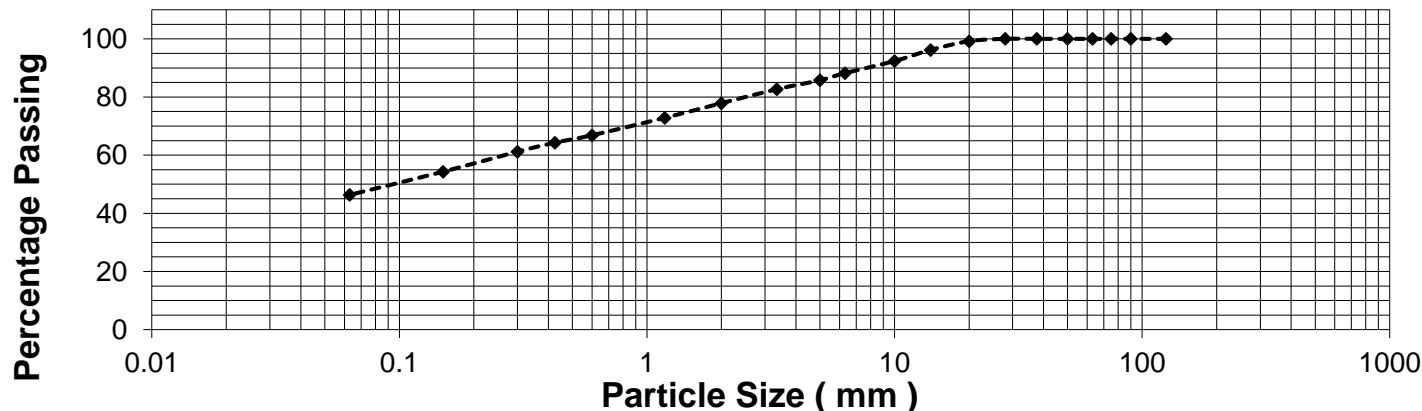
Description of Soil	Silty, sandy, gravelly CLAY brown	Sample Number	SA2655
Supplier	* Ground Investigation Ireland	Date Sampled	26/11/2024
Source	* TP-TH01 @ 1.20m	Date Received	05/12/2024
Deposition / Location	* Potential Wind Farm Co.Laois / Kilkenny	Date Tested	06/12/24
Sample Ref.	* TP-TH01 @ 1.20m	Moisture Content (All in)	23.3 %

BS Sieve	% Passing	Spec
125 mm	100	
90 mm	100	
75 mm	100	
63 mm	100	
50 mm	100	
37.5 mm	100	
28 mm	100	
20 mm	99	
14 mm	96	
10 mm	92	
6.3 mm	88	
5 mm	86	
3.35 mm	83	
2 mm	78	
1.18 µm	73	
600 µm	67	
425 µm	64	
300 µm	61	
150 µm	54	
63 µm	46.3

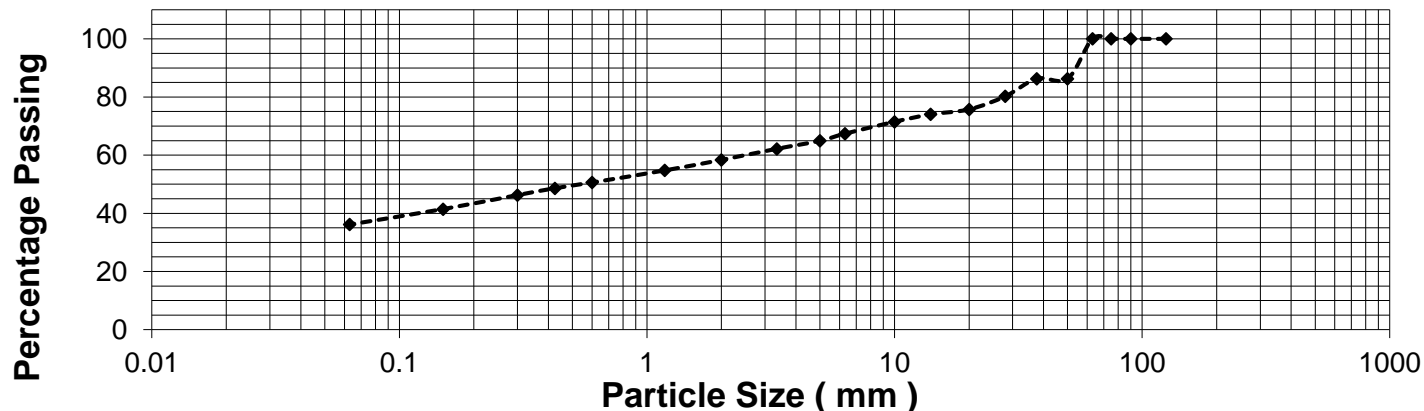
Description of Soil	Silty, sandy, gravelly CLAY brown	Sample Number	SA2654
Supplier	* Ground Investigation Ireland	Date Sampled	26/11/2024
Source	* TP-T08 @3.50m	Date Received	05/12/2024
Deposition / Location	* Potential Wind Farm Co.Laois / Kilkenny	Date Tested	06/12/24
Sample Ref.	* TP-T08 @3.50m	Moisture Content (All in)	9.5 %

BS Sieve	% Passing	Spec
125 mm	100	
90 mm	100	
75 mm	100	
63 mm	100	
50 mm	86	
37.5 mm	86	
28 mm	80	
20 mm	76	
14 mm	74	
10 mm	71	
6.3 mm	67	
5 mm	65	
3.35 mm	62	
2 mm	58	
1.18 µm	55	
600 µm	51	
425 µm	49	
300 µm	46	
150 µm	41	
63 µm	36.2

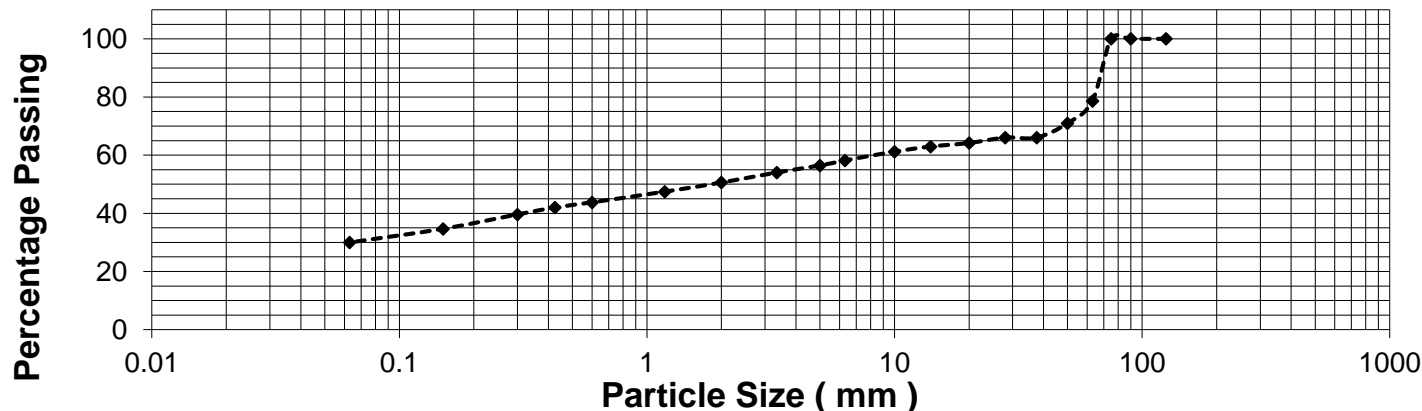
Description of Soil	Silty, sandy, gravelly CLAY brown	Sample Number	SA2653
Supplier	* Ground Investigation Ireland	Date Sampled	04/11/2024
Source	* TP-T08 @1.50m	Date Received	05/12/2024
Deposition / Location	* Potential Wind Farm Co.Laois / Kilkenny	Date Tested	06/12/24
Sample Ref.	* TP-T08 @1.50m	Moisture Content (All in)	10.2 %

BS Sieve	% Passing	Spec
125 mm	100	
90 mm	100	
75 mm	100	
63 mm	79	
50 mm	71	
37.5 mm	66	
28 mm	66	
20 mm	64	
14 mm	63	
10 mm	61	
6.3 mm	58	
5 mm	56	
3.35 mm	54	
2 mm	51	
1.18 µm	47	
600 µm	44	
425 µm	42	
300 µm	40	
150 µm	35	
63 µm	30.0

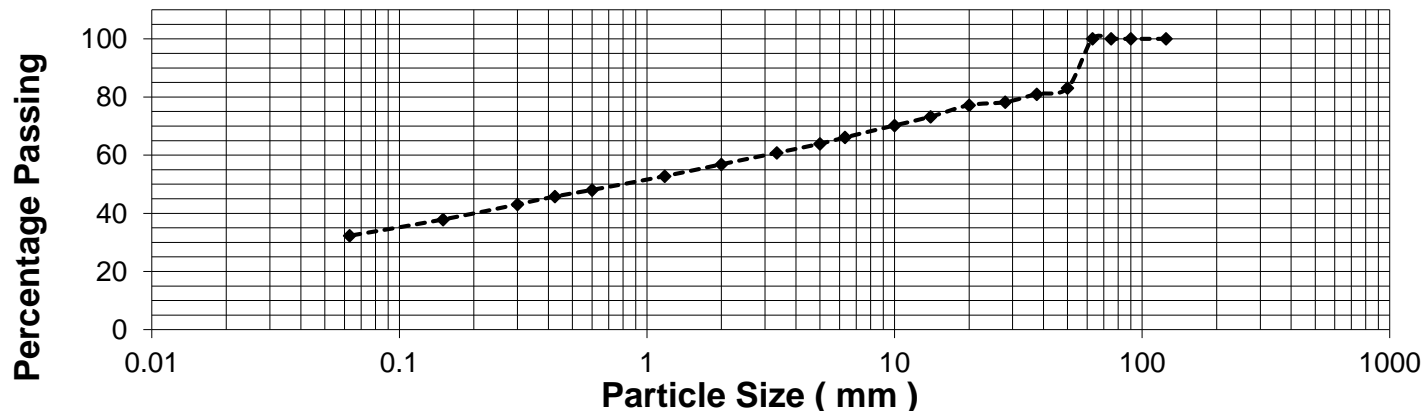
Description of Soil	Silty, sandy, gravelly CLAY brown	Sample Number	SA2652
Supplier	* Ground Investigation Ireland	Date Sampled	26/11/2024
Source	* TP-T07 @2.70m	Date Received	05/12/2024
Deposition / Location	* Potential Wind Farm Co.Laois / Kilkenny	Date Tested	06/12/24
Sample Ref.	* TP-T07 @2.70m	Moisture Content (All in)	9.7 %

CLAY	Fine	Med	Coarse	Fine	Med	Coarse	Fine	Med	Coarse	Coarse	Boulders
	Silt			Sand			Gravel			Cobbles	
	32.3			25			43

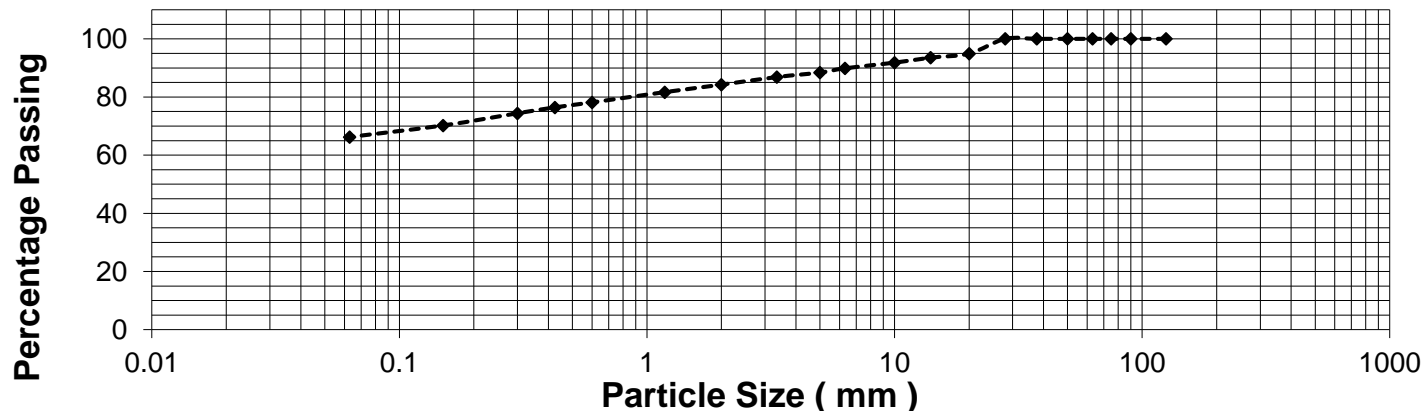
Description of Soil	Silty, sandy, gravelly CLAY brown	Sample Number	SA2651
Supplier	* Ground Investigation Ireland	Date Sampled	26/11/2024
Source	* TP-T07 @0.50m	Date Received	05/12/2024
Deposition / Location	* Potential Wind Farm Co.Laois / Kilkenny	Date Tested	06/12/24
Sample Ref.	* TP-T07 @0.50m	Moisture Content (All in)	31.2 %

CLAY	Fine	Med	Coarse	Fine	Med	Coarse	Fine	Med	Coarse	Coarse	Boulders
	Silt			Sand			Gravel			Cobbles	
	66.2			18			16

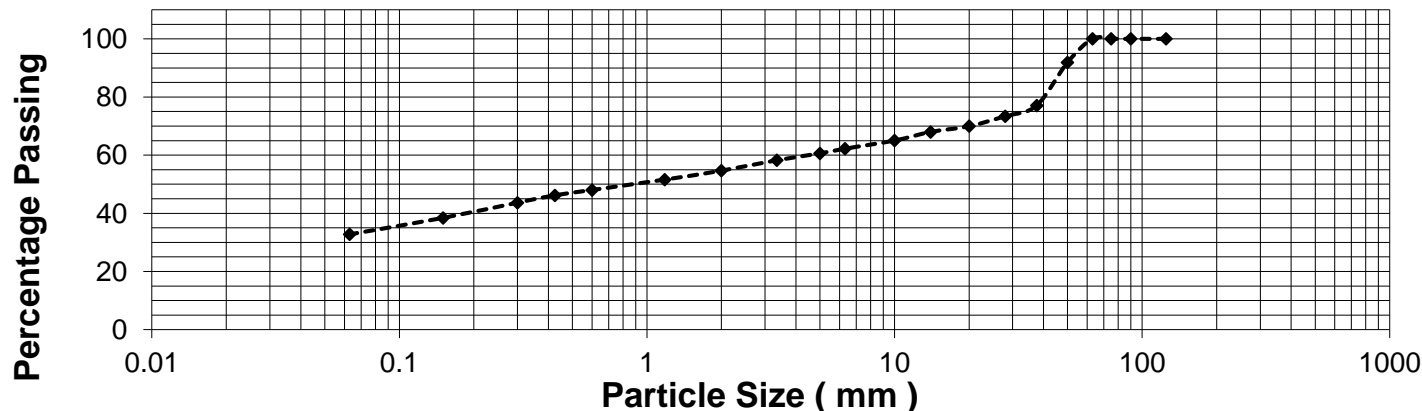
Description of Soil	Silty, sandy, gravelly CLAY brown	Sample Number	SA2650
Supplier	* Ground Investigation Ireland	Date Sampled	05/11/2024
Source	* TP-T06 @1.50m	Date Received	05/12/2024
Deposition / Location	* Potential Wind Farm Co.Laois / Kilkenny	Date Tested	06/12/24
Sample Ref.	* TP-T06 @1.50m	Moisture Content (All in)	12.5 %

BS Sieve	% Passing	Spec
125 mm	100	
90 mm	100	
75 mm	100	
63 mm	100	
50 mm	92	
37.5 mm	77	
28 mm	73	
20 mm	70	
14 mm	68	
10 mm	65	
6.3 mm	62	
5 mm	61	
3.35 mm	58	
2 mm	55	
1.18 mm	52	
600 µm	48	
425 µm	46	
300 µm	44	
150 µm	38	
63 µm	32.8

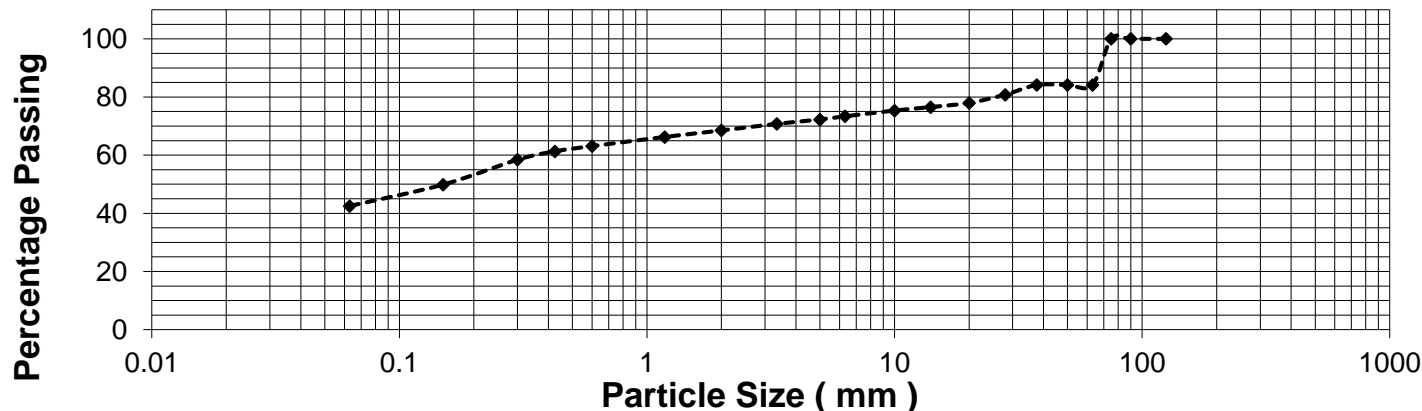
Description of Soil	Silty, sandy, gravelly CLAY brown	Sample Number	SA2649
Supplier	* Ground Investigation Ireland	Date Sampled	26/11/2024
Source	* TP-T04 @1.50m	Date Received	05/12/2024
Deposition / Location	* Potential Wind Farm Co.Laois / Kilkenny	Date Tested	06/12/24
Sample Ref.	* TP-T04 @1.50m	Moisture Content (All in)	25.9 %

BS Sieve	% Passing	Spec
125 mm	100	
90 mm	100	
75 mm	100	
63 mm	84	
50 mm	84	
37.5 mm	84	
28 mm	81	
20 mm	78	
14 mm	77	
10 mm	75	
6.3 mm	73	
5 mm	72	
3.35 mm	71	
2 mm	68	
1.18 µm	66	
600 µm	63	
425 µm	61	
300 µm	58	
150 µm	50	
63 µm	42.5

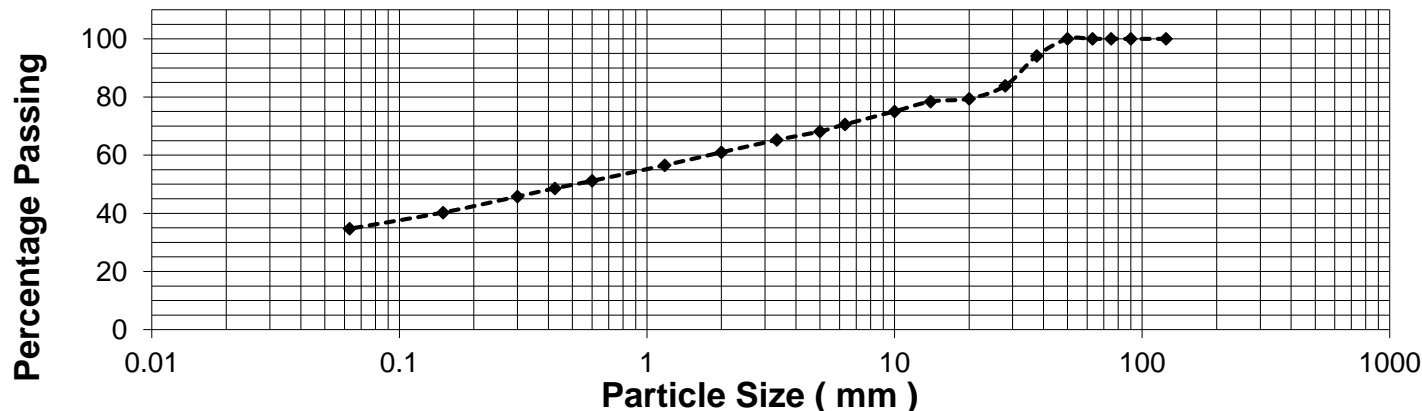
Description of Soil	Silty, sandy, gravelly CLAY brown	Sample Number	SA2648
Supplier	* Ground Investigation Ireland	Date Sampled	26/11/2024
Source	* TP-T03 @2.50m	Date Received	05/12/2024
Deposition / Location	* Potential Wind Farm Co.Laois / Kilkenny	Date Tested	06/12/24
Sample Ref.	* TP-T03 @2.50m	Moisture Content (All in)	9.7 %

BS Sieve	% Passing	Spec
125 mm	100	
90 mm	100	
75 mm	100	
63 mm	100	
50 mm	100	
37.5 mm	94	
28 mm	84	
20 mm	79	
14 mm	78	
10 mm	75	
6.3 mm	71	
5 mm	68	
3.35 mm	65	
2 mm	61	
1.18 µm	57	
600 µm	51	
425 µm	49	
300 µm	46	
150 µm	40	
63 µm	34.7

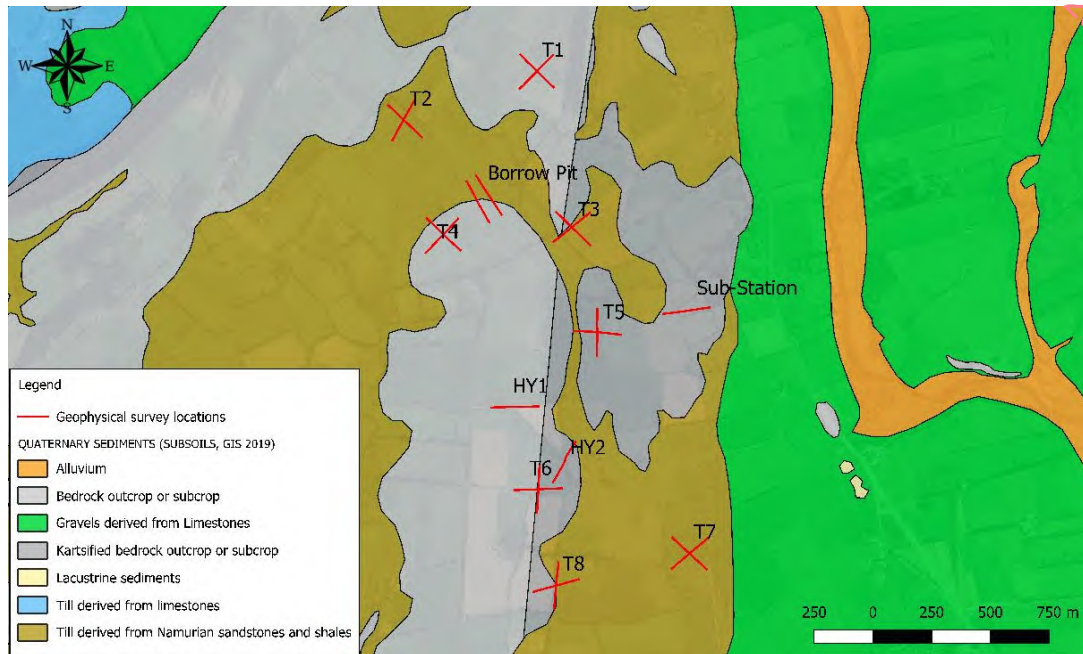
Fig 2.2: Quaternary sediments map with geophysical survey locations.

T3 and T6. Karstified bedrock outcrop and subcrop are observed at HY2, the Substation, and partially at T3, T5, T6, and T8 (Fig. 2.2).

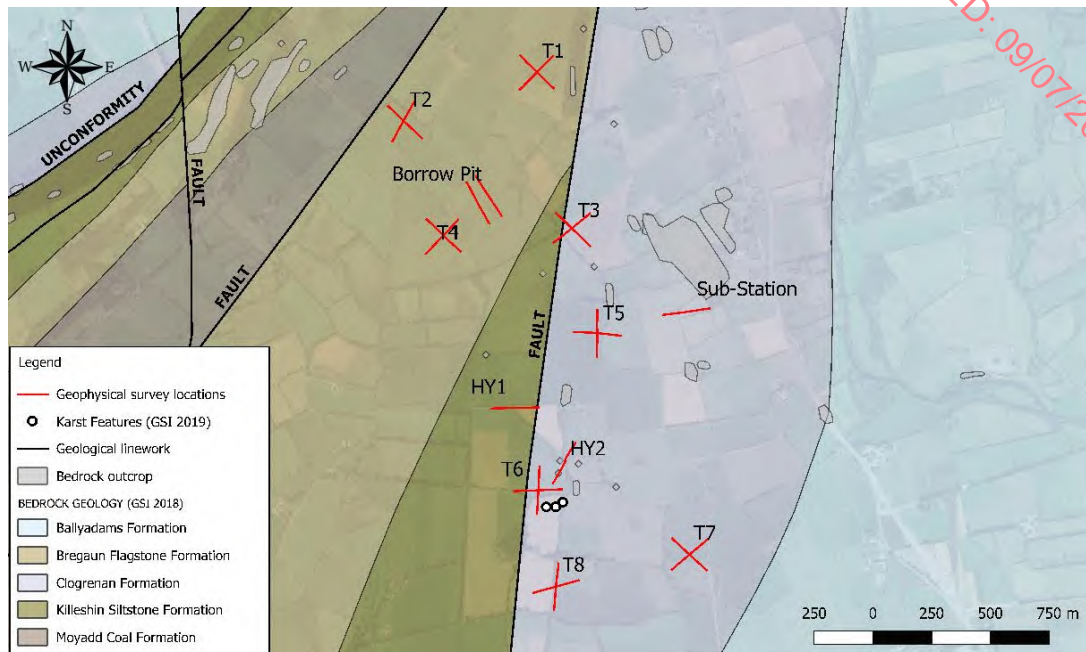
Fig 2.3: Bedrock geology map with geophysical survey locations.

The GSI 1:100k Bedrock Geology Map (GSI, 2018) indicates that the survey area is underlain by three geological formations. The Bregaun Flagstone Formation, characterized by thick flaggy sandstone and siltstone, is indicated at survey locations T1, T2, T4, and the Borrow Pit. The Clogrenan Formation, comprising cherty, muddy, calcarenitic limestone, underlies survey locations T5, T7, T8, and HY2. The Killeshin Siltstone Formation, described as muddy siltstone and silty mudstone, is found at survey location HY1. Survey locations T3 and T6 are underlain by both the Clogrenan and Killeshin Siltstone Formations and are intersected by a southwest-northeast trending geological fault. Bedrock outcrop is indicated near T3, T6, HY2, and the Substation. The GSI karst database indicates a number of swallow holes, southeast of turbine base T6 in the Clongrennan Formation. Karst may be defined as the whole or partial dissolution of limestone bedrock by the action of water and the subsequent whole or partial infill with soil material. The degree of karstification depends on the quantity of limestone which has been dissolved and subsequently infilled.

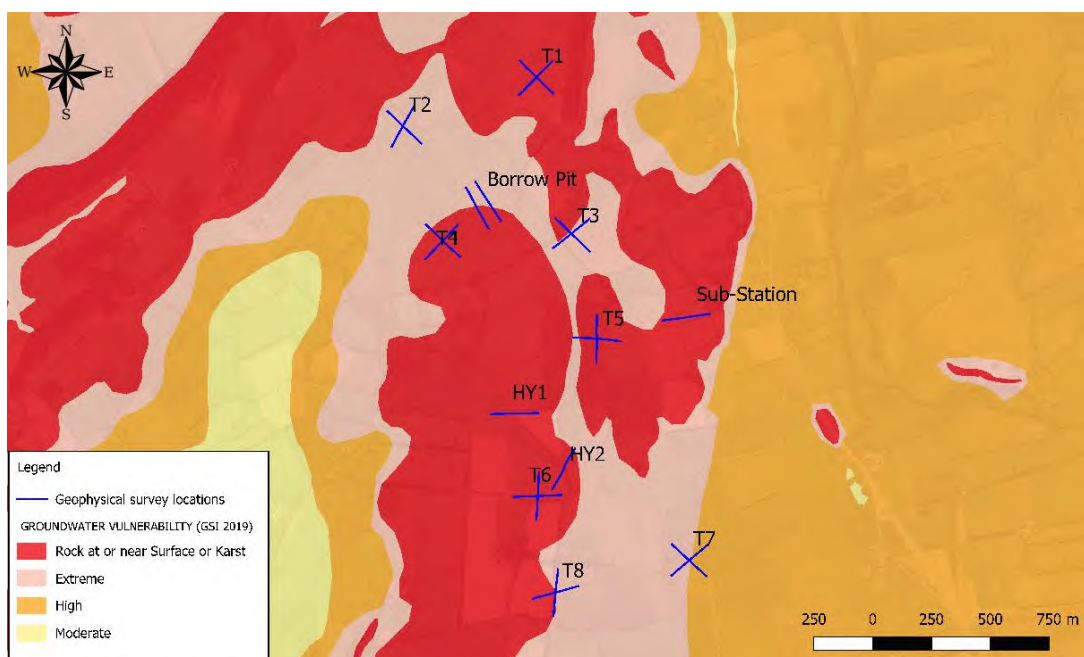
Fig 2.4: Groundwater vulnerability map with geophysical survey locations.

The groundwater vulnerability rating for the site (GSIb, 2019) is classified across the site mainly as 'Extreme' and/or 'Rock at or near surface or karst' while location T7 is classified as 'High' and 'Extreme' (Fig 2.4). Bregaun Flagstone and Killeshin Siltstone formations are classified as 'Poor Aquifer – Bedrock which is generally unproductive except for local zones', while Clogrenan formation is classified as 'Regional important aquifer-Karstified (diffuse)'.

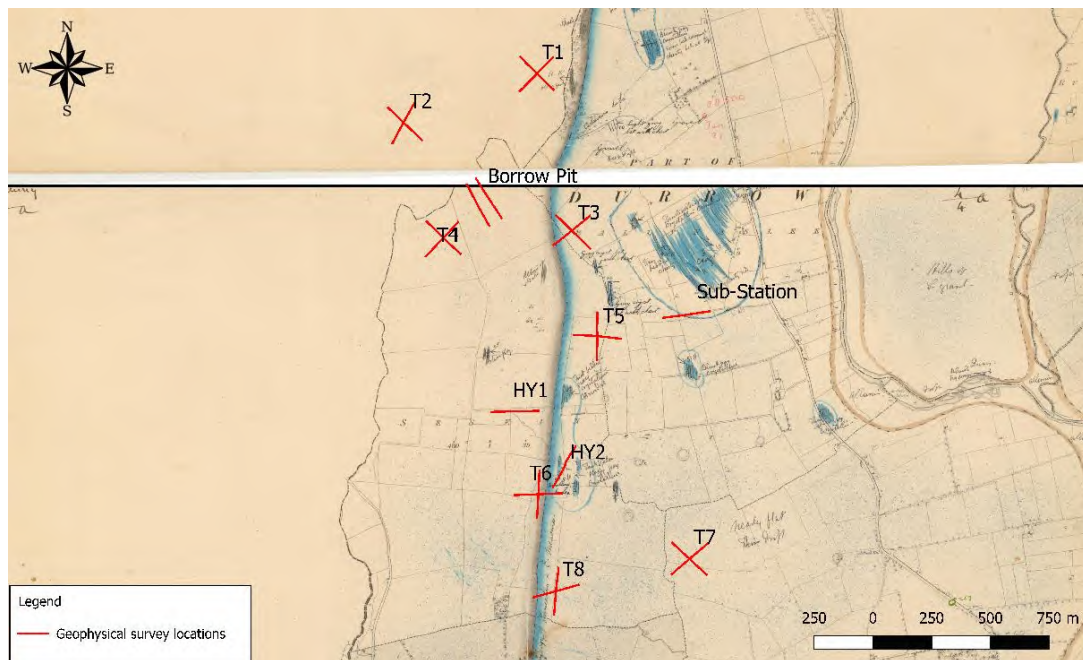
Fig 2.5: Historical 6inch map with geophysical survey locations.

The historical 6-inch sheet for the survey area (Fig. 2.5) delineates key geological features. A south-north dividing line marks a transition from shales on the western side to thick bedded grey crystalline crinoidal limestone at the eastern side. Swallow holes are mapped close to turbine base T6 and profile HY2.

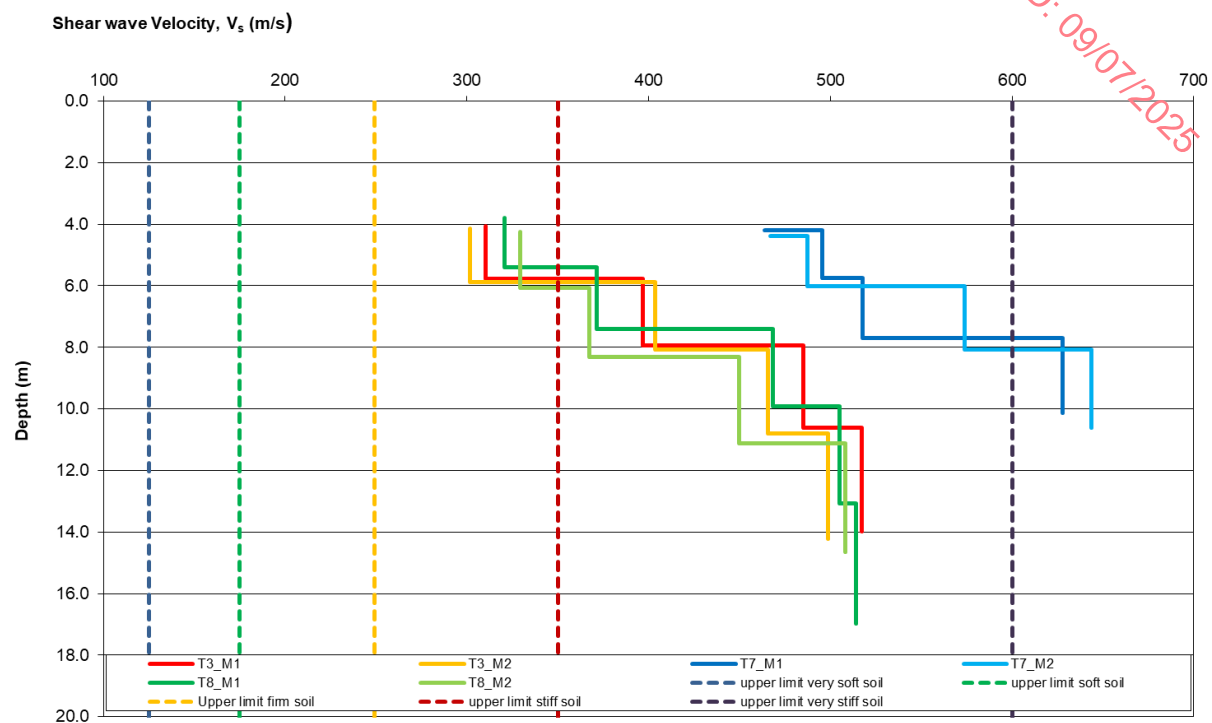
Fig.3.2. Shear wave velocity VS plots for survey locations T3, T7 and T8.

The  $V_s$  values and the derived shear modulus ( $G_{max}$ ) values are display in Figs. 3.2 and 3.3 respectively for turbine bases T3, T7 and T8. The data is also presented in graphical and tabular format for each individual survey location in Appendix D.

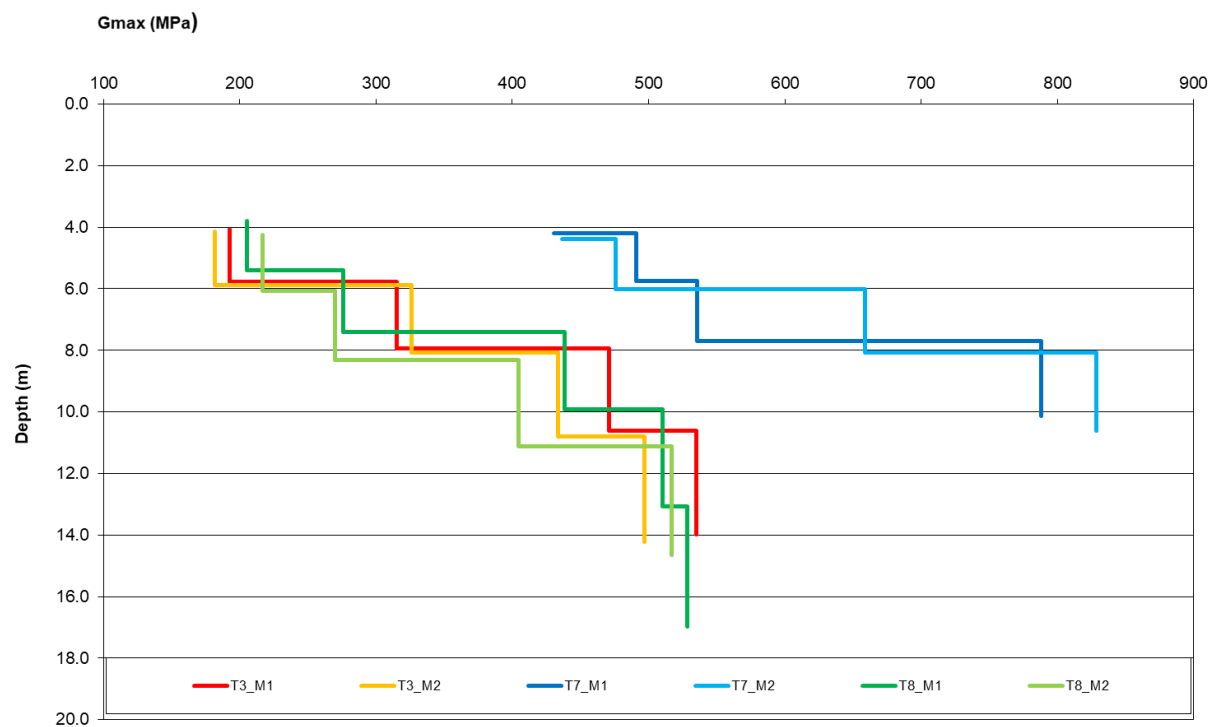
Fig.3.3. Gmax plots for survey locations T3, T7 and T8.

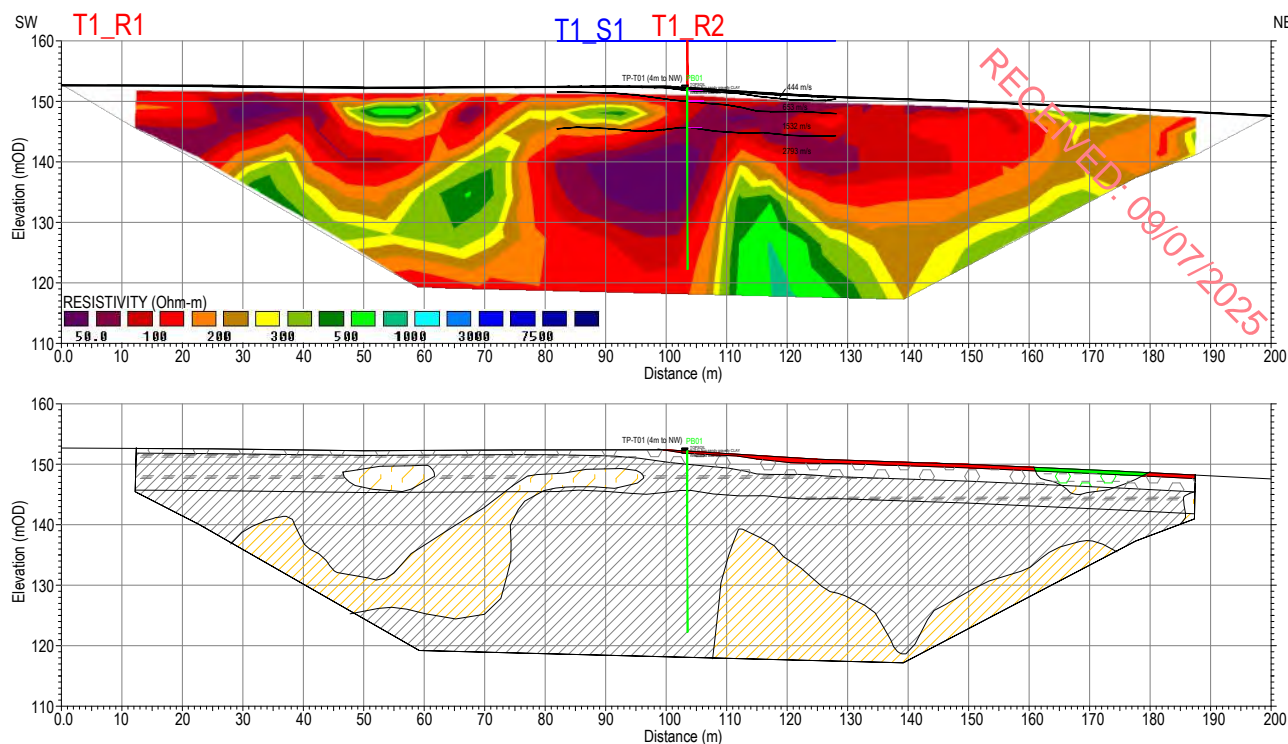
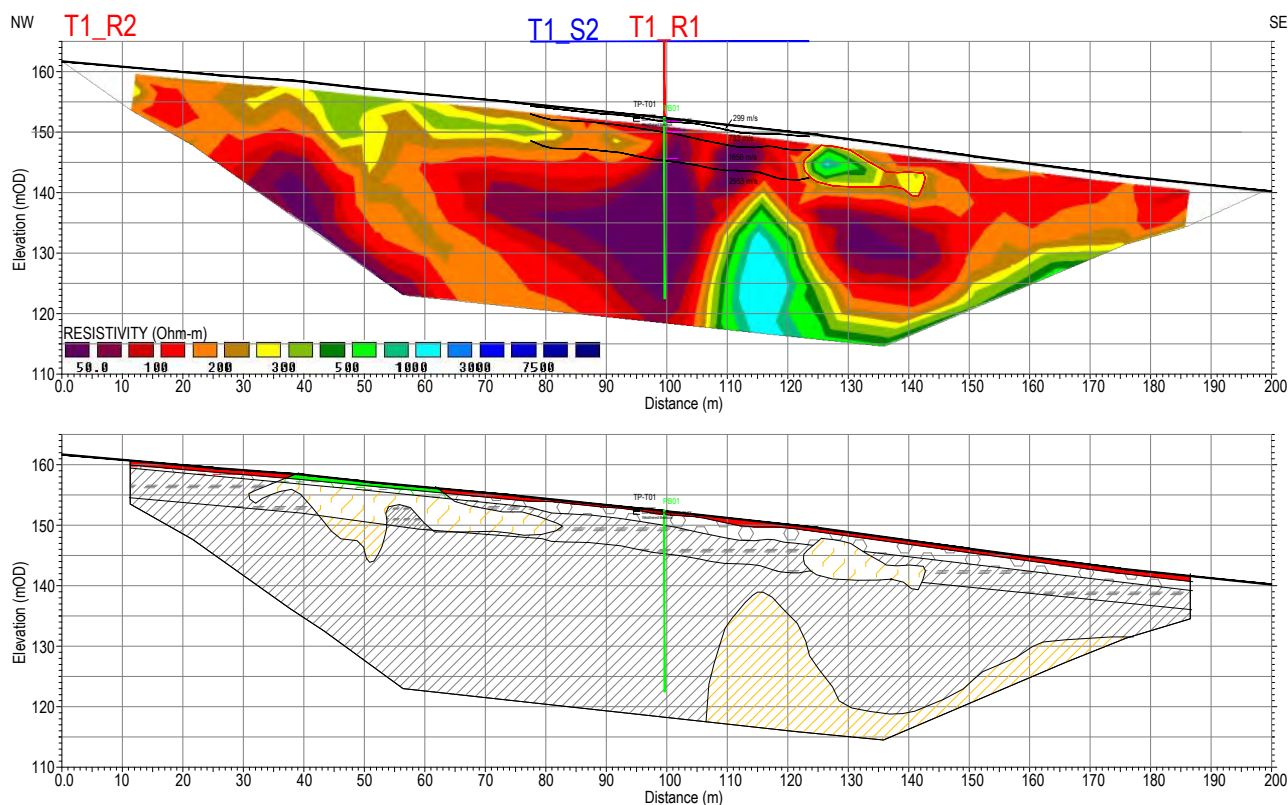
FIG 2: TURBINE BASE T1, RESULTS &amp; INTERPRETATION ERT T1\_R2 &amp; SEISMIC PROFILE T1\_S2

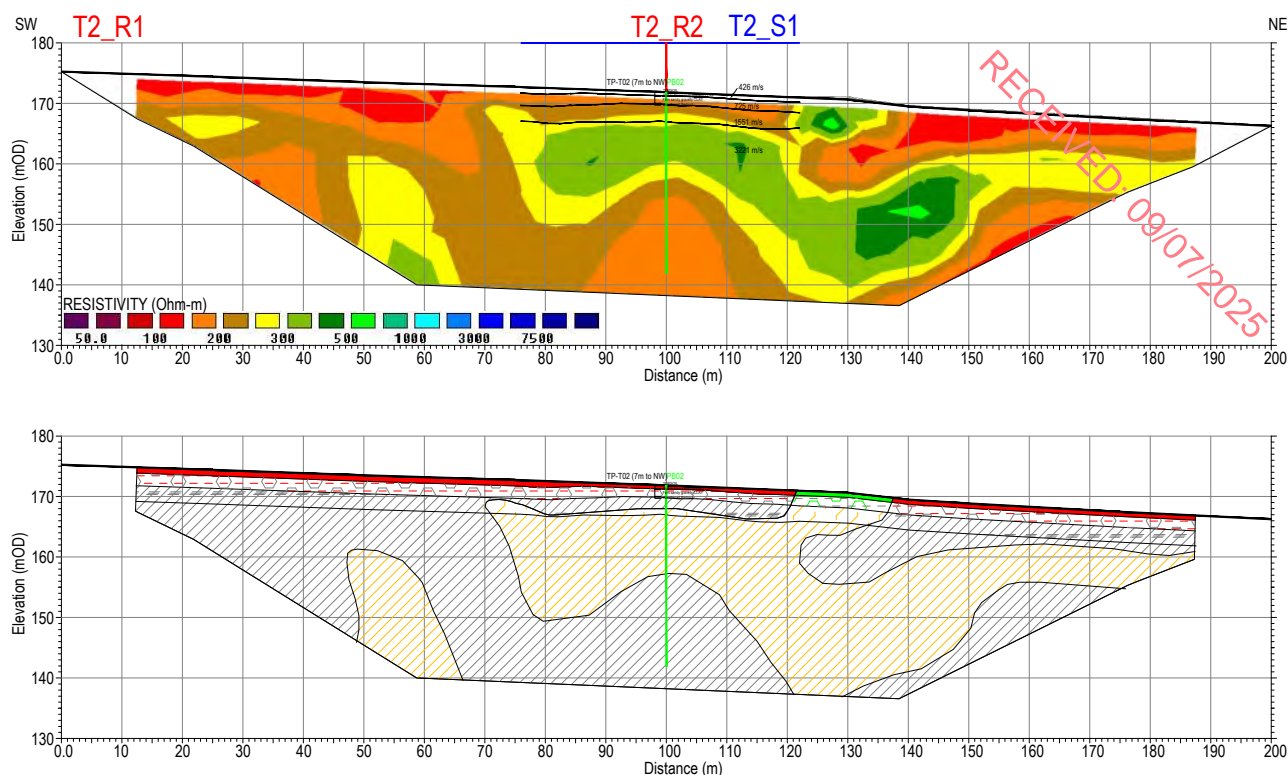
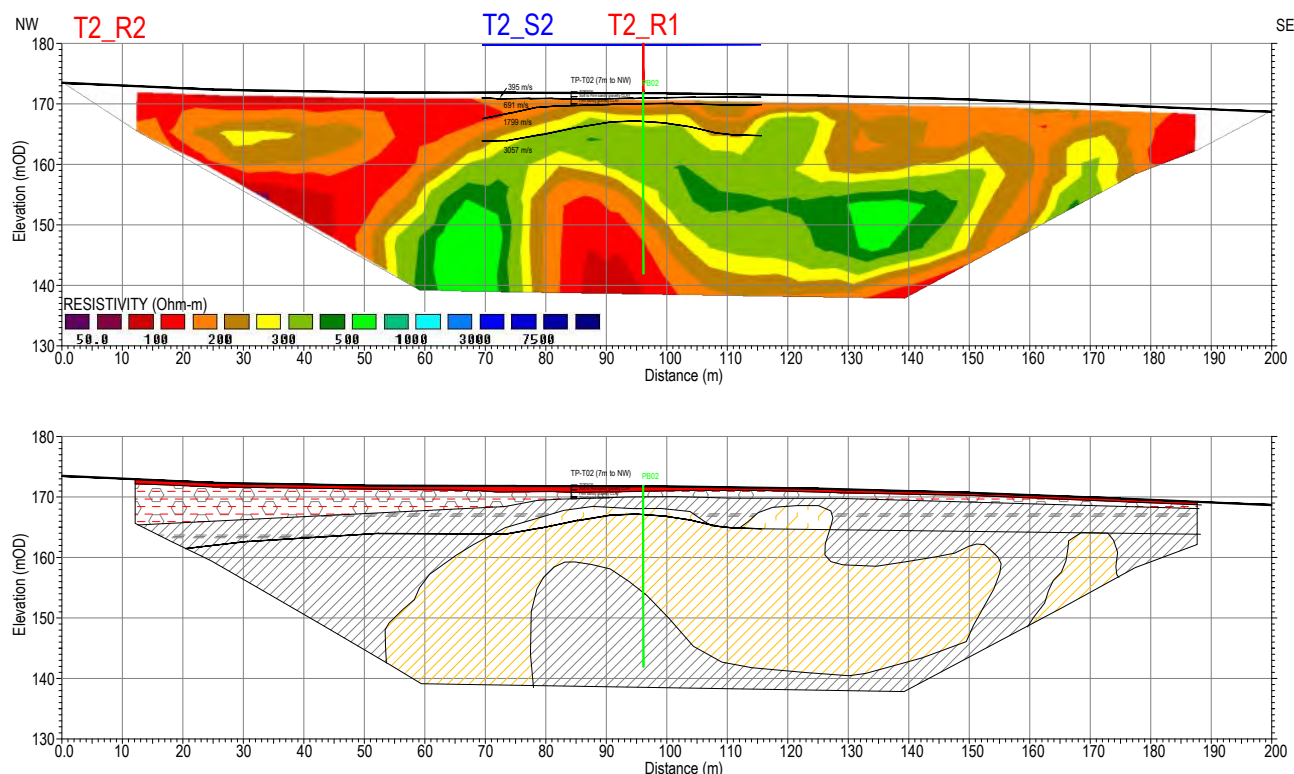
FIG 2: TURBINE BASE T2, RESULTS &amp; INTERPRETATION ERT T2\_R2 &amp; SEISMIC PROFILE T2\_S2

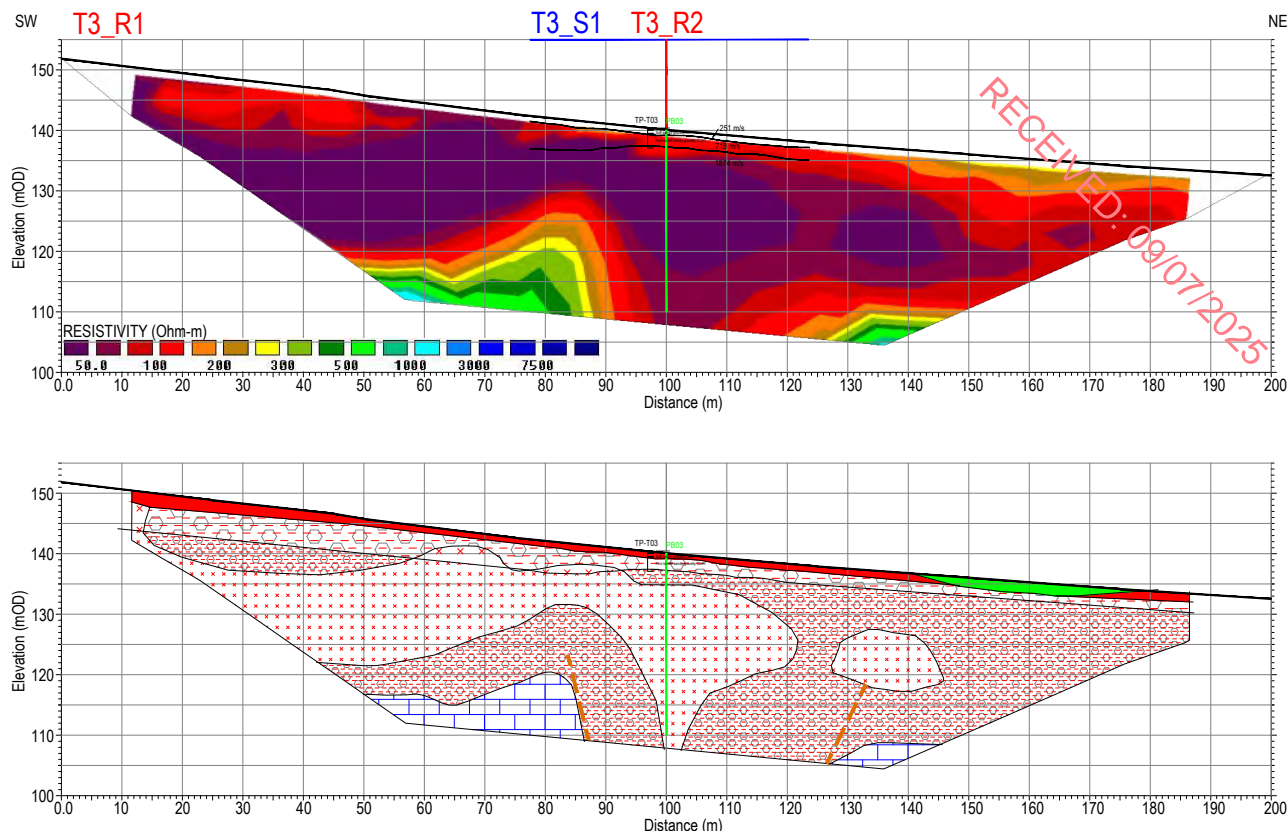
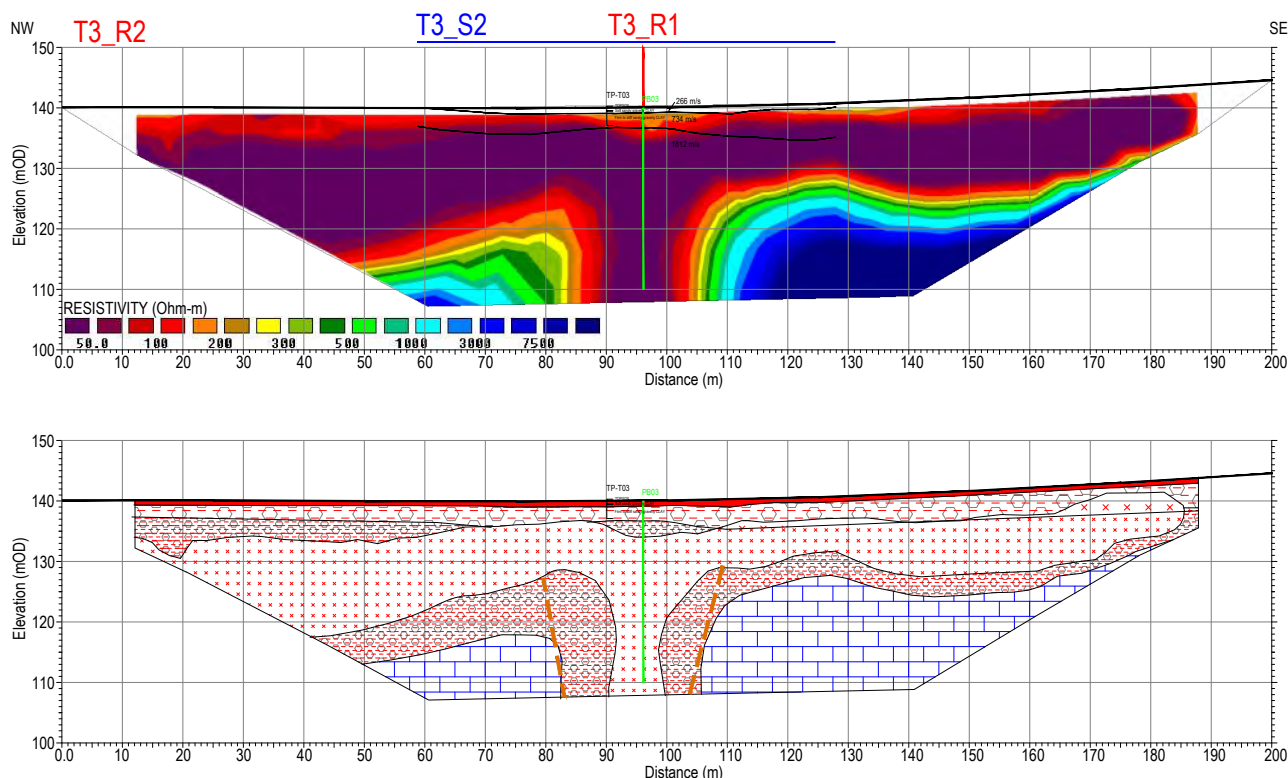
FIG 2: TURBINE BASE T3, RESULTS & INTERPRETATION ERT T3\_R2 & SEISMIC PROFILE T3\_S2

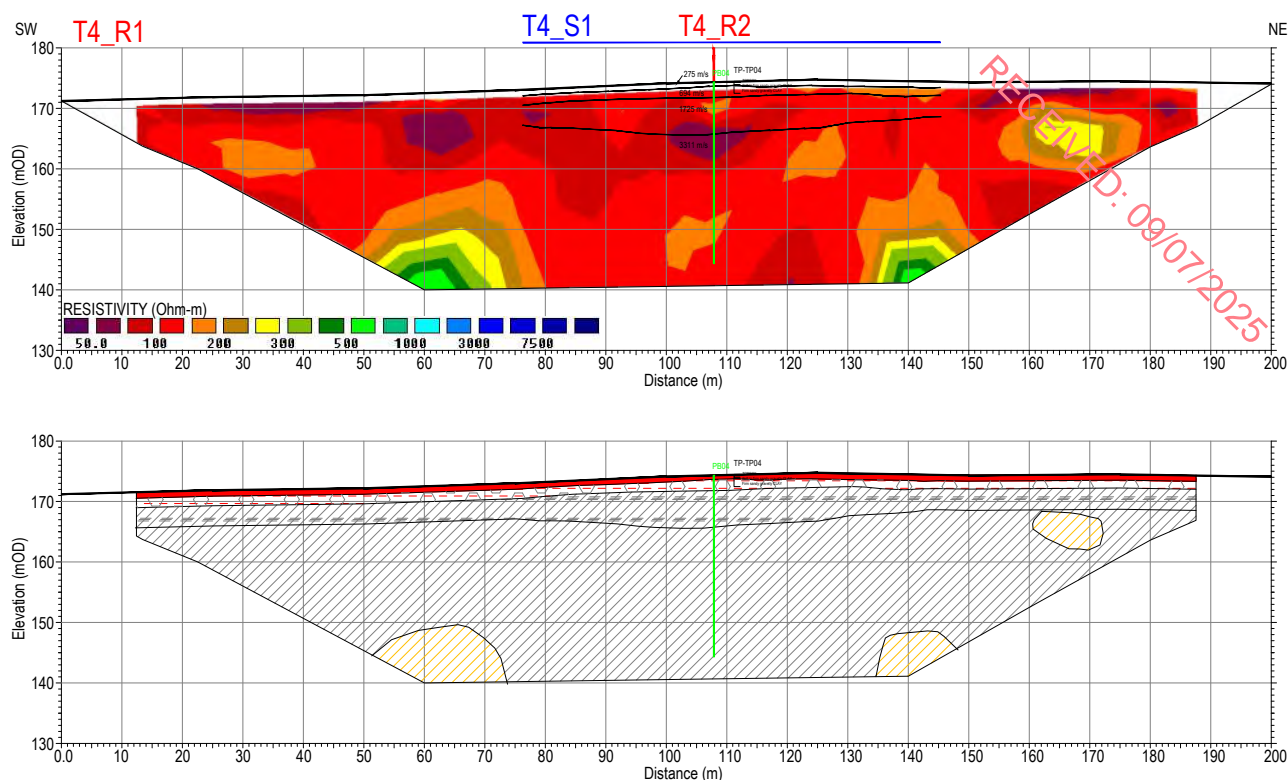
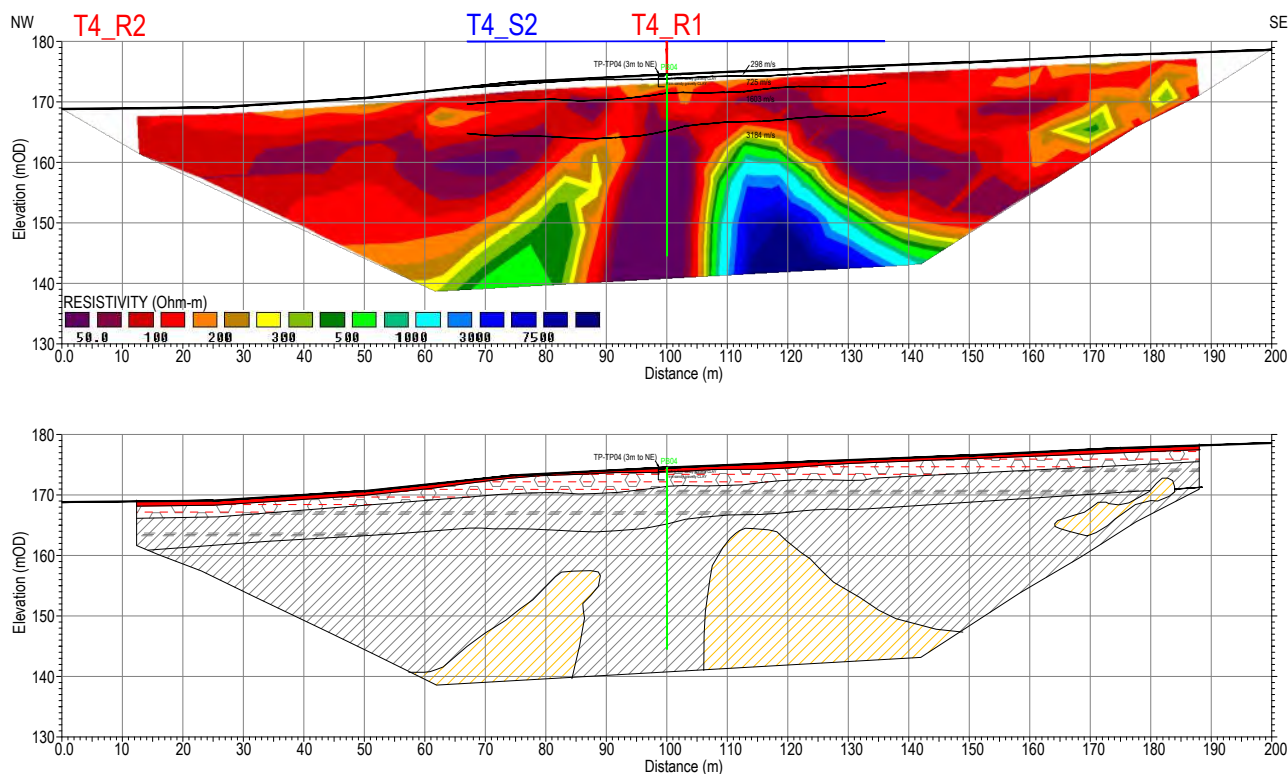
FIG 2: TURBINE BASE T4, RESULTS &amp; INTERPRETATION ERT T4\_R2 &amp; SEISMIC PROFILE T4\_S2

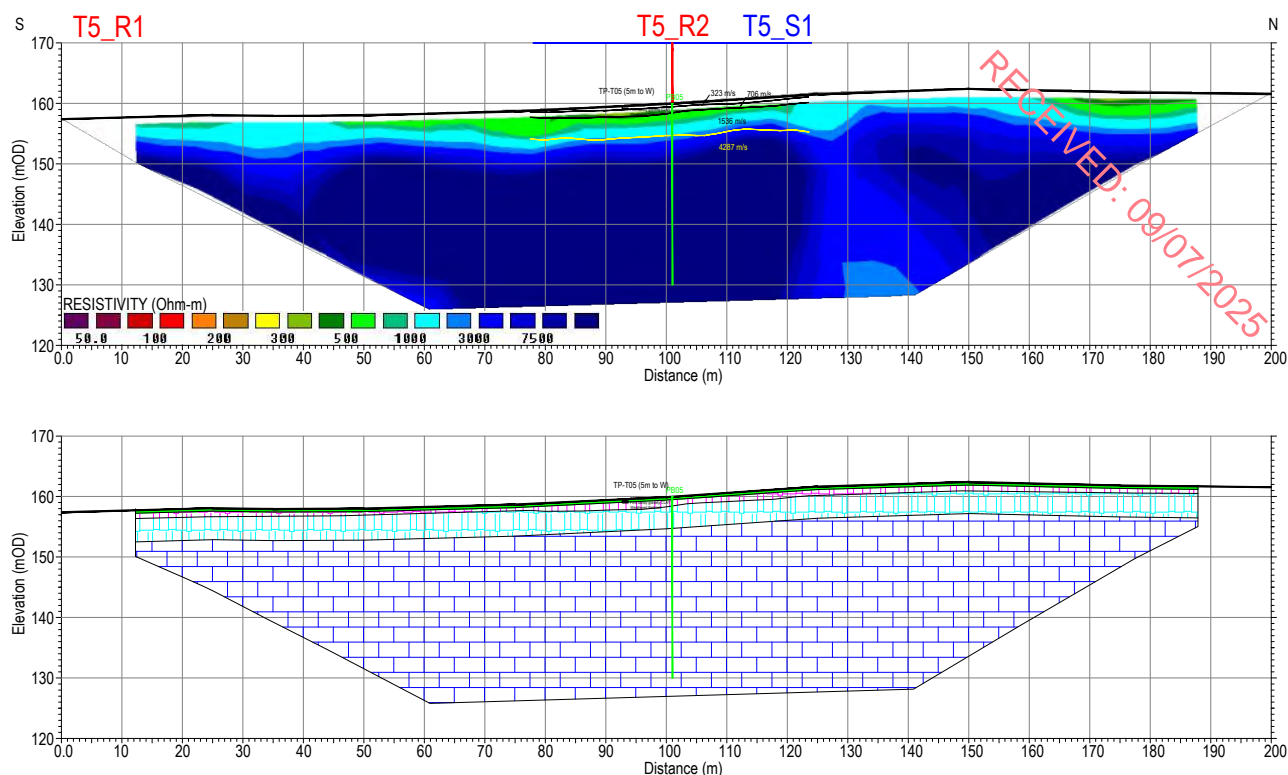
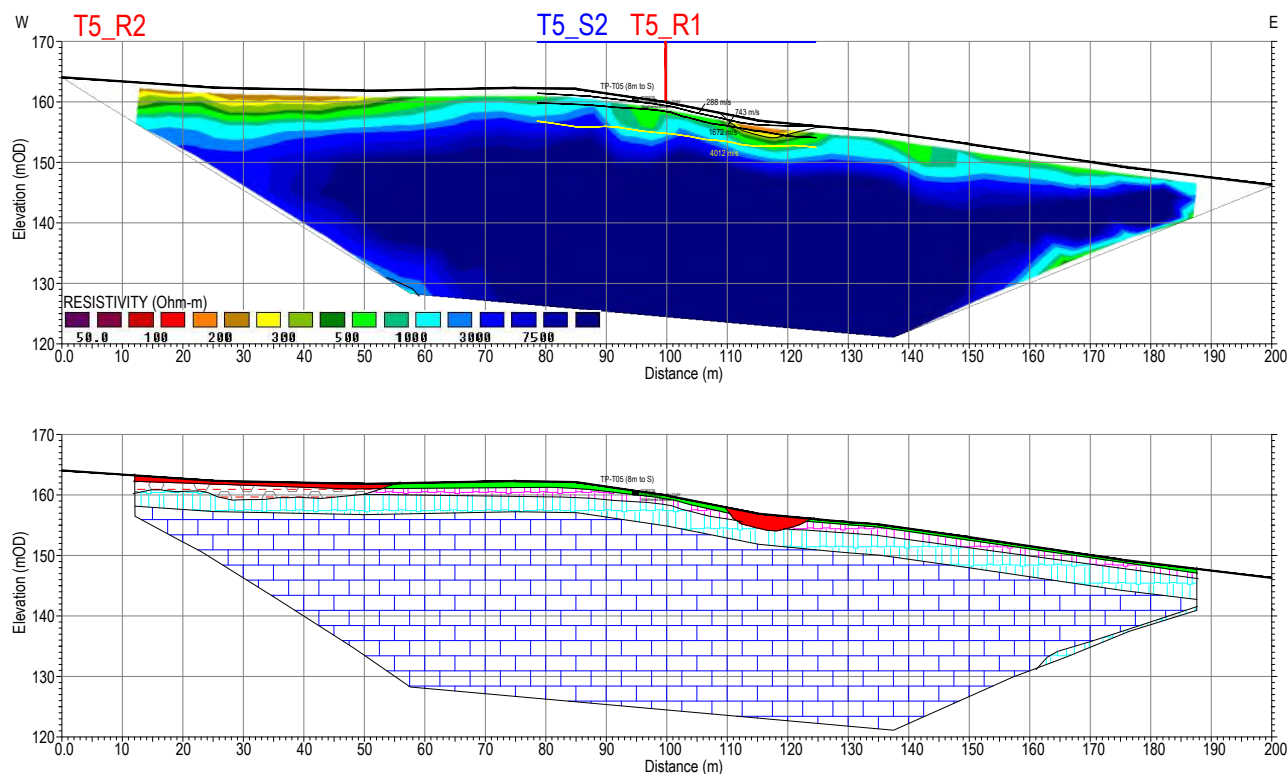
FIG 2: TURBINE BASE T5, RESULTS &amp; INTERPRETATION ERT T5\_R2 &amp; SEISMIC PROFILE T5\_S2
