## Seskin Renewables Wind Farm

## Factual Ground Investigation Report

### January 2025

Project Title	Seskin Renewables Wind Farm
Client	MKO Ireland
Engineer	Hydro-Environmental Services
Project No	14166-09-24
Document Title	Factual Ground Investigation Report

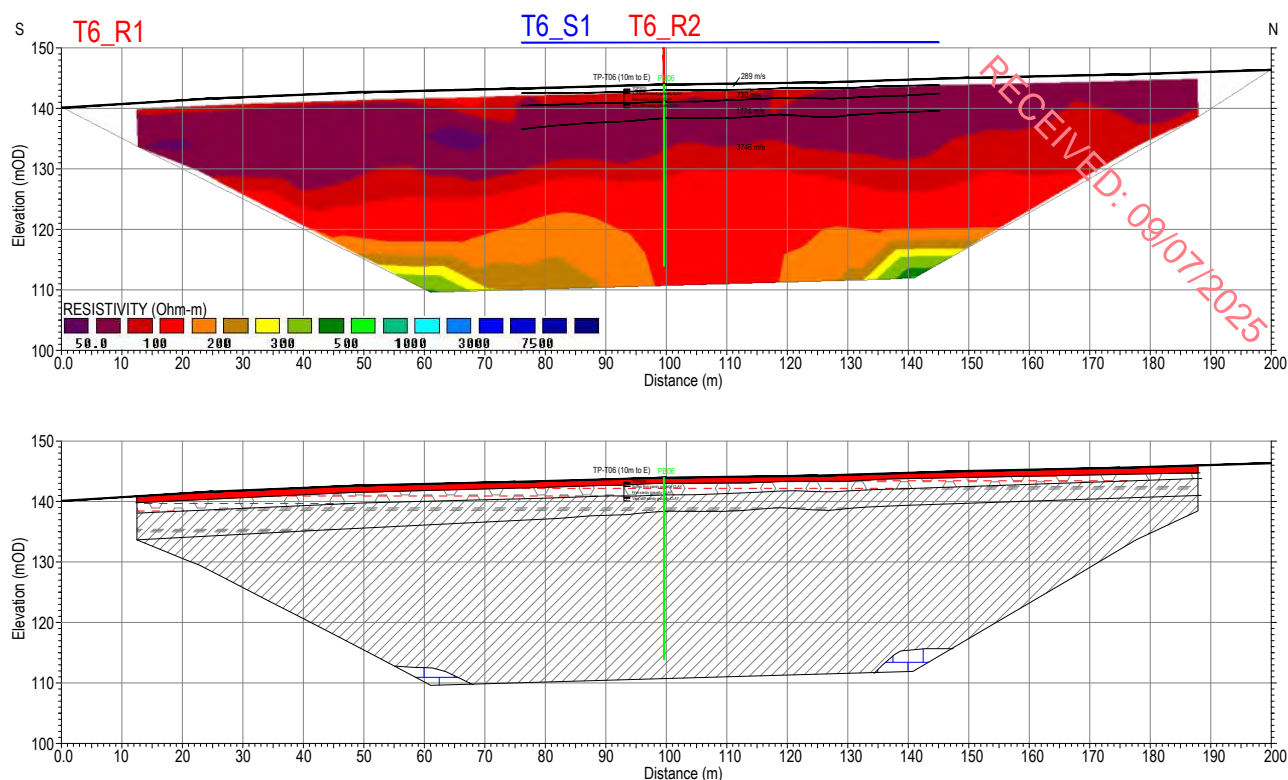
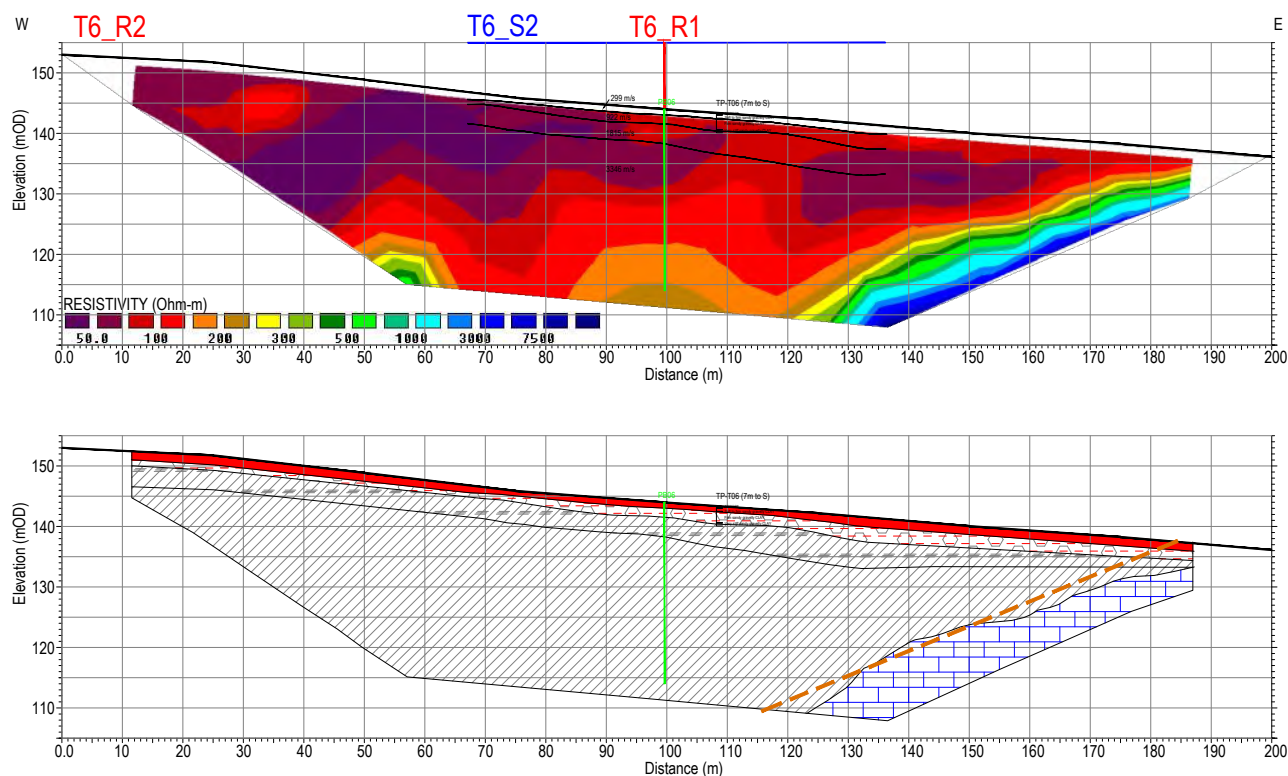
FIG 2: TURBINE BASE T6, RESULTS &amp; INTERPRETATION ERT T6\_R2 &amp; SEISMIC PROFILE T6\_S2

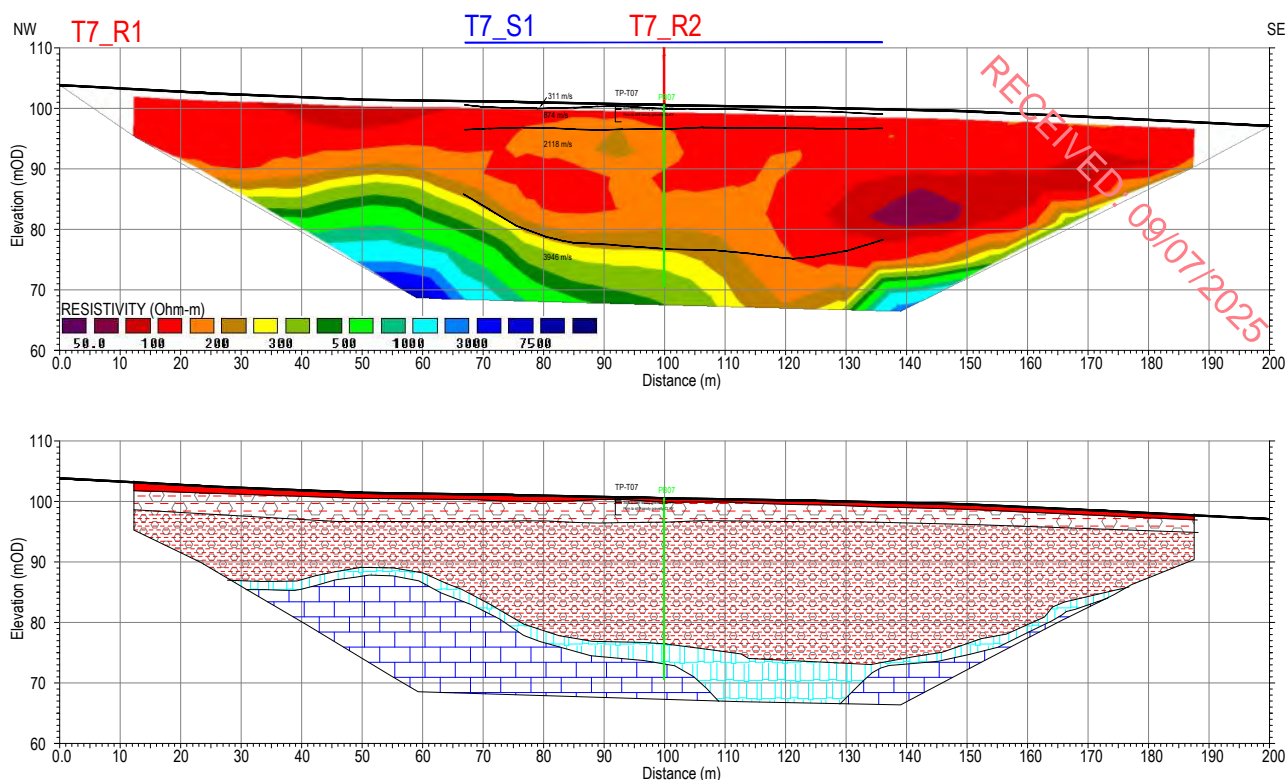
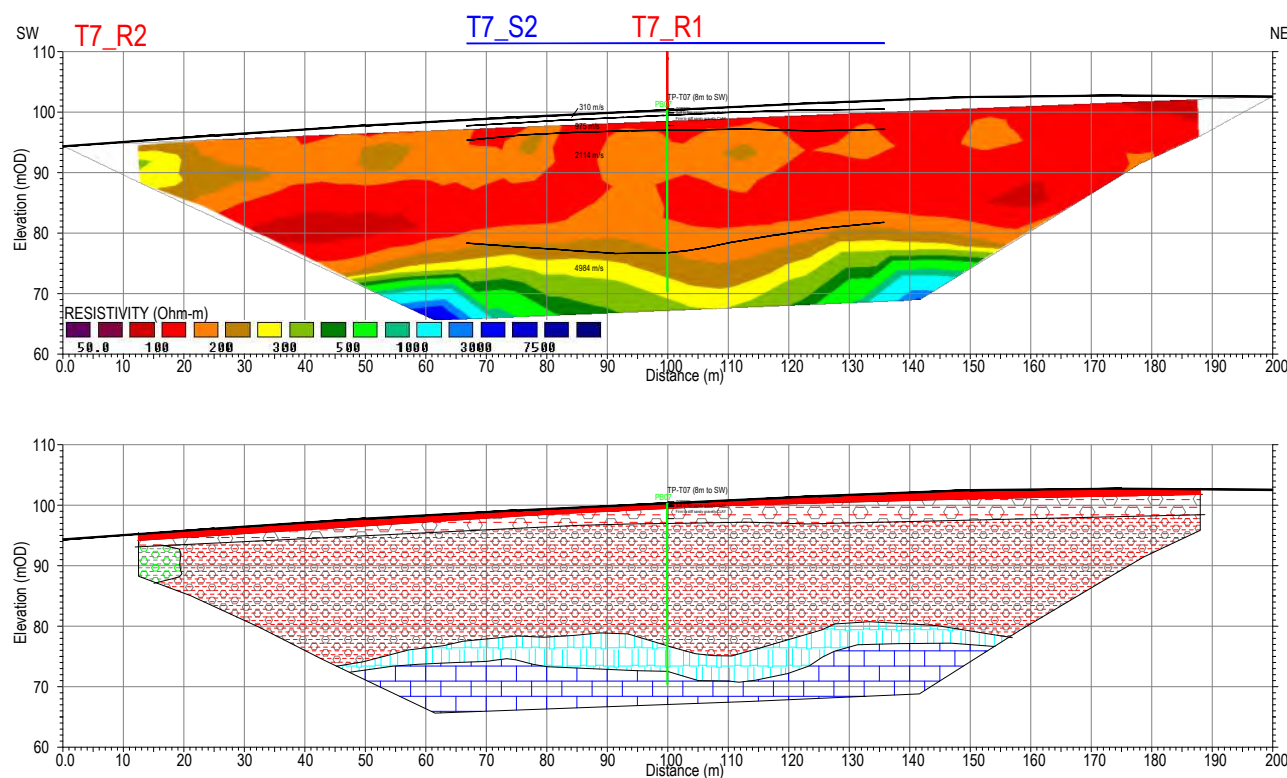
FIG 2: TURBINE BASE T7, RESULTS & INTERPRETATION ERT T7\_R2 & SEISMIC PROFILE T7\_S2

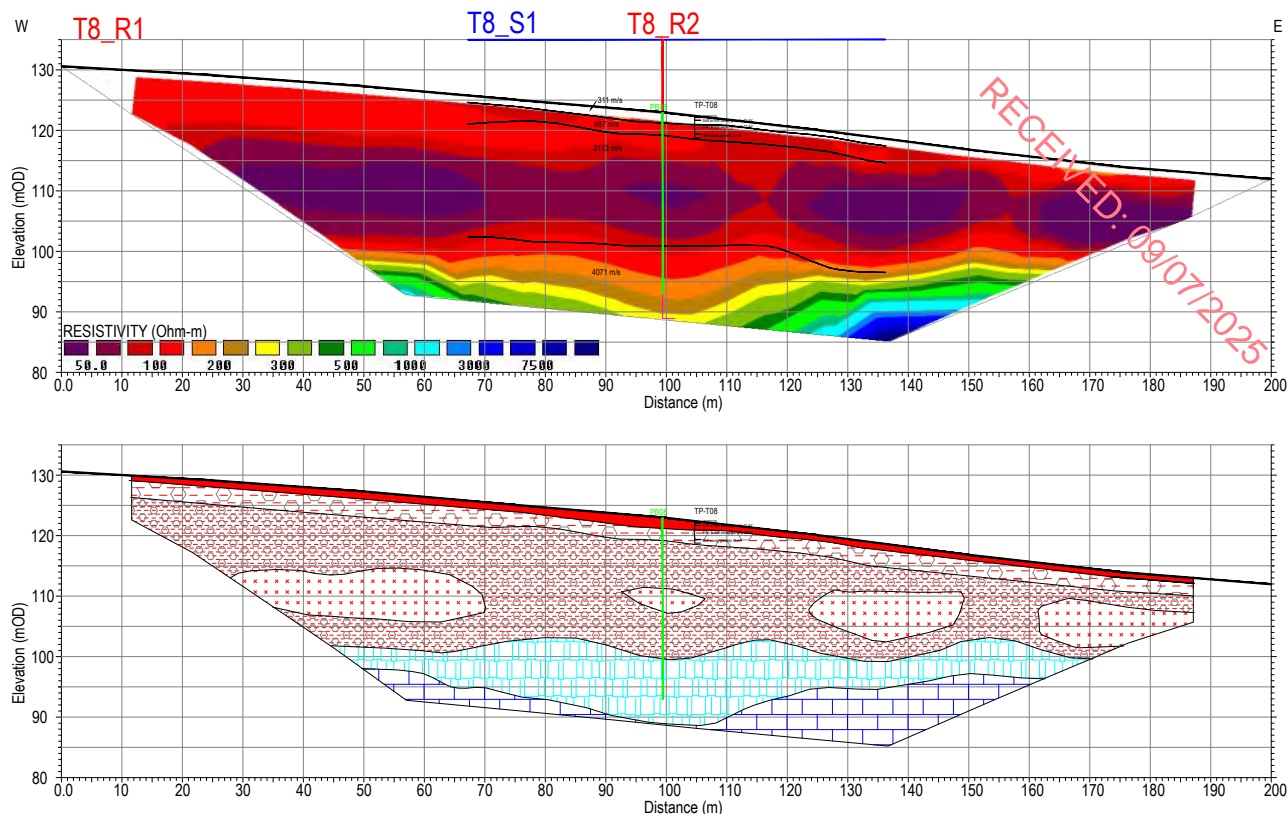
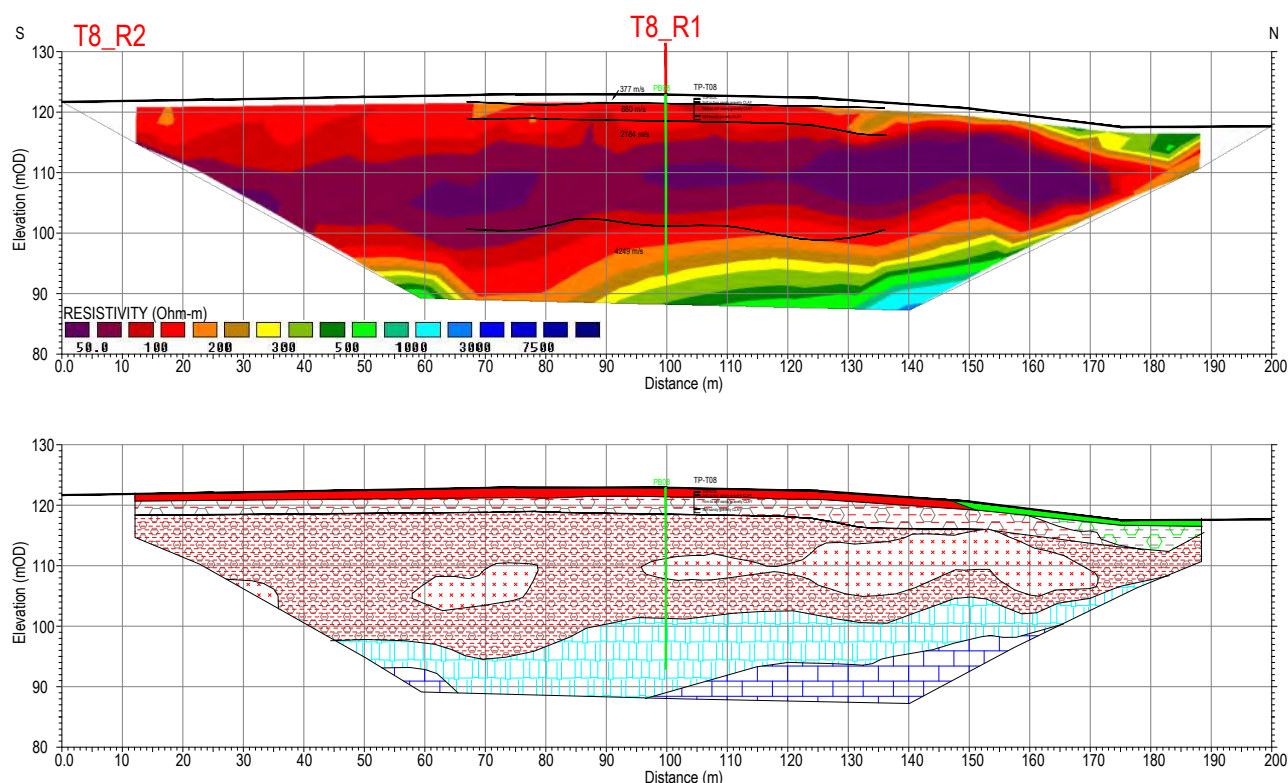
FIG 2: TURBINE BASE T8, RESULTS &amp; INTERPRETATION ERT T8\_R2 &amp; SEISMIC PROFILE T8\_S2

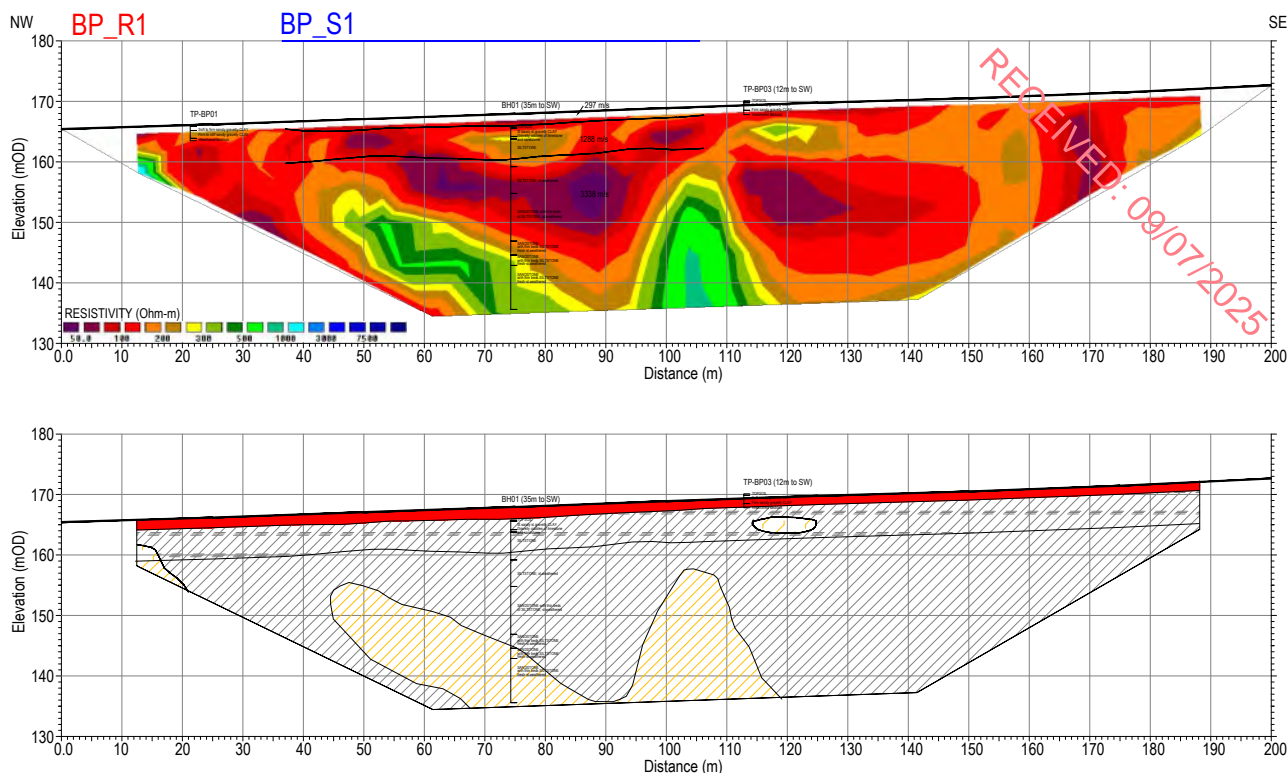
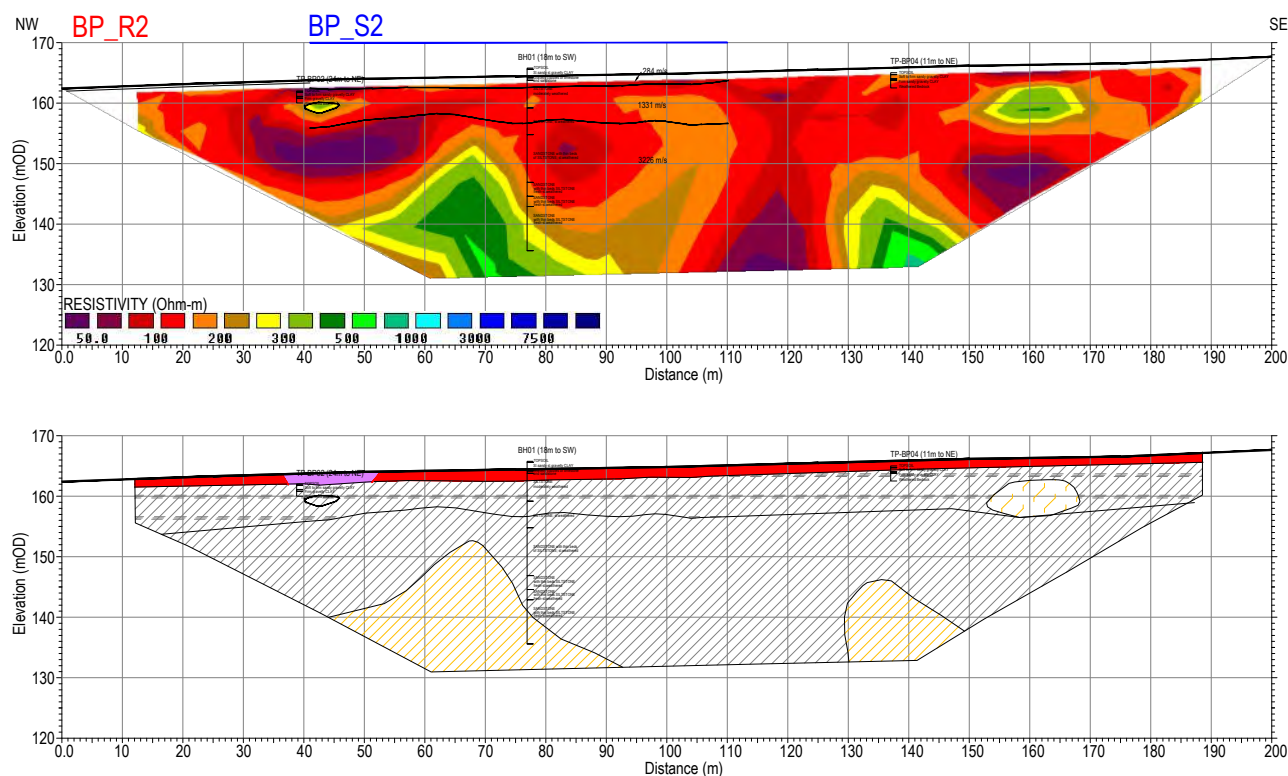
FIG 2: BORROW PIT BP, RESULTS &amp; INTERPRETATION ERT BP\_R2 &amp; SEISMIC PROFILE BP\_S2

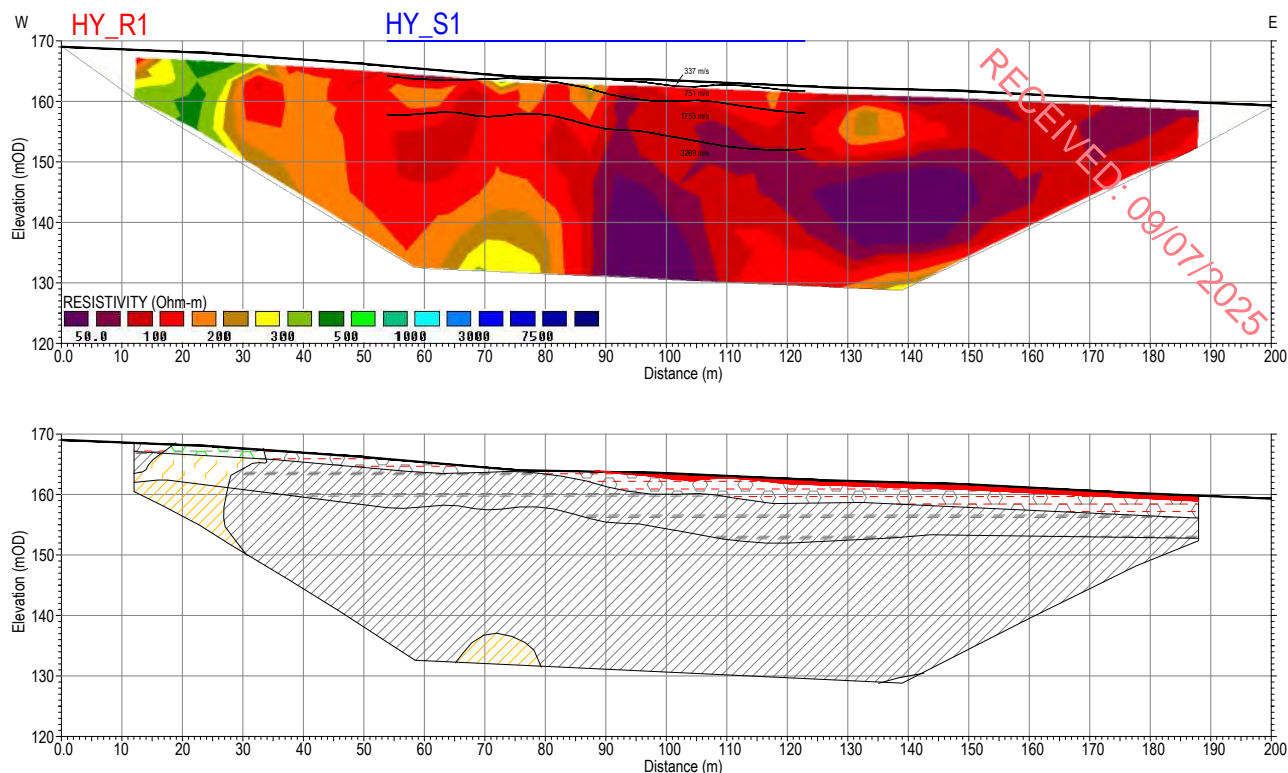
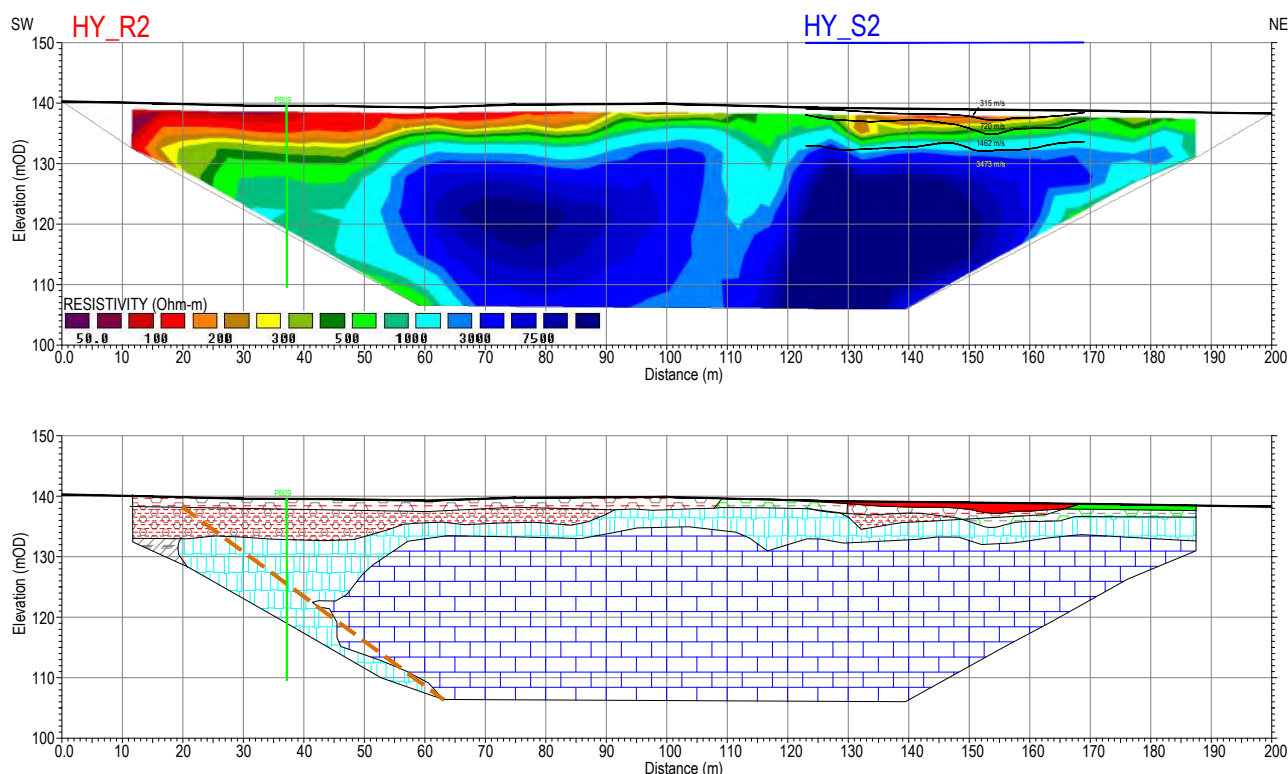
FIG 2: HYDRO LINE HY2, RESULTS & INTERPRETATION ERT HY2\_R2 & SEISMIC PROFILE HY2\_S2

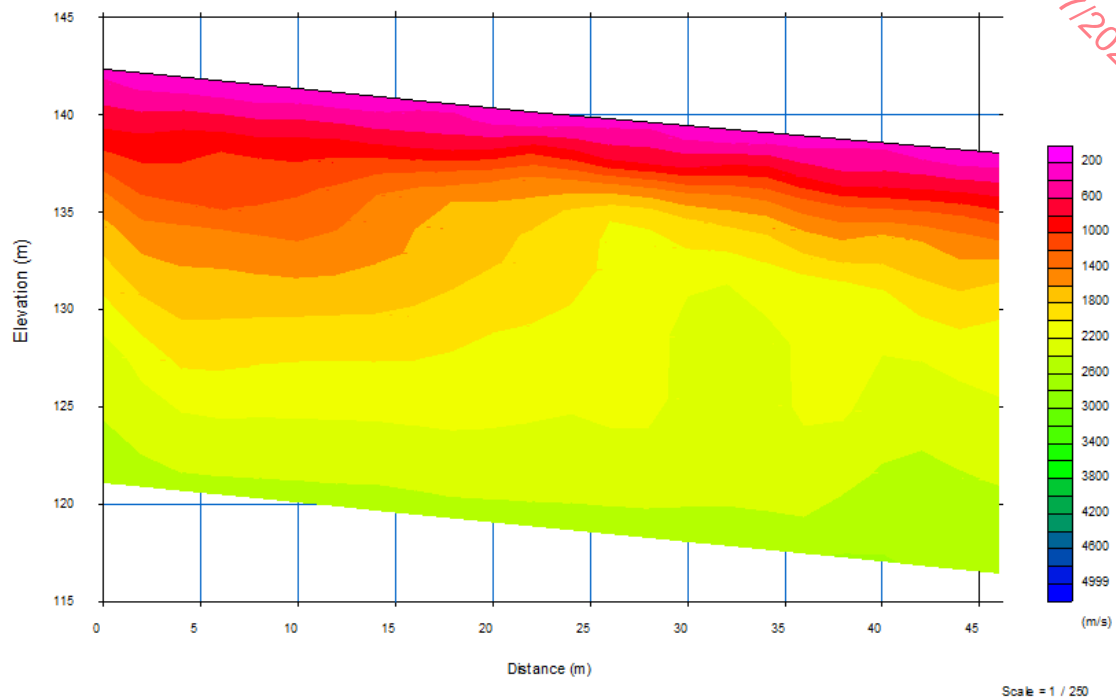
Fig. C.5: Seismic Refraction T3-S1 Tomographic Inversion, plotted SW-NE.

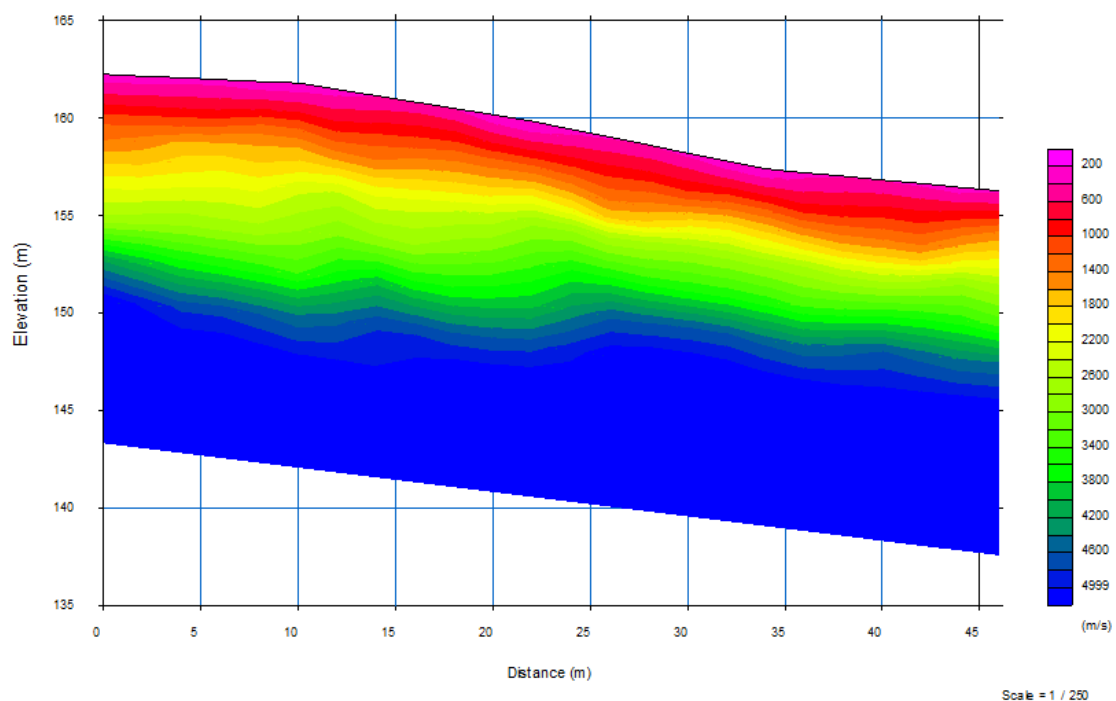
Fig. C.10: Seismic Refraction T5-S2 Tomographic Inversion, plotted W-E.

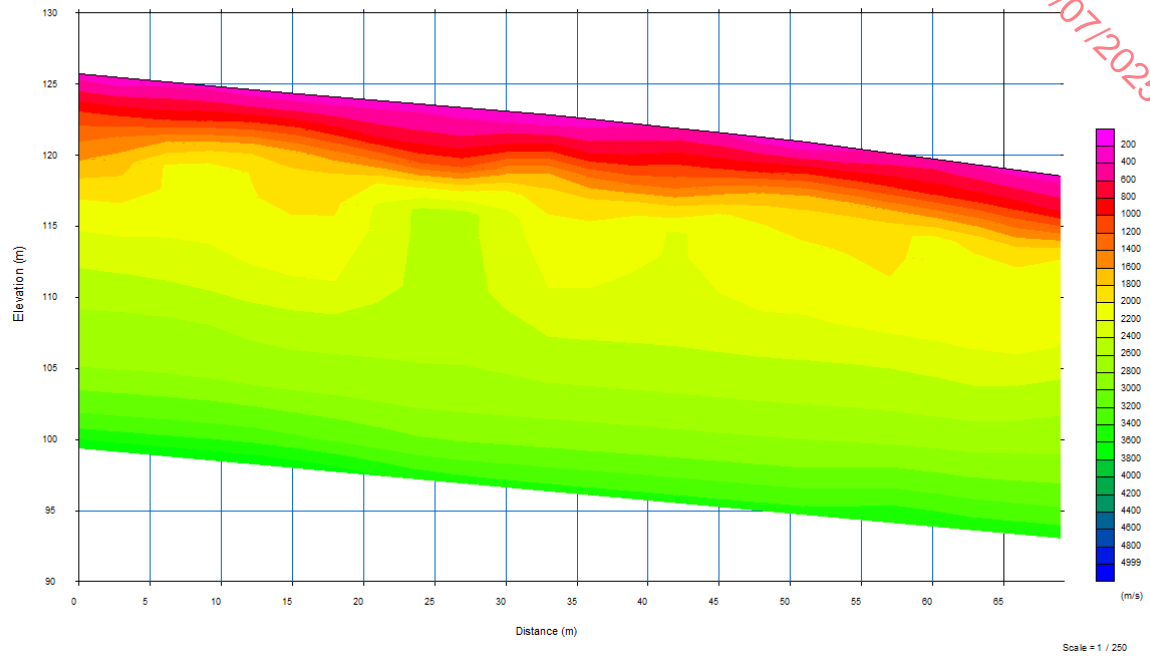
*Fig. C.15: Seismic Refraction T8-S1 Tomographic Inversion, plotted W-E.*

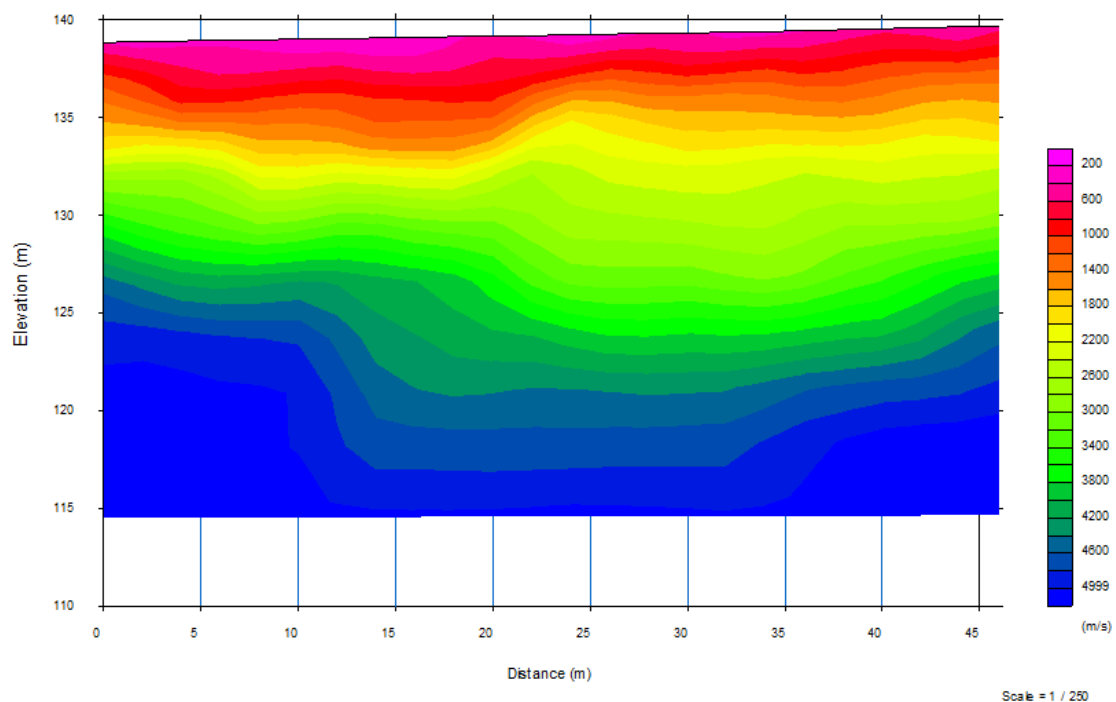
Fig. C.20: Seismic Refraction HY-S2 Tomographic Inversion, plotted NE-SW.

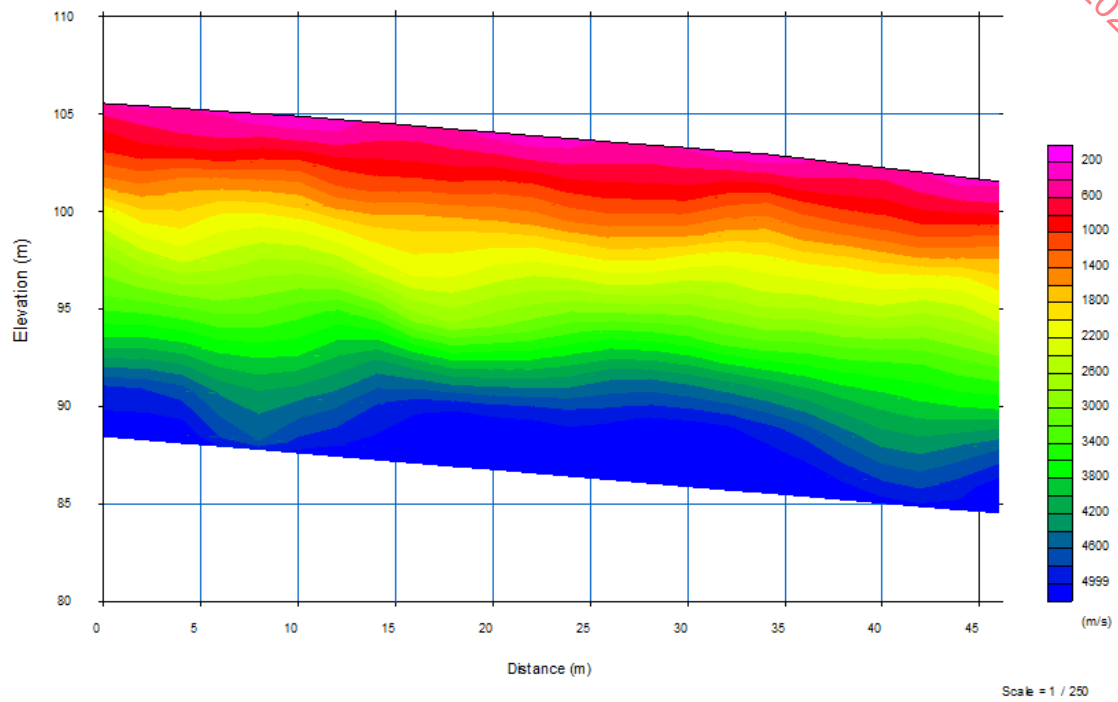
Fig. C.21: Seismic Refraction SS-S1 Tomographic Inversion, plotted W-E.

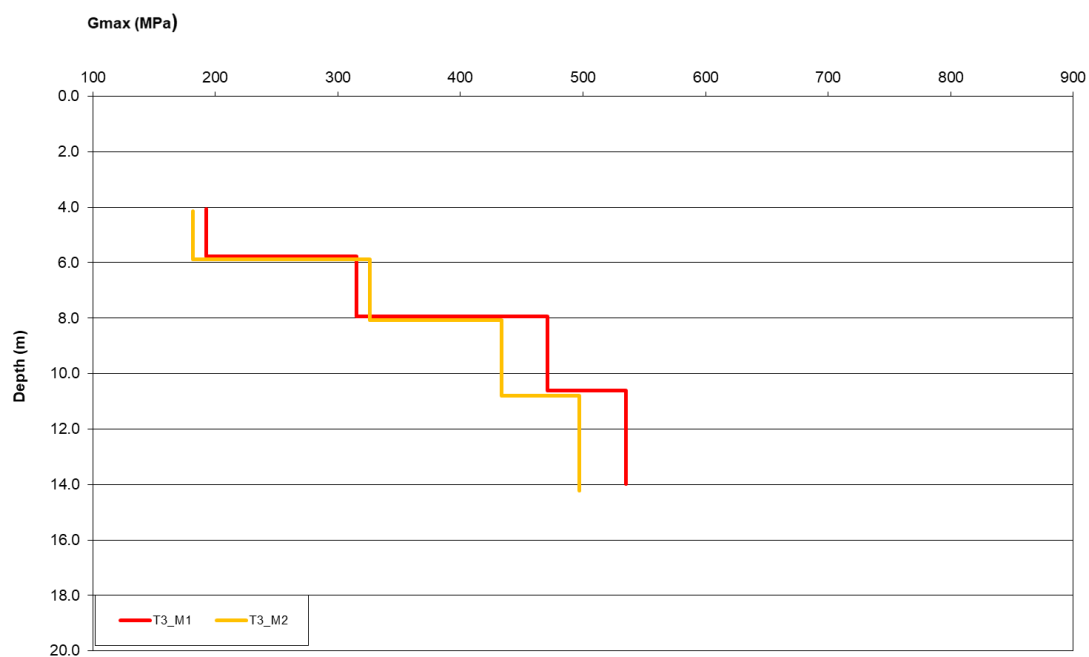
Fig. D.4: Survey location T3 Gmax.

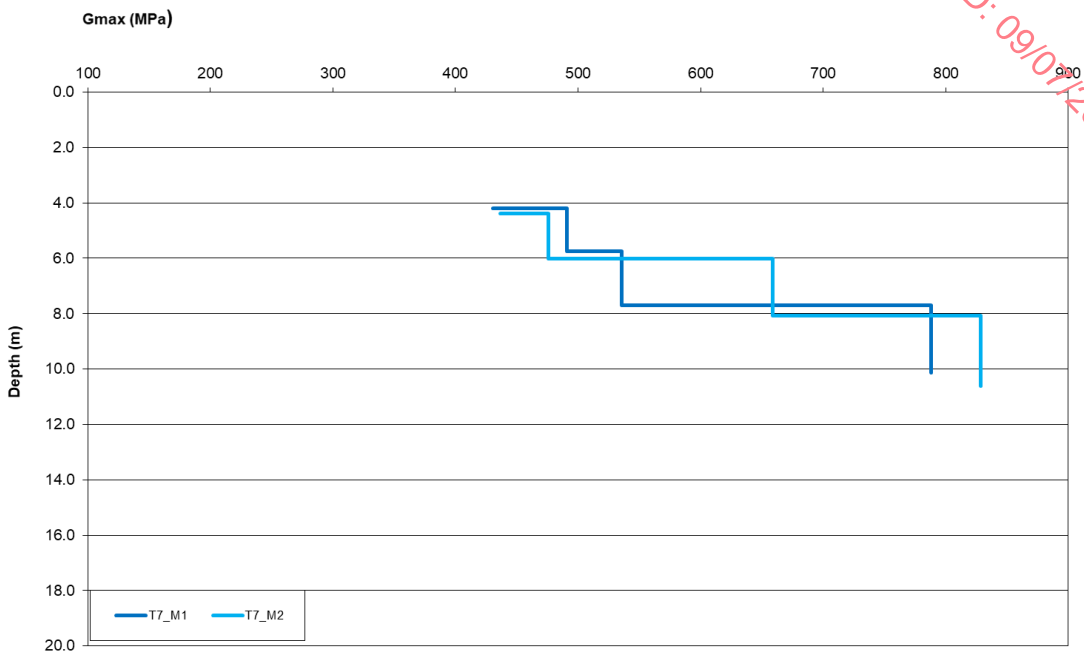
Fig. D.5: Survey location T7 Gmax.

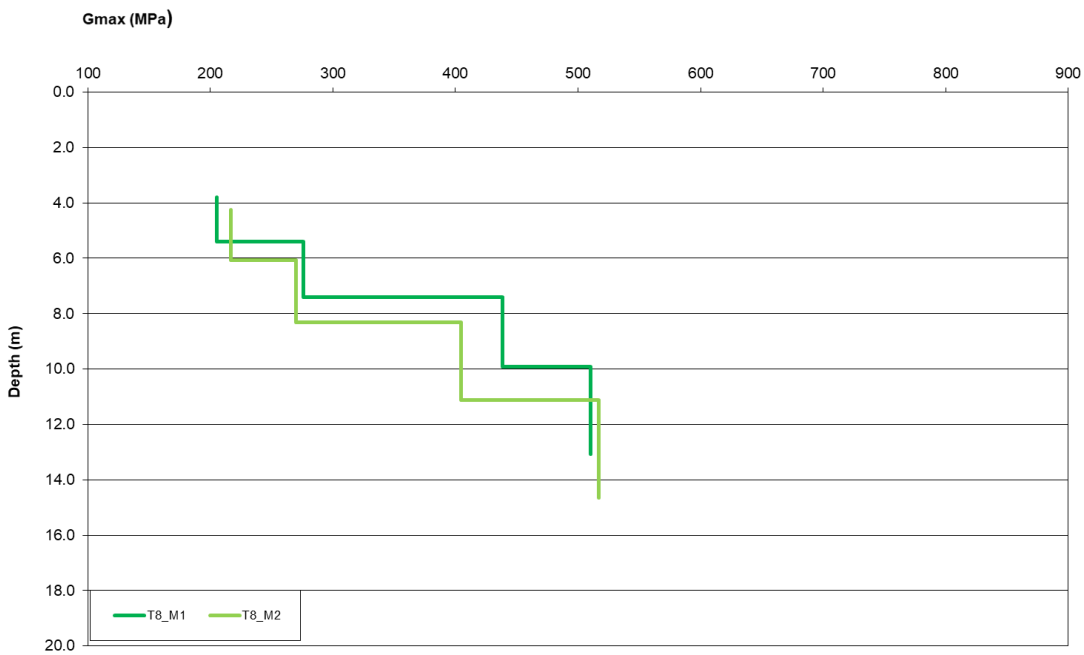
Fig. D.6: Survey location T8 Gmax.
