# **Seskin Renewables Wind Farm**

## Aquatic Baseline Report

Project Title: **Seskin Renewables Wind Farm**

Document Title: **Aquatic Baseline Report**

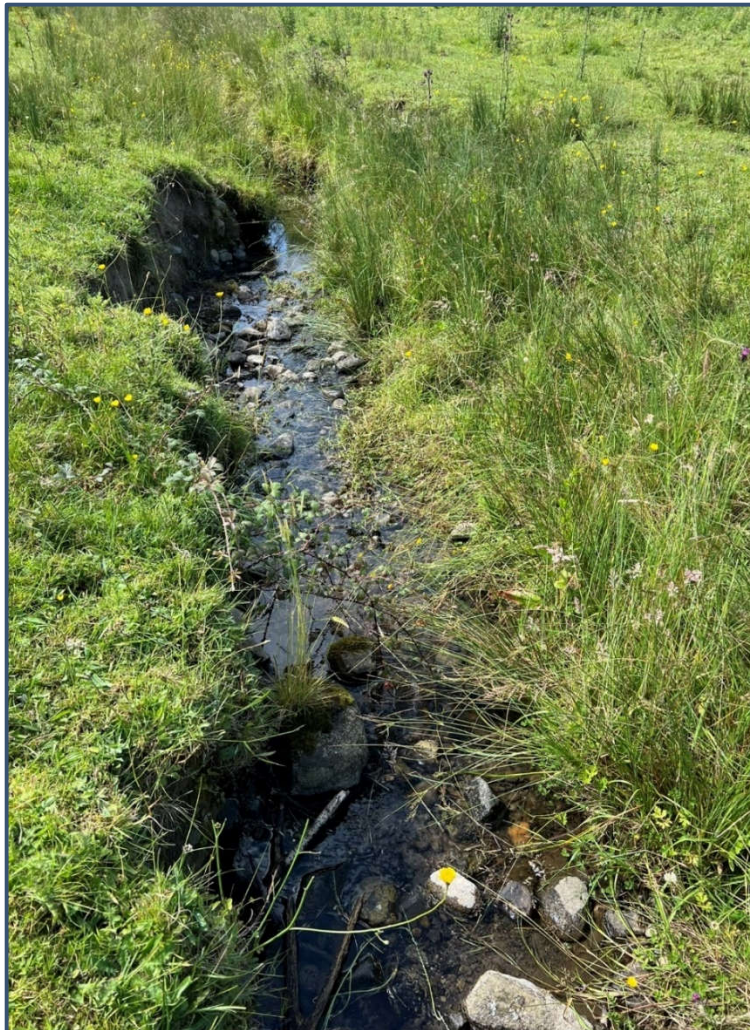
| Properties | Record |
|---|---|
| Substratum Condition | Heavily compacted cobble, loose silt |

European eel and salmonid holding potential were assessed as *Negligible* and *Poor*, respectively given the shallow water depth. Despite the presence of some marginal silt beds, culverts both upstream and downstream of the surveyed stretch of watercourse features may preclude migration of lamprey *spp.* throughout the watercourse, making lamprey ammocoete access to these fine sediment beds unlikely during periods of low flow as observed at the time of survey.

No otter signs were observed at site WF 1. Otter foraging and commuting potential for this localised stretch of the Archerstown watercourse was assessed as *Low* due to small watercourse size, limited prey availability (low fisheries habitat value), surrounding active agricultural land use, absence of riparian cover, a shallowly wetted channel and poor overall connectivity as a result of historic channel modifications and culverting.

Plate 4-1. A representative image of Survey Site WF 1

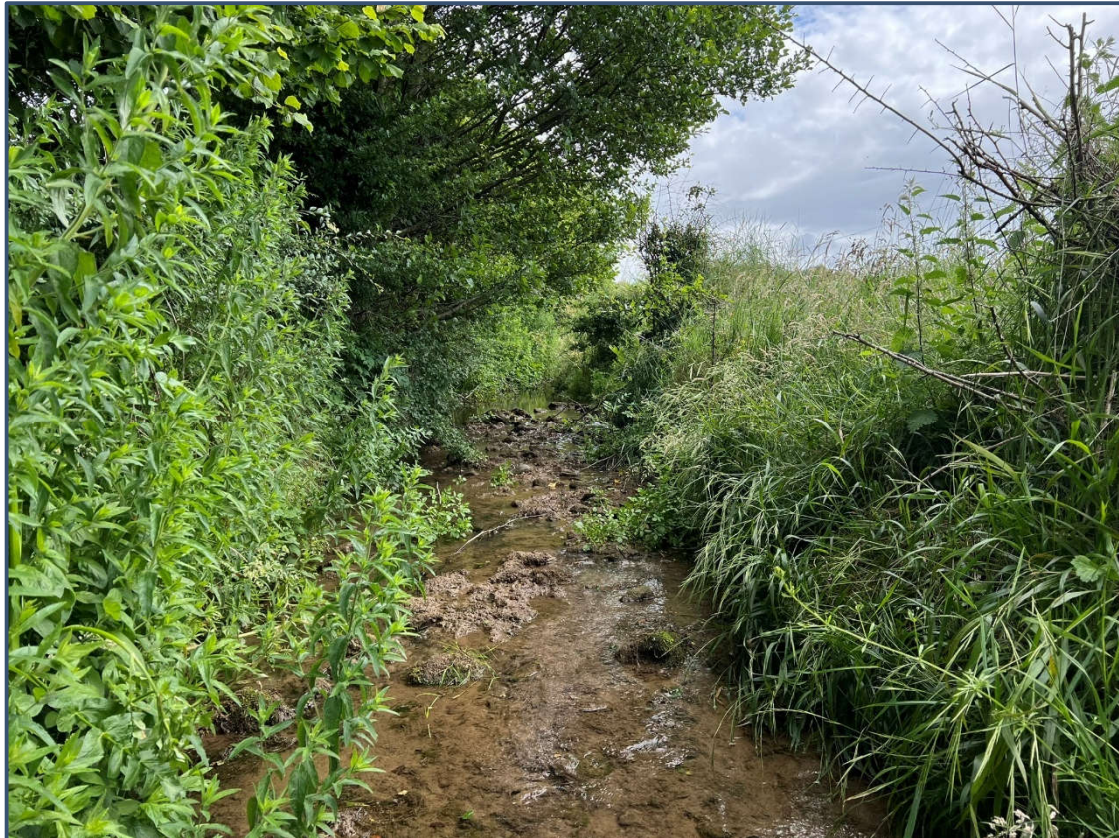
Otter signs in the form of spraint and prints were observed along the survey stretch for site WF 2, indicating that Otter utilise this particular stretch of the Archerstown river.

| Substratum Condition | Semi-compacted boulder and gravel outcrops with localised interstitial gravels and a high degree of siltation. | | | |

Plate 4-2. A representative image of Survey Site WF 2.

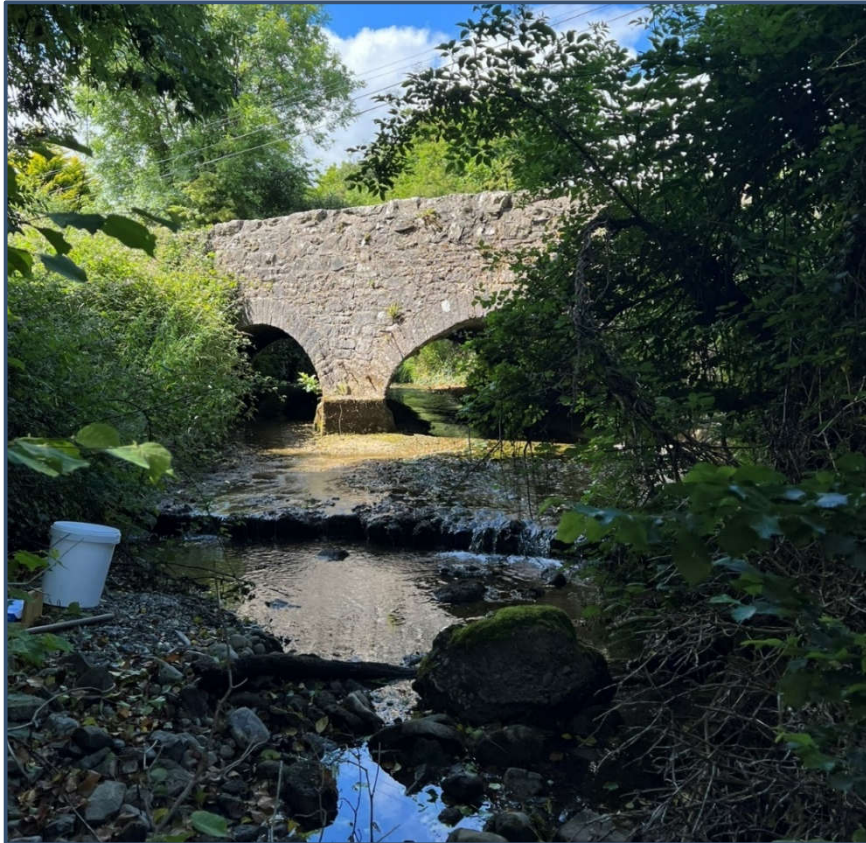
Plate 4-4. A representative image of the upstream extent of Survey Site WF 3.

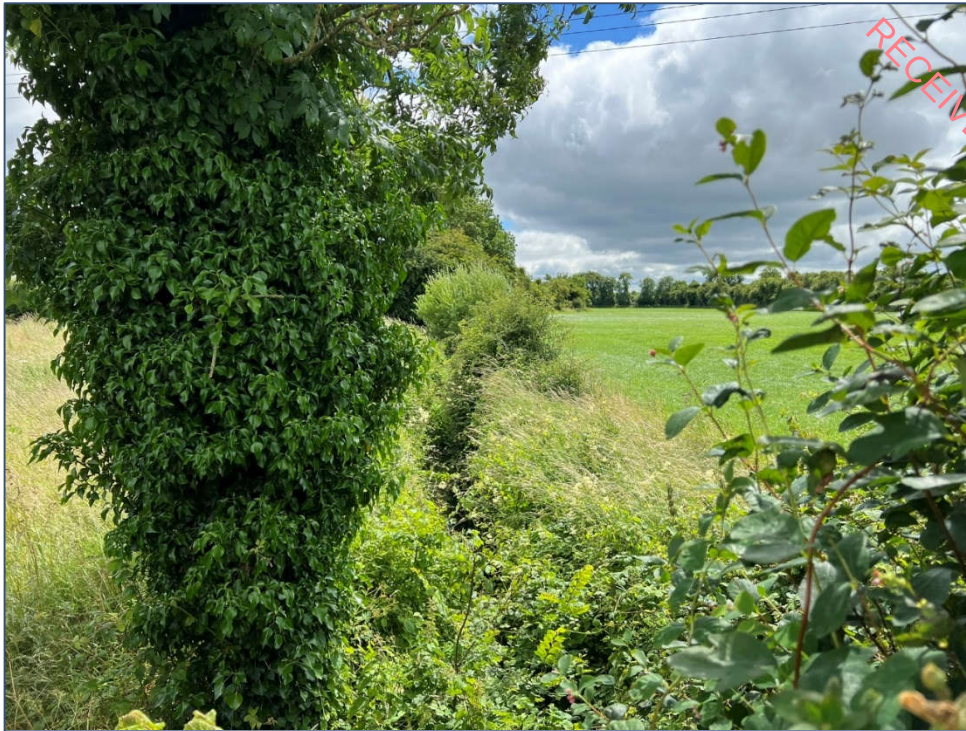
| Properties | Record |
|---|---|
| Substratum Condition | Loose and unconsolidated clay and silt |

Areas of insufficient water depth, no perceptible flow and excessive shading provided *Negligible* spawning, nursery or holding habitat for European eel, salmonid or lamprey species at survey site WF 4. Given the poor-quality channel substrate and barriers to migration in the form of culverting and dense, in-channel vegetation, fisheries habitat downstream of the bridge was also *Poor* and likely only utilised by fish species such as three-spined stickleback (*Gasterosteus aculeatus*). Due to a lack of sufficiently wetted channel, kick-sampling and electrofishing could not take place at survey site WF 4.

No Otter signs were observed at site WF 4. Given low fisheries value and barriers to migration arising from the highly modified nature of this stretch of watercourse, Otter foraging and commuting habitat were assessed as locally *Poor*, with this stretch of watercourse likely only used opportunistically for commuting in periods of higher flow.

Plate 4-5. A representative image of an inaccessible stretch of Survey site WF 4, downstream of the culvert.

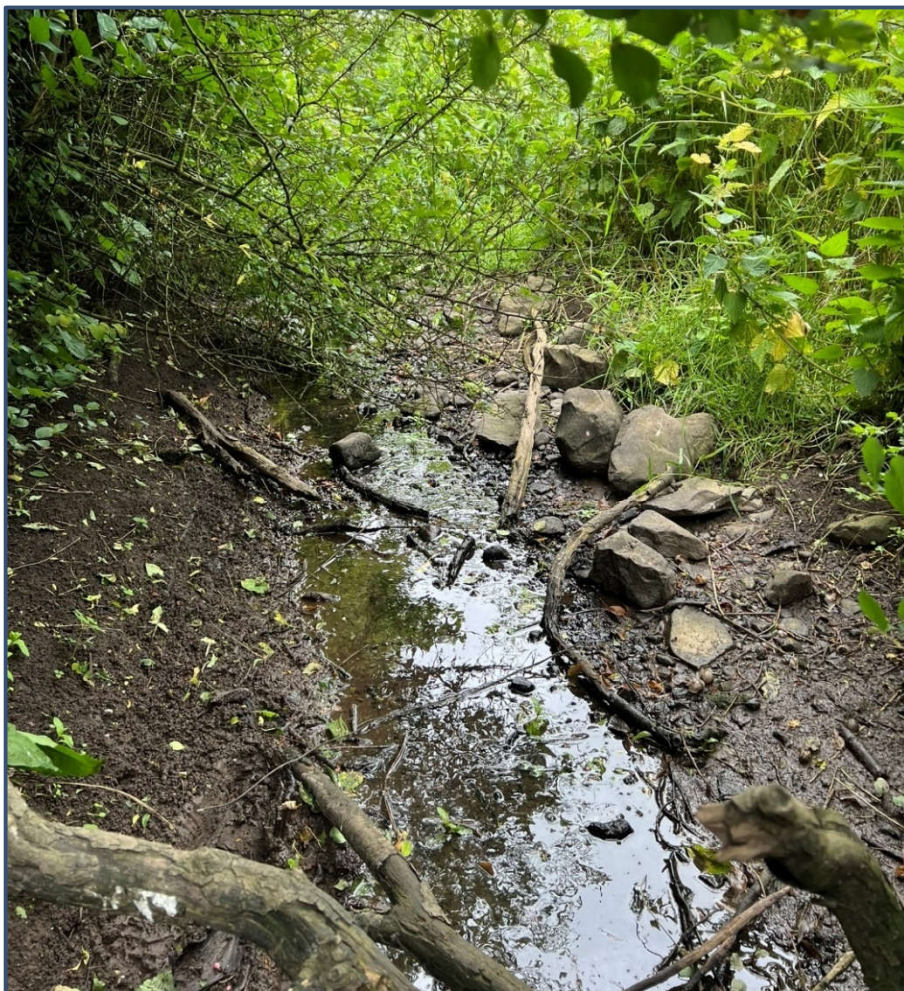
No kingfisher signs were identified in the vicinity of WF 4, which, given the highly tunnelled and unwetted nature of the watercourse, provided *Negligible* foraging or burrowing habitat for the species.

Plate 4-6. A Representative image of Survey Site WF 4, upstream of the culvert.

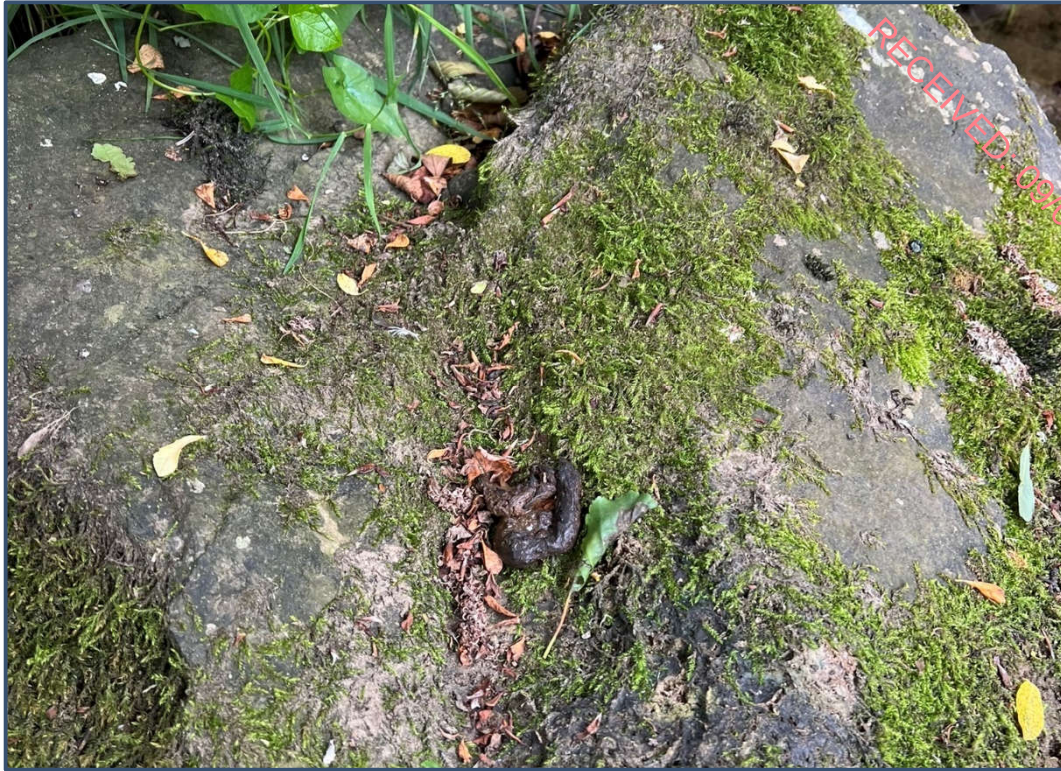
Plate 4-9. Otter spraint found along boulders at Survey site WF 5.

No otter holts or couches were identified at the survey sites in the vicinity of the Proposed Wind Farm. Otter signs in the form of spraints and prints were found at survey sites WF 2 and WF 5, indicating that otter actively utilise these watercourses (namely Lisdowney Stream). Given the high fisheries potential and good connectivity of other sites within the vicinity of the Proposed Wind Farm it is likely that otter also actively utilise the stretch of watercourse at WF7 (Erkina River) for commuting and foraging.

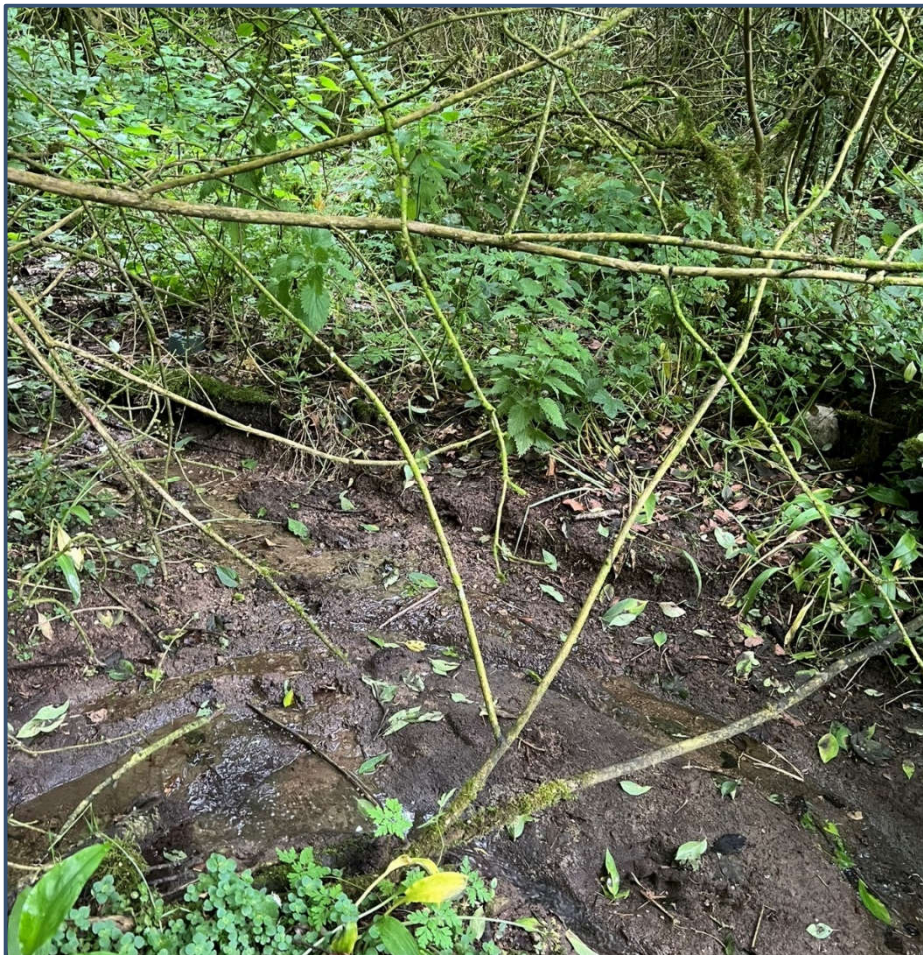
| Properties | Record | | | |
|---|---|---|---|---|
| Substratum Condition | Loose | | | |

The channel profile for this stretch of watercourse was not clearly demarcated, with no clear channel margins or flow path (in wetted areas) and exposed, gradually sloping earthen banks amid the wider **(Mixed) broadleaved woodland (WD1)**. Areas of wetted channel were littered with woody material, detritus and fallen tree limbs. Woodland canopy composed of Beech (*Fagus sylvatica*), Elder (*Sambucus nigra*), Elm (*Ulmus sp.*) and Sycamore (*Acer pseudoplatanus*) provided heavy shading to the entire area. Woodland ground flora included areas of Bramble and Hawthorn **Scrub (WS1)**, as well as Cleaver (*Galium aparine*), Creeping Buttercup (*Ranunculus repens*), Elder (*Sambucus nigra*), Dog's Mercury (*Mercurialis perennis*), Hart's-Tongue Fern (*Asplenium scolopendrium*), Herb Robert, Ivy, Meadowsweet, Nettle, and Wood Dock.

Plate 4-10. A representative picture of Survey Location WF 6.

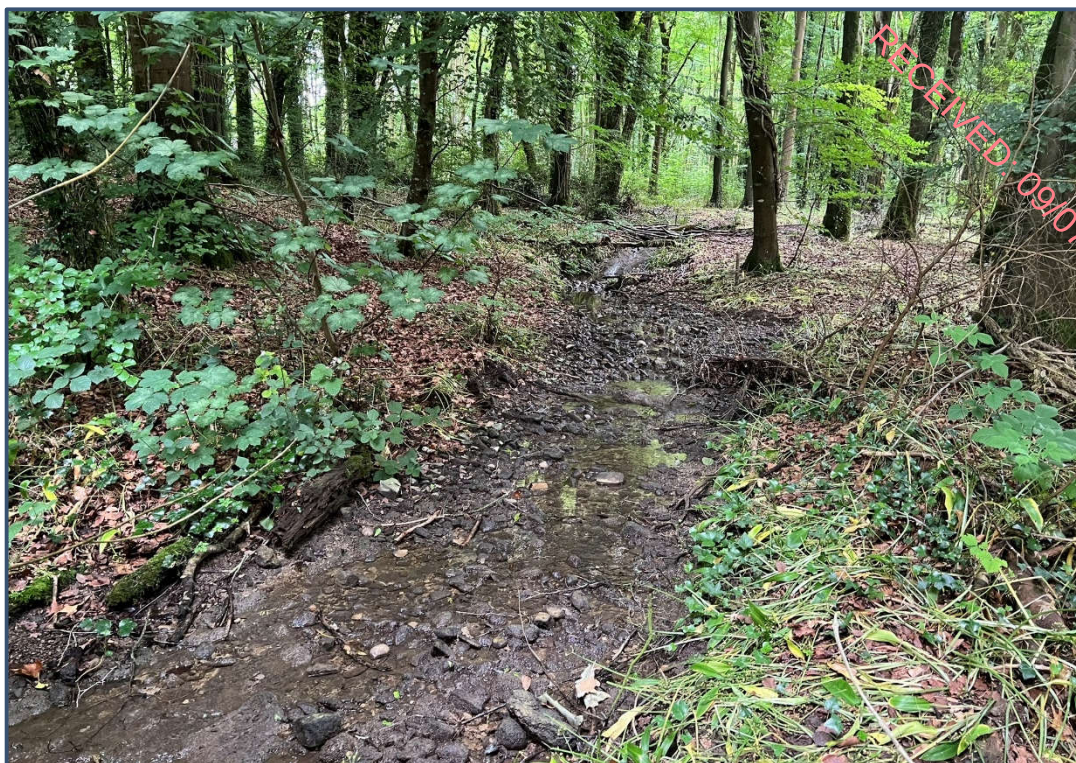
The accessible length of the Durrow\_Townparks watercourse within Knocknatrina woods was walked to assess areas suitable for kick-sampling and electrofishing surveys, with much of the unculverted length of watercourse unsurveyable due to either dry or insufficiently wetted channel. Consequently, kick-sampling and electrofishing could not be carried out at survey site WF 6. At the time of survey, WF 6 provided *Negligible* fisheries habitat. No other signs were found in the vicinity of survey site WF 6. No kingfisher signs were identified in the vicinity of the unwetted channel at WF 6.

Plate 4-11. A short, insufficiently wetted section of cobble-dominant watercourse at Survey site WF 6.

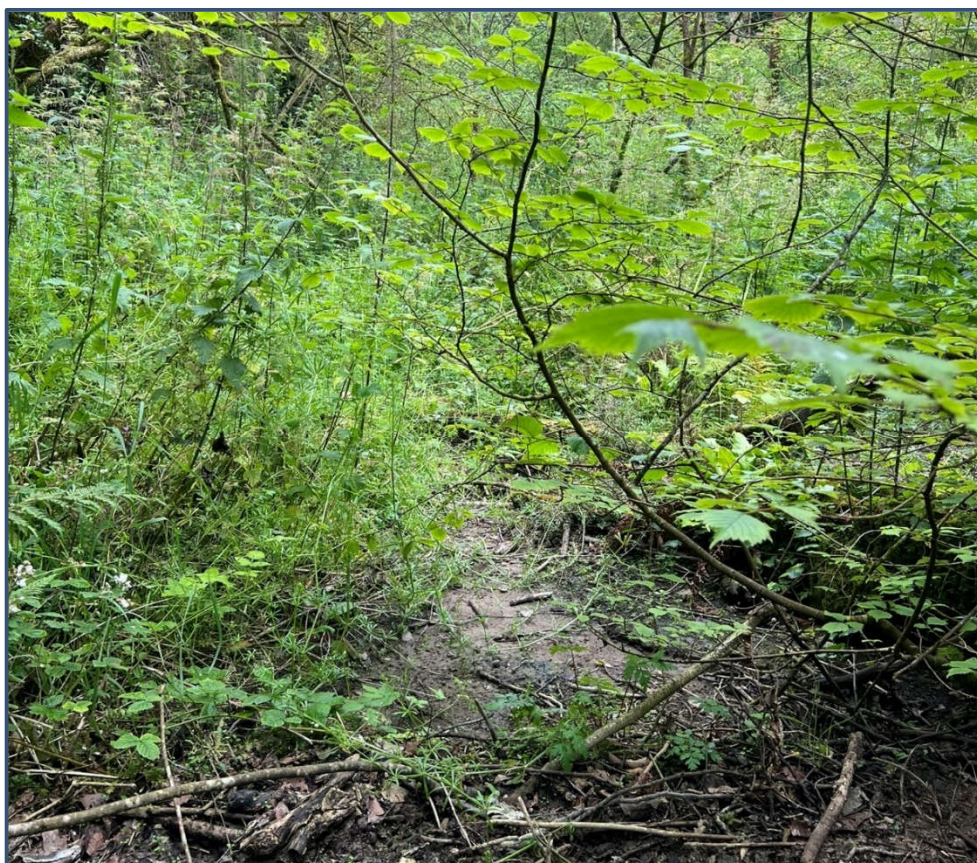
Plate 4-12. A completely unwetted section of channel along the walked stretch for Survey site WF 6.

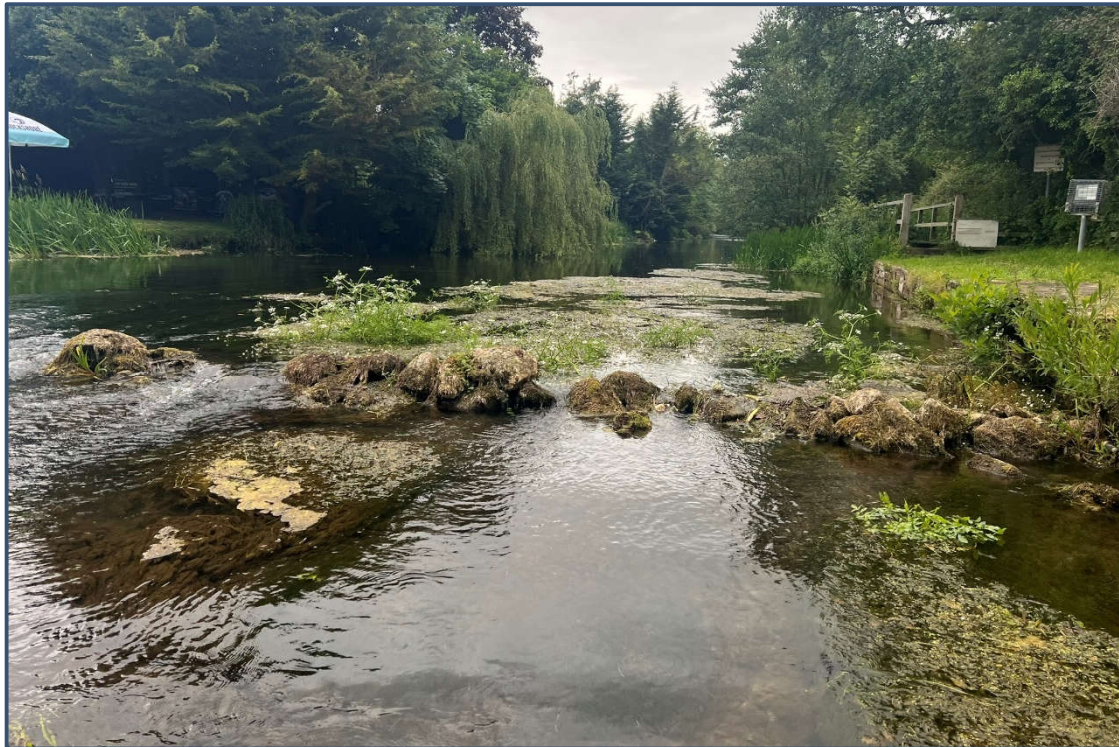
| Properties | Record |
|---|---|
| Substratum Condition | Semi-compacted |

No otter signs were observed in the vicinity of survey site WF 7. Despite the semi-urban location and high level of human activity in the vicinity of the stretch of watercourse, the Erkina River at this survey location provides *Good* commuting and foraging for otter, being a high fisheries value habitat with good connectivity to the wider catchment.

Plate 4-13. A representative image of the upstream extent of Survey site WF 7.

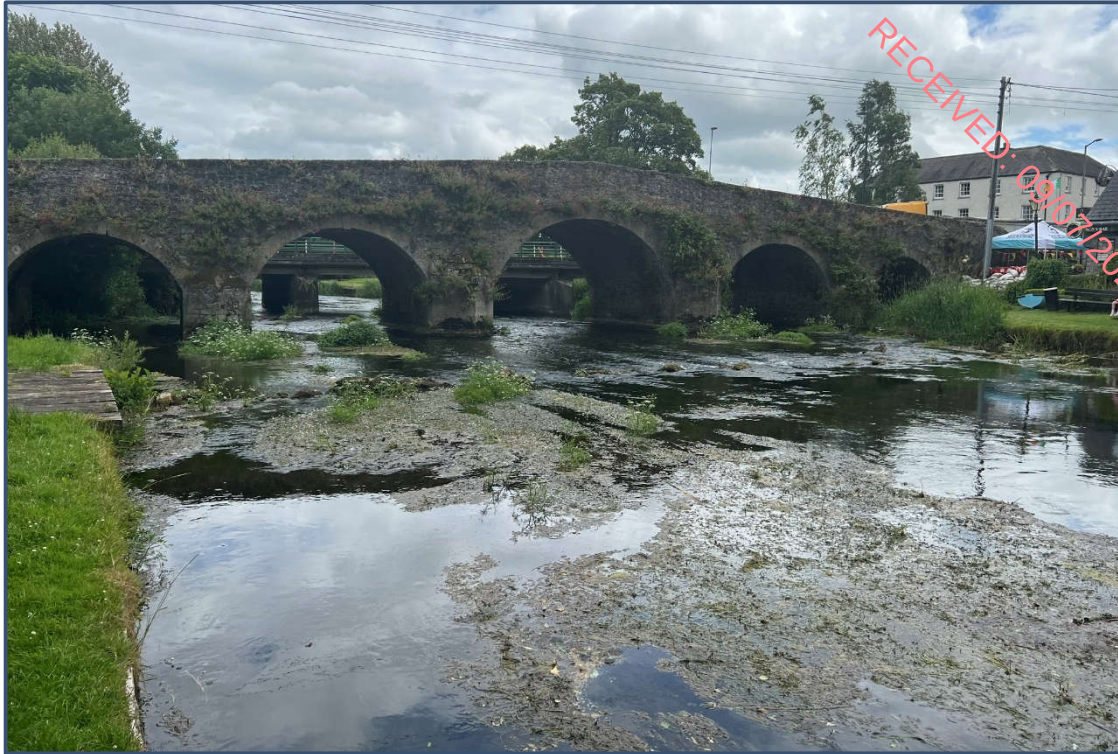
Plate 4-14. A representative image of the downstream extent of Survey site WF 7.

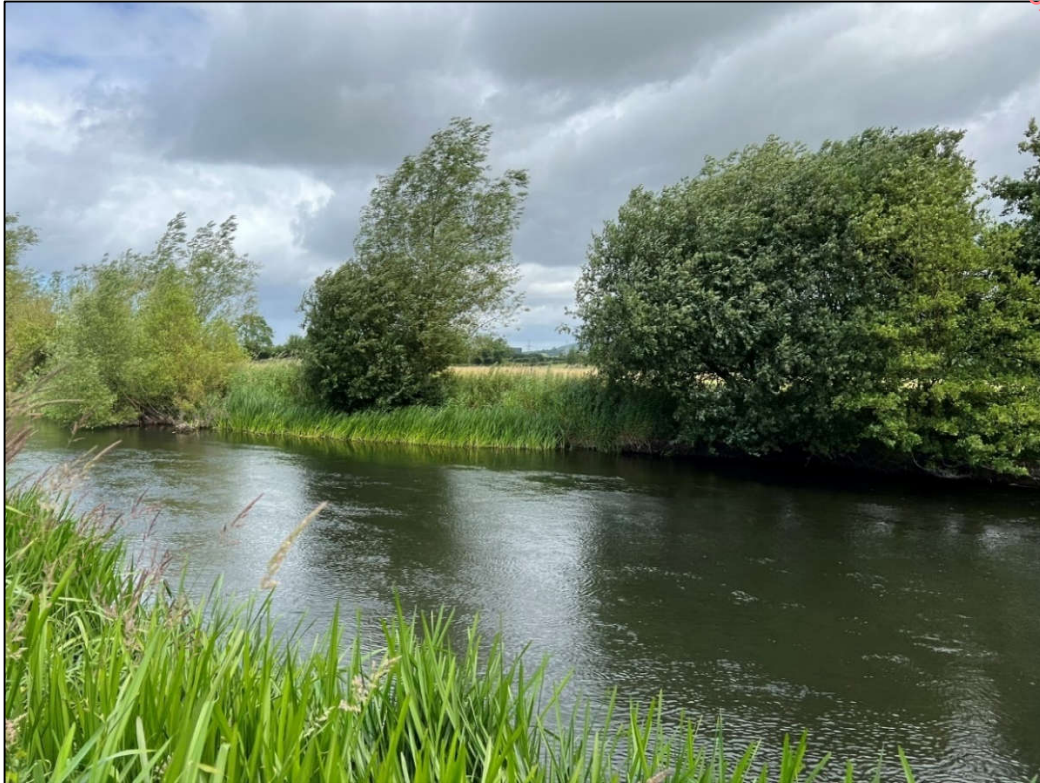
| Properties | Record |
|---|---|
| Substratum Condition | Compacted |

No kingfisher signs were identified in the vicinity of GC1. However, the stretch of the River Nore at this site provided *Good* potential foraging habitat for Kingfisher.

Plate 4-15. A representative image of the downstream extent of Survey site GC1.

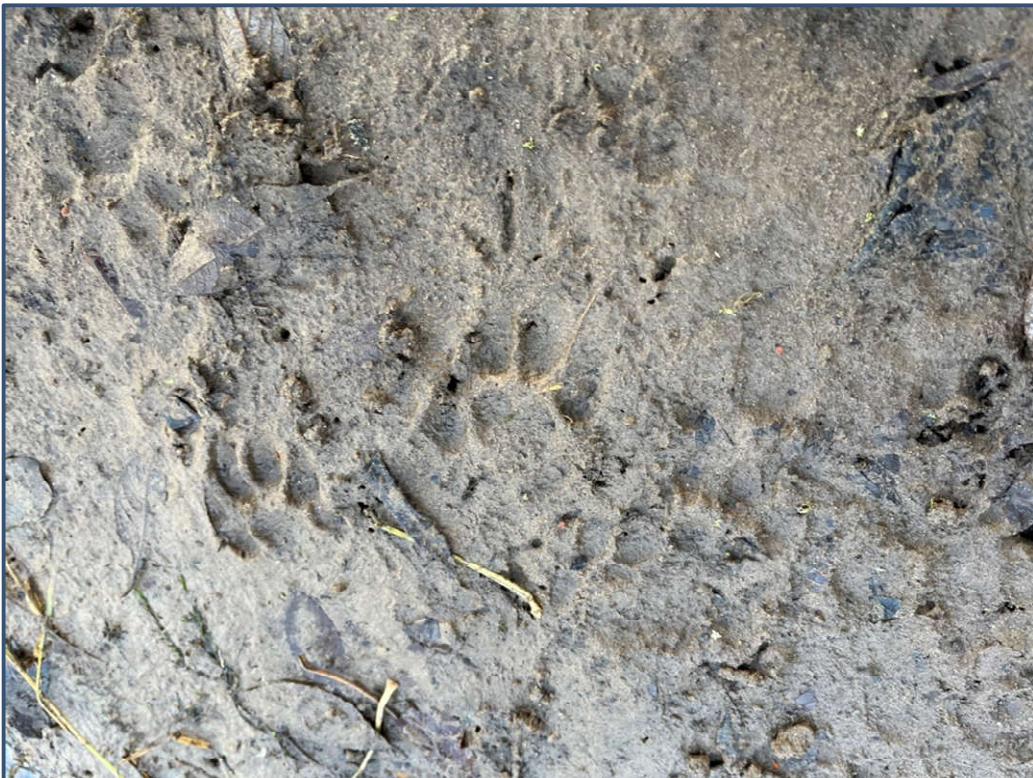
Plate 4-16. Otter prints observed downstream of survey site GC1

The Proposed Grid Connection crossing point passes through the River Barrow and River Nore SAC, which is designated for the **QI** species Otter. Otter signs were identified along the banks within the vicinity of GC1 (spraint, prints, feeding remains). In addition, an active, non-breeding otter holt was recorded along the right bank of the River Nore in the proximity of survey site GC 1. The holt was found to be in regular use by a single individual. Based on camera trap footage, it is not considered to be a natal holt. Otter have been shown to be in frequent use of the River Nore upstream, downstream and in the vicinity of the Proposed Grid Connection crossing point.

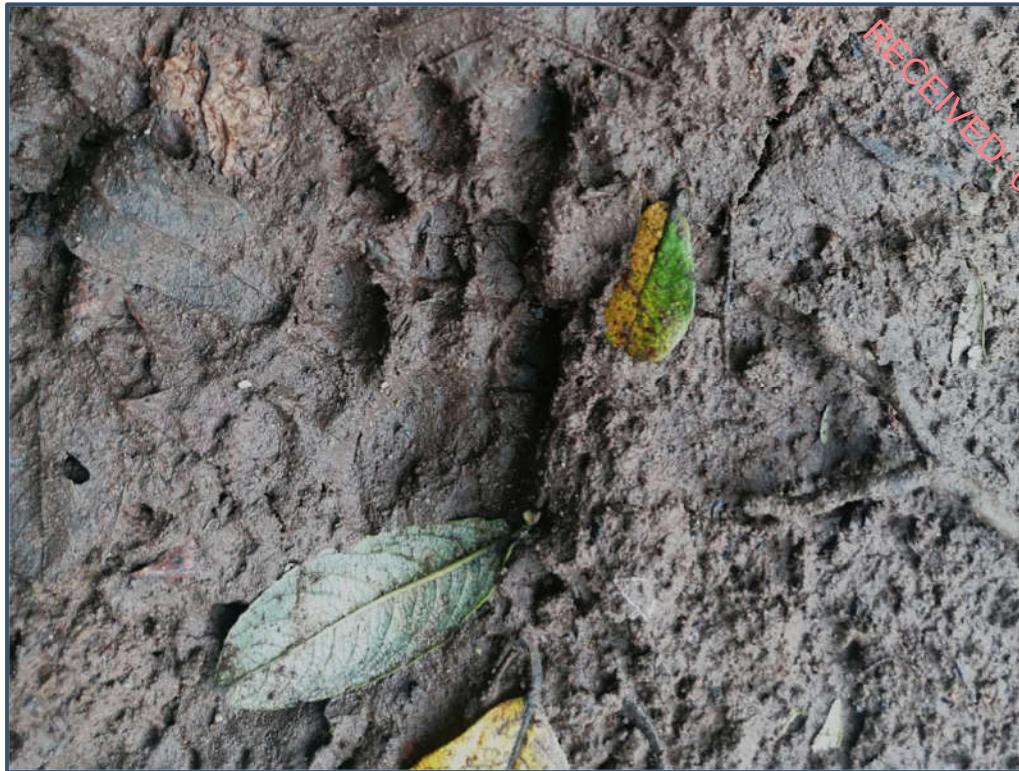
Plate 4-17: Otter print recorded within the vicinity of GC1 during the multidisciplinary walkover survey.

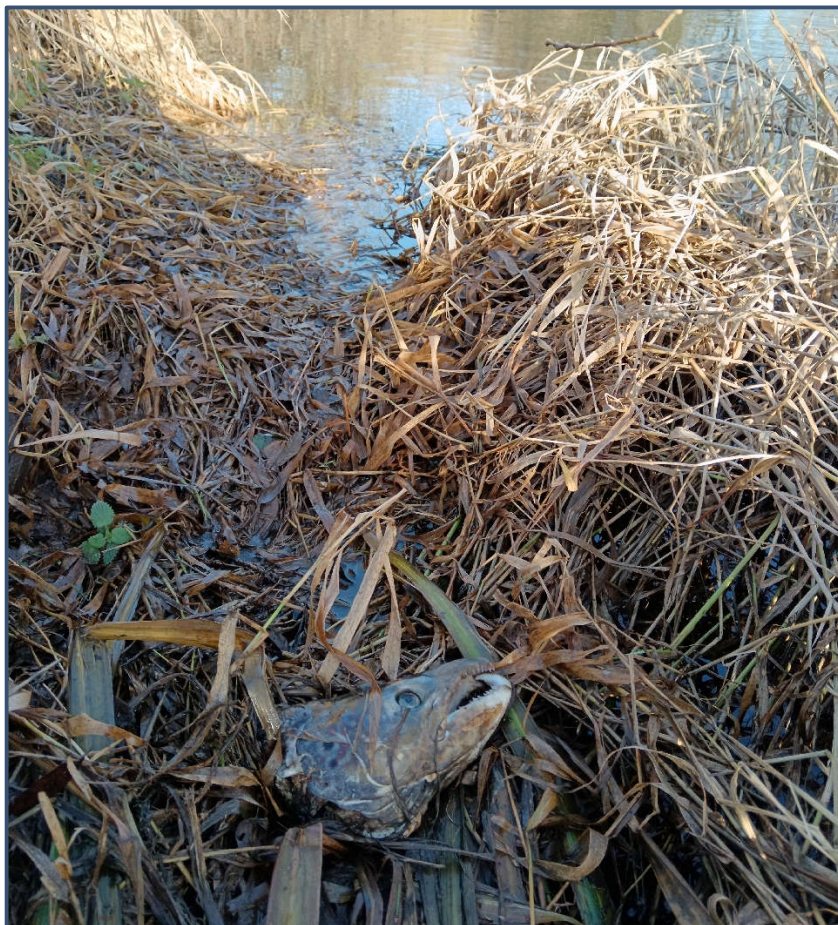
Plate 4-18: Salmon head remains from feeding otter in the vicinity of survey site GC1

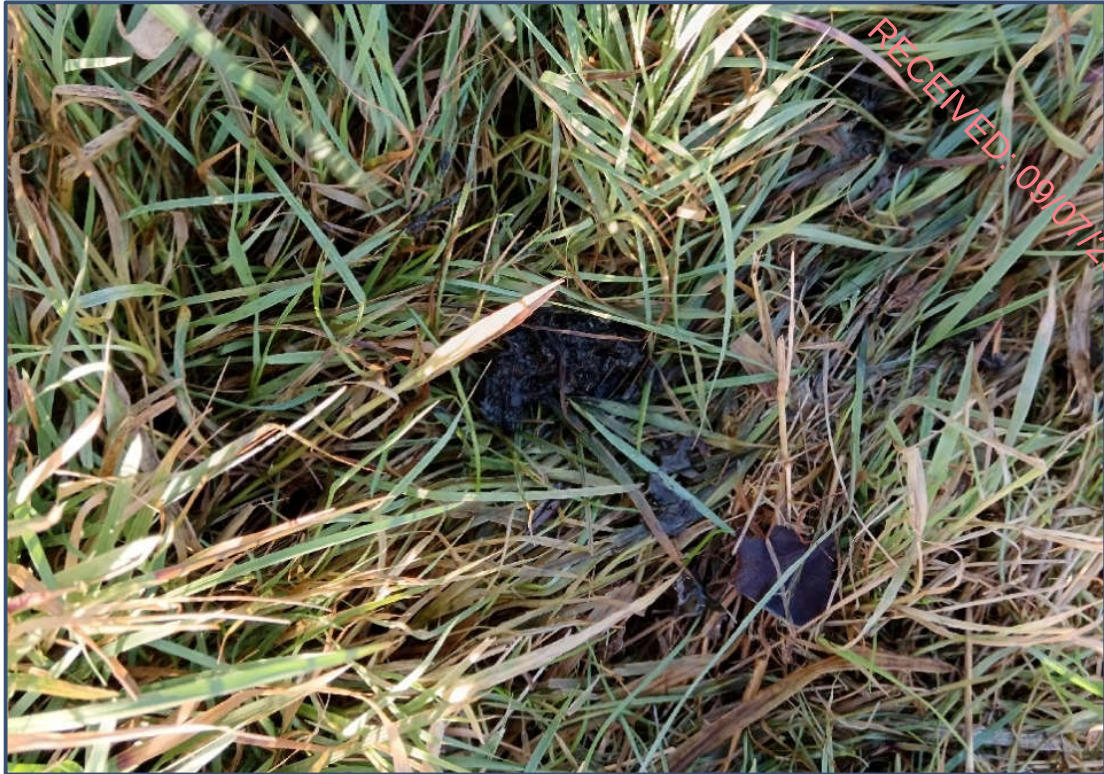
Plate 4-19: Otter spraint observed in the vicinity of Survey site GC1.

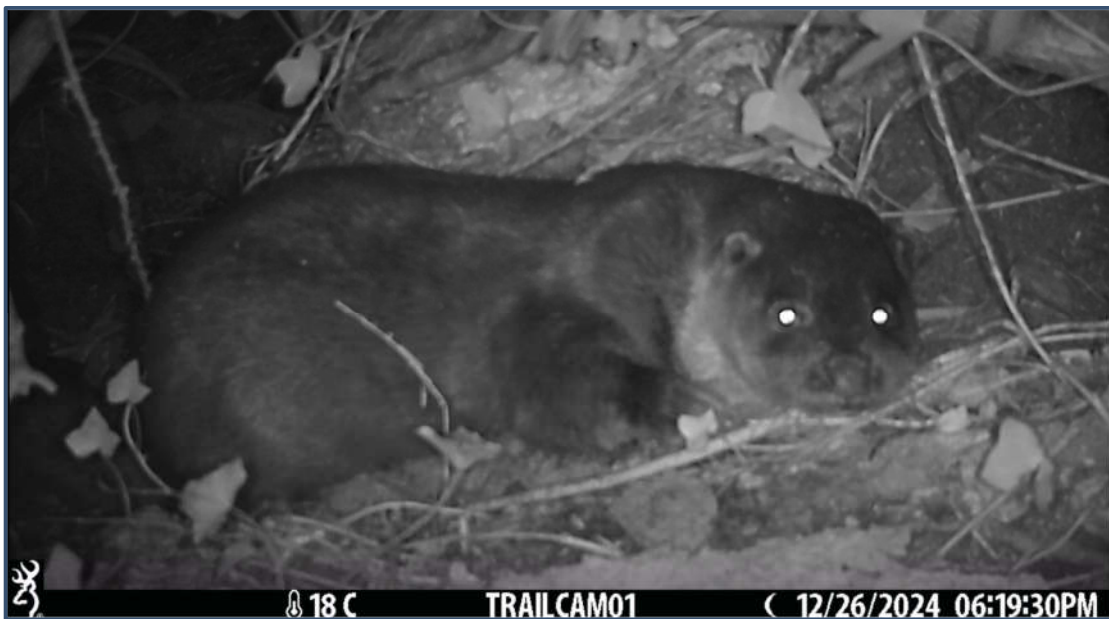
regular use by a single individual during the time the camera was deployed (from 19.12.2024 to 14.01.2025). Based on the footage captured it is not considered to be a natal holt.

Plate 4-20: Otter recorded by trail camera approximately 165m upstream of GC1.
