Seskin Renewables Wind Farm

Aquatic Baseline Report

Project Title: **Seskin Renewables Wind Farm**

Document Title: **Aquatic Baseline Report**

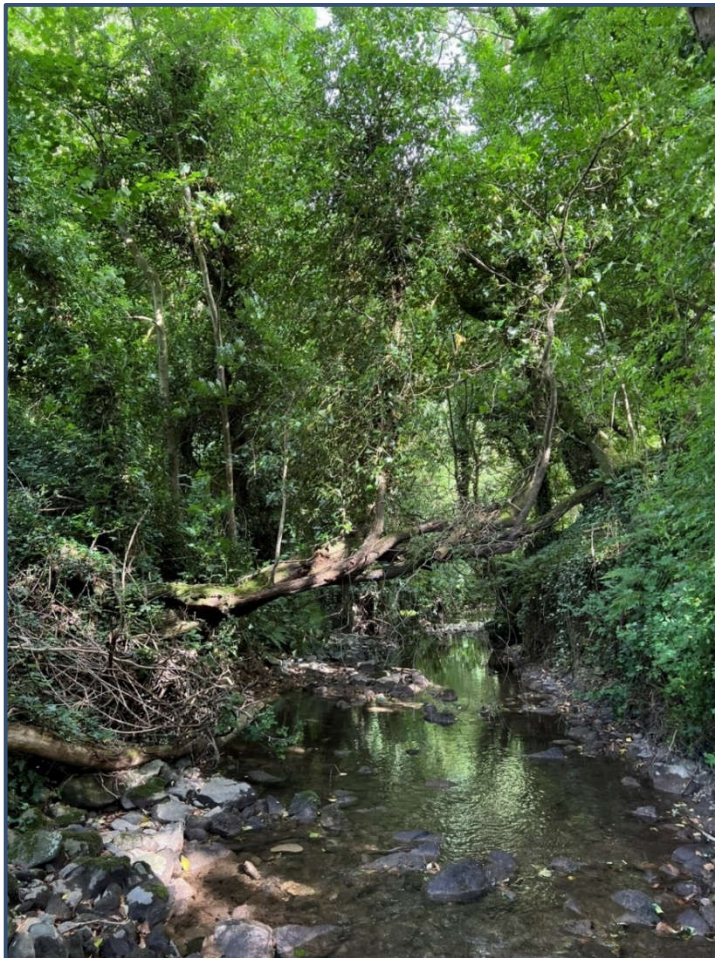
Plate 4-3. A representative image of the downstream extent of Survey Site WF 3.

Bank height (m)	LHB	1.5	RHB	2
Dominant Substrates	Boulder (>128mm): 20% Cobble (>32–128mm): 40% Gravel (8-32mm): 15% Fine gravel (2-8mm): 15% Silt (<0.25mm): 10%, forming a continuous layer over much of the channel substrata			
Substratum Condition	Semi-compacted

No otter signs were observed at site WF 3. Given the localised moderate fisheries potential of this survey site, in combination with marginal refugia and bankside features which may be utilised by feeding otters, otter foraging and commuting potential for this section of the Lisdowney Stream was assessed as *Moderate*.

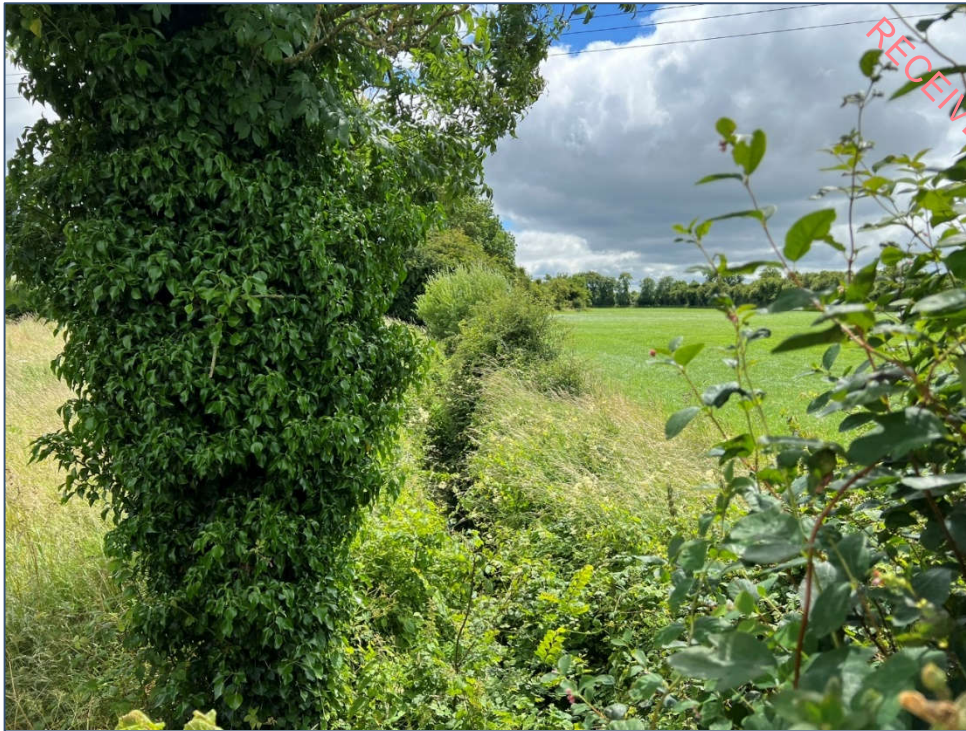
Properties	Record
Average Depth (m)	< 0.05 in wetted sections of channel, with several areas completely unwetted
Average Bank Width (m)	1.5
Wet Width (m)	0.3–0.5
Flow	Low–Dry
Colour	Brown
Clarity	Slightly turbid even when undisturbed
Bank height (m)	LHB 1.4 RHB 0.3
Dominant Substrates	Boulder (>128mm): 5% Cobble (>32–128mm): 5% Fine gravel (2–8mm): 20% Clay and silt(<0.25mm): 70%
Substratum Condition	Loose and unconsolidated clay and silt

Areas of insufficient water depth, no perceptible flow and excessive shading provided *Negligible* spawning, nursery or holding habitat for European eel, salmonid or lamprey species at survey site WF 4. Given the poor-quality channel substrate and barriers to migration in the form of culverting and dense, in-channel vegetation, fisheries habitat downstream of the bridge was also *Poor* and likely only utilised by fish species such as three-spined stickleback (*Gasterosteus aculeatus*). Due to a lack of sufficiently wetted channel, kick-sampling and electrofishing could not take place at survey site WF 4.

Plate 4-5. A representative image of an inaccessible stretch of Survey site WF 4, downstream of the culvert.

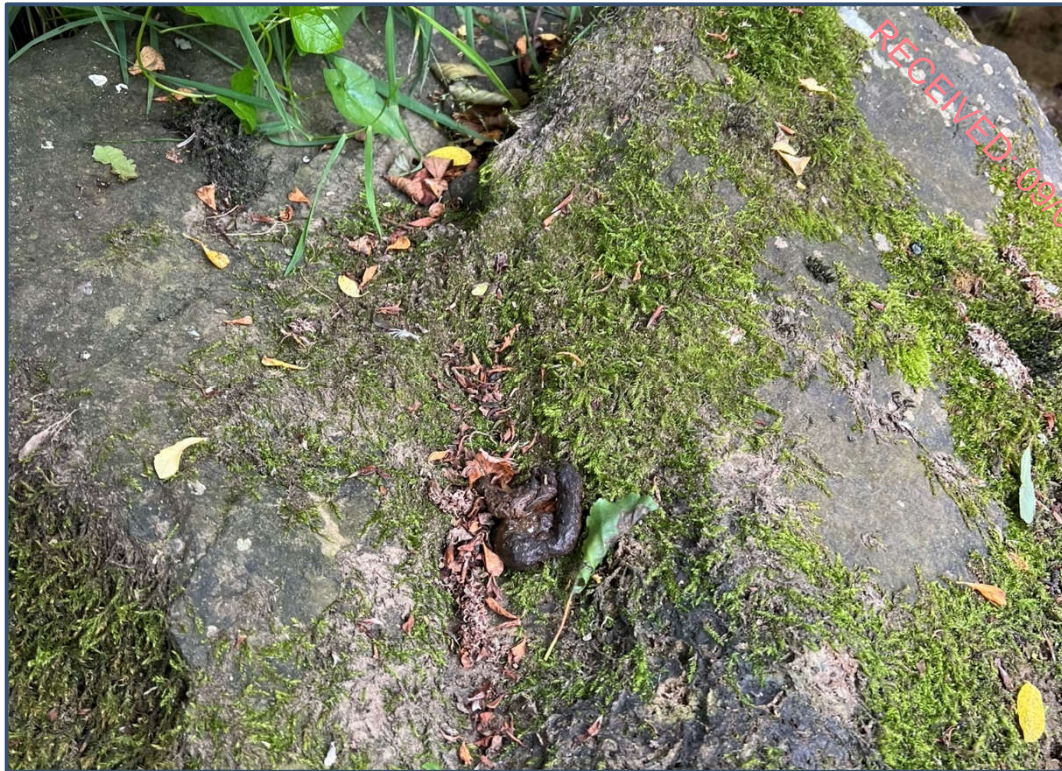
Plate 4-9. Otter spraint found along boulders at Survey site WF 5.

No otter holts or couches were identified at the survey sites in the vicinity of the Proposed Wind Farm. Otter signs in the form of spraints and prints were found at survey sites WF 2 and WF 5, indicating that otter actively utilise these watercourses (namely Lisdowney Stream). Given the high fisheries potential and good connectivity of other sites within the vicinity of the Proposed Wind Farm it is likely that otter also actively utilise the stretch of watercourse at WF7 (Erkina River) for commuting and foraging.

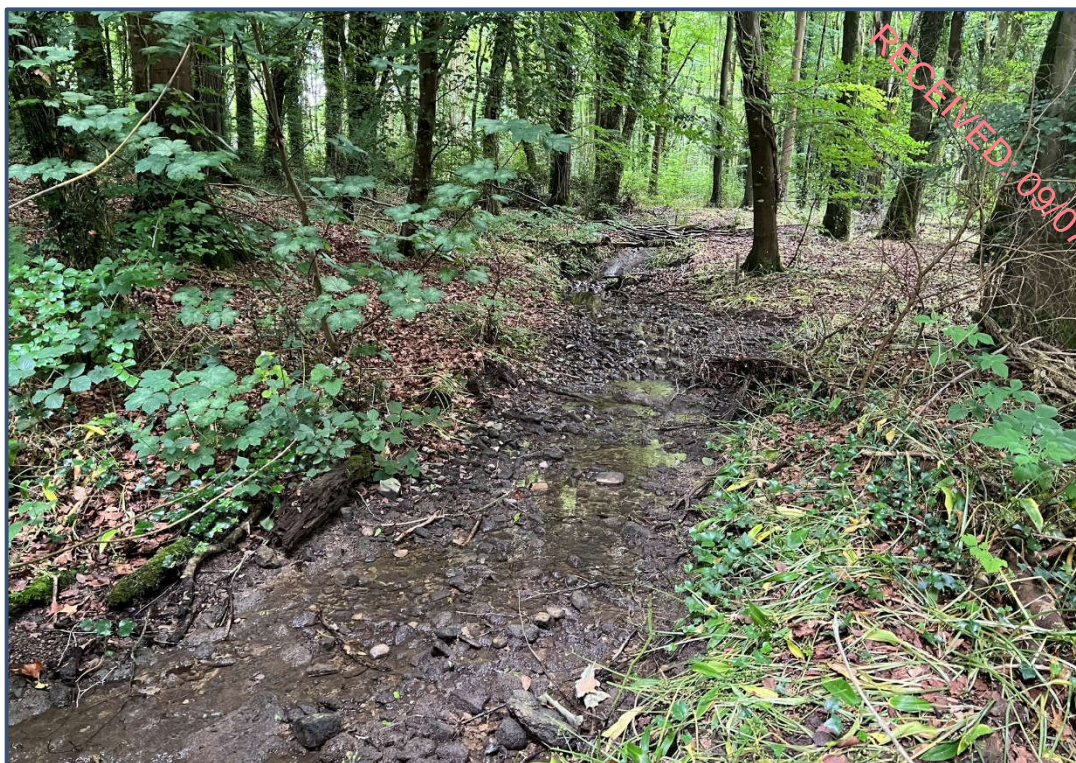
Plate 4-11. A short, insufficiently wetted section of cobble-dominant watercourse at Survey site WF 6.

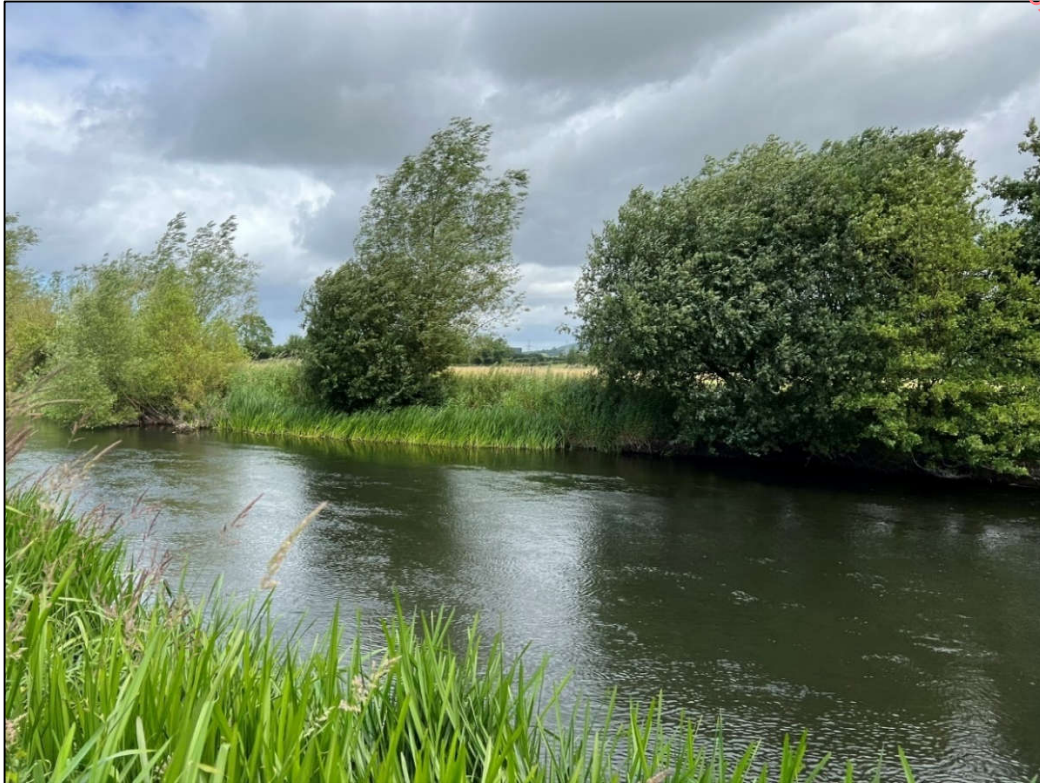
Plate 4-15. A representative image of the downstream extent of Survey site GC1.

Properties	Record
Average Depth (m)	0.8–1.2
Bank Width (m)	20
Wet Width (m)	20
Bank height (m)	LHB 1.6 RHB 1.2
Flow	Moderate flow and fast velocity
Colour	No distinct colouration
Clarity	Clear when undisturbed
Dominant Substrates	Boulder (>128mm): 5% Cobble (>32–128mm): 60% Gravel (8-32mm): 20% Silt (<0.25mm): 15%
Substratum Condition	Compacted

No kingfisher signs were identified in the vicinity of GC1. However, the stretch of the River Nore at this site provided *Good* potential foraging habitat for Kingfisher.

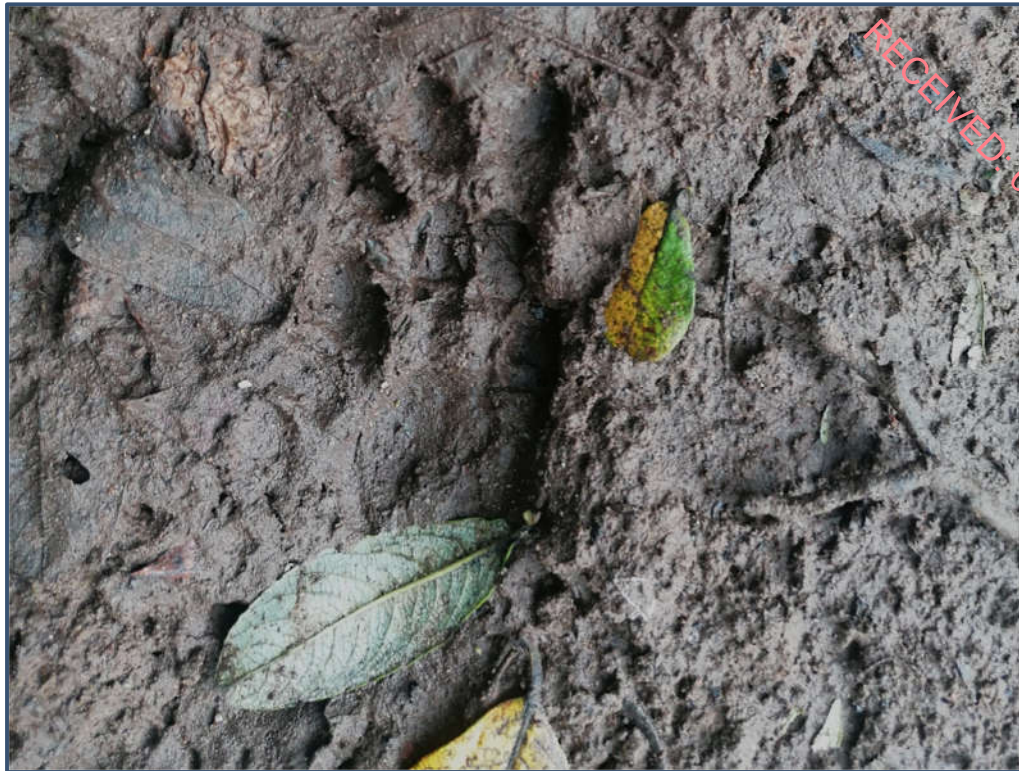
Plate 4-17: Otter print recorded within the vicinity of GC1 during the multidisciplinary walkover survey.

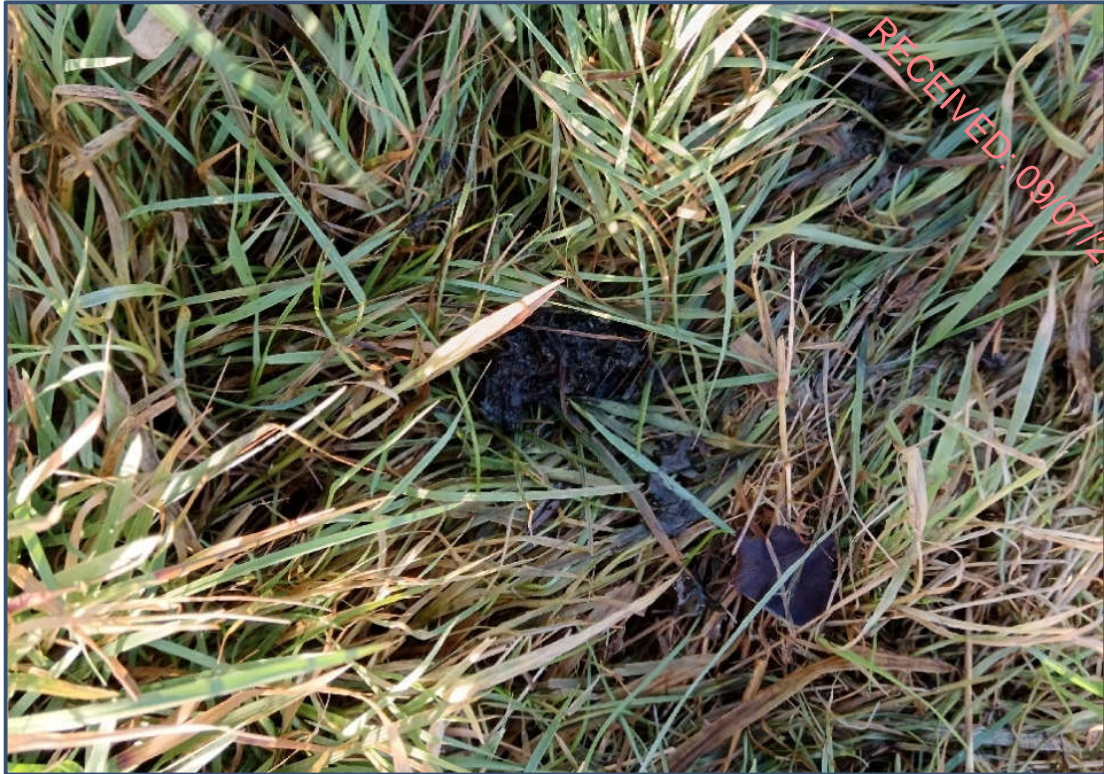
Plate 4-19: Otter spraint observed in the vicinity of Survey site GC1.
