Appendix 10A

Archaeological Marine Survey Information

Table D1: Side Scan Anomaly list interpreted from the 500 kHz side-scan sonar survey of the proposed Rossaveel harbour development.

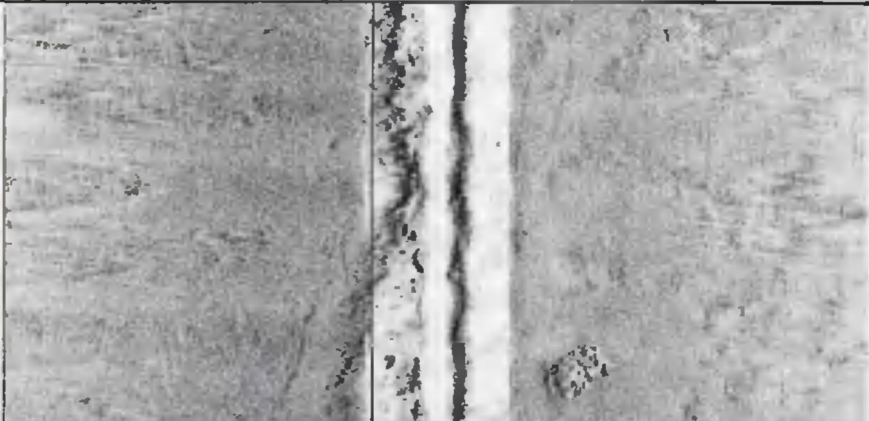
ID	Type Image
S1

ID	Dimensions (m)	Description and Interpretation
S1	13.7 x 10.5	Description: Series of discrete high backscatter reflectors on the starboard channel. Interpretation: Debris mound on the seafloor – reminiscent of a ballast mound.
S2	25.4 x 14.0	Description: Series of low and high backscatter reflectors surrounding an area of uniform low tonal returns on starboard channel. Interpretation: Seafloor depression with a series of upstanding targets on its perimeter.
S3	5.9 x 1.0	Description: Linear high backscatter reflector with shadow on port channel. Interpretation: Upstanding linear feature.
S4	37.0 x 25.0	Description: Series of four high backscatter reflector groups in a cruciform arrangement on the seafloor, centred on the given co-ordinate on the starboard channel. Interpretation: It is impossible to tell if these discrete reflectors are related. Each target measures approximately 3m ² .
S5	6.4 x 1.0	Description: High backscatter sub-linear parallel targets on the port channel, with associated shadow. Interpretation: Upstanding linear target, 0.25m proud of the seafloor. The target lies adjacent to a series of bedrock outcrops, but has a distinctive geophysical signature from the natural reflectors.

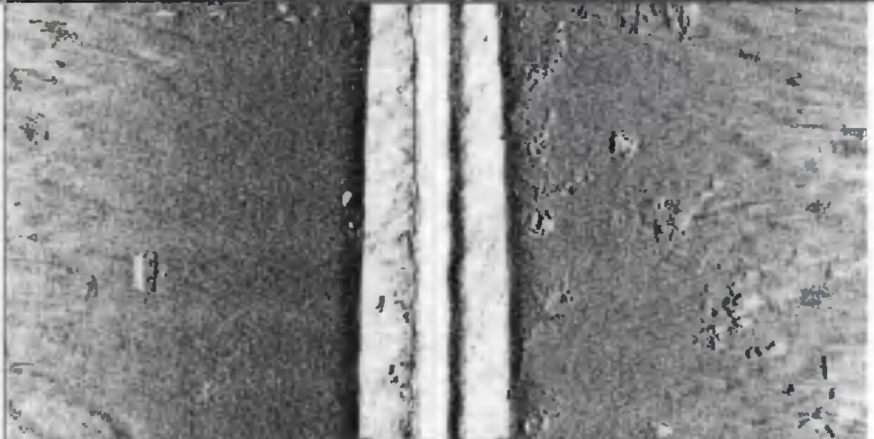
S6	8.5 x 2.0	Description: Medium backscatter anomaly with high backscatter leading edge. Associated shadow. Interpretation: Upstanding rectangular shaped target. Shadow indicates the feature stands 0.5m off the seafloor.
S7	8.2 x 3.4	Description: Series of linear and curvilinear reflectors, alligned in the same orientation on an otherwise unifrom substrate. Interpretation: The morphology, geophysical signature and dimensions of the target, together with the signature of the surrounding seafloor, indicates the target may be a vessel. However, no shadow is obvious, indicating the target is lying concordant with the seafloor.
S8	20 x 20	Description: Series of high backscatter linear targets with associated shadows. Interpretation: The linear, discrete nature of the targets lying amongst bedrock indicates they are probably man-made.
S9	7.5 x 5.3	Description: Series of high backscatter linear- and sub-circular reflectors with associated shadows. Interpretation: Debris scatter.
