Appendix 10B

Archaeological Marine Monitoring Report 2024

**Archaeological Monitoring
Deep Water Quay, Dredging
Ros an Mhíl (Rossaveel), Co. Galway
24D0056, 24D0009, 24R0010**

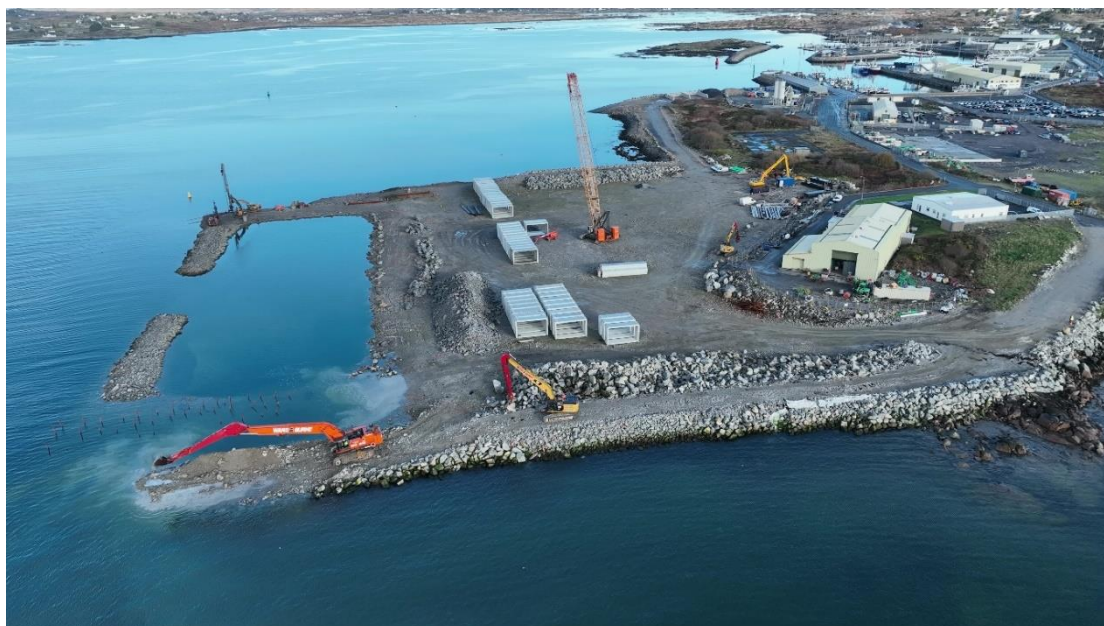
Construction has been ongoing since January 2023, focused on reclaiming the foreshore by extending out approximately 130m from the existing shoreline (Plate 1). These works infilled the shoreline directly on to bedrock.

In anticipation of the construction of the 200m-long quay, several finger platforms were extended 40m long by 14m wide at right angles to the future quay, and projecting over a berthing pocket. In addition, a temporary breakwater was constructed on the channel side, to facilitate works (Plate 1).

Plate 1: Drone image showing development of breakwater adjacent to the berthing circle.

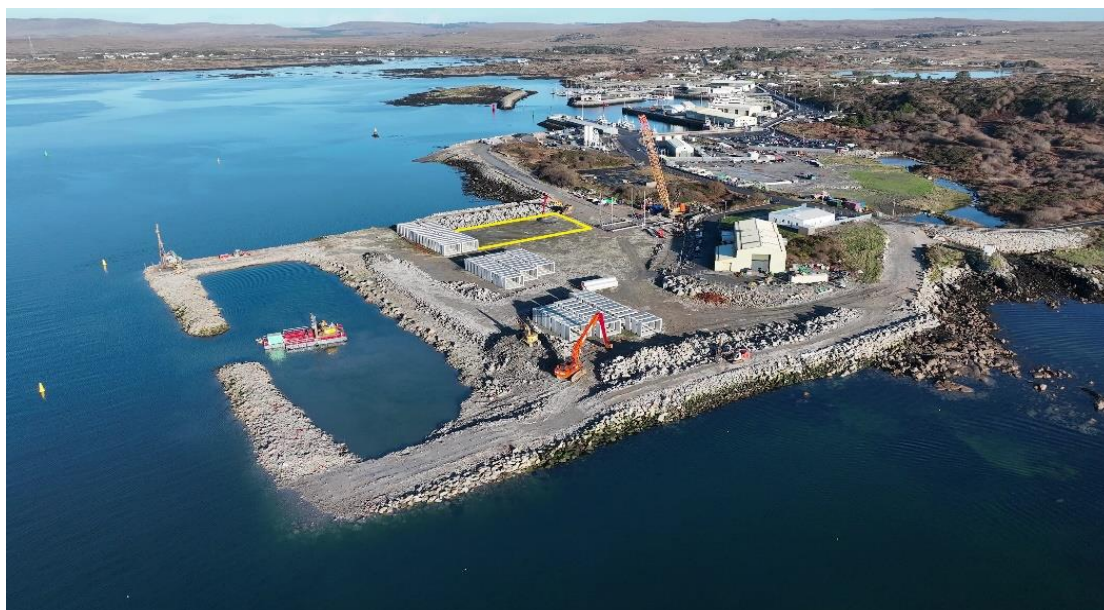
A narrow linear trench measuring 14m wide was dredged along the toe of the future quay wall (Figure 1). The risings were recovered to the reclaimed area (Plate 2).

Plate 2: Drone image showing development of breakwater adjacent to the berthing circle. Dredge material designated placement area (yellow box).

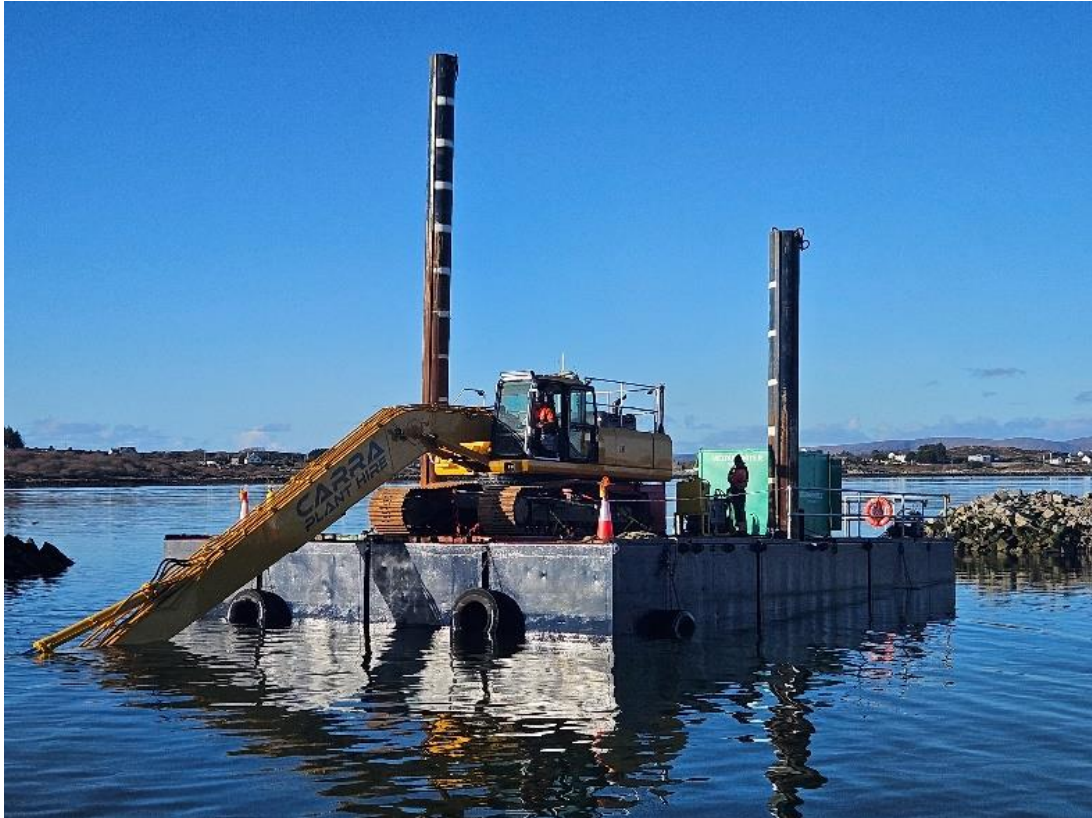
The dredging was carried out using a long-reach excavator mounted on an unpropelled pontoon barge (Plate 3). ADCO had access to the barge for monitoring when necessary, and could also monitor from the shore when the barge was in proximity to the shore.

Plate 3: The dredging plant comprised a long-reach excavator mounted on to pontoon barge.

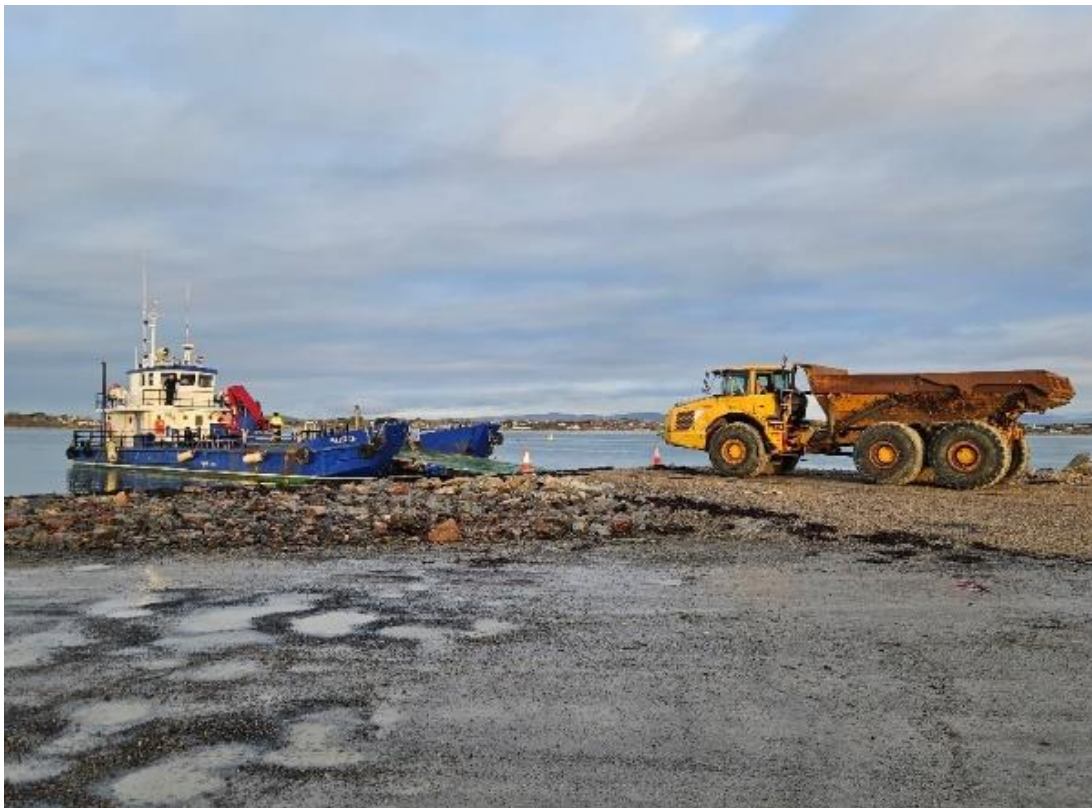
Dredged risings would be transferred to the barge *Madelene*, which would transport the risings to shore, where the risings would be unloaded to a dump truck that would in turn transfer the risings to the reclaimed area for inspection (Plate 4).

Plate 4: The barge Madelene, which conveyed dredging risings to shore.
