Appropriate Assessment

Graiguenamanagh-Tinnahinch Flood Relief Scheme

Report No. W3451-AYE-ENV-R010

Kilkenny County Council

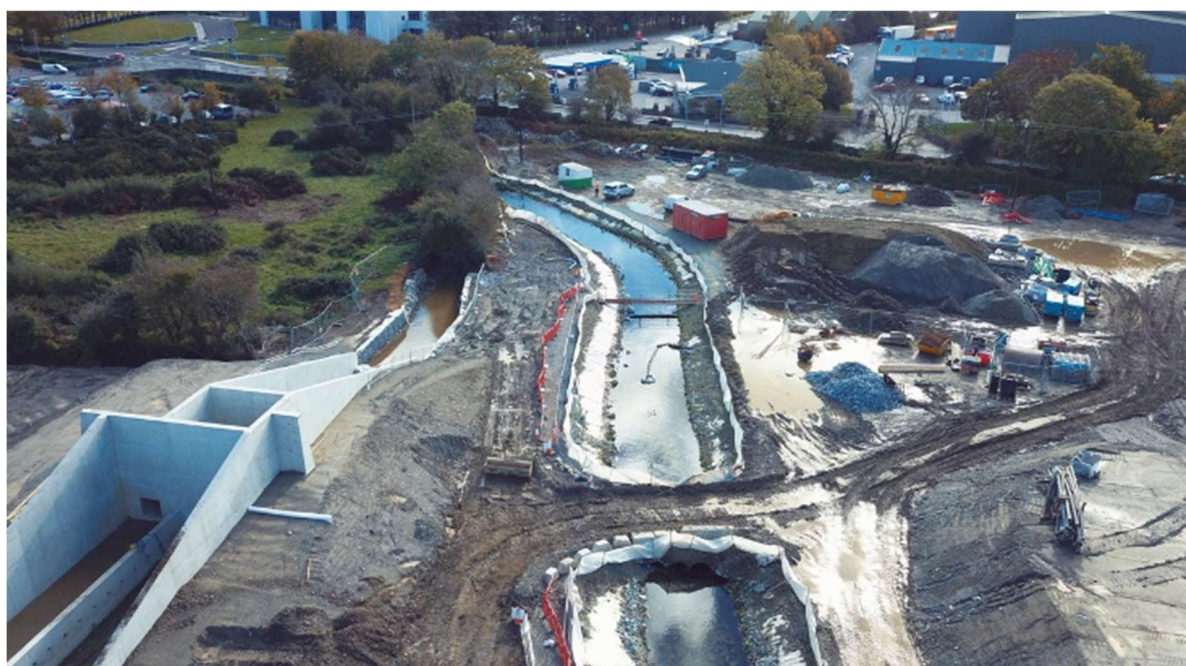
In order to build instream online structures, the River Duiske will need to be temporarily diverted. This will entail constructing a new channel around the works area. The channels will be lined or hydroseeded to reduce sediments entering the watercourse.

Figure 1-3: Example River diversion (on right) with access crossing to allow structure construction in watercourse (left)

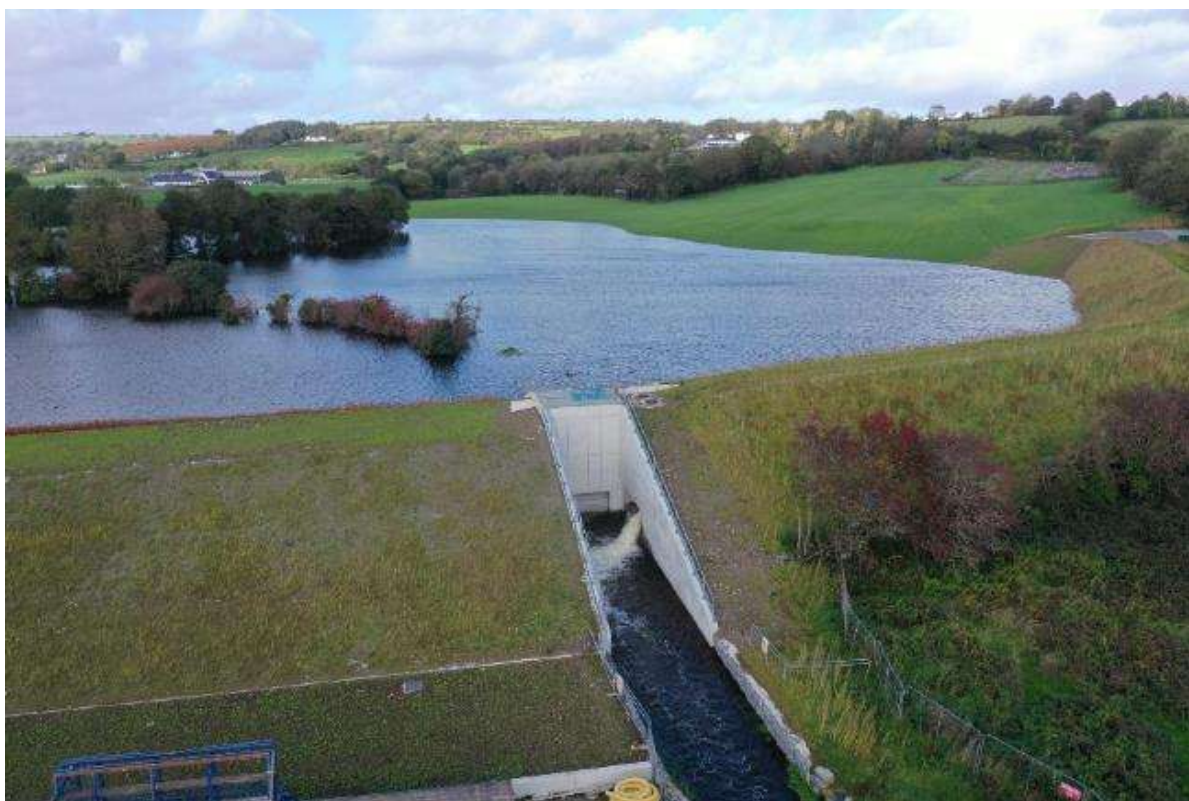
Figure 1-4: Example storage area with flow control structure in flood conditions
 (Source: <https://www.wardandburke.com/project/river-feagle-clonakilty-certified-drainage-scheme/>)

The structures will be built inline on the River Duiske. They involve the excavation of the bed of the watercourse to lay concrete structures to control flows. All work will be executed in the dry following a river diversion/ damming.

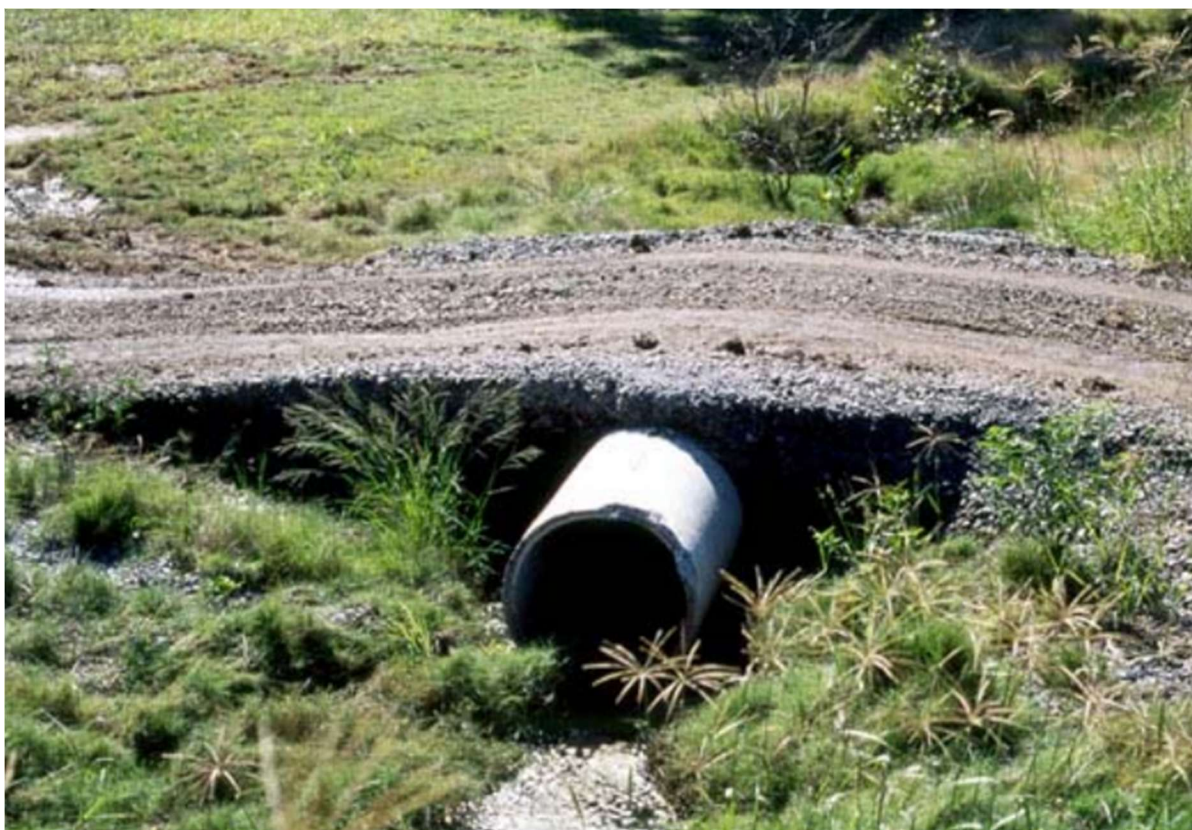
In order to obtain access to both banks of a watercourse, it will be necessary to provide a temporary access through the river. The river will be culverted for the duration of the works and reinstated afterwards. The temporary culvert will be designed in a manner as not to impede the passage of fish along the river. The typical process would be to lay a terram layer on the riverbed, place pipework, and then backfill with suitable granular material, over which a temporary road is constructed.

Figure 1-5: Example temporary river crossing
(Source: <https://www.austieca.com.au/documents/item/319>)

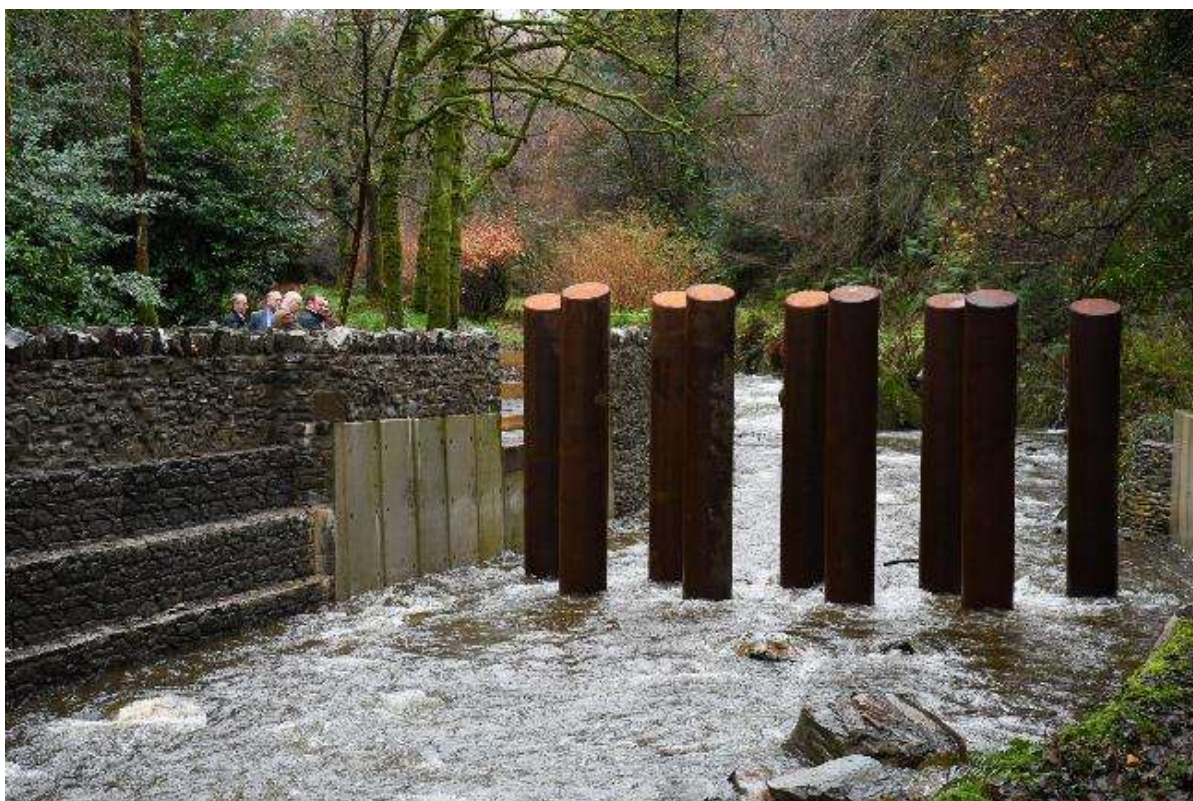
The structure consists of columns constructed instream at a location where they will catch debris for removal by those maintaining the scheme. To construct the columns, the riverbed must be excavated, and the columns inserted.

Figure 1-6: Example Column Debris Trap

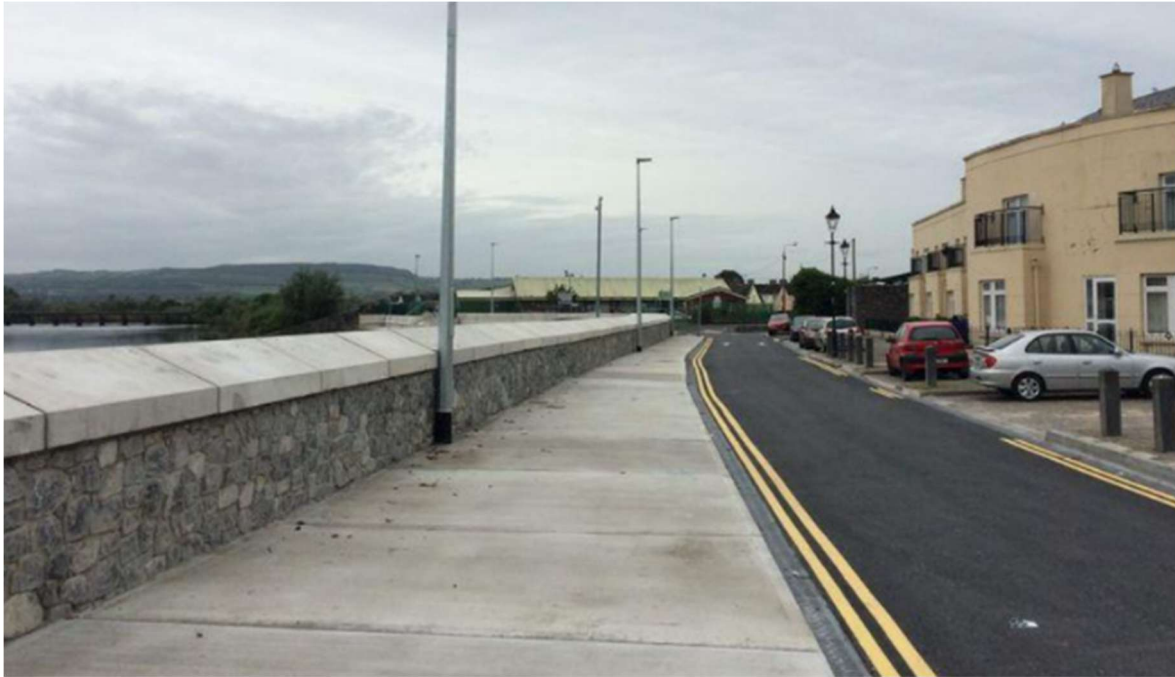
Figure 1-7: Example wall construction including stone facing.

There are typically concrete, or sheet piled structure, sometimes with a cladding such as timber, stone or concrete to finish. They can be built on traditional soil bearing foundations or placed on piles.

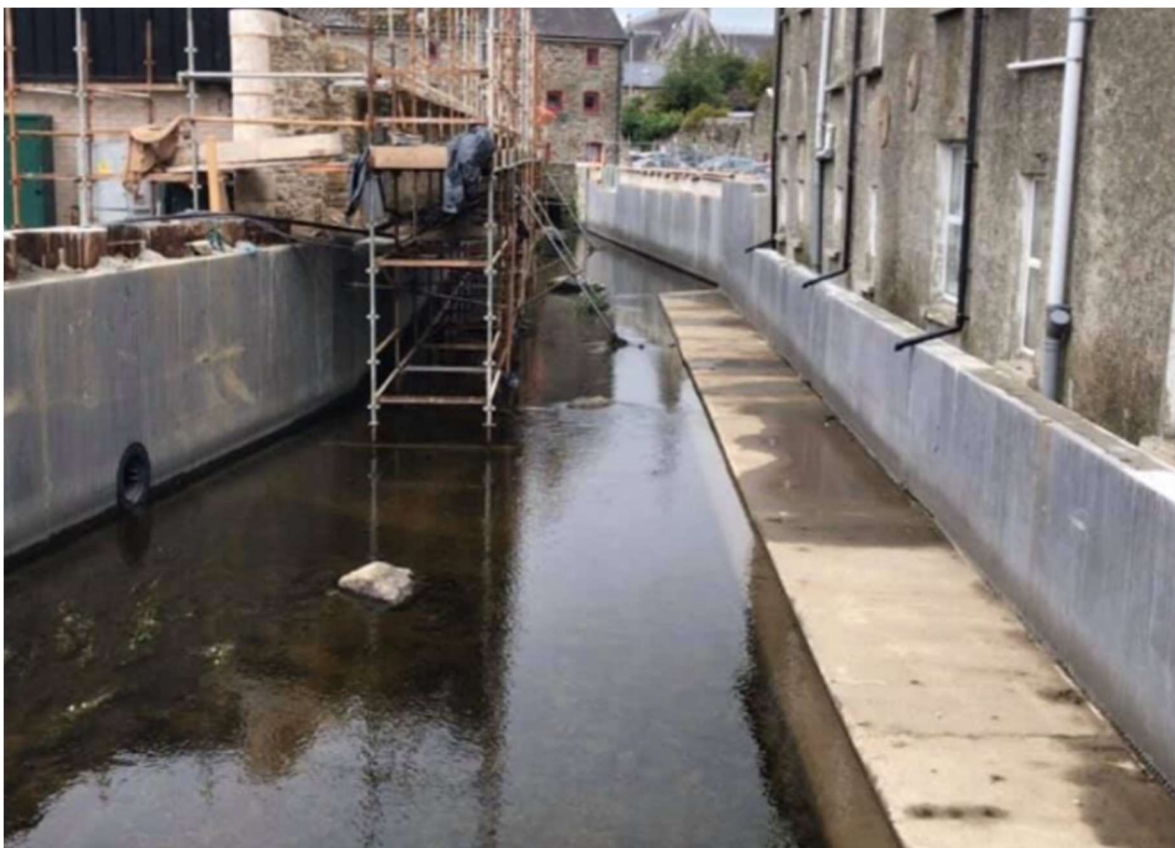
Figure 1-8: Example Wall Construction/Improvements (relevant to Turf Market and at The Globe)

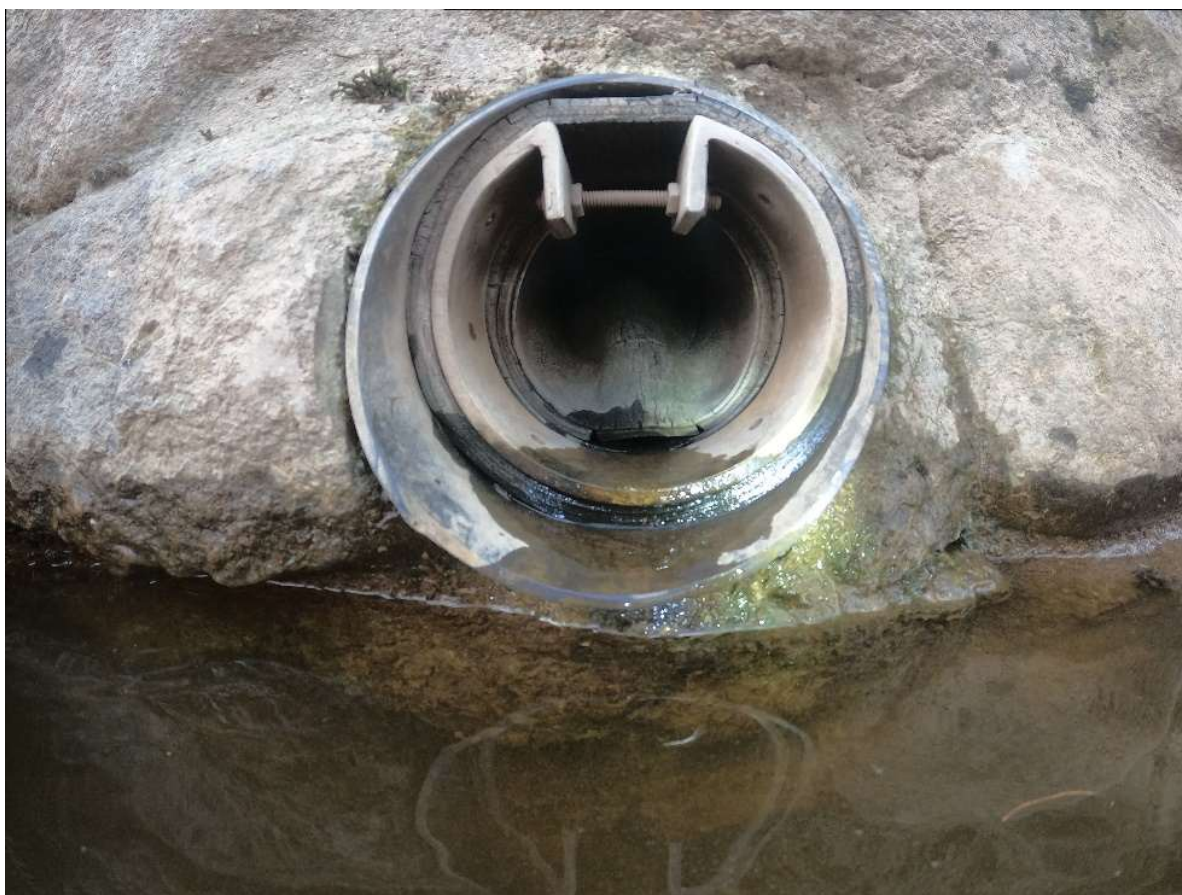
Non-return valves (NRVs) are placed on existing and proposed outfalls to ensure flood water do not back-up and surcharge the pipeline. They typical take the form of flap valves and in-line rubberised valves.

Figure 1-10: NRV placed on a pre-existing outfall in Graiguenamanagh.

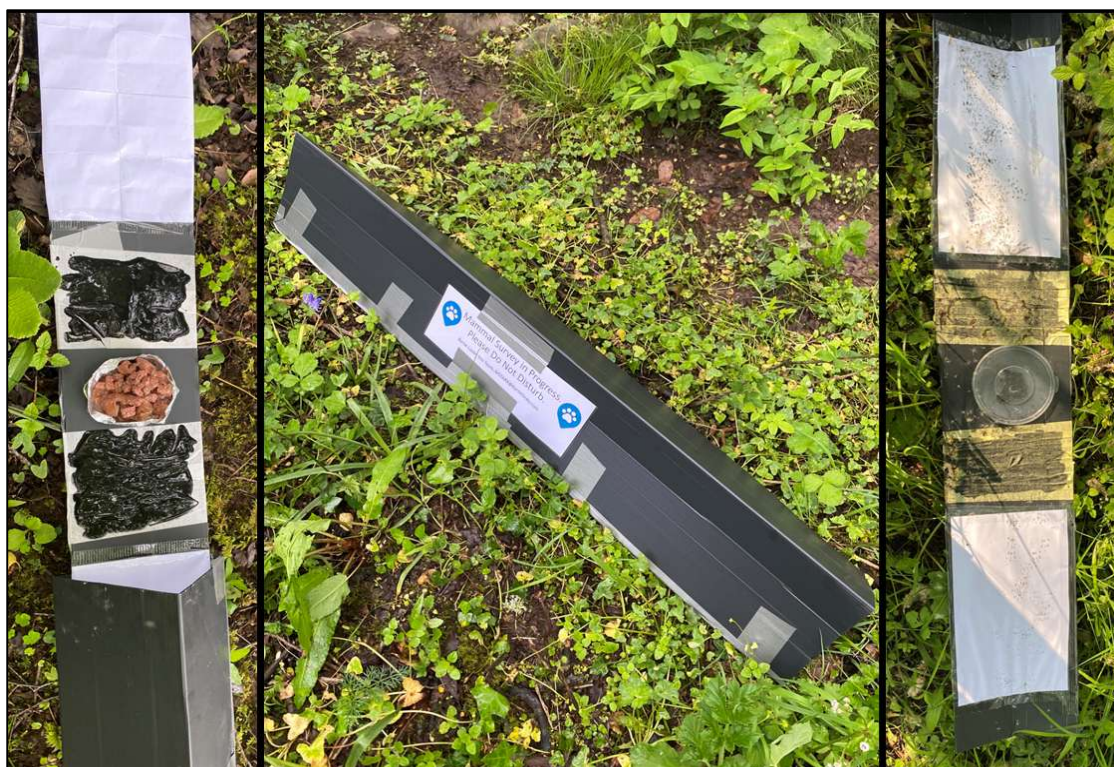
Additionally, strips of masking tape were used to serve as ink pads by pouring the ink on top of the tape placed on either side of the bowl. Two labelled A4 sheets were secured onto the bait tray at either end to be used as the tracking paper (Figure 3-6). Dog food pouches in jelly/gravy was used as bait for the mammal tunnels. Once the bait trays were set up, they were slid back into the triangular tunnel and pegged into position using camping pegs in suitable sheltered locations, namely along hedgerows and riverbanks. The tunnels were left in place for one week at locations indicated in Figure 3-7.

Figure 3-6: Mammal footprint tunnels (left: setup; right: results three days later).

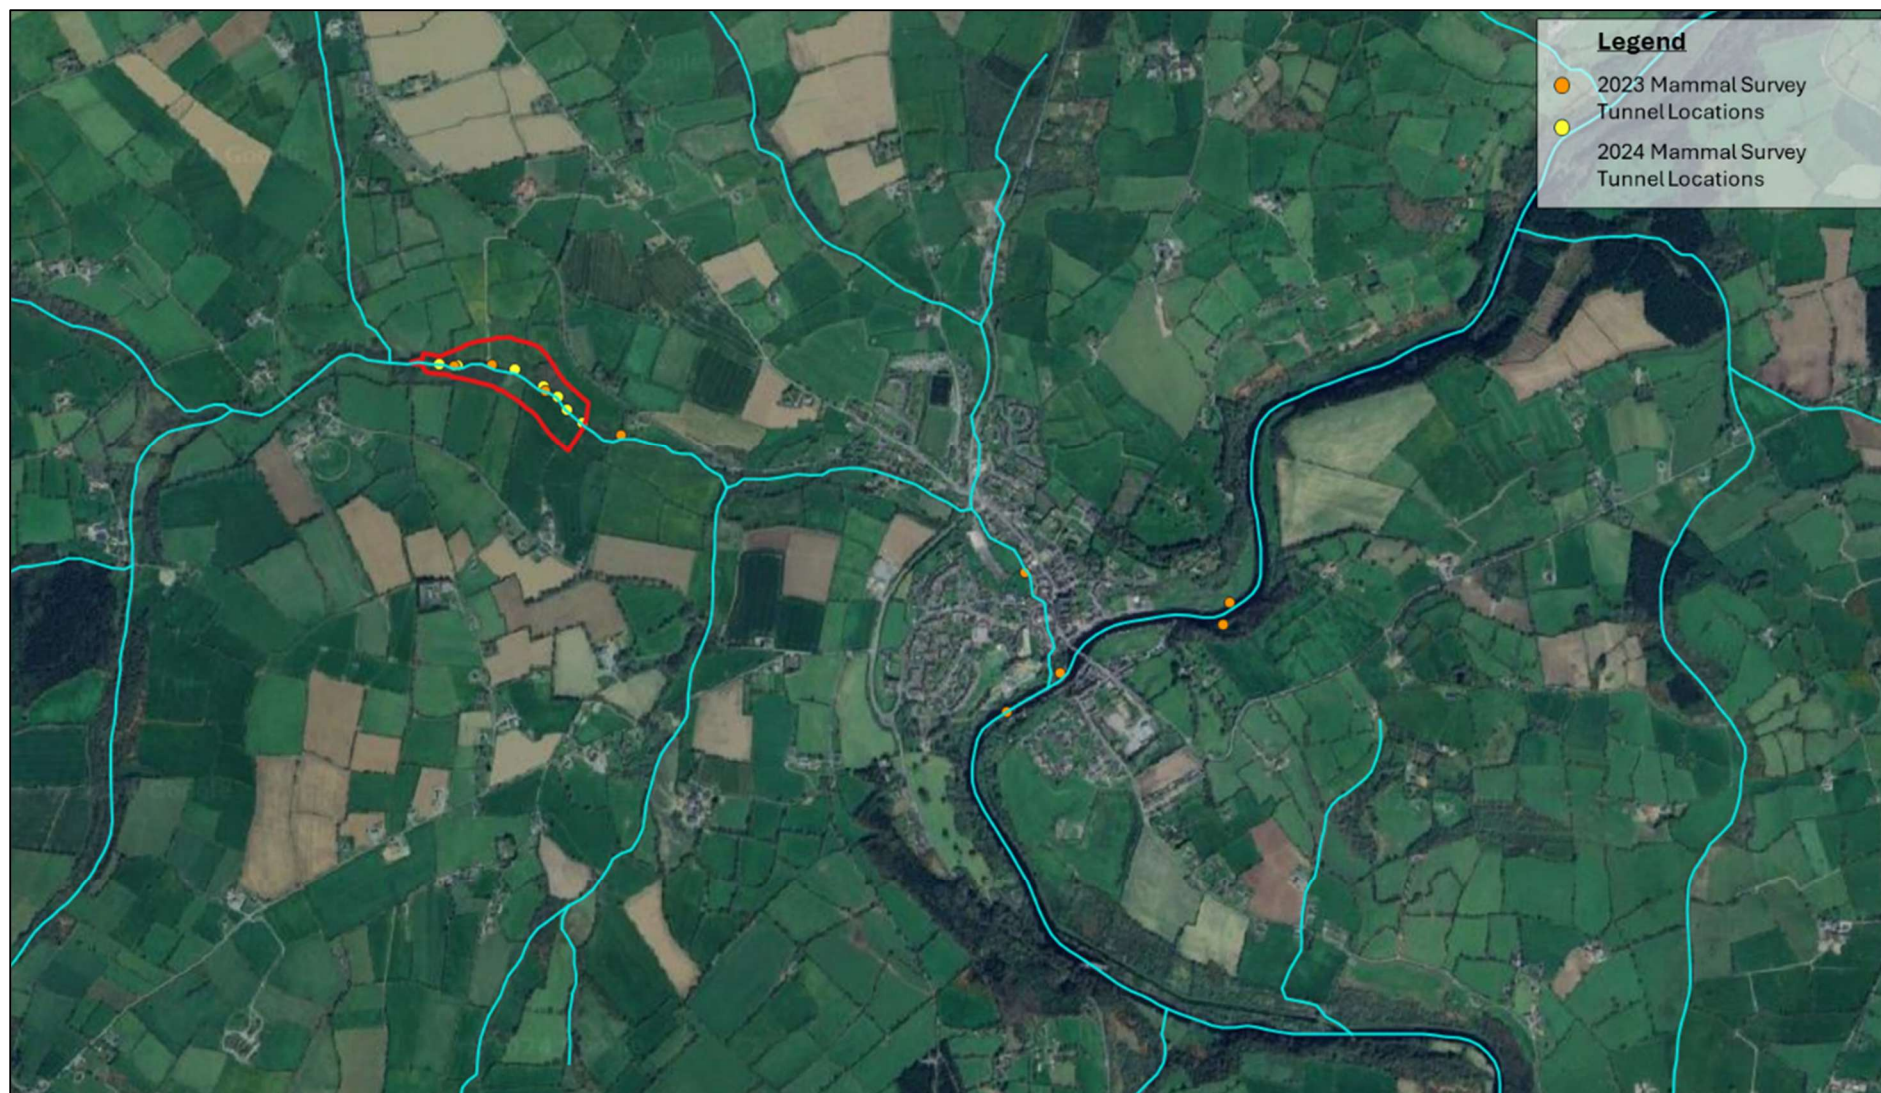
Figure 3-7: Locations of mammal tunnels utilised in the 2023 & 2024 surveys.

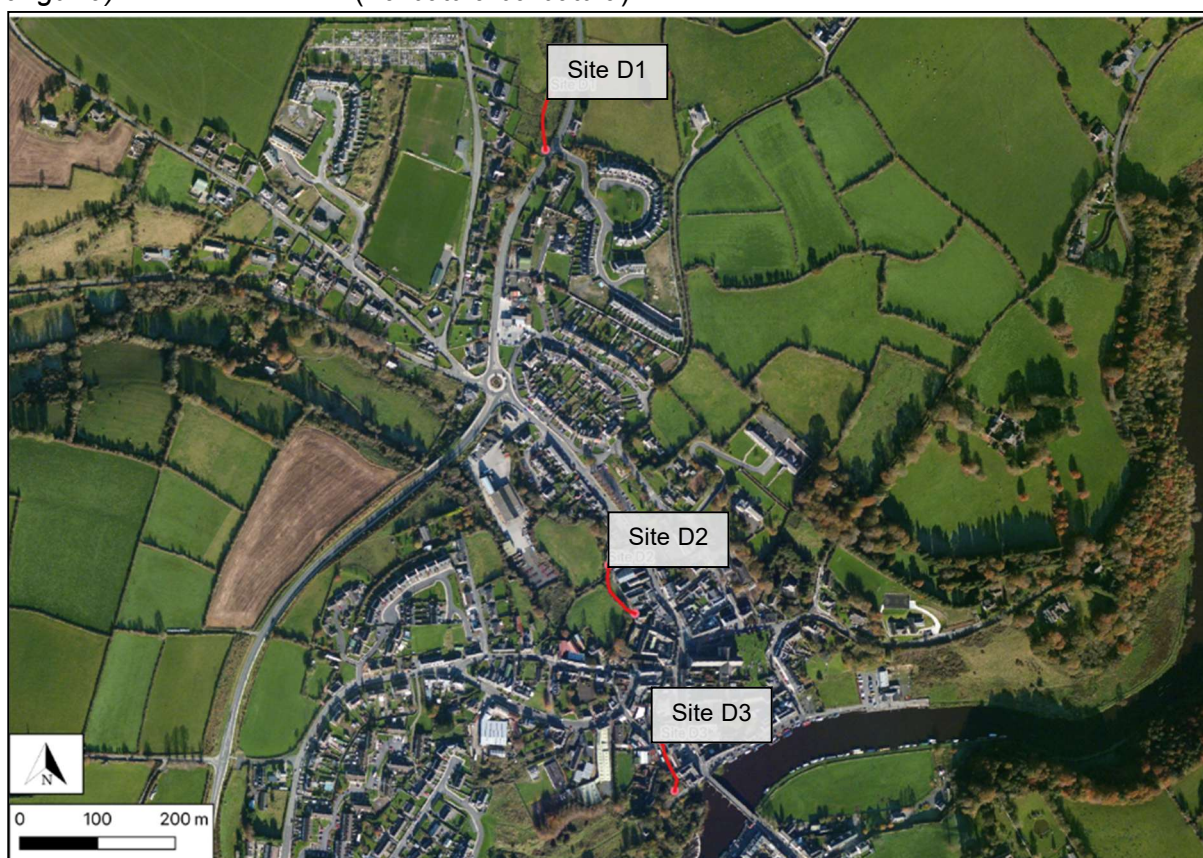
Figure 4-4: Electrofishing survey locations (Site D1, D2 and D3) – from AQUAFAC (2021)

Atlantic salmon was present at the two sites on the Duiske River but was absent at site D1 on the Graiguenamanagh Stream. Brown trout was present at all of the survey locations. Brook lamprey was present at two of the three sites being absent at the most downstream site D3. Eels were present at both sites on the Duiske River but were absent at site D1 on the Graiguenamanagh Stream. A single stone loach was found on the most downstream survey site D3. Results are presented in Table 4-3: Results of electrofishing survey (AQUAFAC, 2021).

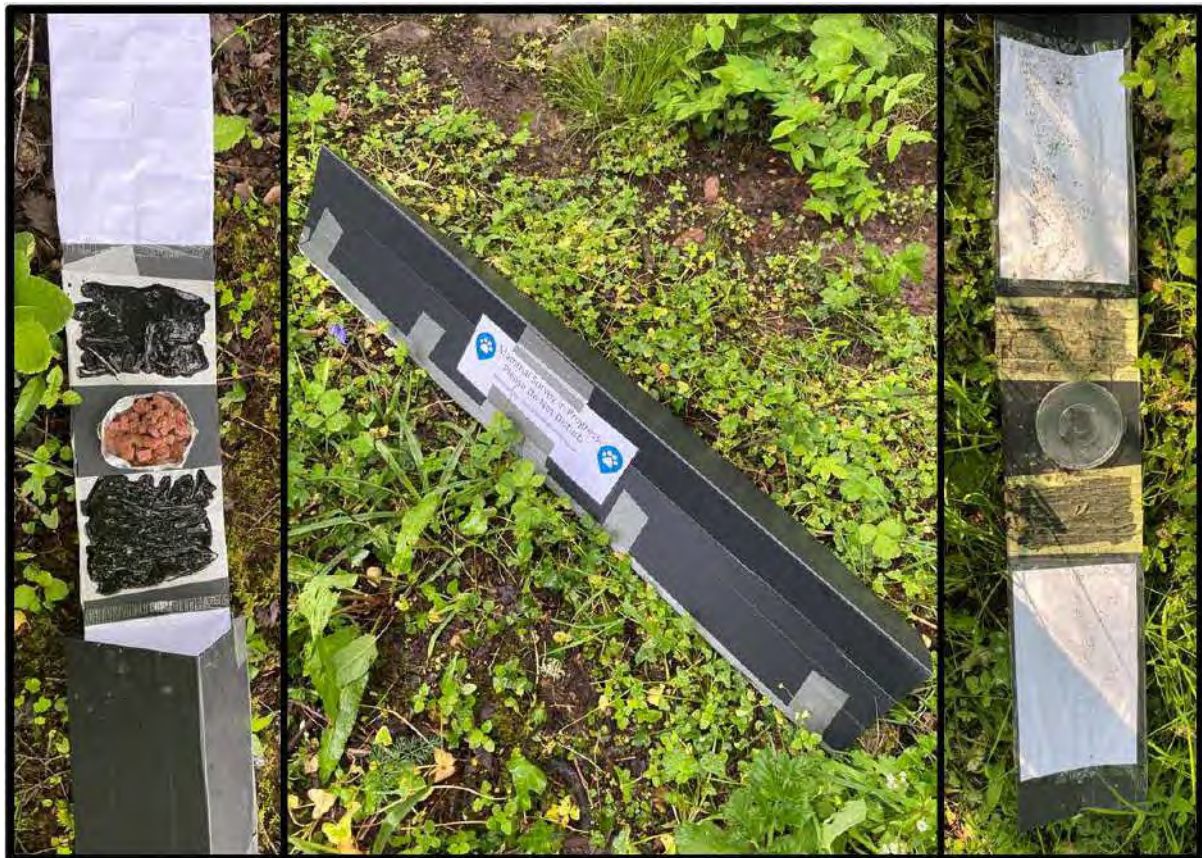
Additionally, strips of masking tape were also used to serve as ink pads by pouring the ink on top of the tape placed on either side of the bowl. Two labelled A4 sheets were secured onto the bait tray at either end to be used as the tracking paper (Figure 5-4). Dog food pouches in jelly/gravy was used as bait for the mammal tunnels. Once the bait trays were set up, they were slid back into the triangular tunnel and pegged into position using camping

Figure 5-4: Mammal Footprint Tunnels - setup and results three days later.

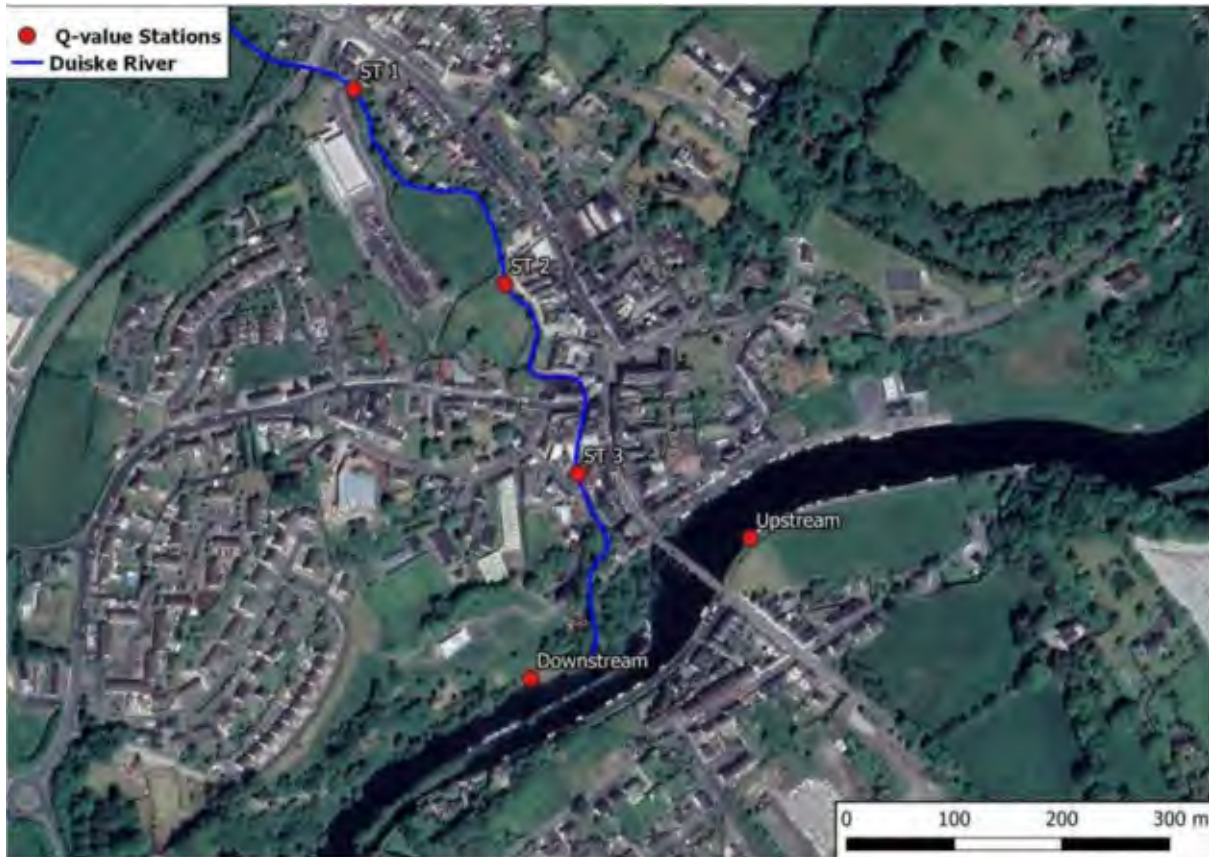
Five kick samples were taken, see Figure 8.1 and Table 8.1. Stream morphology at each station can be seen in Table 8.2. The two-minute kick and one minute stone wash sampling method was employed to collect samples of macroinvertebrates for analysis. This involved placing a standard hand net of pore size 500µm in the river, facing upstream and disturbing the riverbed in front of the net mouth. The ecologist then moved in a diagonal direction upstream to ensure that different micro-habitats were included in the sample. The kick method dislodges macroinvertebrates from the substrates and submerged plant material. This was continued for approximately two minutes and followed by one minute of stone washing.

Figure 8.1. Graiguenamanagh Q-value station locations.

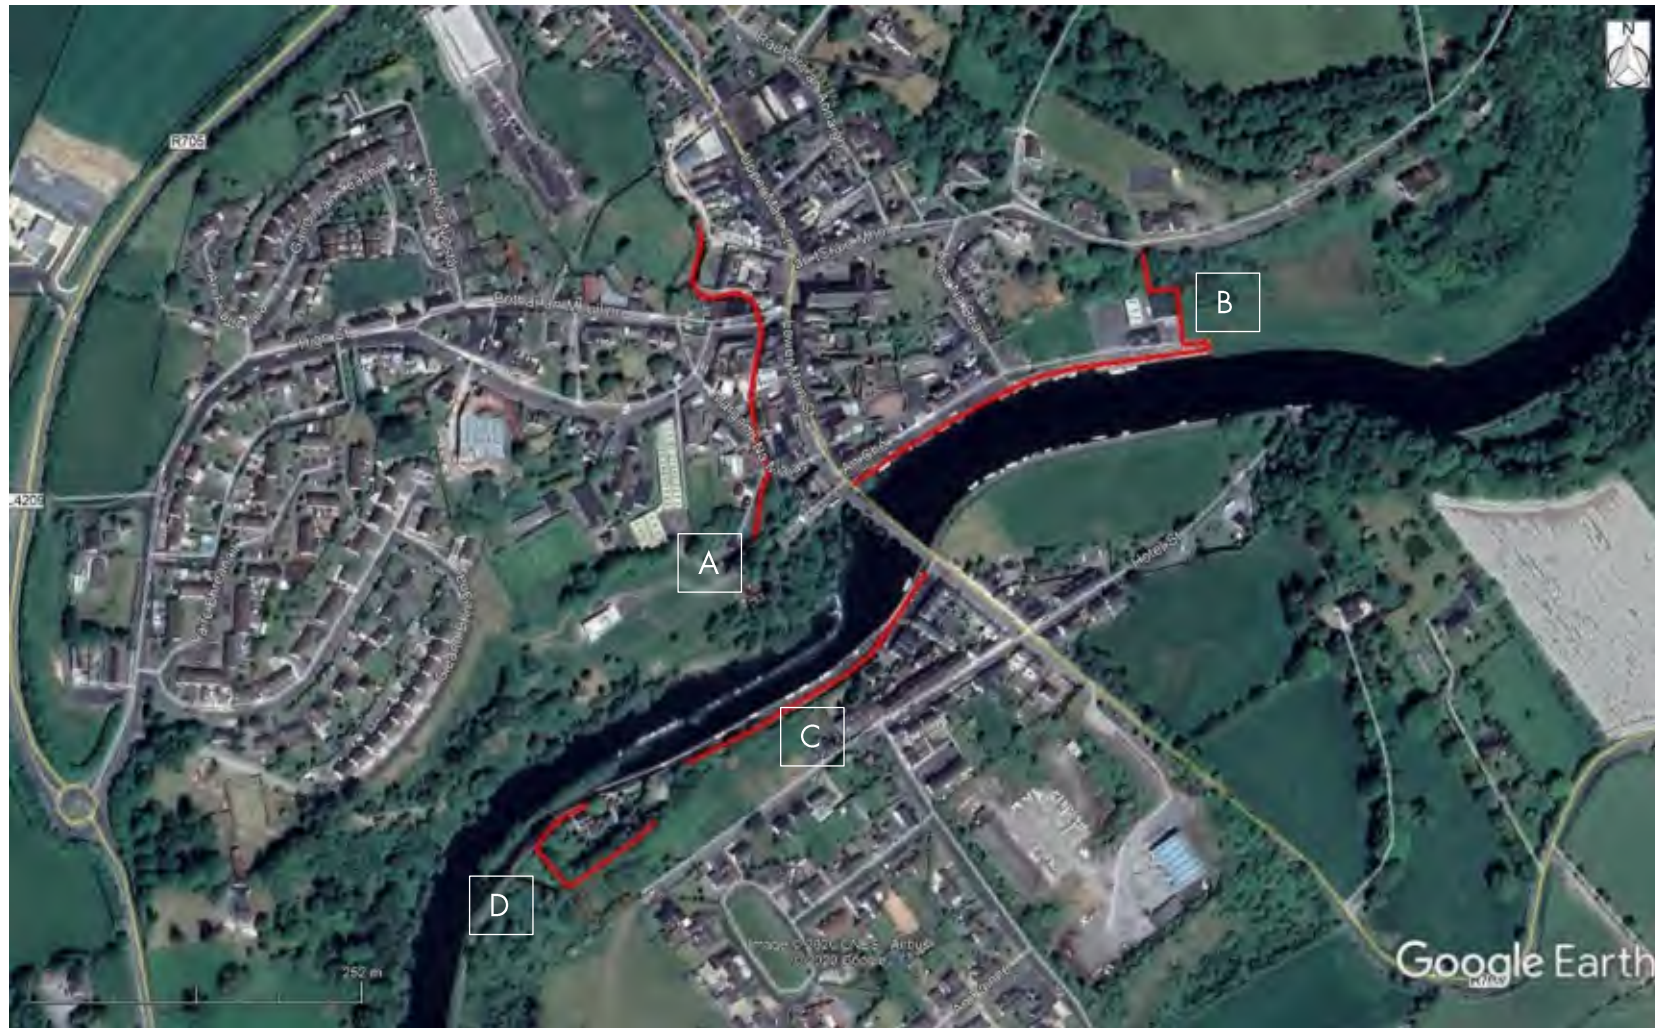
Figure 1.2. Graigenamanagh-Tinnahinch Bat Survey Routes (shown as red lines)

The survey area focused on the areas shown in Figure 1.2 where works are proposed to be implemented (as per correspondence from the OPW).

Graiguenamanagh-Tinnahinch is located on the border between counties Kilkenny and Carlow, where the River Barrow and the River Duiske converge. The town is known for its attractive examples of 18th and 19th-Century civil engineering structures and architecture. The survey routes A, B, C and D (as shown in Figure 1.2) are described below. All potential roost locations are shown in Figure 3.1 at the end of this section.

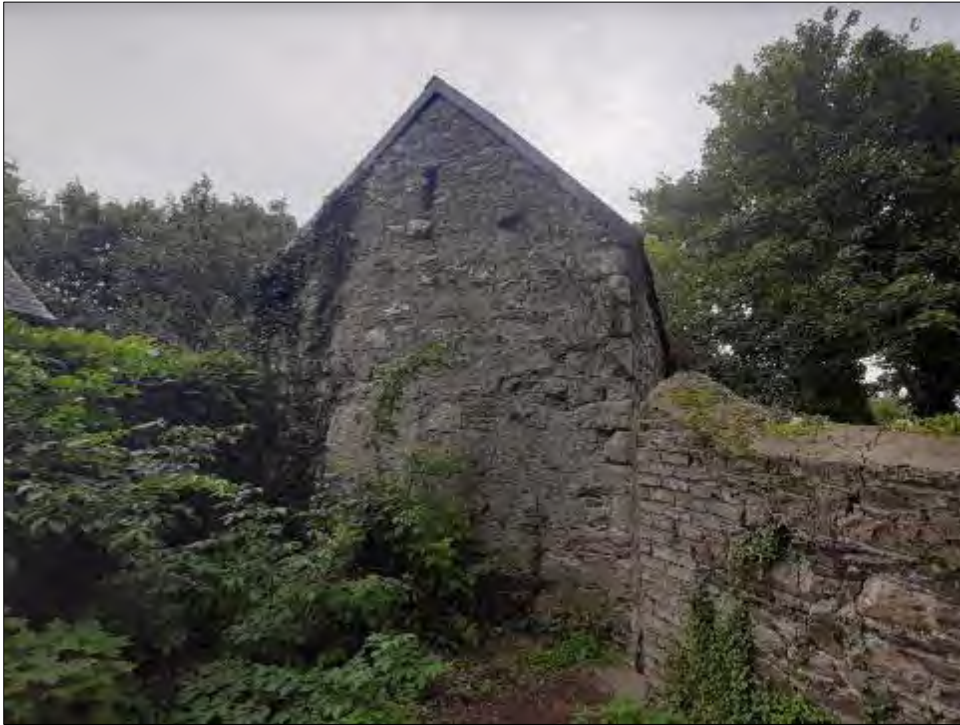
Figure 7.1. PR1 – note potential entry/exit point near top of gable end (14/09/20).

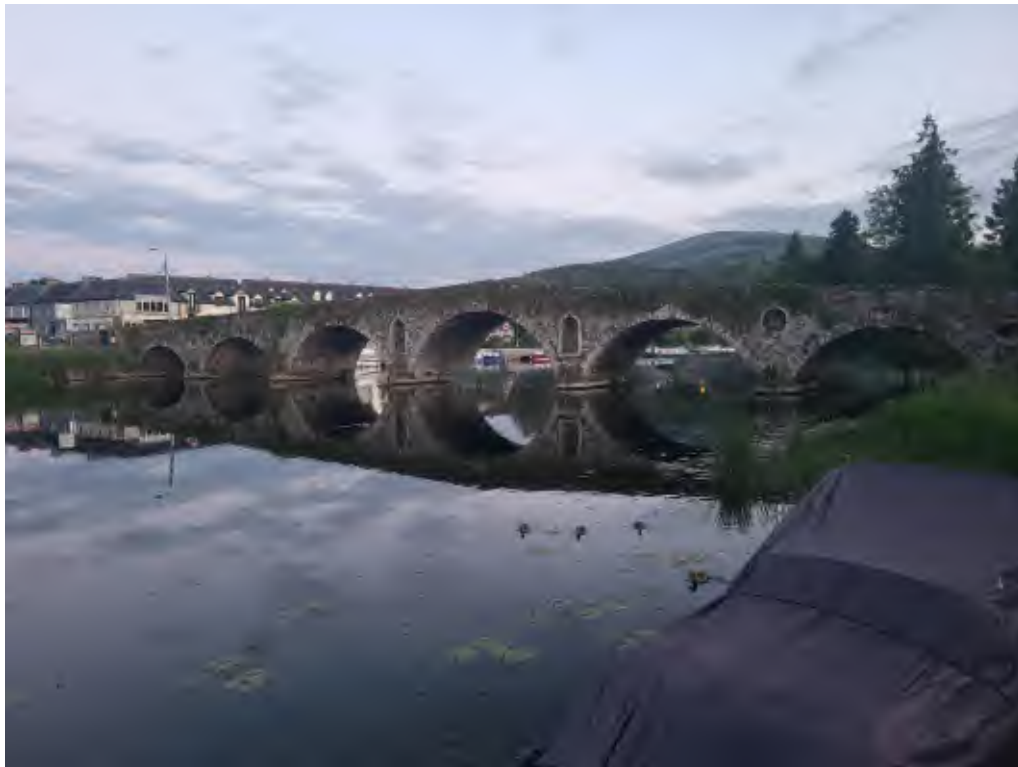
Main bridge in Graiguenamanagh (no Daubenton's roosts present)

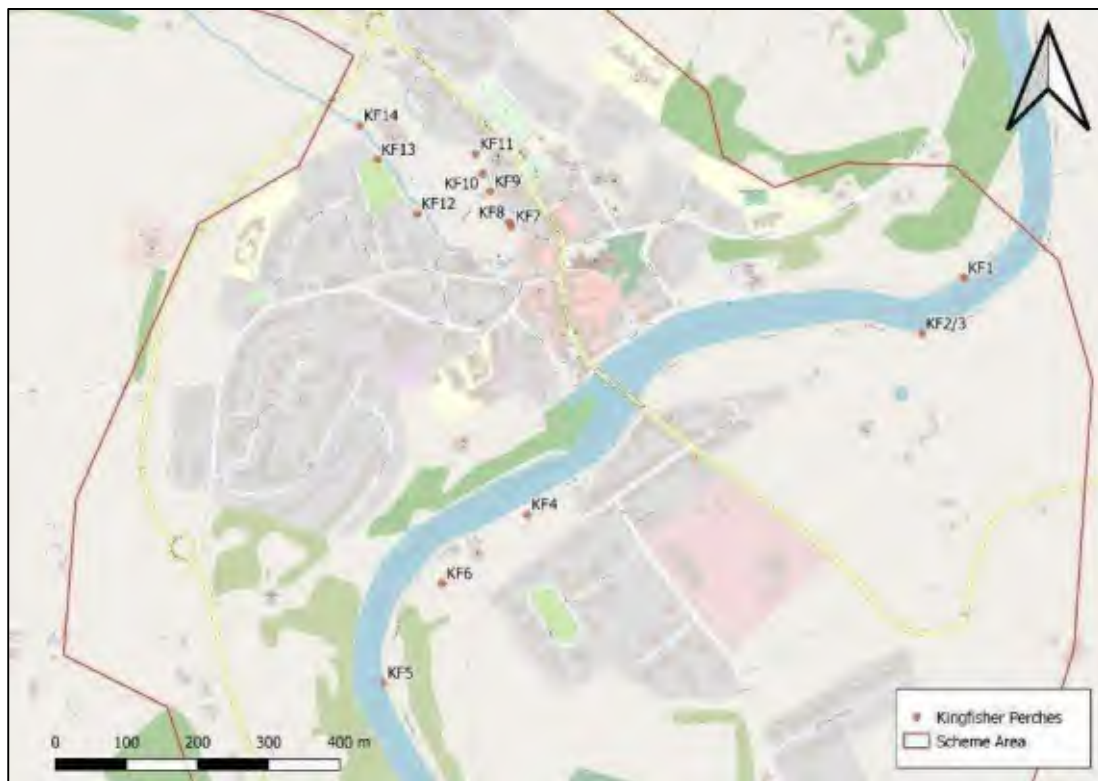
Figure E-1: Kingfisher Perches (KF1-KF14)

ID	Coordinates (ITM)	Notes
KF1	671422, 643799	Alder branches
KF2/3	671362, 643720	Ash branches
KF4	670806, 643465	Pollarded tree – species unconfirmed (probably willow)
KF5	670605, 643229	Ash branches
KF6	670688, 643377	Overhanging willow
KF7	670785, 643871	Willow branches
KF8	670781, 643876	Alder branches
KF9	670755, 643920	Alder branches
KF10	670744, 643945	Ash and sycamore branches
KF11	670735, 643972	Sycamore branches
KF12	670735, 643972	Overhanging ivy
KF13	670596, 643965	Steel bar associated with concrete structure on mill race
KF14	670572, 644012	Fallen branch (blackthorn) spanning mill race
KF15	670267, 644235	Collection of dead stumps and branches spanning Duiske
KF16	670226, 644244	Alder branches
KF17	670126, 644179	Fallen branches with ivy spanning Duiske
KF18	669975, 644210	Sycamore branches

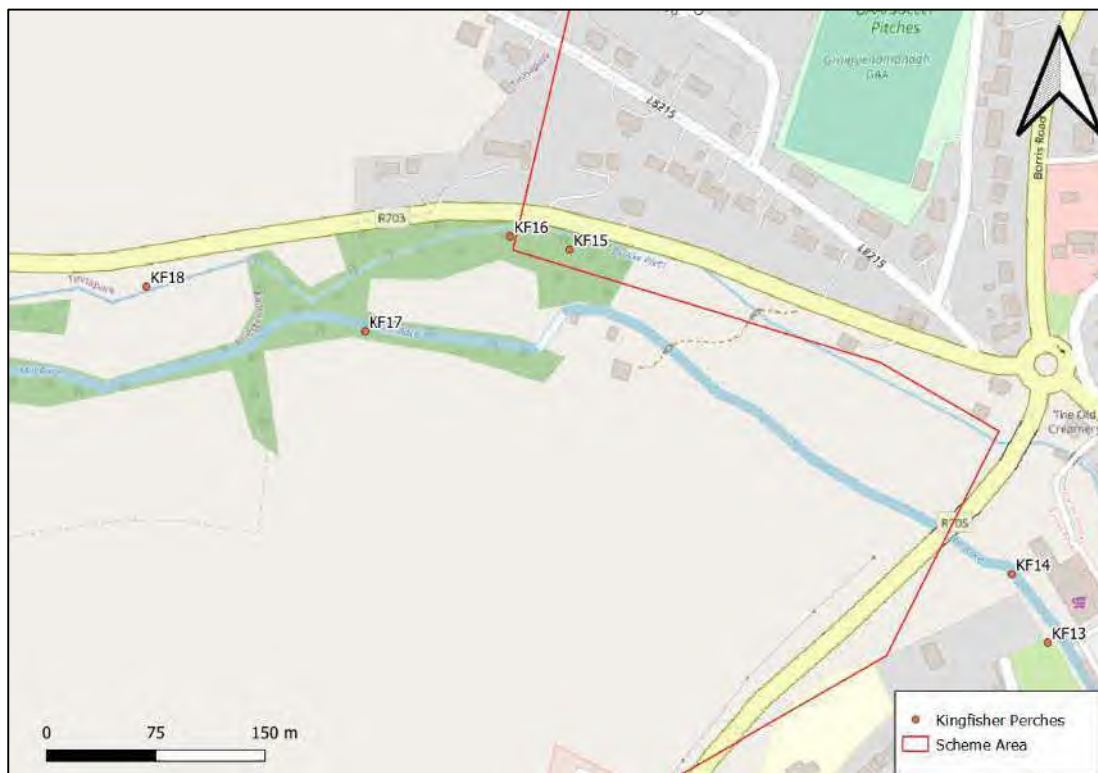
Figure E-2: Kingfisher Perches (KF15-KF18)

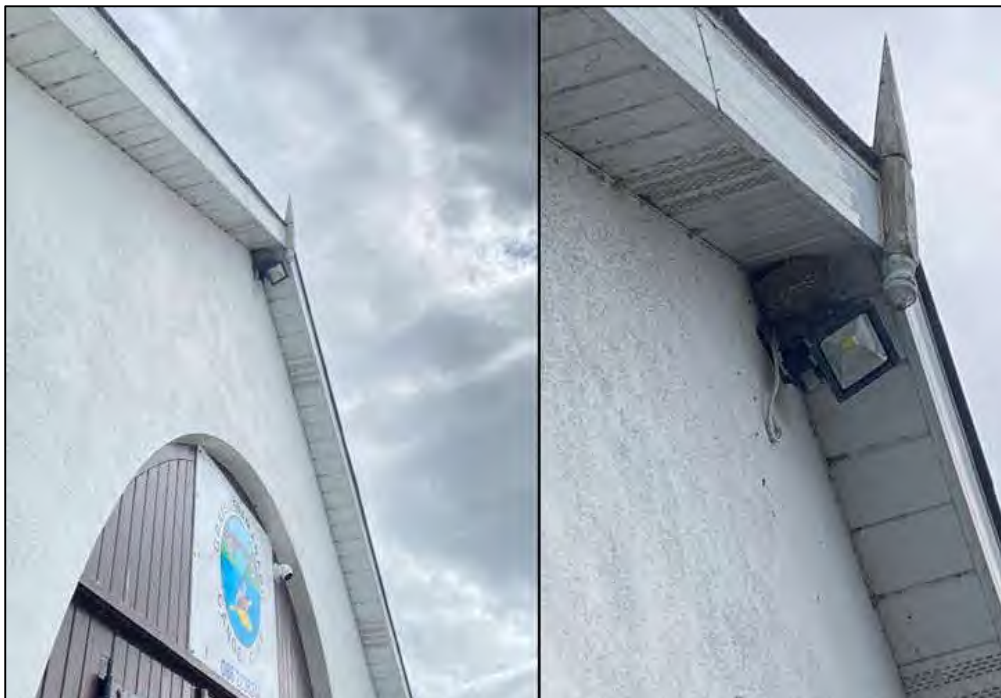
Figure F-2: House Martin nest seen at the top of the verge soffit on Graiguenamanagh-Tinnahinch Rowing Club. Birds seen exiting and entering - 23/05/2024.

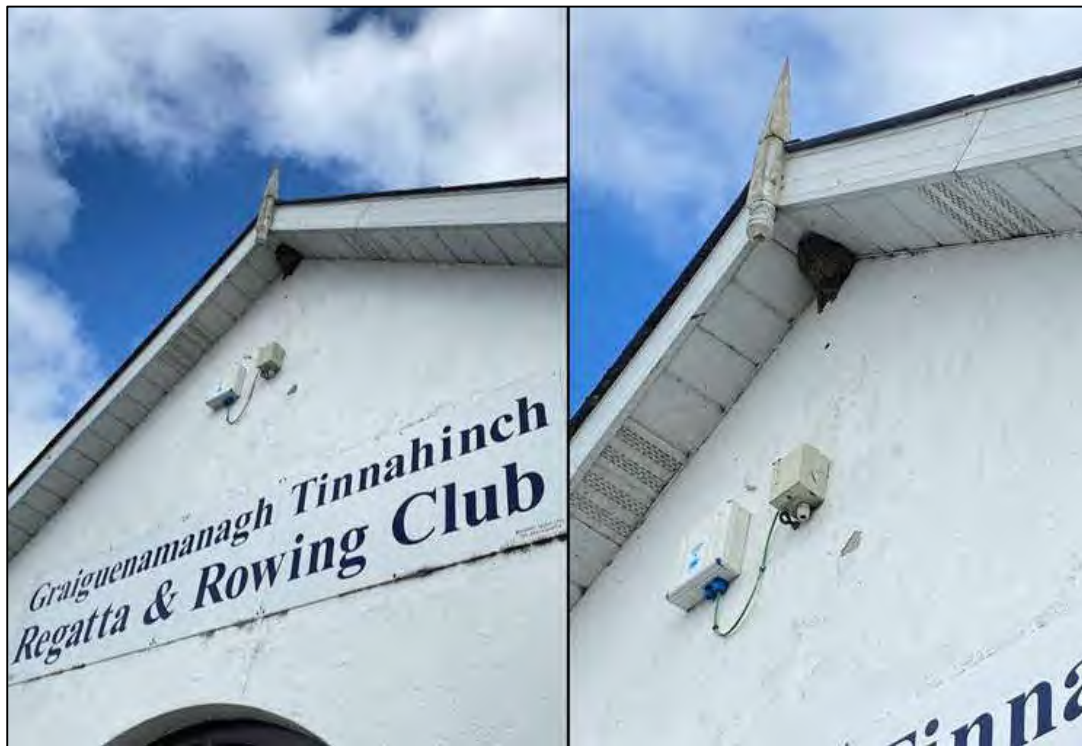
Figure F-3: House Martin nest seen at the top of the verge soffit on Graiguenamanagh-Tinnahinch Rowing Club. Birds seen exiting and entering - 23/05/2024.

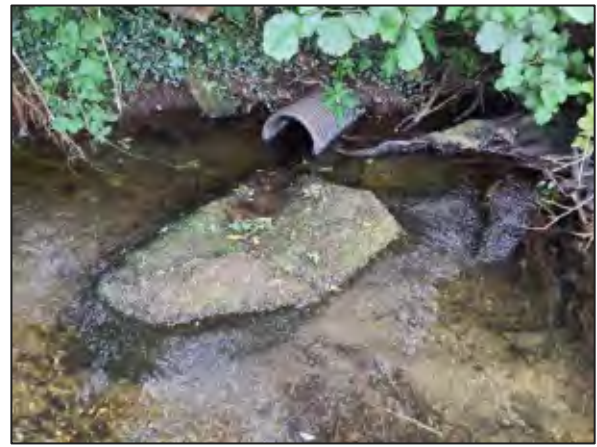
Plate 22 Land drain outflow -2

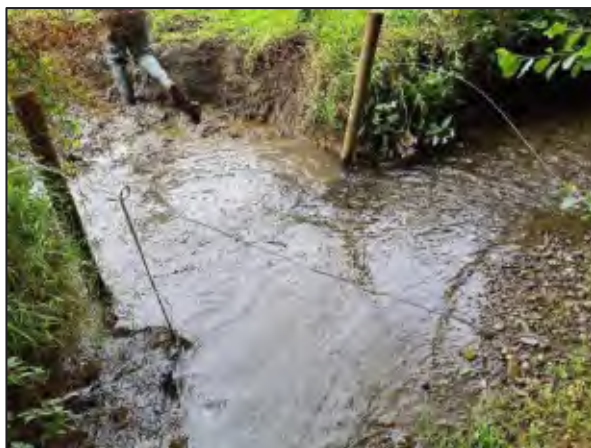
Plate 23 Livestock access point with poaching

Himalayan Balsam, *Impatiens glandulifera*, is present on both banks along the entire stretch of the surveyed river, with dense areas being observed (Figure 7), including at the area of proposed works (Plate 19-Plate 20). Areas of suboptimal silted spawning habitat for salmonids were observed downstream, as well as at areas of the channel impacted by poaching from livestock (Plate 15-Plate 16, Plate 23).

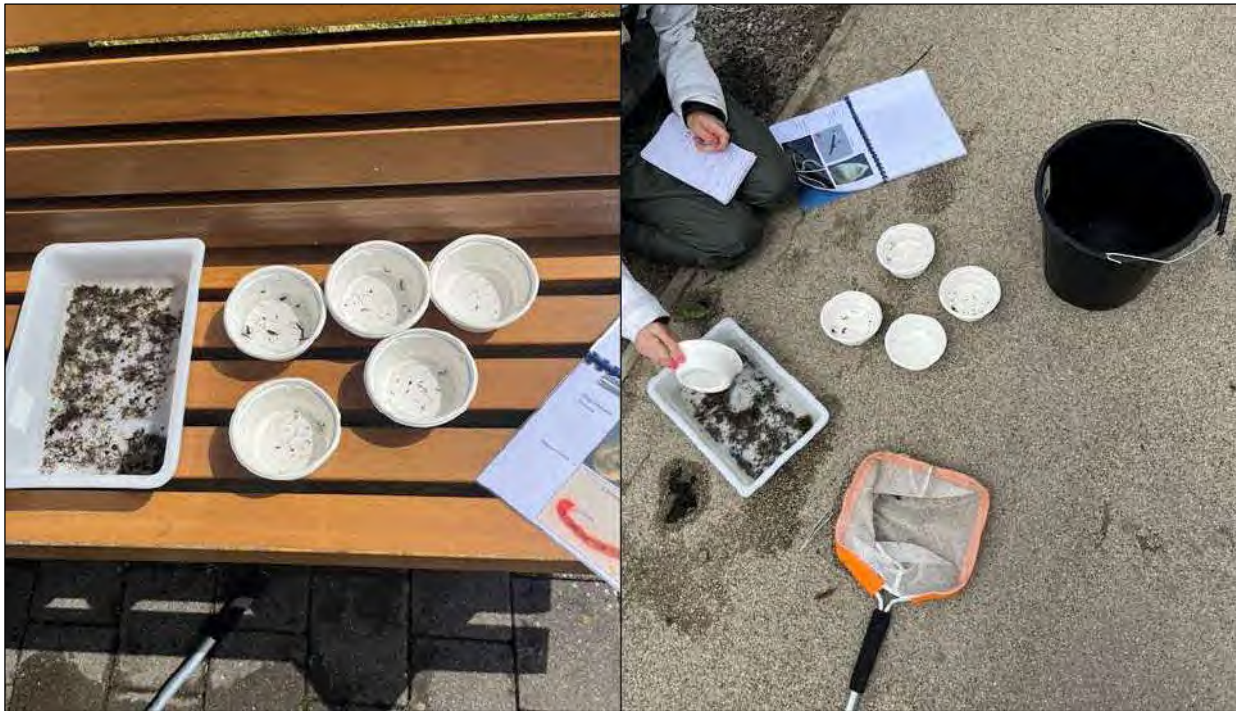
Figure L.1: Kick Sample equipment and set up for examining invertebrates – 27/06/2024.

The EPA Q-value classification is assigned based on the assessment of a macroinvertebrate sample, which involves recording the taxa present at a suitable and attainable taxonomic resolution (under field conditions) and their categorical relative abundance determined using approximate counts (as described in Feeley *et al.*, 2020). From this, the number of taxa present and categorical relative abundance of sensitive (Group A), less sensitive (Group B), tolerant (Group C), very tolerant (Group D) and most tolerant (Group E) taxa to organic pollution is examined. Additional Qualifying Criteria are also considered, consisting of recording the abundance of *Cladophora* spp, macrophytes, and slime growths / sewage fungus, as well as dissolved oxygen percent saturation and the level of substratum siltation. Then, based on the combination of number and relative abundance of the sensitive or tolerant groups present, a Q-value is assigned. Details on the assignment of the scores can be found in Toner *et al.*, (2005).
