Appropriate Assessment

Graiguenamanagh-Tinnahinch Flood Relief Scheme

Report No. W3451-AYE-ENV-R010

Kilkenny County Council

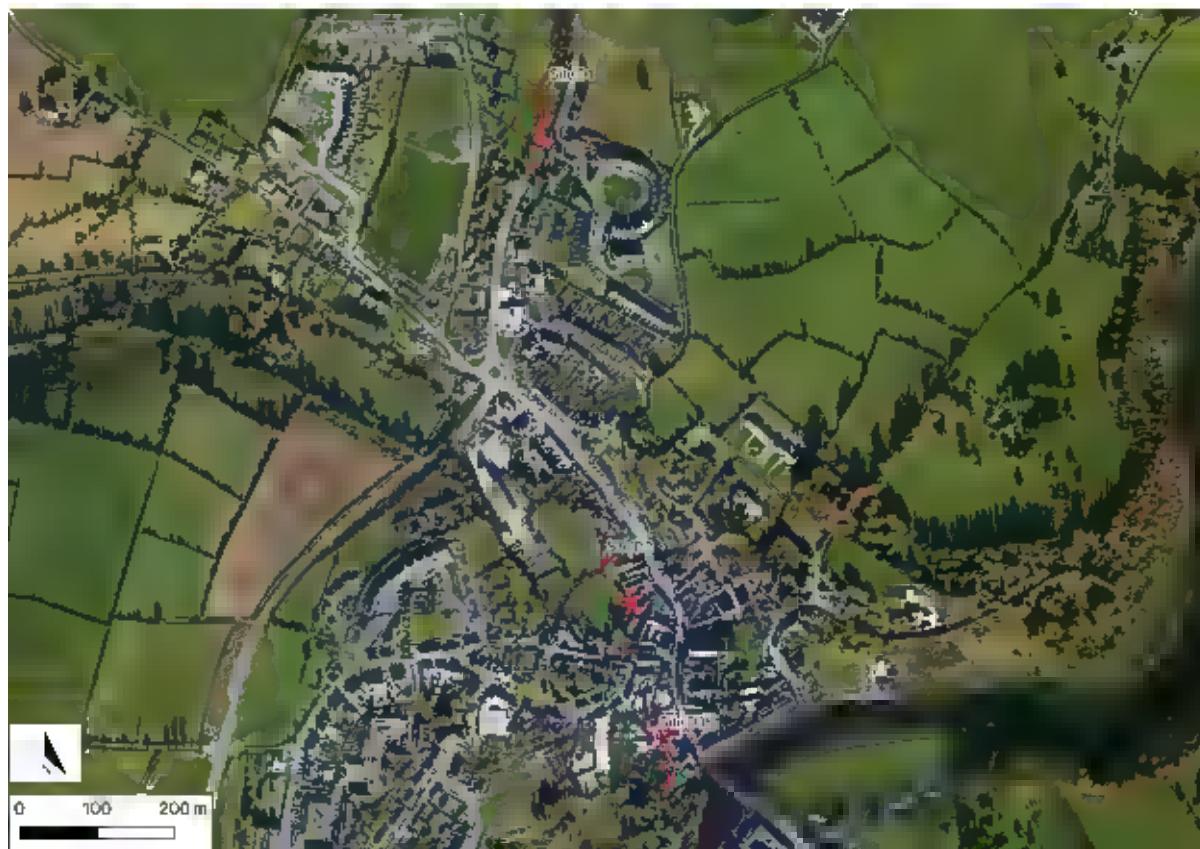
Figure 1: Map showing the three electrofishing locations on the Duiske River and the Graiguenamanagh Stream.

Site D1 - Graiguenamanagh Stream	Conductivity (µS/cm)	317	
Date: 10th February 2021	Temperature °C	5.7	
River conditions: Base flow and clear	Elapsed Time	600s	
	Fishing Time	450s	
Elevation: 37m	GPS us end (dd)	52.54755206	6.958477104
	GPS ds start (dd)	52.54687845	6.958537284
	Site Dimensions and Area	90m*1.5m	135m ²

Site D2 - Duiske (Well Lane footbridge)	Conductivity (µS/cm)	236	
Date: 10th February 2021	Temperature °C	6.4	
River conditions: Base flow and clear	Elapsed Time	600s	
	Fishing Time	380s	
Elevation: 16m	GPS us end (dd)	52.54212717	6.956910104
	GPS ds start (dd)	52.54158303	6.956362787
	Site Dimensions and Area	70m*4m	280m ²

Site D3 - Duiske, Graignamanagh Town centre	Conductivity (µS/cm)	236	
Date: 10th February 2021	Temperature °C	6.4	
River conditions: Base flow and clear	Elapsed Time	600s	
	Fishing Time	320s	
Elevation: 20m	GPS us end (dd)	52.5401302	6.955719109
	GPS ds start (dd)	52.53956131	-6.95542303
	Site Dimensions and Area	50m*4m	200m ²

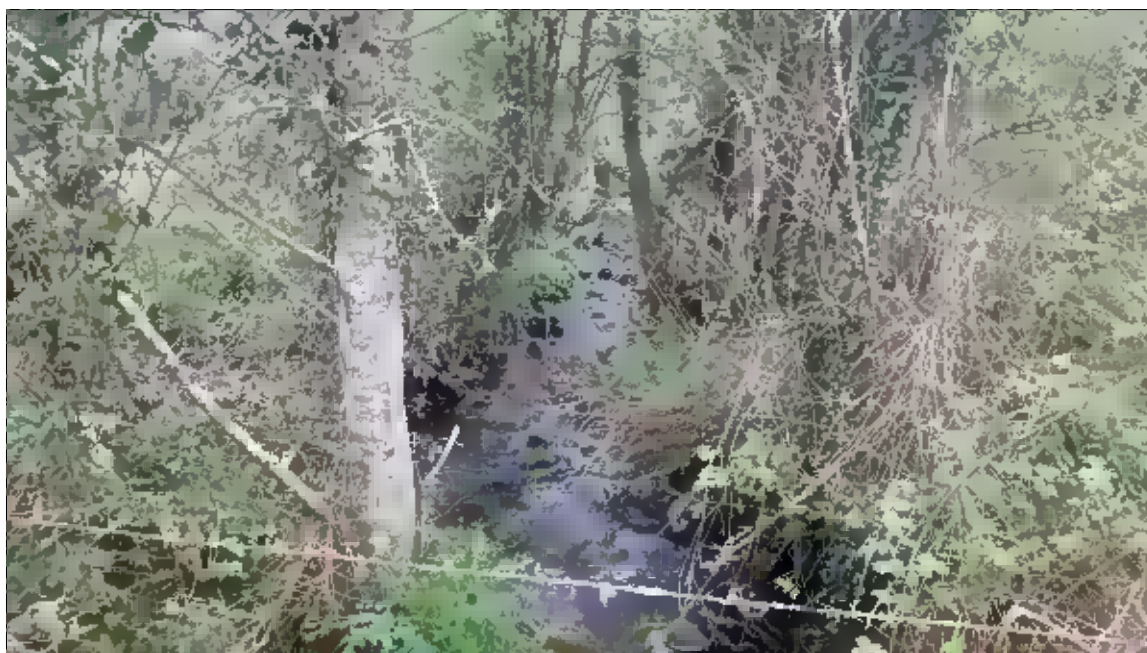
Plate 3.1 Site D1 on the Duiske River at the Tinnapark River confluence.

Site D1 was located on the Duiske River at the Tinnapark River confluence, upstream of the proposed flood relief scheme boundary. Here, the Duiske River was a largely natural, high-energy upland eroding watercourse (FW1; Fossitt, 2000). The narrow channel averaged 2-2.5m wide and 0.1-0.3m deep in a habitat dominated by fast glide and riffle with only localised pool (0.7m max.). Given high flow rates, the site featured partially bedded (locally heavily bedded) substrata. Despite frequent boulder, these were bedded with silt which precluded crayfish access to potential refugia. Cover of filamentous algae was moderate. The river was bordered by narrow but mature riparian treelines supporting alder (*Alnus glutinosa*), willow (*Salix* sp.) and ash (*Fraxinus excelsior*) with scrubby understories. Shading was moderate and this resulted in low instream growth, with macrophytes limited to marginal hemlock water dropwort (*Oenanthe crocata*). The aquatic moss *Platyhypnidium riparoides* was common on instream boulder with *Hygroamblystegium* sp. occasional. The red alga *Lemanea* sp., characteristic of high-energy watercourses, was also occasional.

No white-clawed crayfish were recorded via sweep-netting or hand-searching of $n=25$ instream refugia (*i.e.* boulder and large woody debris). Although some tree root systems provided some potential habitat, refugia were typically not accessible to crayfish (bedded/compacted) and the banks were not suitable for crayfish burrowing. The high energy nature of the site was sub-optimal for the species. Superior crayfish habitat was present further downstream.

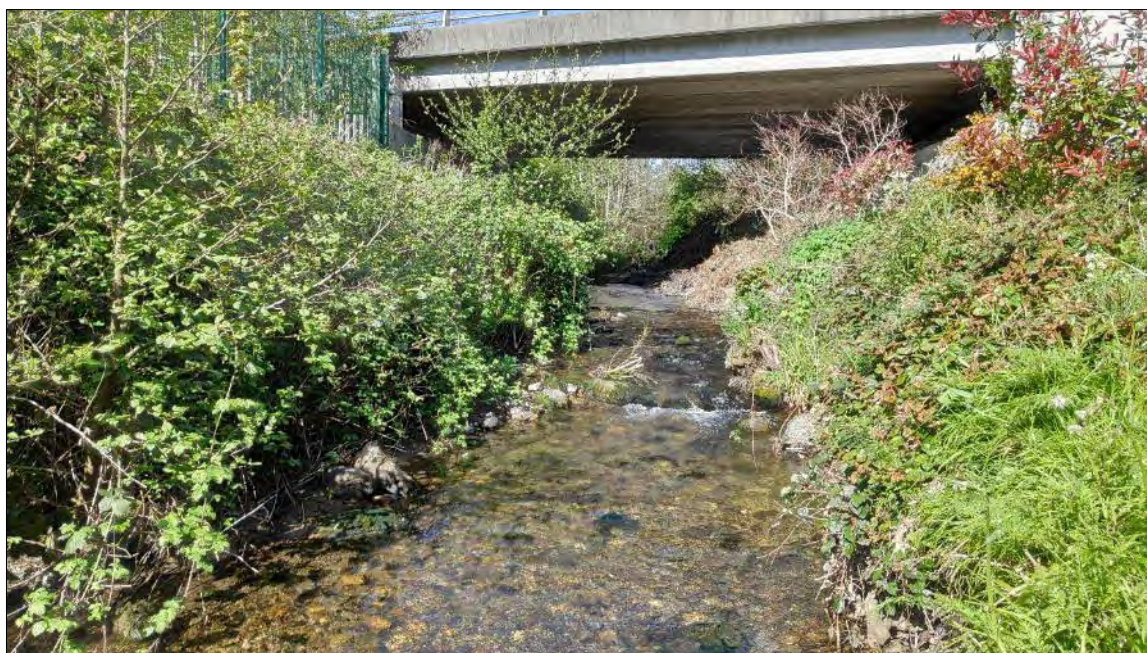
Plate 3.2 The modified Duiske River downstream of the R705 road bridge

No white-clawed crayfish were recorded via sweep-netting or hand-searching of $n=25$ instream refugia (*i.e.* boulder and cobble). Given high flow rates, refugia were typically not accessible to crayfish (bedded/compacted) and the banks were not suitable for crayfish burrowing. The high energy nature of the site was sub-optimal for the species. Superior crayfish habitat was present further downstream.

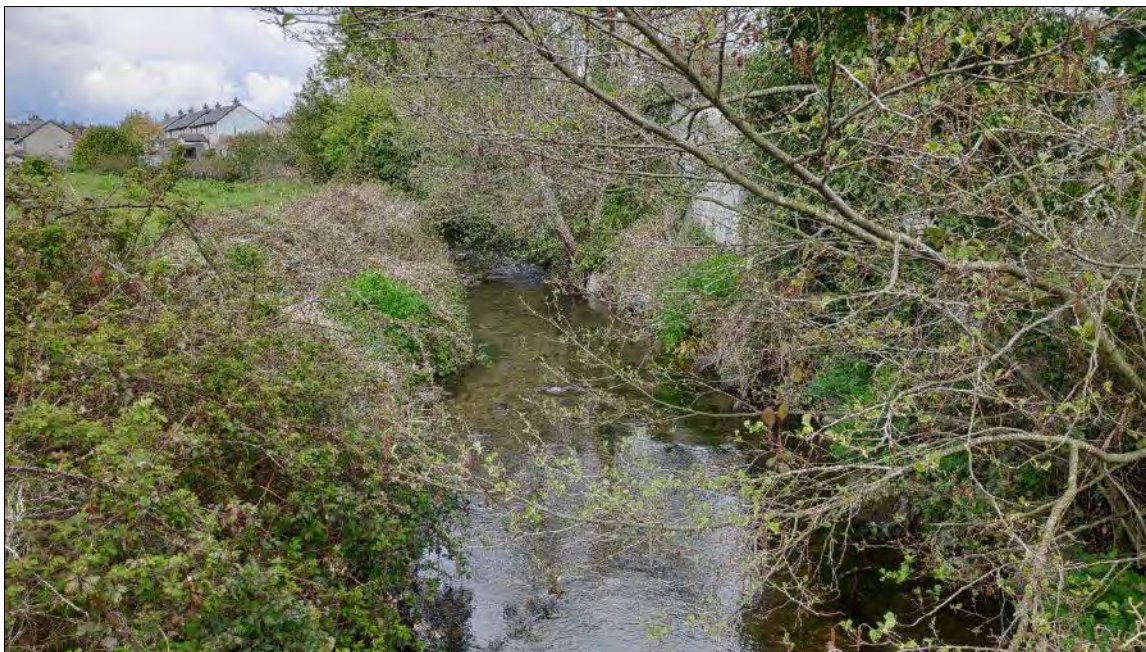
Plate 3.3 The Duiske River facing upstream of the Well Lane footbridge.

Site D3 on the Duiske River was located at the Well Lane footbridge (**Figure 2.1**). The river averaged 2.5-3m in width and 0.1-0.3m in depth. The upland eroding watercourse (FW1) was slower-flowing than upstream sites but still characterised by swift, shallow glide with occasional riffles and only localised pool (1m max.). The riverbed featured more in the way of mixed gravels and coarse sand, though the predominant substrata was still cobble with frequent boulder. The substrata were moderately compacted but still accessible to crayfish. Some limited sand/silt accumulations were present in the vicinity of the bridge. Natural scouring has resulted in the western bank being substantially undercut (underneath an adjoining hedgerow/scrub). The site was bordered by scattered treelines of alder and scrub dominated by bramble (*Rubus fruticosus* agg.). Water crowfoot (*Ranunculus* sp.) was frequent downstream of the bridge with hemlock water dropwort (margins only) and *Platyhypnidium riparoides* common. Filamentous algal cover was relatively low but present (*Cladophora* sp.).

Despite some good suitability, no white-clawed crayfish were recorded via sweep-netting or hand-searching of $n=25$ instream refugia (*i.e.* boulders, cobbles, macrophyte beds and undercut banks). The crayfish habitat was much improved over upstream sites given the presence of instream macrophyte beds and undercut banks (featuring tree root systems). However, though less compacted compared with upstream areas, the boulder and cobble substrata were still partially bedded. Nonetheless, many were accessible to crayfish but none were recorded. Otter spraint recorded underneath the footbridge did not contain any crayfish remains.

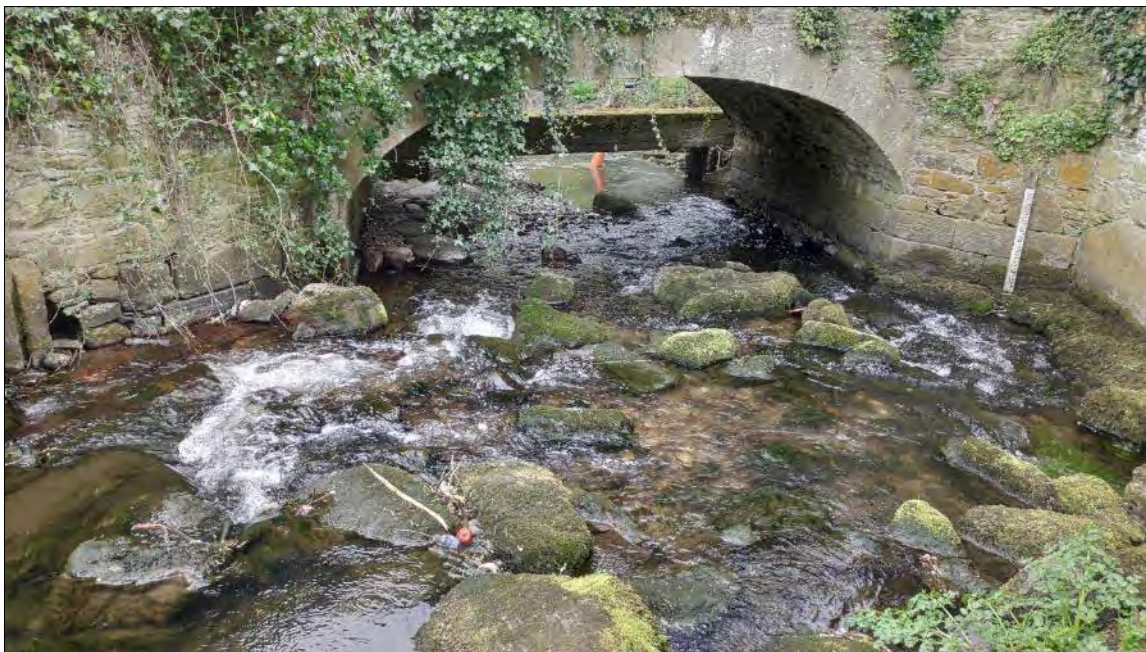
Plate 3.4 Site D4 on the lower reaches of the Duiske River (facing downstream towards bridge).

Site D4 was located at Old Dock Bridge on the lower reaches of the Duiske River, approx. 90m upstream of the River Barrow confluence (**Figure 2.1**). The upland eroding watercourse (FW1) had been historically modified and straightened locally, with retaining walls on both banks. Good recovery was evident. The channel was 3-3.5m wide and 0.2-0.5m deep, with fast-flowing glide predominating. Small pools to 1m were associated with upstream meanders. The substrata were dominated by boulder and cobble with small patches of interstitial gravel/coarse sand. Siltation was low given the high flow rates. Enrichment was evident with abundant filamentous algal cover on substrata (*Cladophora* sp. & *Vaucheria* sp.) as well as high amounts of floc. These substrata were bedded/compacted given the high flow rates of the river (as observed upstream). Instream macrophytes were limited to occasional hemlock water dropwort with a relatively high coverage of bryophytes such as *Platyhypnidium riparoides*.

Despite some moderate suitability, no white-clawed crayfish were recorded via sweep-netting or hand-searching of $n=25$ instream refugia (*i.e.* boulders, cobbles). Boulder refugia, whilst frequent, were invariably inaccessible to crayfish given high compaction/bedding of the substrata. Some refugia such as tree roots and flood walls were present but no crayfish were recorded. Otter spraint recorded at the site did not contain any crayfish remains.

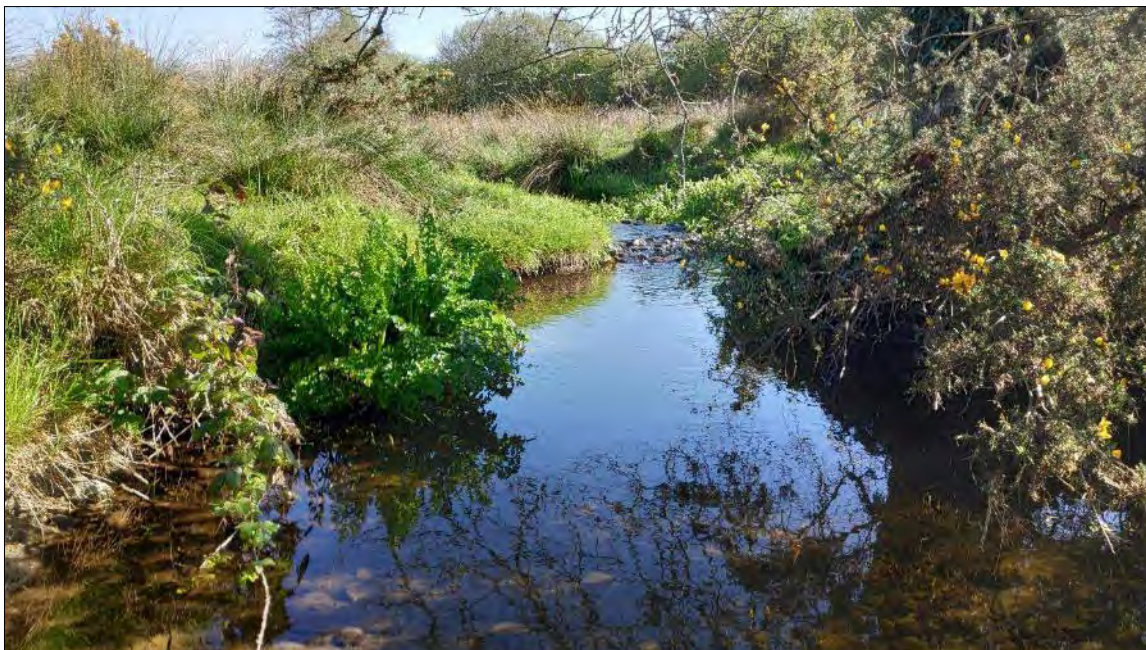
Plate 3.5 Representative image of site G1 on the upper Graiguenamanagh River.

Site G1 was located on the upper reaches of the Graiguenamanagh River, upstream of an extensive culvert to the Duiske River (**Figure 2.1**). The river represented a small, swift-flowing lowland depositing watercourse (FW2) with a semi-natural profile featuring frequent meanders with riffle, glide and pool sequences. The channel width varied between 1.5-2m with low banks (0.5m bank height). The river was shallow and averaged 0.1-0.2m deep with very occasional pools to 0.3-0.7m max. The bed comprised of mixed large cobble, coarse, medium and fine gravels and sand with frequent silt. The substrata were compacted with moderate siltation that increased in depositing pool areas. Boulder was also present but localised. The exposed hard substrata on the channel margins supported frequent hemlock water dropwort with occasional fool's watercress (*Apium nodiflorum*), lesser water parsnip (*Berula erecta*) and water mint (*Mentha aquatica*). The riparian zone was dominated by open pasture with abundant soft rush (*Juncus effusus*), gorse (*Ulex europaeus*) and scattered alder (*Alnus glutinosa*).

The upper Graiguenamanagh River supported some moderate to good quality crayfish habitat given the presence of large cobble and marginal macrophyte beds. However evident compaction and sedimentation reduced the viability of the habitat for crayfish. None were recorded during the survey. Approximately 50 refugia were searched which included sweeps of macrophytes and large cobble. Further examination with the bathyscope did not reveal any evidence of the species. The notable absence of salmonids (which would typically be expected in such a site) indicated a potential pollution event that may have impacted the small river historically.

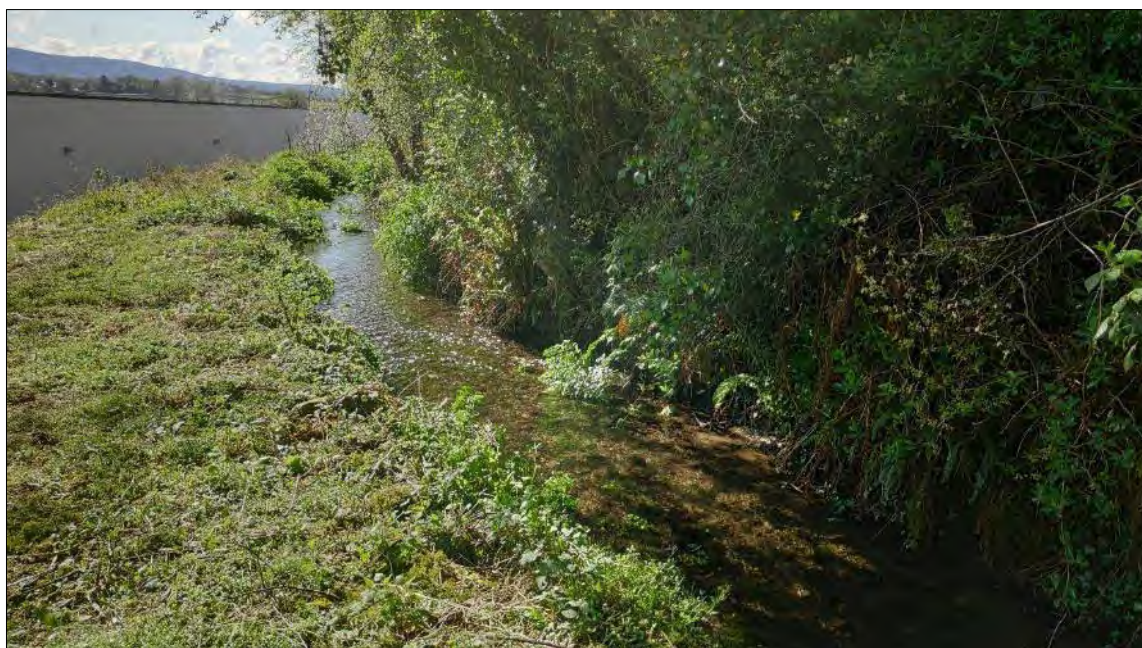
Plate 3.6 The Duiske Mill Race channel downstream of the R705 road crossing (adjacent to Aldi).

Located at the R705 road bridge (adjacent to Aldi Graiguenamanagh), the Mill Race channel was a small, 1.5-2m wide, swift-flowing lowland depositing watercourse (FW2). The Mill Race at site M1 was a 1m-wide artificial channel (mature) that averaged 0.1m deep with low (0.5m) bankfull heights. The substrata comprised bedded mixed fine, medium and coarse gravels with small cobble. No large boulders or cobble were present. Siltation was moderate to high locally given the more depositional nature of the habitat. Accumulations of soft sediment were present along the channel margins. Enrichment was also evident with filamentous algae present (10% cover). Instream macrophytes were limited to frequent encroaching hemlock water dropwort with the moss *Chiloscyphus polyanthos* also frequent. The riparian zone was dominated by hedgerows/scrub of hawthorn (*Crataegus monoygna*), bramble and scattered mature trees which provided moderate levels of shading. Amenity grassland (GA2) bordered the channel to the north.

No crayfish were recorded from site M1 via sweep netting or hand-searching. The small, shallow channel provided poor suitability for crayfish given the paucity of suitable refugia and bedded substrata. The banks were also largely unsuitable for burrowing. However, suitability improved slightly further downstream where deeper glide became more prominent.

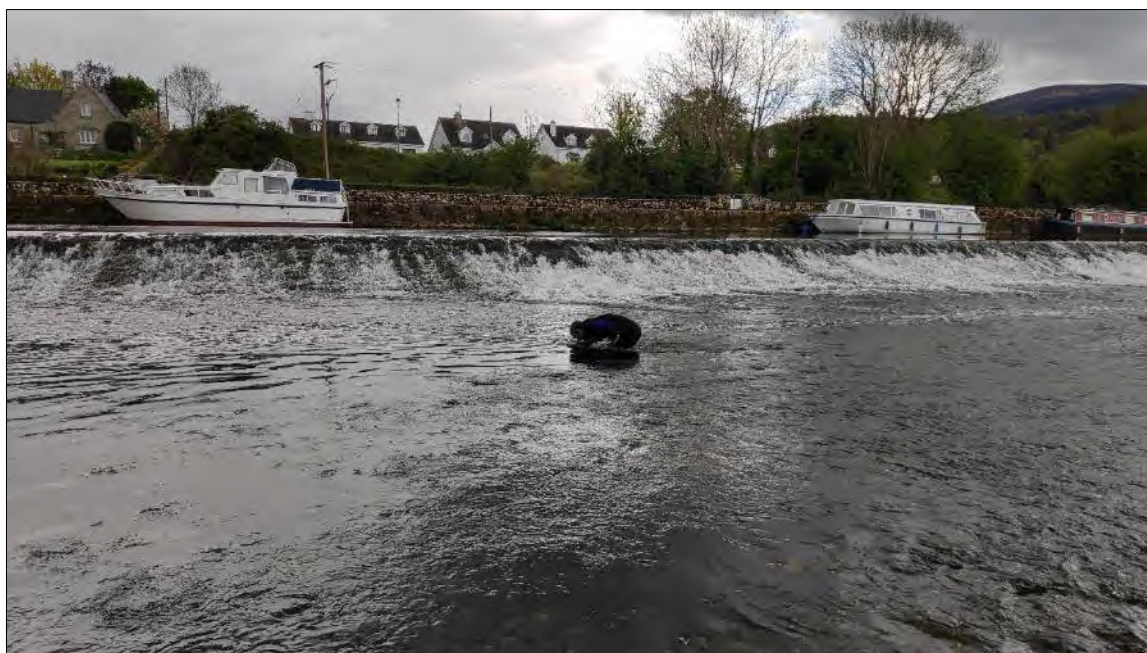
Plate 3.8 Hand-searching and sweep netting for crayfish below Graiguenamanagh Weir.

Site B1 on the River Barrow was located downstream of Graiguenamanagh Weir (Figure 2.1). The river averaged 20-25m wide with 1-1.5m deep fast glide, grading to deeper, slower-flowing glide (>2.5m) downstream. The bed in the vicinity of the weir was dominated by cobble and coarse gravel with occasional boulder with larger areas of coarse sand with marginal silt downstream of weir pool. Larger substrata, although frequent, were typically compacted and bedded given the high flow rates. Filamentous algal cover was excessively high (>50%), indicating significant enrichment. The weir face featured many crevices and cracks suitable as crayfish refugia and, downstream of the weir pool area, soft steep marginal slopes along the western shore provided some suitability for crayfish burrowing. Growth of instream macrophytes was sparse but arrowhead (*Sagittaria sagittifolia*), clubrush (*Schoenoplectus lacustris*) and very occasional yellow water lily (*Nuphar lutea*) were present. Bryophyte cover was low given abundant filamentous algae and floc.

Despite some high suitability, no crayfish were recorded via hand-searching, sweep-netting or snorkelling at site B1. Approximately 50 refugia were searched which included sweeps of macrophytes, boulder/large cobble, banks suitable for burrowing and the weir structure – areas which historically supported white-clawed crayfish at this site (pers. obs.).

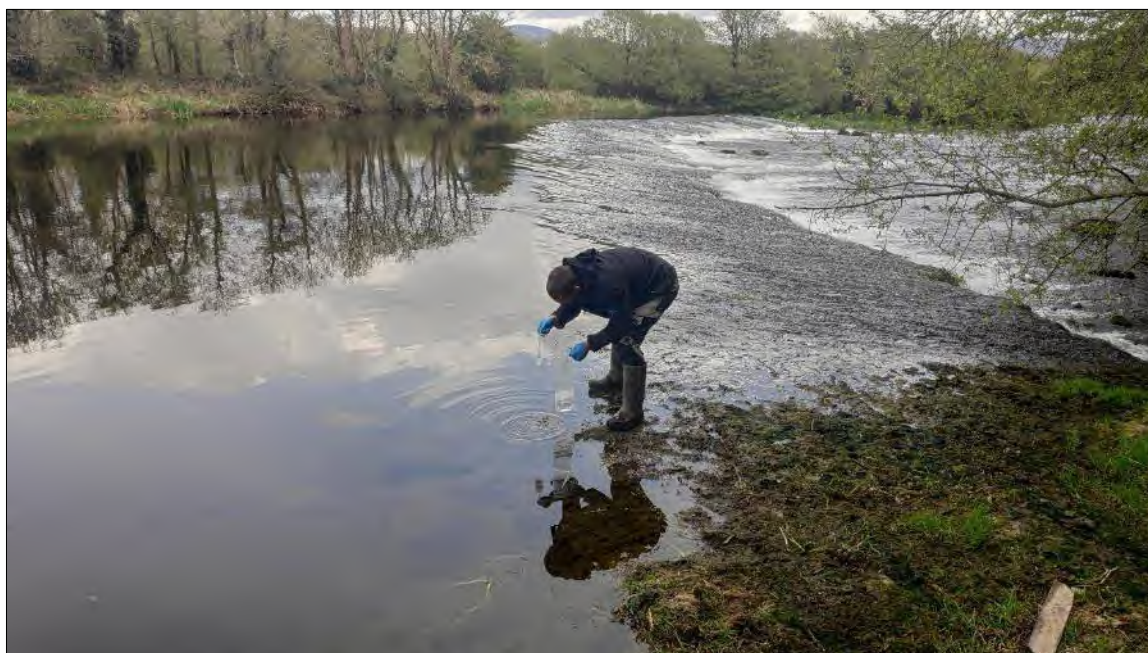
Plate 3.9 eDNA sampling for white-clawed crayfish and crayfish plague at Lower Tinnahinch Weir, April 2021.

Site B2 on the River Barrow was located at Lower Tinnahinch Weir (Figure 2.1). Upstream of the weir featured 100% deep (2-3m), slow-flowing glide habitat 30-40m wide with frequent large substrata and instream macrophyte beds. Downstream of the weir was turbulent in nature with abundant large boulders in addition to frequent cobble and coarser gravels in a water depth of <1m. The high flow rates here resulted in a moderately compacted bed but low siltation. Filamentous algal cover was high at the time of survey (30% cover). The weir face featured many crevices and cracks suitable as crayfish refugia and, downstream of the weir pool area, soft steep marginal slopes along the northern bank provided some suitability for crayfish burrowing. Large woody debris was also present which provided some high value as crayfish refugia. Growth of instream macrophytes was sparse downstream of the weir but arrowhead, clubrush, hemlock water dropwort and yellow water lily were present. Bryophyte cover was high downstream of the weir on larger instream substrata. The site was bordered by mature treelines and mixed broad-leaved woodland.

Despite some high suitability (and historical presence), no crayfish were recorded via sweep netting, hand-searching or snorkelling at site B2. Furthermore, eDNA sampling did not identify the presence of crayfish at or upstream of this location – see section 3.2 below. Lower Tinnahinch Weir offered abundant suitable refugia for crayfish by way of large boulders, cobble, macrophyte beds, large woody debris and weir sill crevices but the examination of approx. 60 refugia did not reveal any crayfish. Furthermore, otter spraint recorded on the top of the weir structure did not contain any visible crayfish remains.

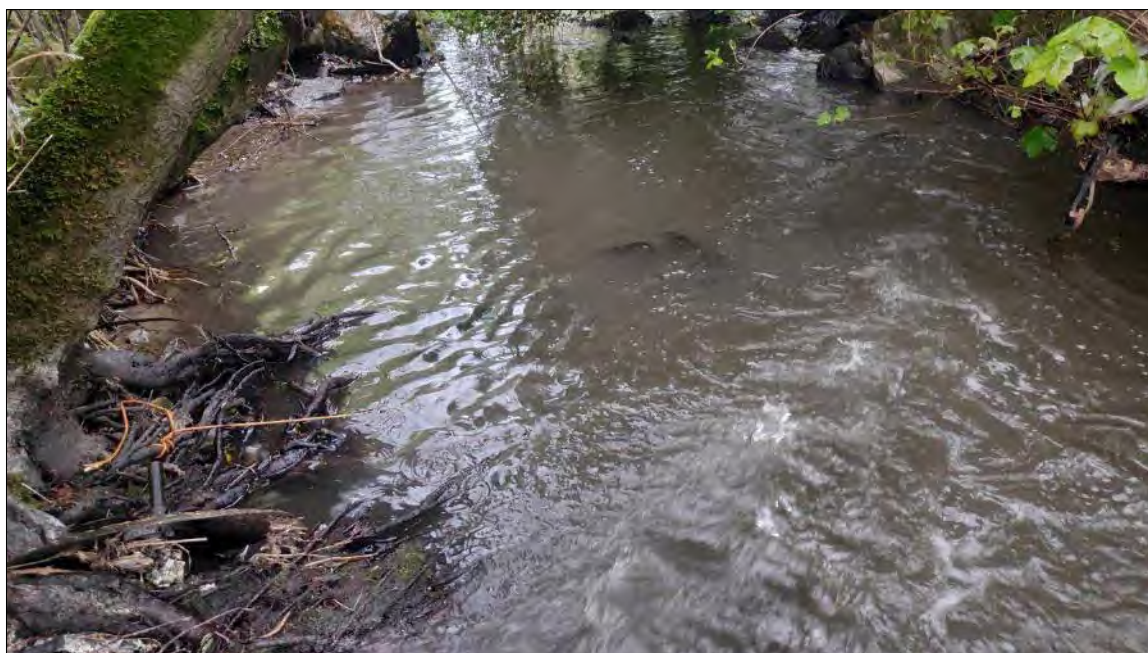
Plate 3.10 Trapping for white-clawed crayfish at site T1 on the Duiske River.

Trapping site T1 was located on the Duiske River immediately downstream of the Aldi access bridge, approx. 30m downstream from the Graiguenamanagh River confluence (**Figure 2.1**). The swift-flowing river averaged 2.5-3m wide and 0.5-1.5m deep downstream of the access bridge. The substrata were dominated by boulder and cobble with localised patches of mixed gravels and coarse sand. Given high flow rates, the substrata were moderately compacted, with some siltation in pool slacks. Riparian shading (from mature treelines and scrub) was high and instream macrophyte growth was absent. However, aquatic bryophyte coverage was high.

The site was chosen for overnight trapping due to the presence of a 1.5m-deep, tree-lined pool with abundant crayfish refugia by way of tree root systems, undercut banks and large boulders. However, despite high physical suitability, no crayfish were recorded via trapping.

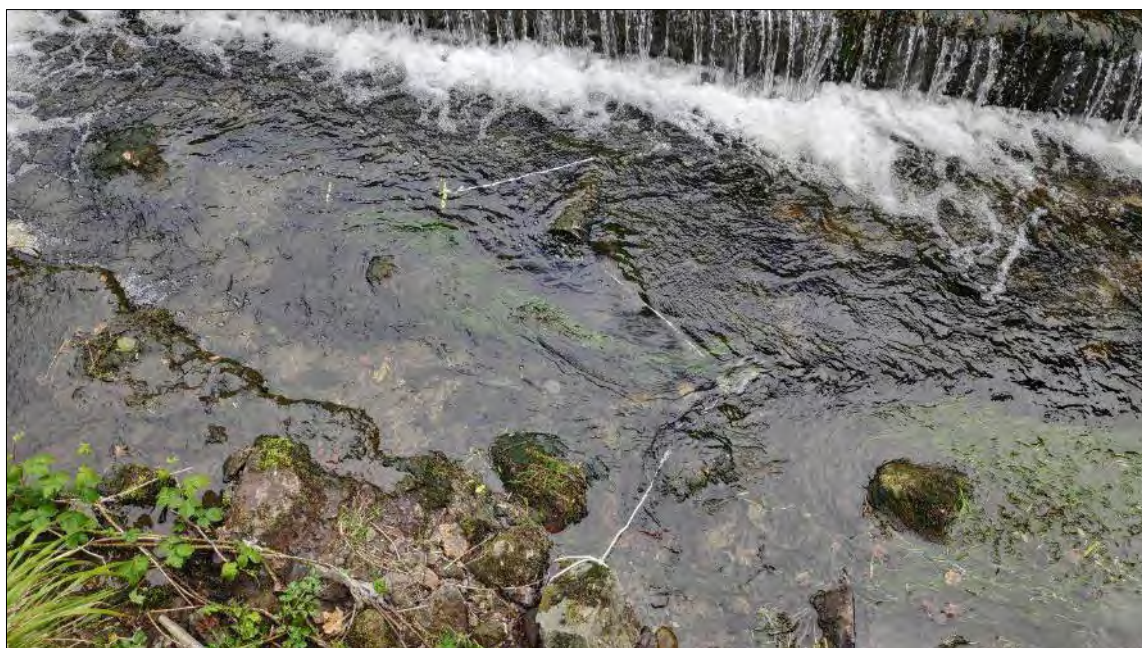
Plate 3.11 Trapping the small weir pool at Turfmarket Weir on the lower reaches of the Duiske River.

Site T2 was located downstream of Turfmarket Weir on the lower reaches of the Duiske River (**Figure 2.1**). The upland eroding watercourse (FW1) had been historically modified and straightened locally, with retaining walls on both banks in addition to a small weir (0.3m fall). The channel was 3m wide and 0.2-0.5m deep, with fast-flowing glide predominating. Small pools to 0.7-1m were associated with the small weir and downstream meanders. The substrata were dominated by boulder and cobble with small patches of interstitial gravel/coarse sand. Siltation was low given the high flow rates. Enrichment was evident with abundant filamentous algal cover on substrata. These were also bedded given high flow rates of the river (as observed upstream).

Despite some good suitability in terms of crayfish refugia (macrophytes, boulders, large cobbles, weir face crevices, retaining wall base crevices *etc.*), no crayfish were recorded via trapping.

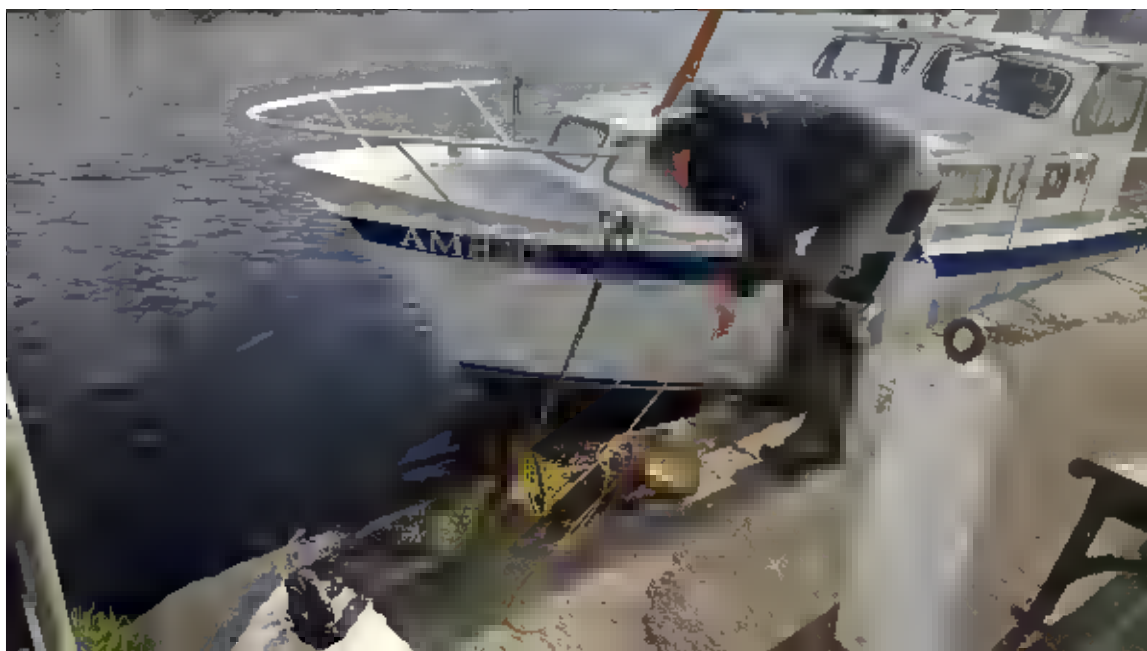
Plate 3.12 Setting baited crayfish traps on the River Barrow at site T3.

Site T3 was located on the River Barrow upstream of Graiguenamanagh Bridge, adjacent to the diving board at Graiguenamanagh Rowing Club (**Figure 2.1**). The river upstream of Graiguenamanagh Bridge was 40-50m-wide canalised channel (FW2) with depths varying from 1.5-2.5m. The river was bound by a retaining wall along the west (town) bank, with historical modifications present on the east. The river at this location was depositional in nature and featured 100% deep slow-flowing glide. The substrata were dominated by silt with localised areas of sand and bedded cobbles and gravels, particularly associated with the marginal slopes of the channel. Abundant filamentous algae was present on the substrata (very high cover).

Despite some good suitability, no crayfish were recorded via trapping. Furthermore, SCUBA diving undertaken in April 2021 as part of the accompanying freshwater pearl mussel survey for the scheme in this section of river did not identify any white-clawed crayfish. Whilst impacted by both siltation and high filamentous algae/floc cover (**Plate 3.13**), refugia accessible and suitable for crayfish were abundant, such as large boulders, retaining wall crevices and instream debris.

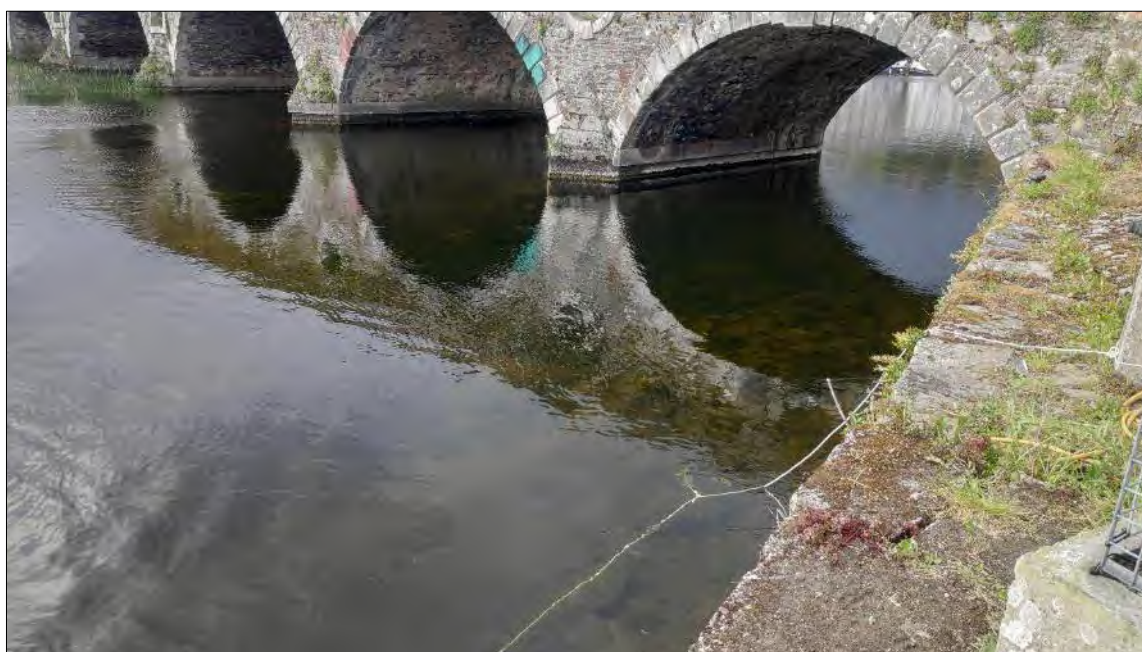
Plate 3.14 Set crayfish traps on the River Barrow at Graiguenamanagh Bridge (east bank).

Site T4 was located on the River Barrow immediately downstream of Graiguenamanagh Bridge, along the east bank of the river (**Figure 2.1**). The river upstream of the weir, at the bridge, was a 60-70m-wide canalised channel (FW2) with depths varying from 1.5-2m. The river was bound by retaining walls on both banks. Swift-flowing glide predominated with localised pool areas. The substrata alternated between plains of coarse sand and silt with boulder zones in the centre channel. Abundant boulders were present under the bridge arches. Abundant filamentous algae and floc was present on the substrata (very high cover). Macrophyte growth near the trapping site was absent with only localised bryophyte growth (mostly covered by algae).

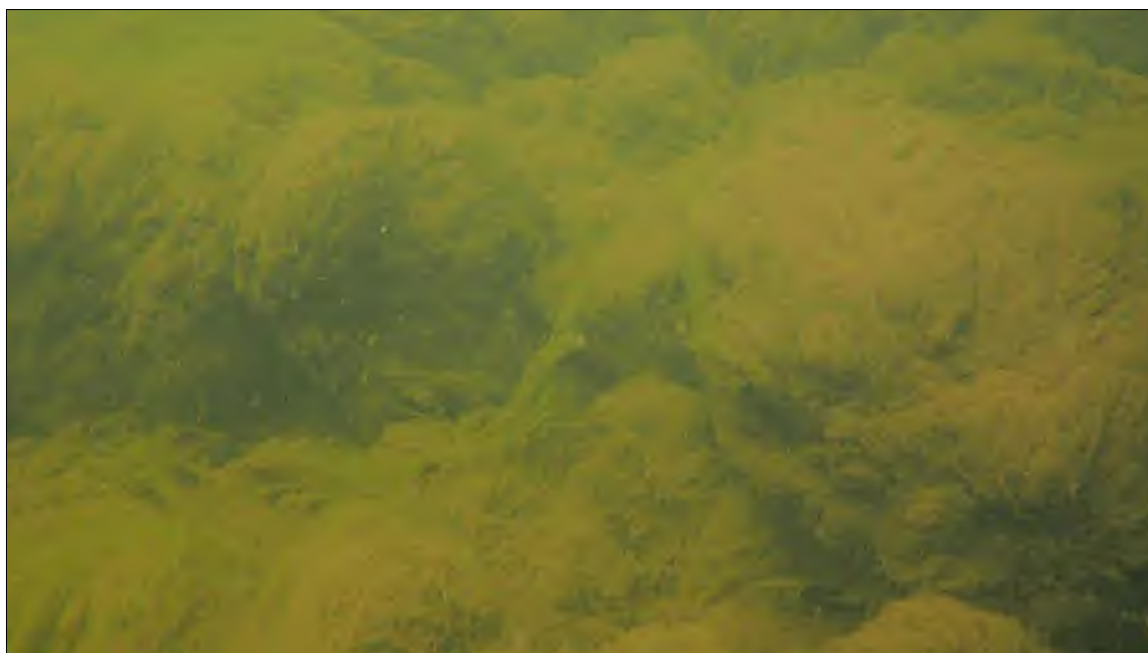
Plate 3.15 Boulder zone in the vicinity of Graiguenamanagh Bridge with very high cover of filamentous algae and floc.

Despite some good suitability, no crayfish were recorded via trapping. Furthermore, SCUBA diving undertaken in April 2021 as part of the accompanying freshwater pearl mussel survey for the scheme in this section of river did not identify any white-clawed crayfish. Whilst impacted by both siltation and high filamentous algae/floc cover (Plate 3.15), refugia accessible and suitable for crayfish were abundant, such as large boulders, retaining wall crevices and instream debris.

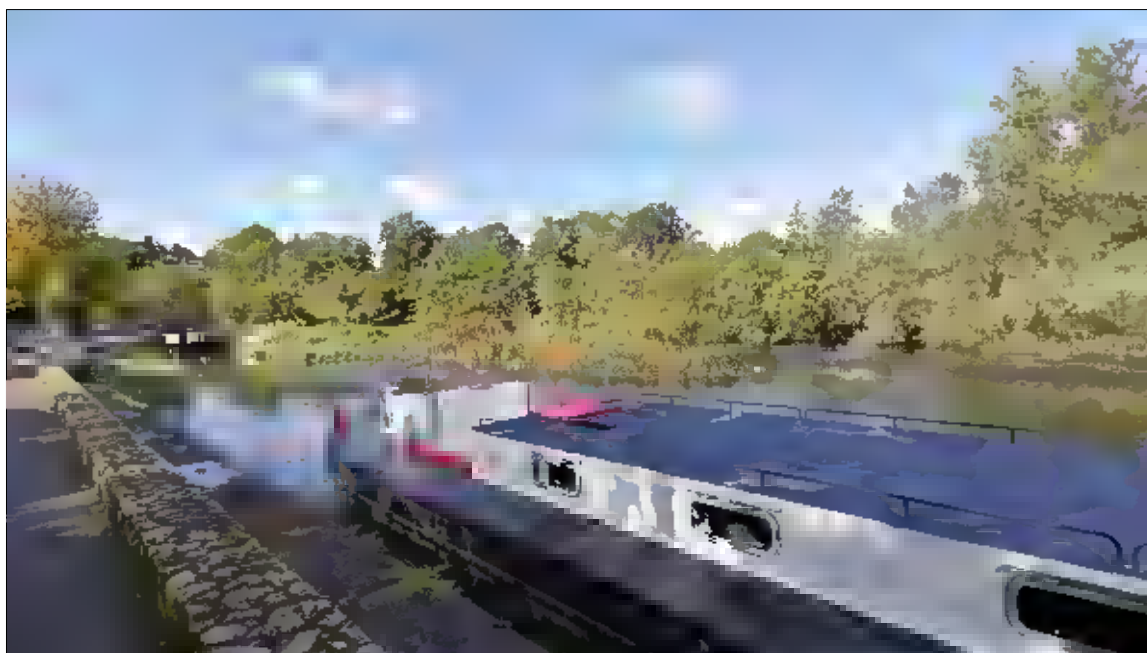
Plate 3.16 Trapping area upstream of Tinnahinch Lock (Upper).

Site T5 was located upstream of the Lock gates at Tinnahinch Lock (Upper) adjacent to Graiguenamanagh Weir on the River Barrow (**Figure 2.1**). The channel was of variable width (5-12m) as it was situated in a macrophyte rich bay upstream of the canal lock gates (**Plate 3.16**). The depth ranged between 1.3m and 2.5m and the water had a very slight flow only. The substrata were dominated by silt although localised boulder and cobble were present. The bed supported submerged arrowhead, yellow water lily, spiked water milfoil and common clubrush. The area had some suitability for crayfish that could utilise the quay walls, adjoining boulder substrata and or macrophyte beds. However, none were recorded during trapping and snorkelling of the area.

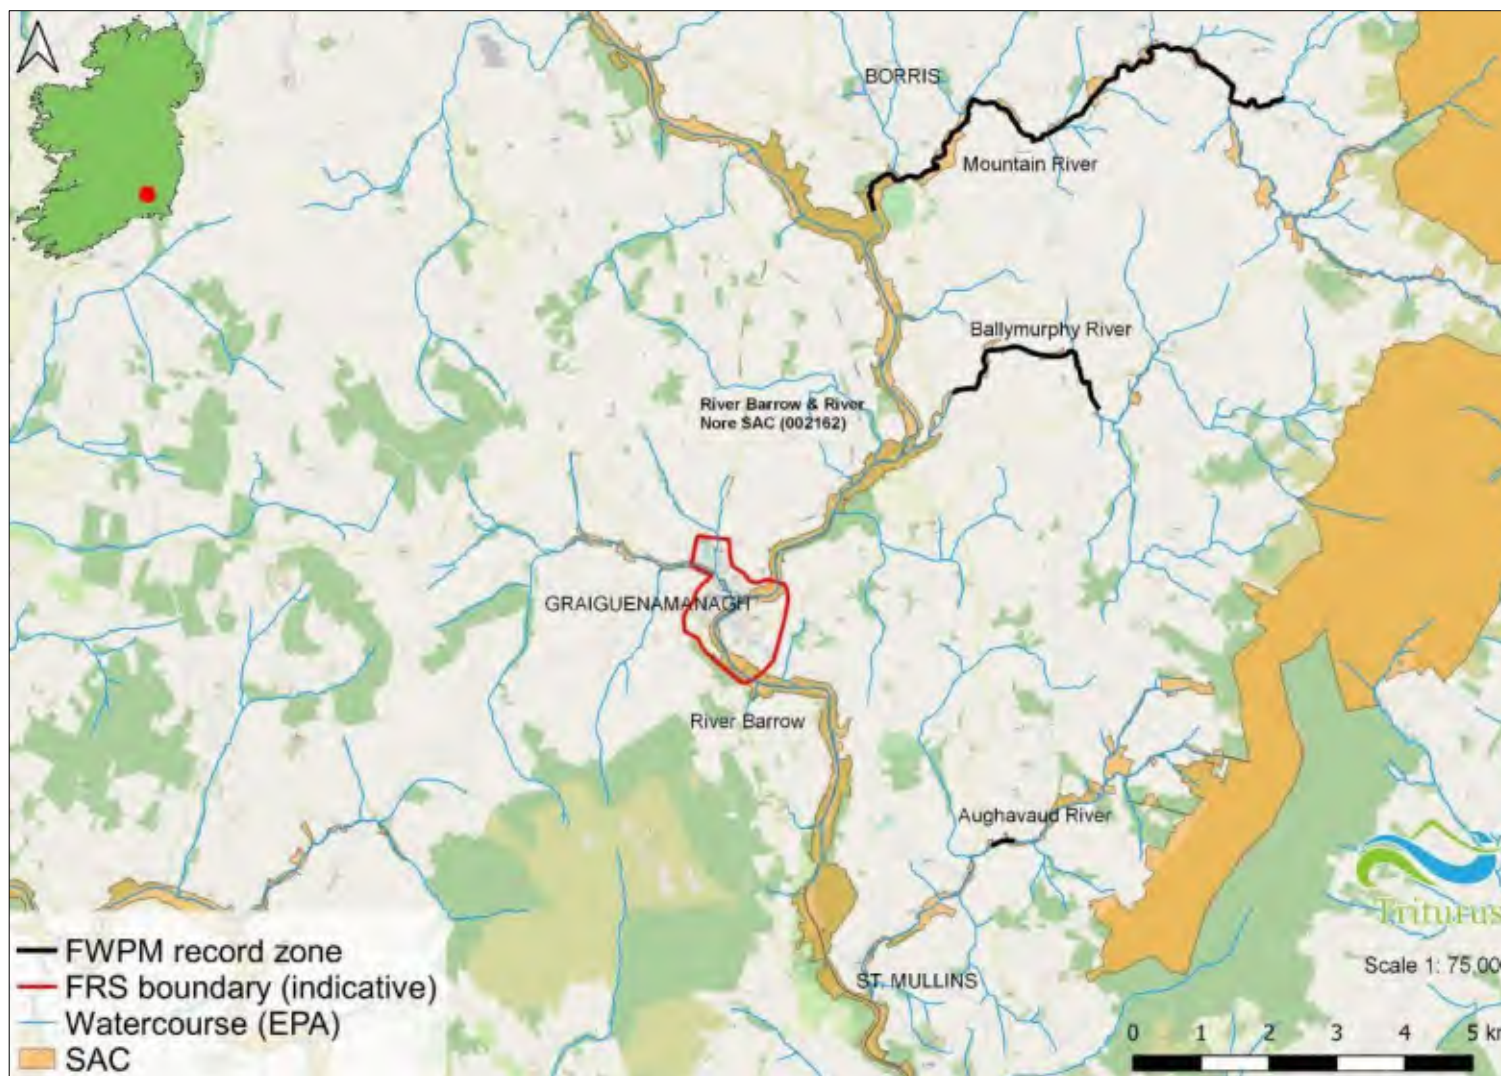
Figure 1.1 Extent of the freshwater pearl mussel records in the River Barrow catchment (adapted from DEHLG 2010a, 2010b and 2010c).

The nearest populations to Graiguenamanagh and Tinnahinch are in the Mountain and Ballymurphy Rivers located $\geq 4\text{km}$ upstream (see **Figure 1.1**). Although a live specimen was recorded in the River Barrow in 1991, c. 5km upstream of Graiguenamanagh near Ballynagrane Lock (Sweeny, 2011), the freshwater pearl mussel would appear to be extinct in the main channel of the River Barrow (Lucey, 1998). Whilst 2008 surveys failed to identify any live mussels in the Aughavaud River (DEHLG, 2010c), which adjoins the River Barrow near St. Mullin's, Co. Carlow (**Figure 1.1**), recent NPWS data (2018) indicates low numbers of pearl mussels within this sub-

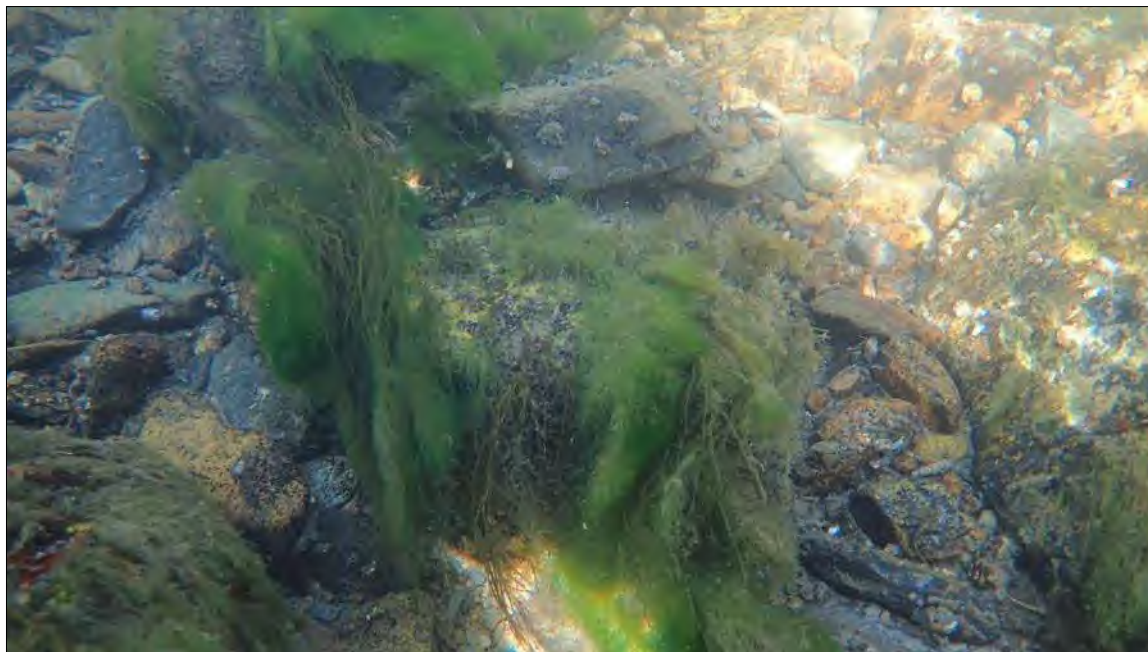
Plate 3.3 Underwater image showing compacted bed with growth of red algae (*Lemanea* sp.) and filamentous algae (*Cladophora* sp.).

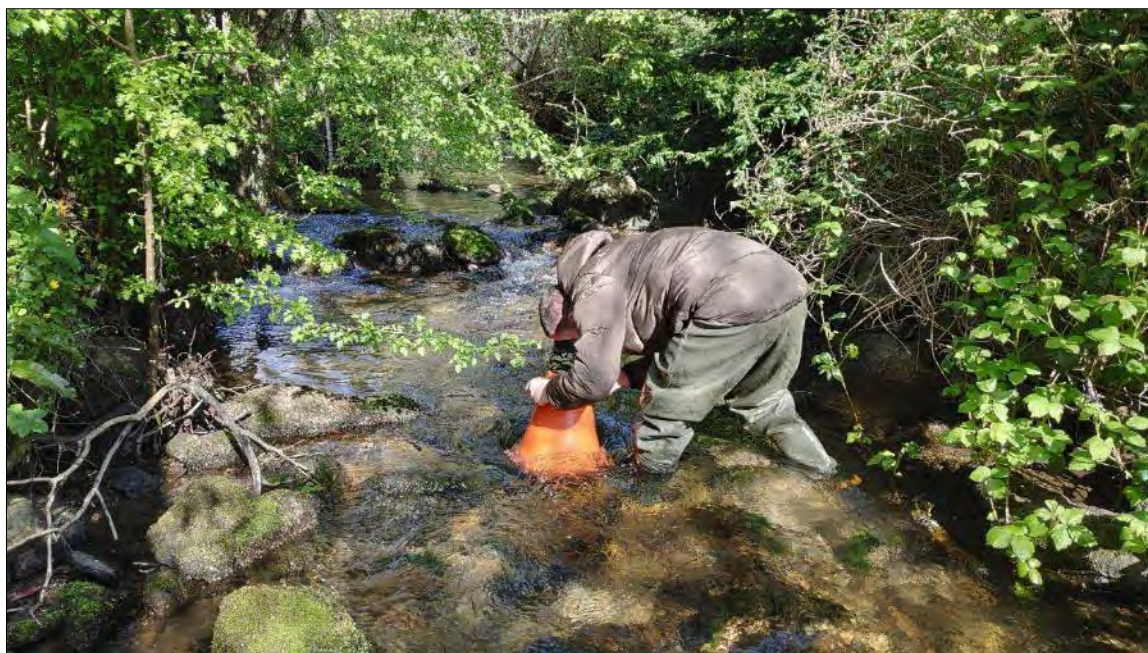
Plate 3.4 Bathyscope survey of the Duiske River upstream of the R705 road bridge.

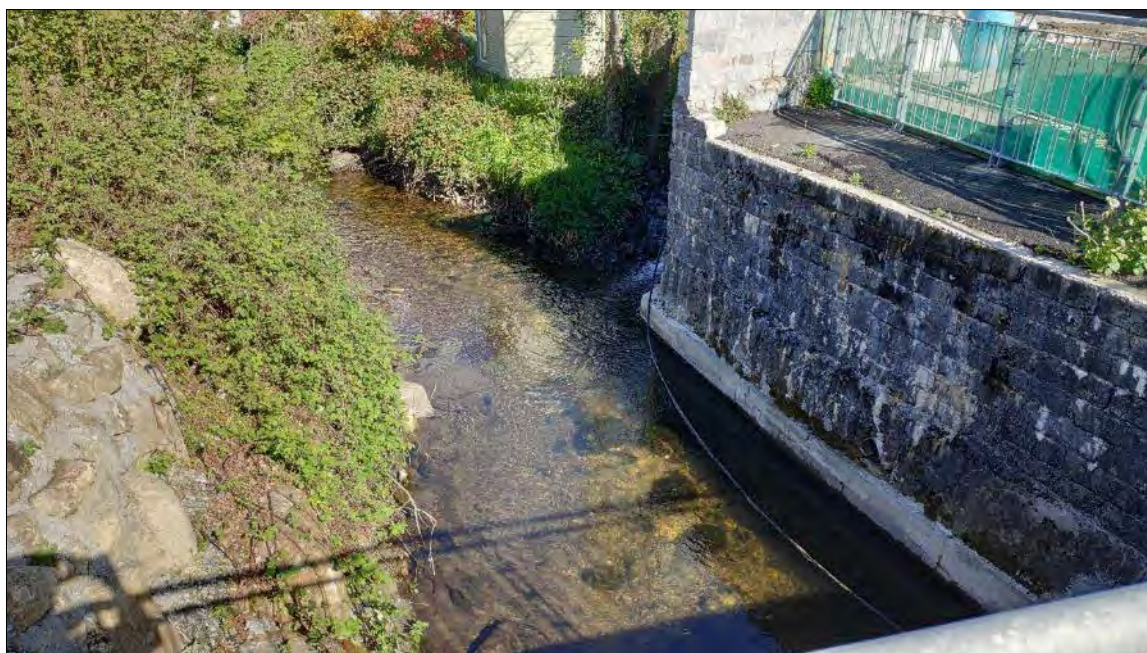
Plate 3.6 The historically modified Duiske River at the Graiguenamanagh River confluence (near Aldi).

Located downstream of the Graiguenamanagh River confluence (**Figure 2.1**), the lower reaches of the Duiske River in section B were semi-natural (FW1 with some FW2 characteristics in lowermost reaches). However, the high energy (spate-like) river had been historically modified and straightened through Graiguenamanagh town and residential areas with retaining walls often present on both banks (invariably >2-2.5m high). The river channel averaged 3-4m wide with depths of 0.2-0.4m, with occasionally deeper pool to 0.8m. Fast shallow glide and riffle dominated the section with only occasional pool (e.g. on meanders). Despite modification, good instream recovery was present although enrichment was evident with abundant filamentous algal cover on substrata (mostly *Cladophora* sp.). Coverage of floc was also high (up to >50%) in areas of lower flow. Substrata cover often exceeded 30-40%. The substrata were dominated by boulder and cobble with patches of gravel/coarse sand. Given the high flow rates, compaction was relatively high and siltation was low overall (as per upstream section A). However, some sediment accumulations (sand/silt) were present in the lowermost reaches near the Barrow confluence and on some meanders. Instream macrophyte cover was greater than upstream section A, with *Ranunculus* sp. vegetation dominating (often >20% cover). The aquatic bryophyte *Platyhypnidium riparioides* was often common on instream boulder and cobble.

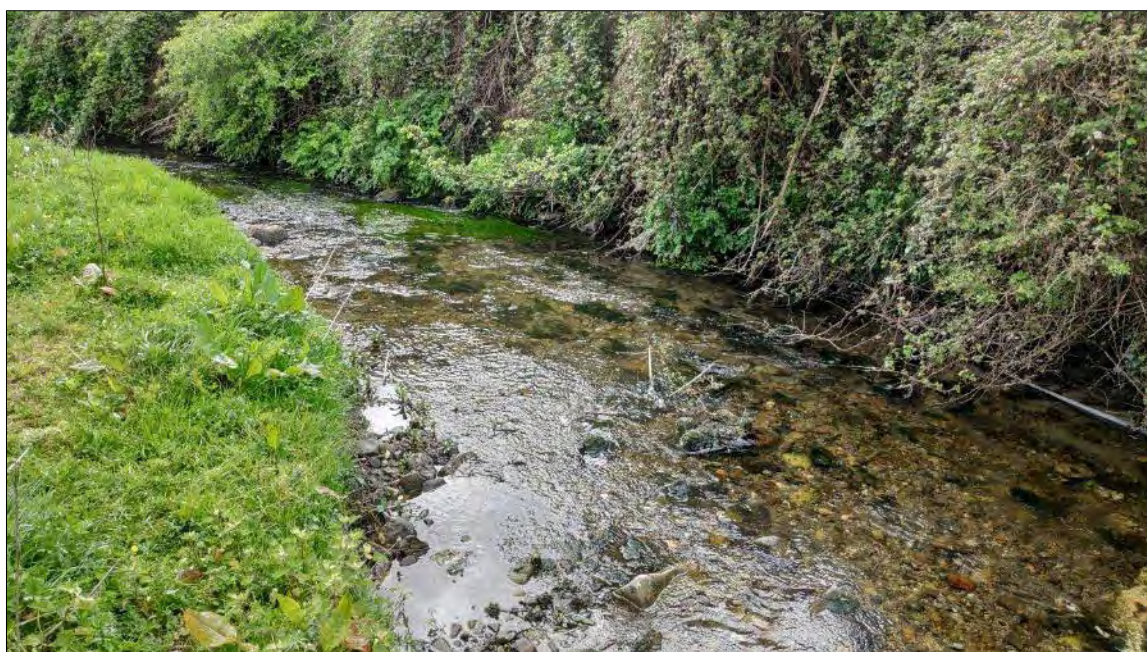
Plate 3.7 The Duiske River immediately downstream of the Well Lane footbridge.
