Appropriate Assessment

Graiguenamanagh-Tinnahinch Flood Relief Scheme

Report No. W3451-AYE-ENV-R010

Kilkenny County Council

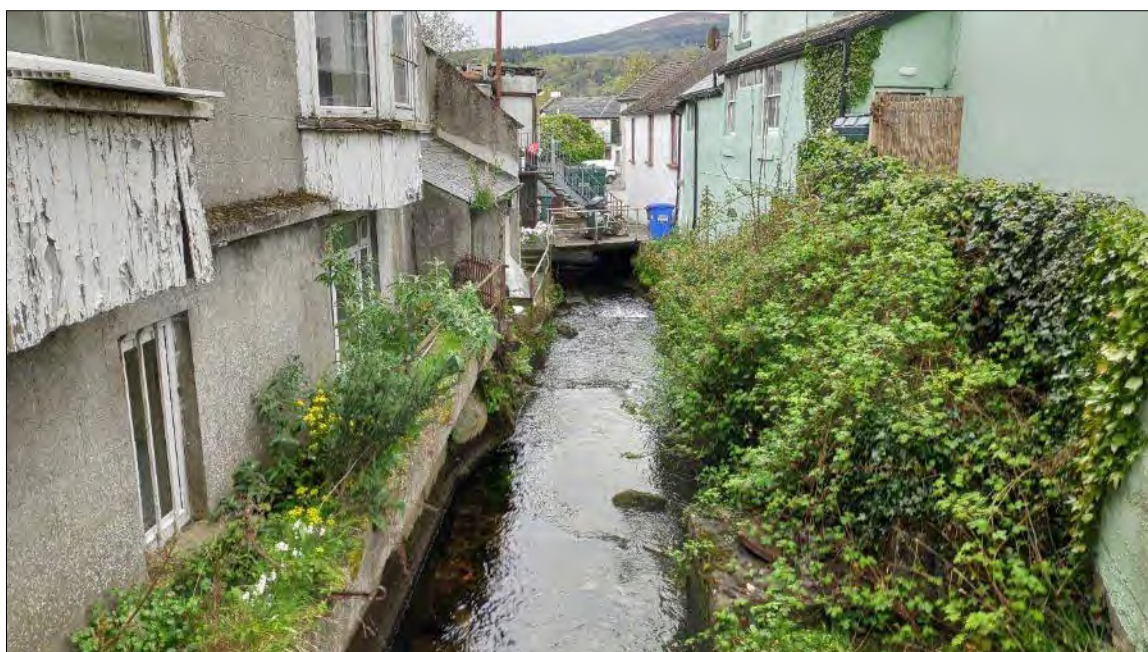
Plate 3.9 The modified Duiske River at Mill Road Bridge (facing downstream).

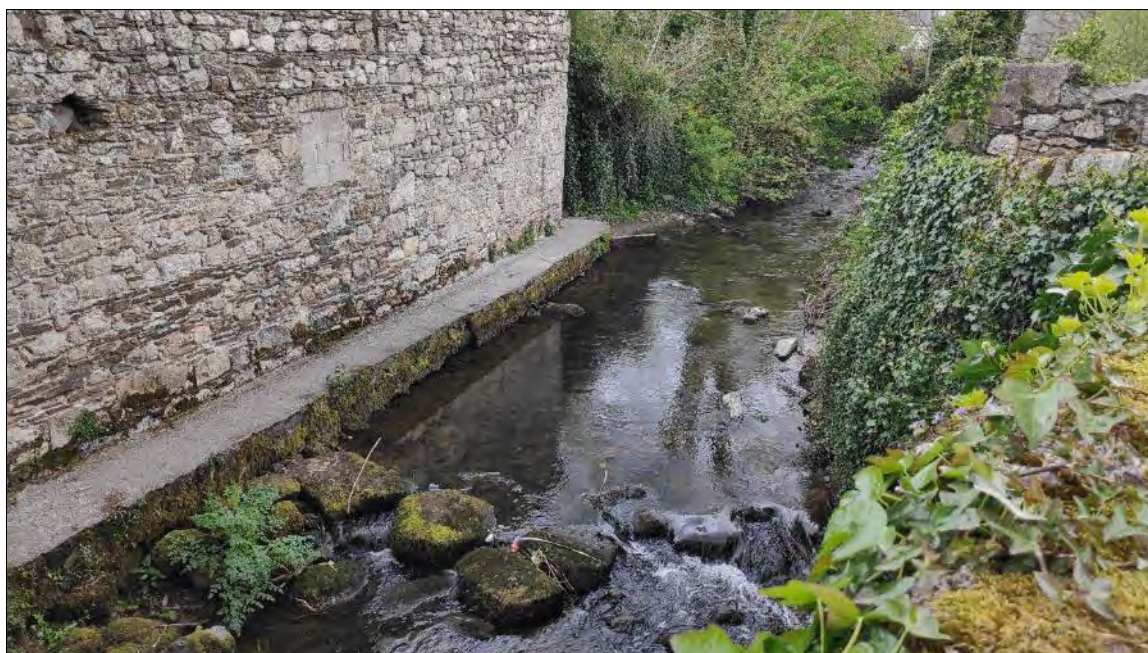
Plate 3.10 The modified Duiske River at Old Dock Road Bridge (facing upstream).

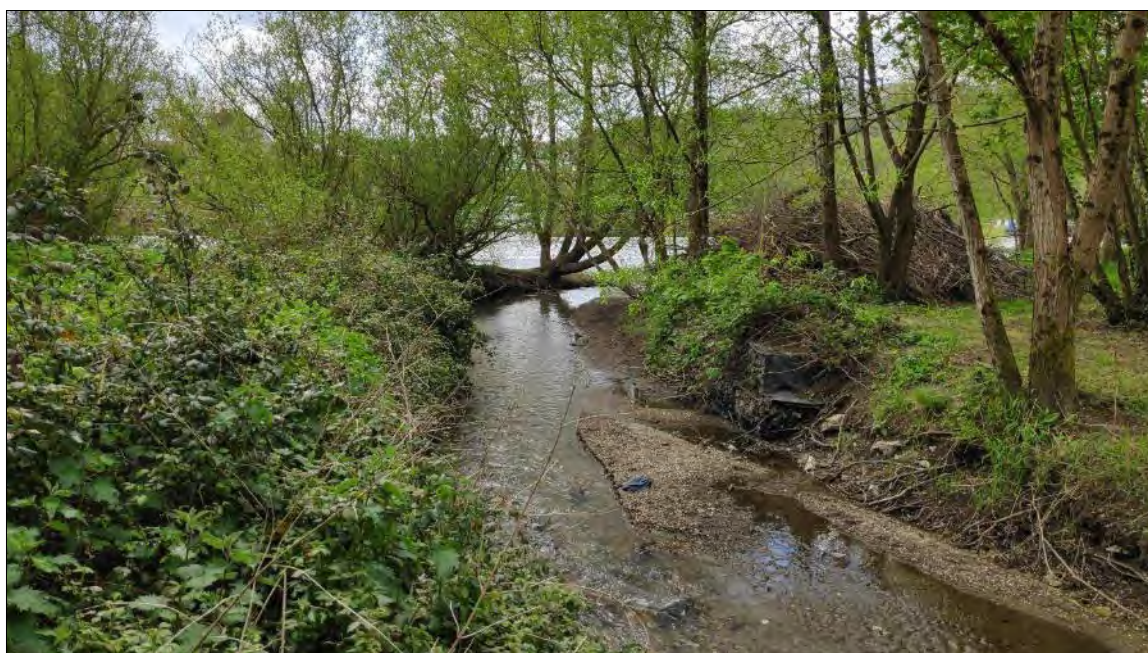
Plate 3.11 The Duiske River at the Barrow confluence showing clean gravel substrata with marginal soft sediment accumulations.

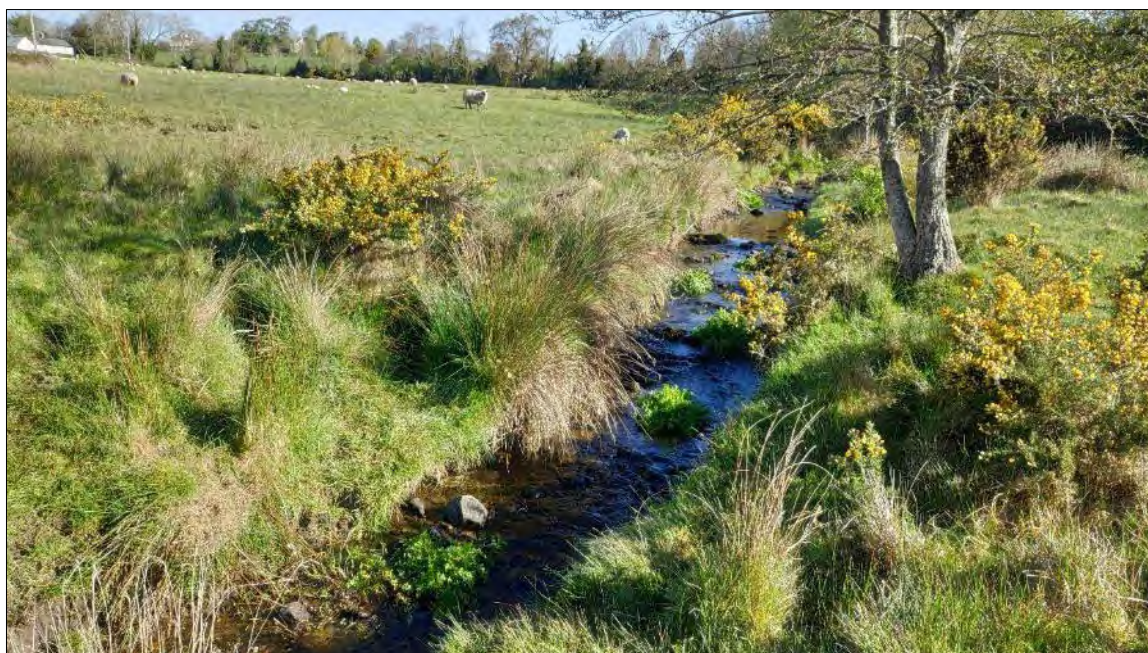
Plate 3.12 Representative image of the upper survey reaches of the Graiguenamanagh River.

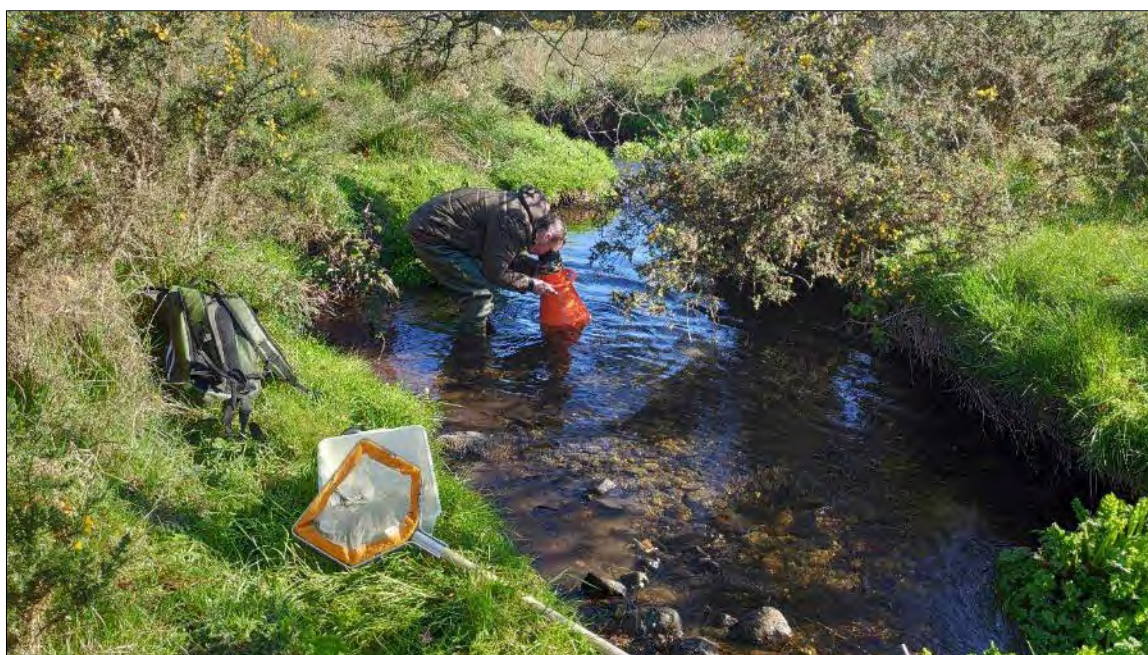
Plate 3.13 Bathyscope survey on the upper reaches of the Graiguenamanagh River.

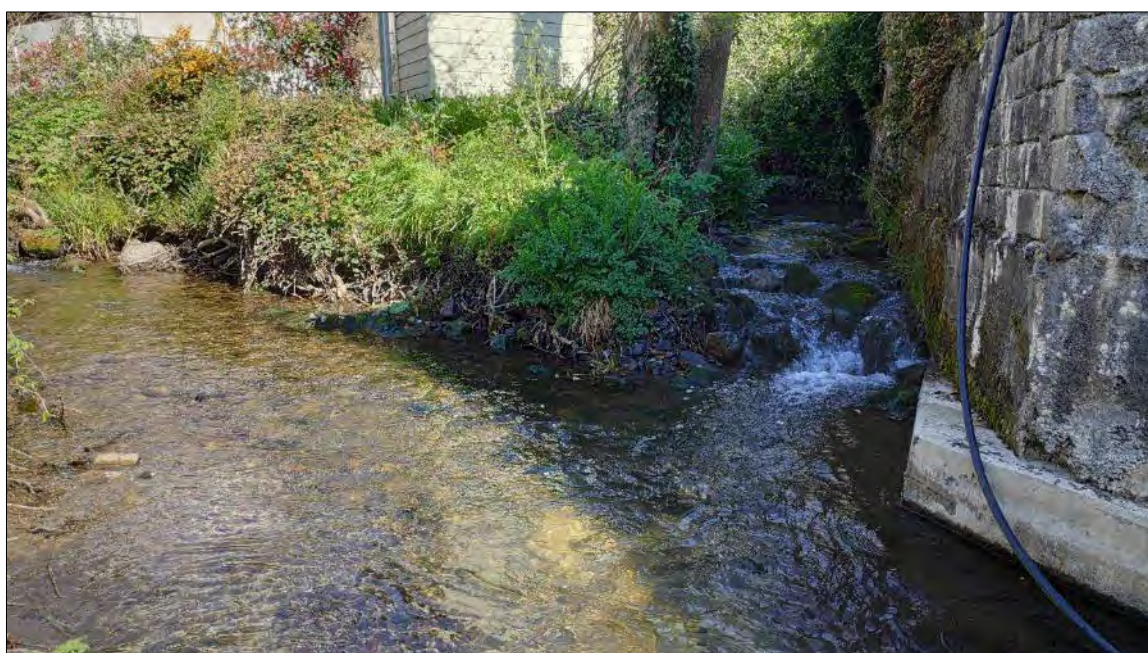
Plate 3.15 The Graiguenamanagh River (right) at the Duiske River confluence.

The lower reaches of the Graiguenamanagh River represented an upland eroding watercourse (FW1) flowing over a moderate gradient, with frequent cascades over large instream boulder. The river emanated from a large pipe culvert under the Harristown Roundabout (R705) and adjoined the Duiske River approx. 30m downstream. This short section had been historically straightened but not deepened, with retaining walls along both banks (gabion baskets on north, retaining wall on south bank). The channel averaged 1.5m wide with depths highly variable from 0.1-0.5m. Fast glide predominated in between frequent plunge pools (0.6m max). Riffle was present near the Duiske confluence. The substrata were partially bedded given relatively high flow rates, with boulder and cobble dominating. However, medium-fine gravels and sand were frequent interstitially. Flocculent silt deposits were present in pool/margins slacks (rare). Riparian shading was high from retaining walls and scrub vegetation (bramble and ornamental garden plants). No macrophytes were present instream although *Hygroamblystegium* sp. moss was common. *Vaucheria* sp. algae was also common, indicating significant enrichment. The site was of moderate value for salmonids in the lowermost reaches, although the extensive pipe culvert effectively blocked upstream fish passage.

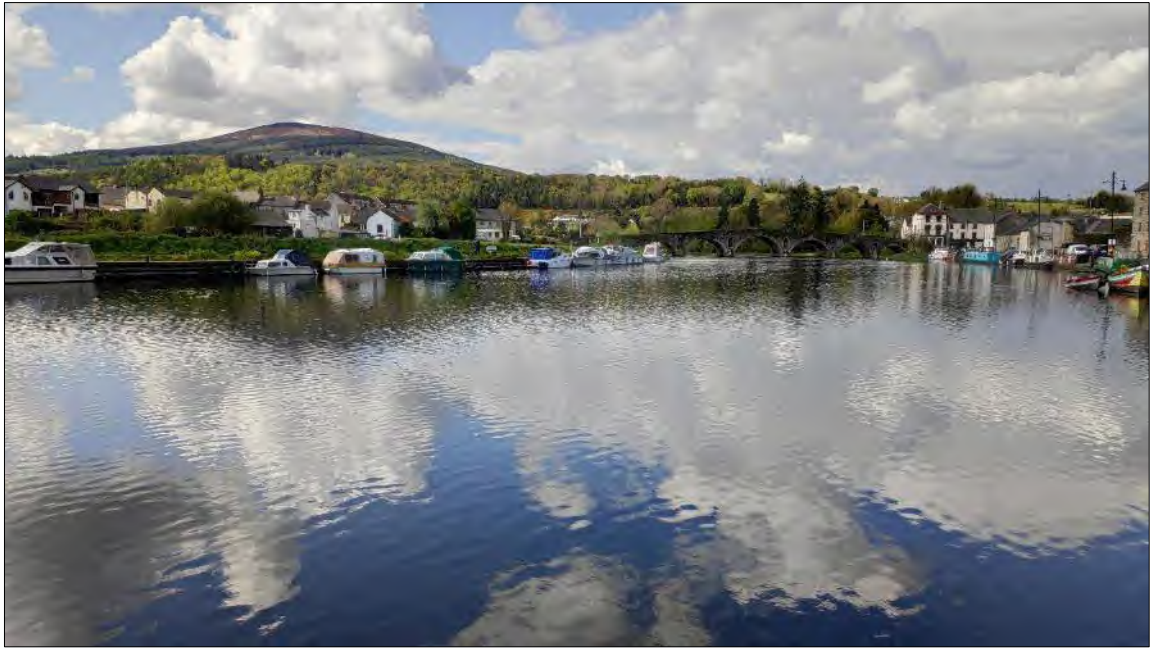
Plate 3.16 The River Barrow upstream of Graiguenamanagh Bridge (100% deep depositional glide habitat).

Located upstream of Graiguenamanagh Weir, the River Barrow in survey section D was a large 40-50m wide canalised channel with depths varying from 1.5-2.5m. The river was bound by a retaining wall along the west (town) bank, with historical modifications present on the east. The river at this location was depositional in nature and featured 100% deep slow-flowing glide. The substrata were dominated by silt with localised areas of sand and bedded cobbles and gravels, particularly associated with the marginal slopes of the channel. Downstream of bridge (upstream of the weir), the substrata alternated between plains of coarse sand and silt with boulder zones in the centre channel. Abundant boulders were present under the bridge arches, which often supported freshwater sponges (see **Plate 3.23**). Sand and silt dominated immediately upstream of the weir structure. Abundant filamentous algae was present on the substrata (very high cover). Macrophytes were limited to heterophyllous yellow water lily (*Nuphar lutea*) (submerged more so than emergent) with occasional patches of submerged clubrush (*Schoenoplectus lacustris*) and water mint in marginal areas. Perfoliate pondweed (*Potamogeton perfoliatus*) was occasional with rare spiked water milfoil (*Myriophyllum spicatum*). The channel was lined with reed canary grass (*Phalaris arundinacea*), marsh marigold (*Caltha palustris*), iris (*Iris pseudacorus*), arrowhead (*Sagittaria sagittifolia*), water mint, hemlock water dropwort and scattered invasive Himalayan balsam (*Impatiens glandulifera*).

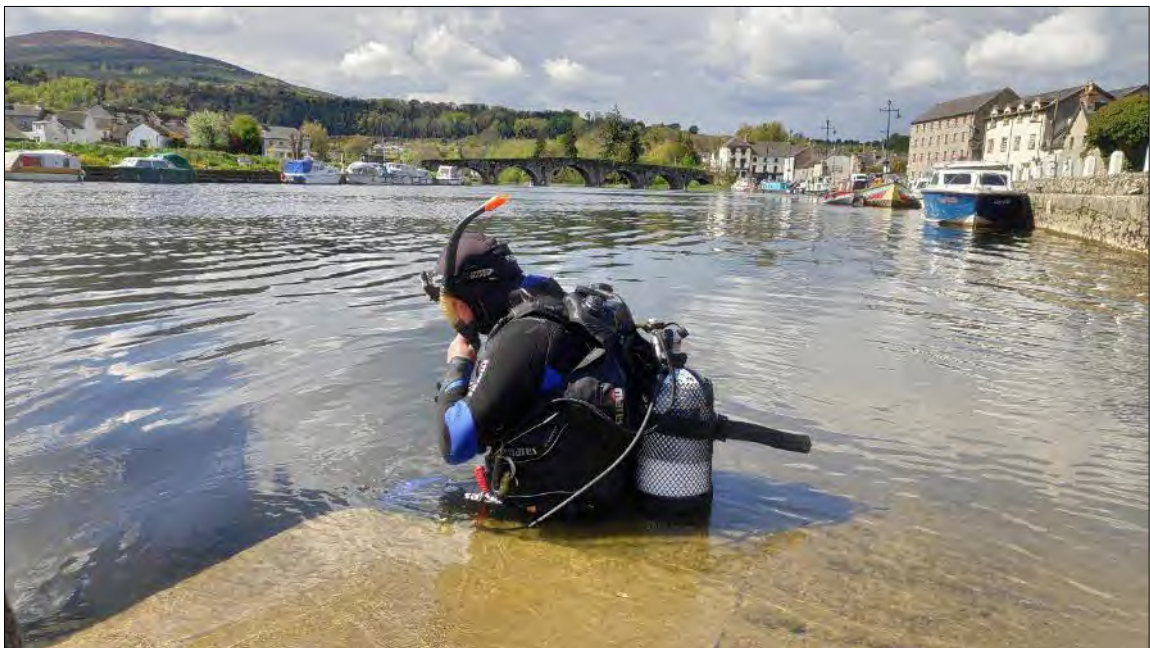
Plate 3.17 SCUBA dive survey of the River Barrow upstream of Graiguenamanagh Bridge, April 2021.

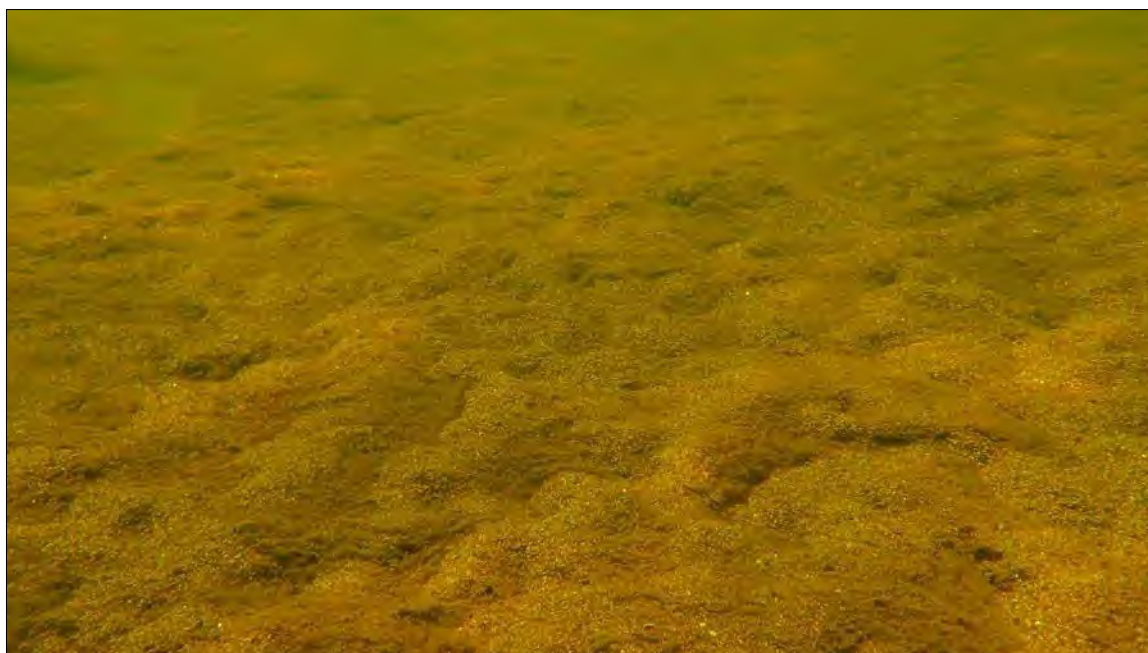
Plate 3.18 Underwater image of the heavily silted substrata present in survey section D (upstream of Graiguenamanagh Bridge).

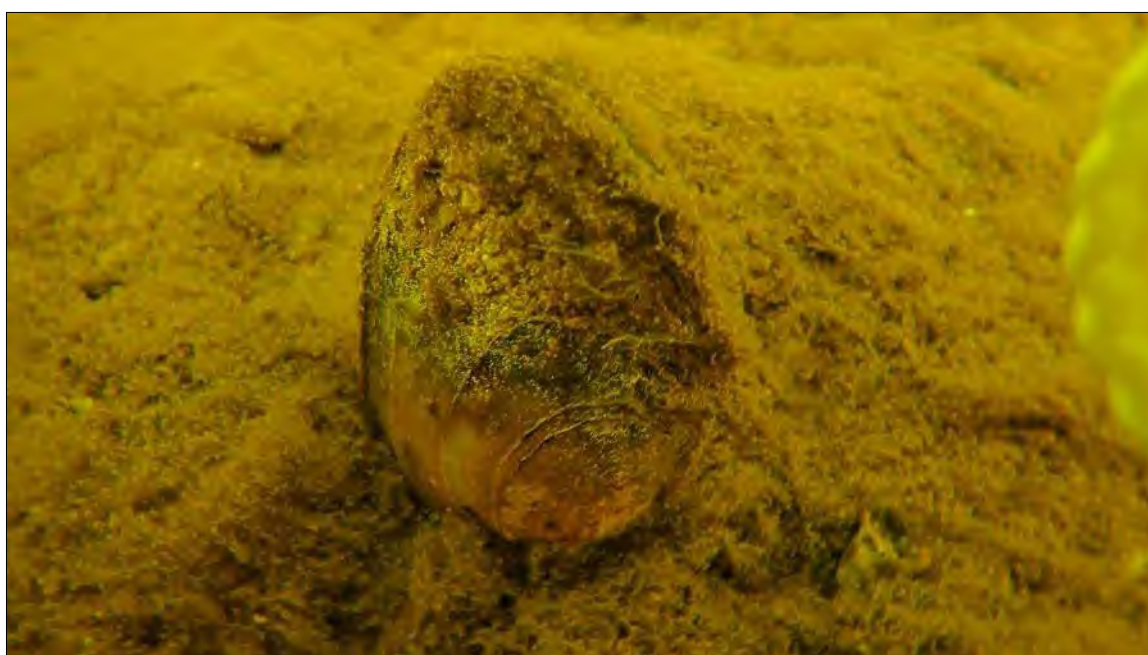
Plate 3.19 Example of duck mussel (*Anodonta anatina*) recorded in soft sediment upstream of Graiguenamanagh Bridge.

No live or dead freshwater pearl mussels were recorded via bathyscope or SCUBA diving surveys in survey section D (**Figure 3.1**). The River Barrow upstream of Graiguenamanagh Weir had no suitability for freshwater pearl mussel. However, the deep glide habitat upstream of the bridge did support duck mussel (*Anodonta anatina*), at an average density of 1 per 10m² (**Plate 3.19, 3.20**). The majority of these were located at the base of the quay wall slope (45° angle). This slope had metal debris, cobble and boulder with patches of coarse sand and silt. Duck mussels were present in coarse sand and silt at base of slope, with most mussels recorded covered in silt and evidently choking. A number of dead duck mussels (some recently deceased) were also recorded in a small, heavily-silted off-shoot channel along Old Dock Road (**Plate 3.21**).

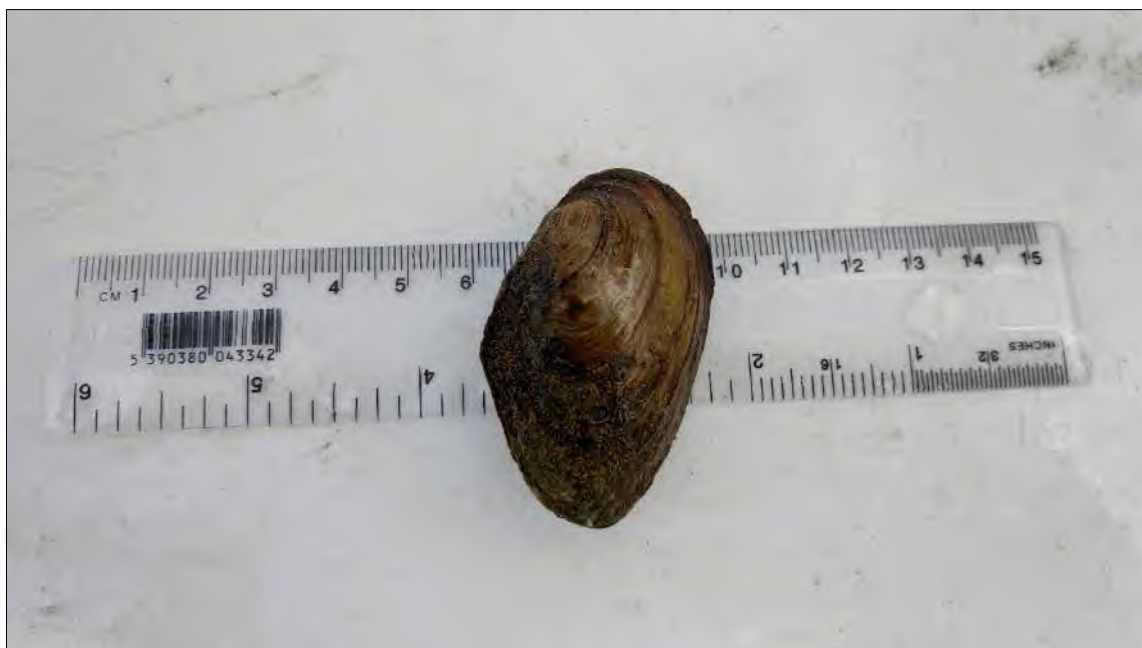
Plate 3.20 Example of duck mussel (*Anodonta anatina*) recorded from survey section D.

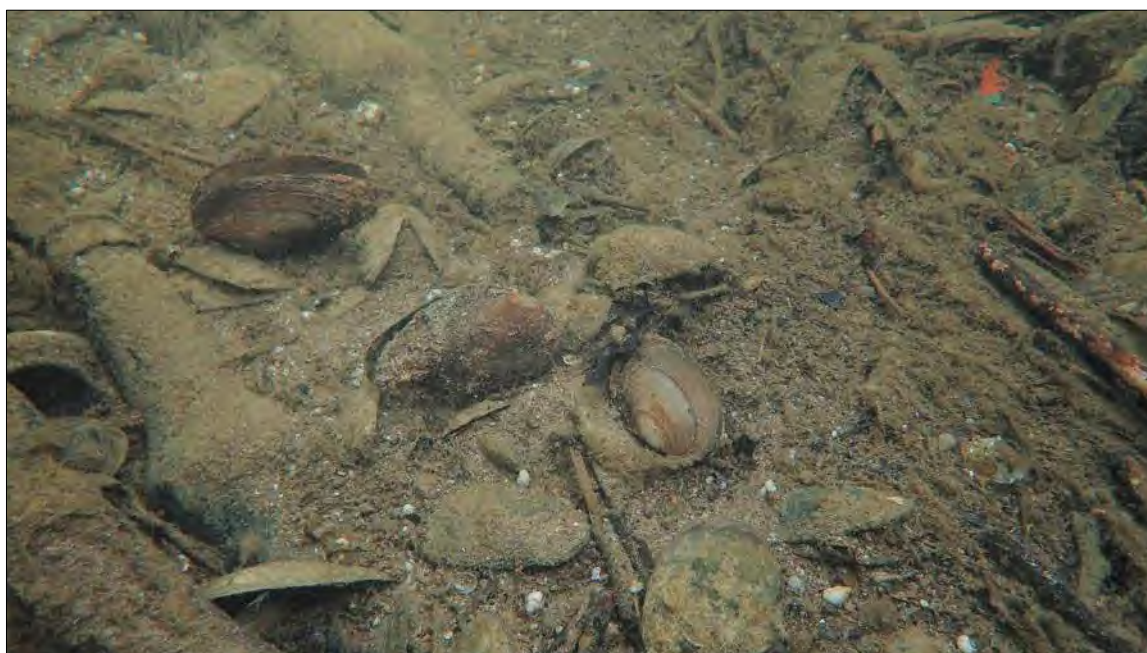
Plate 3.21 Dead duck mussel (*Anodonta anatina*) and shells recorded from the small off-shoot channel along Old Dock Road.

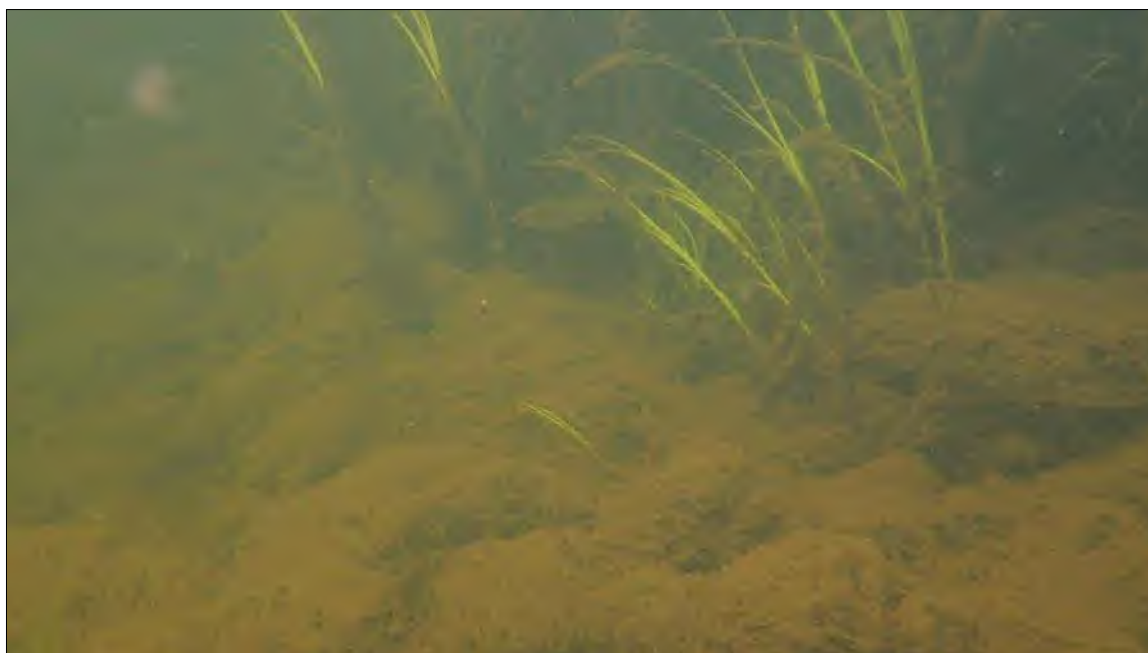
Plate 3.22 Underwater image showing macrophyte growth and heavy coverage of filamentous algae and floc in survey section D (conditions inimical to freshwater pearl mussel).

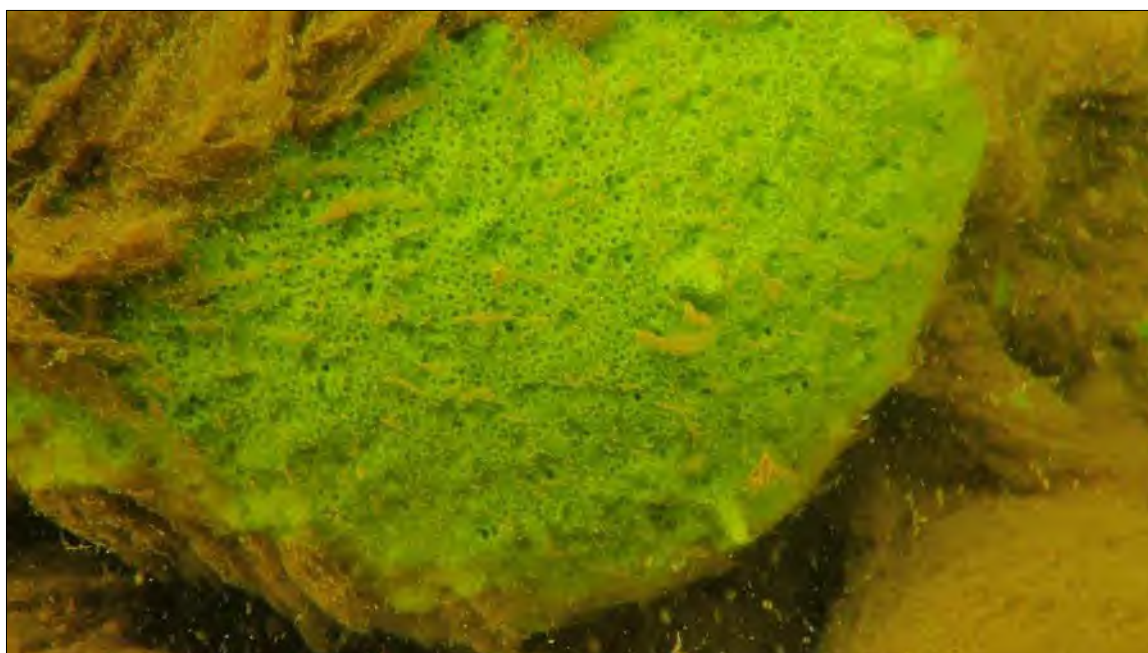
Plate 3.23 Freshwater sponge growing on submerged boulder in the vicinity of Graiguenamanagh Bridge (high coverage of filamentous algae and floc evident).

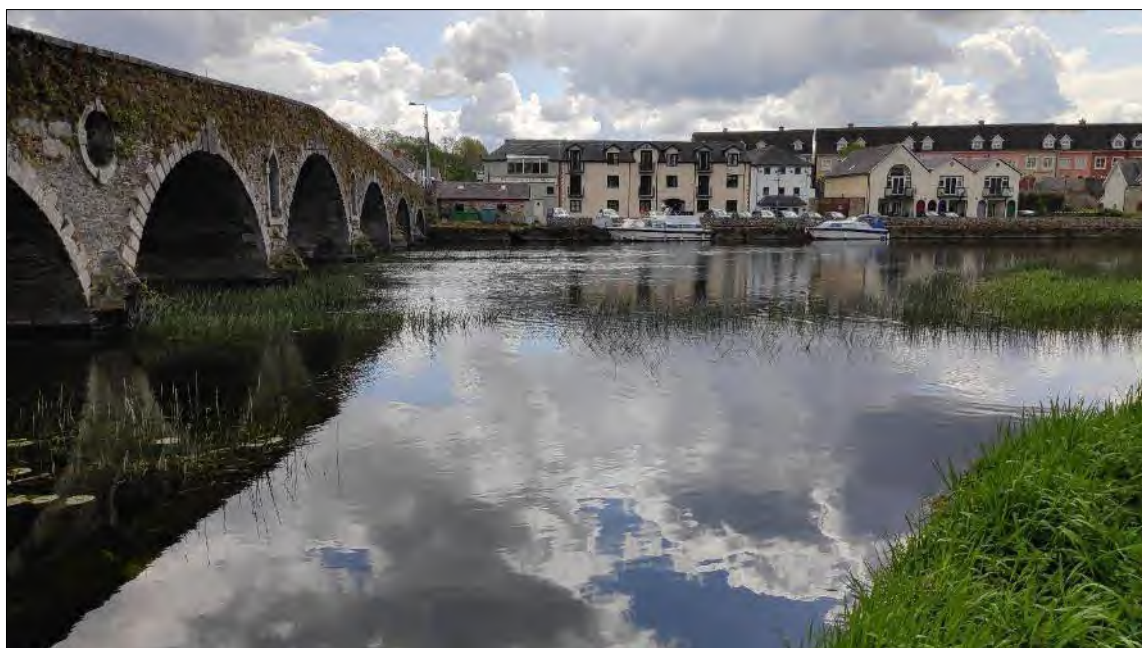
Plate 3.24 The River Barrow downstream of Graiguenamanagh Bridge and upstream of Graiguenamanagh Weir.

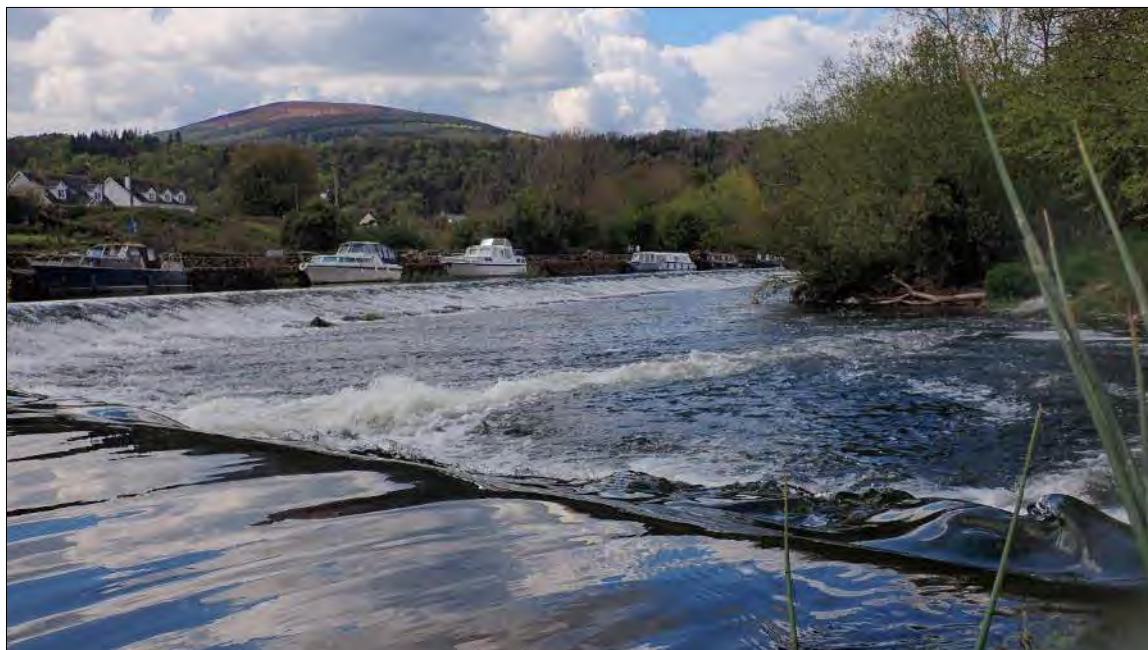
Plate 3.25 Graiguenamanagh Weir facing downstream from the weir sill.

Located downstream of Graiguenamanagh Weir, survey section E was dominated by riffle and shallow deep glide grading into deeper glide and pool downstream. The river averaged 1-1.5m deep adjoining the weir but deepened significantly to >3m c.100m downstream. From Graiguenamanagh Lock to Tinnahinch Weir, the river was exclusively deep glide and pool. The bed was dominated by cobble and coarse gravel with occasional boulder. Outside of shallower areas associated with the weir, these were heavily silted with relatively high levels of compaction and partial bedding. Excessive filamentous algae was present throughout the survey section, particularly in vicinity of the weir (**Plate 3.26**). Macrophytes were rare but arrowhead, clubrush and localised yellow water lily were present. Scattered, mature treelines of willow (*Salix* spp.), ash and occasional sycamore bordered the river.

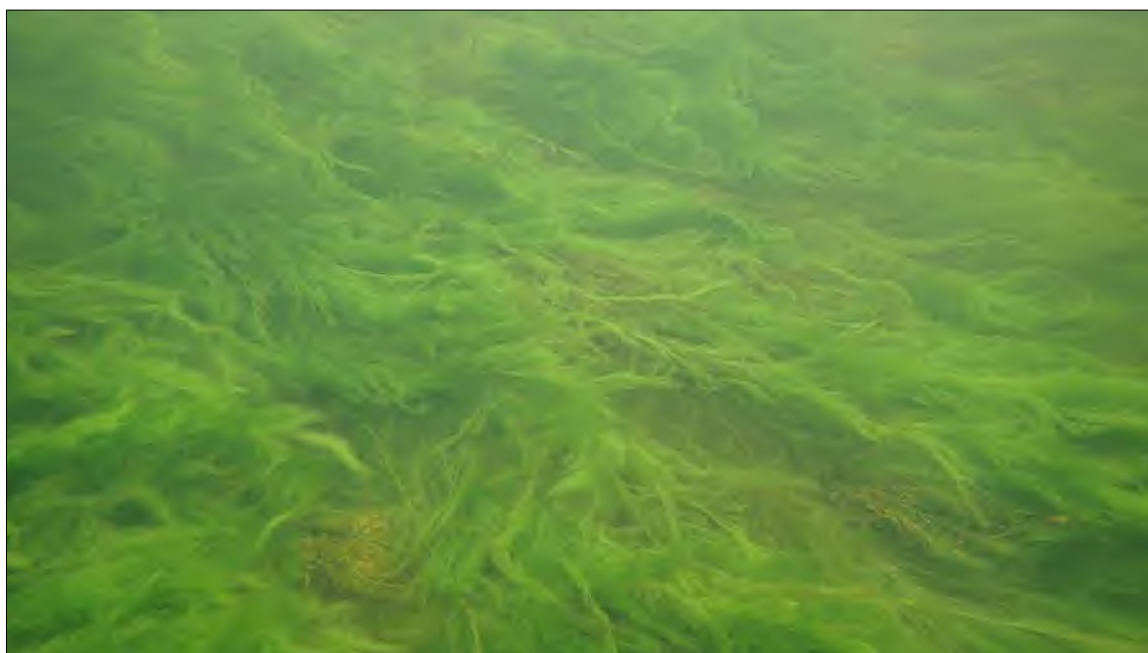
Plate 3.26 Extreme cover of filamentous algae (*Cladophora* sp.) on compacted cobbles immediately downstream of Graiguenamanagh Weir.

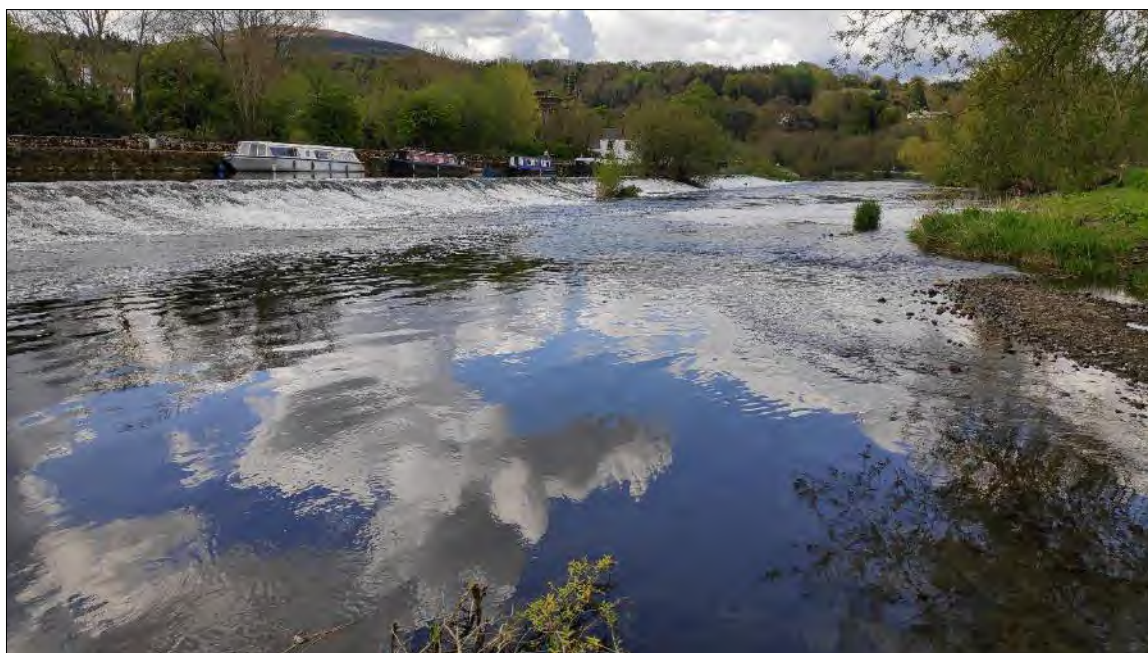
Plate 3.27 Downstream of Graiguenamanagh Weir at Duiske River confluence (right foreground).

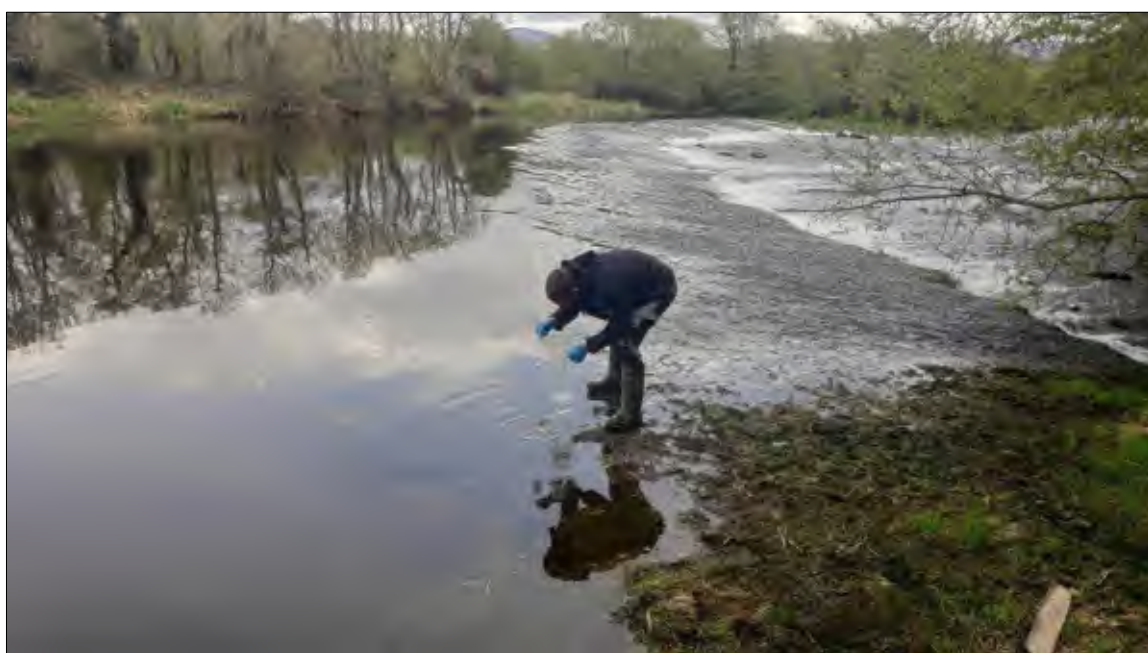
Plate 3.28 Sampling for *Margaritifera margaritifera* eDNA at Lower Tinnahinch Weir, April 2021.

The high sensitivity of eDNA analysis likely enabled a detection of these upstream freshwater pearl mussel populations from the Lower Tinnahinch Weir water sample. Although highly variable, downstream transport of eDNA in riverine environments is known to extend to >100km (Pont *et al.*, 2018), with reported detectable distances for freshwater bivalves ranging from as little as 25m to 12km (e.g. Preece *et al.*, 2020; Lor *et al.*, 2020; Stoekle *et al.*, 2015; Deiner & Altermatt, 2014). Although studies are lacking, the greatest reported distance at which freshwater pearl mussel eDNA has been detected from a known downstream population is 1.7km (Wacker *et al.*, 2019a). In light of this, it is unclear whether our analysis detected pearl mussel eDNA from the upstream Mountain River or Ballymurphy River populations. The Mountain River and Ballymurphy River populations are located c. 7km and 5km upstream of Graiguenamanagh, respectively (see **Figure 1.1**). Alternatively, the detected eDNA may have originated from pearl mussel washed into the main Barrow channel from the Mountain River. Fluvial mussel migration from the Mountain River to the main Barrow channel has been noted previously in the River Barrow catchment (in 1991, Sweeny, 2011). Recent NPWS data (2018) indicate low numbers of pearl mussels within the main Barrow channel downstream of the Mountain River and Little Ballyine River confluences, respectively. These are likely individuals originating in the Mountain River. The closest live pearl mussel record for the River Barrow record is located approx. 6.1km upstream of Graiguenamanagh (Ballyine River confluence). It is possible that our analysis detected eDNA emanating from this location or from an overlooked site of fluvially-migrated mussels from a Barrow tributary.

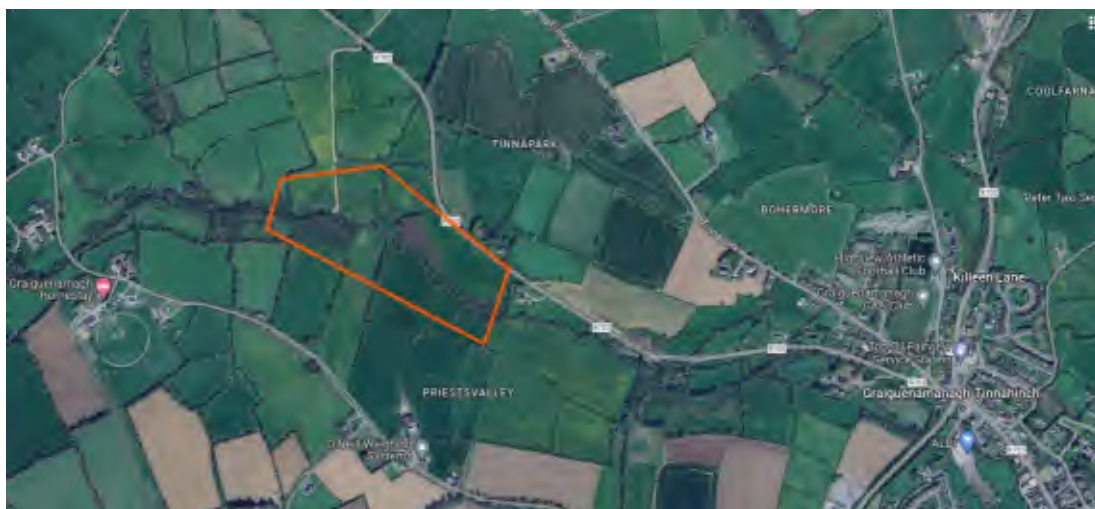
Figure 1: Area 1 outlined in orange.

- 4.1 The survey was divided into five areas.
- 4.2 Area 1 is where the upstream storage area is proposed, north-west of the towns (see Figure 1). It is the largest of the areas and it consists of agricultural grass fields that slope down to form a valley with the River Duiske which meanders through its centre. Mature hedgerows comprised of species such as hawthorn (*Crataegus monogyna*), blackthorn (*Prunus spinosa*), elder (*Sambucus nigra*), goat willow (*Salix caprea*), holly (*Ilex aquifolium*) and spindle (*Euonymus europaeus*) make up the boundaries between these fields, and mature trees including ash (*Fraxinus excelsior*), oak (*Quercus robur*), horse chestnut (*Aesculus hippocastanum*), sycamore (*Acer pseudoplatanus*) and alder (*Alnus glutinosa*) make up the upper canopies of these hedgerows. All the ash trees display symptoms of ash dieback – causal agent *Hymenoscyphus fraxineus*. The oak trees in this area hold the highest merit, the majority of which have been given Category A grades. There are also two semi-mature forestry plantations in this area comprised of ash (*Fraxinus excelsior*), oak (*Quercus robur*), beech (*Fagus sylvatica*) and alder (*Alnus glutinosa*).

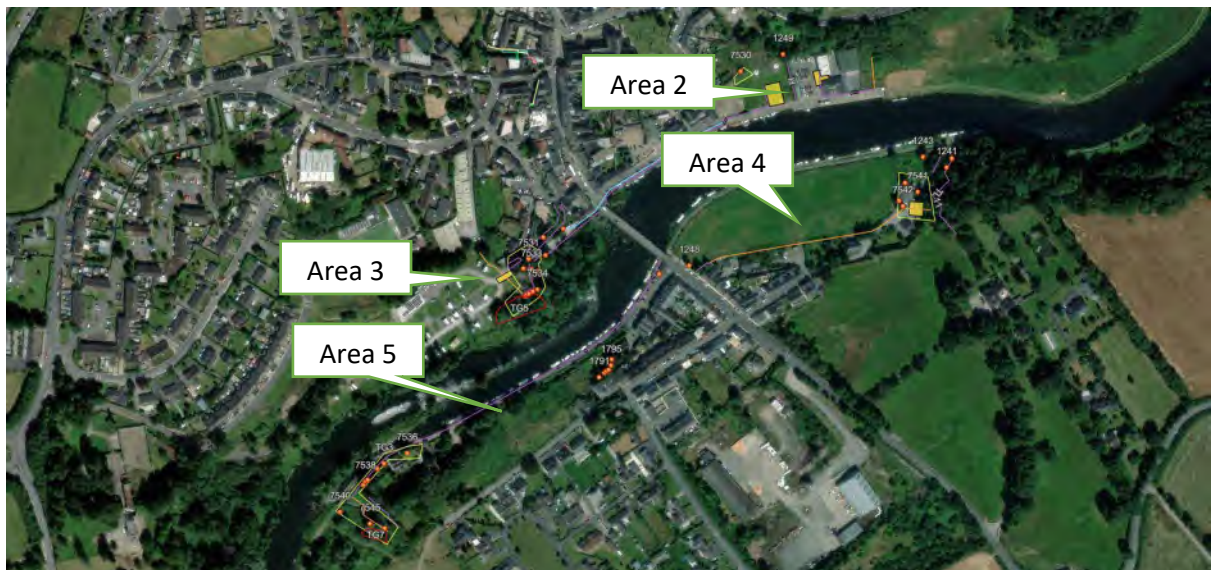
Figure 2: Overview of Town Areas Nos. 2-5 in their environs.

- 4.3 Area 2 is a grass field bounded by walls and fences, with a single mature hawthorn (*Crataegus monogyna*) and sycamore (*Acer pseudoplatanus*) towards the back (north) of the field (see Figure 2).

- 4.5 Area 4 is the trees adjacent to the planned embankment and raised ground behind Tinnahinch Quay (see Figure 2). This area is mainly a private garden, with four, self-set trees - a semi mature and early mature ash (*Fraxinus excelsior*), a semi mature sycamore (*Acer pseudoplatanus*) and a mature goat willow (*Salix caprea*). There is also a mixed species, mature woodland on the higher ground to the west of this area, separated by a retaining wall, the trees that make up the outer canopy formation of this woodland, and overhang Area 4, include ash (*Fraxinus excelsior*), western red cedar (*Thuja pilcata*) and larch (*Larix decidua*).

- 4.6 Area 5 is the trees along the planned raised defence wall adjacent to Tinnahinch Castle and the quay (see Figure 2). Significant trees in this area include a mature horse chestnut (*Aesculus hippocastanum*) and a mature sycamore (*Acer pseudoplatanus*), both located on the adjoining property side of the wall that runs parallel to the public walkway and river. Outside of this, in the overgrown scrub area to the south of the river, there is a mature white willow (*Salix alba*) and a group of semi mature alder (*Alnus glutinosa*) and white willows (*Salix alba*). To the east of this area, but still along the quay, there is a group of three, mature, moderate quality, Category B, Lawson cypress (*Chamaecyparis lawsoniana*) trees and a mature, moderate quality, Category B, birch (*Betula pendula*) growing in a small grass area adjoining residences.

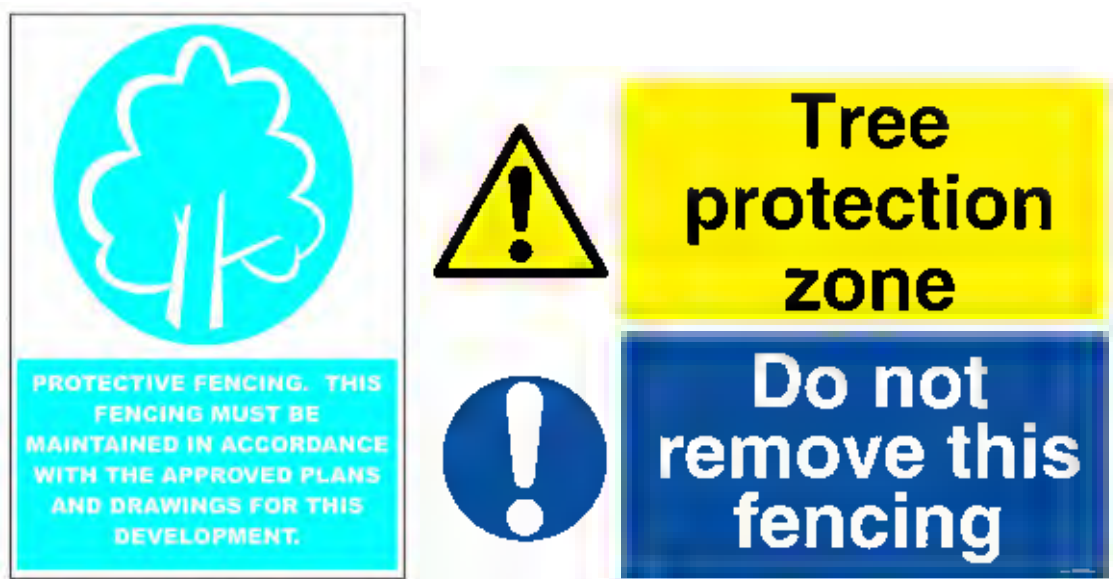
Figure 5: 'Keep Out' sign examples for tree protective fencing.

6.5.3 All weather 'Keep Out' signs will be secured to the fences.

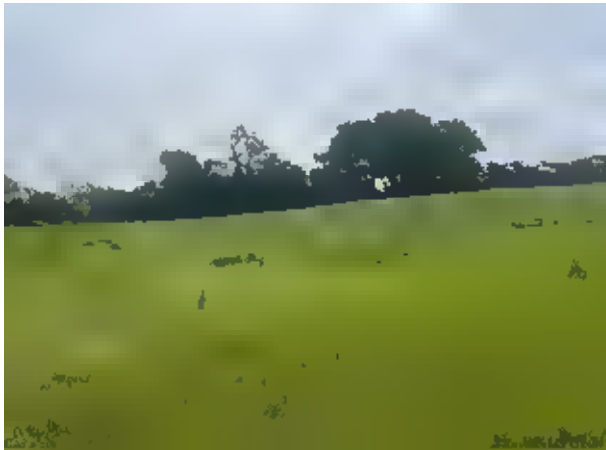
Image 1: Typical topography of Area 1 with the sloping fields divided by hedgerows and tree lines

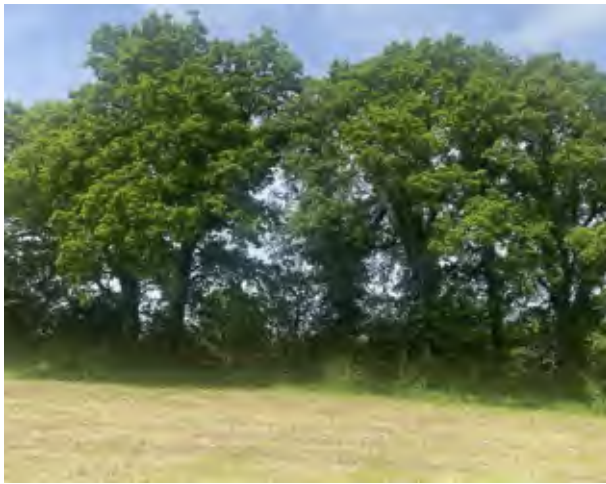
Image 2: Tree Line No. 7 – mature oak trees growing out of Hedge No. 9

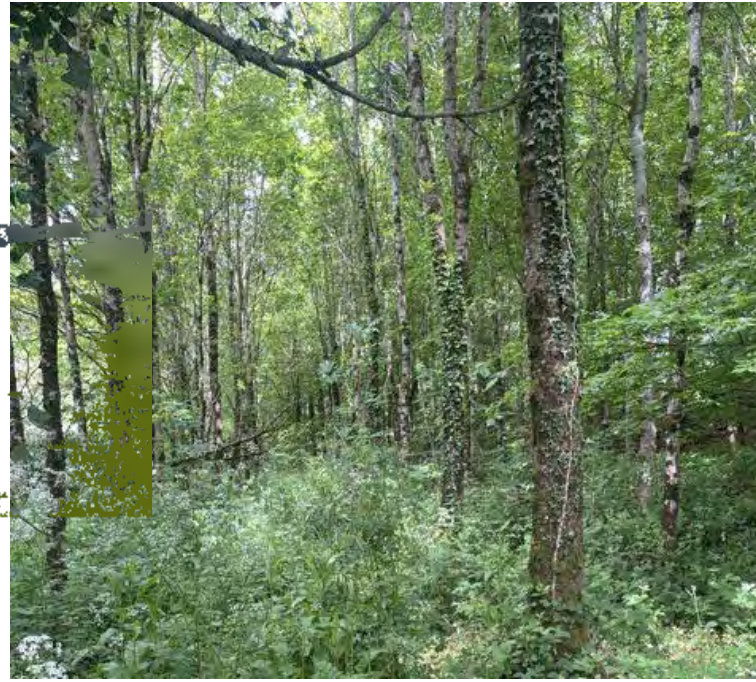
Image 3: Woodland Block No. 2 – semi mature trees that are poorly tapered due to competition for light

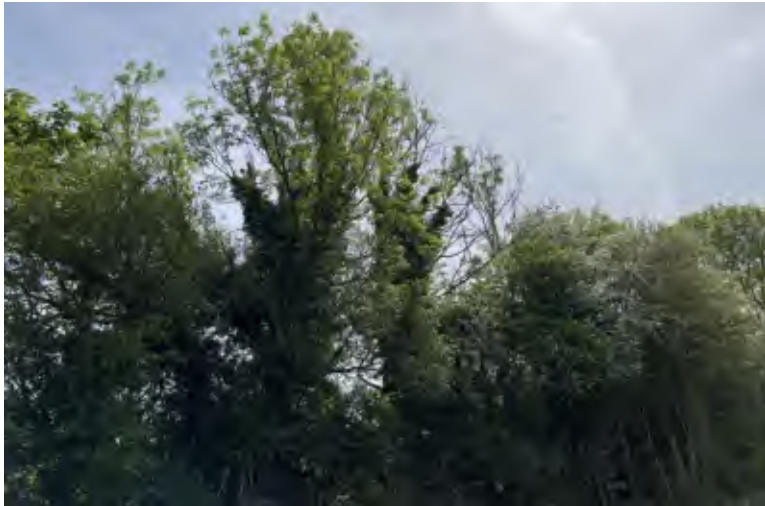
Image 4: Tree Line No. 2, growing out of Hedge No. 2 , with symptoms of ash dieback – as do most ash trees in this area

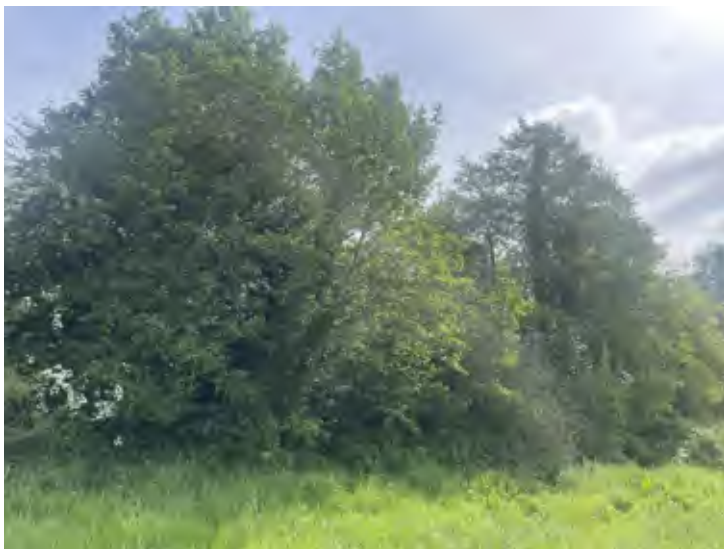
Image 5: Hedge No. 1B with Tree Line No. 5 in the upper canopy

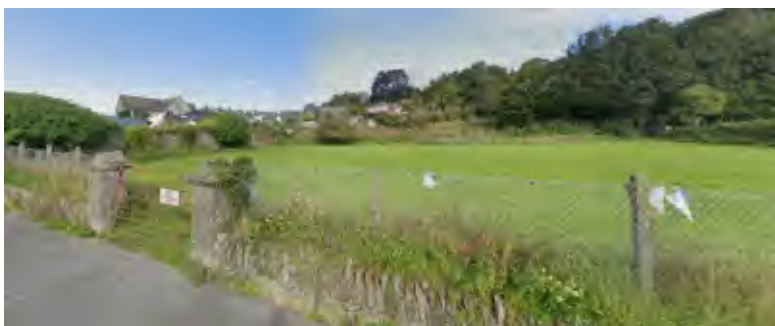
Image 6: Area 2 is mainly an open field with a single hawthorn – Tag No. 7530 – at the back

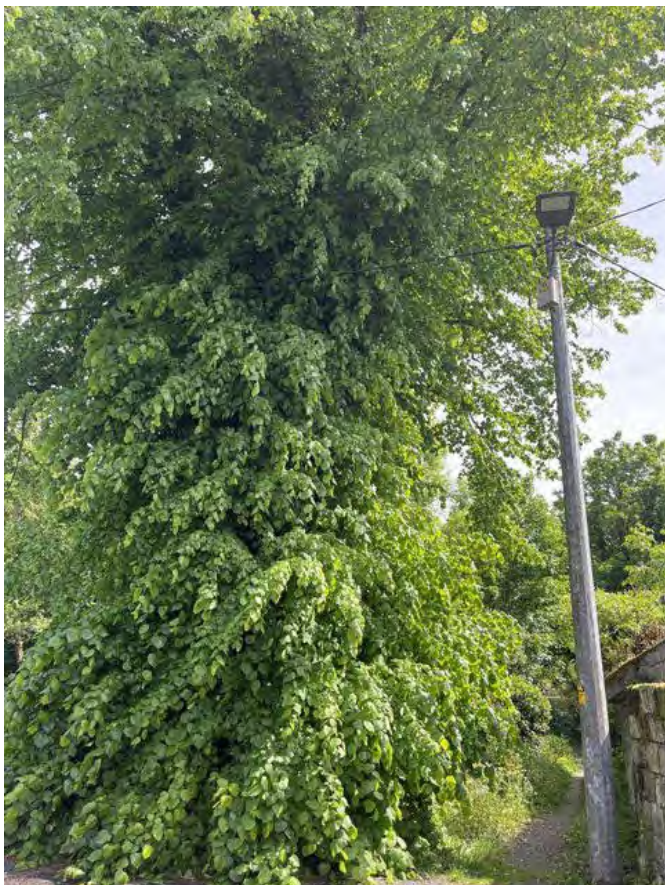
Image 8: Tag No. 7535, a mature large-leaved lime

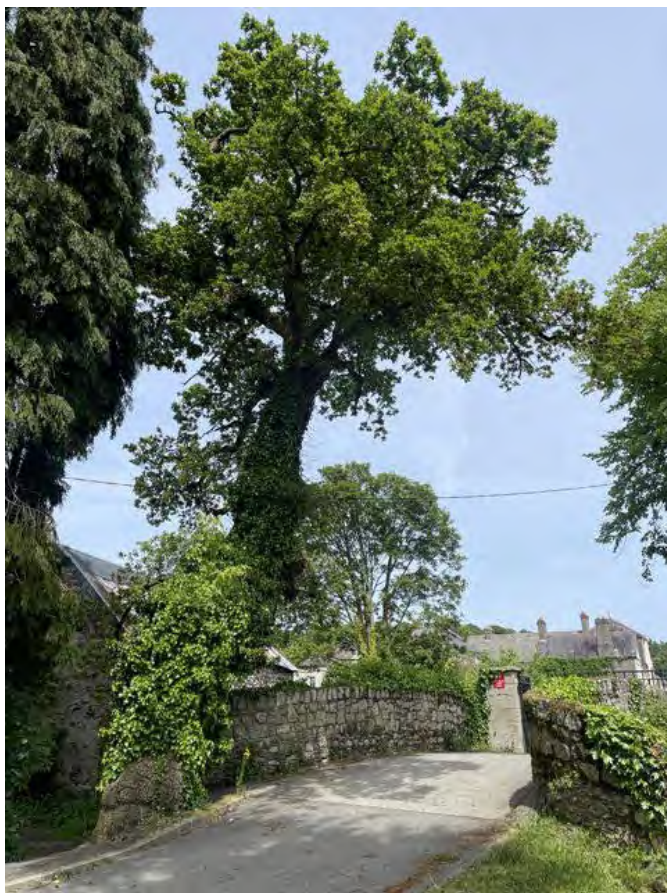
Image 9: Tag No. 7531, mature oak next to the bridge
