Appropriate Assessment

Graiguenamanagh-Tinnahinch Flood Relief Scheme

Report No. W3451-AYE-ENV-R010

Kilkenny County Council

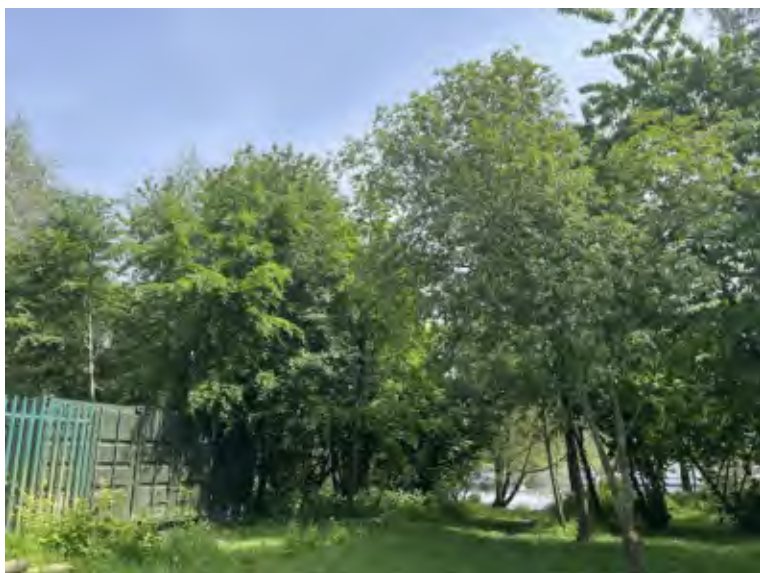
Image 10: Tree Group No. 5 along the river, made up of alder, beech, willow, cherry and hazel

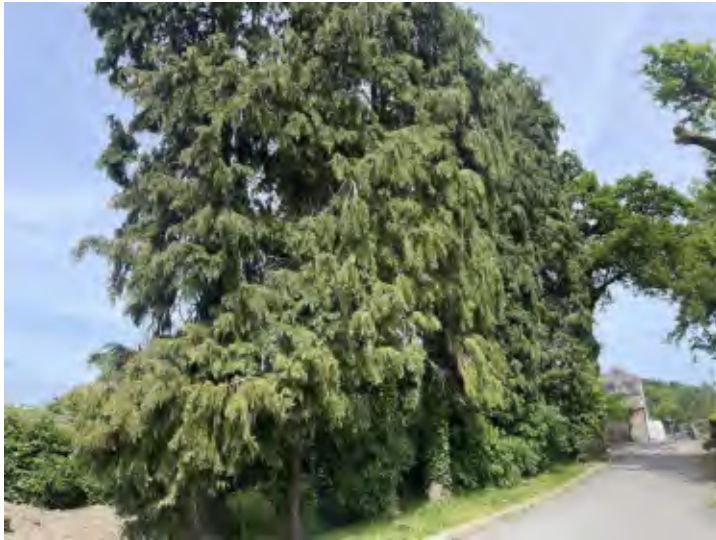
Image 11: Tree Group No. 2, Lawson cypress' next to the bridge

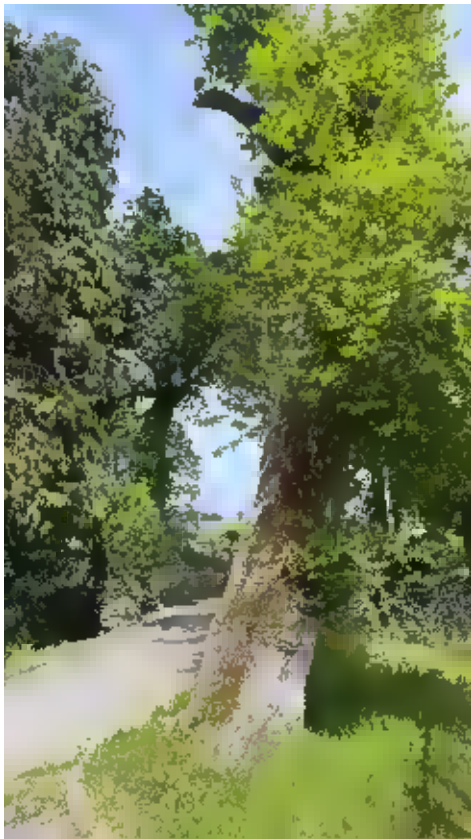
Image 12: Tag No. 7532, mature oak next to the bridge

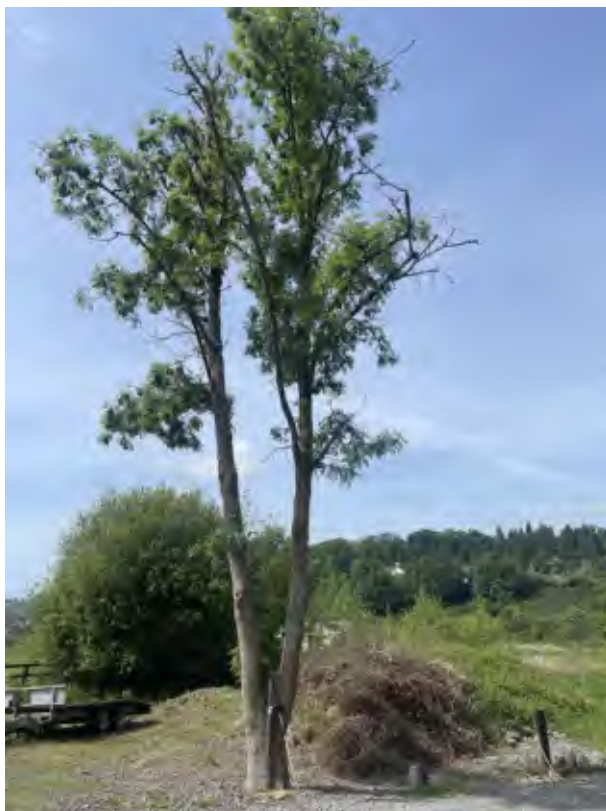
Image 14: Tag No. 7541 in decline from ash dieback

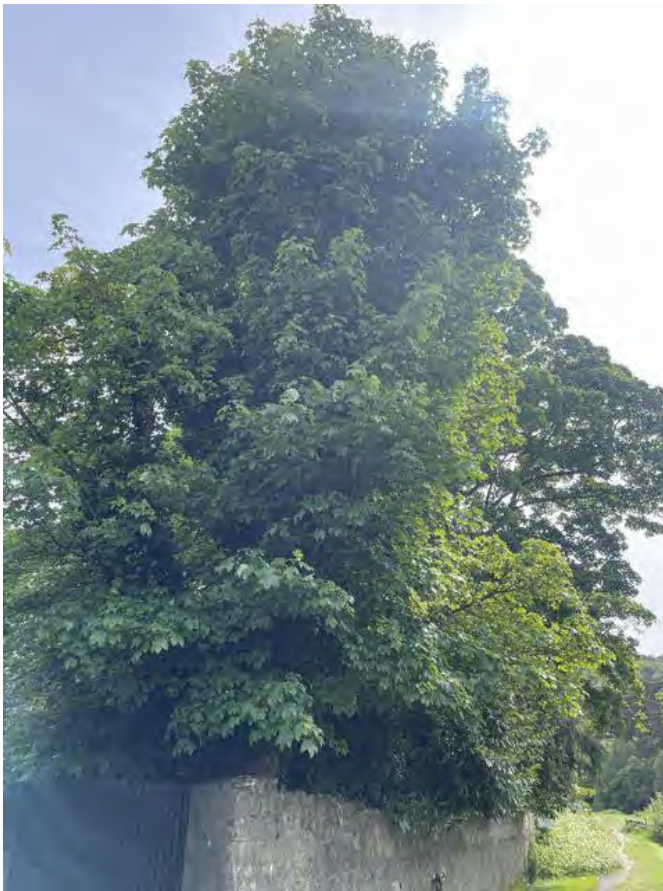
Image 15: Tag No. 7537, mature sycamore with *Kretzschmaria deusta* fungus at base – see management recommendations in Tree Survey in Appendix 1.

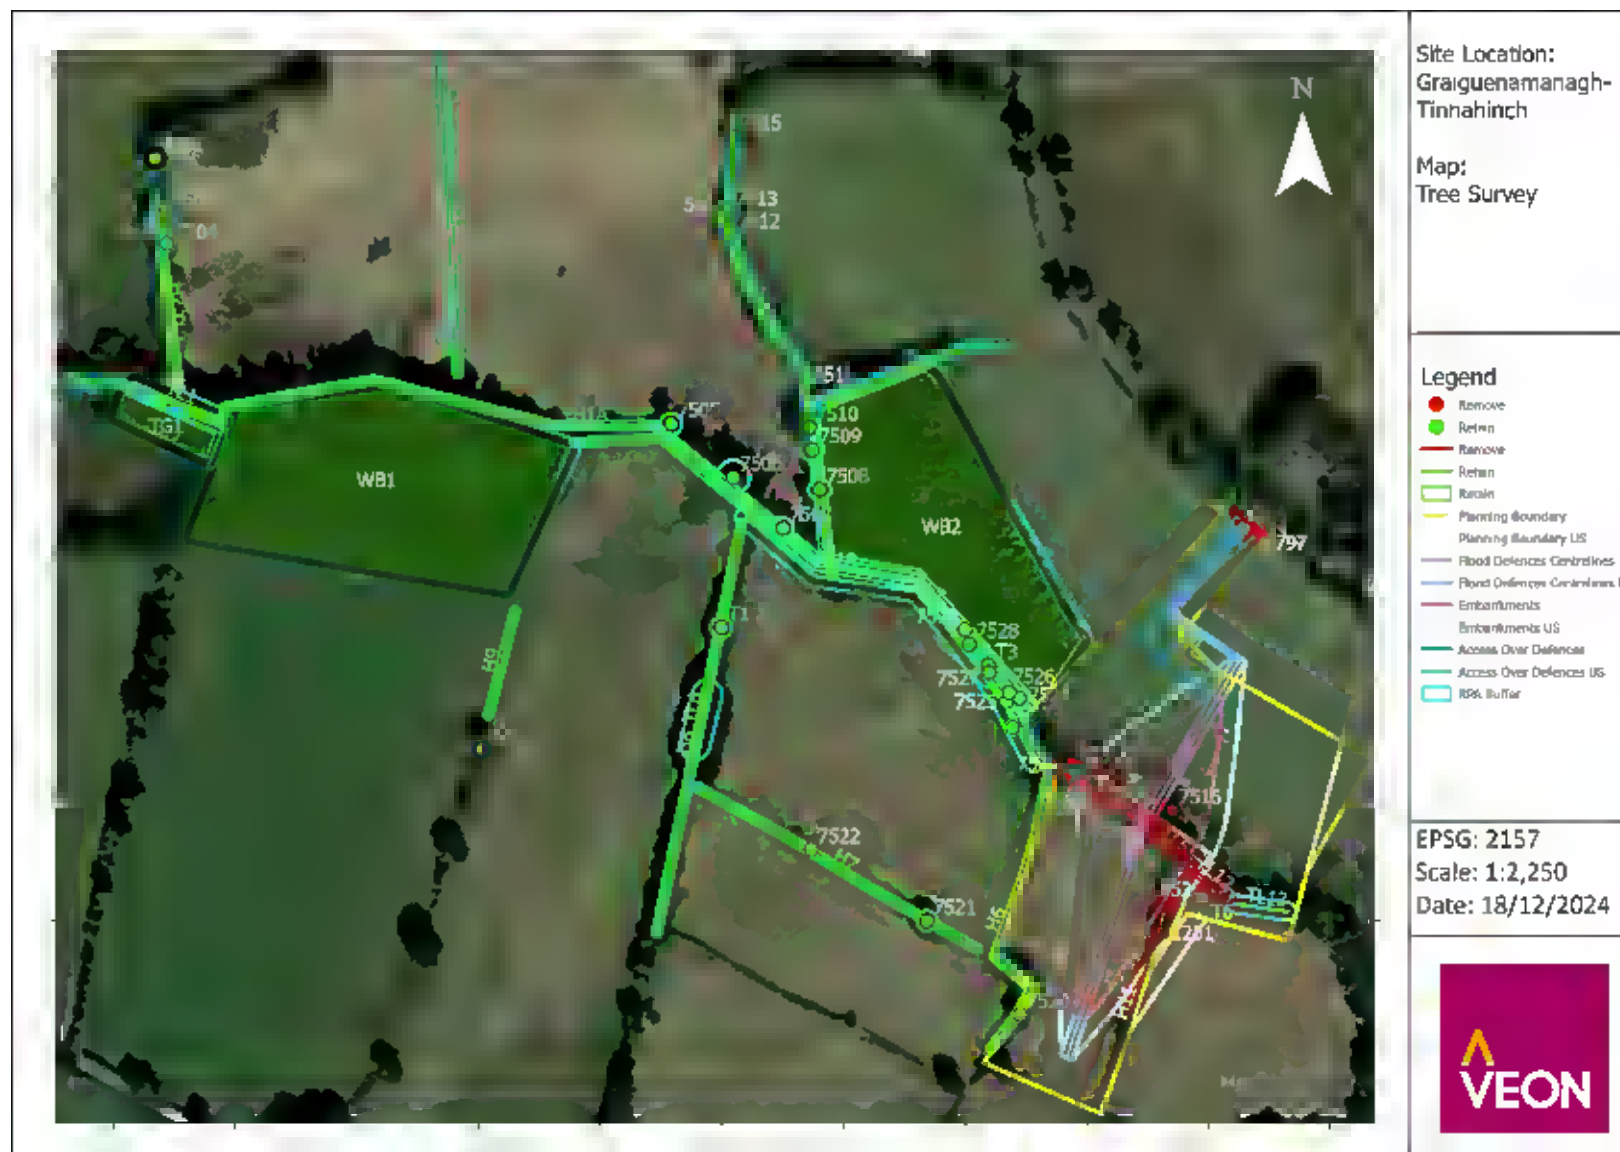
Figure 8: Area 1 - Tree removal/retention and Root Protection Area constraints

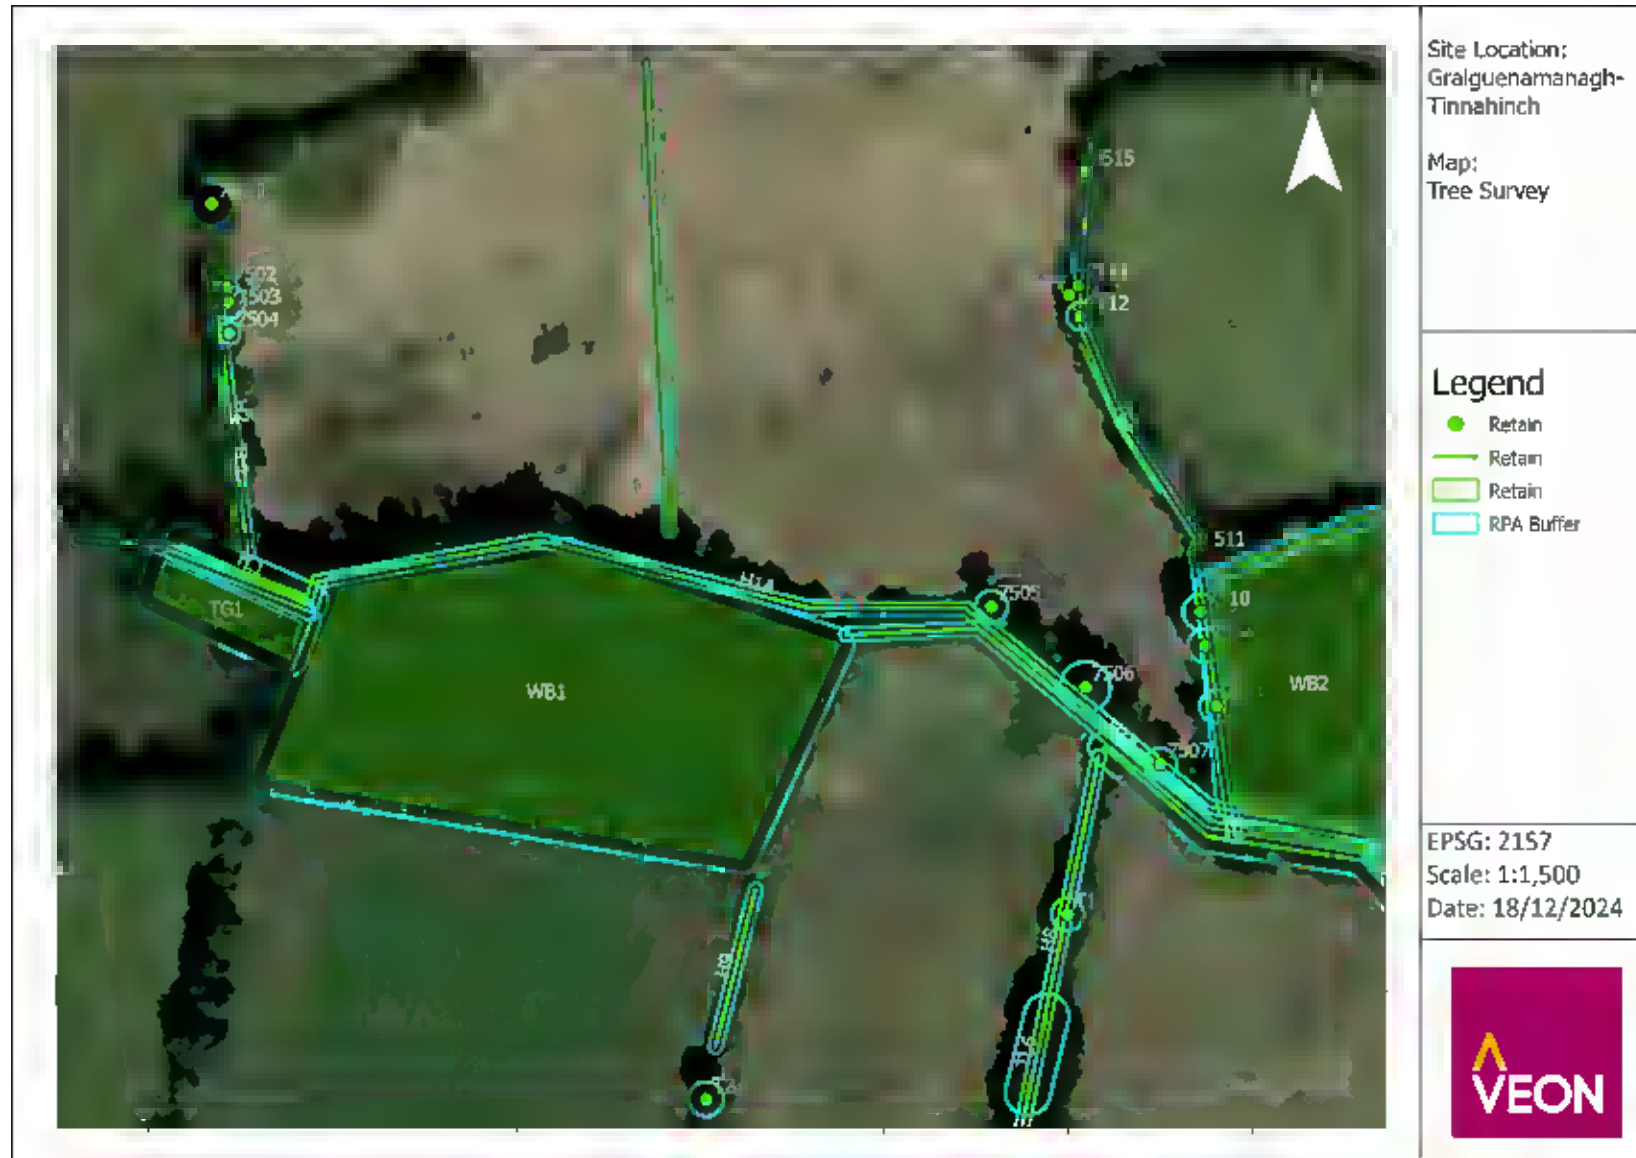
Figure 9: Western section of Area 1

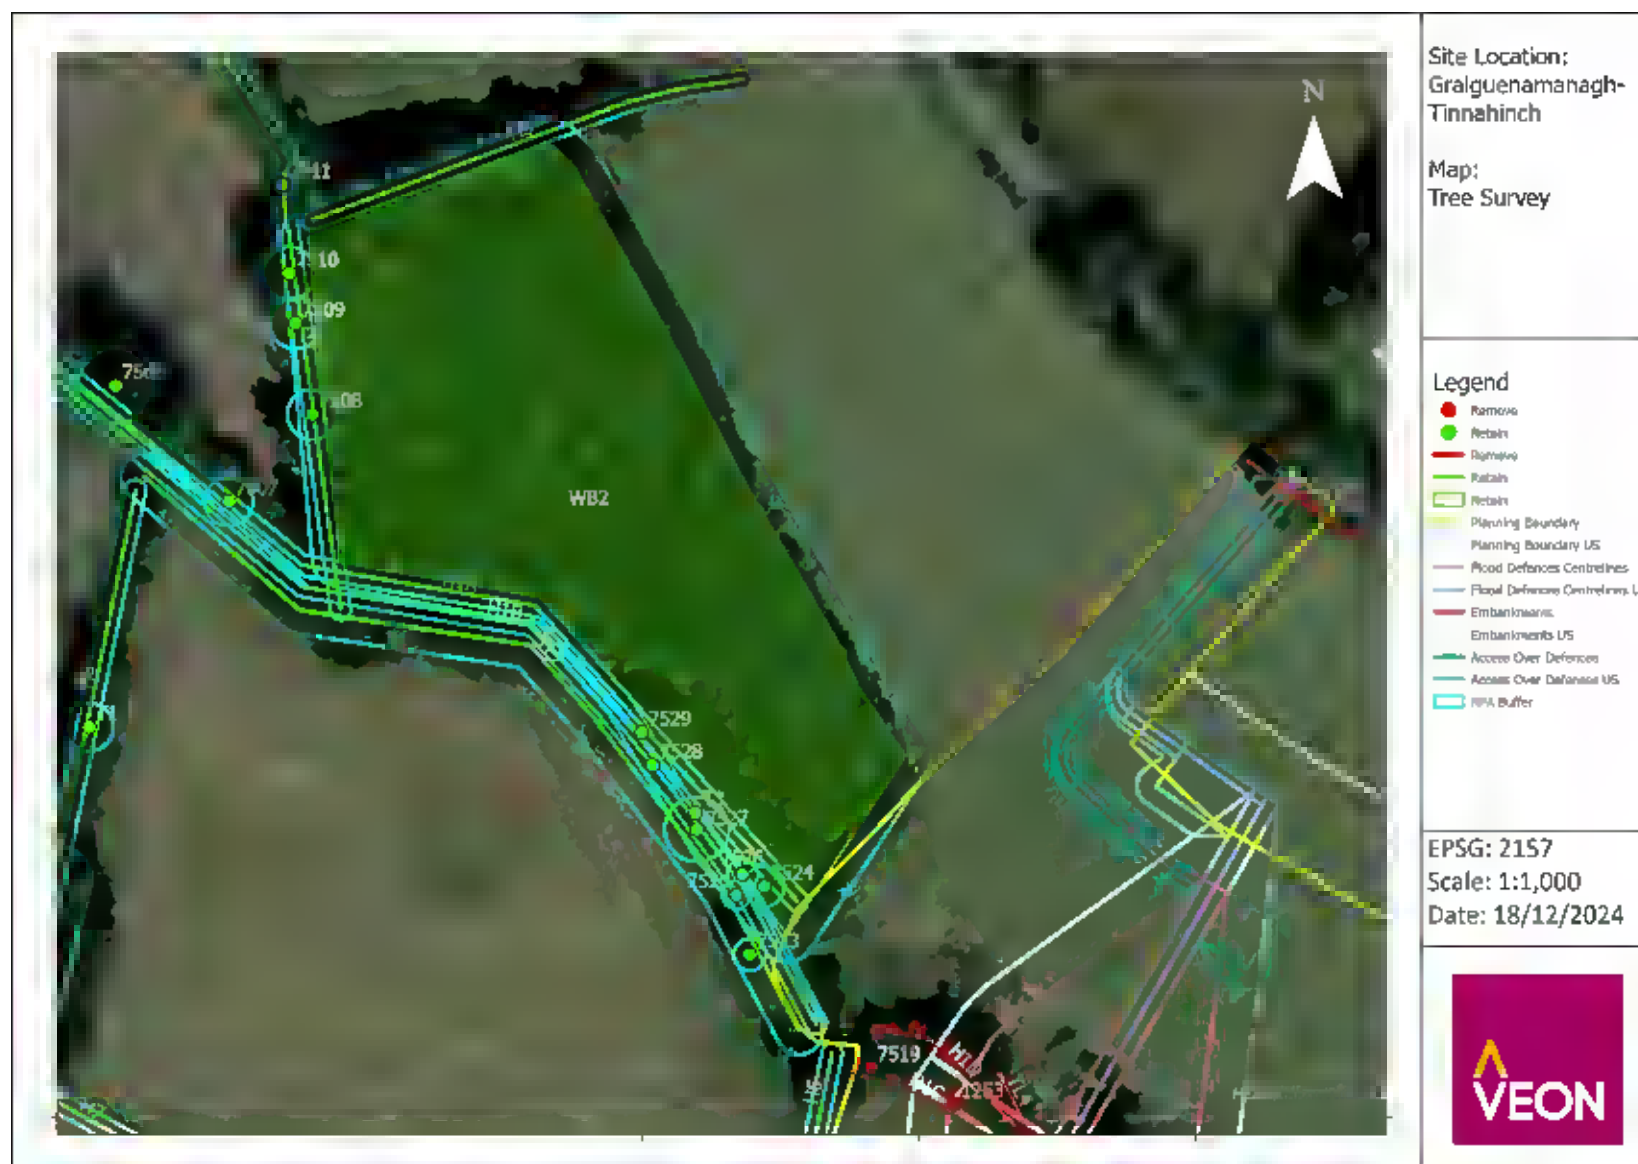
Figure 10: Northern section of Area 1

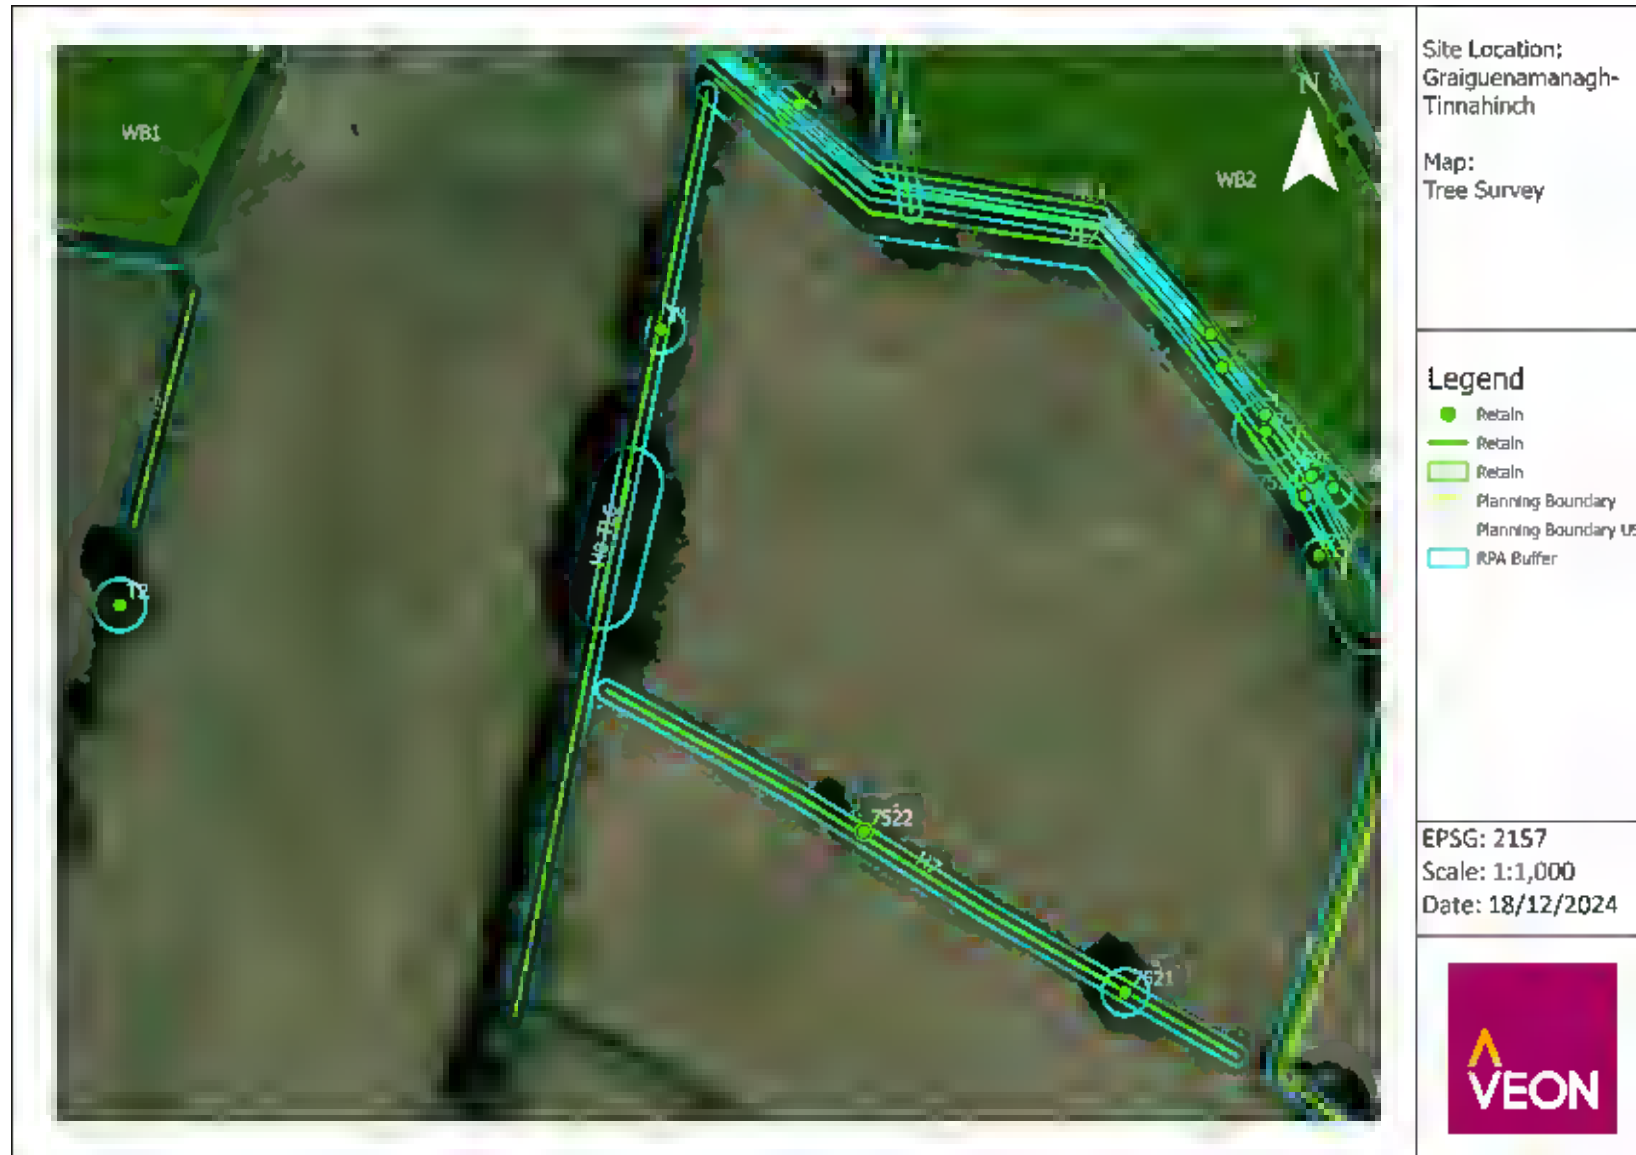
Figure 11: Southern section of Area 1

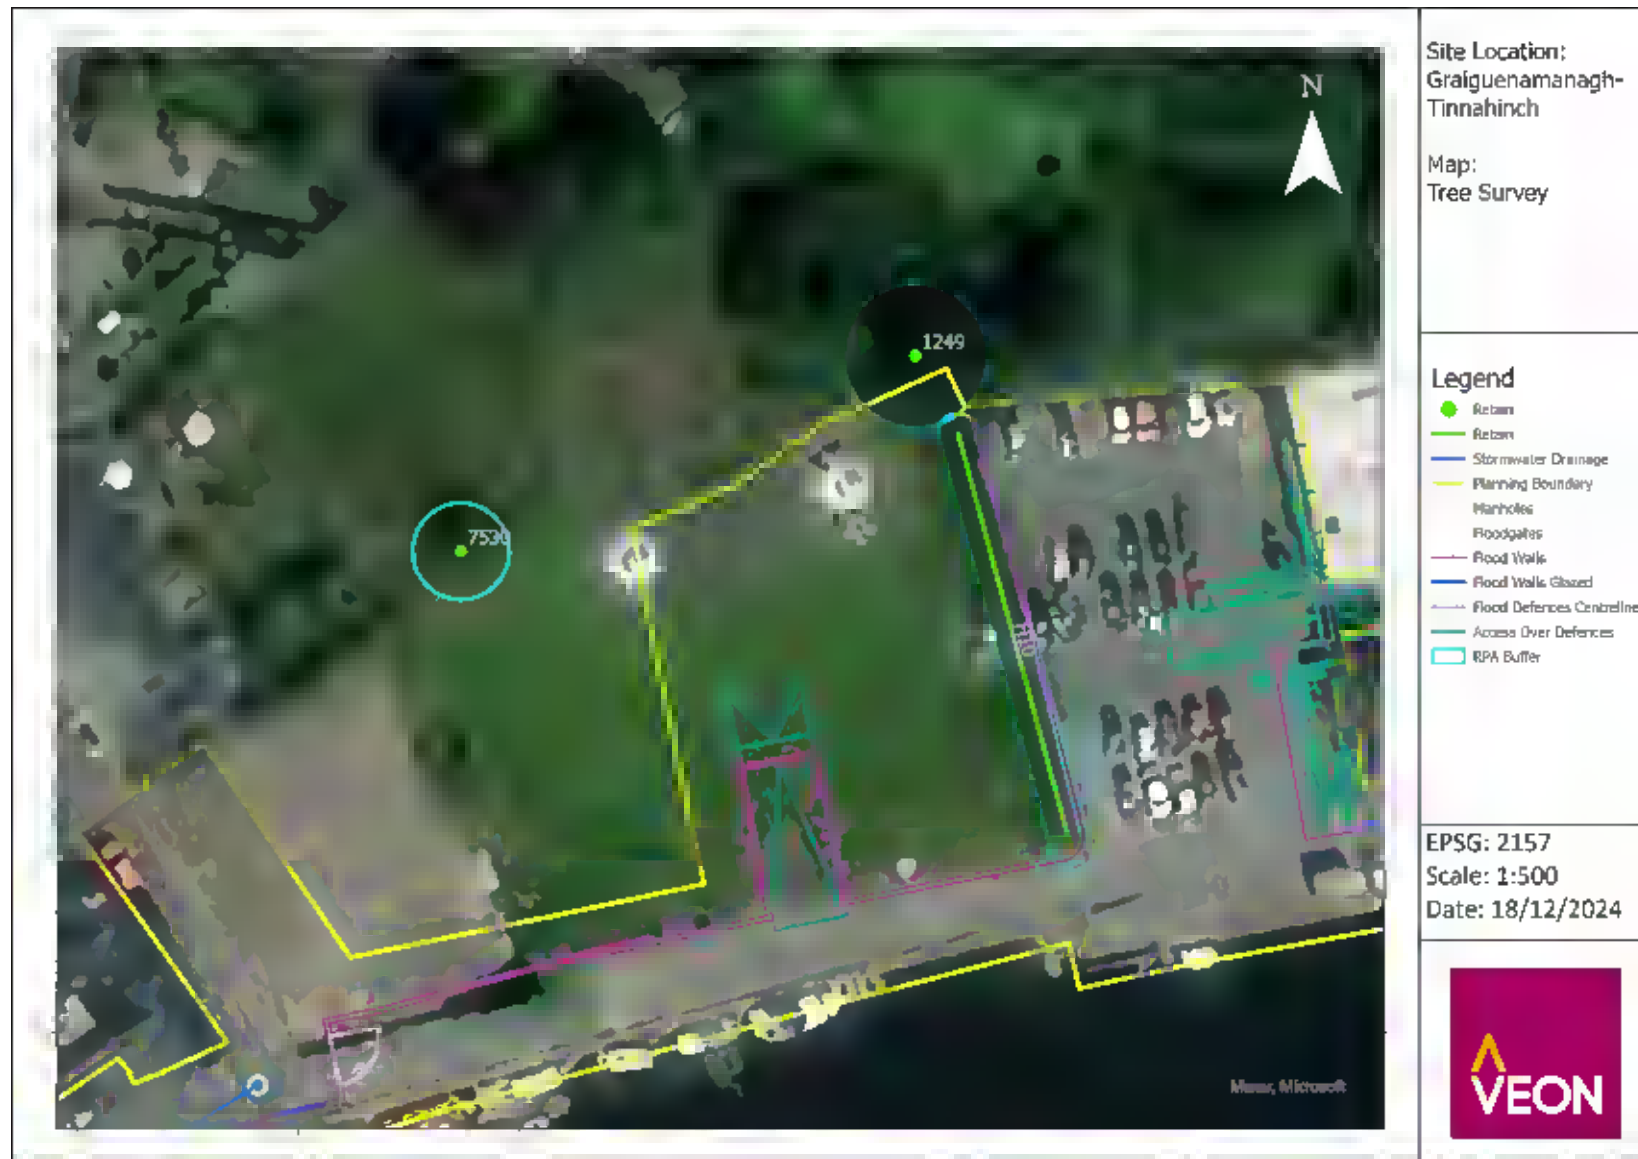
Figure 14: Close up of Area 2

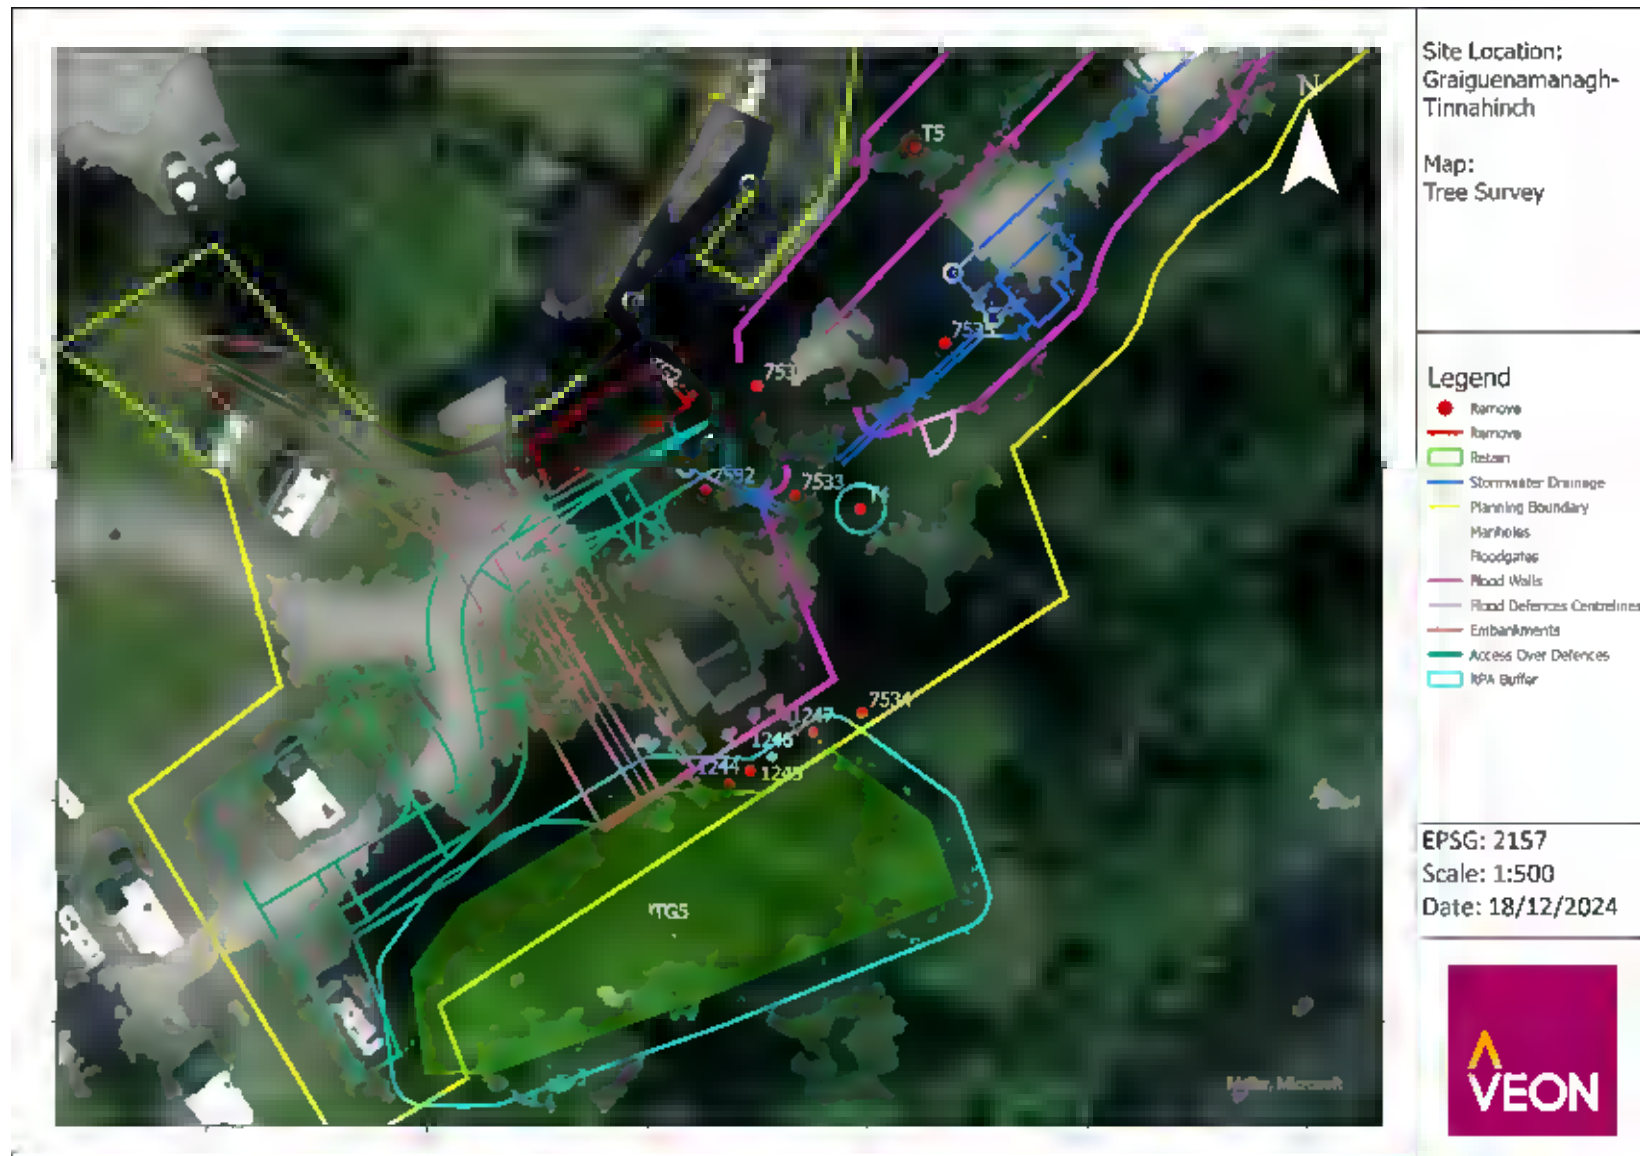
Figure 15: Close up of Area 3 – Note that the outline of TG5 is crown spread, not stems, so these trees can be retained

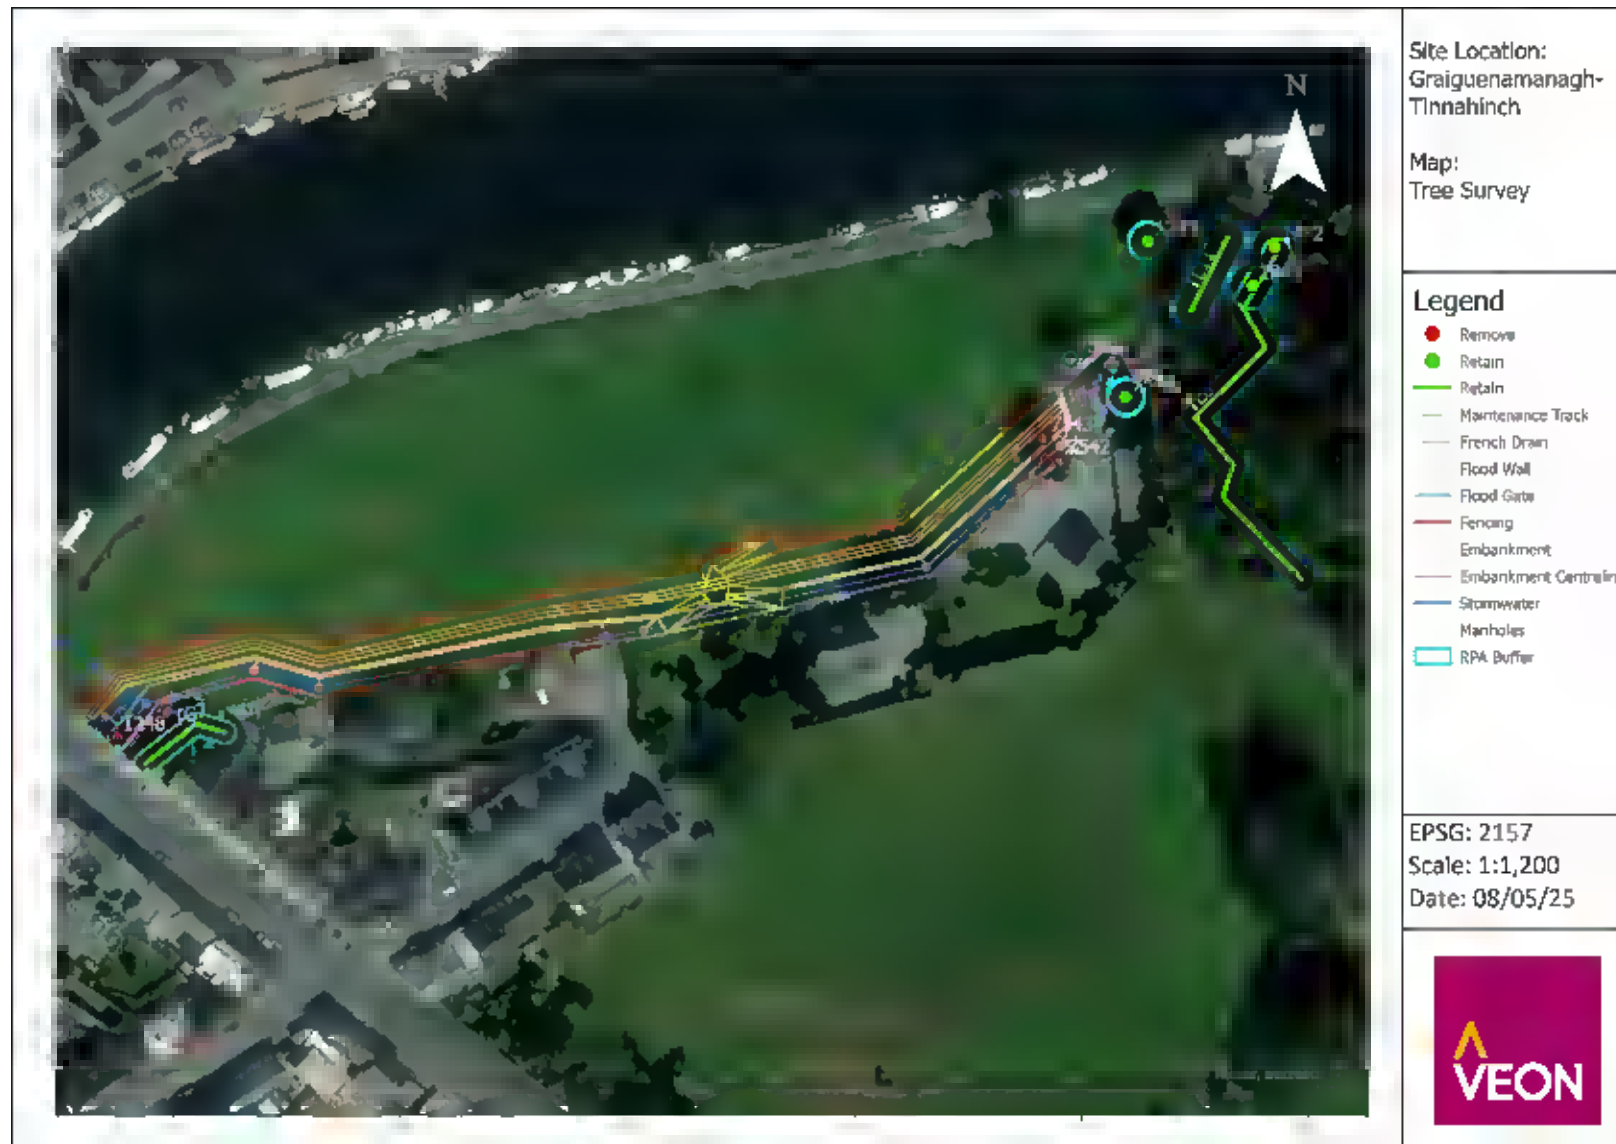
Figure 16: Close up of Area 4

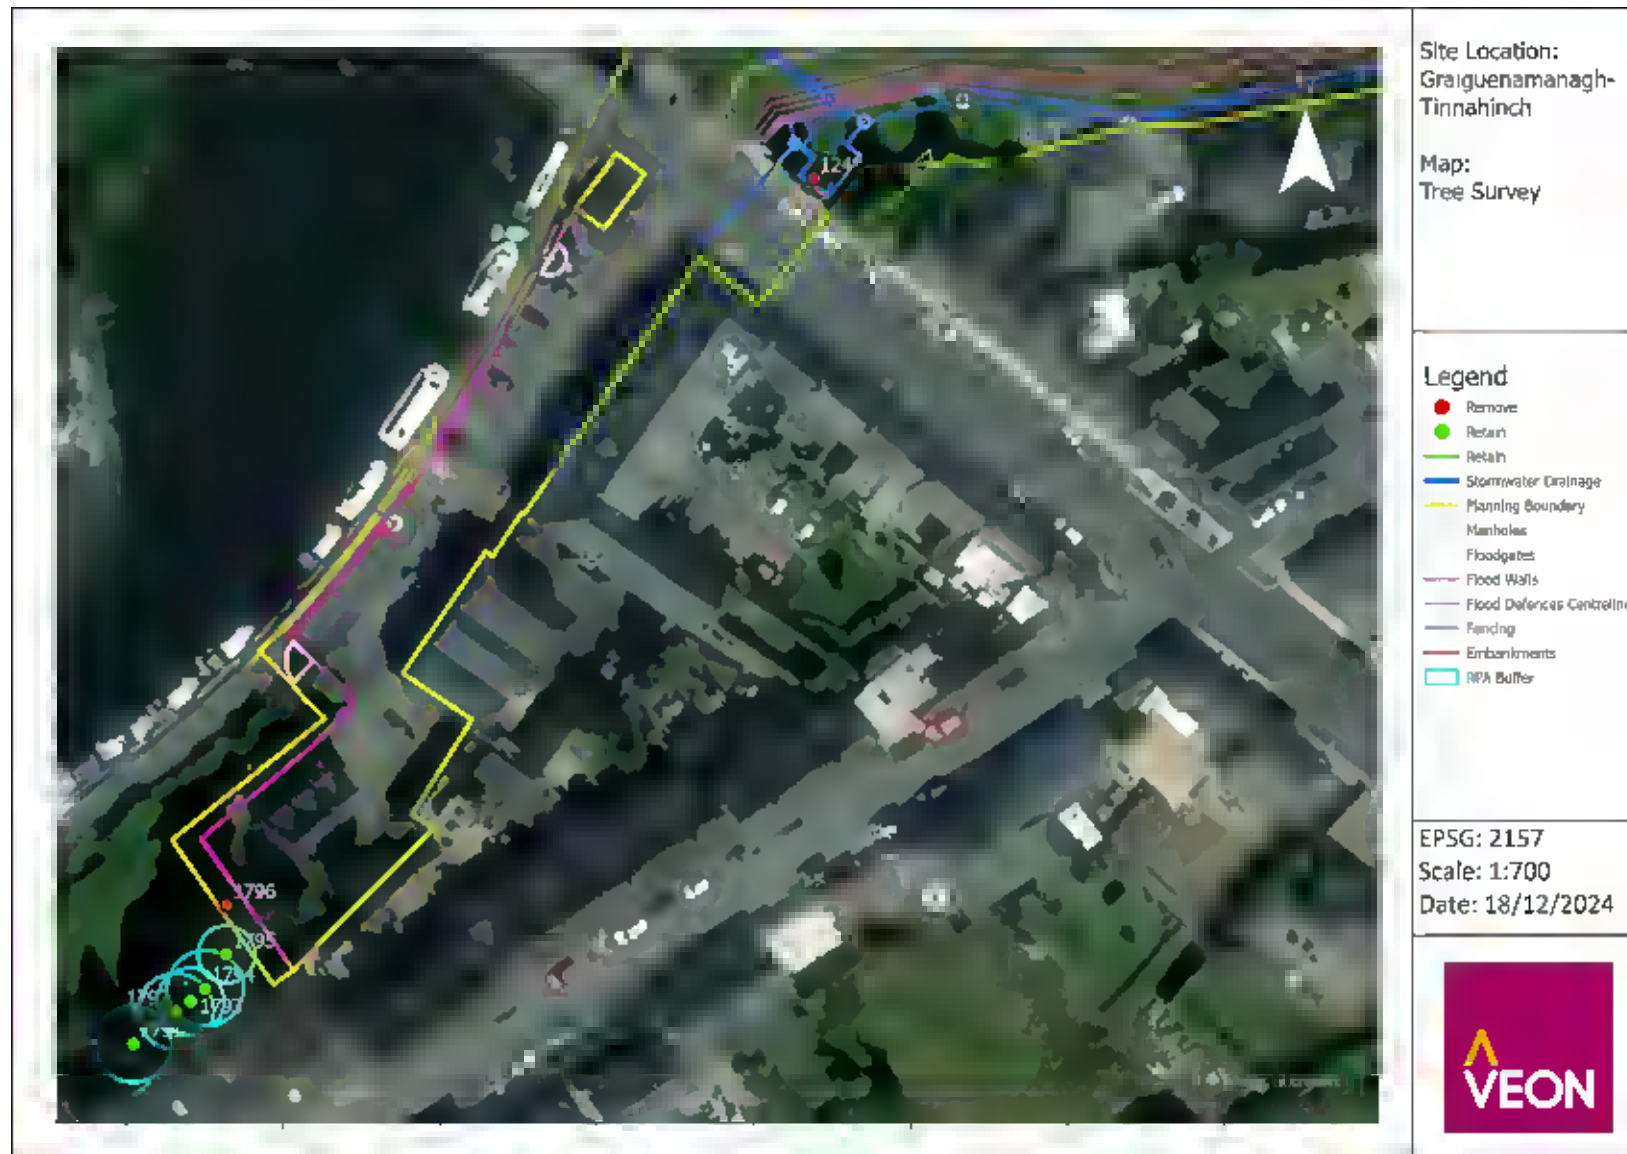
Figure 17: Eastern section of Area 4 & western section of Area 5

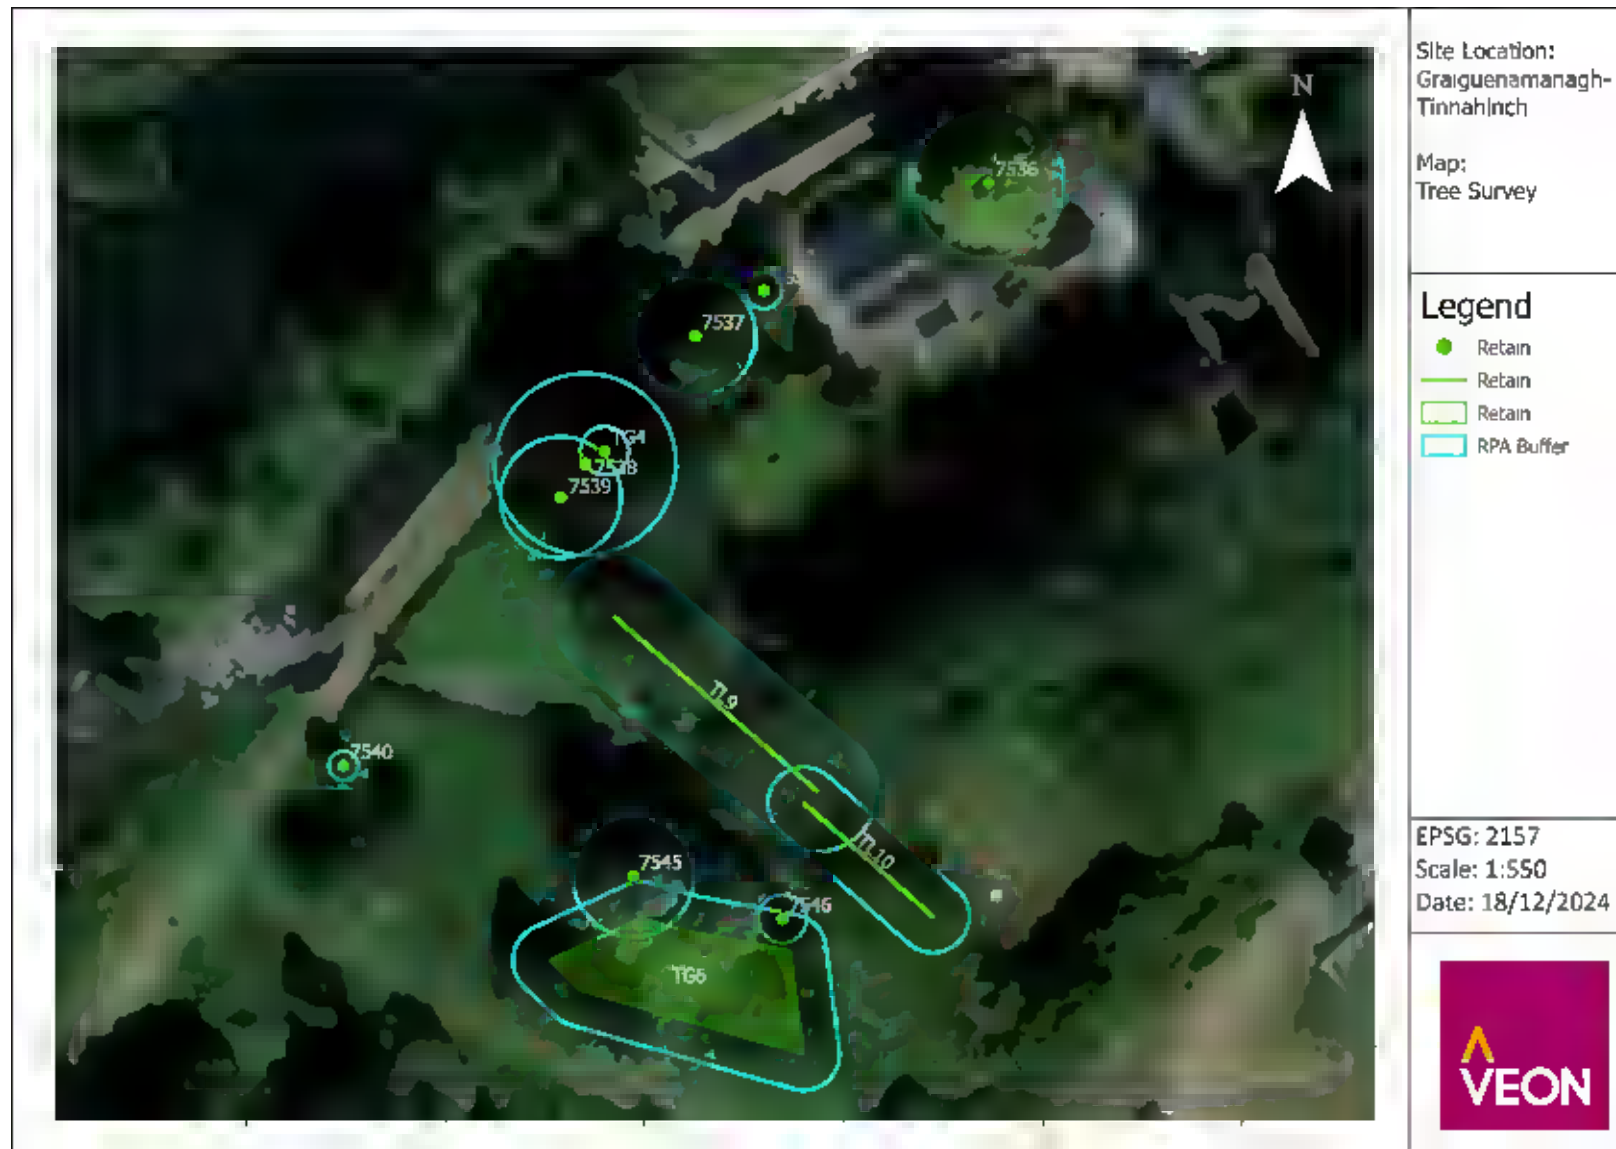
Figure 18: Close up of Area 5
