Haggardstown LRD

Appendices

**PROPOSED RESIDENTIAL DEVELOPMENT
BLACKROCK
DUNDALK
COUNTY LOUTH**

FACTUAL AND INTERPRETATIVE REPORT

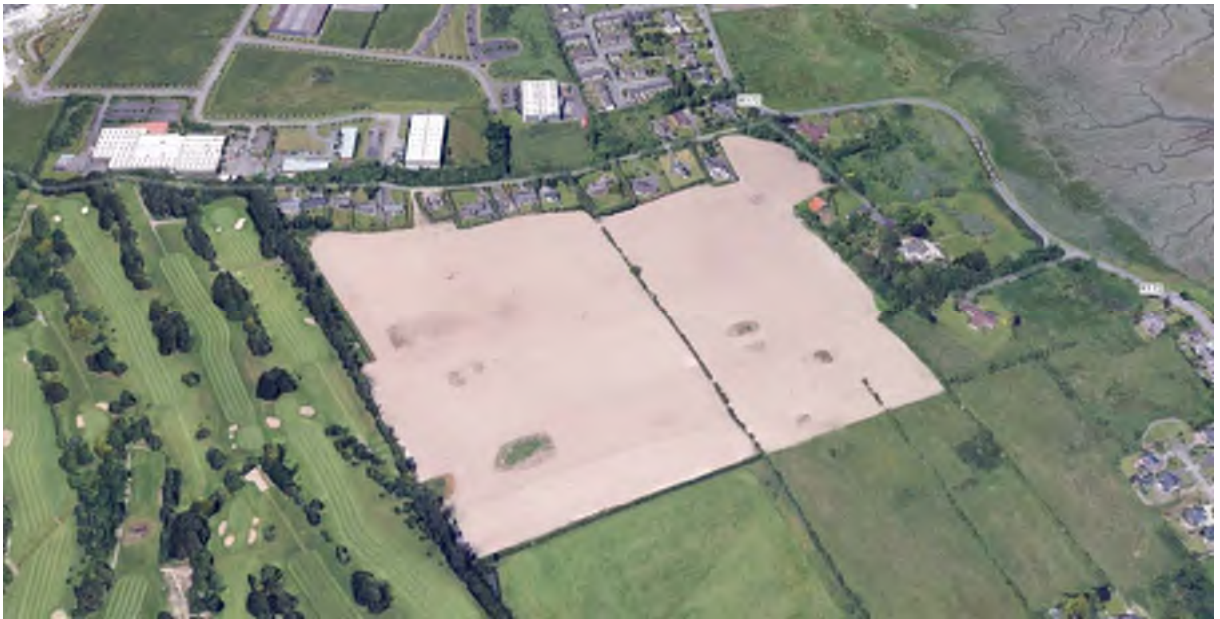
The site is currently used for agricultural purposes. At the time of writing the fields were used for the growing of barley. There is a hedgerow running down the (approximate) centreline of the site.

Photo 2: Aerial View of Site Looking towards the North

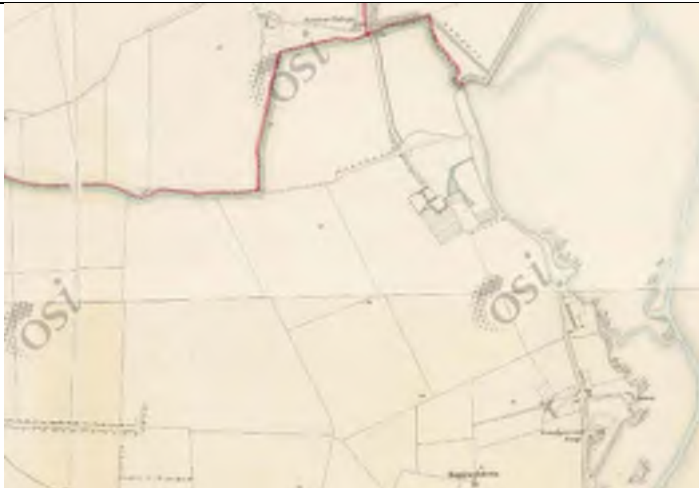
Date	Historical Land Uses
1837

<p><i>Site Area:</i> Undeveloped</p> <p><i>Surrounding Area:</i> Area generally undeveloped and only a few small farm dwelling present in local area</p>

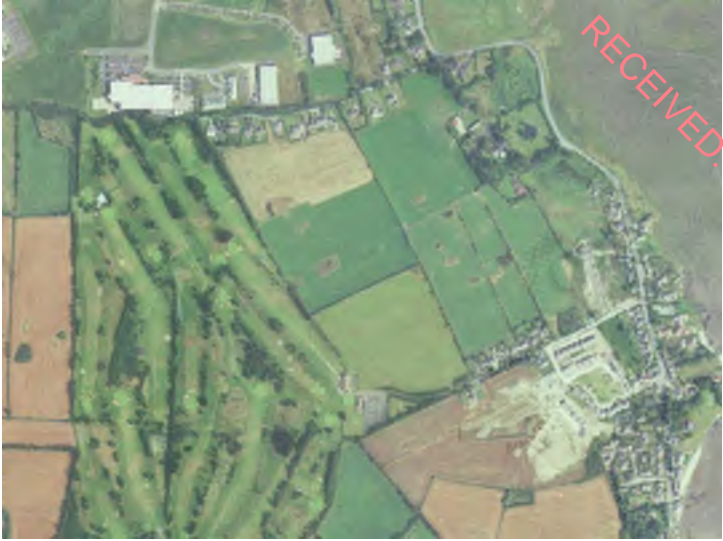
2000

<p><i>Site:</i> No significant changes <i>Surrounding Area:</i> No significant changes</p>
Present Day (recent)

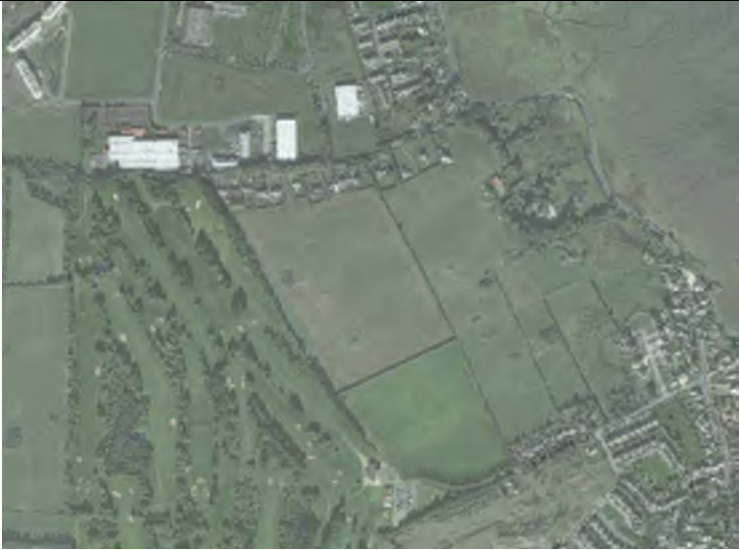
<p><i>Site:</i> No changes on the site <i>Surrounding Area:</i> Increased industrial development to north and increase in size of Blackrock village to the south. No other significant changes</p>
