Ground Investigation and Geotechnical Interpretive Report (2023)

Haggardstown

**Ground Investigation &
Geotechnical
Interpretative Report**

Project No. 24490

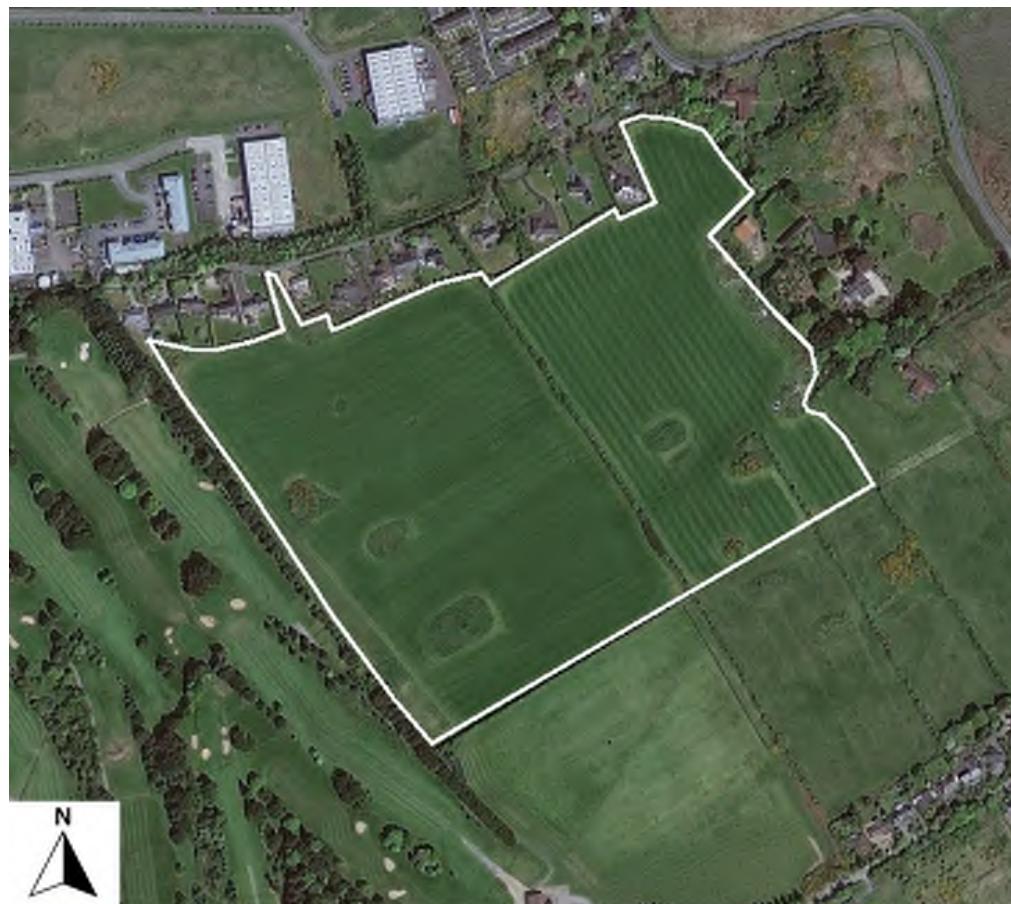
Figure 1 – Site Location Plan (perimeter outlined in white). The roughly circular, more elevated parts of the site can be seen omitted from agricultural use.

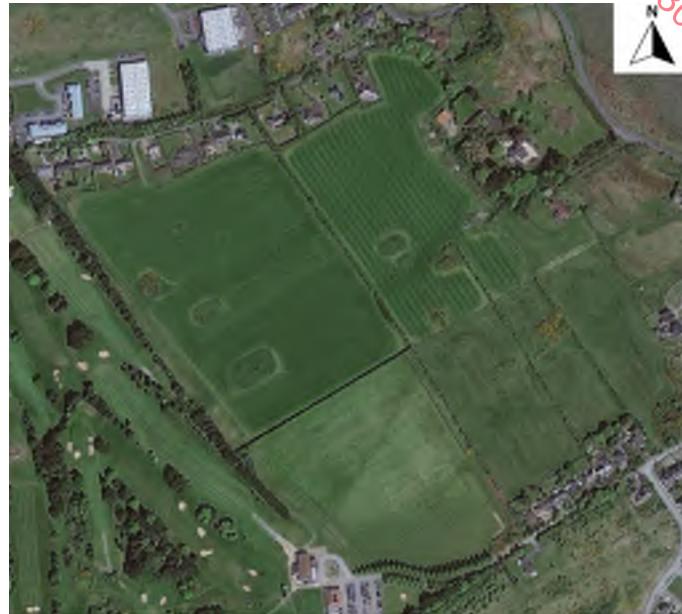
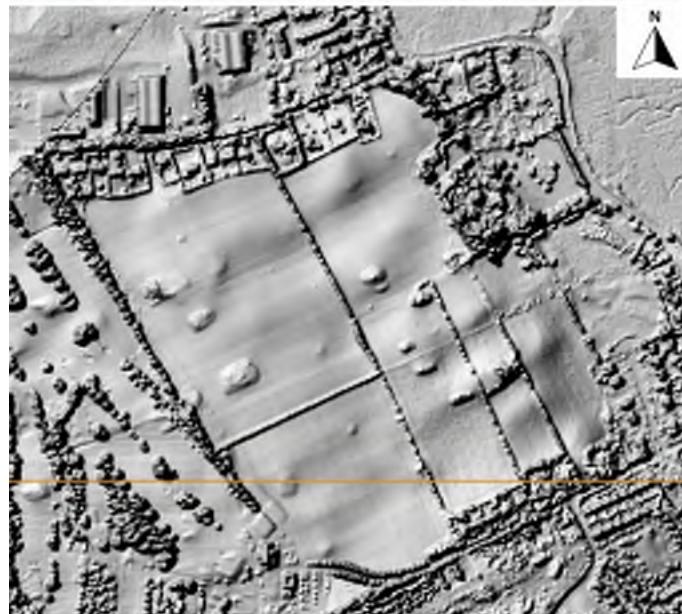
Figure 2A & 2B – Google Earth Professional view of site and environs dated 04/2011. Lidar view of site retrieved from the GSI Open Topographic Data Viewer

The site comprises two connected field enclosures separated by a mature hedgerow. There are a number of topographic knolls which are present in both the western and eastern field. They form prominent local peaks. The Lidar view (Figure 2B) clearly depicts the individual knolls. Geophysical traverses found that they generally correspond to local bedrock highs.

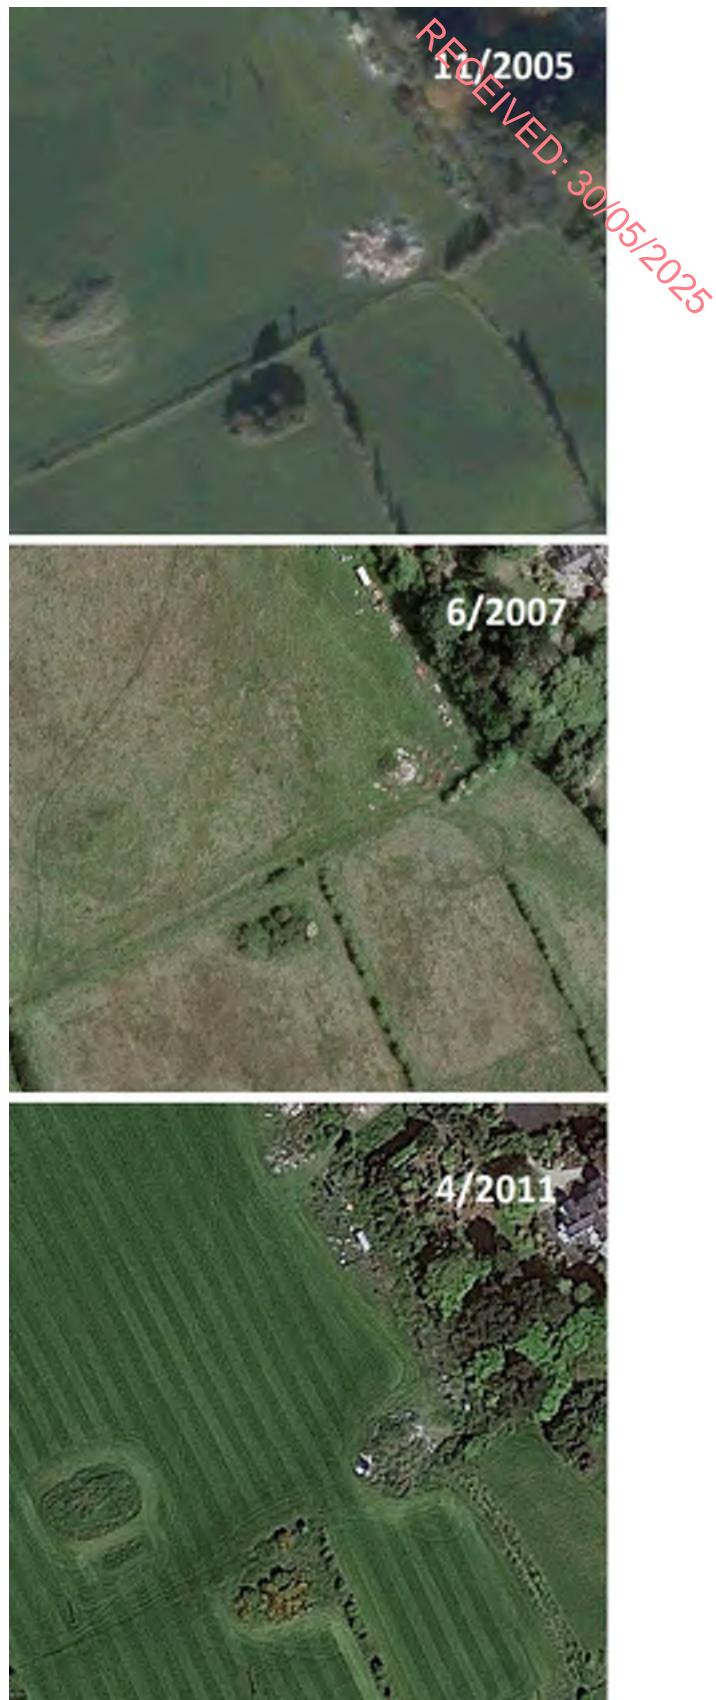
Figure 3 illustrates the appearance initially in ca. 2005 of what appears to be construction and demolition rubble in the southeastern corner of the site. By 2007, the rubble pile appears to have been reduced in area. However, by 2011 it has grown in areal extent but is largely covered in vegetation. Later images show the heap of material has disappeared. Its appearance may be related to an episode of building / renovation nearby.

Figure 3 – Google Earth Professional images dated 11/2005, 06/2007 and 04/2011 showing what appears to be tipped C&D waste in the south eastern corner of the east field.

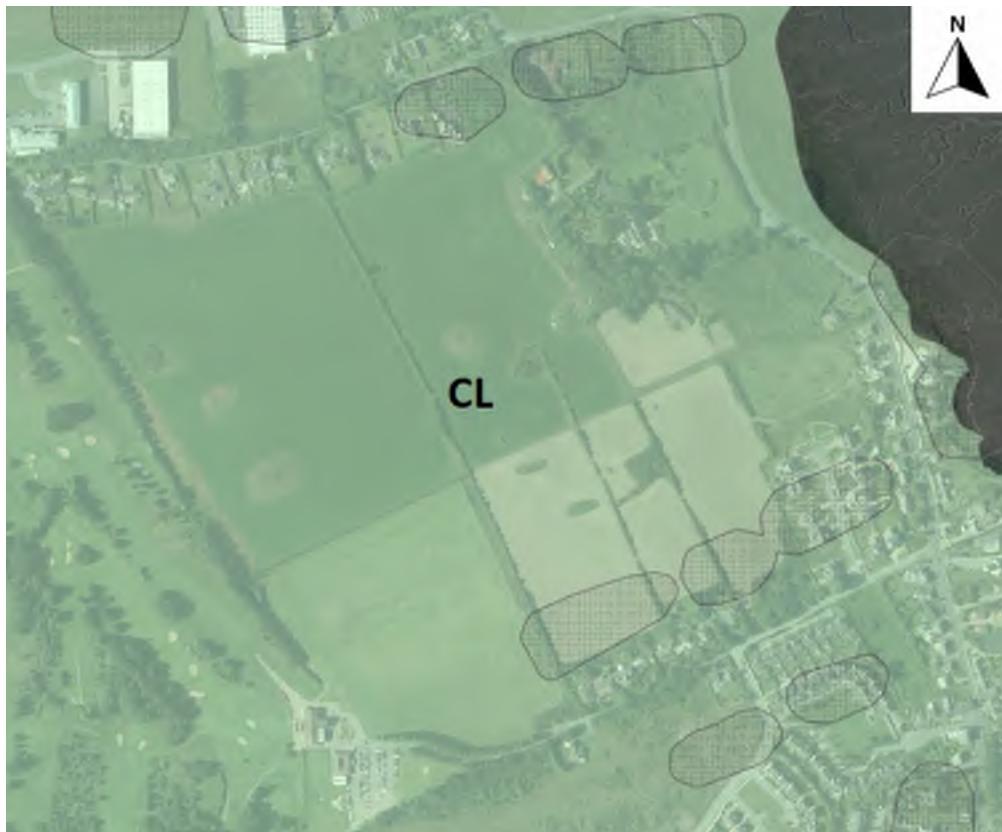
Figure 5 - Bedrock Geological Map for the Haggardstown Site (retrieved from GSI website)

Key: RK = Clontail Formation
Hatched areas denote rock outcrop / subcrop

Reference to the GSI map for the area (Figure 5, 1:100,000 Solid Geology series) shows that the site is underlain by the Silurian Llandovery-aged Clontail Formation. The rock formation consists of green-grey, medium to thickly bedded, coarse and very fine grained greywackes, with dark grey, thinly bedded, poorly graded, quartzose fine sandstone to siltstone units. No actual outcrops were found on site but excavation did reveal rockhead within the upper metre in certain areas. The findings of rotary drilling and rock excavation trial pits are dealt with in more detail in Section 5.2

As noted in Section 4, the GSI map for the area (Figure 5, 1:100,000 Solid Geology series) shows the site is underlain by the Clontail Formation. The rock formation consists of green-grey, medium to thickly bedded, coarse and very fine grained greywackes, with dark grey, thinly bedded, poorly graded, quartzose fine sandstone to siltstone units.

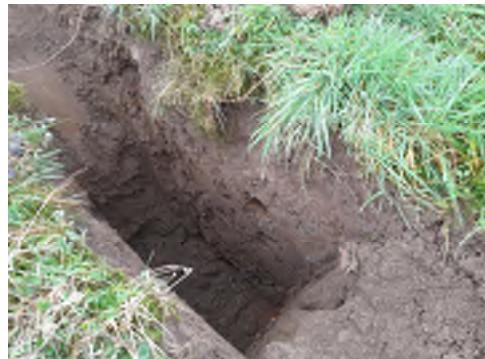
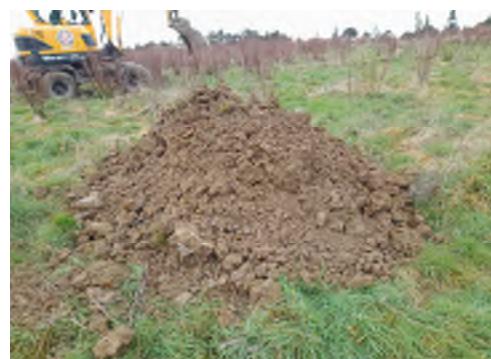
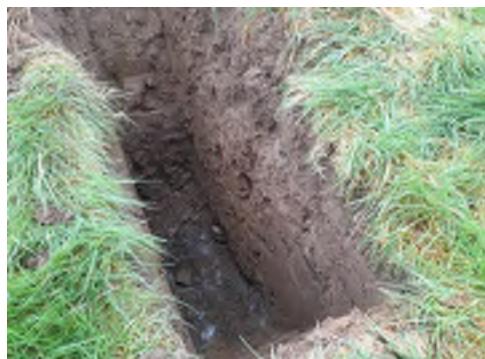
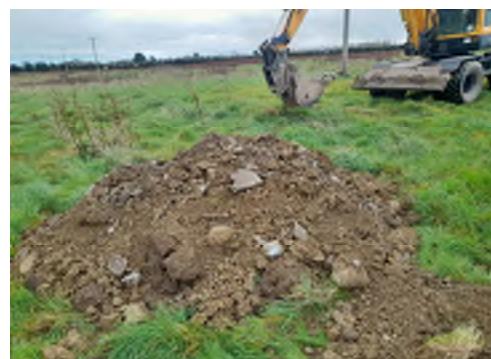
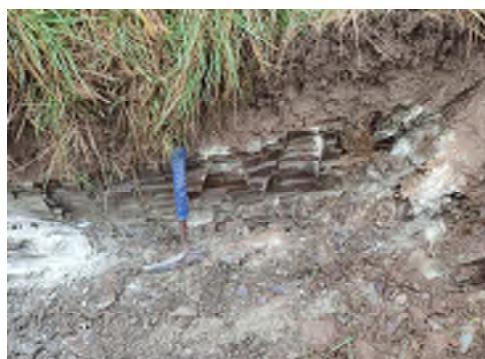
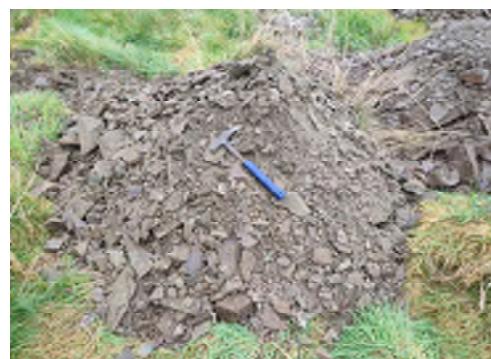
Figures 7A – 7F Photographs taken pitside during trial excavation in Area 1. **Fig 7A** Sidewall photo of BRE08 Topsoil to 300mm, underlain by a firm brown sandy gravelly cobbly CLAY to 1.0m in turn underlain by a firm very gravelly sandy silty CLAY with a medium to high cobble content to an end depth of 2.40m (12.97m OD). **Fig 7B** Spoil **Fig 7C** Sidewall profile of BRE10 showing rock in base from 1.60m (15.35m OD) to eventual end depth of 2.10m (14.85m OD). **Fig 7D** Spoil **Fig 7E** Rock exposed in REXTP01 from 400mm bgl. **Fig 7F** Platy tabular SANDSTONE/SILTSTONE rock recovered from hydraulic breaking in REXTP01.

Fracture spacings recorded in the core drillholes revealed close to medium, occasionally widely spaced discontinuities, which were locally clay smeared. Upper rockhead in REXTP pits was remarked as stained brown, likely due to iron-oxide staining. There were also instances of very closely spaced and extremely closely spaced discontinuities localised in the upper bedrock / weathered horizon (See Figure 7E).

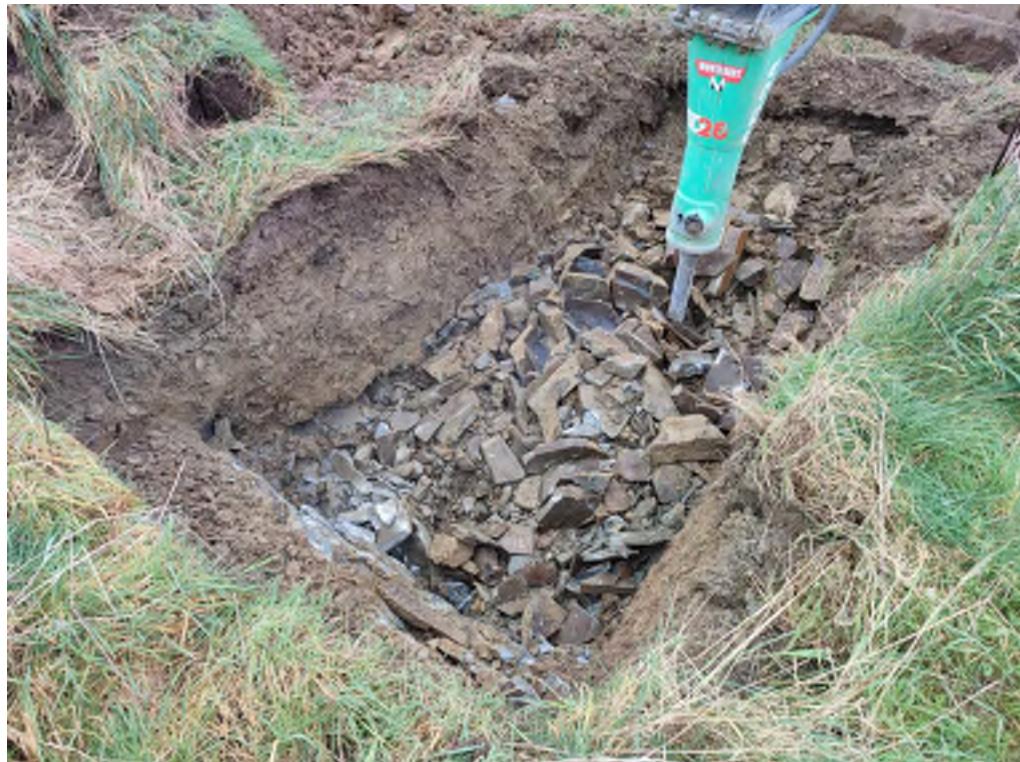
Figure 9 – Hydraulic breaking in REXTP02

○ REXTP02 was terminated at 1.40m, with hydraulic breaking having been deployed from 0.50m.

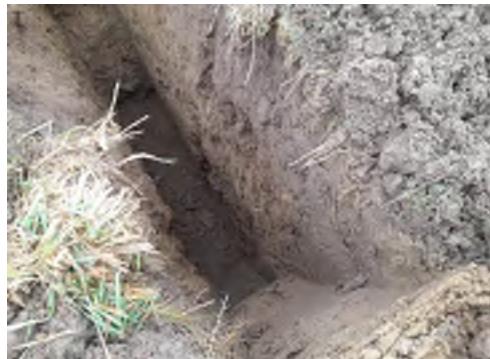
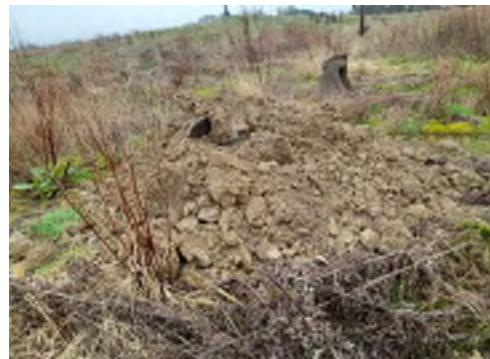
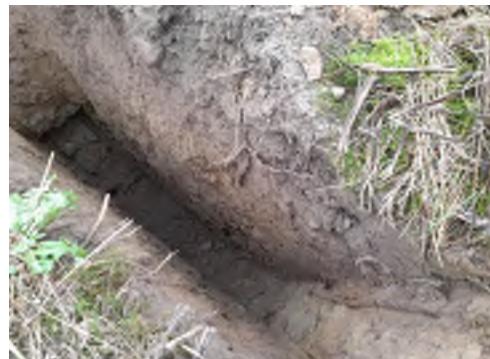
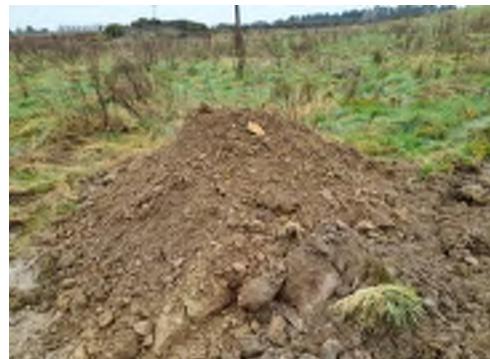
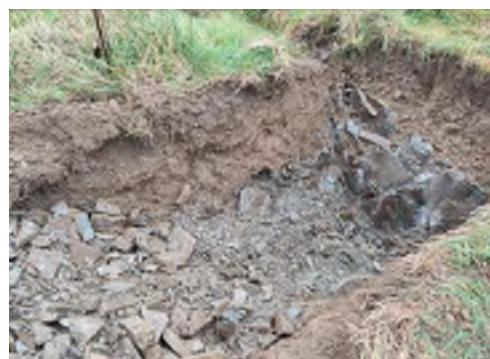
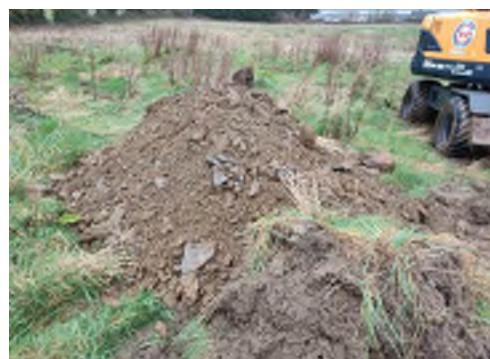
Figures 10A – 10F Photographs taken pitside during trial excavation in Area 2. **Fig 10A** Sidewall photo of BRE01 Topsoil over a firm brownish yellow SILT to 1.50m underlain by a firm brown very sandy silty gravelly CLAY with a medium cobble content to an end depth of 2.50m (6.50m OD). **Fig 10B** Spoil **Fig 10C** Sidewall profile of BRE05 to pit base of 2.50m (11.62m OD). **Fig 10D** Spoil **Fig 10E** Rock exposed in REXTP02 from 500mm bgl. **Fig 10F** Variable sized fragments (up to 500mm) of SANDSTONE/SILTSTONE rock recovered from hydraulic breaking in REXTP02.

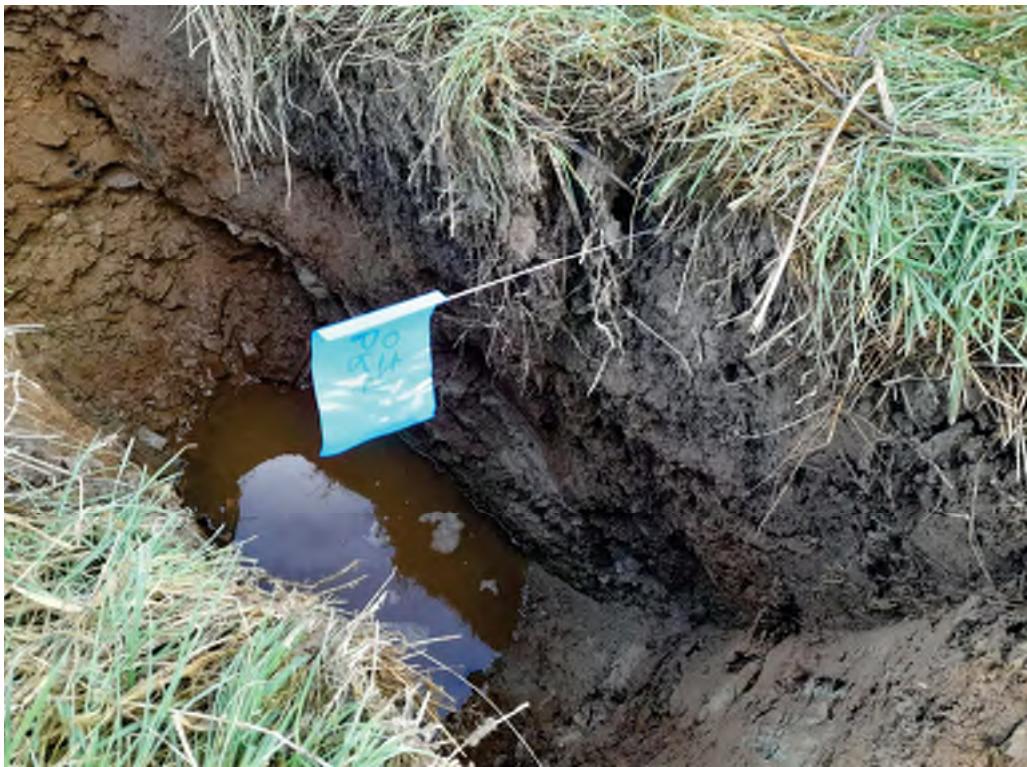
BRE07 - 2 of 3 Water from infiltration test

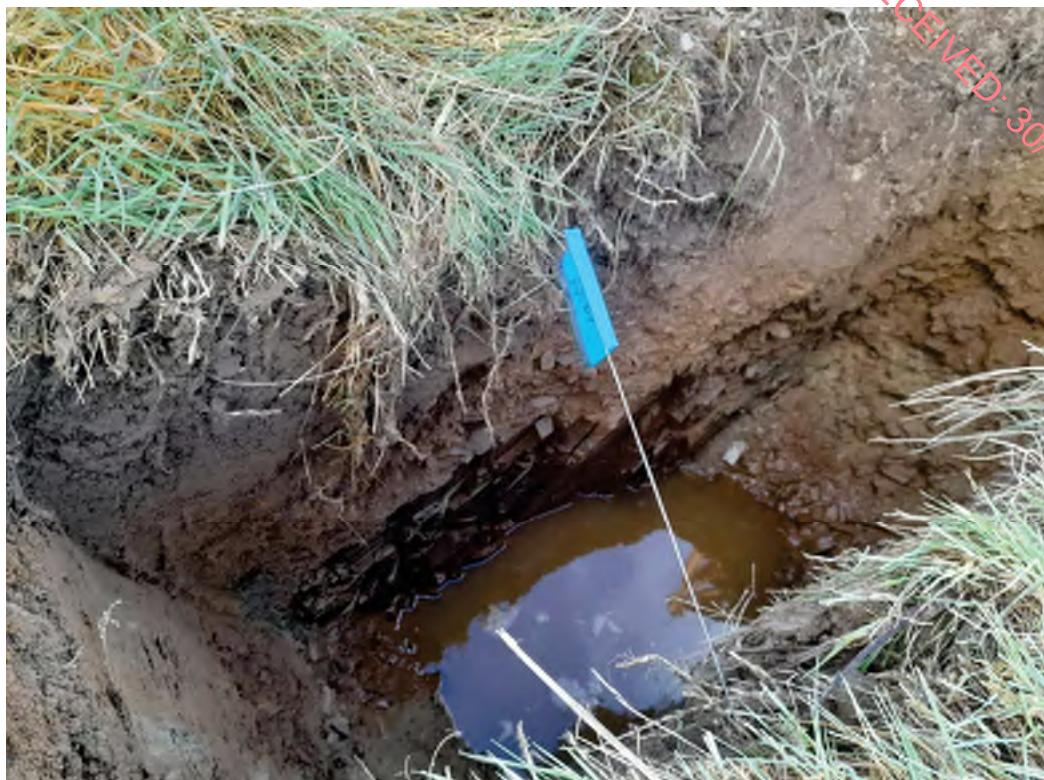
BRE07 - 3 of 3 Water from infiltration test

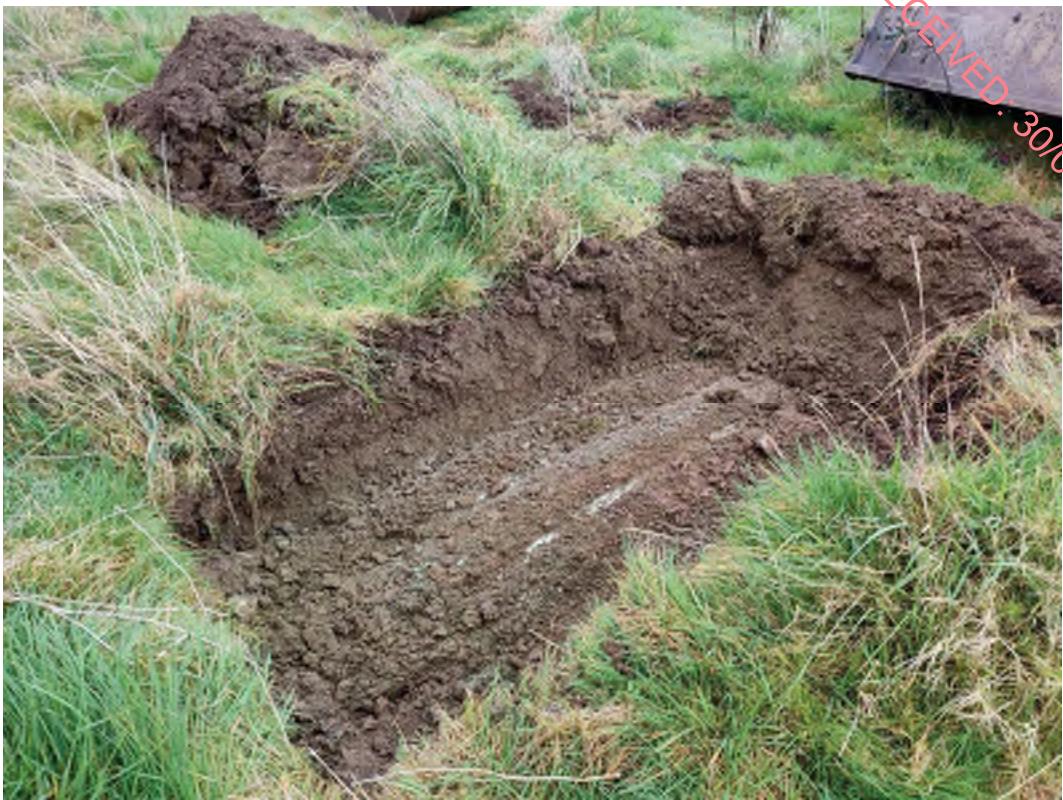
REXTP01 – 1 of 16 Rockhead at 0.40m

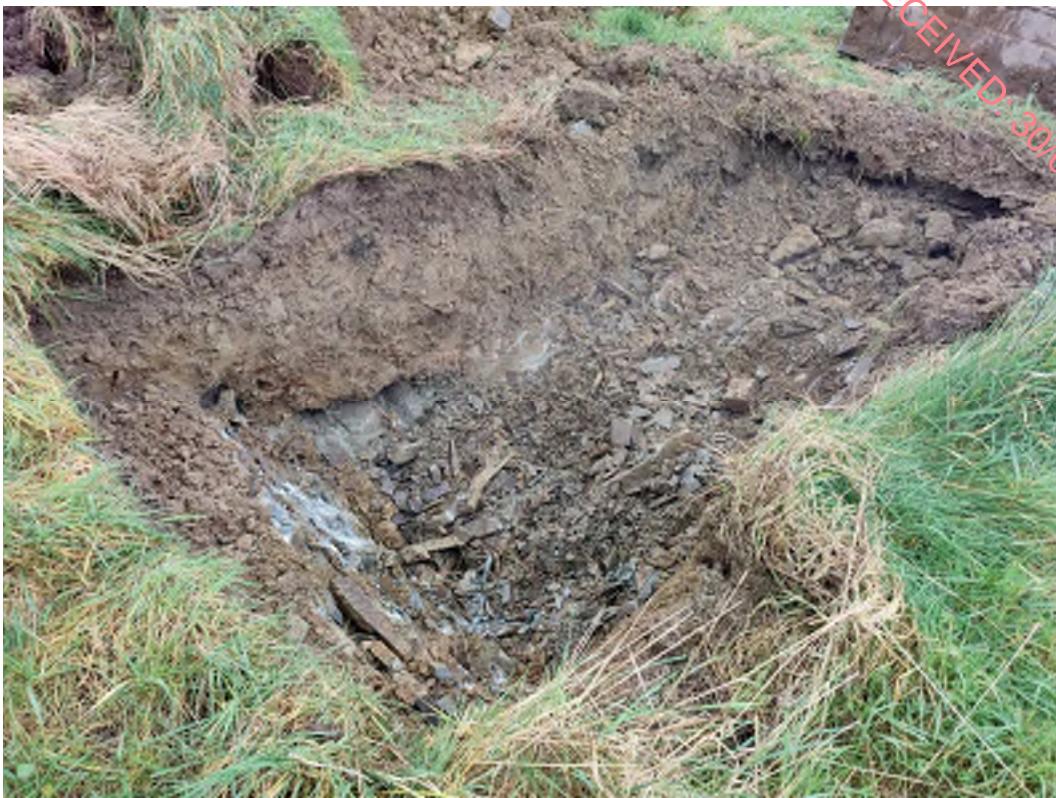
REXTP02 – 1 of 6 Undulating rockhead from 0.50m to 0.80m

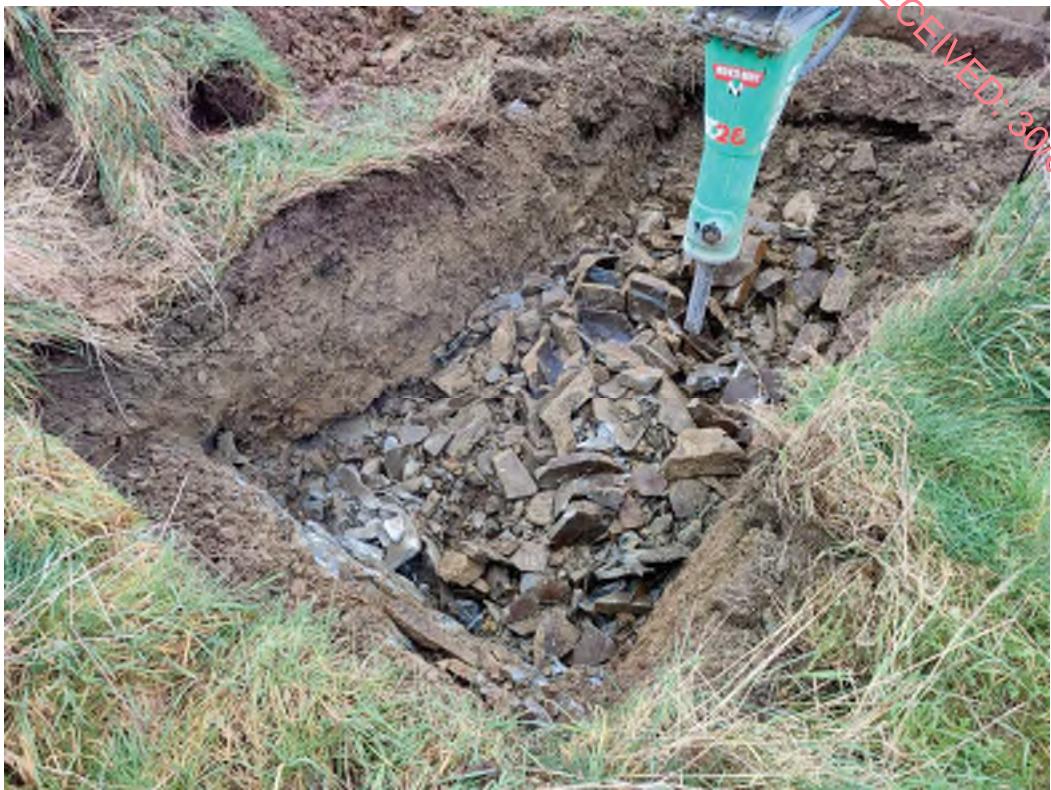
REXTP02 – 3 of 6 Results from initial break

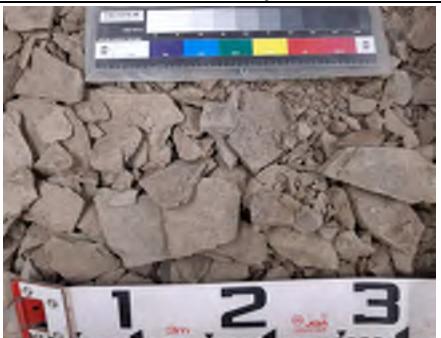
<p>Aggregate consists of sandstone/siltstone with fine grained grey/brown coatings. No evidence of mineralogical changes, encrustations (e.g. gypsum) or deleterious constituents (e.g. calcareous mudstone or shale) in the sample provided. Sample in a dry state.</p>																																																				
Rifflled & Quartered Sub-Sample	Washed Fragments Sub-Sample Characteristics

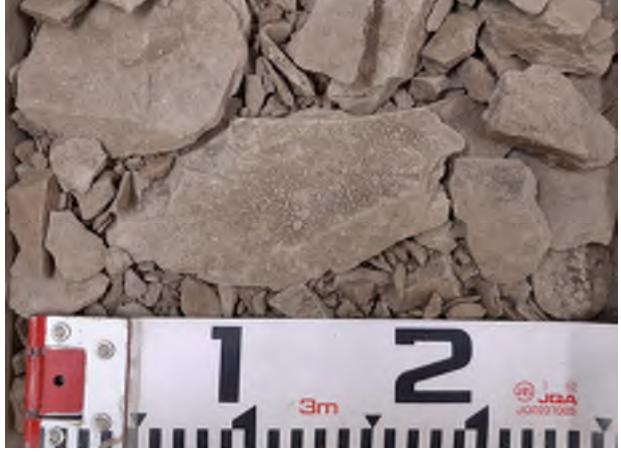
<p>Particle Sizes Estimation (mm):</p> <table border="1" style="margin-left: auto; margin-right: auto;"> <tr> <th style="text-align: center;">Max</th><th style="text-align: center;">Mean</th><th style="text-align: center;">Min.</th></tr> <tr> <td style="text-align: center;">110</td><td style="text-align: center;">30</td><td style="text-align: center;">10</td></tr> </table> <p>Particle Shape: Angular to subangular, tabular</p> <p>Nature of Fines: Grey/brown, silt or clay size</p> <p>Nature of Coatings: Grey/brown, fine sand & silt / clay size</p>	Max	Mean	Min.	110	30	10

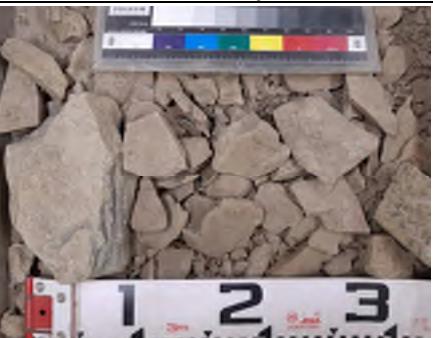
<p>Aggregate consists of sandstone/siltstone with fine grained grey/brown coatings. No evidence of mineralogical changes, encrustations (e.g. gypsum) or deleterious constituents (e.g. calcareous mudstone or shale) in the sample provided. Sample in a dry state.</p>										
Rifflled & Quartered Sub-Sample	Washed Fragments Sub-Sample Characteristics

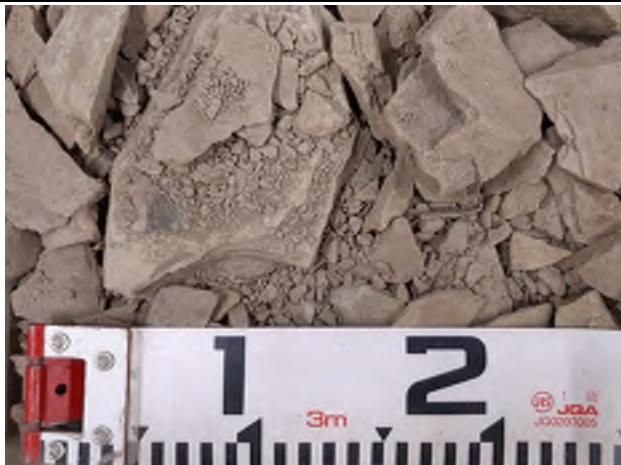
<p>Particle Sizes Estimation (mm):</p> <table border="1" style="margin-left: auto; margin-right: auto;"> <tr> <th style="text-align: center;">Max</th><th style="text-align: center;">Mean</th><th style="text-align: center;">Min.</th></tr> <tr> <td style="text-align: center;">170</td><td style="text-align: center;">30</td><td style="text-align: center;">10</td></tr> </table> <p>Particle Shape: Angular to subangular, tabular</p> <p>Nature of Fines: Grey/brown, silt or clay size</p> <p>Nature of Coatings: Grey/brown, fine sand & silt / clay size</p>	Max	Mean	Min.	170	30	10

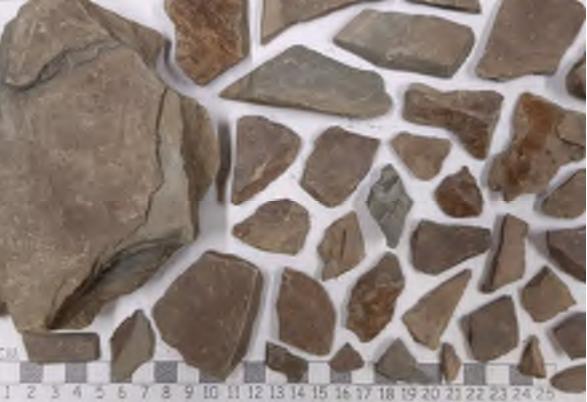
<table border="1" style="width: 100%;"> <thead> <tr> <th style="text-align: center;">Rock Types</th><th style="text-align: center;">% Present</th></tr> </thead> <tbody> <tr> <td style="text-align: center;">Type 1: Sandstone/Siltstone</td><td style="text-align: center;">100%</td></tr> <tr> <td style="text-align: center;"> </td><td style="text-align: center;"> </td></tr> <tr> <td style="text-align: center;"> </td><td style="text-align: center;"> </td></tr> <tr> <td style="text-align: center;"> </td><td style="text-align: center;"> </td></tr> </tbody> </table> <p>Note: Rock types and proportions assesed by examining bulk sample and washing the fragments and examining by naked eye, hand lens and binocular microscope.</p>	Rock Types	% Present	Type 1: Sandstone/Siltstone	100%

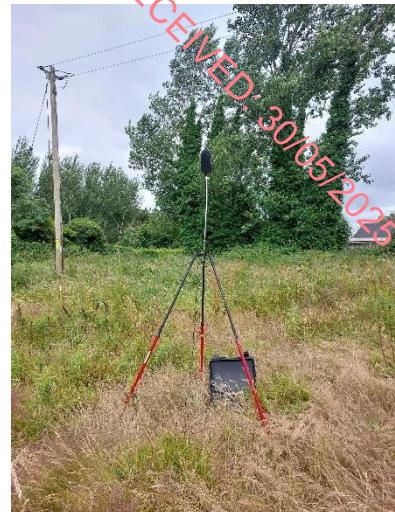
Location N1 To the North-West of the site with the microphone positioned at ground floor level at a location representative of the proposed residential dwellings near the Dundalk Golf Course. This noise survey position comprised attended daytime monitoring.

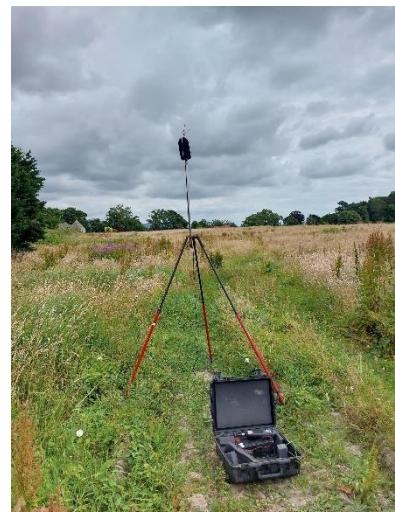
Location N2 At the North of the site with the microphone positioned at ground floor level at a location representative of a proposed development façade and proposed amenity space. This noise survey position comprised attended daytime monitoring.

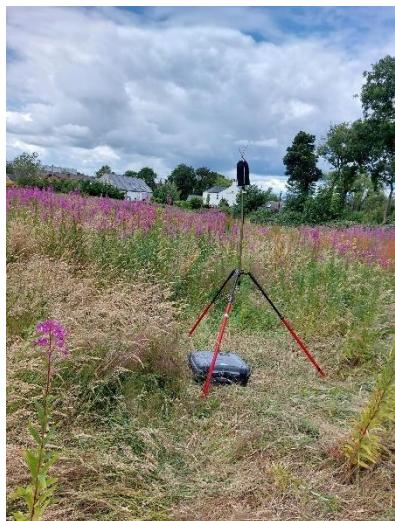
Location N3 To the North-East of the site with the microphone positioned at a location representative of the proposed development facade that is closest to the nearby main road (R172) and existing residents. This noise survey position comprised of attended daytime monitoring and unattended monitoring for an approximate 7-day period. Noise data, captured at this location is used as reference in order to estimate noise levels at the proposed development façade during both day and night-time periods.

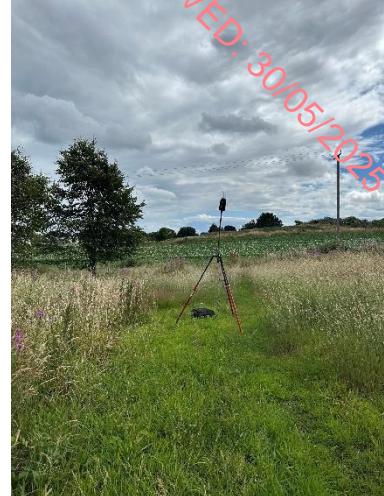
Location N4 At the South-West of the site with the microphone positioned at a location representative of the proposed development façade and proposed amenity space that is closest to the nearby main road (R172) and existing residents. This noise survey position comprised attended daytime monitoring.

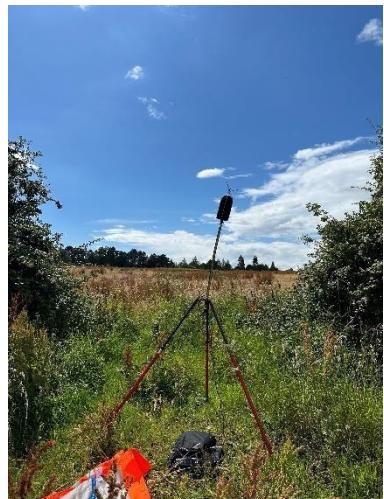
Location N5 At the Centre of the site with the microphone positioned at ground floor level at a location representative of a proposed amenity space. This noise survey position comprised attended daytime monitoring.

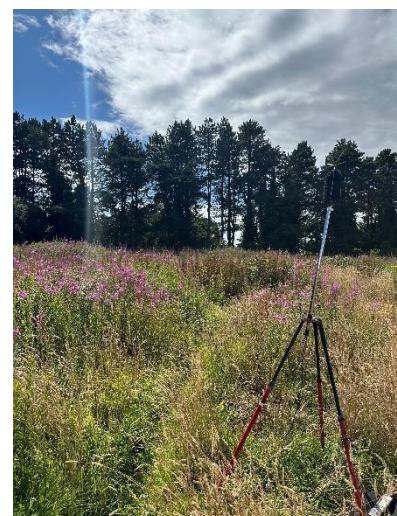
Location N6 At the South-West of the site with the microphone positioned at ground floor level at a location representative of the proposed residential dwellings near the Dundalk Golf Course. This noise survey position comprised attended daytime monitoring.
