BAT FAUNA ASSESSMENT FOR PROPOSED DEMOLITION AND CLEARANCE WORKS AT 1-6 CITY QUAY, DUBLIN 2.

Prepared by: Bryan Deegan (MCIEEM) of Altemar Ltd.
On behalf of: City Art and City Quay Partnership.

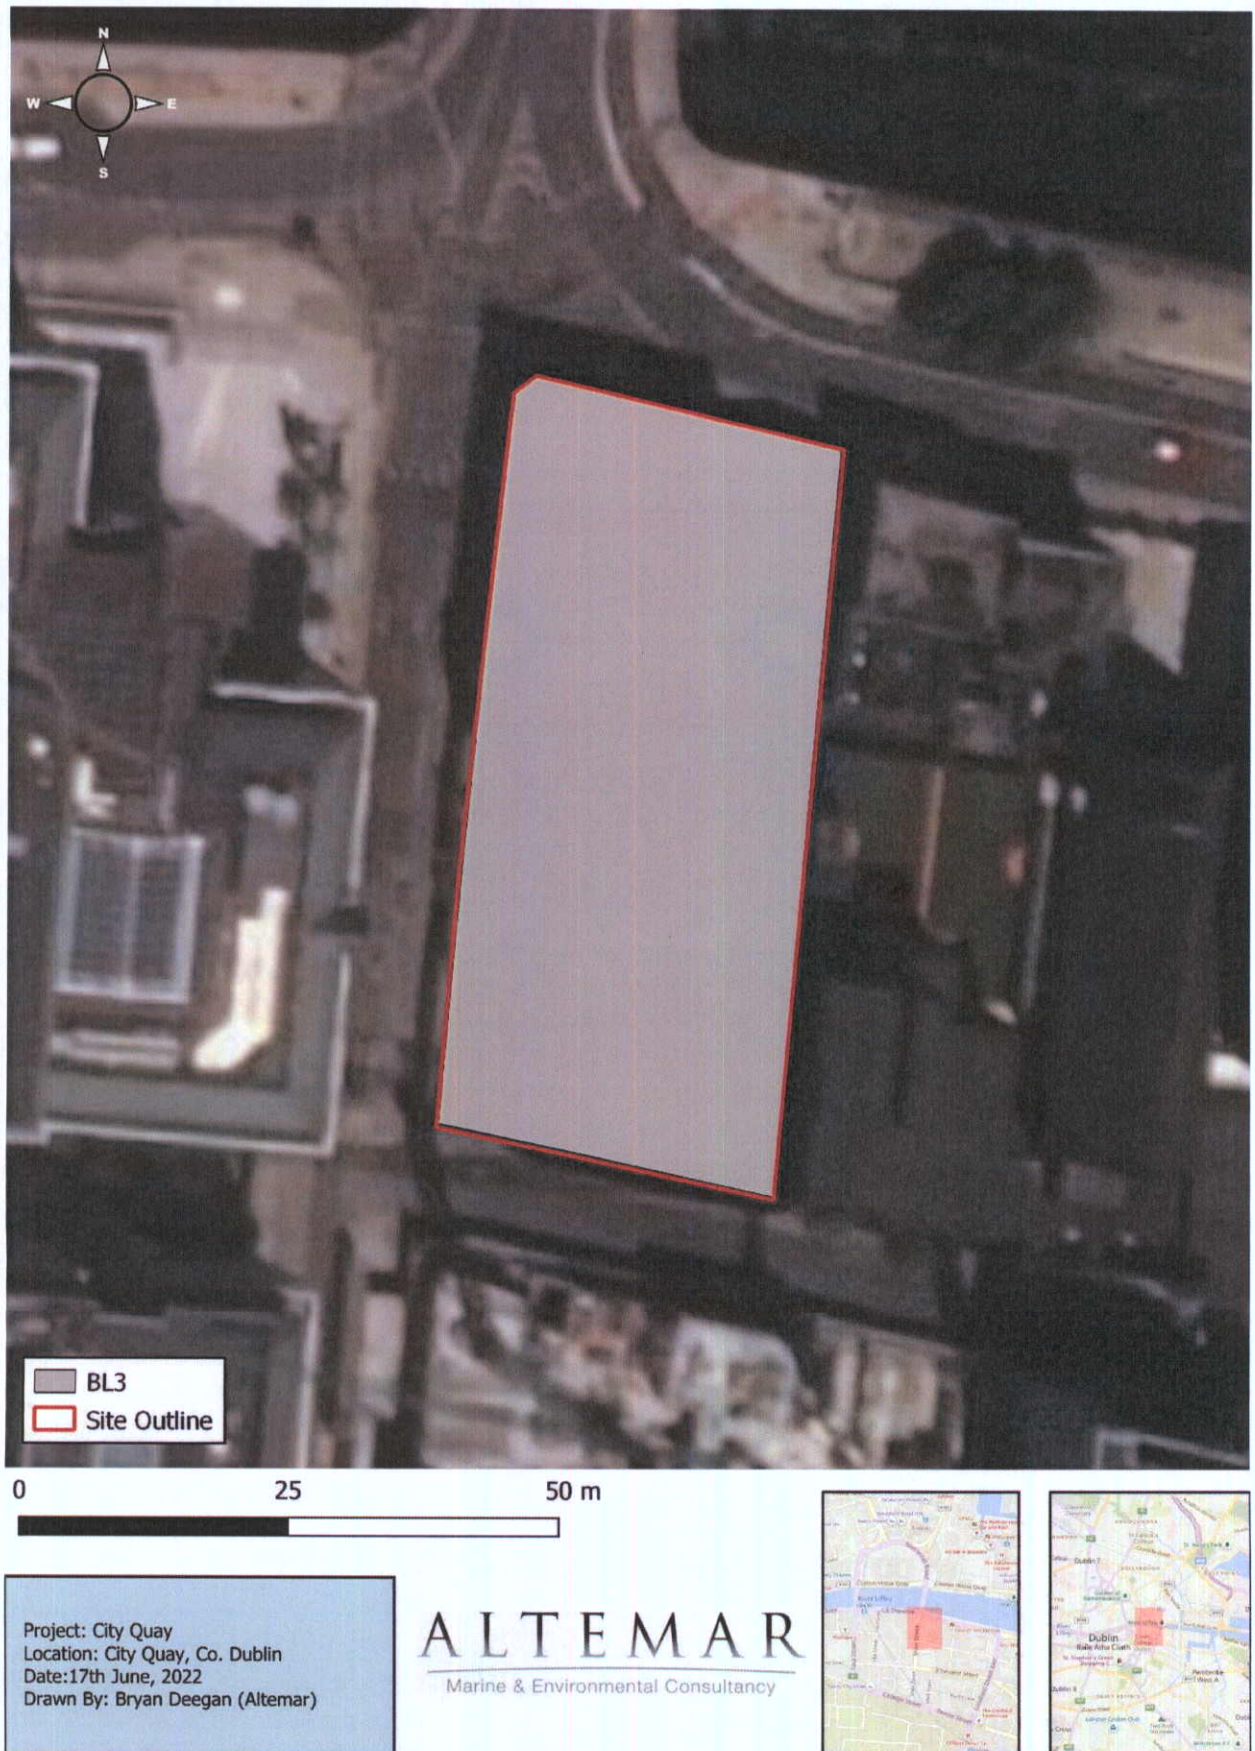
Figure 6.11. Fossitt Habitats on site (See habitat descriptions for the explanation to the Fossitt codes)

- 6.45 The proposed development site is on built land. No habitats of conservation significance were noted within the site outline.

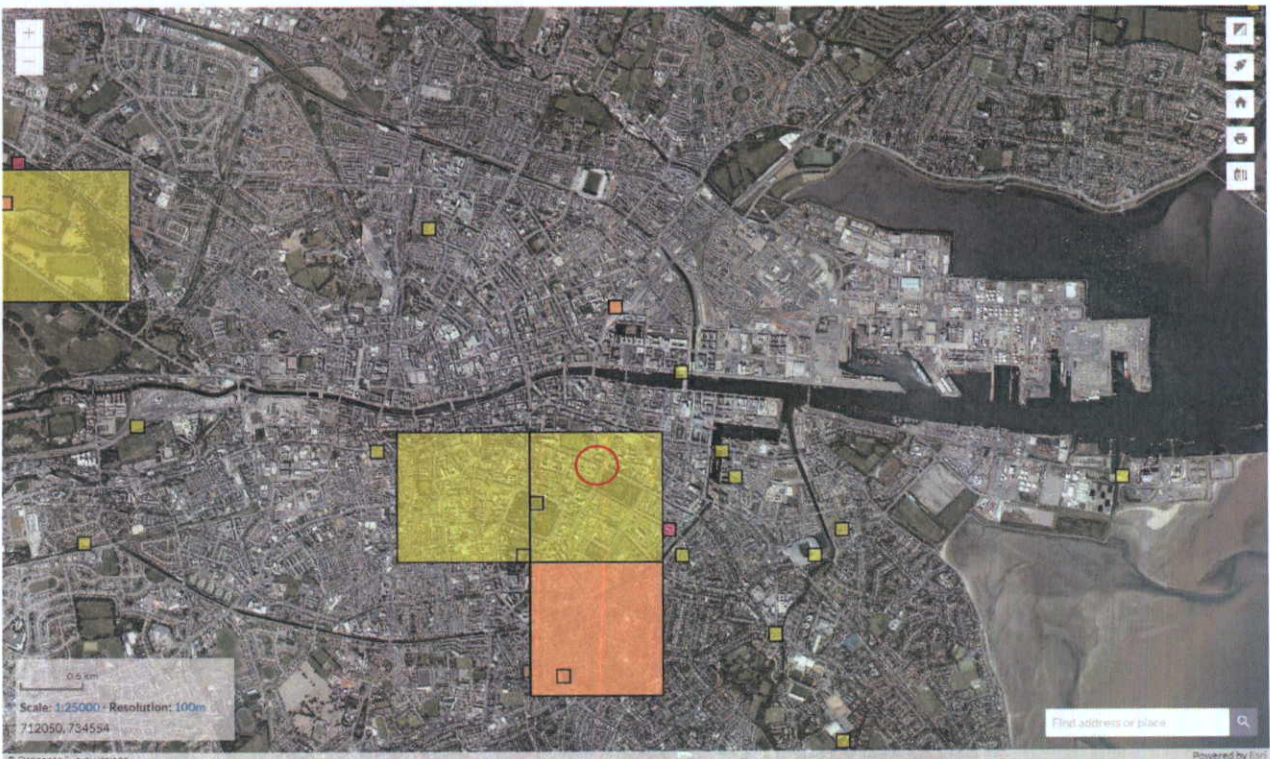
Figure 4. Nathusius's Pipistrelle (*Pipistrellus nathusii*) (purple), Pipistrelle (*Pipistrellus pipistrellus sensu lato*) (species aggregate) (yellow), and both Nathusius's Pipistrelle and Pipistrelle (orange) (Source NBDC) (Site – red circle)

The review of existing bat records (sourced from *Bat Conservation Ireland’s* National Bat Records Database) within a 2km² grid (Reference grid O13S) encompassing the study area reveals that four of the nine known Irish species have been observed locally (Table 1). The National Biodiversity Data Centre’s online viewer was consulted in order to determine whether there have been recorded bat sightings in the wider area. This is visually represented in Figures 2 - 5. The following species were noted in the wider area: Brown Long-eared Bat (*Plecotus auritus*), Soprano Pipistrelle (*Pipistrellus pygmaeus*), Whiskered Bat (*Myotis nattereri*), Daubenton’s Bat (*Myotis daubentonii*), Natterer’s Bat (*Myotis nattereri*), Nathusius’s Pipistrelle (*Pipistrellus nathusii*), and Pipistrelle (*Pipistrellus pipistrellus sensu lato*) (Figures 2 - 5).

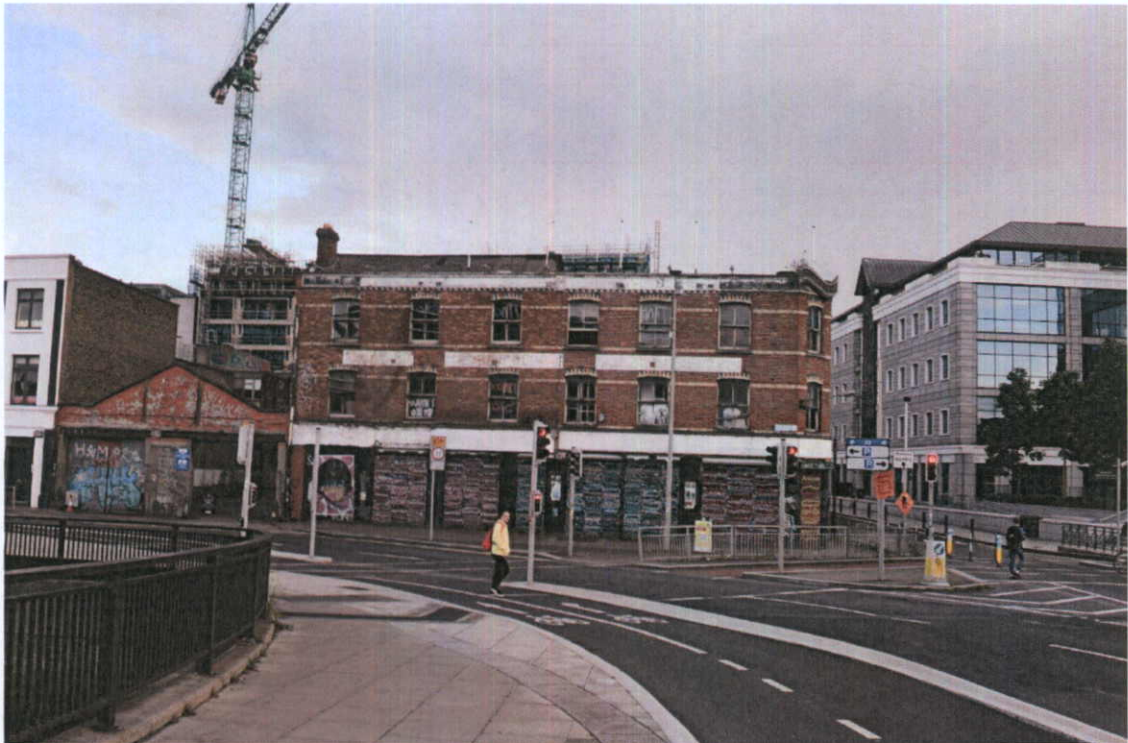
Plate 1. Proposed development site (main building)

The site comprised of a main building and a small outbuilding and a car park. No trees of bat roosting potential were on site. At dusk a survey was carried out by the detector to assess if bats emerged from the buildings. An internal inspection of the buildings was carried out. No bats were observed emerging from on site buildings. No evidence of bat presence or activity was noted internally within the buildings on site.

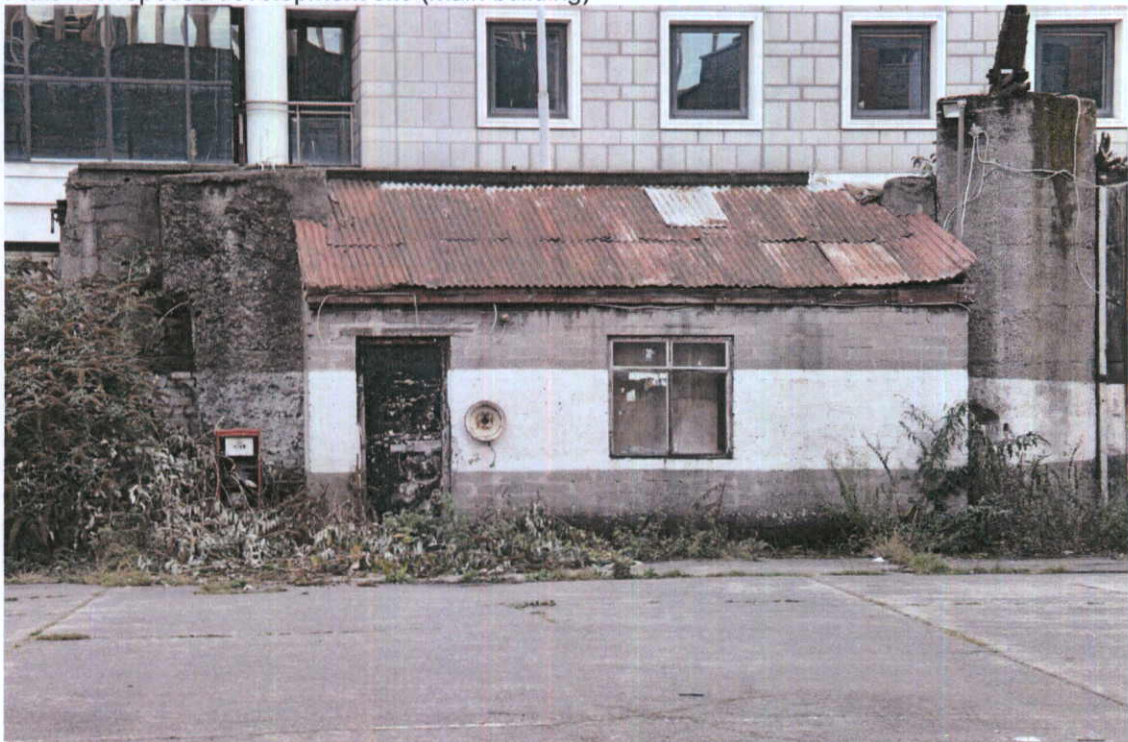
Plate 2. Outbuilding

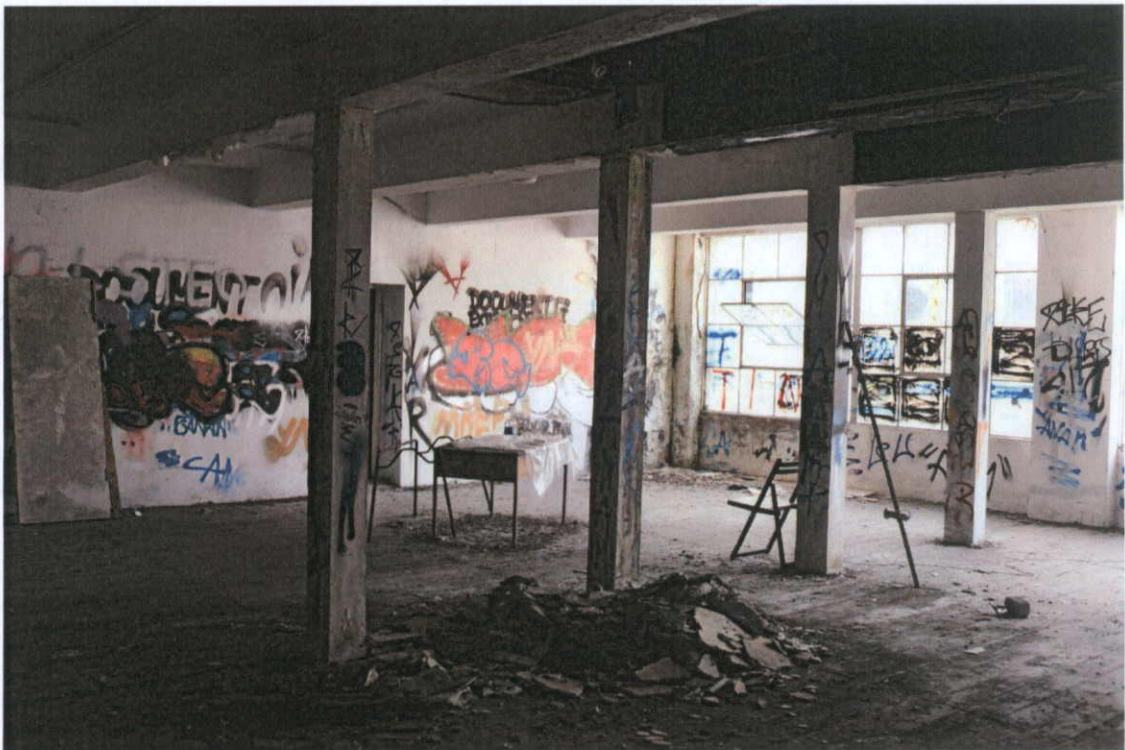
Plate 4. Interior of building.

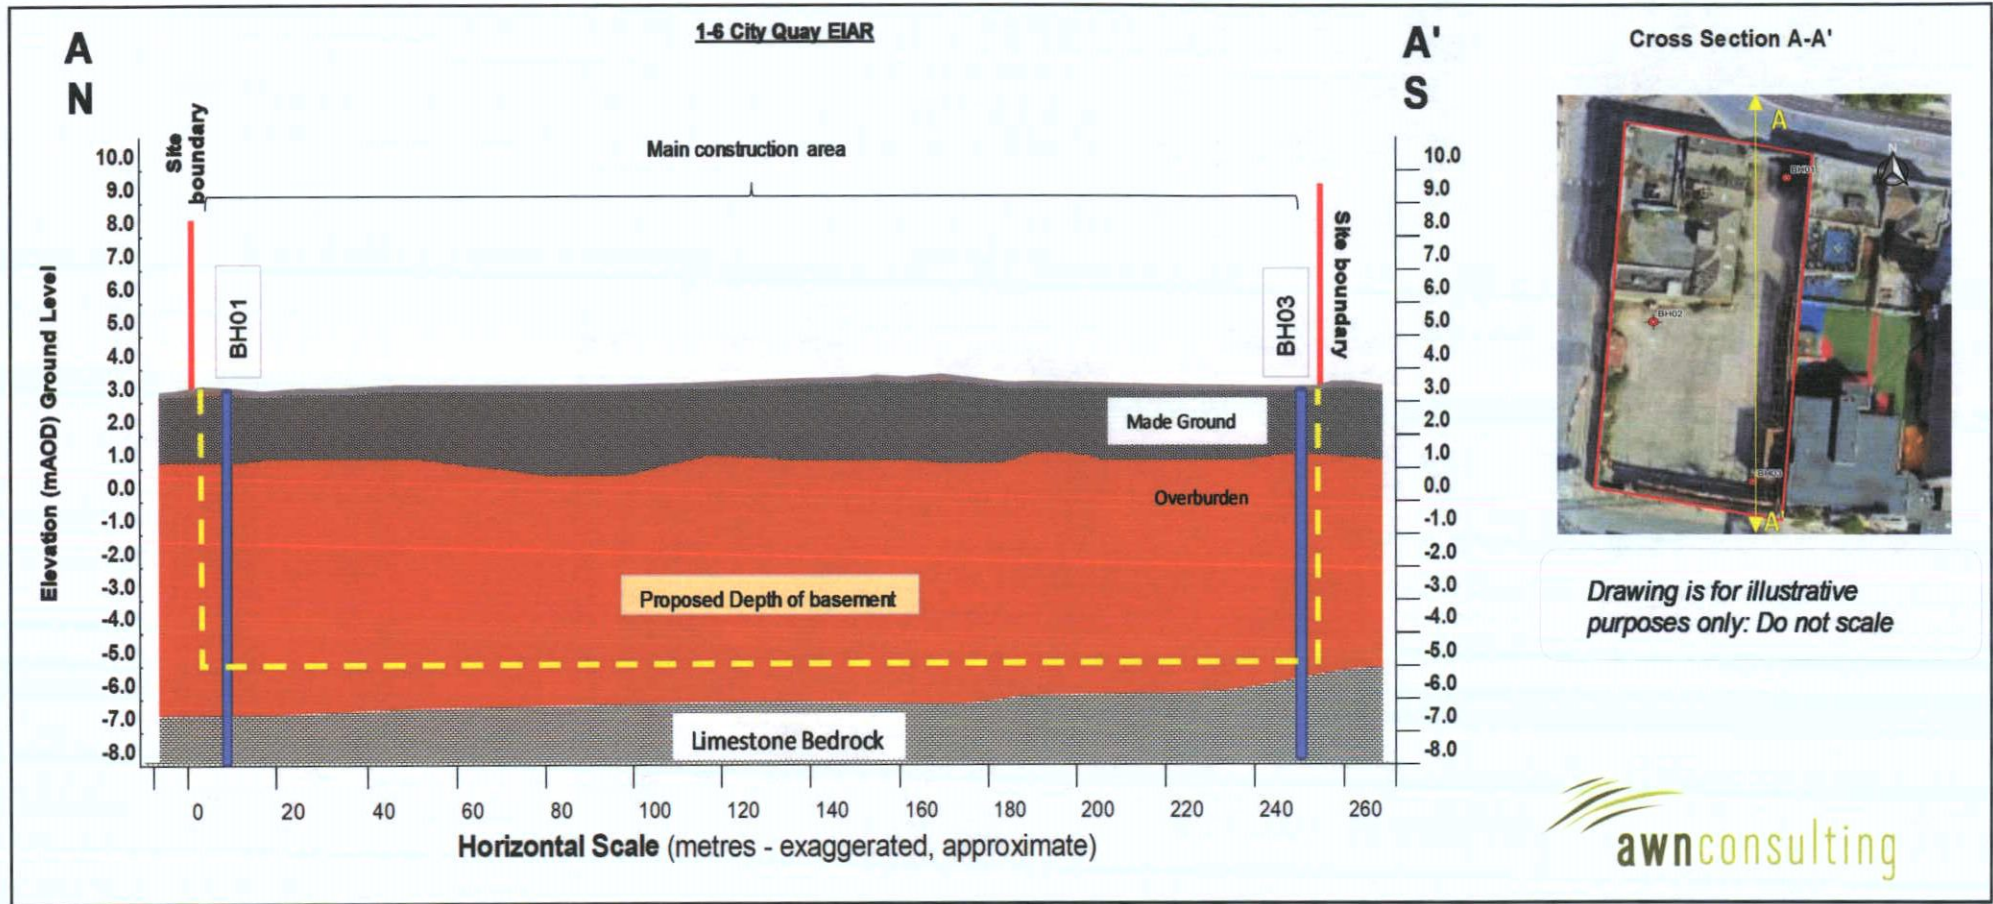
- 7.55 It is proposed that the basement excavation will extend to approx. -5.50m OD, a depth of 9.5m below the highest ground floor level.
- 7.56 A cross section of the site geology has been undertaken (see Figure 7.3 below).

MADE GROUND: Made Ground deposits were encountered beneath the Surfacing and were present to a relatively consistent depth of between 3.50m and 3.80m BGL, with Possible Made Ground noted in BH03 to a maximum depth of 5.30m BGL. These deposits were described generally as *brown/grey clayey gravelly Sand with frequent red brick and concrete fragments onto greyish brown sandy gravelly Clay with red brick and mortar fragments onto greyish dark brown slightly silty slightly sandy gravelly Clay with organic matter*. In BH03 *grey angular coarse gravel FILL* was noted beneath the Surfacing to a depth of 0.30m BGL, overlying Made Ground deposits following the descriptions outlined above.

GRANULAR DEPOSITS: Granular deposits were encountered beneath the Made Ground in BH01 and BH03 and were typically described as *grey slightly clayey slightly sandy subrounded to rounded fine to coarse GRAVEL*. In BH02 there was no recovery from 3.80m to 5.30m BGL, but the driller noted a Sandy deposit. The secondary sand/gravel and silt/clay constituents were relatively consistent across the site but varied with depth. There was no cobble or boulder content recorded.

COHESIVE DEPOSITS: Cohesive deposits were encountered beneath the Granular Deposits and were described typically as *grey sandy gravelly CLAY*, with silt and shells also noted as a secondary constituent in BH01 and BH03. The secondary sand and gravel constituents varied across the site and with depth. The strength of the cohesive deposits varied across the site and with depth, but was typically stiff below 3.80m BGL in most of the exploratory holes.

BEDROCK: The rotary core boreholes recovered *Weak to Medium Strong to Strong thinly laminated grey fine to medium grained LIMESTONE interbedded with weak to Medium Strong thinly laminated fine-grained Mudstone*. This is typical of the Lucan Formation, which is noted on the geological mapping at the proposed site.

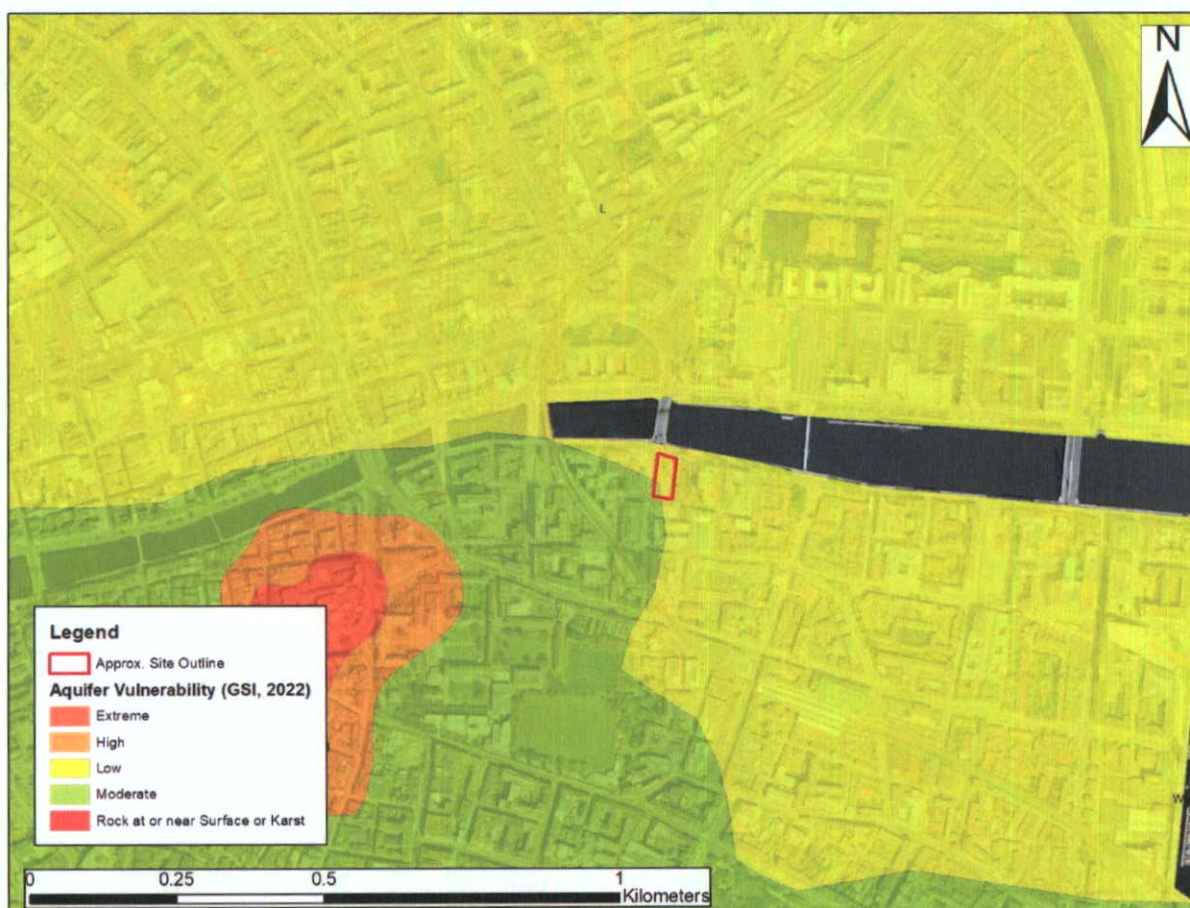
Figure 7.7 Groundwater Vulnerability

- 7.70 As part of this scheme, the GSI have mapped ([Map Series \(arcgis.com\)](http://Map Series (arcgis.com))) the vulnerability of the country's aquifers. Reference to the GSI Vulnerability data indicates that the aquifer vulnerability is considered 'Low' which indicates that there is greater than 10 metres of subsoil thickness which was confirmed in the recent site investigations. A small portion (south-eastern corner) of the proposed development site is underlain by 'Moderate' aquifer vulnerability which indicates a subsoil thickness of 5.0 to 10.0 metres. However, based on recent site investigations by SIL bedrock was not encountered in the top 8.90 metres at this location as BH02 is located within the south-eastern corner of the site.

- 7.54 Reference to the GSI Vulnerability data indicates that the aquifer vulnerability is considered 'Low' which indicates that there is greater than 10 metres of subsoil thickness which was confirmed in the recent site investigations.
