ENVIRONMENTAL IMPACT ASSESSMENT REPORT

**PROPOSED LARGE-SCALE RESIDENTIAL
DEVELOPMENT ON LANDS AT MONALEEN ROAD,
CASTLETROY, LIMERICK**

CHAPTER 15: CULTURAL HERITAGE-ARCHAEOLOGY & BUILT HERITAGE

**SUTTONS LRD
MONALEEN ROAD**

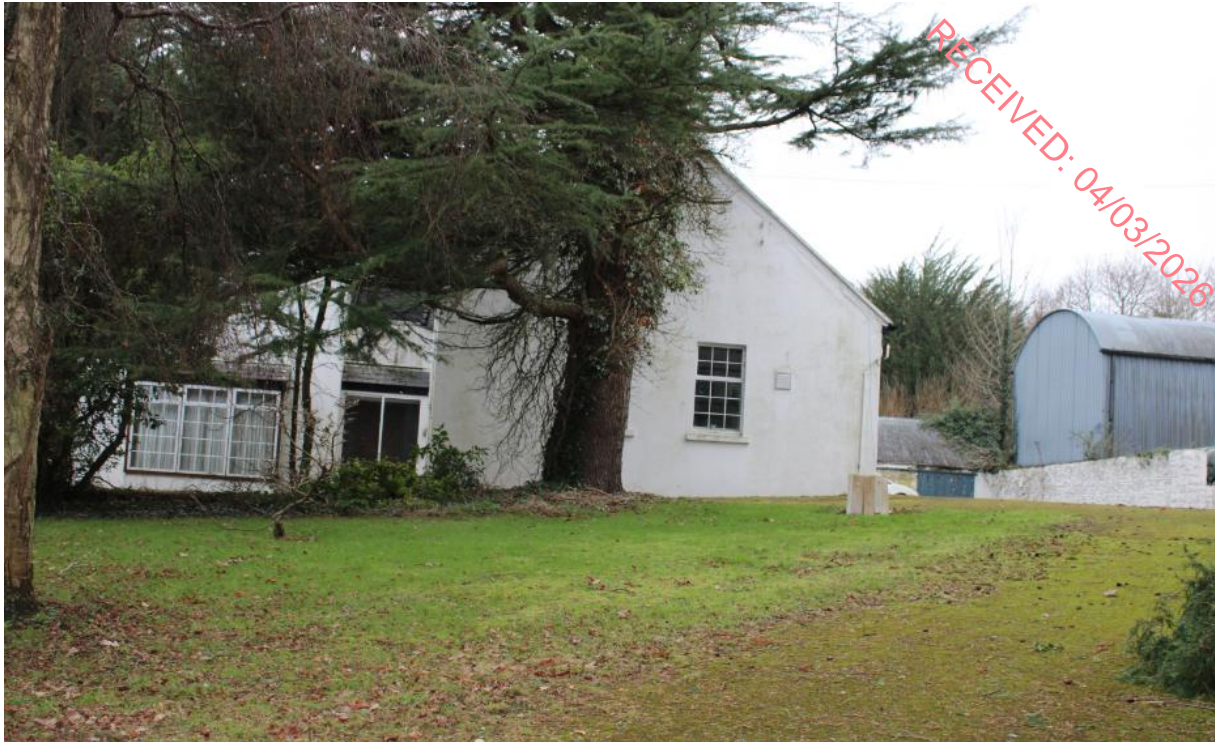
Fig. 15: 7: Farm house and yard on west side of development

A farm house and yard are located on the west (Fig. 15: 7). A tarred access road leads to the farm house from the Monaleen Rd and is on the line of the access road shown on the First and Second editions of the Ordnance Survey maps. The house is recorded as 'Chapel View' on the Third Edition Ordnance Survey map (Fig. 15: 8), presumably as the line of sight to the south-east is to the Church of St. Mary Magdalen. The present house appears relatively modern and may be a replacement of the original farmhouse or upgraded. The farm buildings include a hay barn and outbuildings.

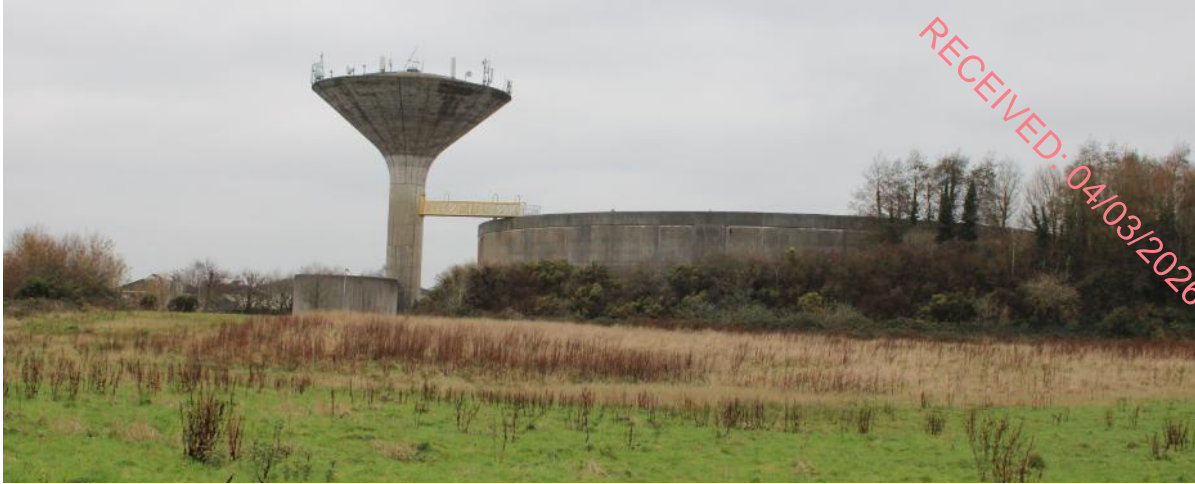
Fig. 15: 9: Newcastle Reservoir (Looking North)

Newcastle Reservoir (Fig. 15: 9) is situated on the crest of the slope on the west side of the site and housing is located west of the reservoir. The reservoir is enclosed on the east side by a high metal fence and scrub vegetation is visible inside the fence.
