## **APPENDIX 12.2**

### **CALIBRATION CERTIFICATES**

### **ENVIRONMENTAL IMPACT ASSESSMENT REPORT**

ARCHAEOLOGICAL TEST EXCAVATION REPORT  
FOR  
WIND TURBINE DEVELOPMENT PROJECT,  
CLOONANNY GLEBE,  
COUNTY LONGFORD.

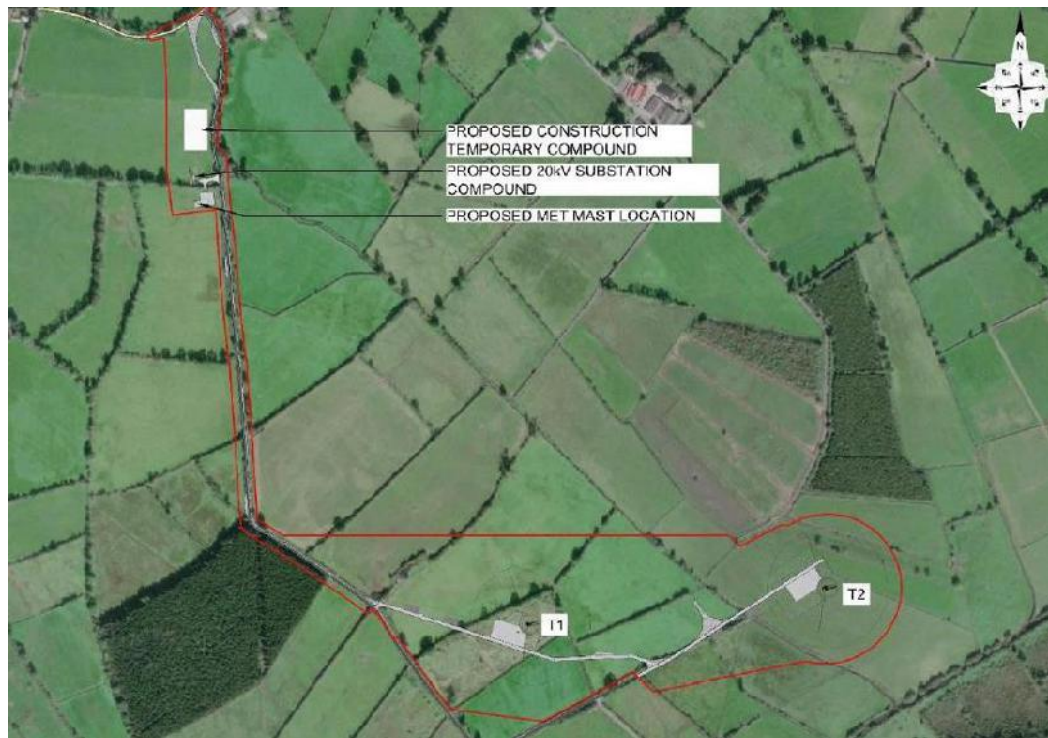
Figure 3 General Development Layout, Cloonanny Glebe, County Longford

The key components of the Cloonanny Wind Farm development will include the following.

- 2 No Wind Turbines with a blade tip height of 200m, foundations and crane hardstand areas
- 1 No. Permanent Meteorological Mast (Met Mast) (32m High) and associated works
- 1 No. 20kV Substation Compound with 2 No. Modular Buildings and associated works
- Underground electrical collection and SCADA system linking the Wind Turbines to the Substation Compound
- Temporary widening of the L50462 public road to accommodate delivery of the Wind Turbines
- Construction of a new Site Access Road and Site Entrances
- Temporary Site Access Road to accommodate delivery of turbines
- 1 No. Temporary Construction Compound and associated temporary welfare accommodation and storage
- Construction of excavated soil repository areas
- Construction of temporary and permanent drainage works

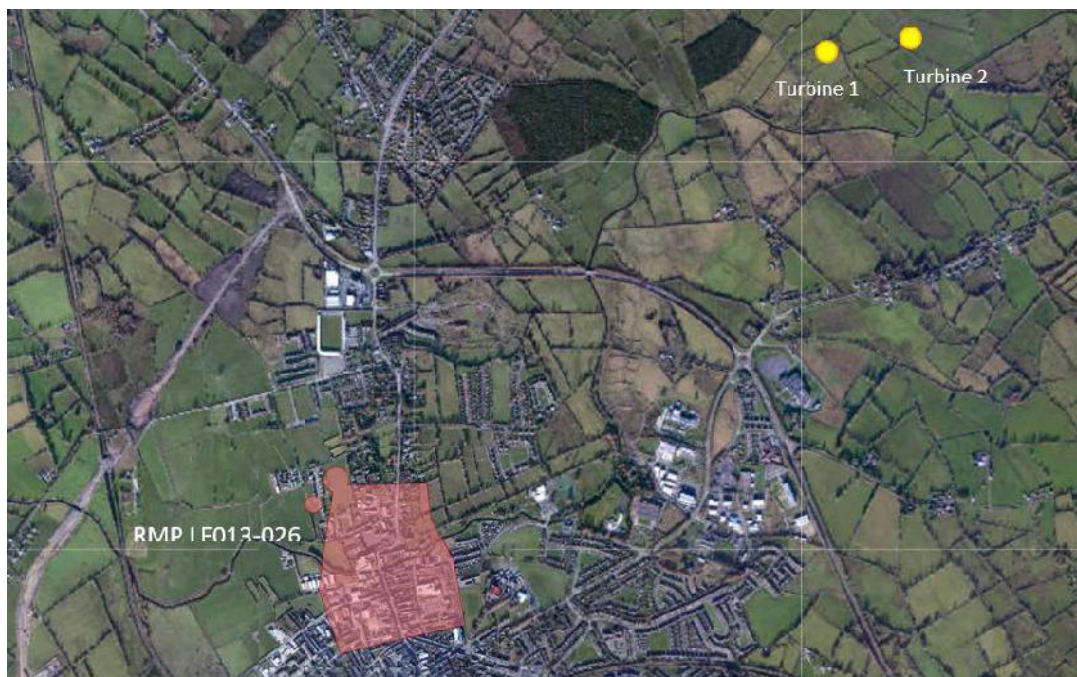
Figure 5 Historic Core Longford Town

The proposed Wind Farm site located at Cloonanny Glebe is approximately 3.3km from Longford Town (see. fig.5). Longford takes its name from the Irish 'longphort', meaning 'fortress'. The earliest settlement dates from the late-medieval period. There is no evidence of any Anglo-Norman settlement, so Longford belongs to a small sample of urban centres whose genesis occurred under native Irish development.

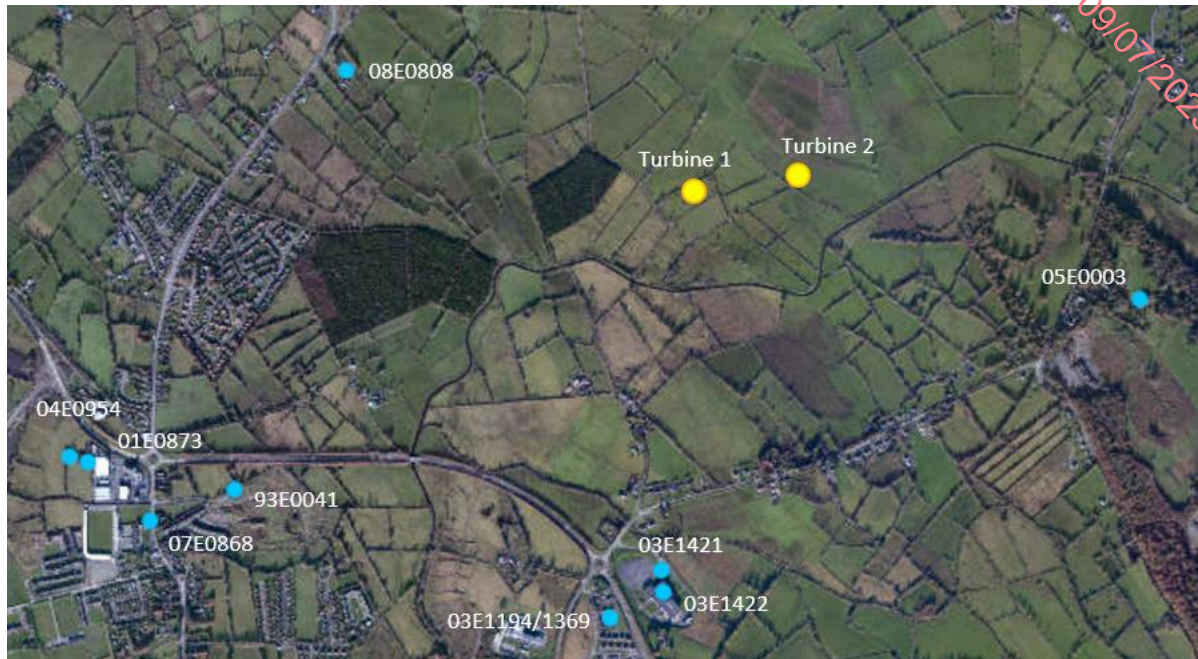
Figure 6 Location of Previous Excavations Within Area of Study, Cloonanny, County Longford

The database of previous excavations was reviewed. The following 10 excavations are recorded within the Area of Study (see fig.6).

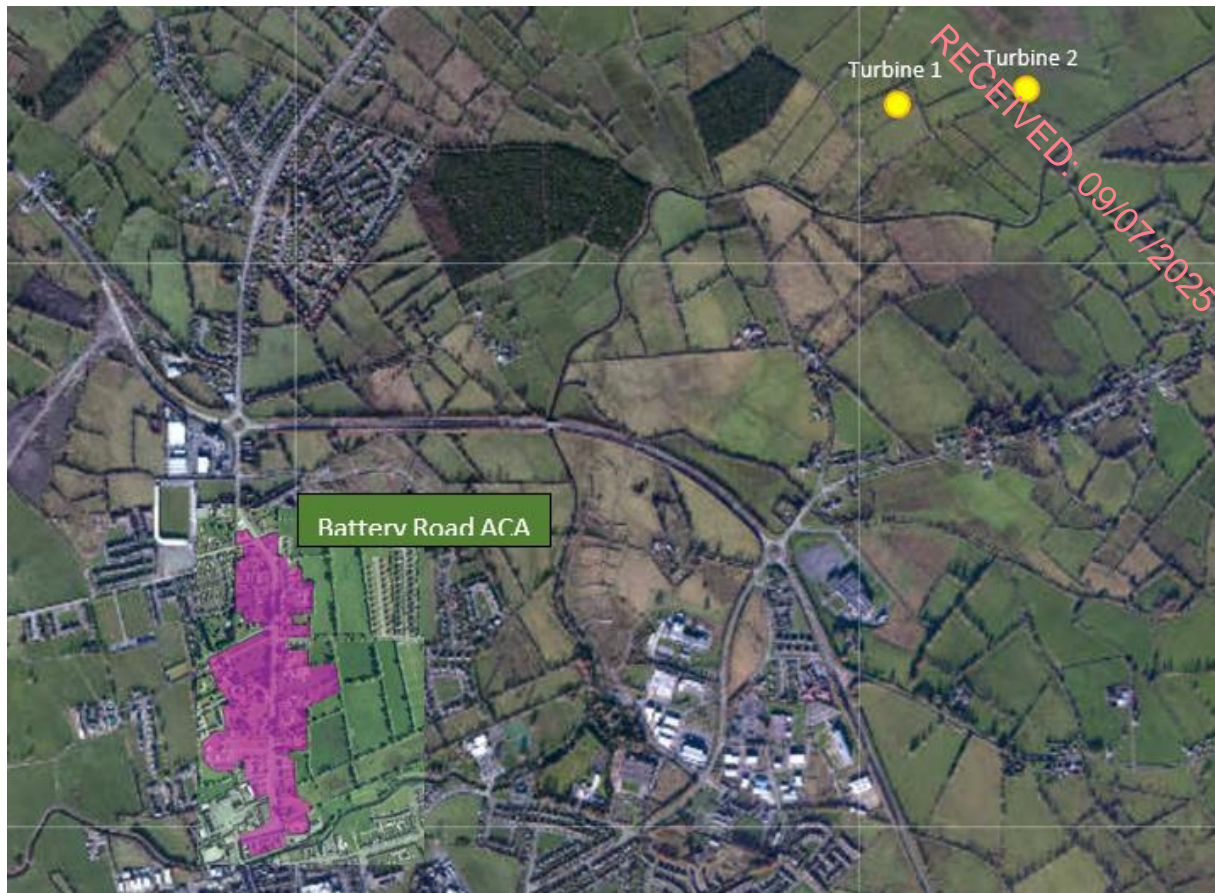
*Figure 12 Battery Road ACA, Longford Town*

There is one designated Architectural Conservation Area (ACA) associated with Longford Town located along Battery Road (see fig.12). The ACA is located 2.35km to the southwest of the proposed development. Battery Road is located along the northern section of Longford Town and derives its name from the military installations that once stretched from the existing barracks on Church Street to the Battery, which is now occupied by Pearse Park GAA grounds and Pearse View housing estate. Battery Road is a major existing approach route into the town from the north.

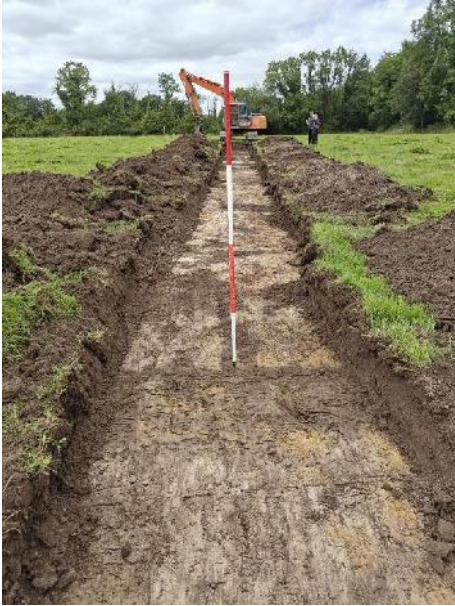
Trench 1	Description
L: 30m, W:1.8m	<p>Aligned NW/SE. This trench was excavated to a depth of 250mm to expose compact glacial clays and scattered stones. No features or finds of archaeological significance were found.</p>

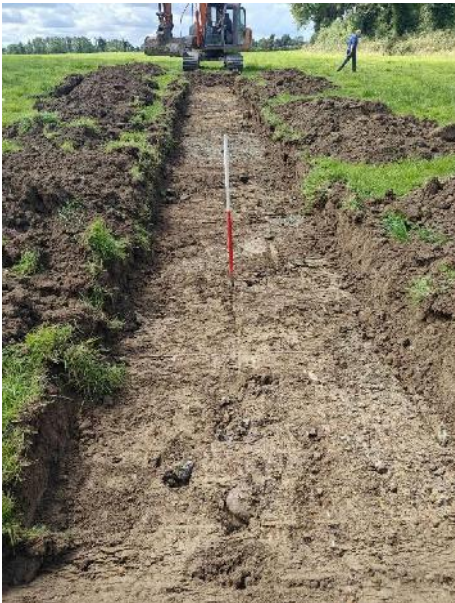
Trench 2	Description
L: 30m, W:1.8m	<p>Aligned NW/SE. This trench was excavated to a depth of 250mm to expose compact glacial clays and scattered stones. No features or finds of archaeological significance were found.</p>

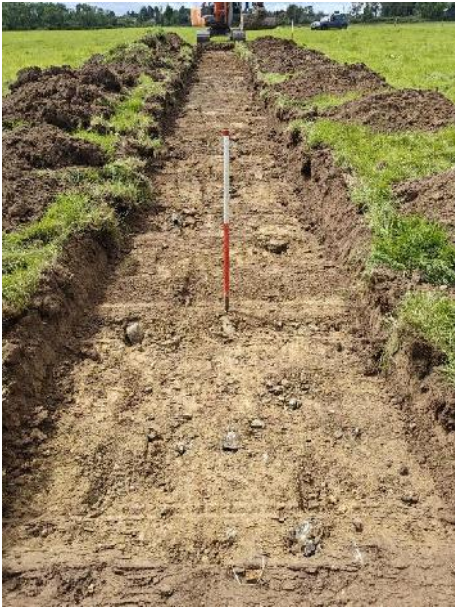
Trench 3	Description
L: 30m, W:1.8m	<p>Aligned NW/SE. This trench was excavated to a depth of 250mm to expose compact glacial clays and scattered stones. No features or finds of archaeological significance were found.</p>

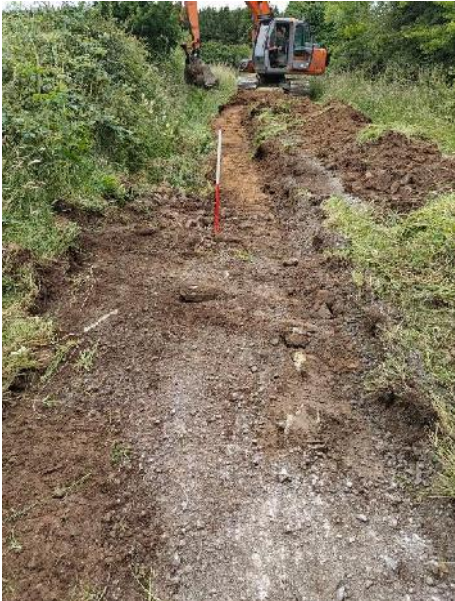
Trench 4	Description
L: 20m, W:1.8m	<p>Aligned N/S. This trench was excavated to a depth of 250mm to expose compact glacial clays and scattered stones. No features or finds of archaeological significance were found.</p>

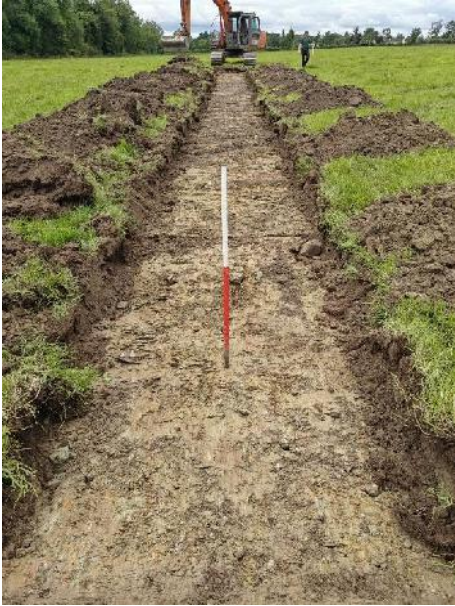
Trench 5	Description
L: 30m, W:1.8m	<p data-bbox="432 241 1382 365">Aligned NW/SE. This trench was excavated to a depth of 250mm to expose compact glacial clays and scattered stones. No features or finds of archaeological significance were found.</p>

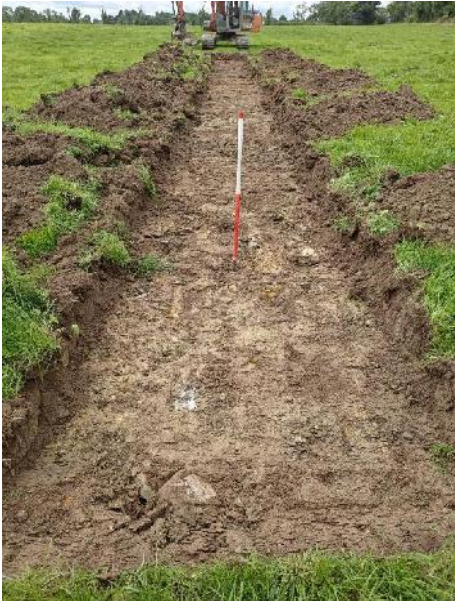
Trench 6	Description
L: 30m, W:1.8m	<p data-bbox="432 1187 1382 1310">Aligned NW/SE. This trench was excavated to a depth of 250mm to expose compact glacial clays and scattered stones. No features or finds of archaeological significance were found.</p>

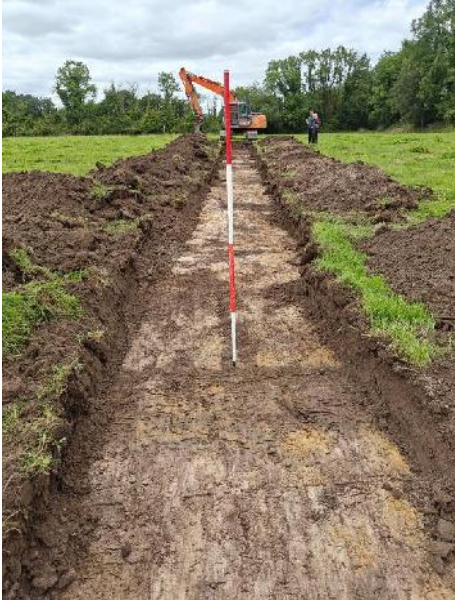
Trench 7	Description
L: 30m, W:1.8m	<p data-bbox="432 241 1382 365">Aligned NW/SE. This trench was excavated to a depth of 250mm to expose compact glacial clays and scattered stones. No features or finds of archaeological significance were found.</p>

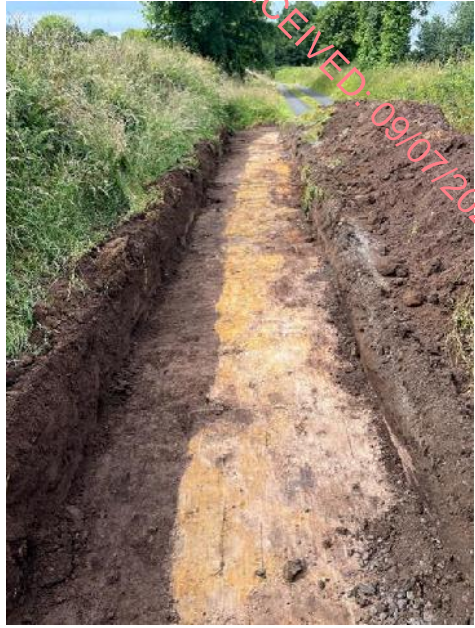
Trench 9	Description
L: 20m, W:1.8m	<p>Aligned N/S. This trench was excavated to a depth of 250mm to expose compact glacial clays and scattered stones. No features or finds of archaeological significance were found.</p>

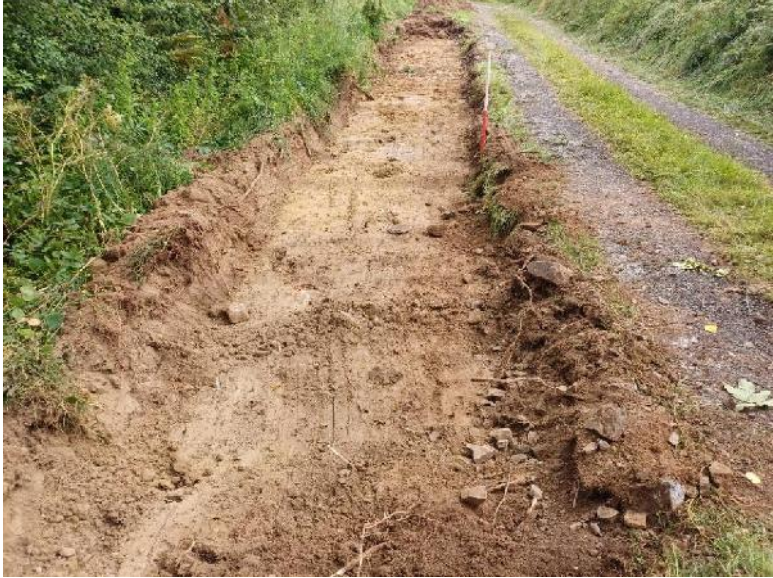
Trench 11	Description
L: 20m, W:1.8m	<p data-bbox="432 239 1383 365">Aligned N/S. This trench was excavated to a depth of 250mm to expose compact glacial clays and scattered stones. No features or finds of archaeological significance were found.</p>

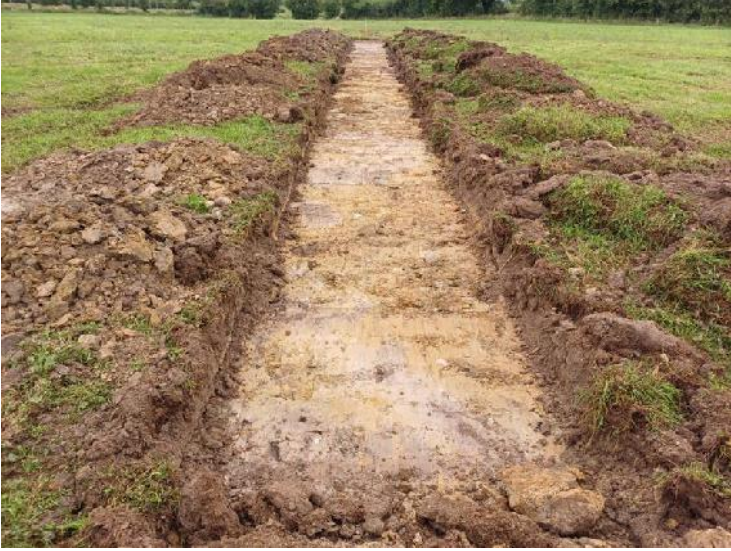
Trench 13	Description
L: 30m, W:1.8m	<p data-bbox="432 241 1382 365">Aligned NW/SE. This trench was excavated to a depth of 250mm to expose compact glacial clays and scattered stones. No features or finds of archaeological significance were found.</p>

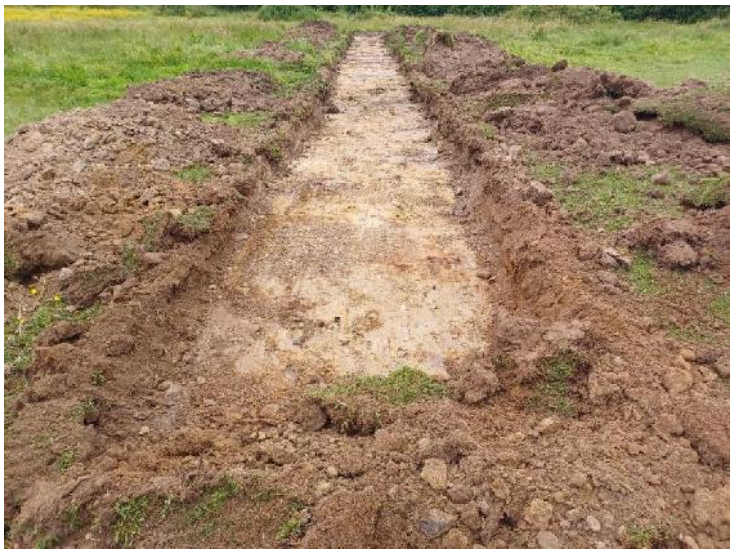
Trench 14	Description
L: 30m, W:1.8m	<p data-bbox="432 1137 1382 1261">Aligned NW/SE. This trench was excavated to a depth of 200mm to expose compact glacial clays and scattered stones. No features or finds of archaeological significance were found.</p>

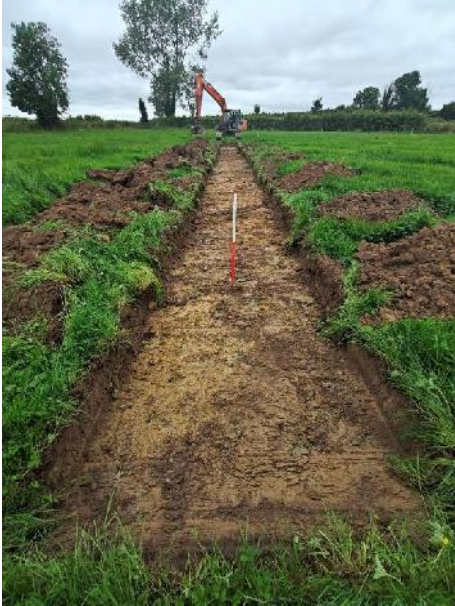
Trench 15	Description
L: 30m, W:1.8m	<p data-bbox="432 241 1382 365">Aligned NW/SE. This trench was excavated to a depth of 250mm to expose compact glacial clays and scattered stones. No features or finds of archaeological significance were found.</p>

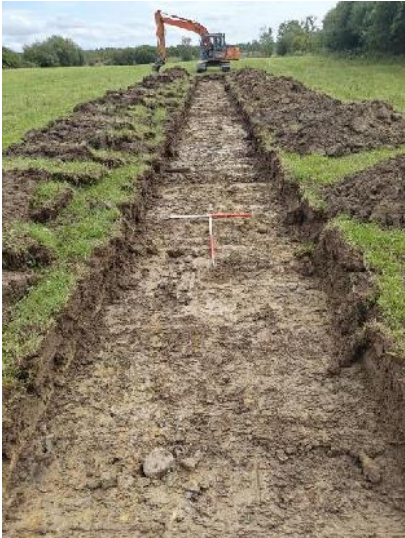
Trench 16	Description
L: 30m, W:1.8m	<p data-bbox="432 1196 1382 1319">Aligned E/W. This trench was excavated to a depth of 350mm to expose compact glacial clays and scattered stones. No features or finds of archaeological significance were found.</p>

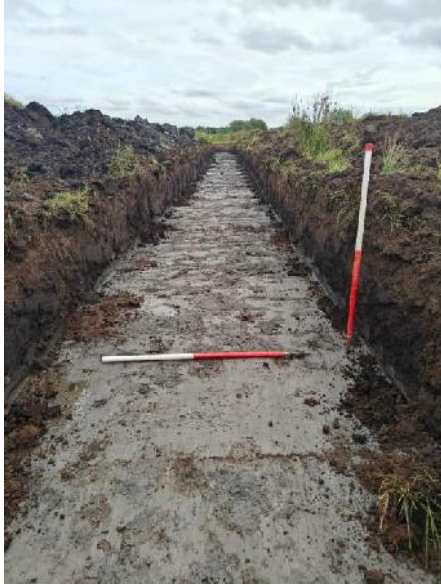
Trench 17	Description
L: 30m, W:1.8m	<p>Aligned E/W. This trench was excavated to a depth of 350mm to expose compact glacial clays and scattered stones. No features or finds of archaeological significance were found.</p>

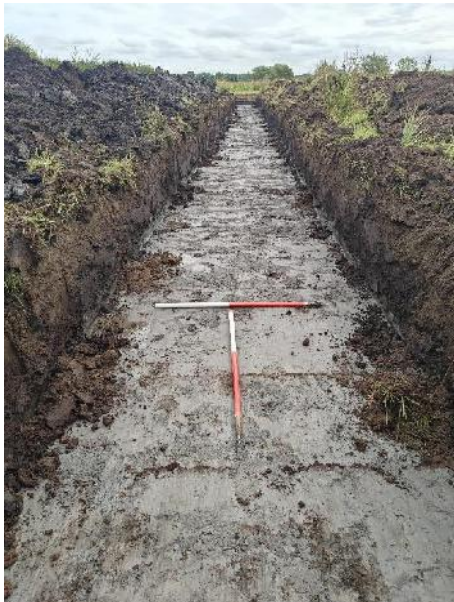
Trench 18	Description
L: 30m, W:1.8m	<p>Aligned E/W. This trench was excavated to a depth of 750mm through organic peat material to expose grey marl. No features or finds of archaeological significance were found.</p>

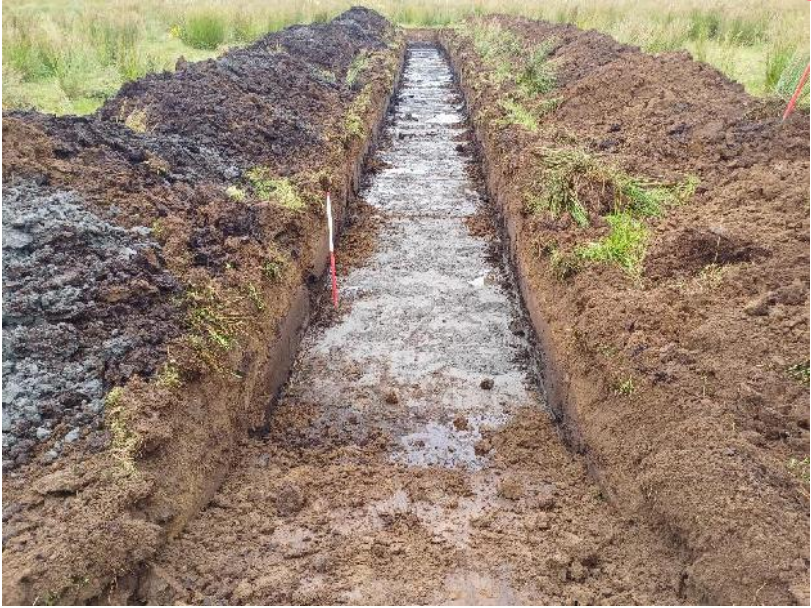
Trench 19	Description
L: 30m, W:1.8m	<p data-bbox="432 241 1383 365">Aligned E/W. This trench was excavated to a depth of 750mm through organic peat material to expose grey marl. No features or finds of archaeological significance were found.</p>
