Appendix 14. Cultural Heritage

Sea Gardens,
Ravenswell,
Bray,
County Wicklow

Archaeological testing report

Proposed residential development, Sea Gardens, Phase 2, Ravenswell and Bray Commons, County Wicklow

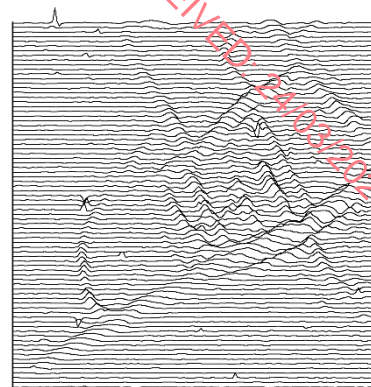
XY Trace

The data are presented as a series of linear traces, enabling a semi-profile display of the respective anomalies along the X and Y-axes. This display option is essential for distinguishing between modern ferrous materials (buried metal debris) and potential archaeological responses. The XY trace plot provides a linear display of the magnitude of the response within a given data set.

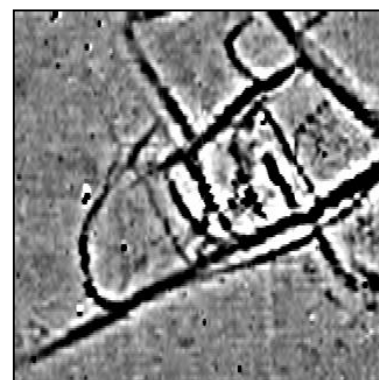
Greyscale*

As with dot density plots, the greyscale format assigns a cell to each datum according to its location on the grid. The display of each data point is conducted at very fine increments, allowing the full range of values to be displayed within the given data set. This display method also enables the identification of discrete responses that may be at the limits of instrument detection. In the summary diagrams processed, interpolated data is presented. Raw un-interpolated data is presented in the archive drawings along with the xy-trace plots.

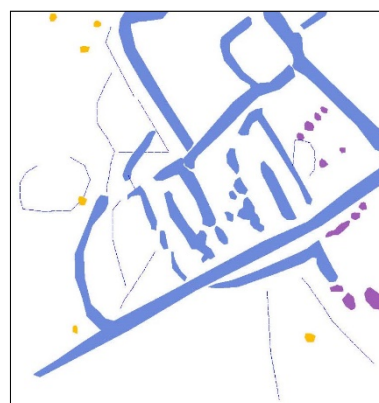
Interpretation

An interpretation of the data is made using many of the plots presented in the final report, in addition to examination of the raw and processed data. The project managers' knowledge and experience allow a detailed interpretation of the survey results with respect to archaeological potential.

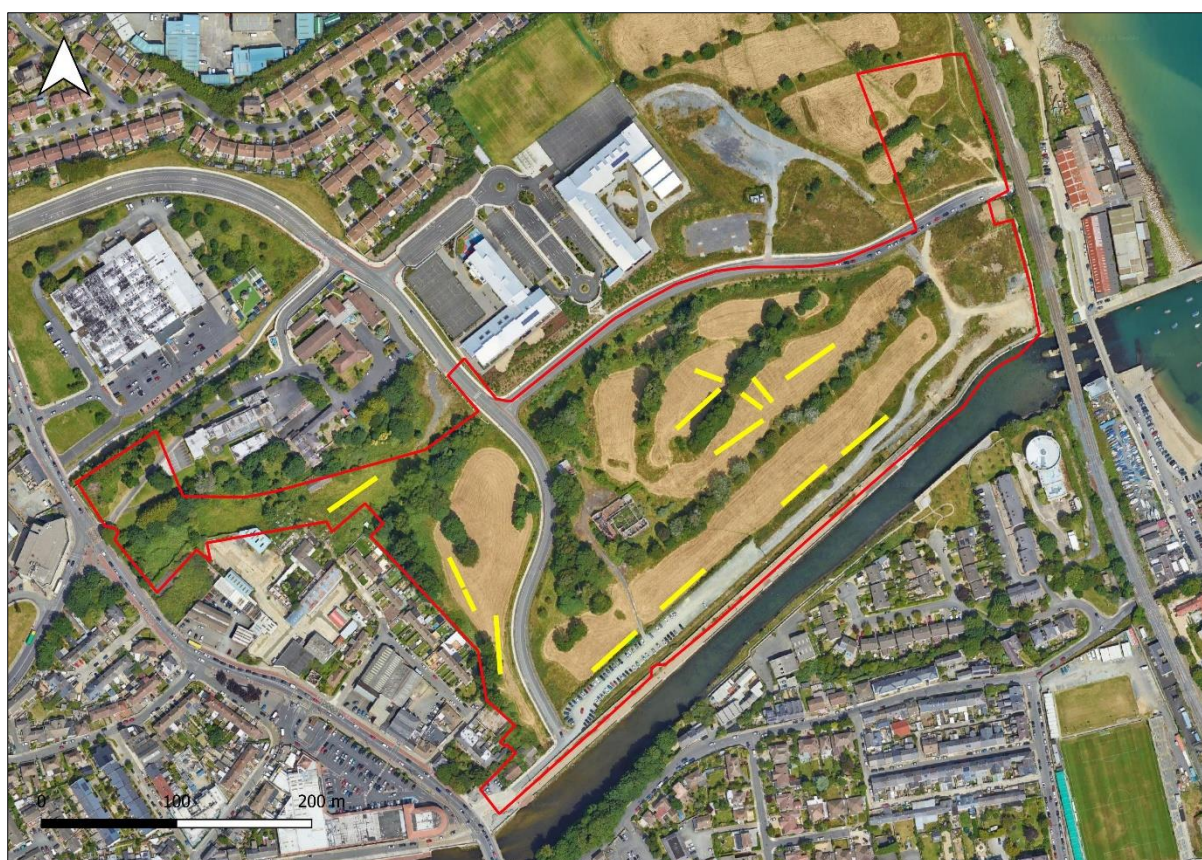
Figure 9: Location of test trenches

The programme of archaeological test trenching described in this report was carried out under Excavation Licence 24E0428 between 16 and 18 April 2024. 13no. linear test trenches (T1, T2, T4 – T13) with a combined length of 450m were excavated under archaeological supervision within the boundaries of the proposed development site (**Figure 9-11**). Trench 3 was not excavated as a cat scan survey indicated several buried services within this area. A c. 5m long portion at the centre of Trench 2 was also left unexcavated in order to avoid a buried electricity cable. Please note that Table 2 of the method statement stated incorrect trench lengths for T5, T8 and T9, these should read 18m, 15m and 20m respectively. Trench 5 was shortened slightly to avoid an existing footpath. All three trenches targeted geophysical anomalies.

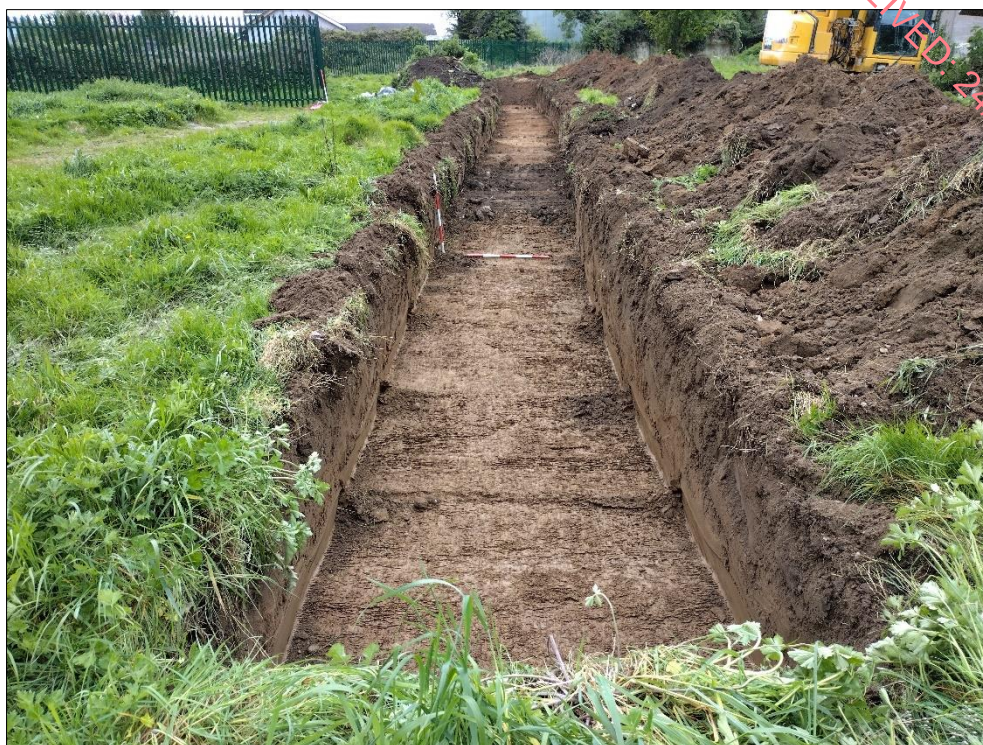
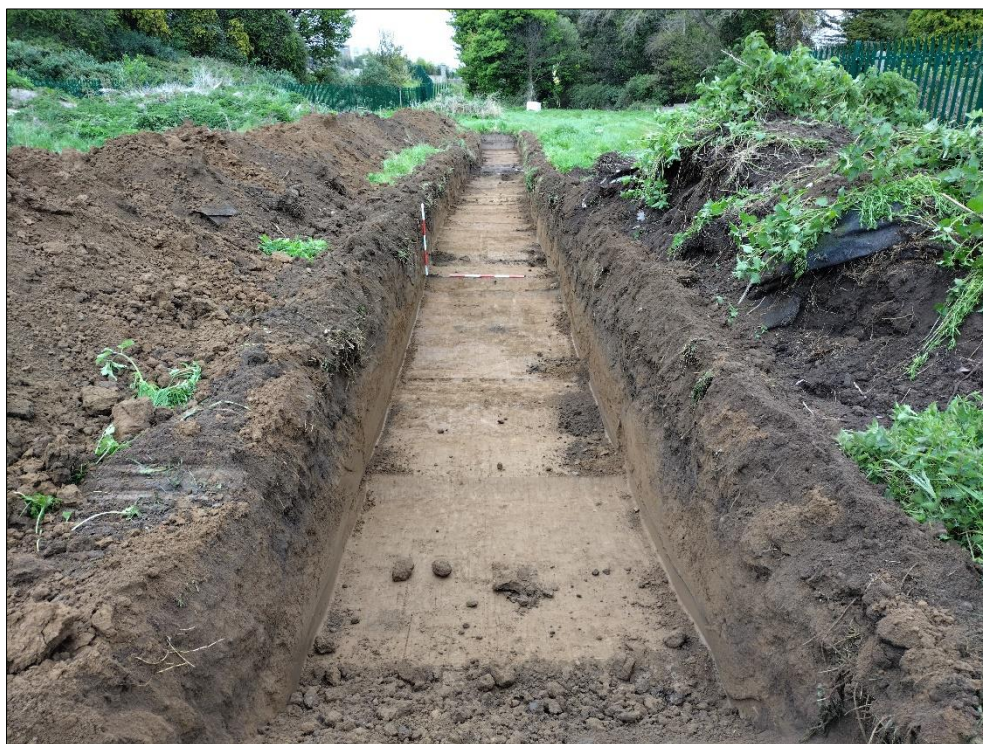
Plate 1: Trench 1 facing southwest

Plate 2: Trench 1 facing northeast

Trench ID	T1
Dimensions	W: 1.8m L: 40m D:0.8-1.0m
Orientation	NE-SW
ITM Co-ords	726156.9/719150.8, 726189.83/719173.53
Description	Test trench 1 (T1) was excavated to a maximum depth of 1.0m below the existing surface level. The trench was excavated through a 0.8-1.0m thick layer of topsoil consisting of medium brown sandy silt which contained frequent modern waste (bits of metal, plastic, stones, slate, redbrick and clear glass fragments). A c. 5m long and min. 1.8m wide pit with buried modern waste was noted at the north-western end of the trench. The topsoil overlay a loose light brownish yellow sand subsoil. Occasional pockets of fine water-rolled gravel were noted within the subsoil. No archaeology was identified in this trench. Plates 1, 2

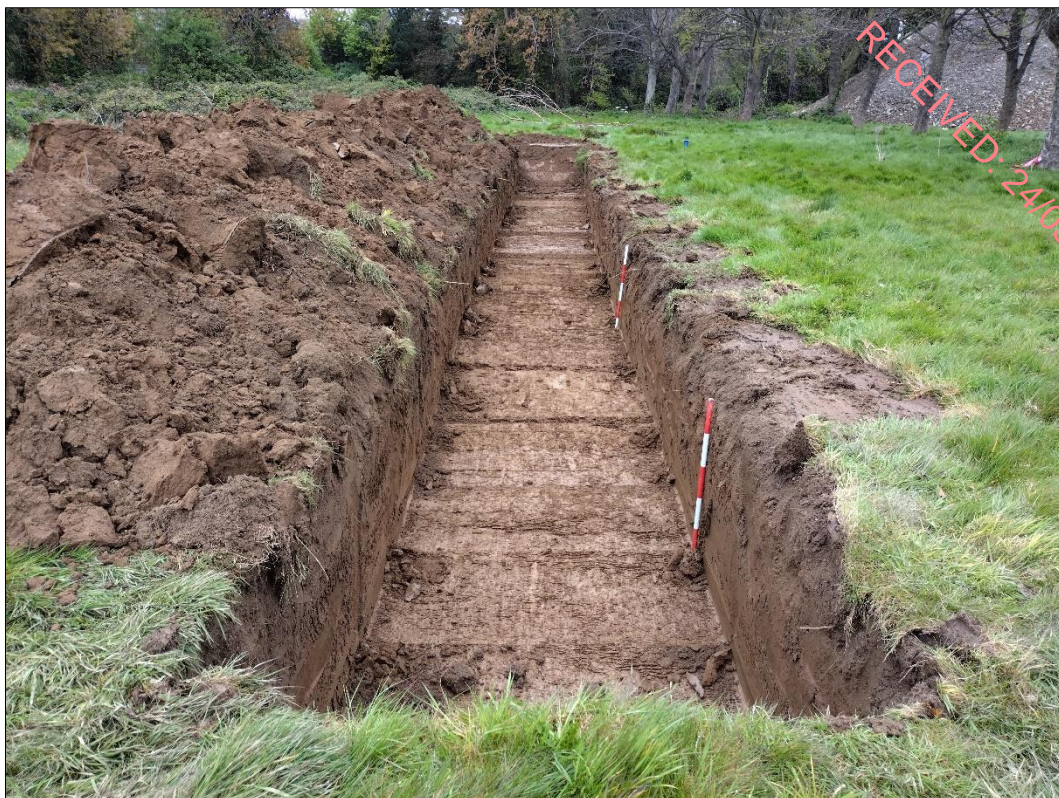
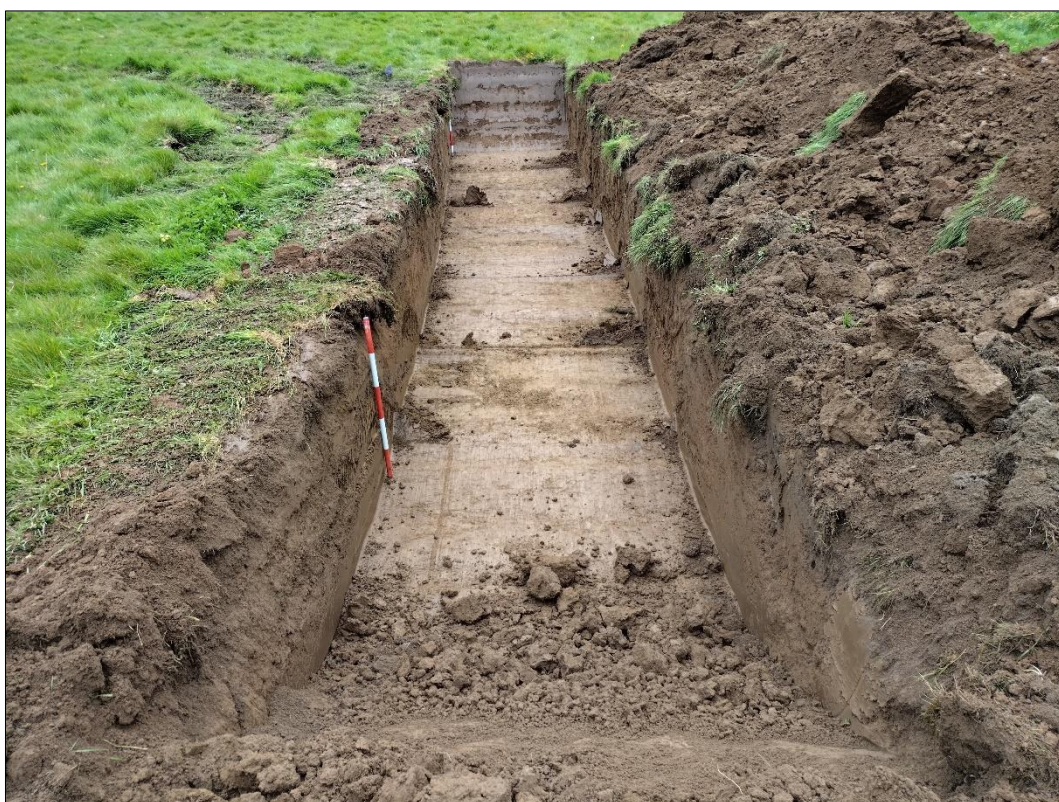
Plate 3: Showing northern half of Trench 2 facing north-northeast

Plate 4: Showing southern half of Trench 2 facing south-southwest

Trench ID	T2
Dimensions	W: 1.8m L: 35m D:1.0-1.1m
Orientation	NNE-SSW
ITM Co-ords	726245.65, 719070.56 / 726262.93, 719077.46
Description	Test trench 2 (T2) was excavated to a maximum depth of 1.1m below the existing surface level. The trench was excavated through a 1.0-1.1m thick layer of topsoil consisting of medium brown sandy silt. The topsoil overlay a loose light brownish yellow sand subsoil. A c. 5m long section at the middle of the trench was not excavated in order to avoid a buried electricity cable. No archaeology was identified in this trench. Plates 3, 4

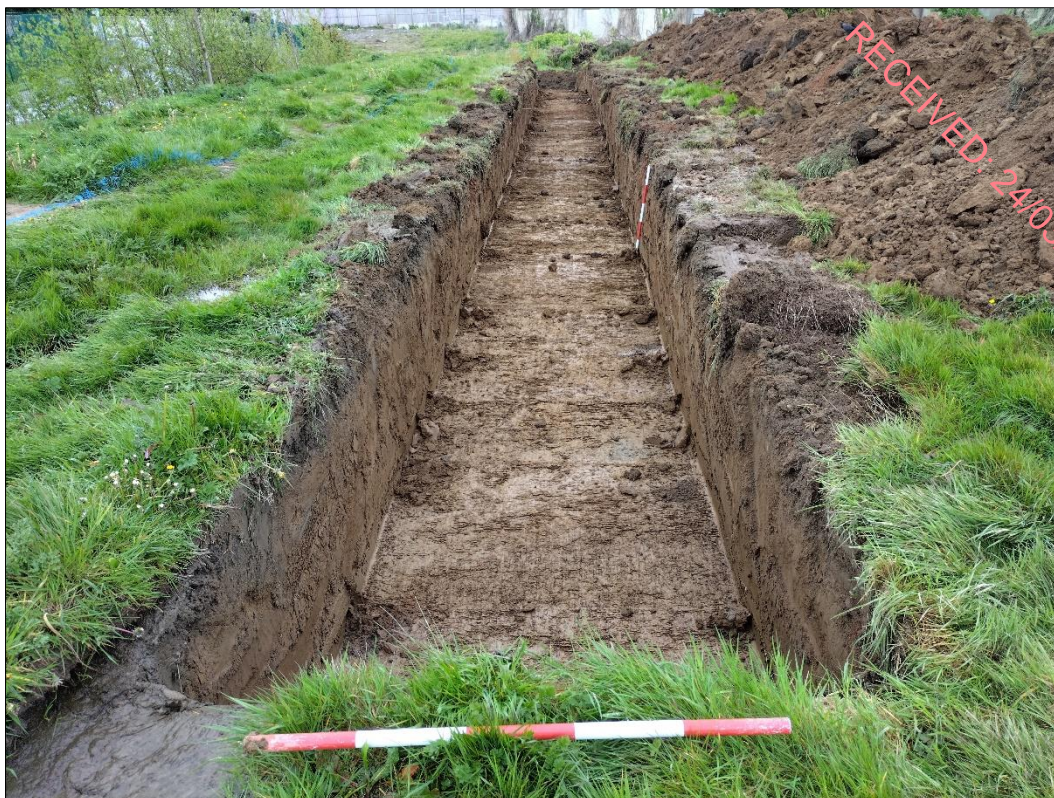
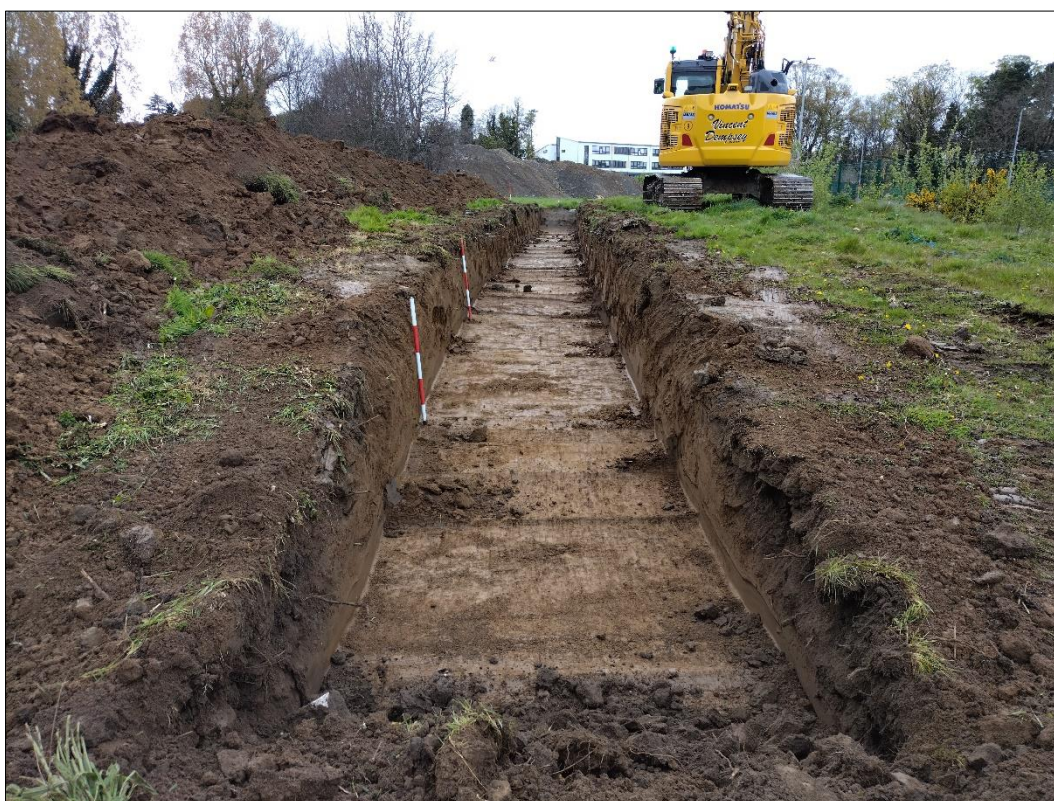
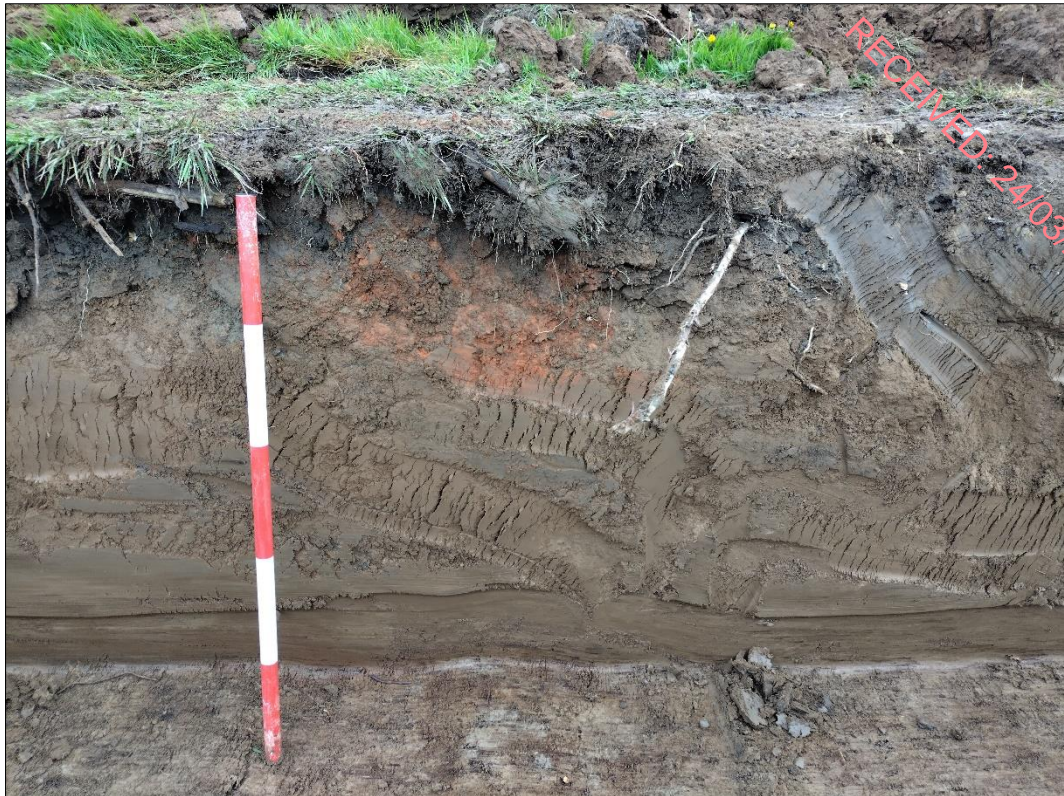
Plate 5: Trench 4 facing south

Plate 6: Trench 4 facing north

Plate 7: Showing line of bricks in topsoil Trench 4 facing east

Trench ID	T4
Dimensions	W: 1.8m L: 40m D:0.7-1.2m
Orientation	N-S
ITM Co-ords	726279.64, 719070.56 / 726282.68, 719030.70
Description	Test trench 4 (T4) was excavated to a maximum depth of 1.2m below the existing surface level. The ground level had been artificially reduced at its southern end. The trench was excavated through a 0.7-1.2m thick layer of topsoil consisting of medium brown sandy silt. The topsoil overlay a loose light brownish yellow sand subsoil. Two parallel lines of crushed red brick, c. 0.3m wide and 0.2m deep, orientated east-west, and set c. 10m apart, were noted within the upper layer of the topsoil. These are interpreted as features associated with the golf course. No archaeology was identified in this trench. Plates 5 – 7

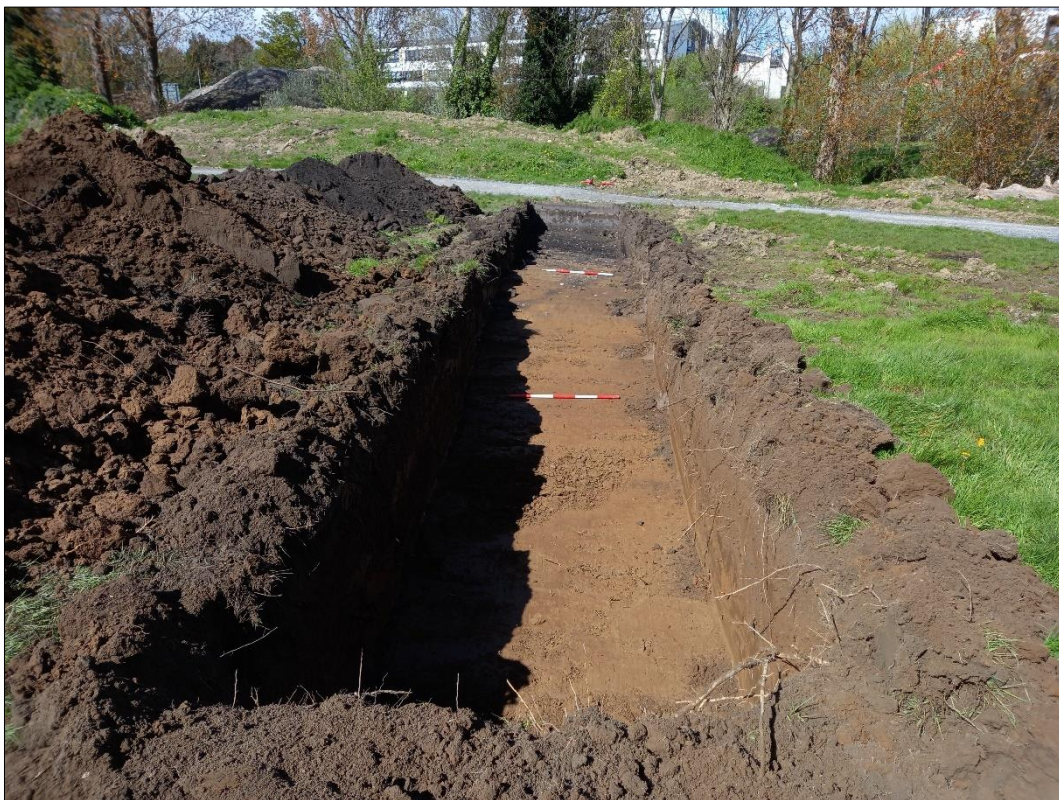
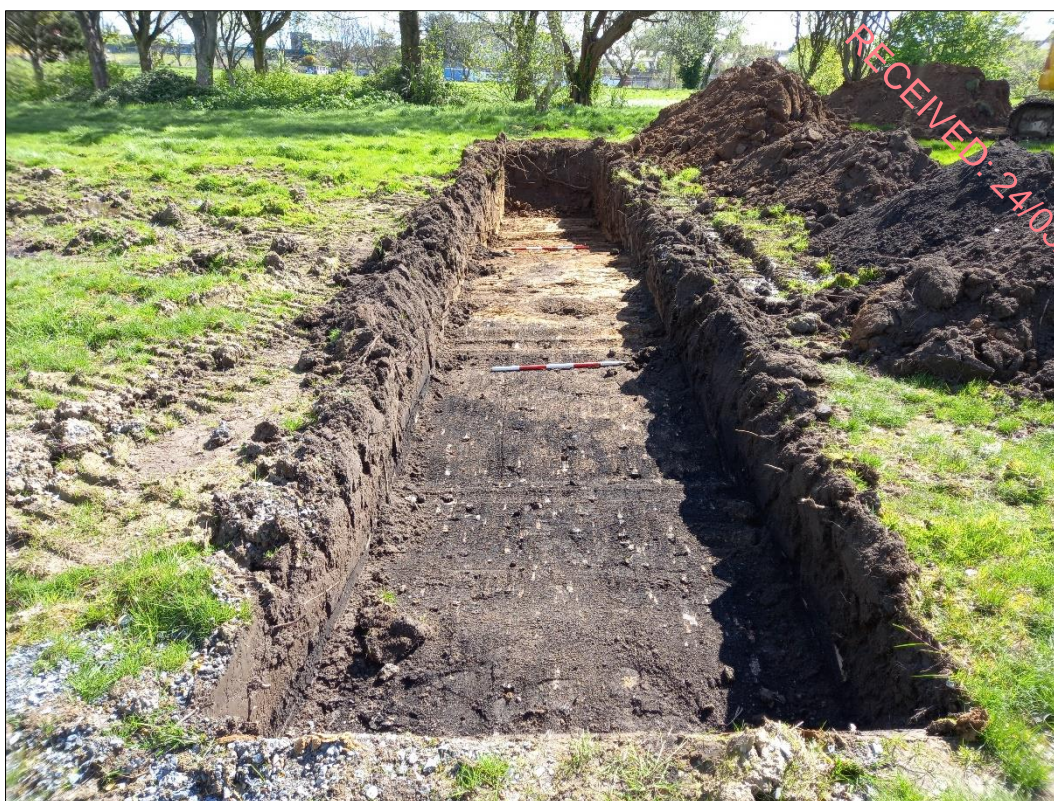
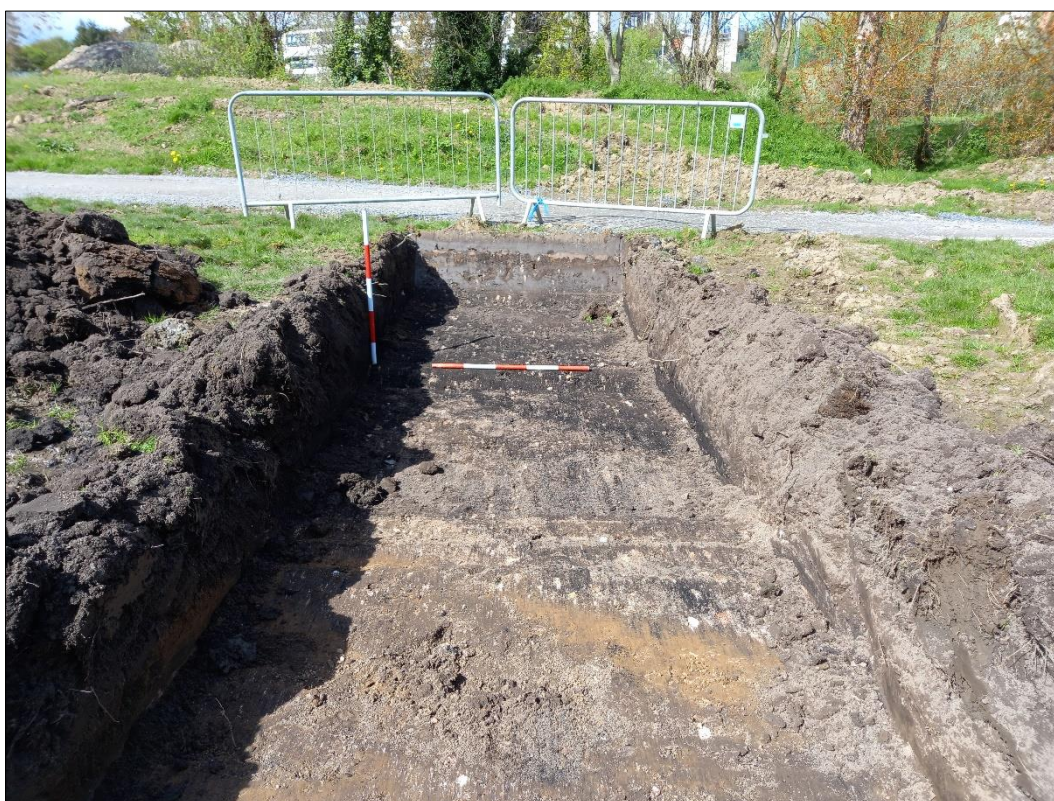
Plate 8: Trench 5 facing west-northwest

Plate 9: Trench 5 facing east-southeast, showing burnt spread in foreground

Plate 10: Showing burnt spread in Trench 5, facing west-northwest

Trench ID	T5
Dimensions	W: 1.8m L: 15m D:0.5-1.1m
Orientation	WNW-ESE
ITM Co-ords	726445.41, 719247.03 / 726431.25, 719251.82
Description	Test trench 5 (T5) was excavated to a maximum depth of 1.1m below the existing surface level. The trench was excavated through a 0.5-1.1m thick layer of topsoil consisting of medium brown sandy silt. The topsoil overlay a loose light brownish yellow sand subsoil. A burnt spread consisting of a black, charcoal rich, sandy silt with frequent heat shattered stones, was uncovered at its northern end. The spread extended beyond the trench to the northwest, east and west but its extent could not be established due to an existing footpath and stockpiled soil in this area. The burnt spread measured c. 4.6m west-northwest/east-southeast and had a minimum width of 1.8m. It was located c. 0.3m below the ground surface. Plates 8 – 10

The discovery of an archaeological feature, a burnt spread, within the subject site during the test trenching will require a programme of archaeological mitigation. The proposed development in its current form will have a direct negative impact on this feature. While preservation *in situ* is the preferred option, the proposed method of mitigation for this feature is preservation by record (full archaeological excavation and recording).

Furthermore, it is recommended that a larger area around the feature is stripped of topsoil in order to find its full extent and any potential associated features, prior to any development work being undertaken at this site. The stripped area will include at least 10m of clearance from the outermost archaeological feature to the edge of the excavation. The supervised topsoil stripping will be undertaken under licence using a mechanical excavator fitted with a toothless bucket which will remove the topsoil down to the uppermost archaeological layer or the surface of natural subsoil in areas where no archaeological material is present. A systematic programme of manual archaeological excavation of all revealed features of archaeological potential will then be carried out in accordance with the method statement submitted to and approved by the National Monuments Service (NMS).

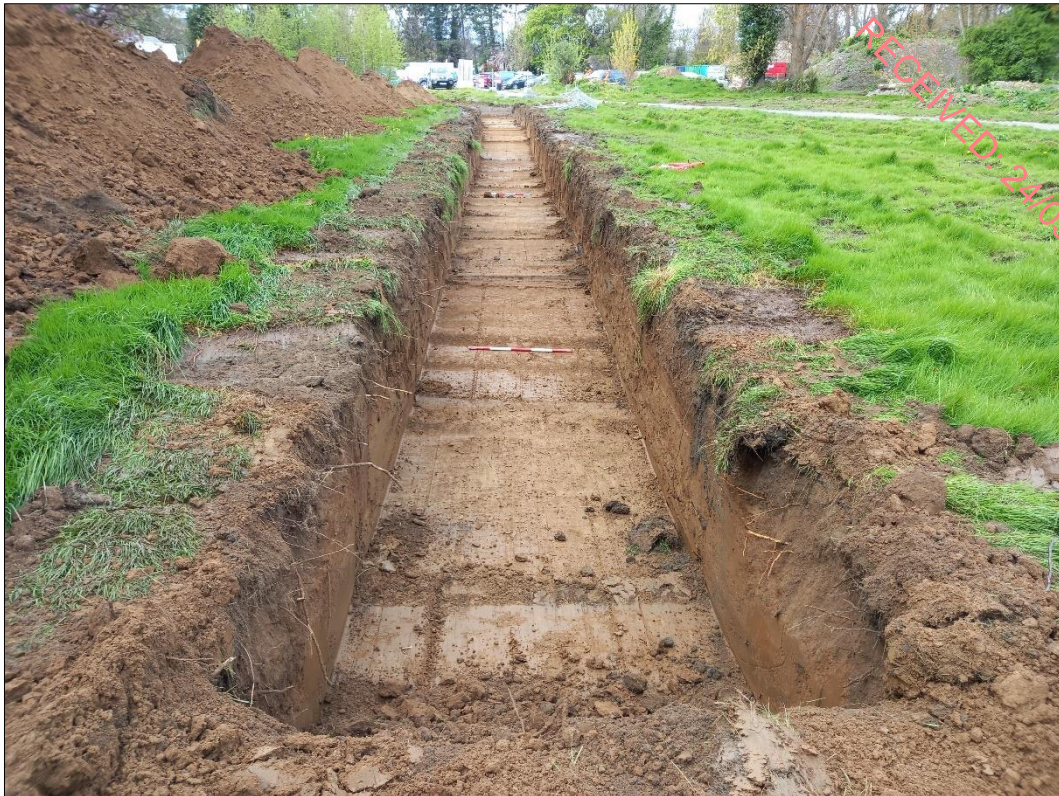
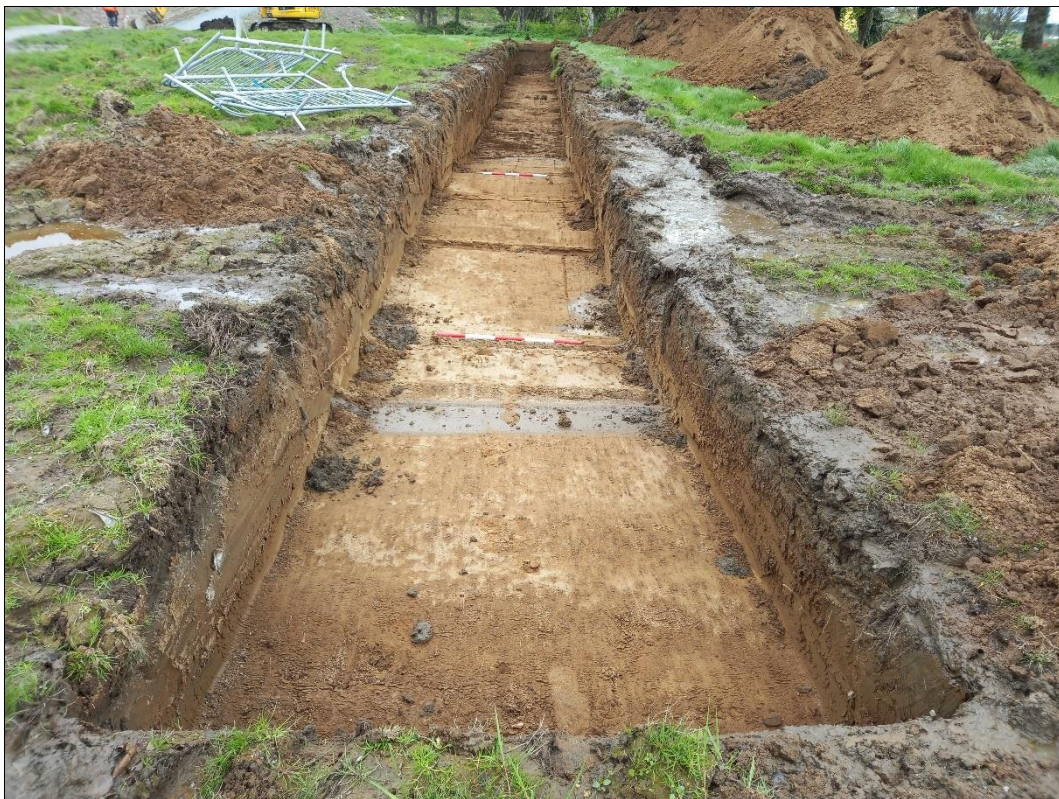
Plate 11: Trench 6 facing southwest

Plate 12: Trench 6 facing northeast

Trench ID	T6
Dimensions	W: 1.8m L: 40m D:0.7-1.2m
Orientation	NE-SW
ITM Co-ords	726444.08, 719238.77 / 726414.46, 719211.71
Description	Test trench 6 (T6) was excavated to a maximum depth of 1.2m below the existing surface level. The trench was excavated through a 0.7-1.2m thick layer of topsoil consisting of medium brown sandy silt. The topsoil overlay a loose light brownish yellow sand subsoil with some root disturbance. No archaeology was found in this trench Plates 11 – 12

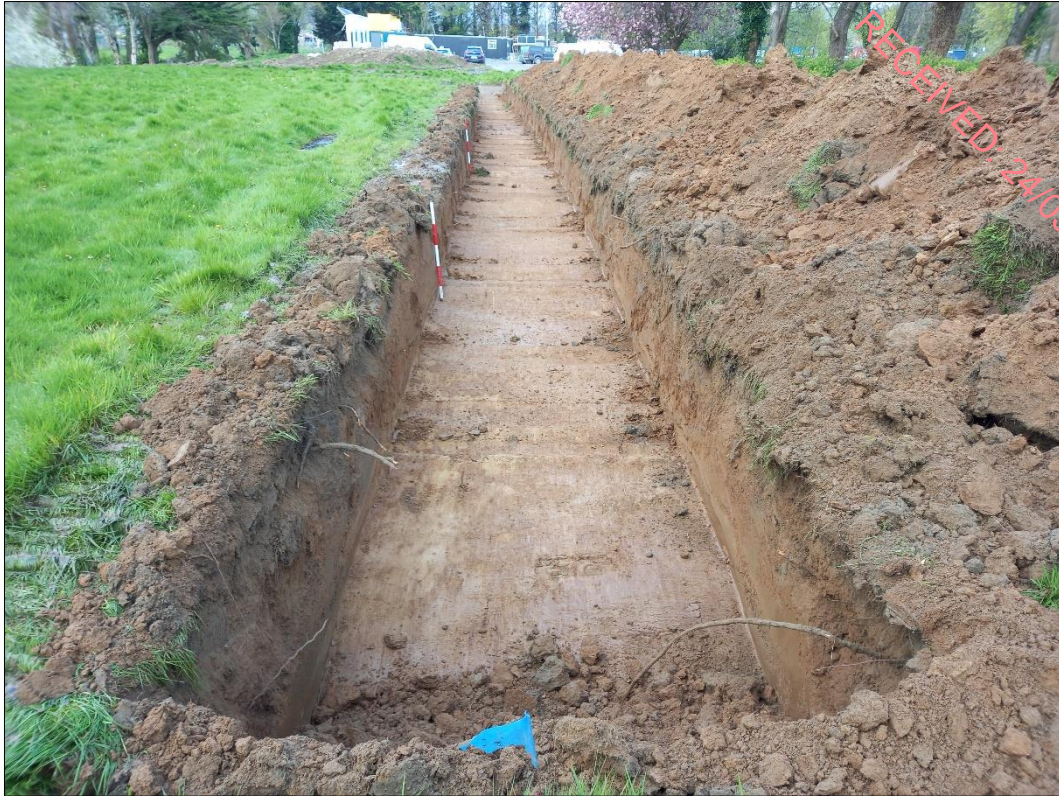
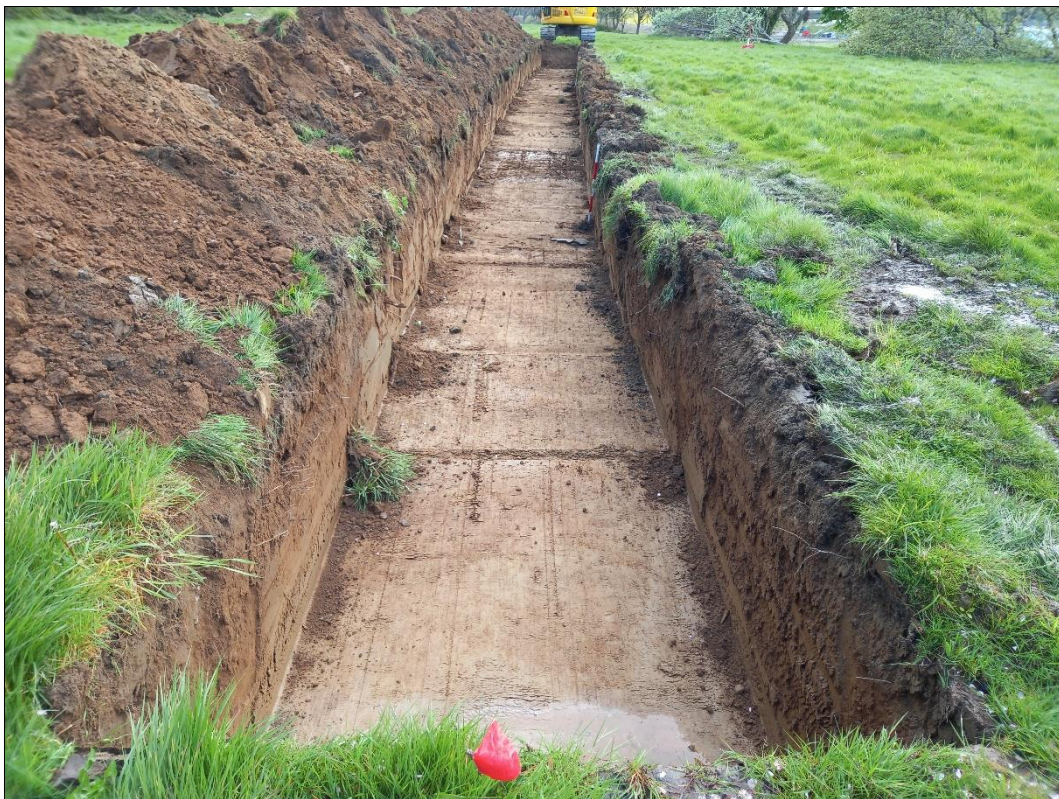
Plate 13: Trench 7 facing southwest

Plate 14: Trench 7 facing northeast

Trench ID	T7
Dimensions	W: 1.8m L: 40m D:1.0-1.2m
Orientation	NE-SW
ITM Co-ords	726475.89, 719215.70 / 726442.94, 719193.22
Description	Test trench 7 (T7) was excavated to a maximum depth of 1.2m below the existing surface level. The trench was excavated through a 0.1-0.2m thick layer of mid grey sandy silt topsoil overlaying a 0.8-0.9m thick layer of reddish brown silty sand. The subsoil consisted of a light brownish grey sand subsoil. No archaeology was found in this trench Plates 13 – 14

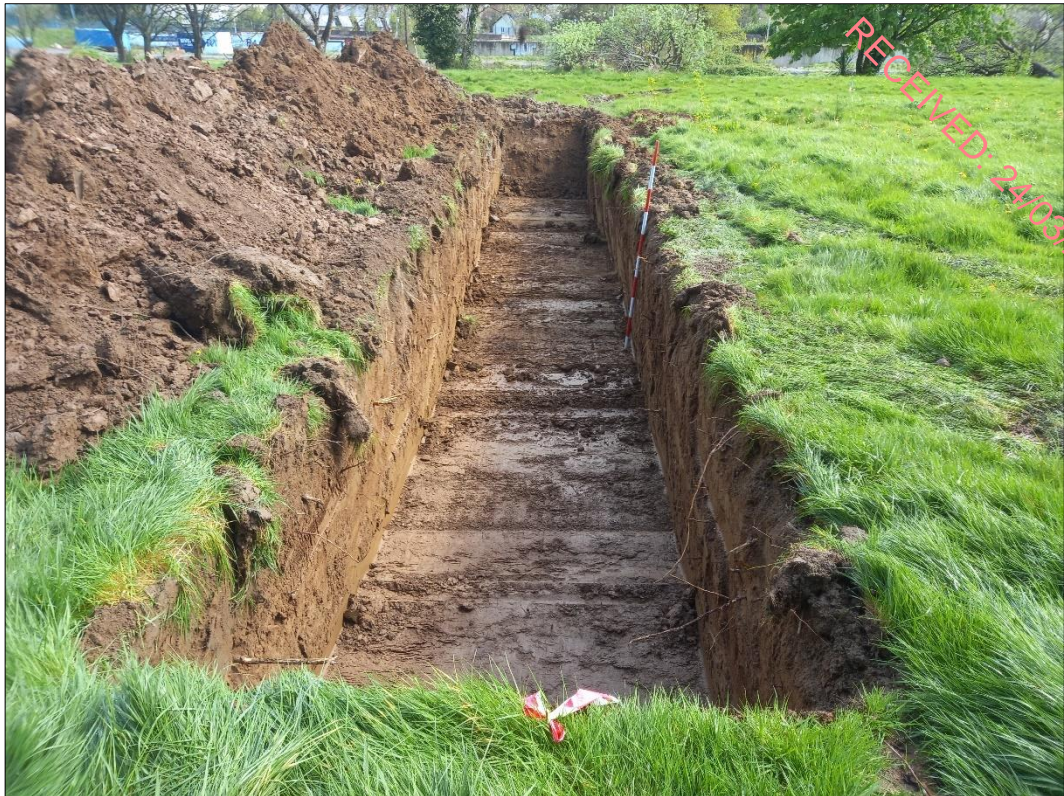
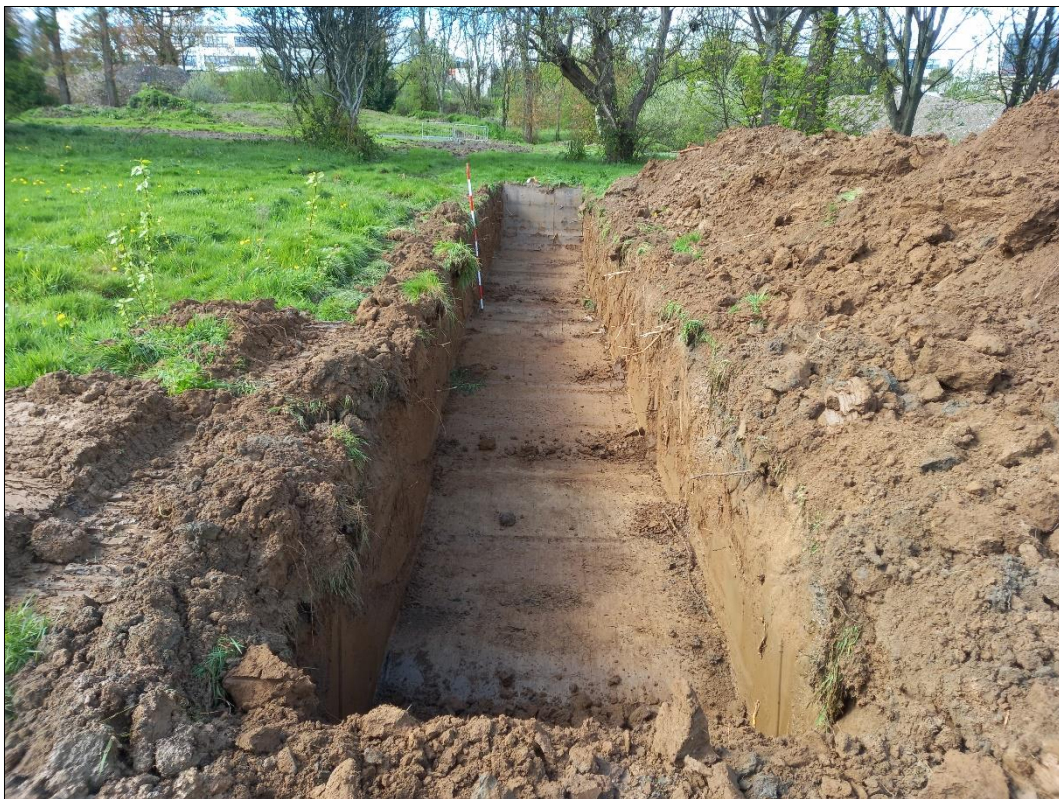
Plate 15: Trench 8 facing southeast

Plate 16: Trench 8 facing northwest

Trench ID	T8
Dimensions	W: 1.8m L: 15m D:1.2m
Orientation	NW-SE
ITM Co-ords	726462.97, 719235.56 / 726475.22, 719226.45
Description	Test trench 8 (T8) was excavated to a maximum depth of 1.2m below the existing surface level. The topsoil consisted of a mid brown clayey silt. Subsoil was not encountered, the trench was not excavated beyond 1.2m due to health and safety reasons. No archaeology was found in this trench Plates 15 – 16

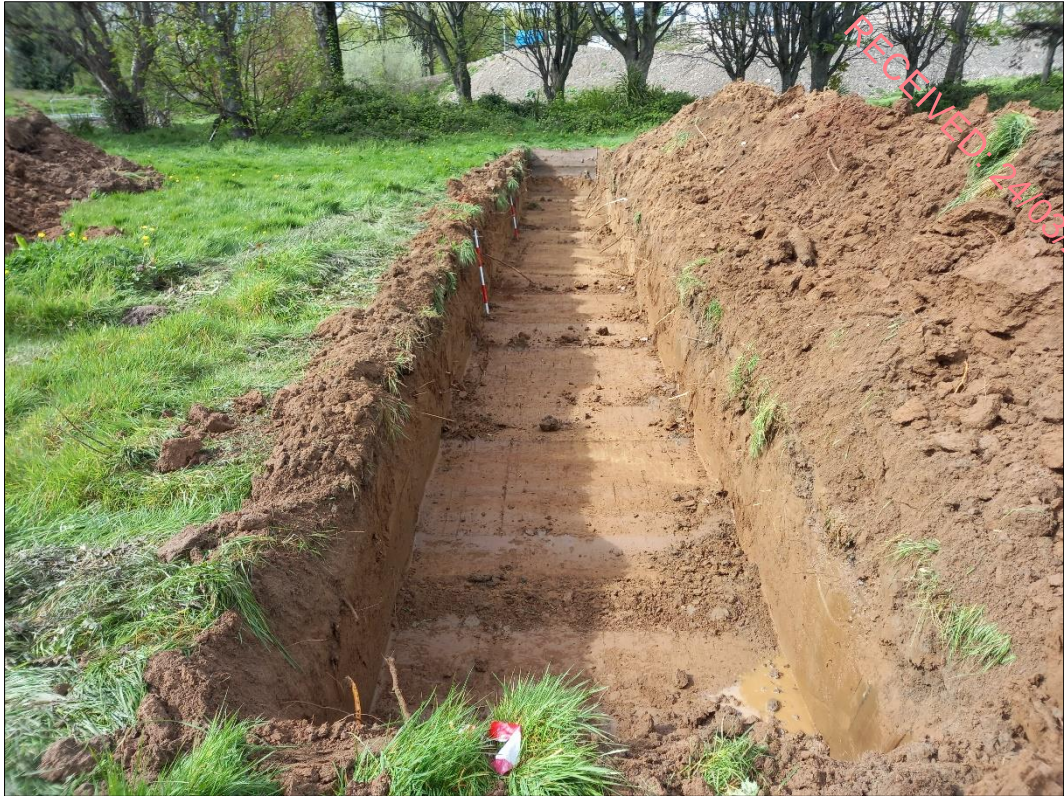
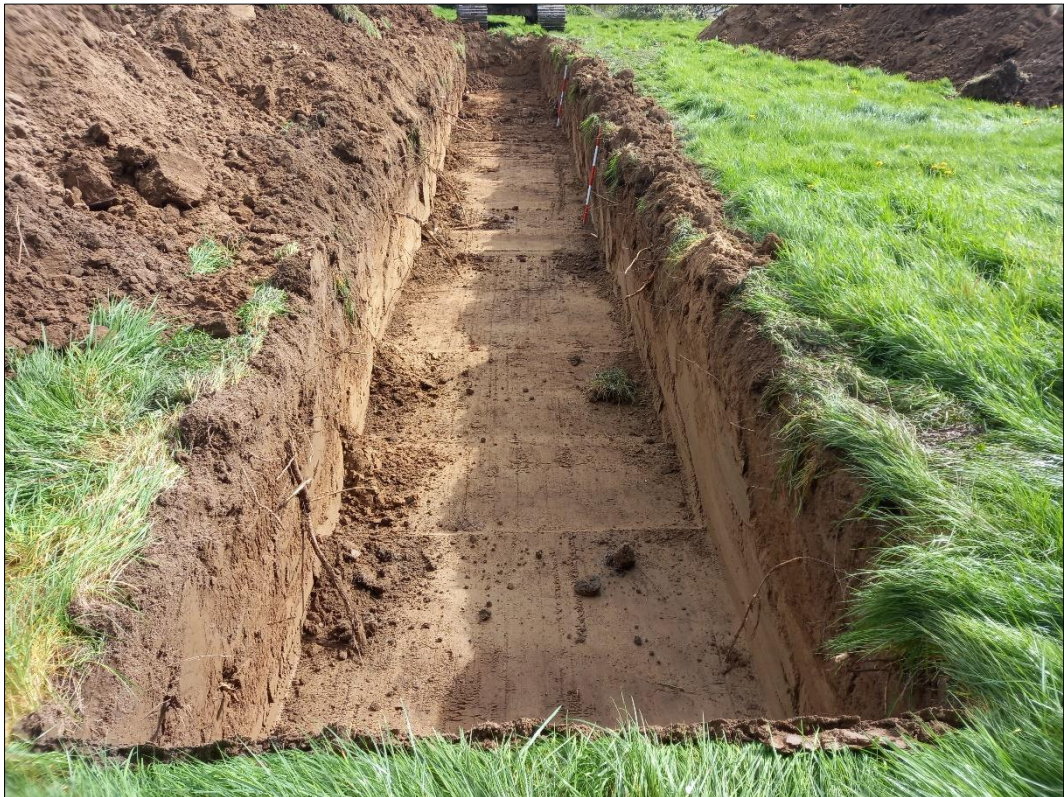
Plate 17: Trench 9 facing northwest

Plate 18: Trench 9 facing southeast

Trench ID	T9
Dimensions	W: 1.8m L: 20m D:1.1-1.2m
Orientation	NW-SE
ITM Co-ords	726470.95, 719246.86 / 726482.91, 719231.67
Description	Test trench 9 (T9) was excavated to a maximum depth of 1.2m below the existing surface level. The trench, which targeted a geophysical anomaly interpreted as a possible pit, was excavated through a 1.1-1.2m thick layer of topsoil consisting of medium brown sandy silt with occasional burnt roots. The topsoil overlay a loose light brownish yellow sand subsoil. No archaeology was found in this trench Plates 17, 18

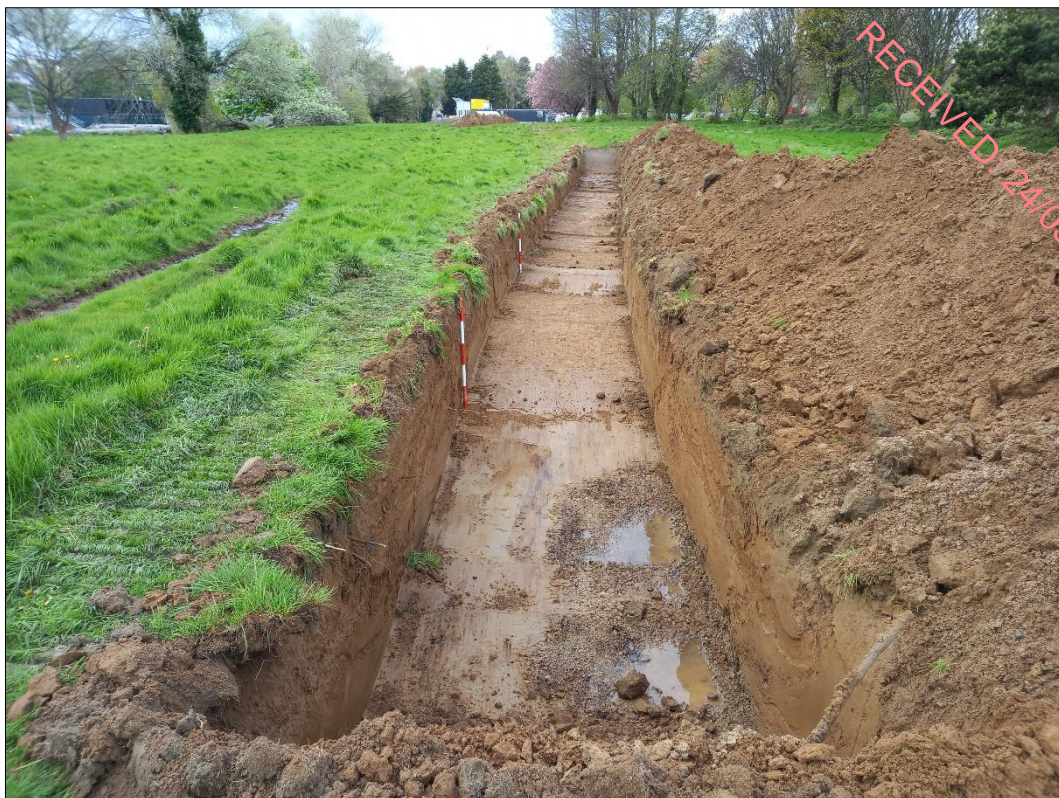
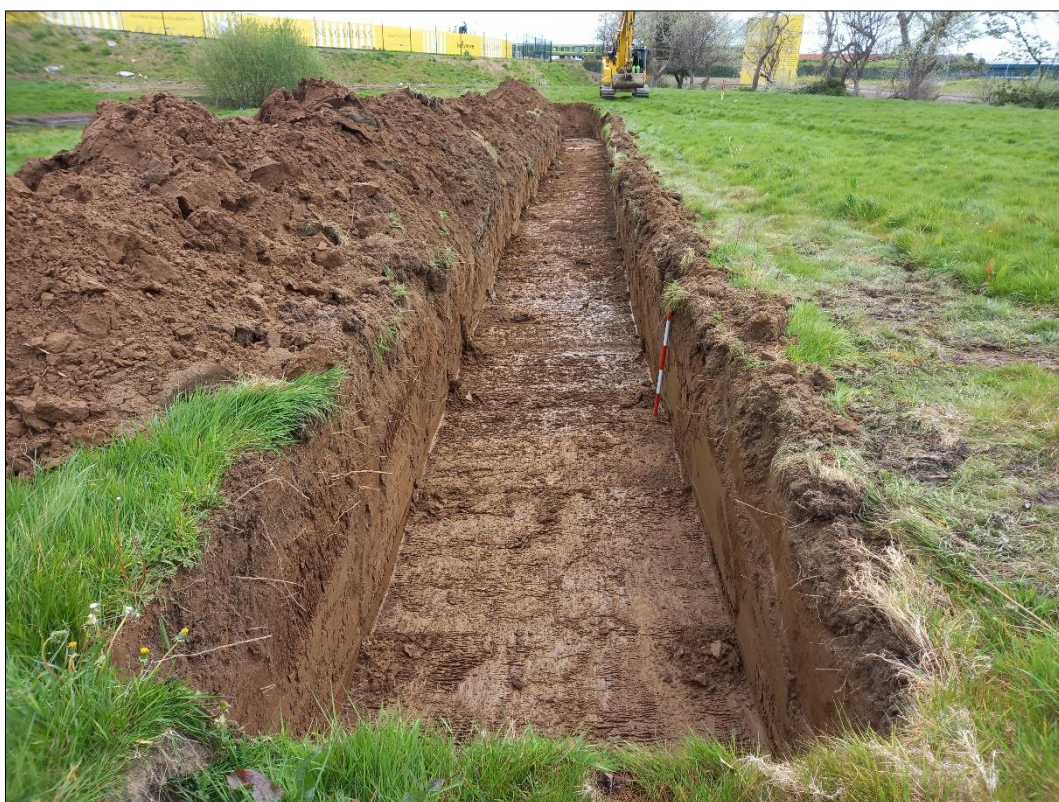
Plate 19: Trench 10 facing southwest

Plate 20: Trench 10 facing northeast

Trench ID	T10
Dimensions	W: 1.8m L: 40m D:0.9-1.0m
Orientation	NE-SW
ITM Co-ords	726495.73, 719248.93 / 726528.77, 719271.81
Description	Test trench 10 (T10) was excavated to a maximum depth of 1.0m below the existing surface level. The trench was excavated through a 0.10-0.2m thick layer of mid grey sandy silt which overlay a 0.8m thick mid reddish brown silty sand topsoil. The topsoil overlay a loose light brownish grey sand subsoil with frequent inclusions of dark brown 'iron pan'. No archaeology was found in this trench Plates 19, 20
