***Peat Stability Risk Assessment-
Proposed Offsetting Lands***

Taurbeg WF Proposed Lifetime Extension Offsetting Measures– Peat Stability Risk Assessment (PSRA)

Project Title: Taurbeg Wind Farm Extension of Operational Life

Document Reference: 24161-PSRA-001-02

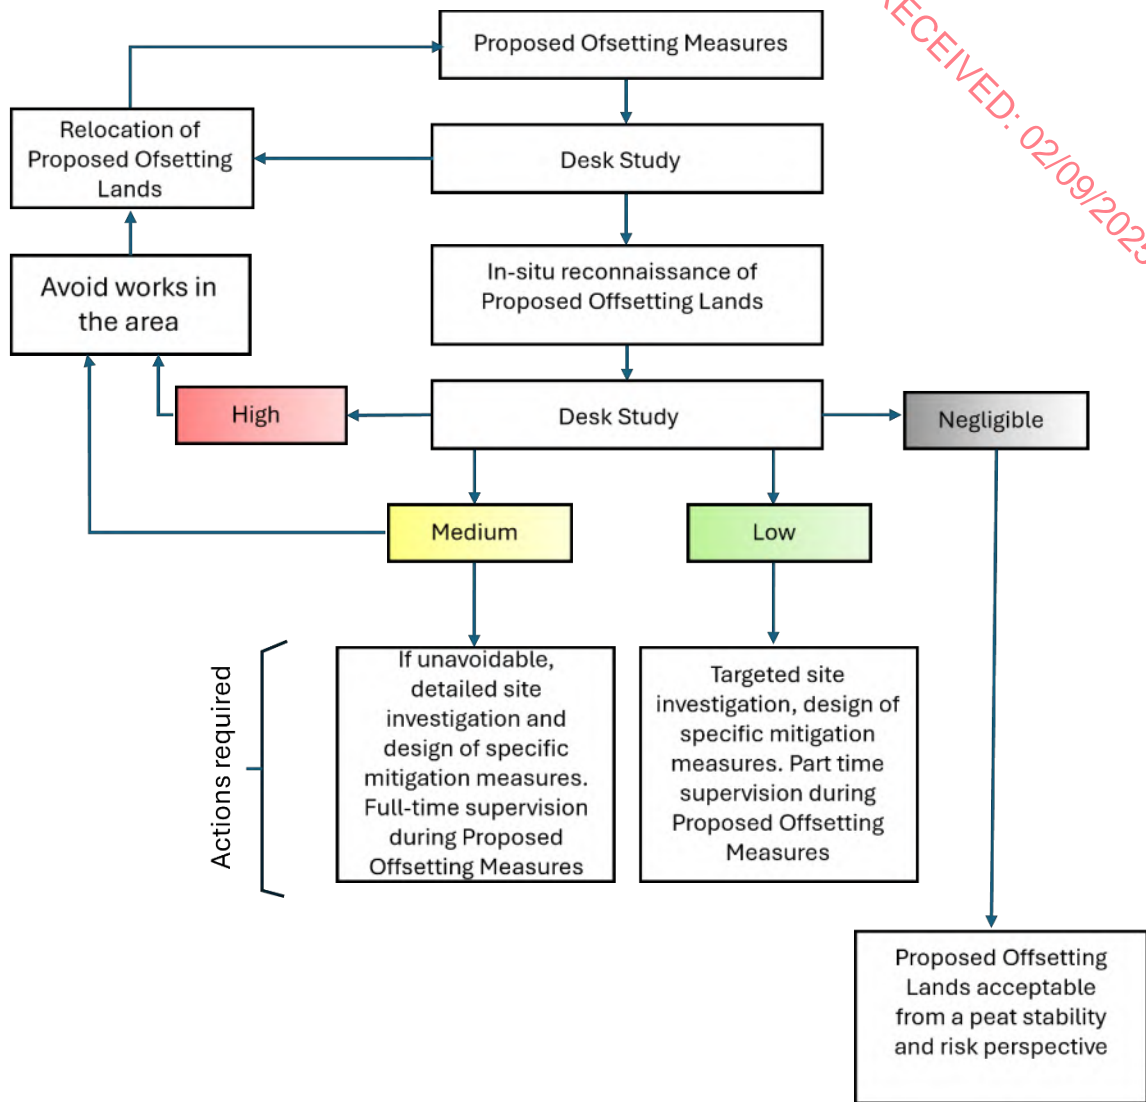
Figure 1-2: Workflow of the PSRA methodology for the acceptability of the Proposed Offsetting Measures (adapted from Scottish Executive, 2017).

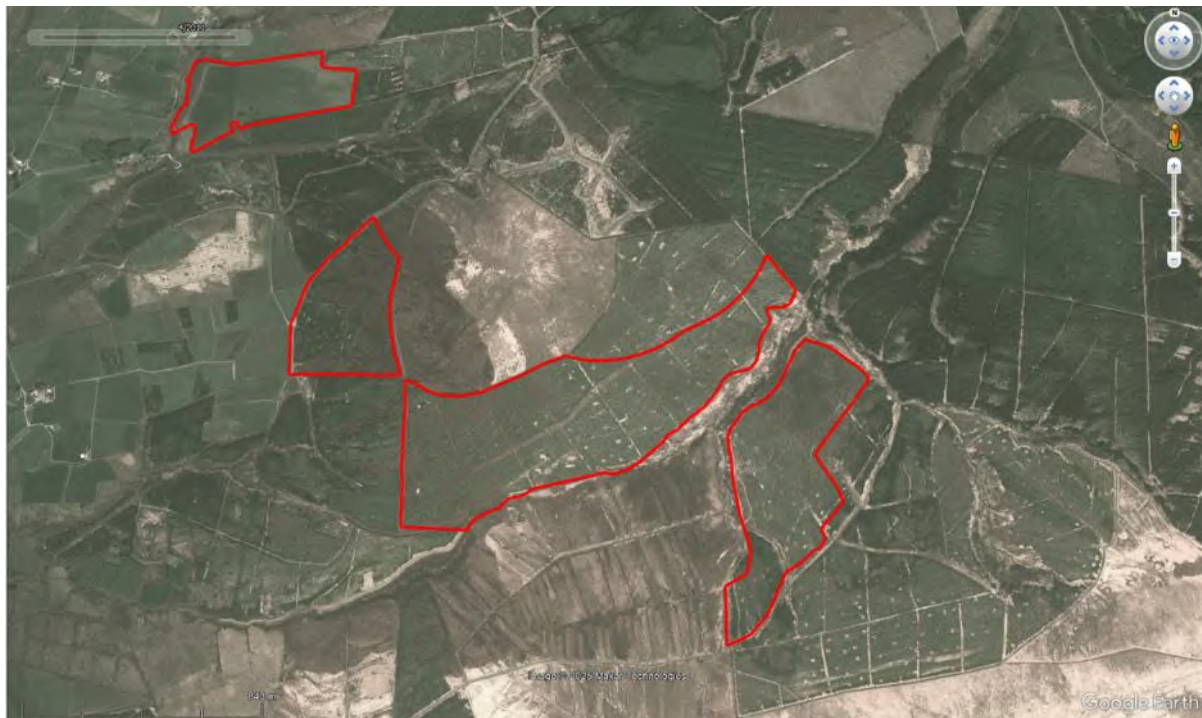
Figure 2-1: Proposed Offsetting Lands Google Earth imagery (2011).

The aerial / satellite imagery used for this report is the OSI Geohive viewer (1995 onwards), and the Google Earth multitemporal imagery (2012 onwards - Figure 2-1 to Figure 2-5). This imagery has been used to:

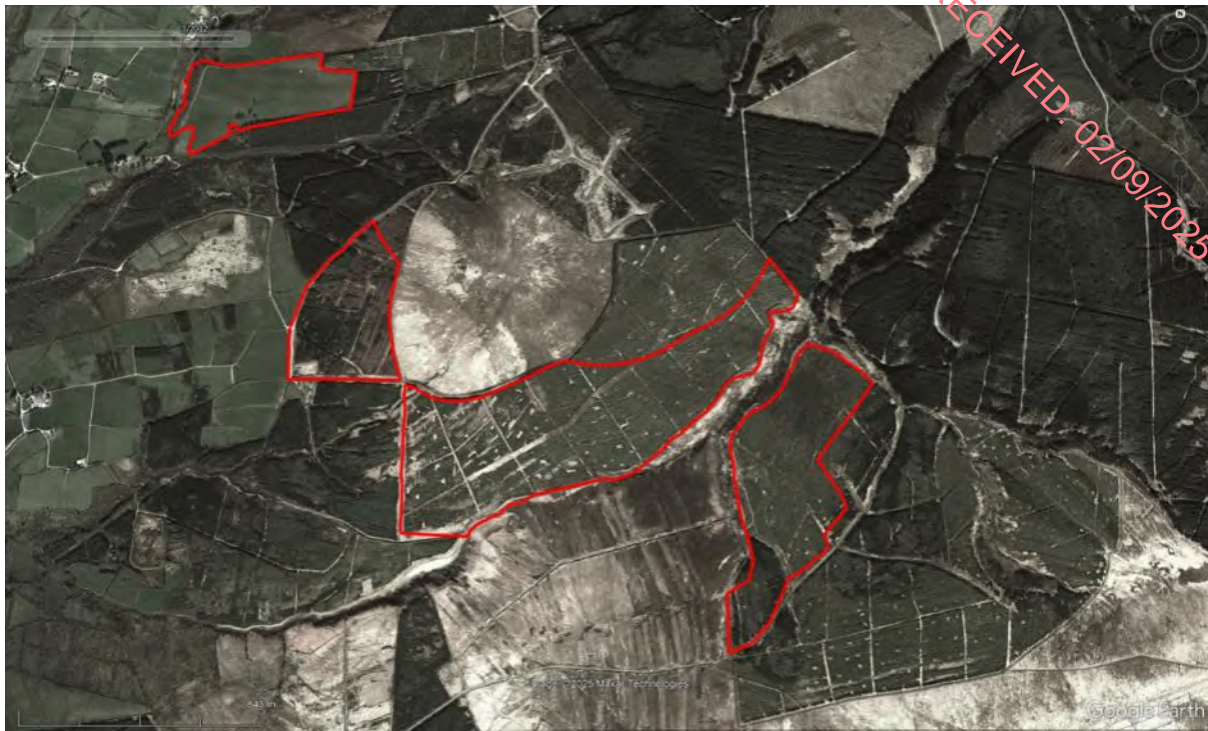
Figure 2-2: Proposed Offsetting Lands Google Earth imagery (2012).

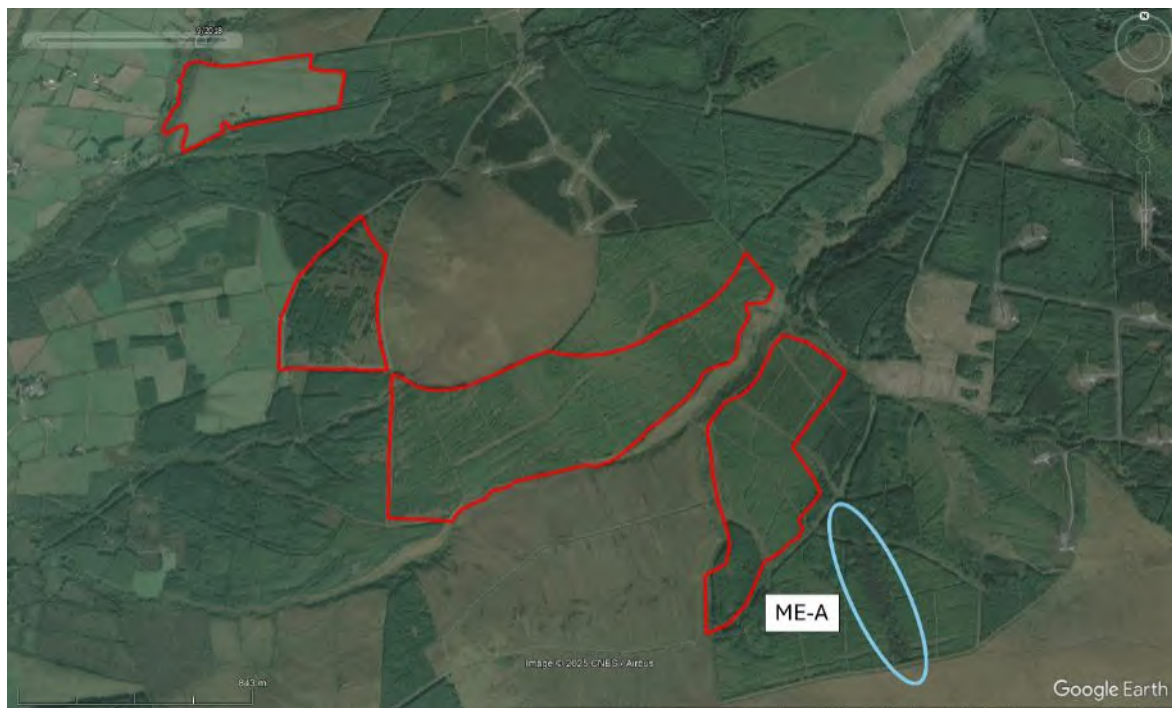
Figure 2-3: Proposed Offsetting Lands Google Earth imagery (2018). ME-A failure visible in the south of the image.

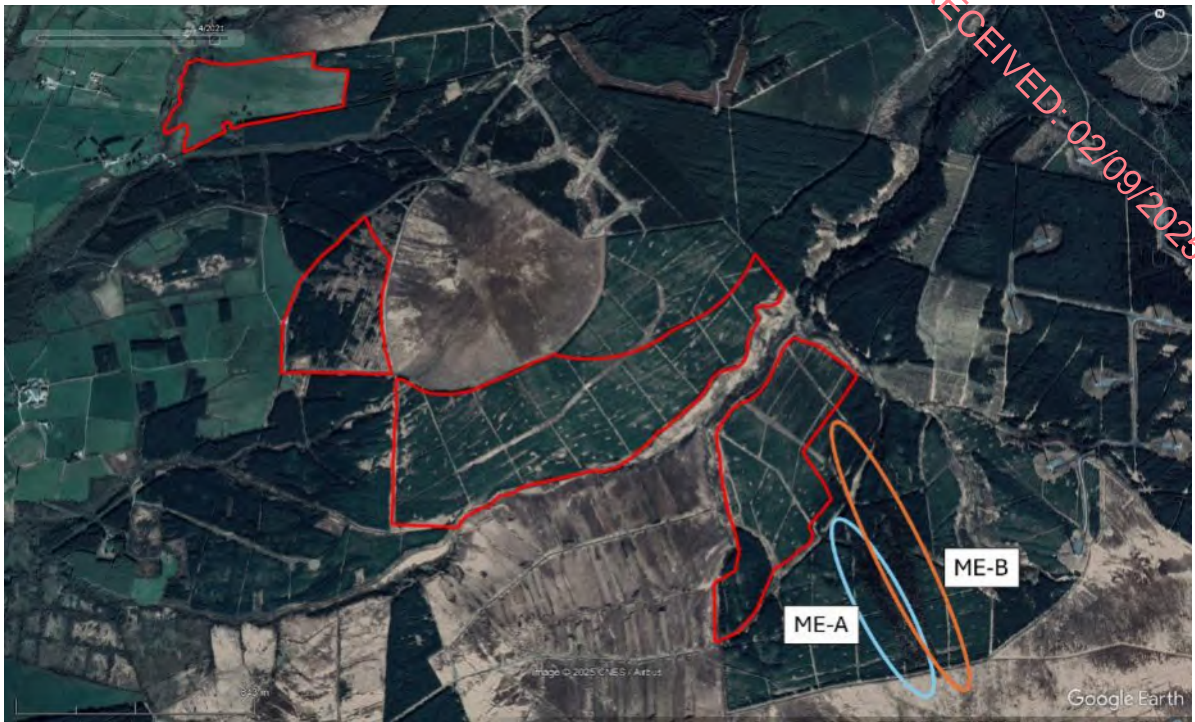
Figure 2-4: Proposed Offsetting Lands Google Earth imagery (2021). ME-A and ME-B failures visible in the south of the image.

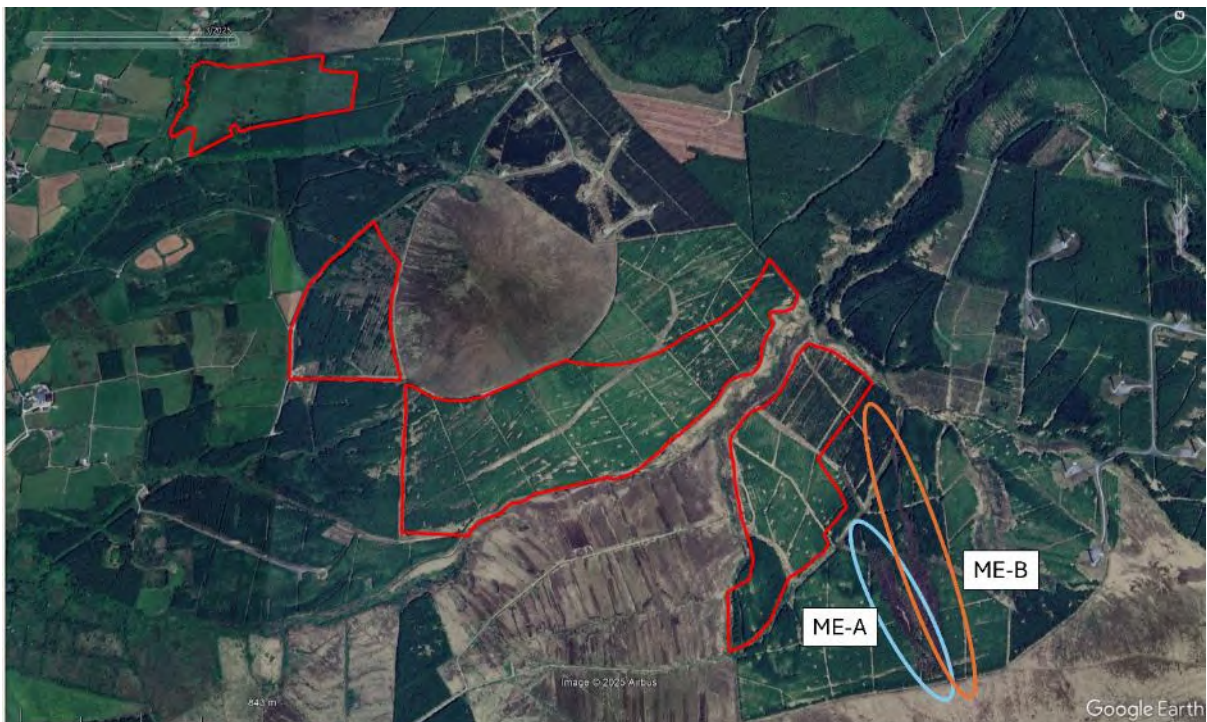
Figure 2-5: Proposed Offsetting Lands Google Earth imagery (2023). ME-A and ME-B failures visible in the south of the image.

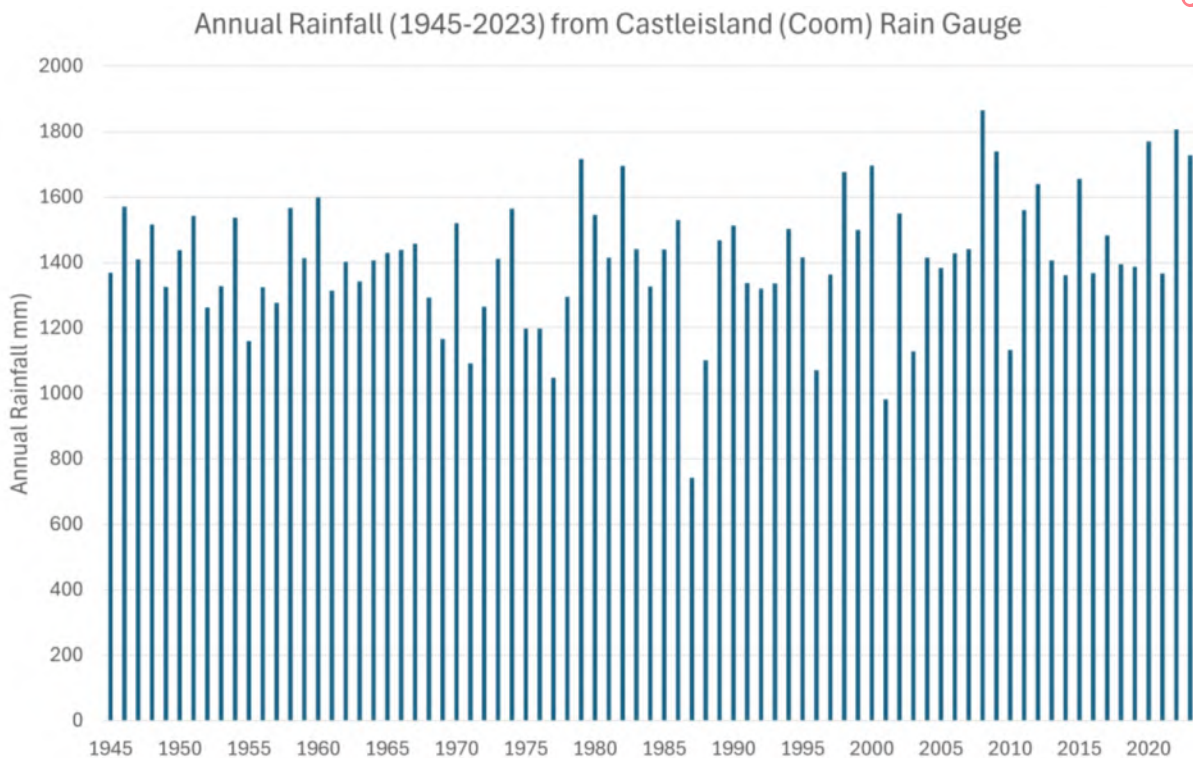
Figure 2-6: Annual rainfall records from Castleisland (Coom) rain gauge (1945-2023).

Rainfall records from the Met Éireann rain gauge at Castleisland (Coom), roughly 1.3km SW of the Proposed Offsetting Lands (Figure K- 1), are available as far back as 1944, and have been examined as part of this assessment between 1945 and 2023 (the first and last complete years available), in Figure 2-6. The minimum recorded rainfall was 742mm, recorded in 1987, and the maximum recorded rainfall was 1865mm, recorded in 2008.

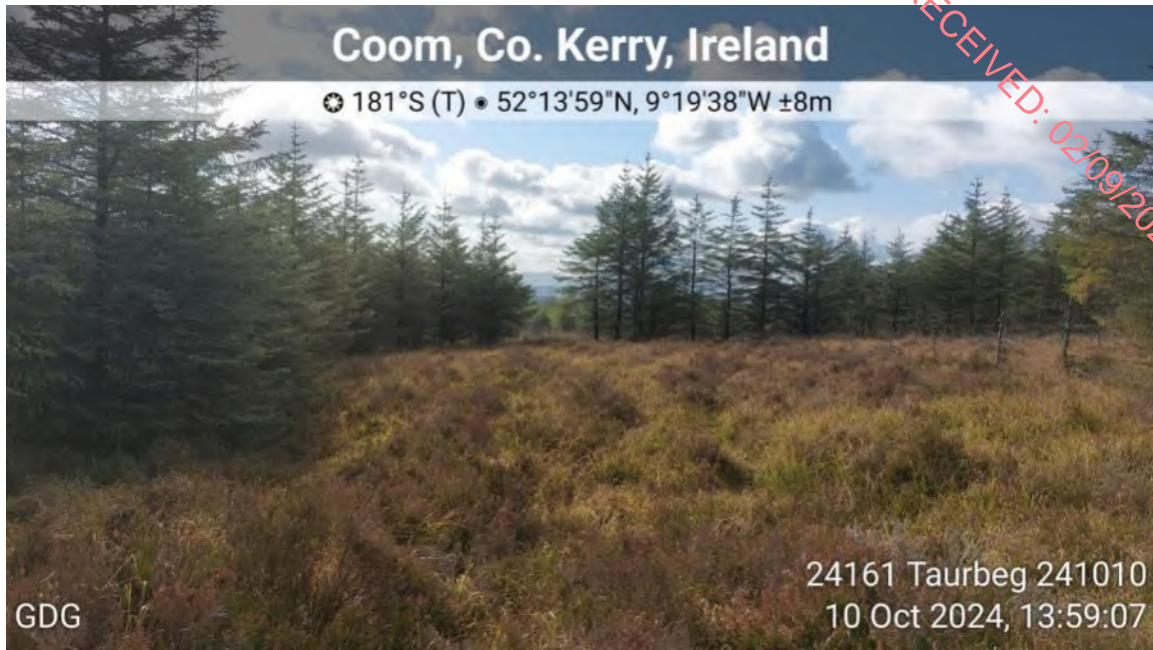
Figure 3-1: Afforested blanket peat from firebreak in Area 1 (refer to Appendix A for Site Location and key to Areas)

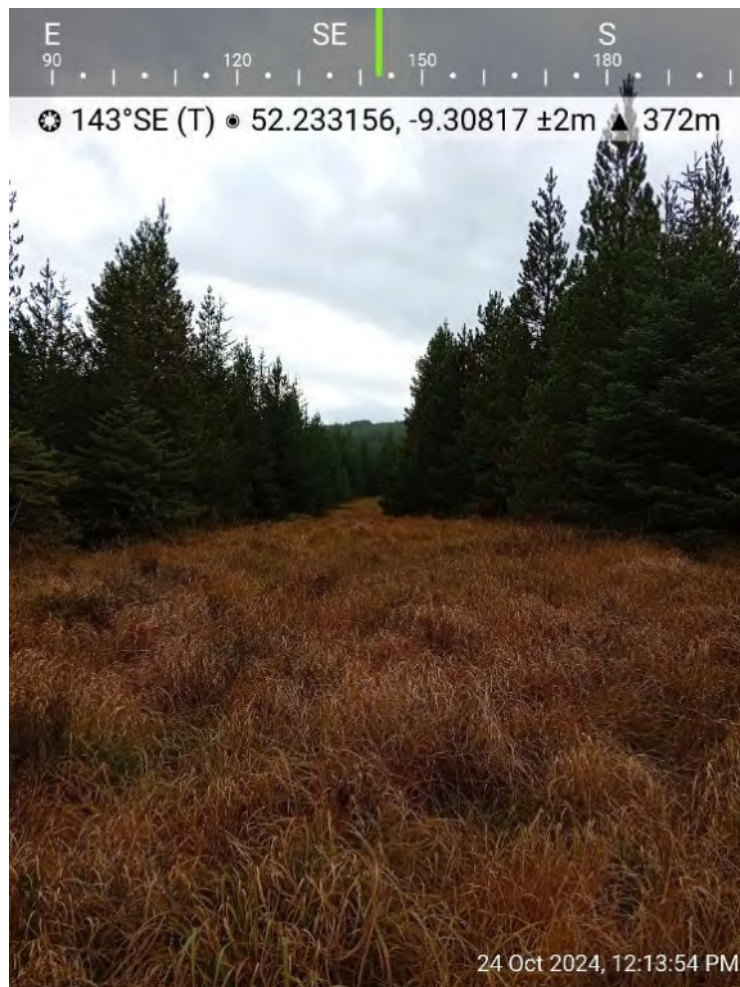
Figure 3-2: Afforested blanket peat from firebreak in Area 4

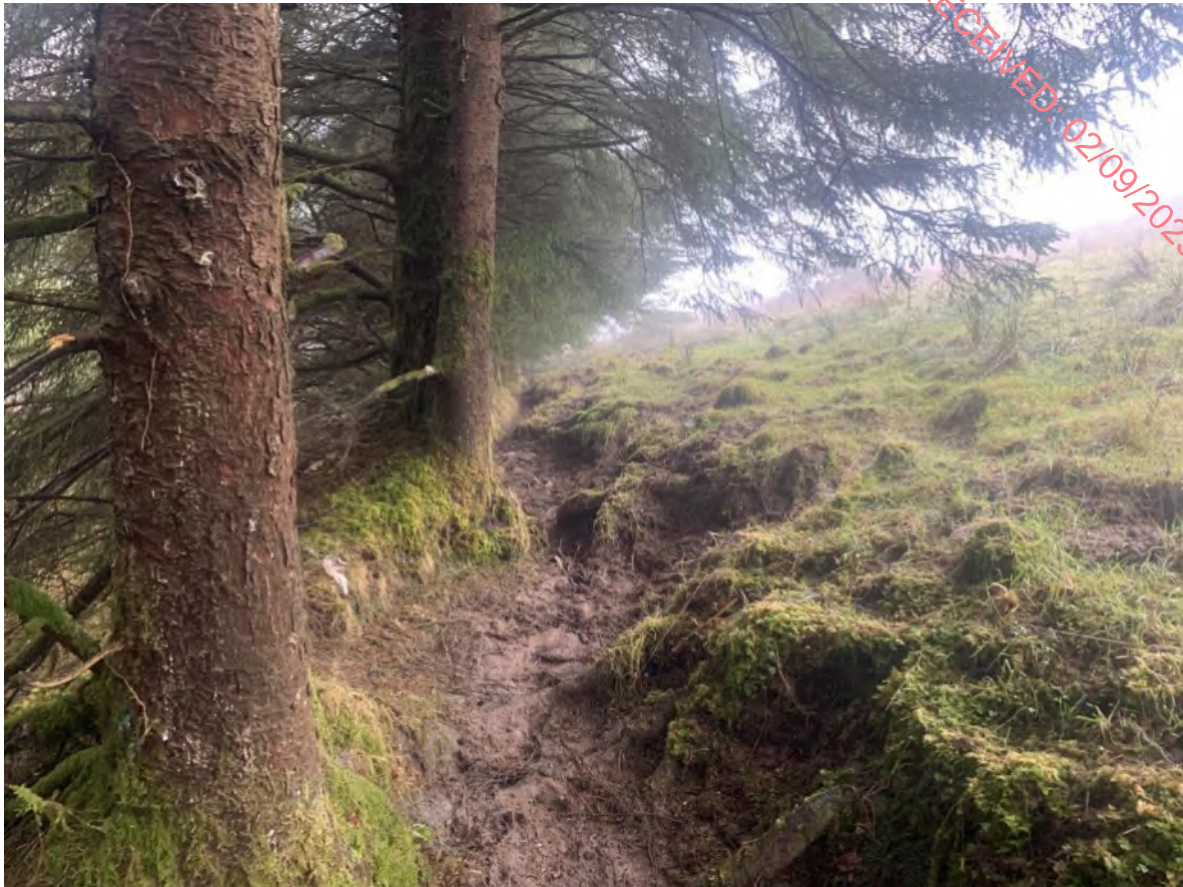
Figure 3-3: Mineral soils exposed at the edge of the forestry at the eastern edge of Area 3.

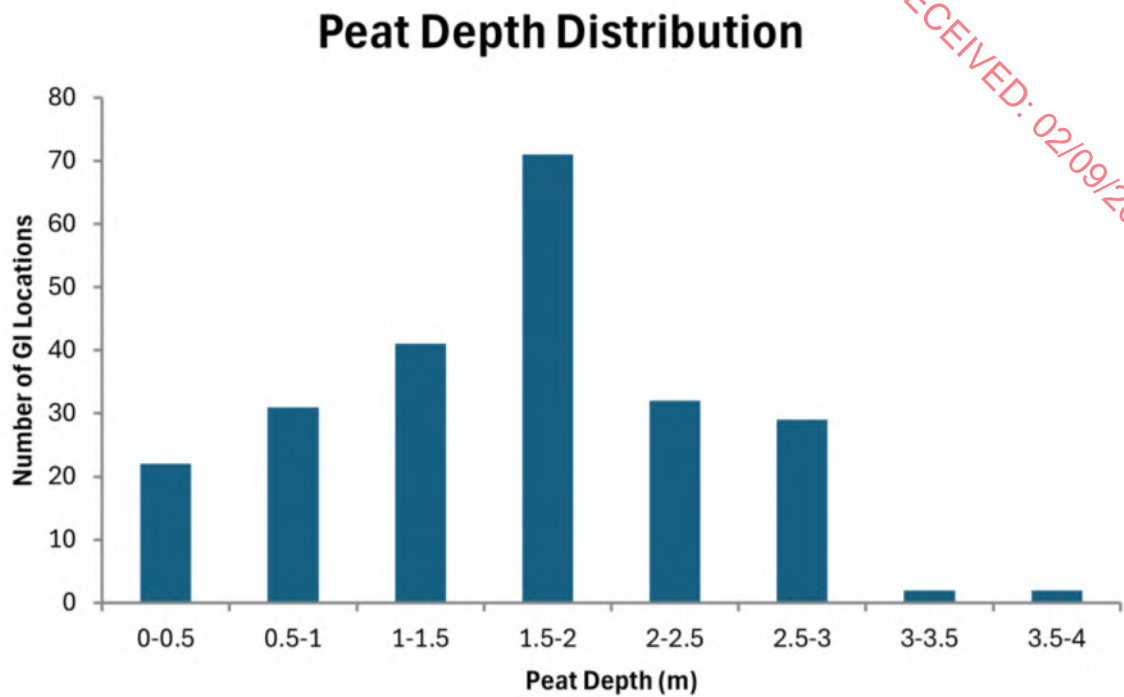
Figure 3-4: Histogram of peat depth frequency.

Almost the entirety of the Proposed Offsetting Lands are covered in afforested blanket peat, with areas of open blanket peat observed to the north of the Proposed Offsetting Lands, approximately 350m south of the southern boundary. The frequency of different peat thicknesses is shown in Figure 3-4.

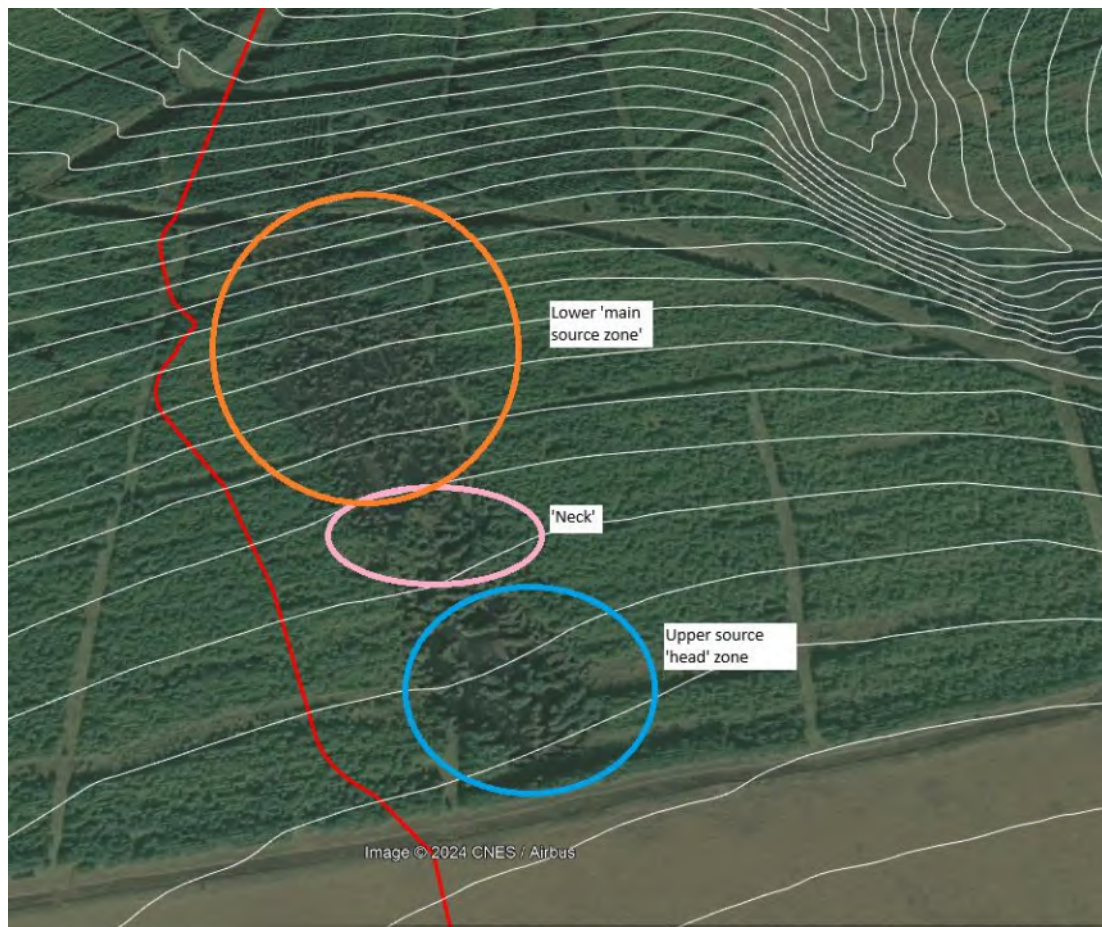
Figure 4-1: ME-A slide morphology (Google Earth, 2018).

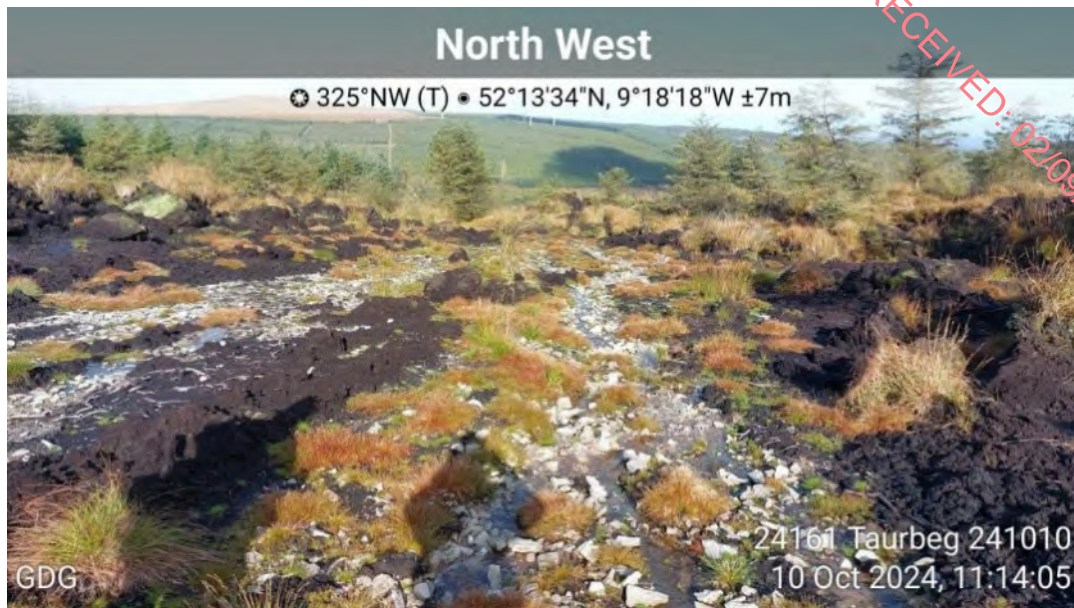
Figure 4-2: View downslope of ME-A failure, with peat rafts and exposed substrate visible.

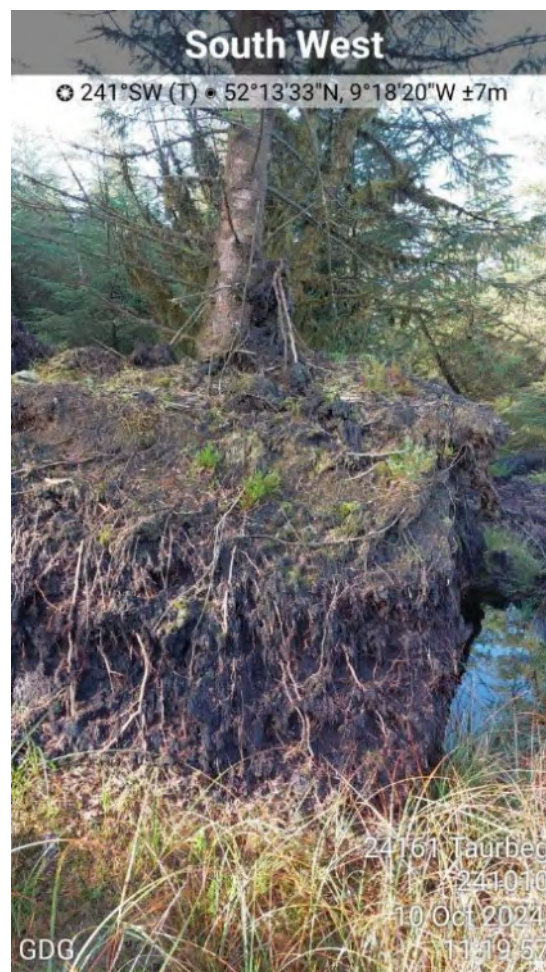
Figure 4-3: Peat raft at the western margin of ME-A.

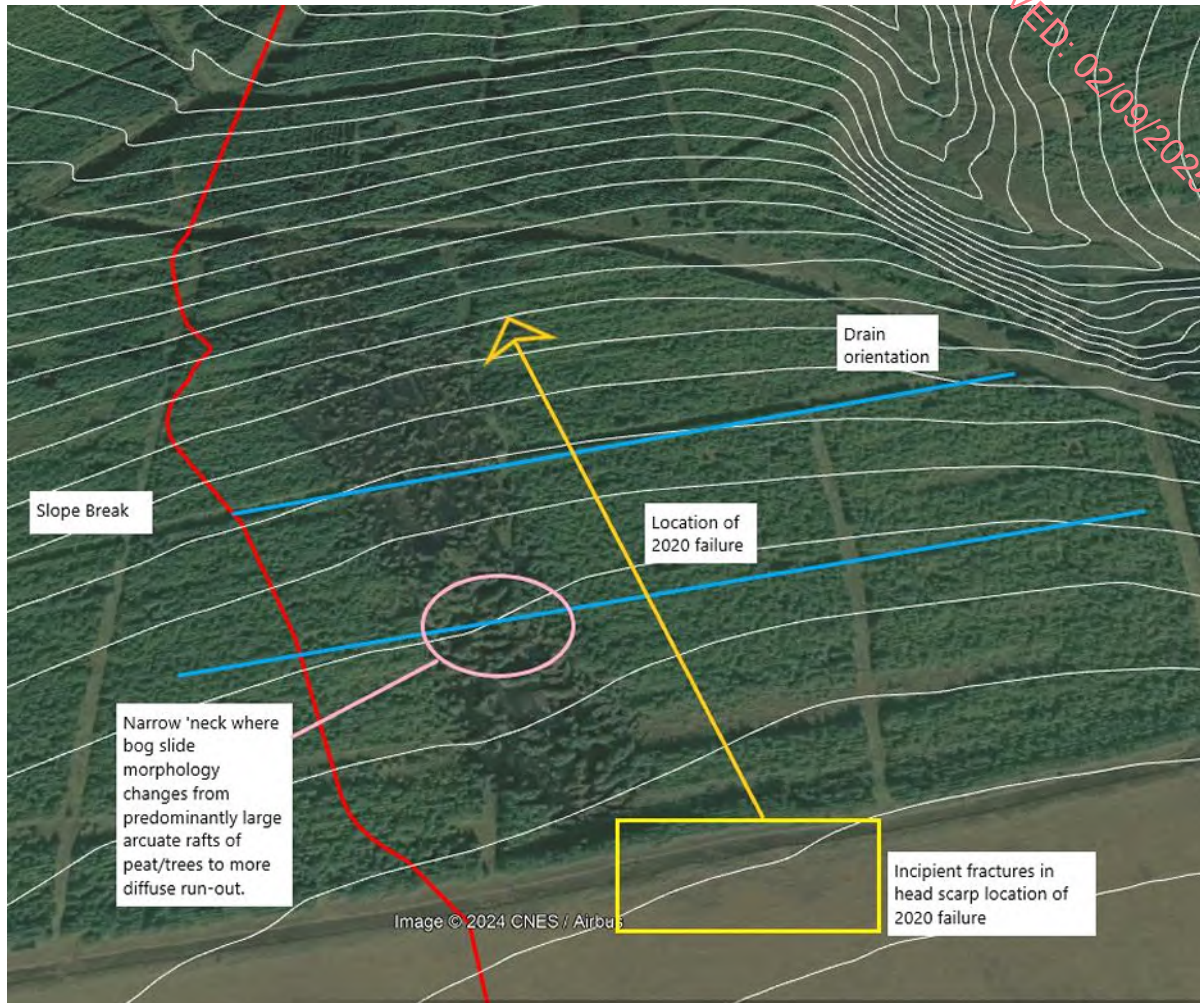
Figure 4-4: ME-A morphology, and incipient tension cracking at the future ME-B location (google Earth, 2018).

The area included within the narrow 'neck' (roughly 60m wide and 70m long, Figure 4-4), contains a large number of larger, more coherent peat rafts, with multiple trees. This area also shows less evidence of large scale sliding and lacks the large scale evacuation of peat slurry seen further downslope. This section of the failure coincides with a localised area of lower slope angle (3-5°), suggesting that this change in morphology can be attributed to greater basal sliding friction in this part of the slope. The area upslope of the 'neck' contains a large number of stranded peat rafts, arranged in a concentric, arcuate pattern at the head of the slide, but with a greater concentration of stranded rafts with significant peat evacuation around them. This area of reduced peat raft density coincides with an increase in slope angle, suggesting that this change in morphology can be attributed to reduced basal sliding friction in this part of the slope. The area at the head of the failure appears not to show evidence for significant evacuation of basal peat from above the arcuate peat rafts.

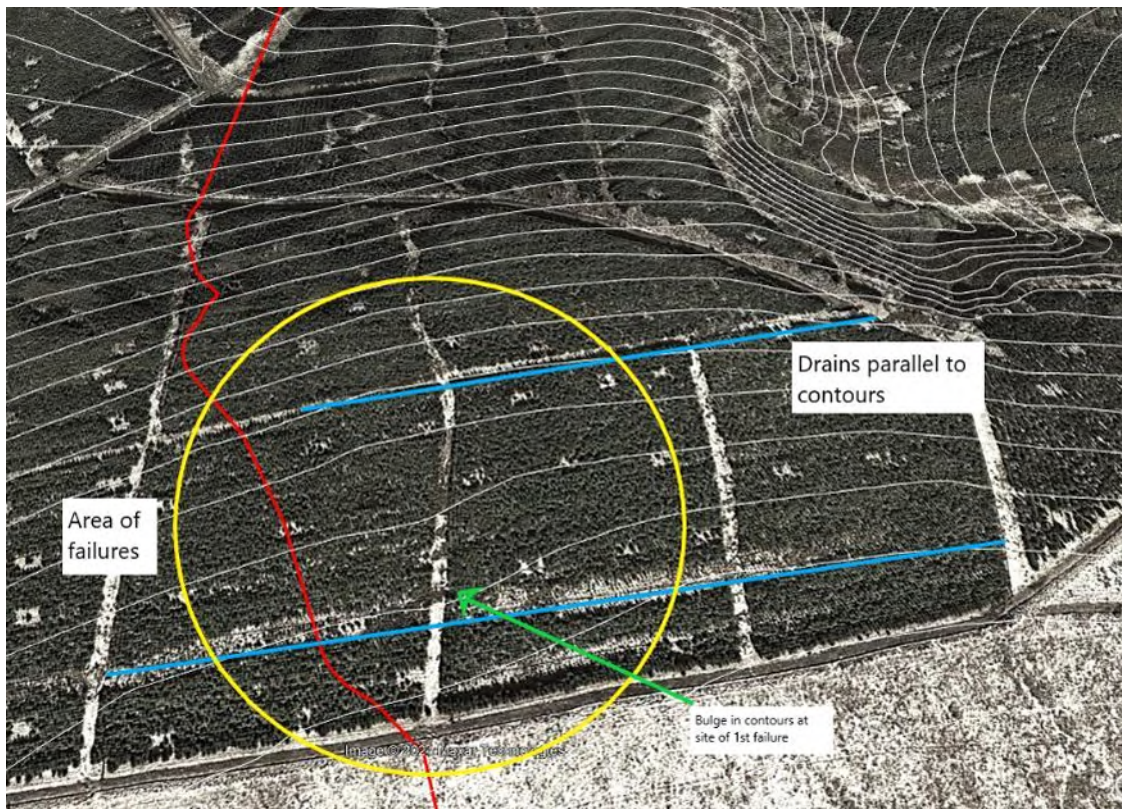
Figure 4-5: Drains cut parallel to contours in area of existing eat landslides (Google Earth, 2012).

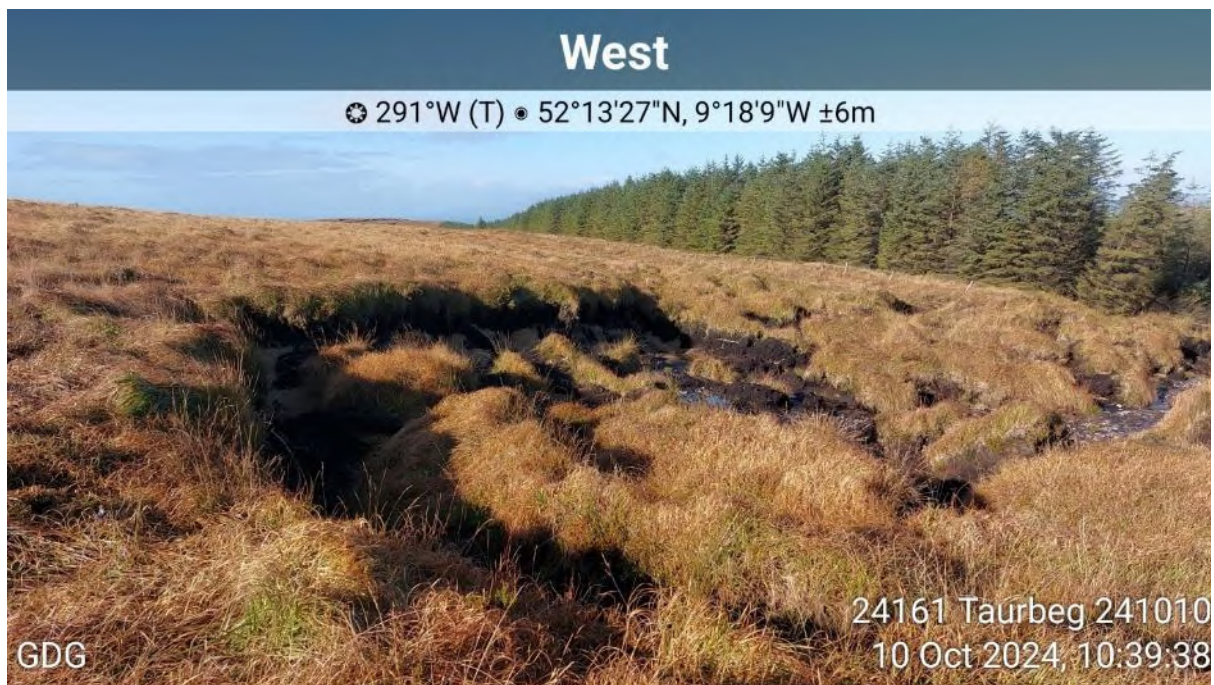
Figure 4-6: Arcuate, concentric tension cracks at the head scarp of ME-B.

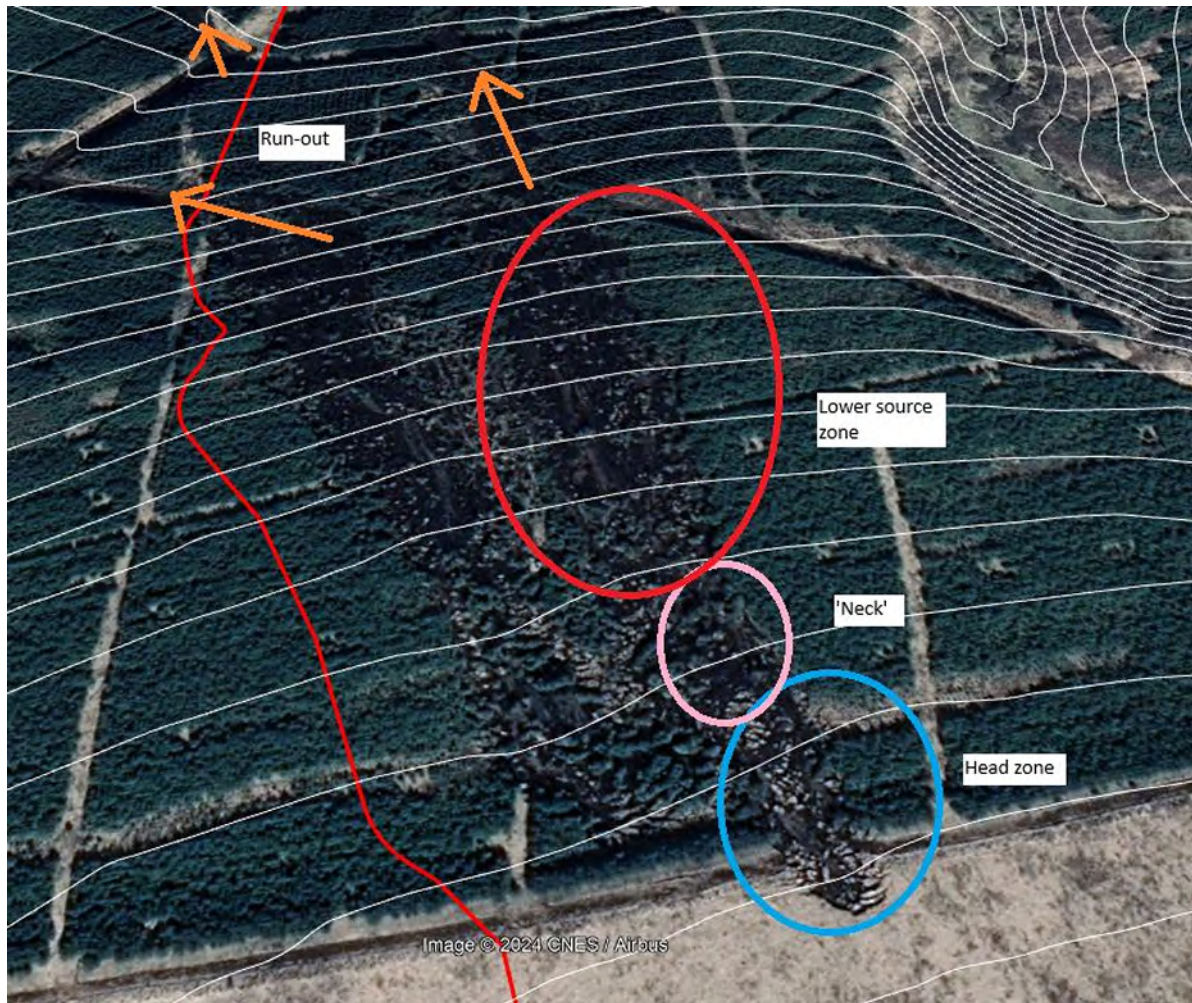
Figure 4-7: ME-B Slide morphology (Google Earth, 2021).

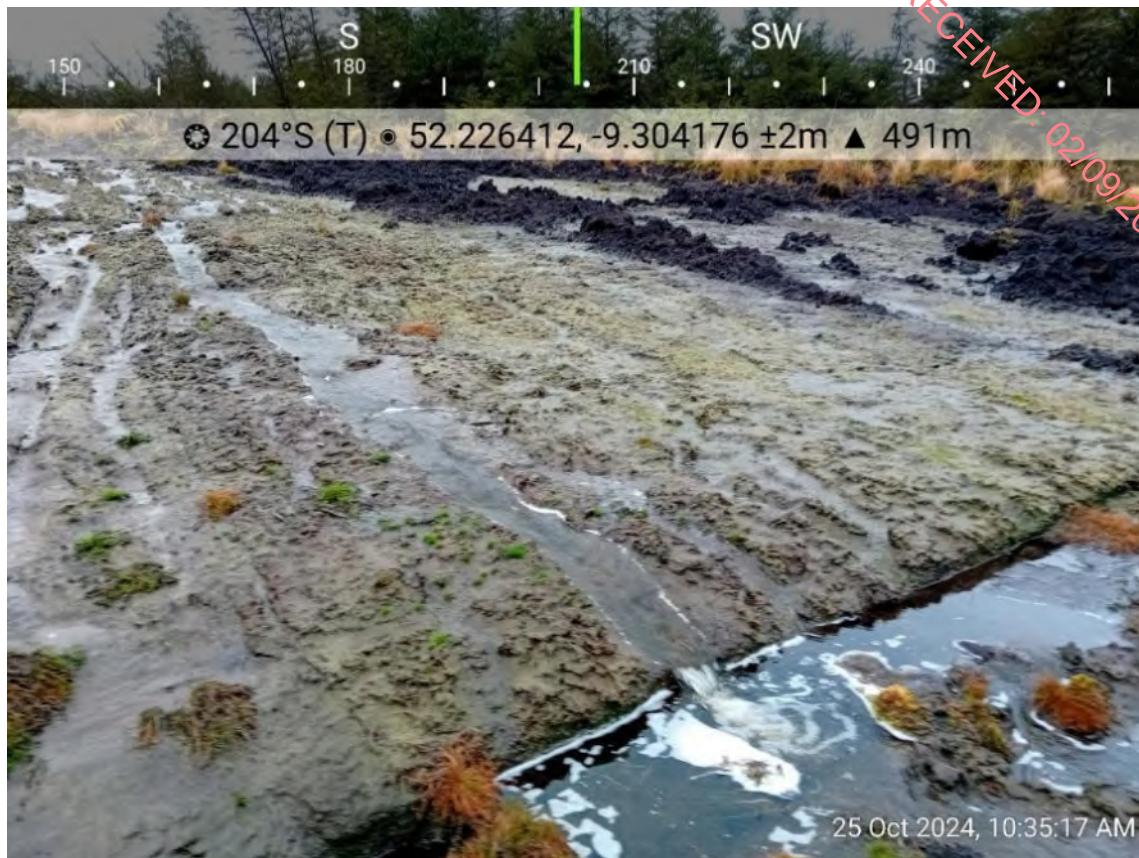
Figure 4-8: Potential basal peat shear plane with flow paths, and contour parallel drain visible in foreground.

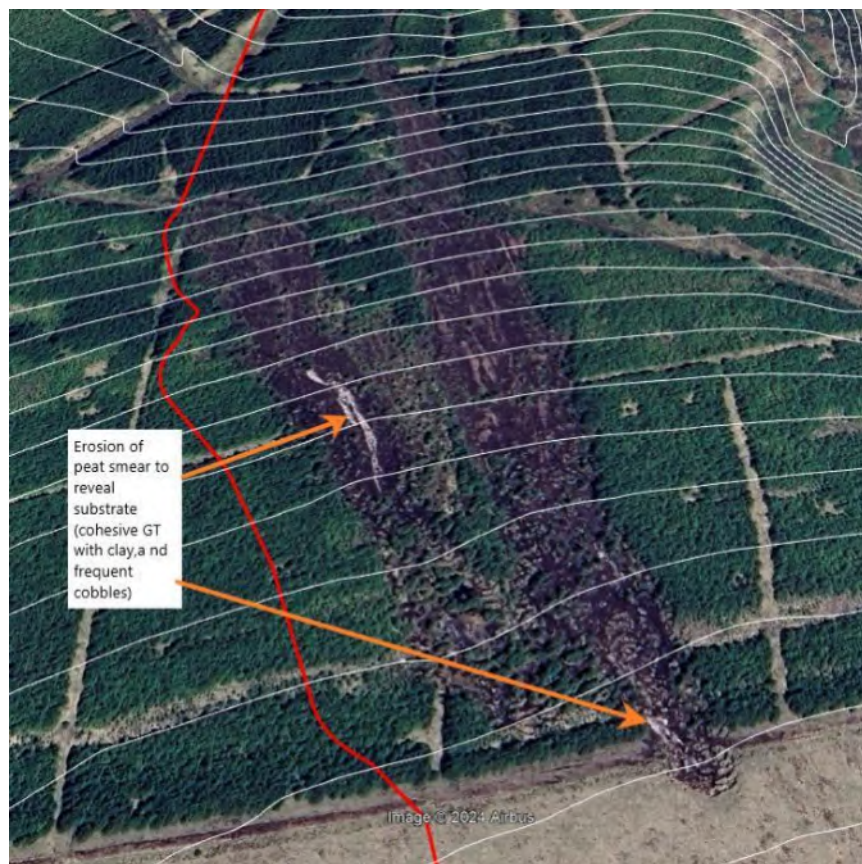
Figure 4-11: 2023 Google Earth imagery showing erosion of basal peat to mineral substrate.

In the October 2024 site walkovers, the mineral substrate was observed to be exposed within the central and downslope parts of the main source zone (Figure 4-9, Figure 4-11), although it appears from the earlier aerial imagery (Figure 4-10) that a thin layer of peat slurry initially covered much of the floor of the otherwise fully evacuated source zone. This peat shear surface was observed on site in a small number of locations (Figure 4-8). It is difficult to tell the condition of the basal peat from the aerial imagery, but these could reflect a basal sliding surface. The margins of the main source zone are fairly well defined, with some lateral fissures/tears extending into the forestry.

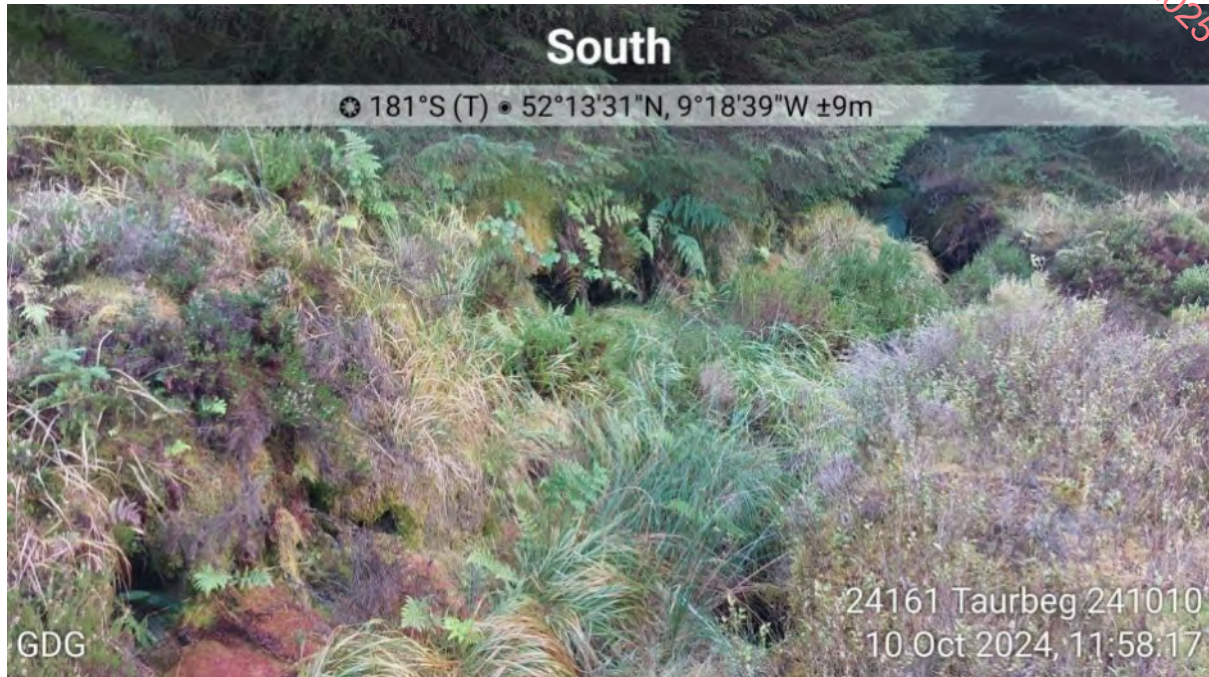
Figure 4-12: Possible peat failure scarps. Possible evidence for relict instability.

Two additional areas of potential relict/active instability have been identified during the 2024 GDG site walkovers. Both areas were identified on the north facing slope to the west of the ME-A and ME-B landslides, between 20m and 260m south of the Proposed Offsetting Lands. These areas have been considered as areas of peat instability in the qualitative assessment in Section 7.3.7.

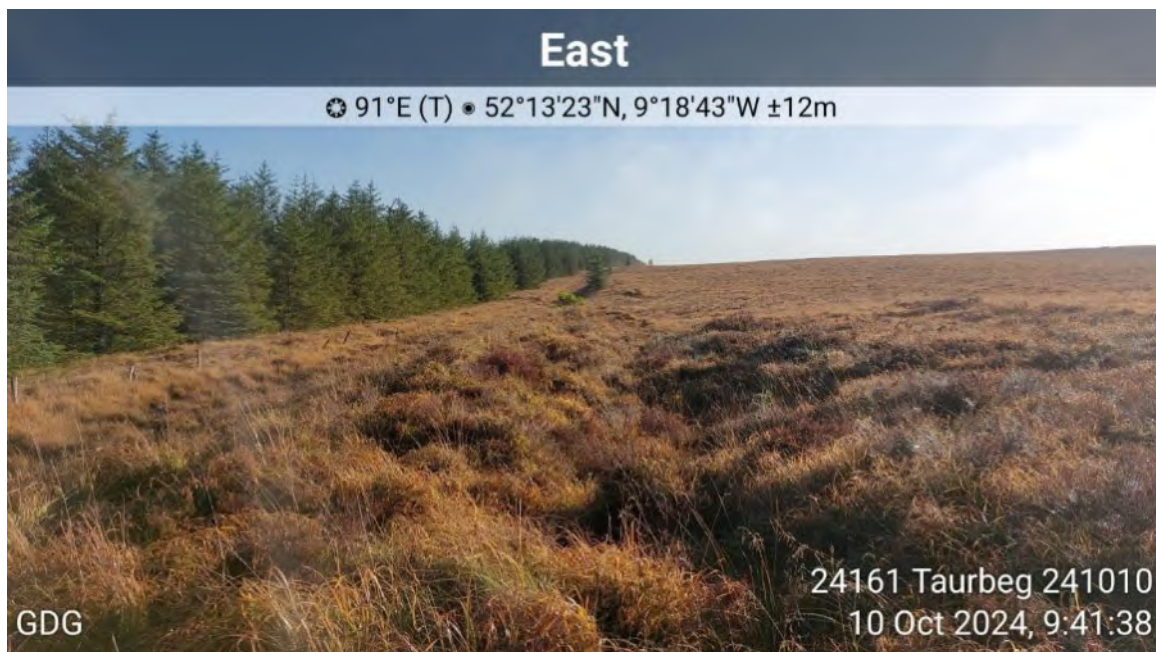
Figure 4-13: Area of tension cracking observed in peat approximately 260m south of Proposed Offsetting Measures boundary.

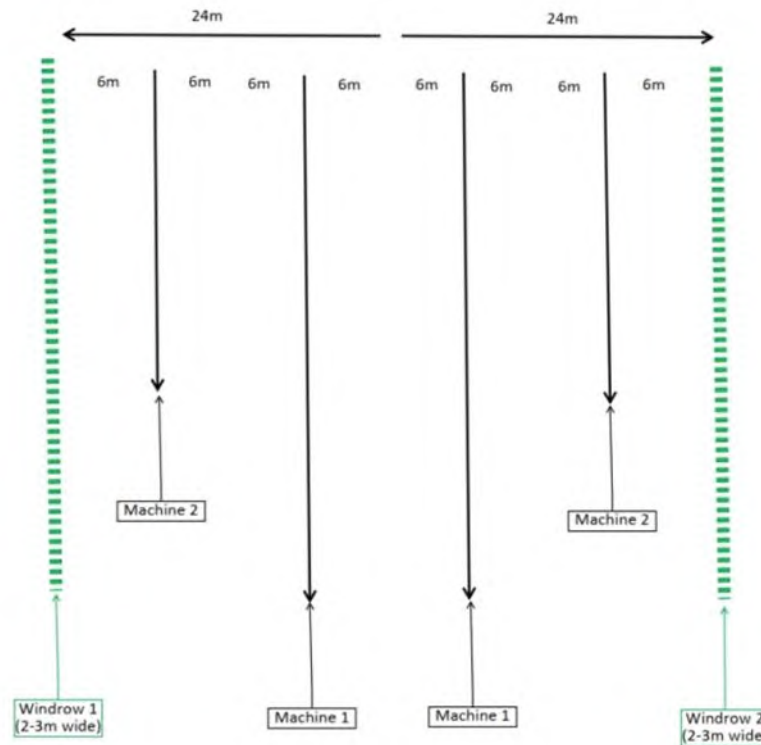
Figure 5-1: Indicative sketch of windrow orientation.

The key hazards to peat stability here is the application of surcharge to the peat by plant tracking. Felled trees will not be placed in areas calculated as being of elevated risk for peat instability (as outlined in Section 8.2).

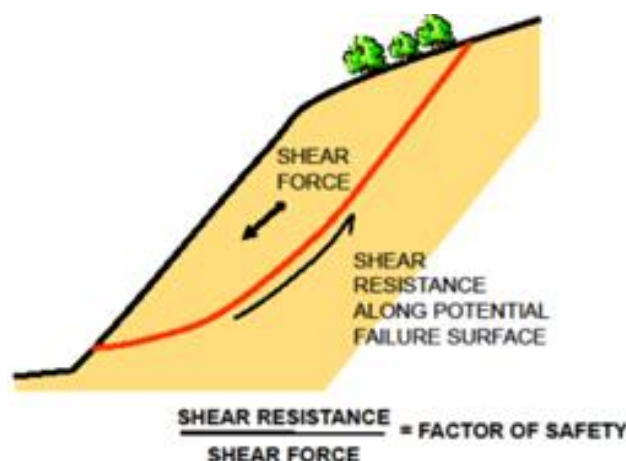
Figure 6-1: Balance of forces in a slope (Scottish Executive, 2017).

The factor of safety is a measure of the stability of a slope. For any slope, the degree of stability depends on the balance between the landslide driving forces (weight of the slope) and its inherent shear strength, illustrated in Figure 6-1.
