***Peat Stability Risk Assessment-
Proposed Offsetting Lands***

Taurbeg WF Proposed Lifetime Extension Offsetting Measures– Peat Stability Risk Assessment (PSRA)

Project Title: Taurbeg Wind Farm Extension of Operational Life

Document Reference: 24161-PSRA-001-02

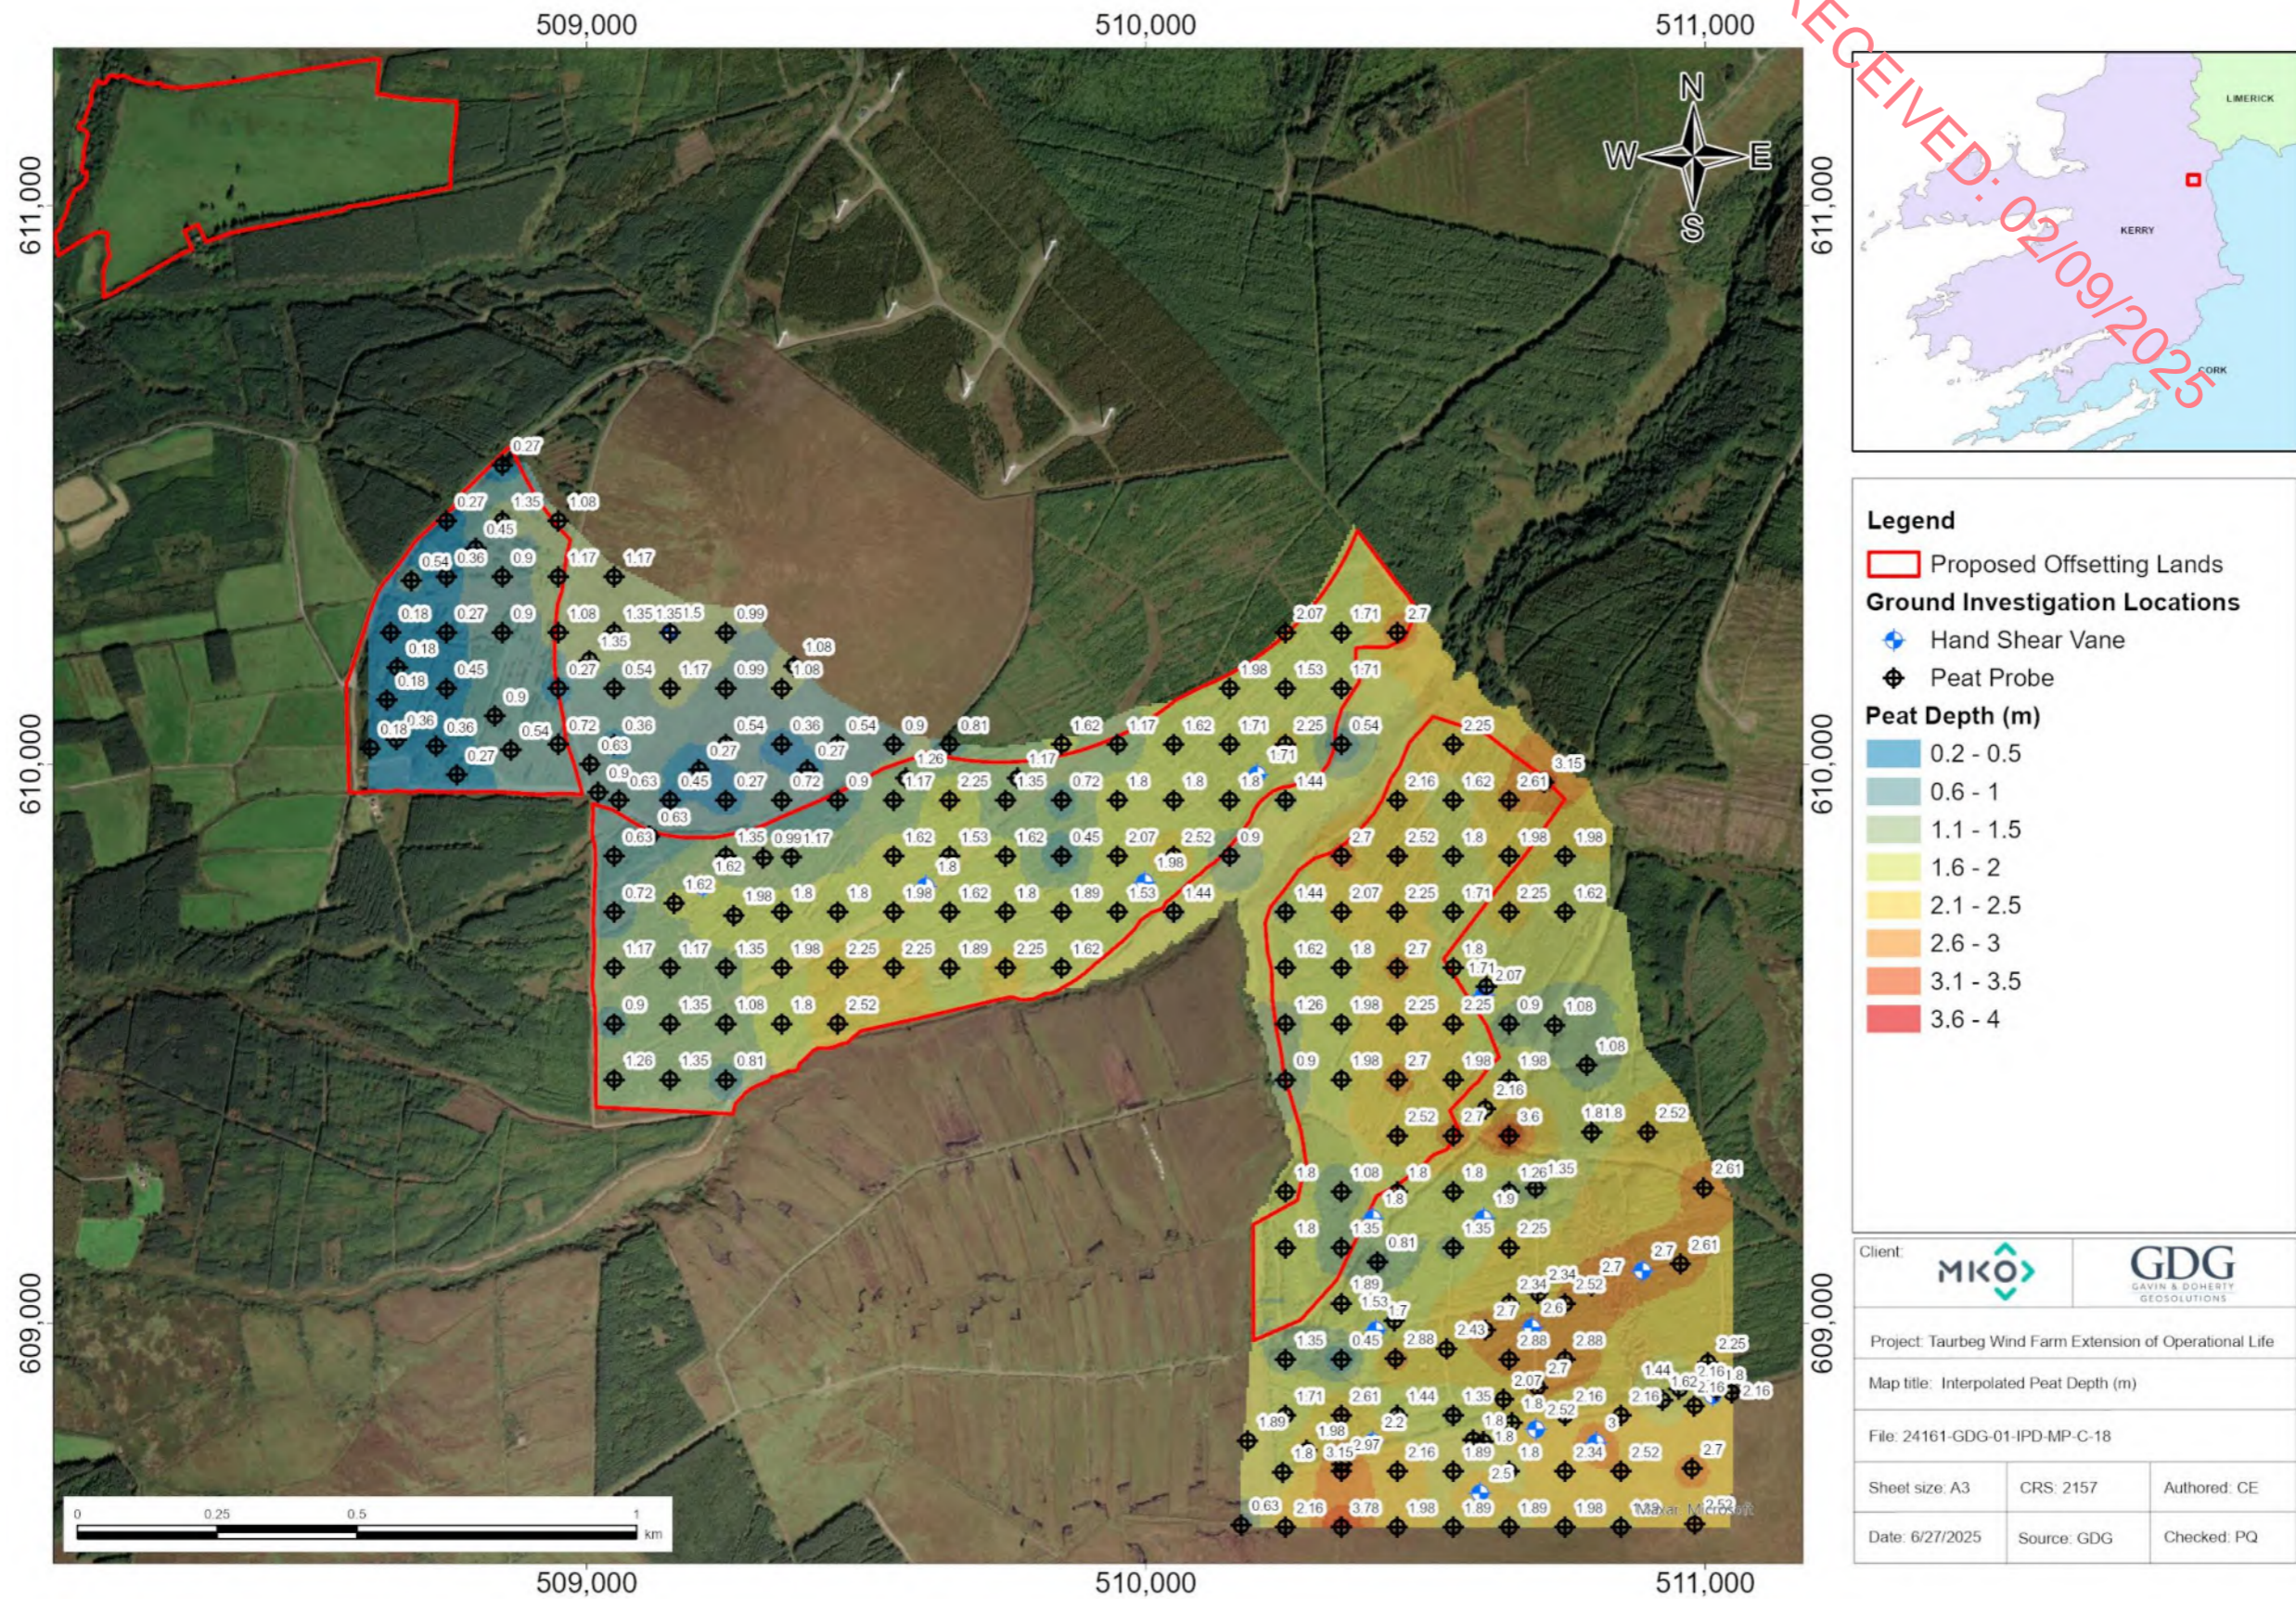
Figure L- 3: Interpolated Peat Depths.

A raster map was created in GIS software, presenting the interpolated peat depth across a site from the peat probe points using the Inverse Distance Weighted (IDW) method. This interpolated raster of peat depth is represented in Figure L- 3 in Appendix L.

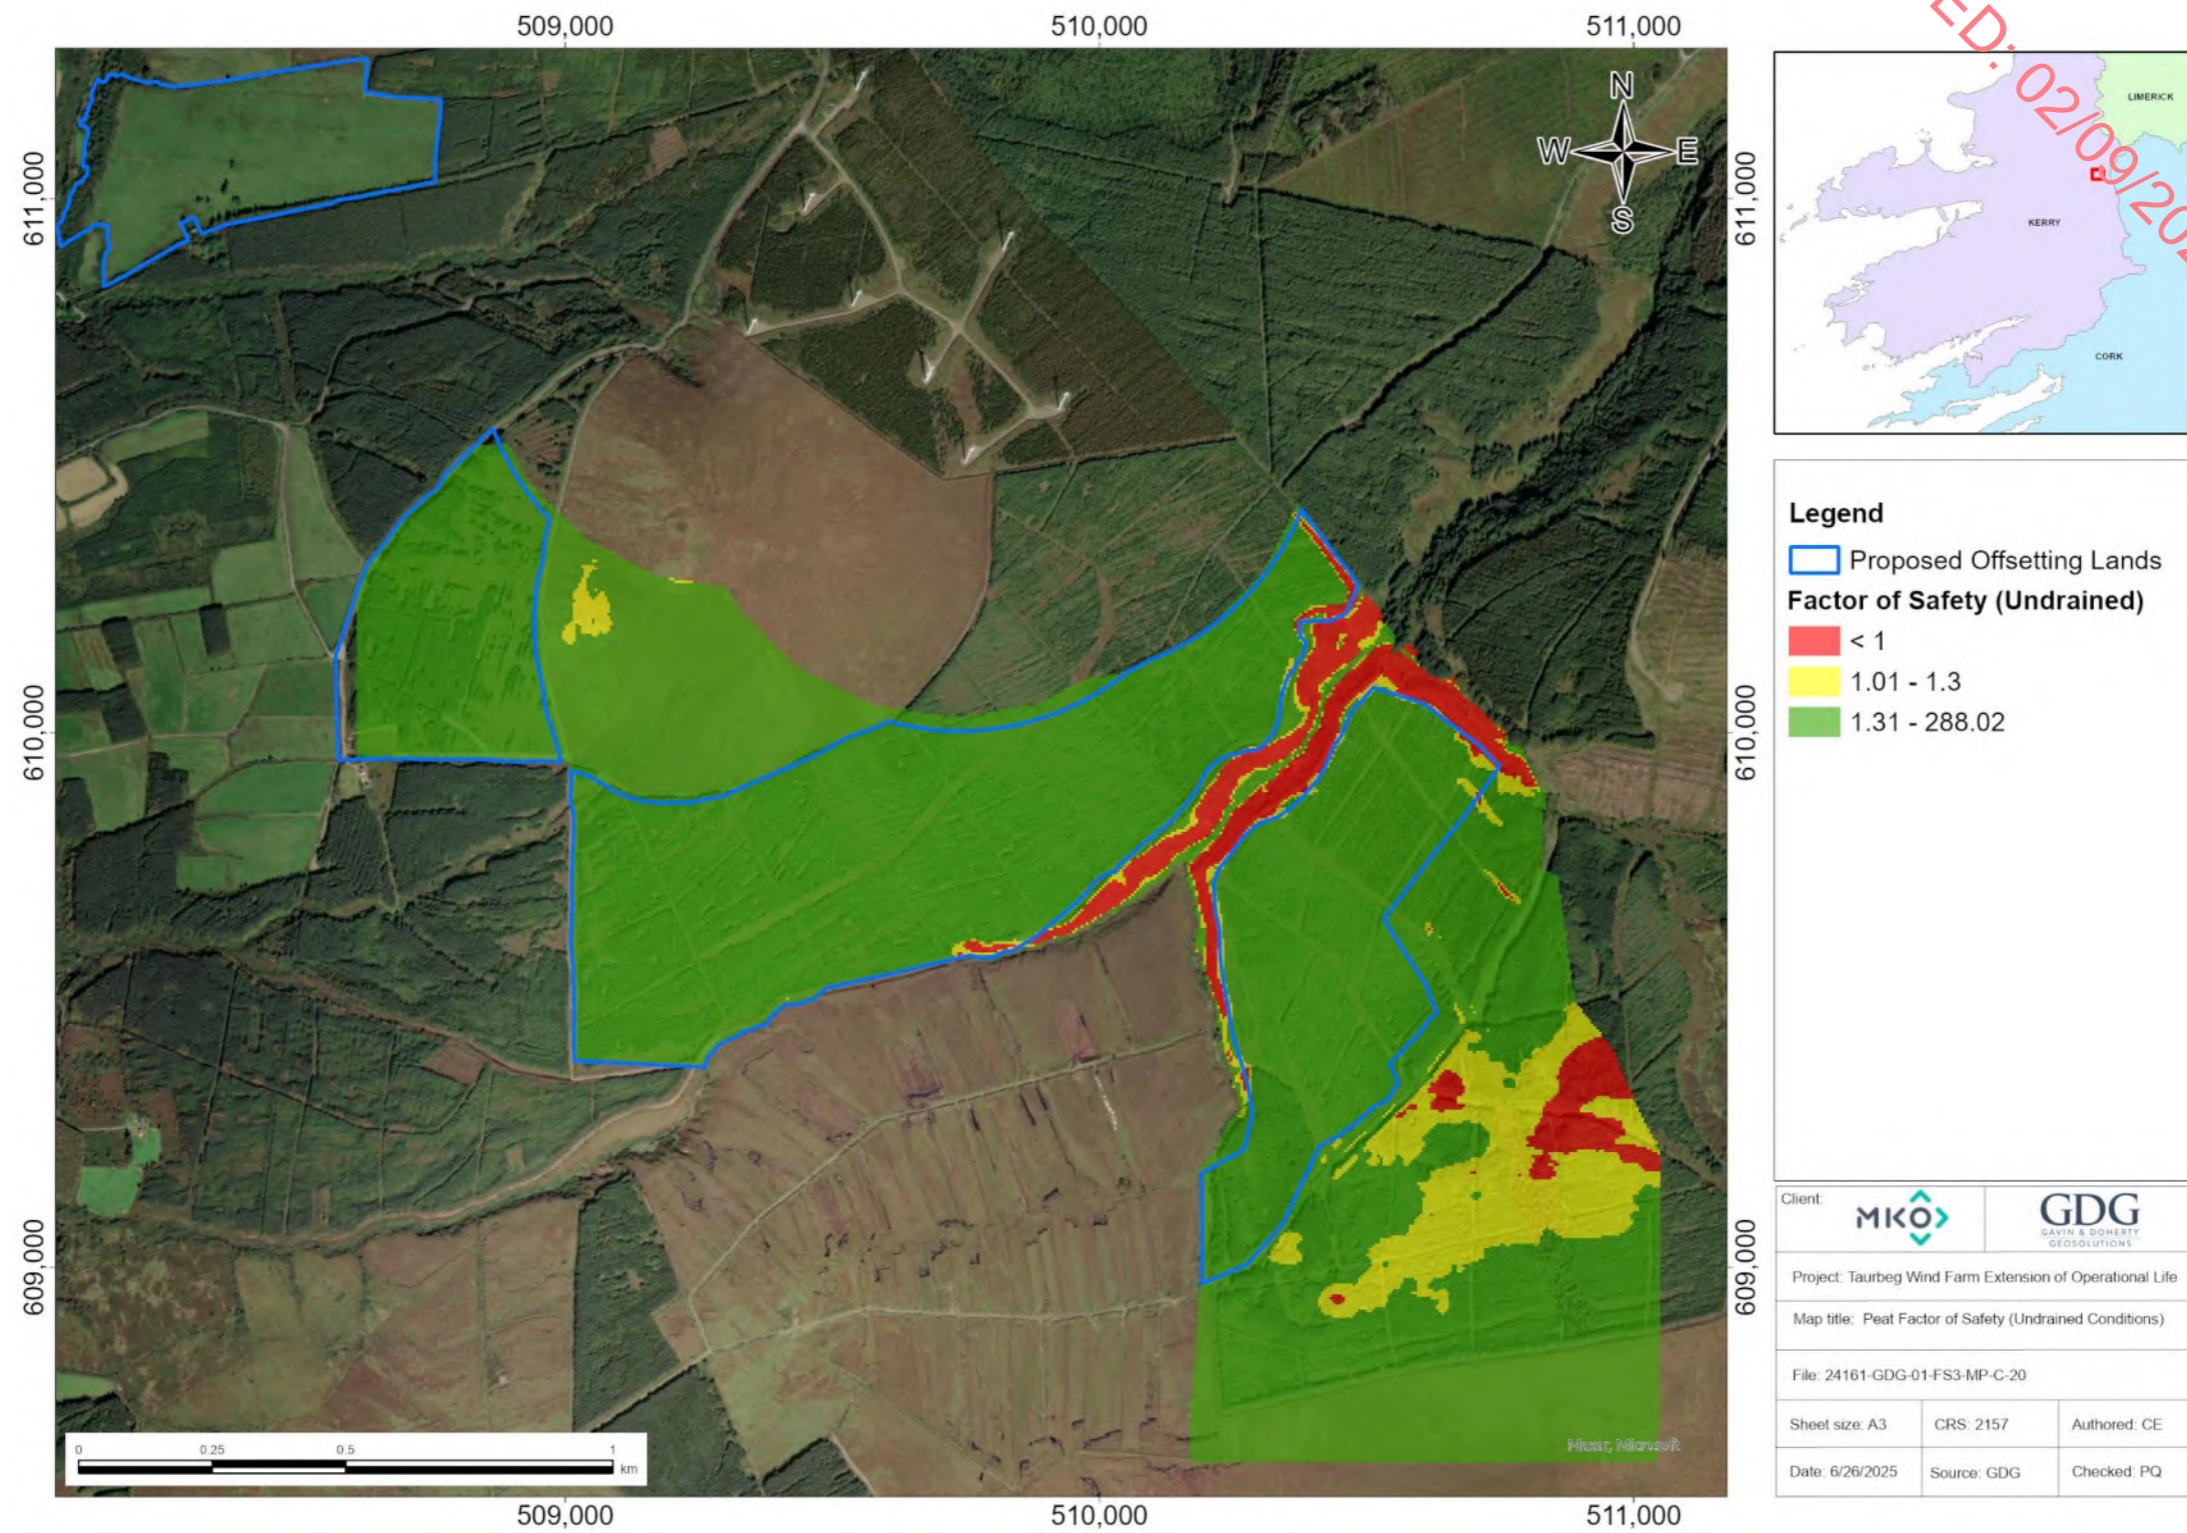
Figure M- 1: Peat Factor of Safety for Undrained Conditions.

*Area 3 contains no peat and so has not been assigned a peat FoS value, as this area was not included in the peat thickness interpolation.

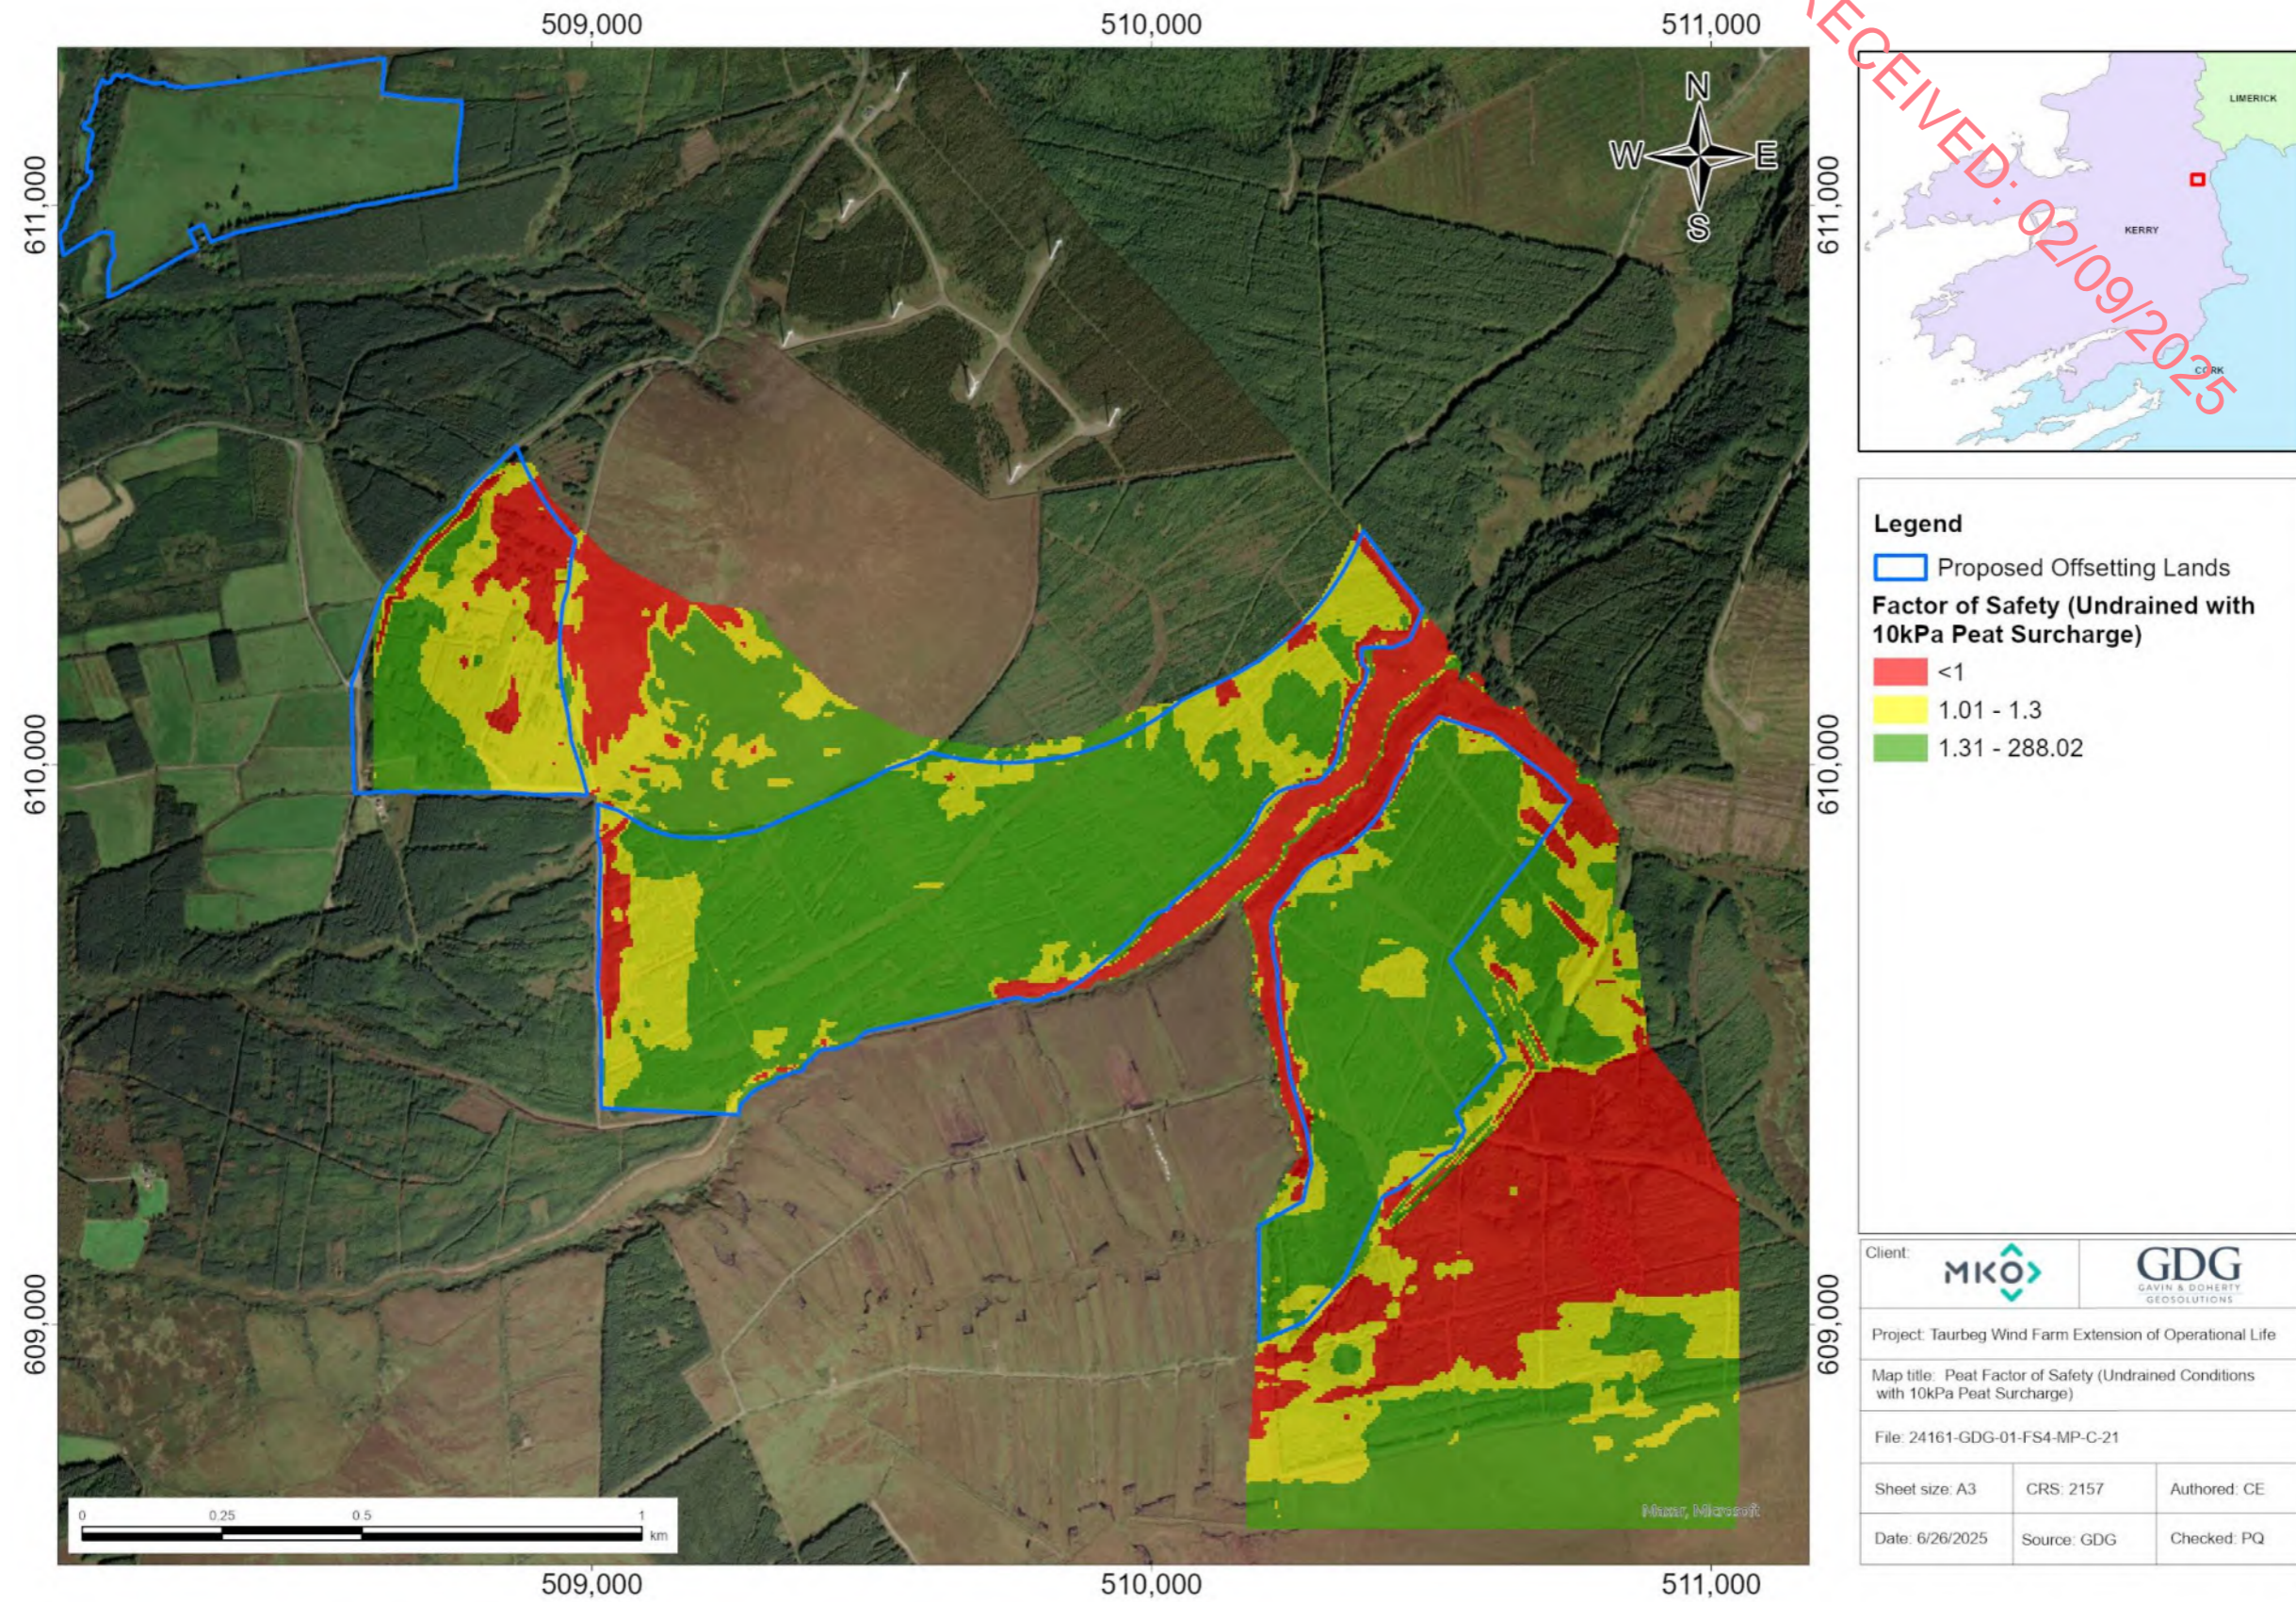
Figure M- 2: Peat Factor of Safety for Undrained Conditions with 10kPa Surcharge.

*The area at the northern entrance boundary contains no peat and so has not been assigned a peat FoS value, as this area was not included in the peat thickness interpolation.

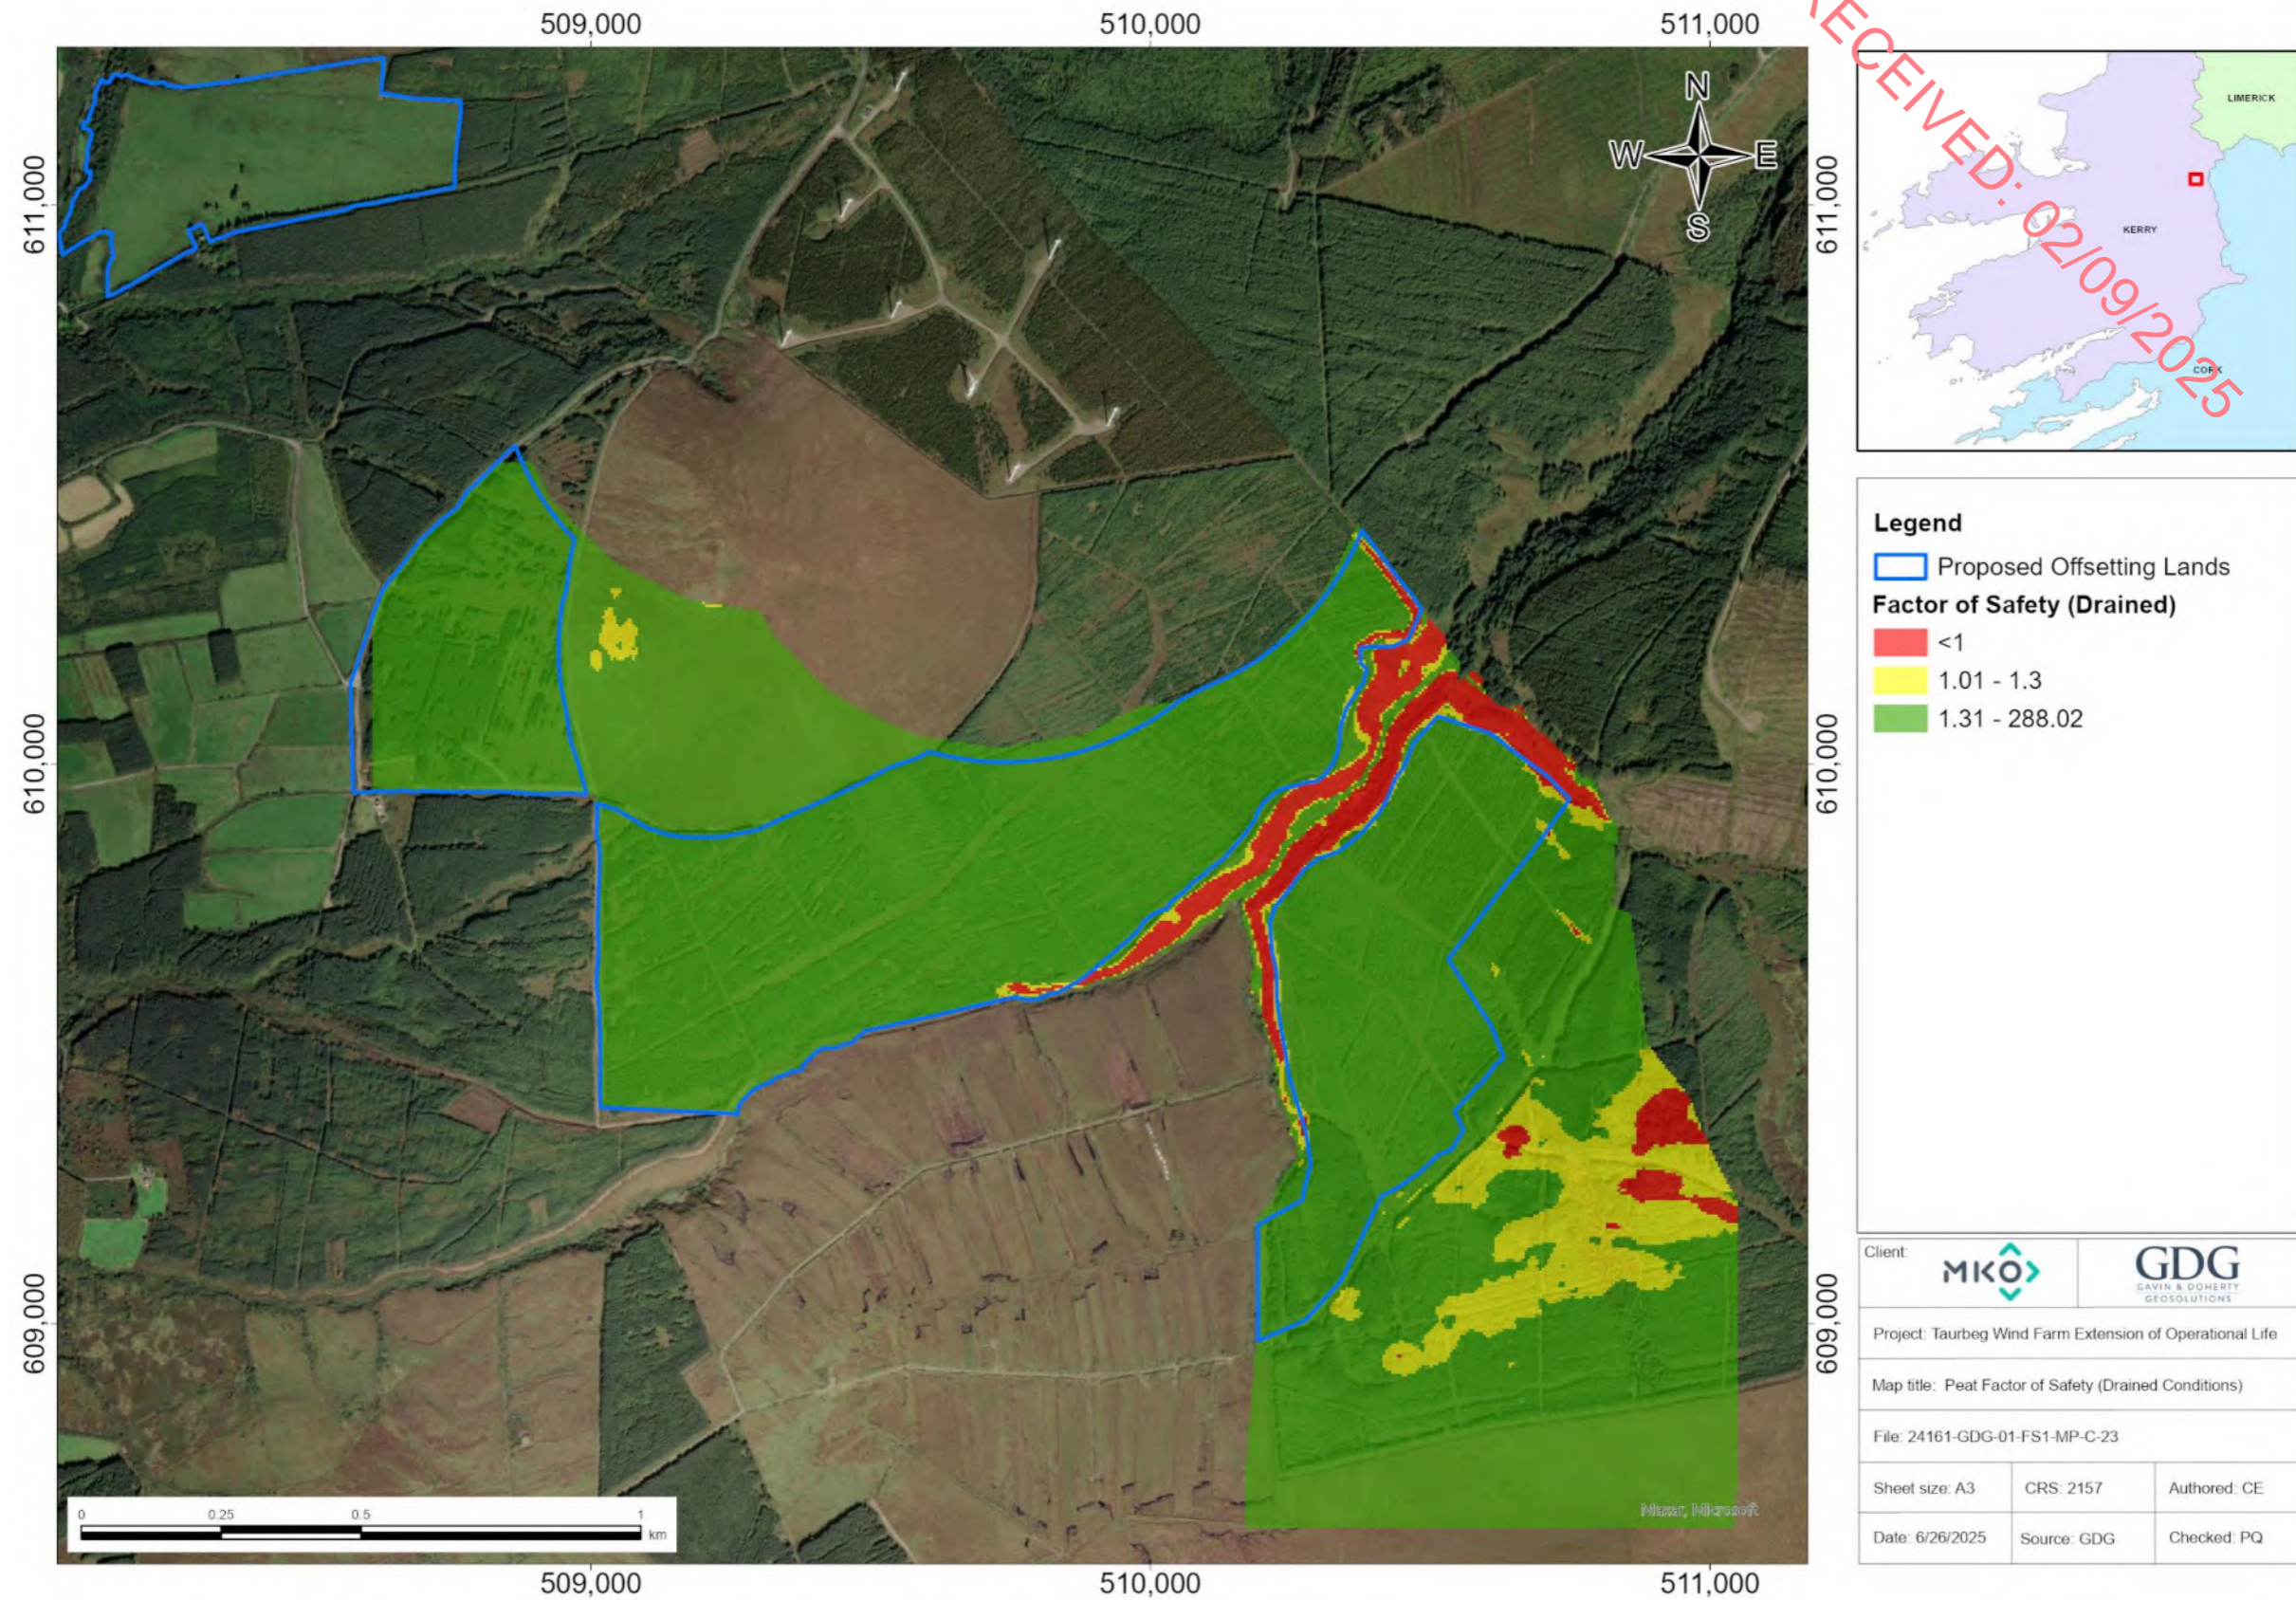
Figure M- 3: Peat Factor of Safety for Drained Conditions.

*The area at the northern entrance boundary contains no peat and so has not been assigned a peat FoS value, as this area was not included in the peat thickness interpolation.

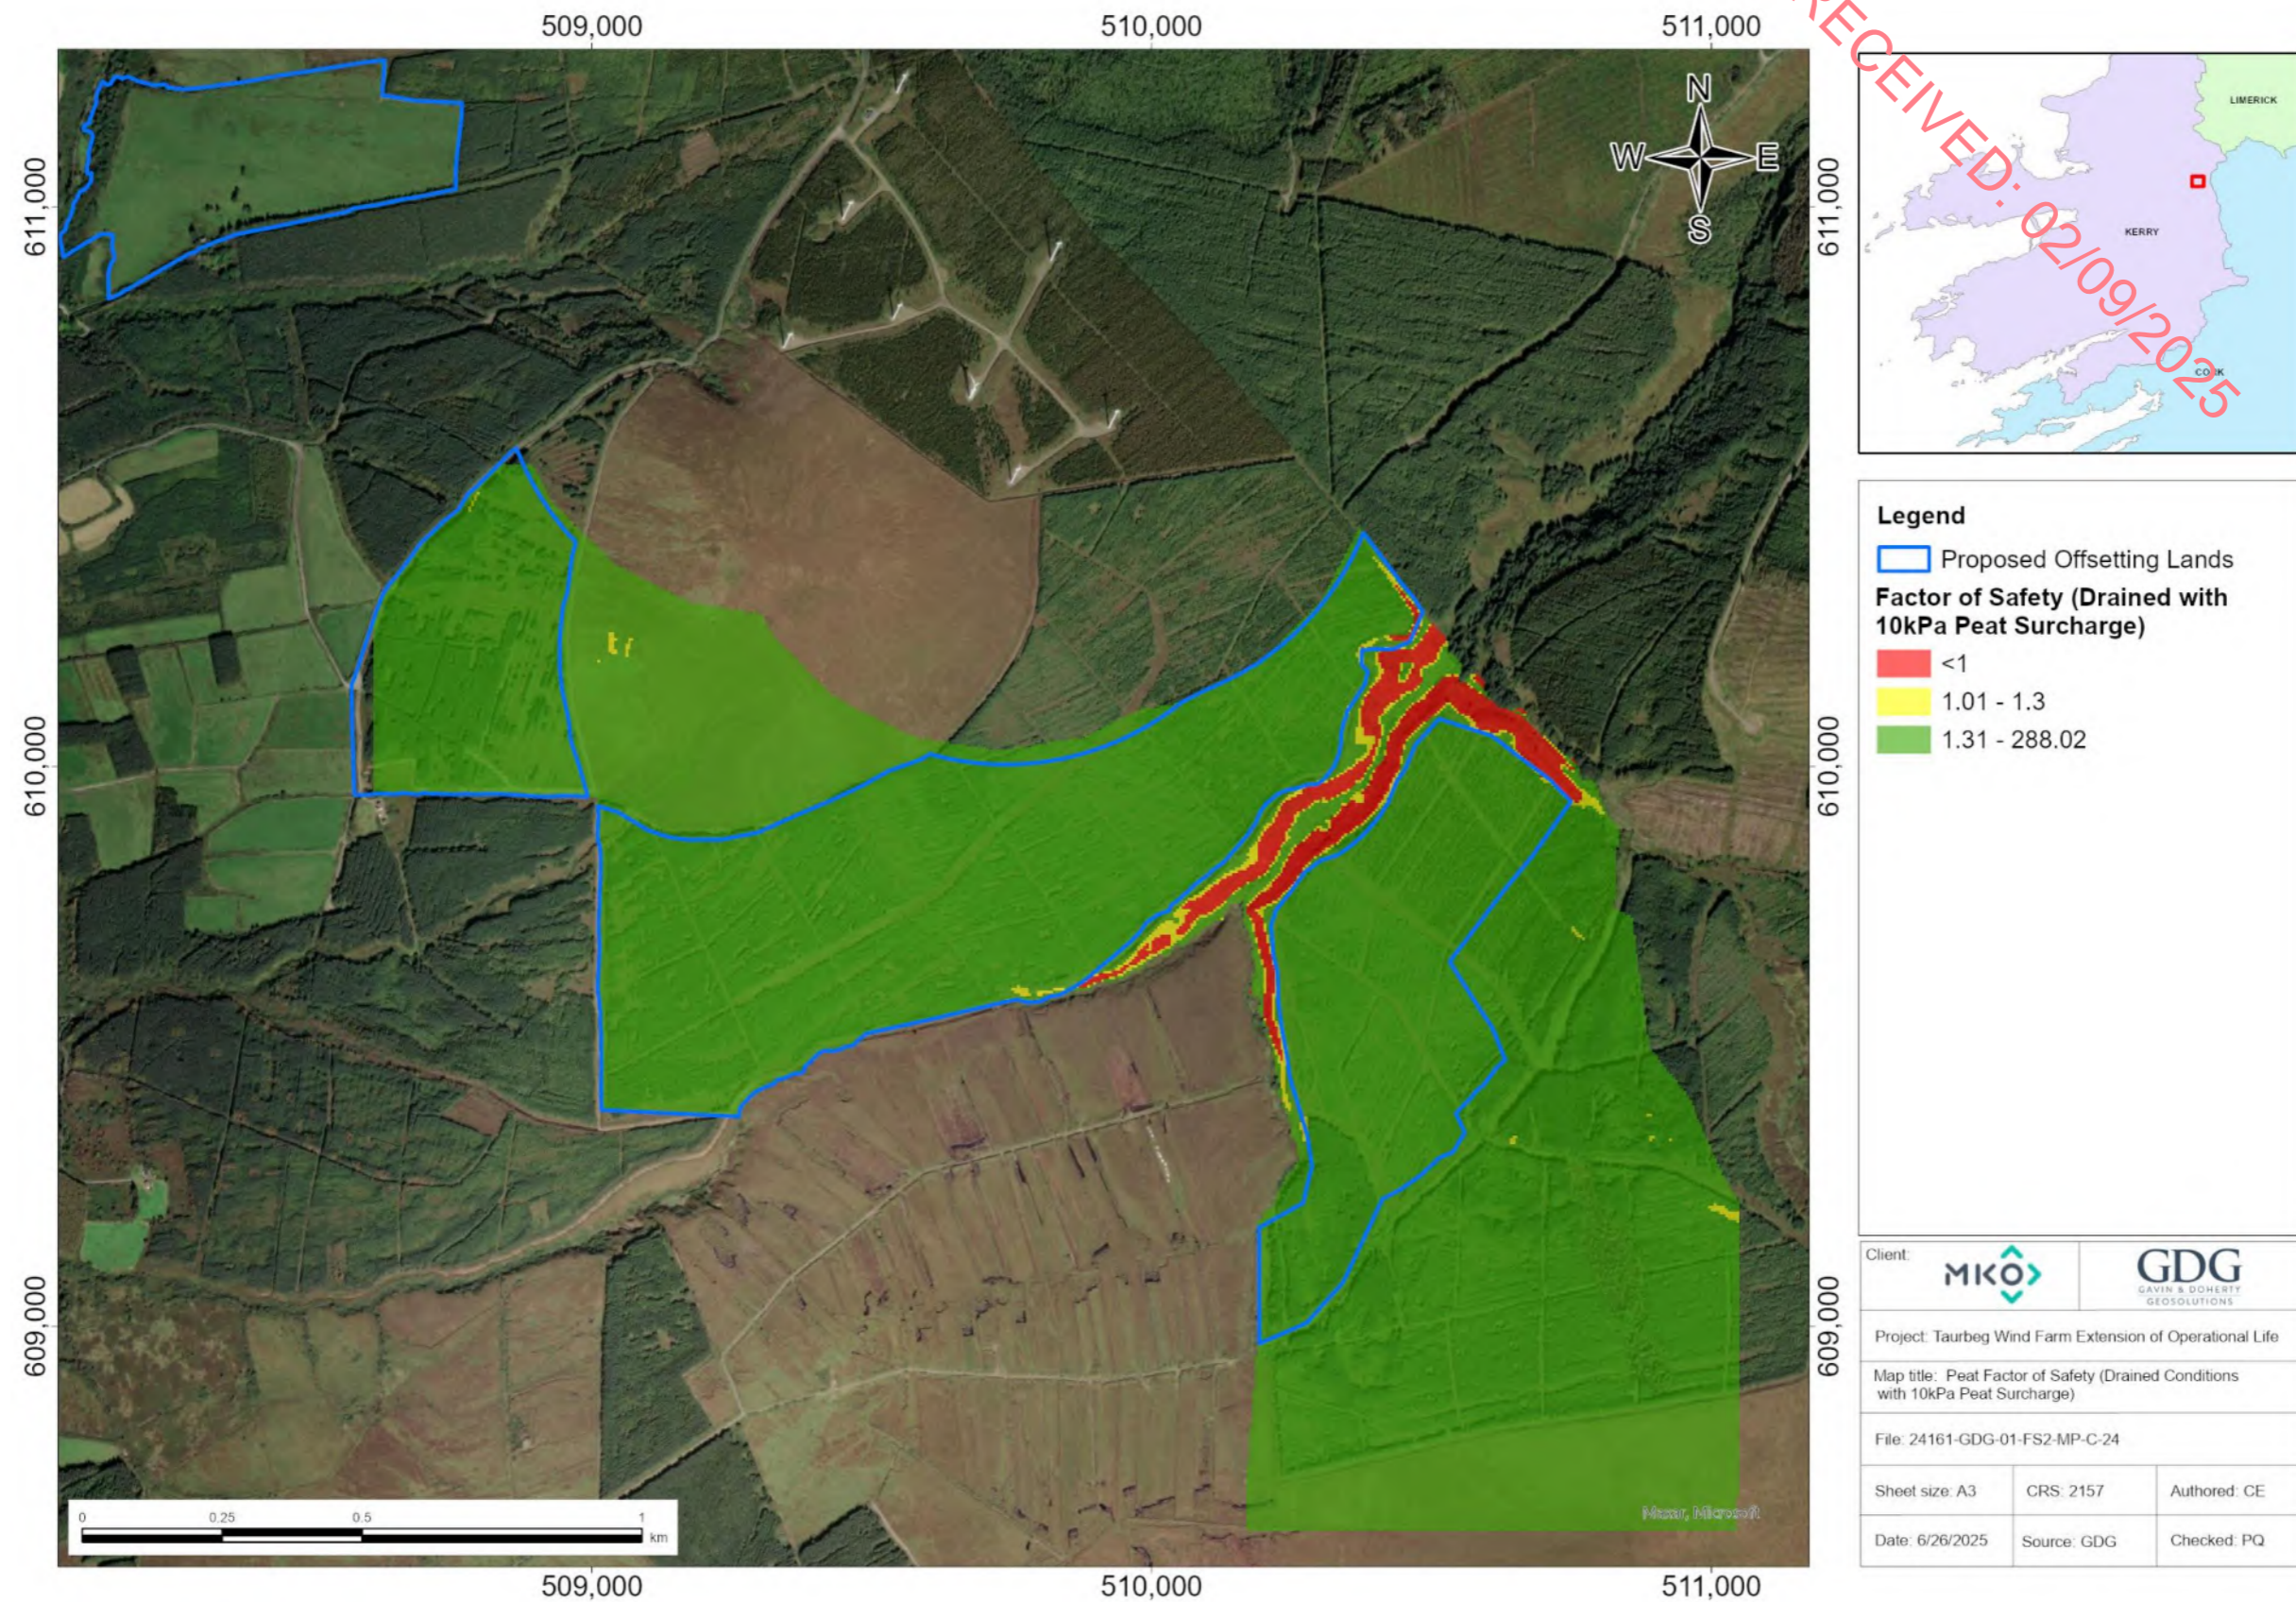
Figure M- 4: Peat Factor of Safety for Drained Conditions with 10kPa Surcharge.

*The area at the northern entrance boundary contains no peat and so has not been assigned a peat FoS value, as this area was not included in the peat thickness interpolation

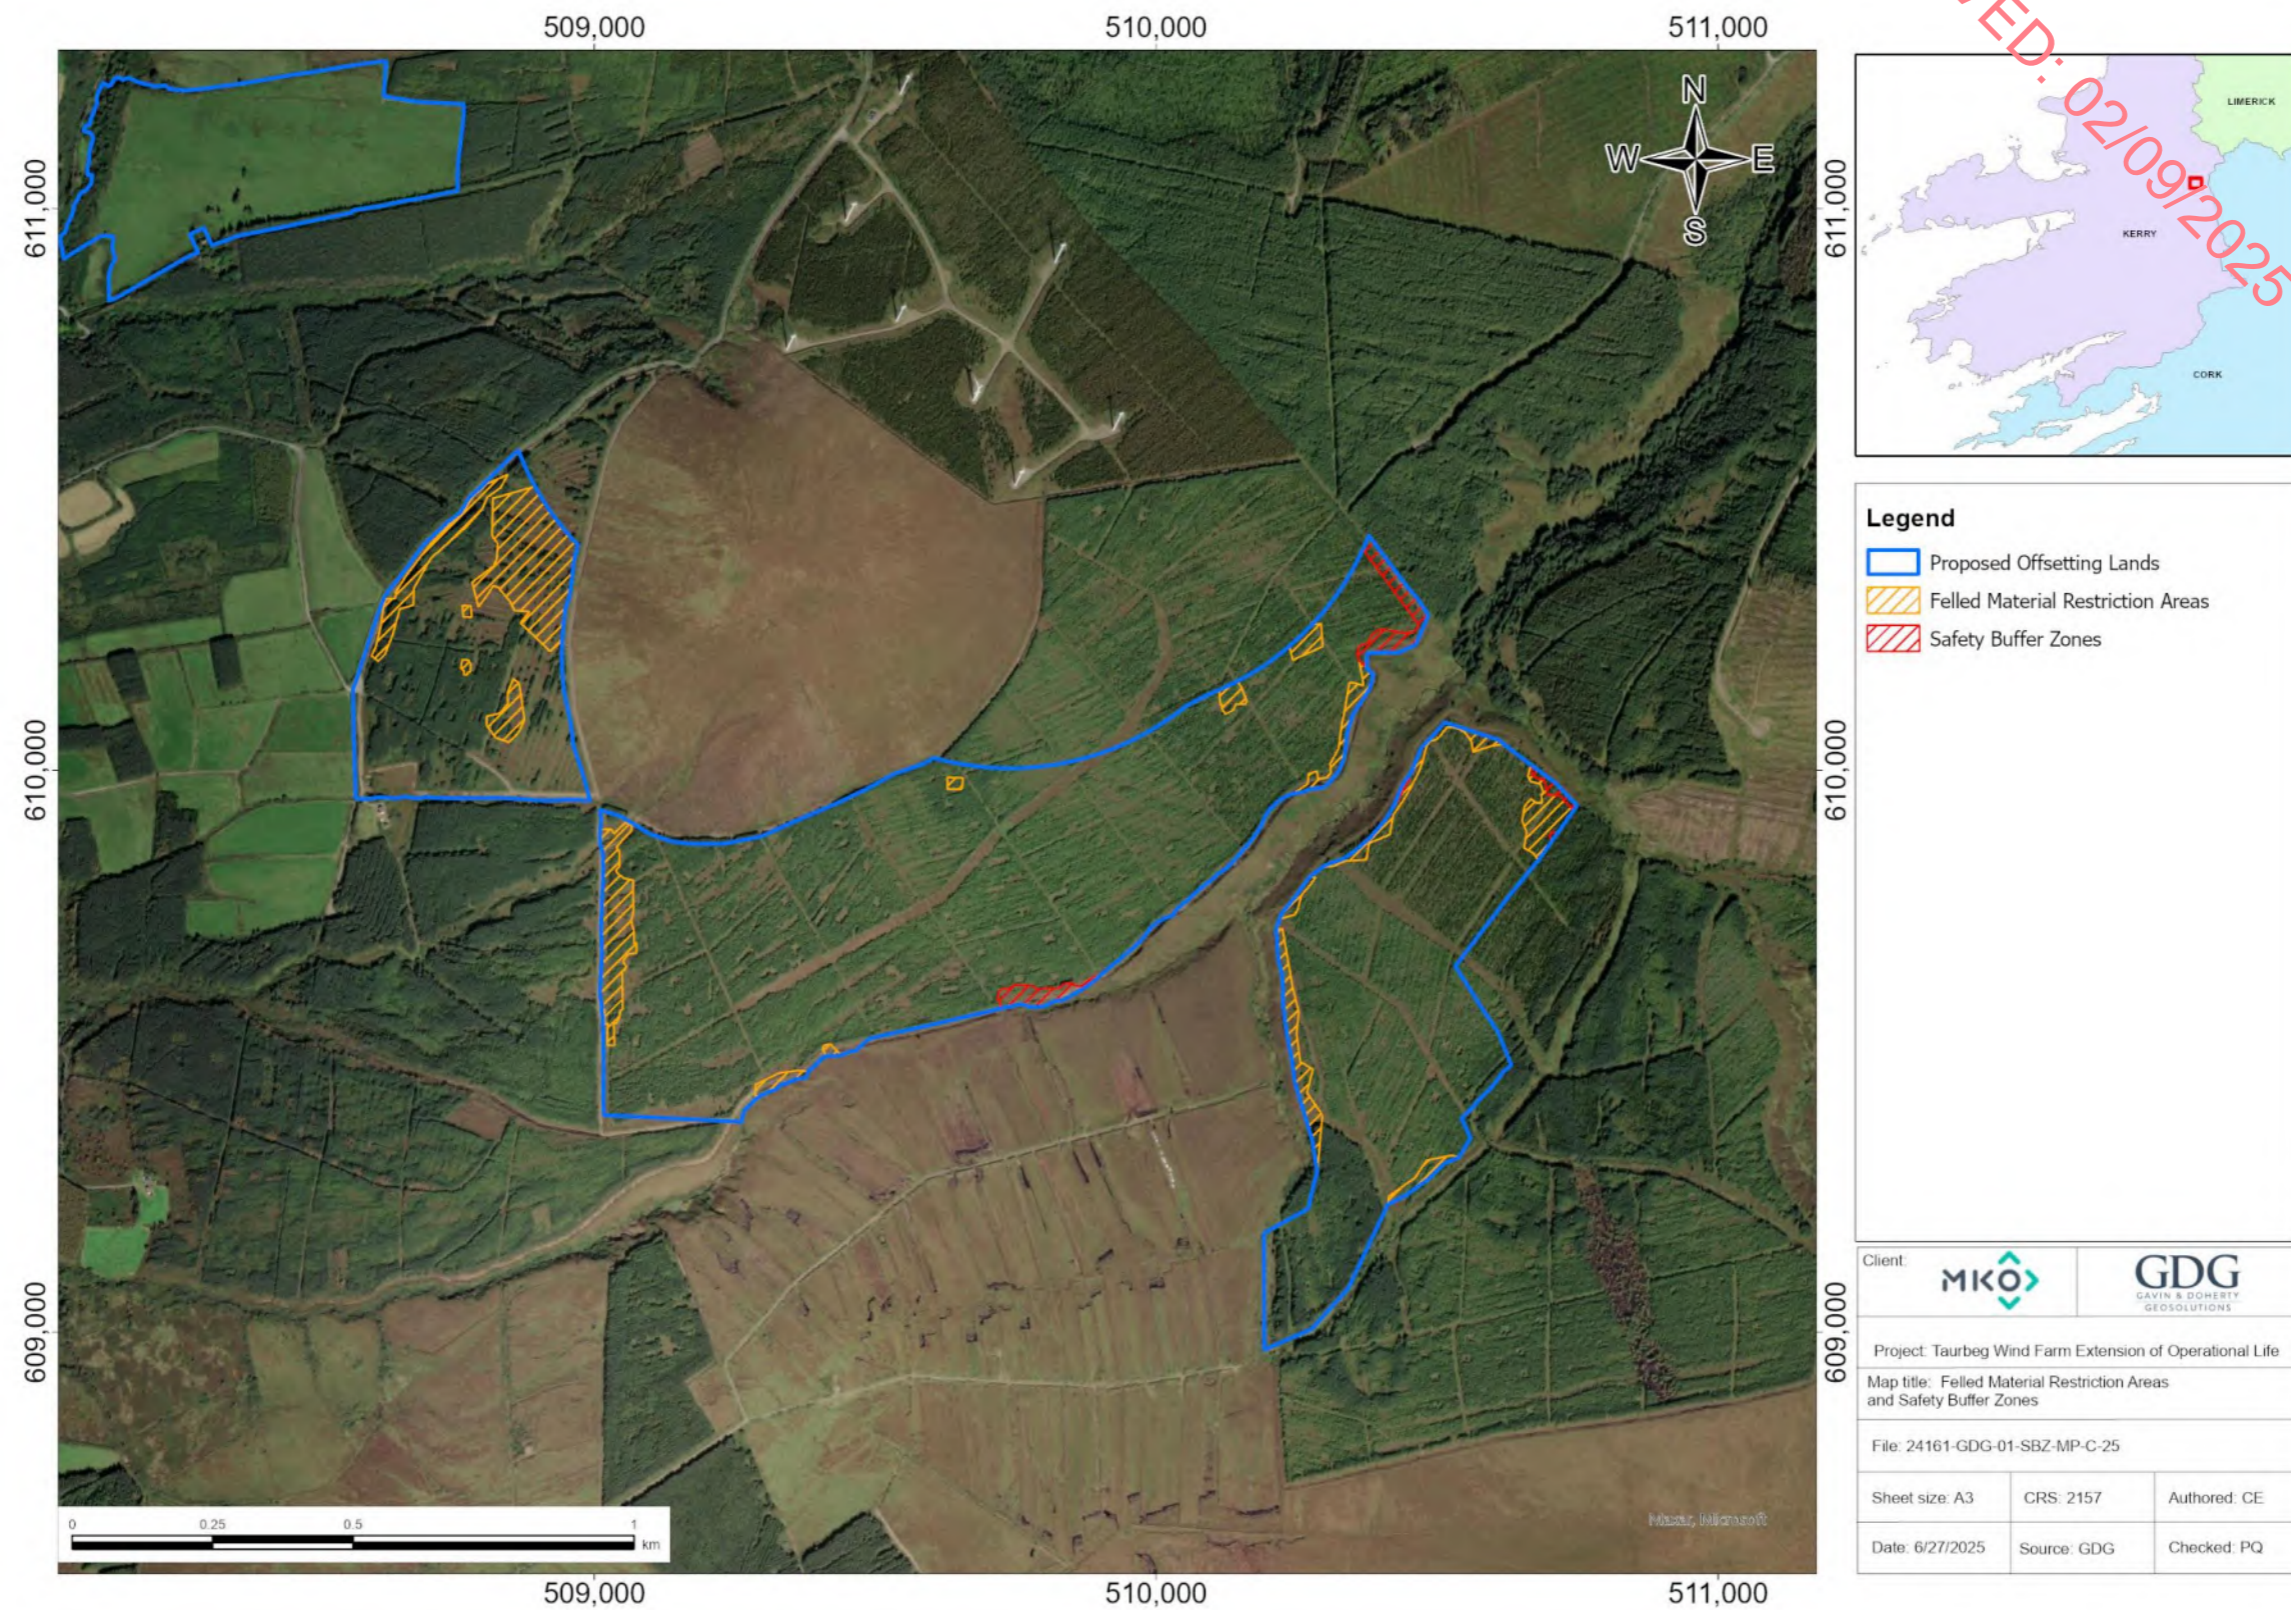
Figure O- 1: Safety Buffer and Felled Material Restriction areas.
