## 6.0 Biodiversity (1 of 3)

The proposed development is located in the townlands of Keerglen, Ballinglen and Ballykinlettragh in north County Mayo, and relates to the proposed the construction of an eight-turbine wind farm for an operational period of 30 years. A detailed description of the proposed development is provided in Chapter 3 of this EIAR.

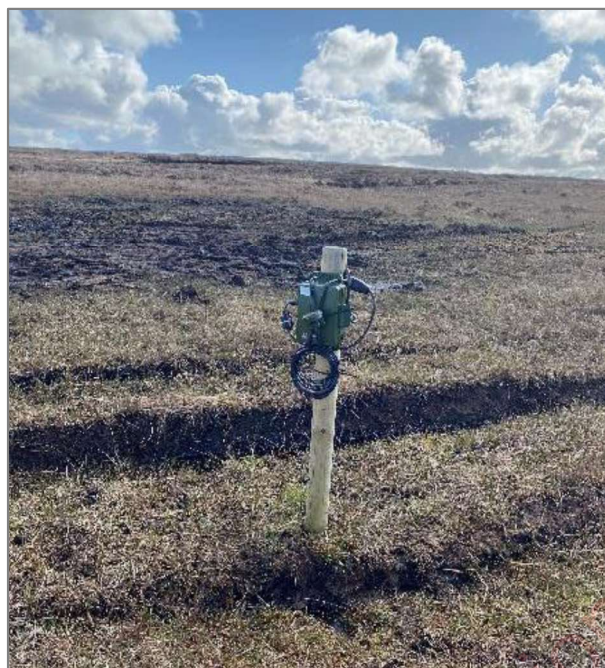
**Plate 6.1 Wildlife Acoustic's SM4 full-spectrum bat detector deployed at the proposed Turbine 7 location.**

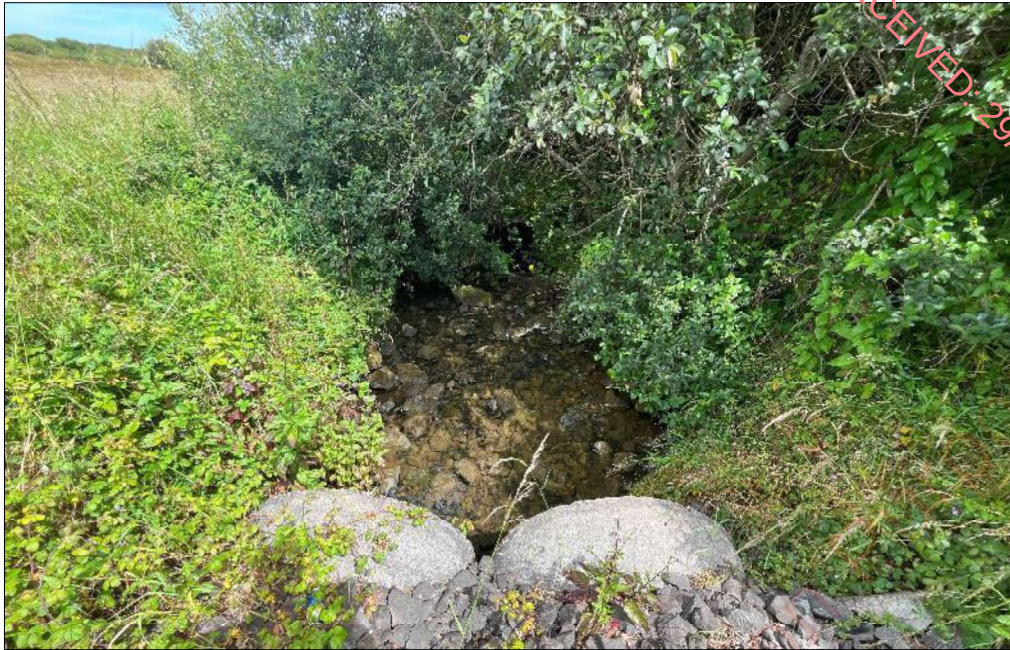
**Plate 6.45** Representative image of site D1 on the Moyne Stream (downstream of the existing double-pipe culvert).

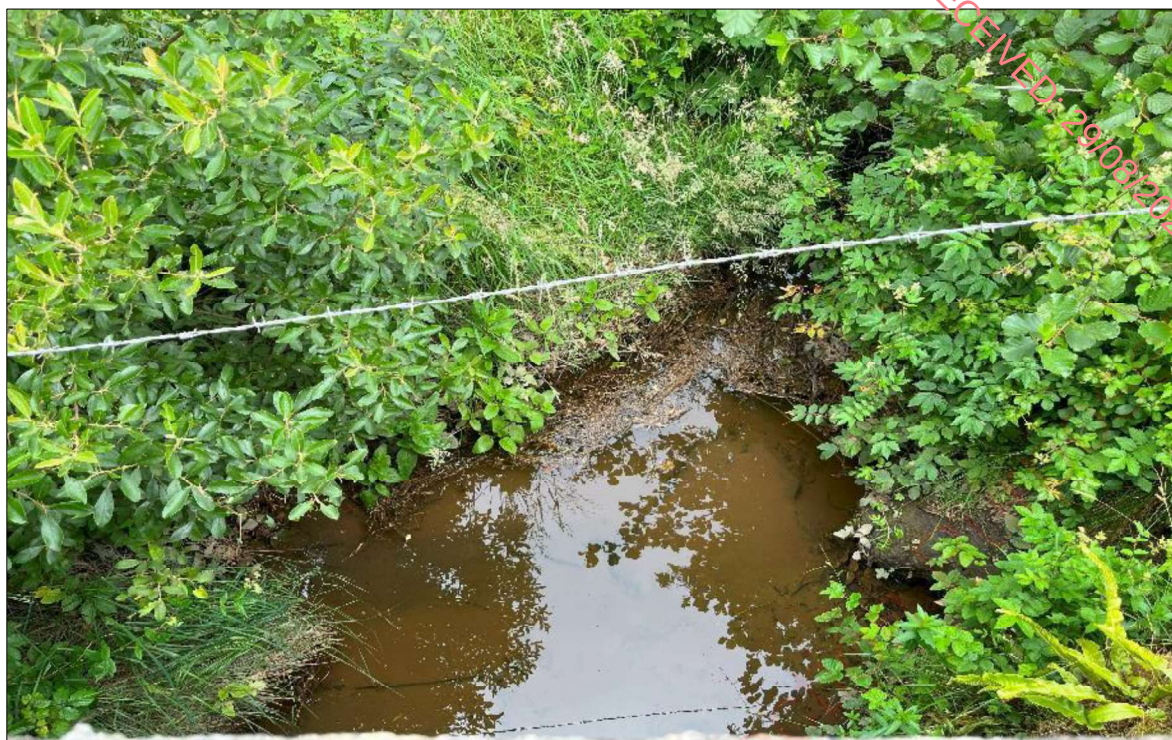
**Plate 6.46** Representative image of site D2 on the Moyne Stream (downstream of the existing box culvert).
