Kellystown Wind Farm, Drogheda, Co. Louth, Ireland

Preliminary Ground Investigation

Report No: 2200-23B Rev01

[SOILS AND GEOLOGY STUDY – PRELIMINARY GROUND INVESTIGATION]

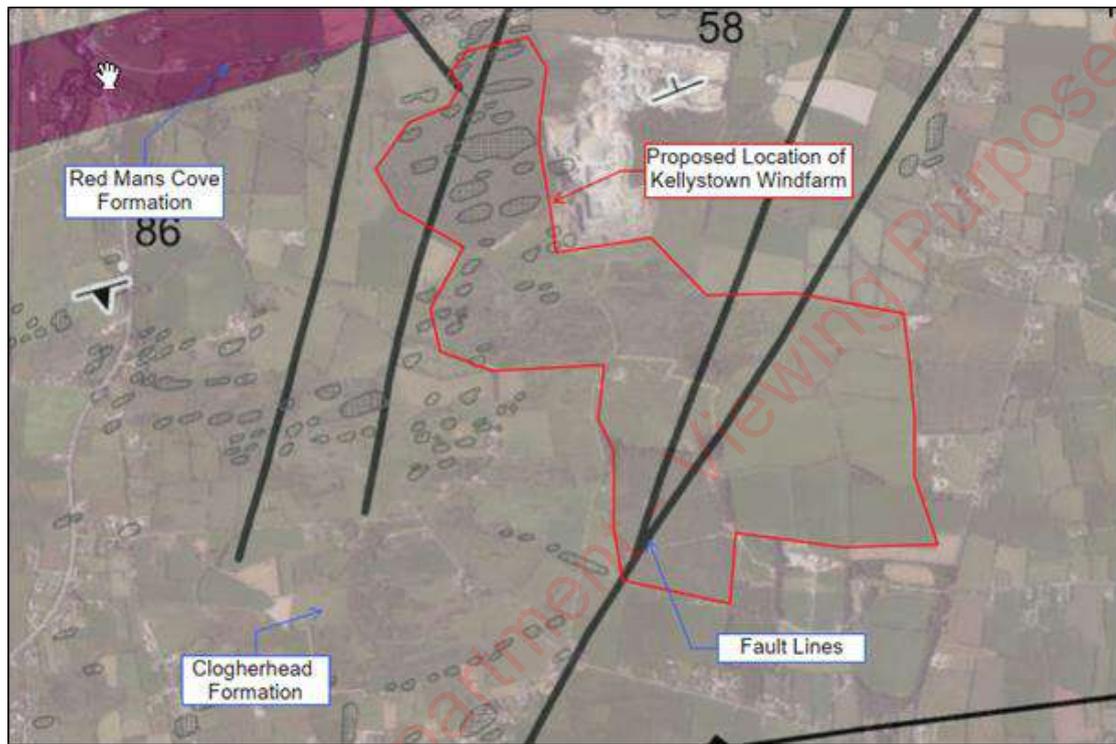
Figure 1 – Bedrock Solid Geology
Reproduced courtesy of GSI Datasets Public Viewer

According to the GSI online database, the proposed development area for Kellystown Wind Farm site is immediately underlain by the Clogherhead Formation which consists of, thickly bedded calcareous greywacke.

Also present just outside the development area, north east of the site boundary, is the Red Mans Cove Formation which consists of, red, green, black mudstone

A series of three faults bisect the proposed development area trending in an approximately north north east – south south west direction and potentially impact the subsurface rock

formation at WTG02, WTG04 and WTG05, where they have the potential to have caused highly fractured and deeply weathered bedrock and / or the channelling of groundwater flow.

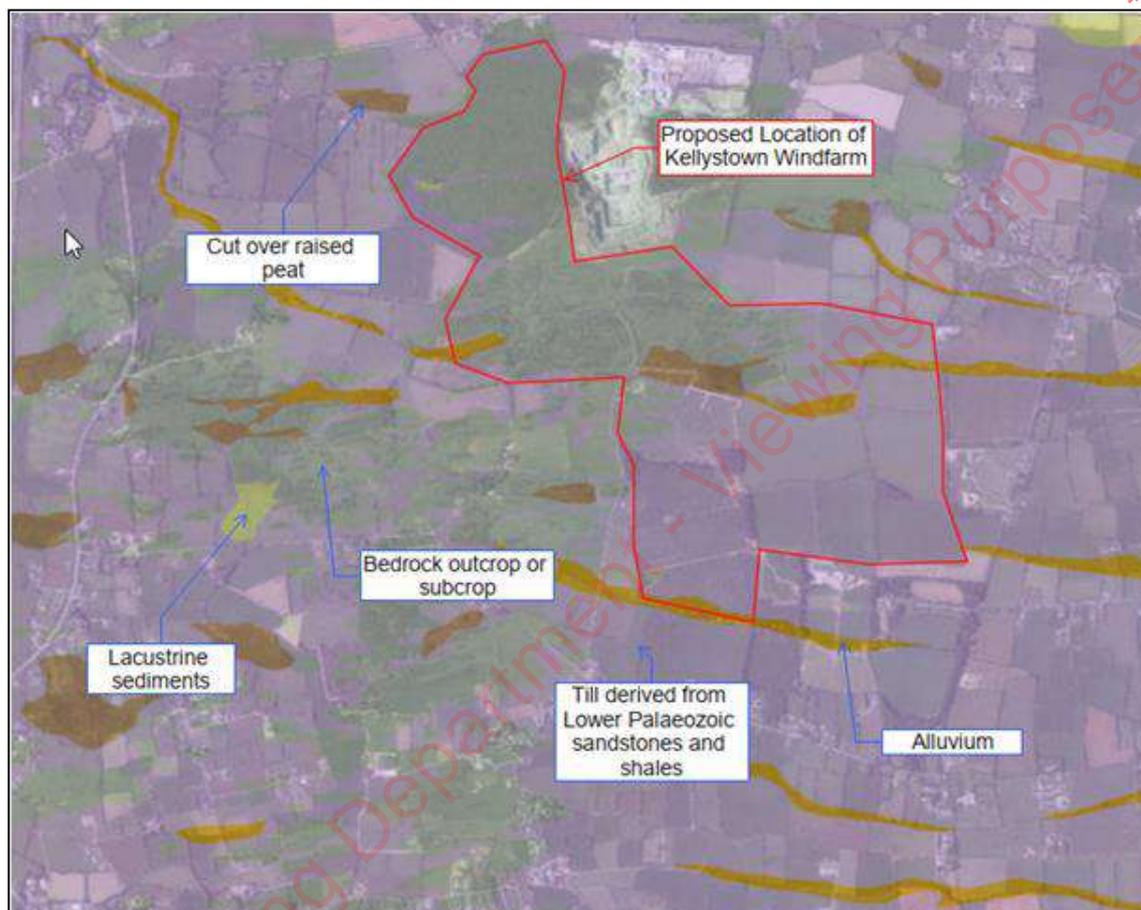
Figure 2 – Superficial Geology
Reproduced courtesy of GSI Datasets Public Viewer

Superficial soils present within the wind farm consist of thin glacial till soils overlying shallow, often outcropping greywacke rock to the north and west. Thicker glacial tills derived from Lower Palaeozoic sandstones are present towards the south and east of the site.

Alluvium is present throughout the Site with some isolated area of peat also indicated outside the proposed construction footprint.

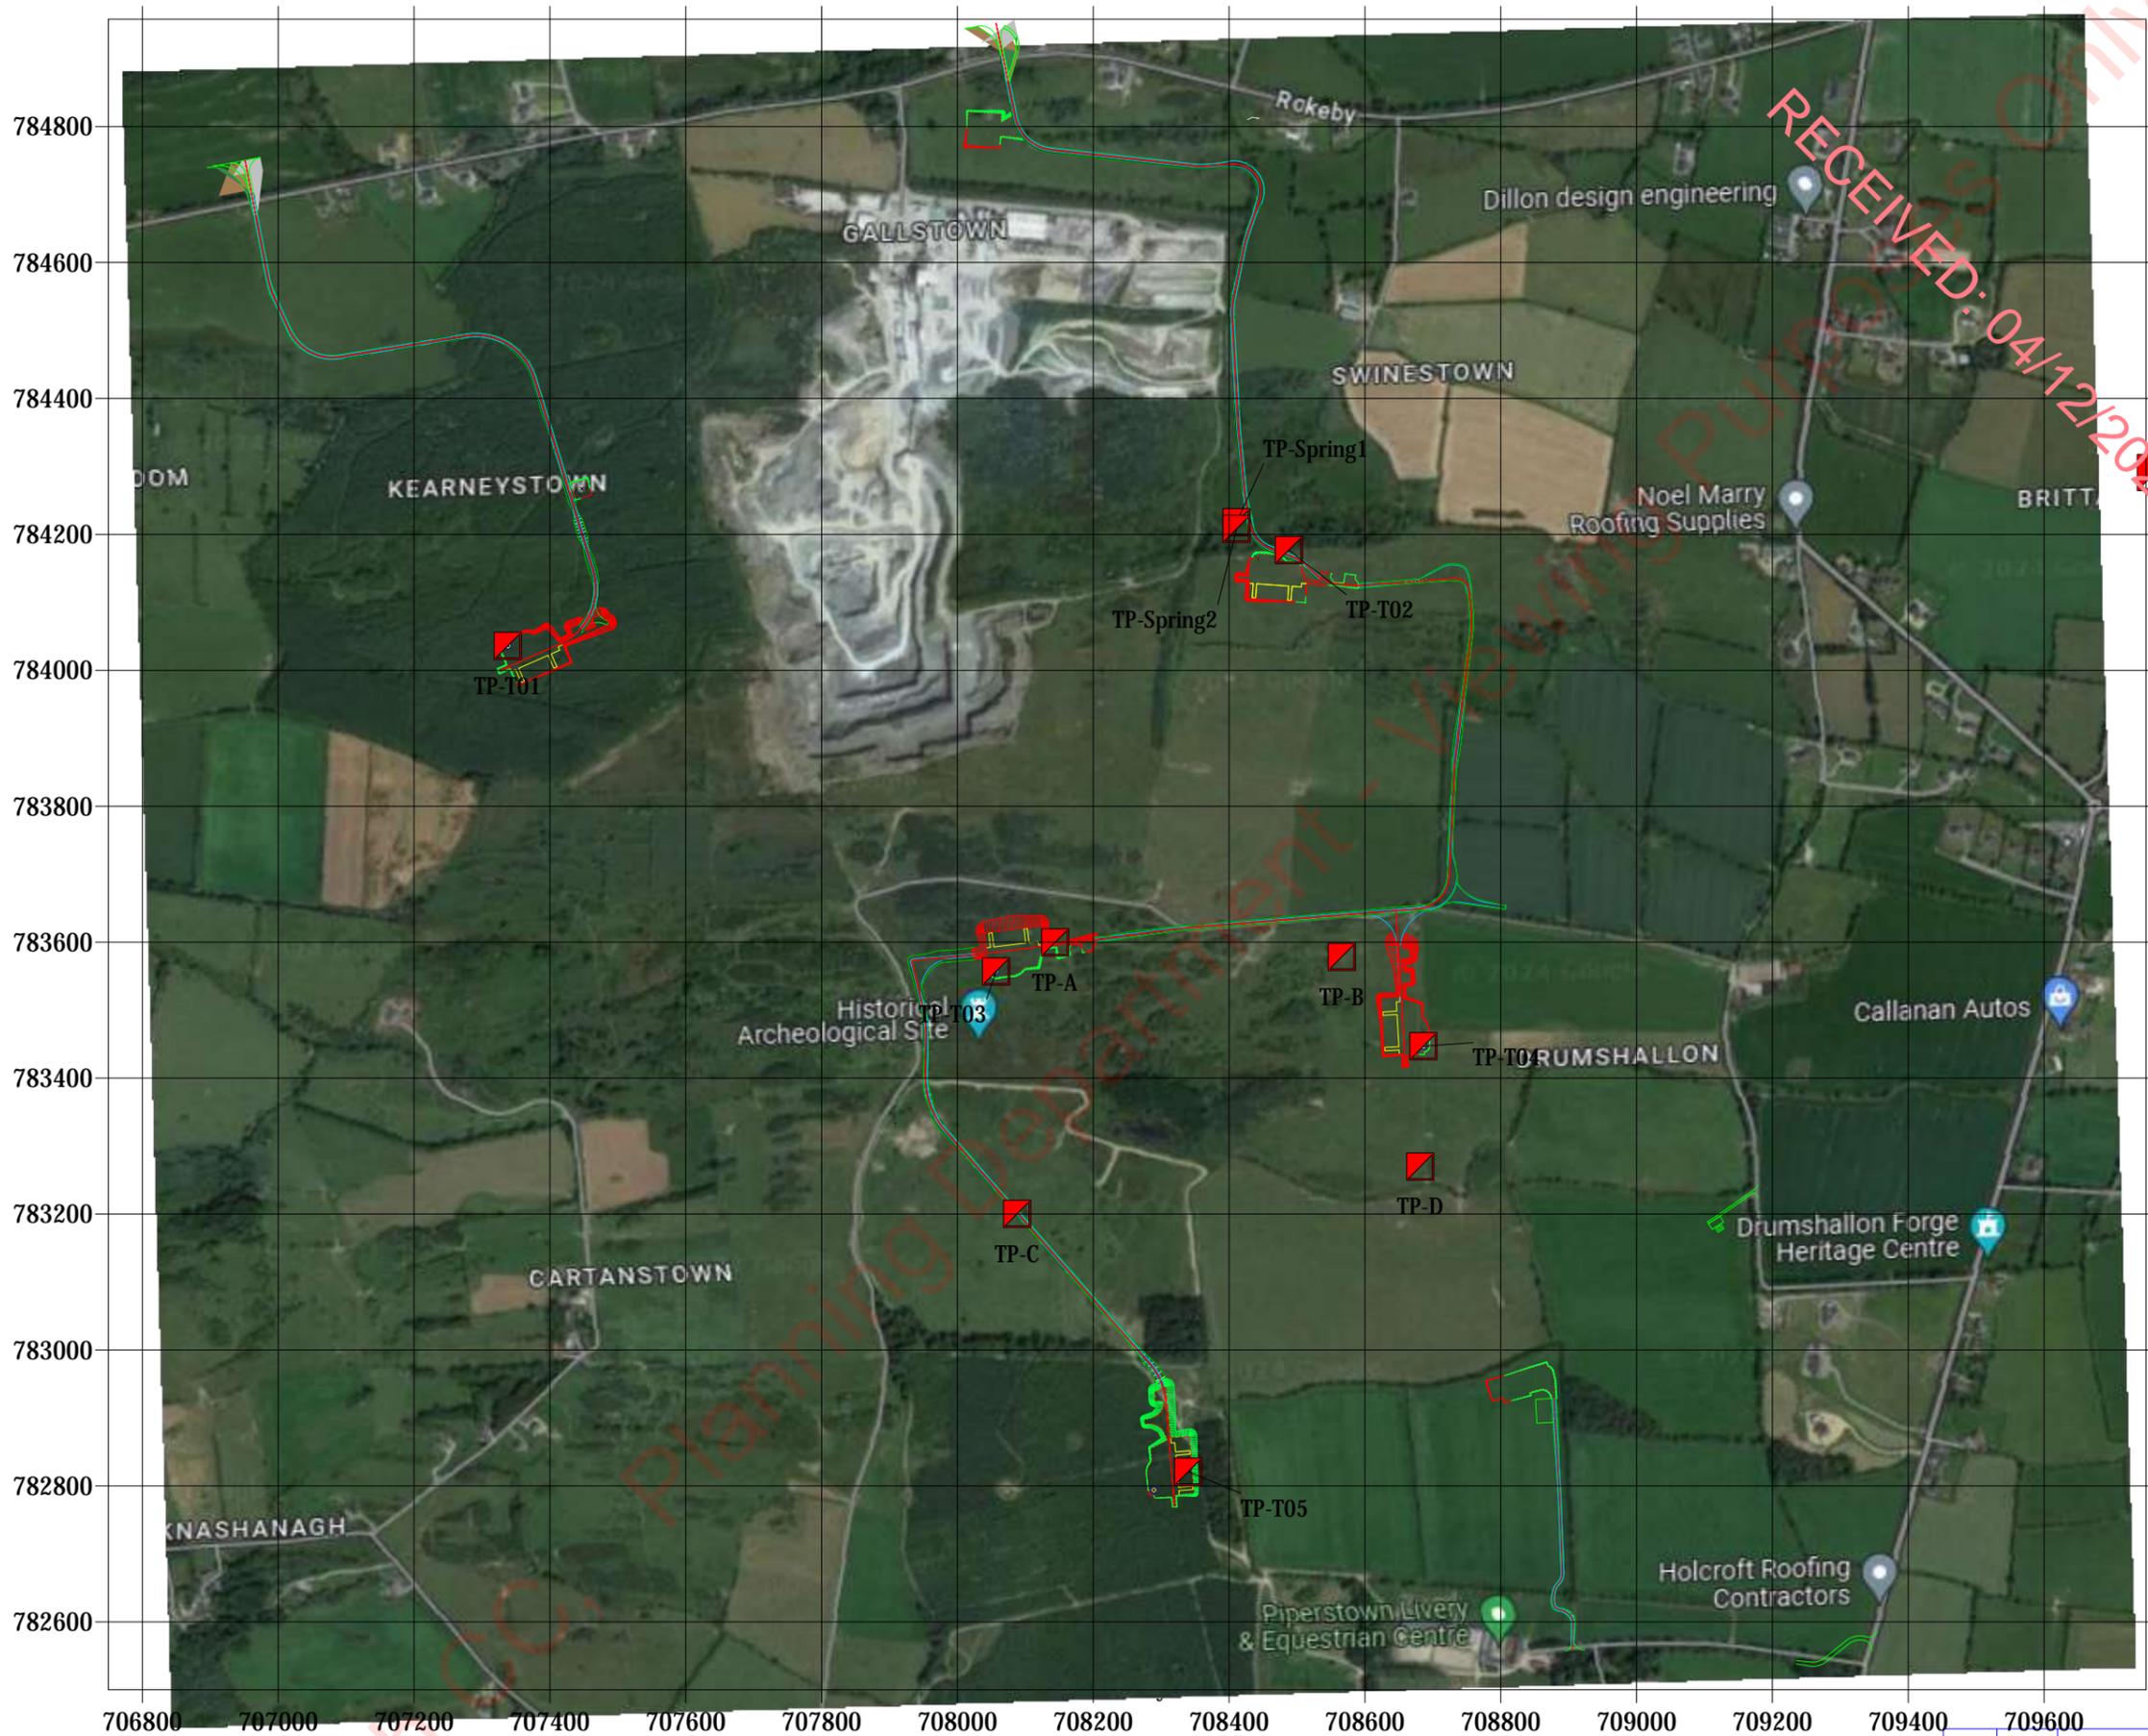
Position of Exploratory Trial Hole

Designed by	Checked by	Approved by - date	Drawing No.	Date	Scale
JW	JW	JM 08/04/24	2200/23 - L1	08/04/2024	1 : 10,000
Whiteford Geoservices Ltd Straid House 2 Main Street, Straid, BALLYCLARE, Co. Antrim, UK BT39 9 NE			Preliminary Ground Investigations As-built Exploratory Hole Plan Kellystown Wind Farm		
			Edition	Sheet	
			1	A3

Please refer to Appendix A for the location of all geotechnical investigations undertaken.

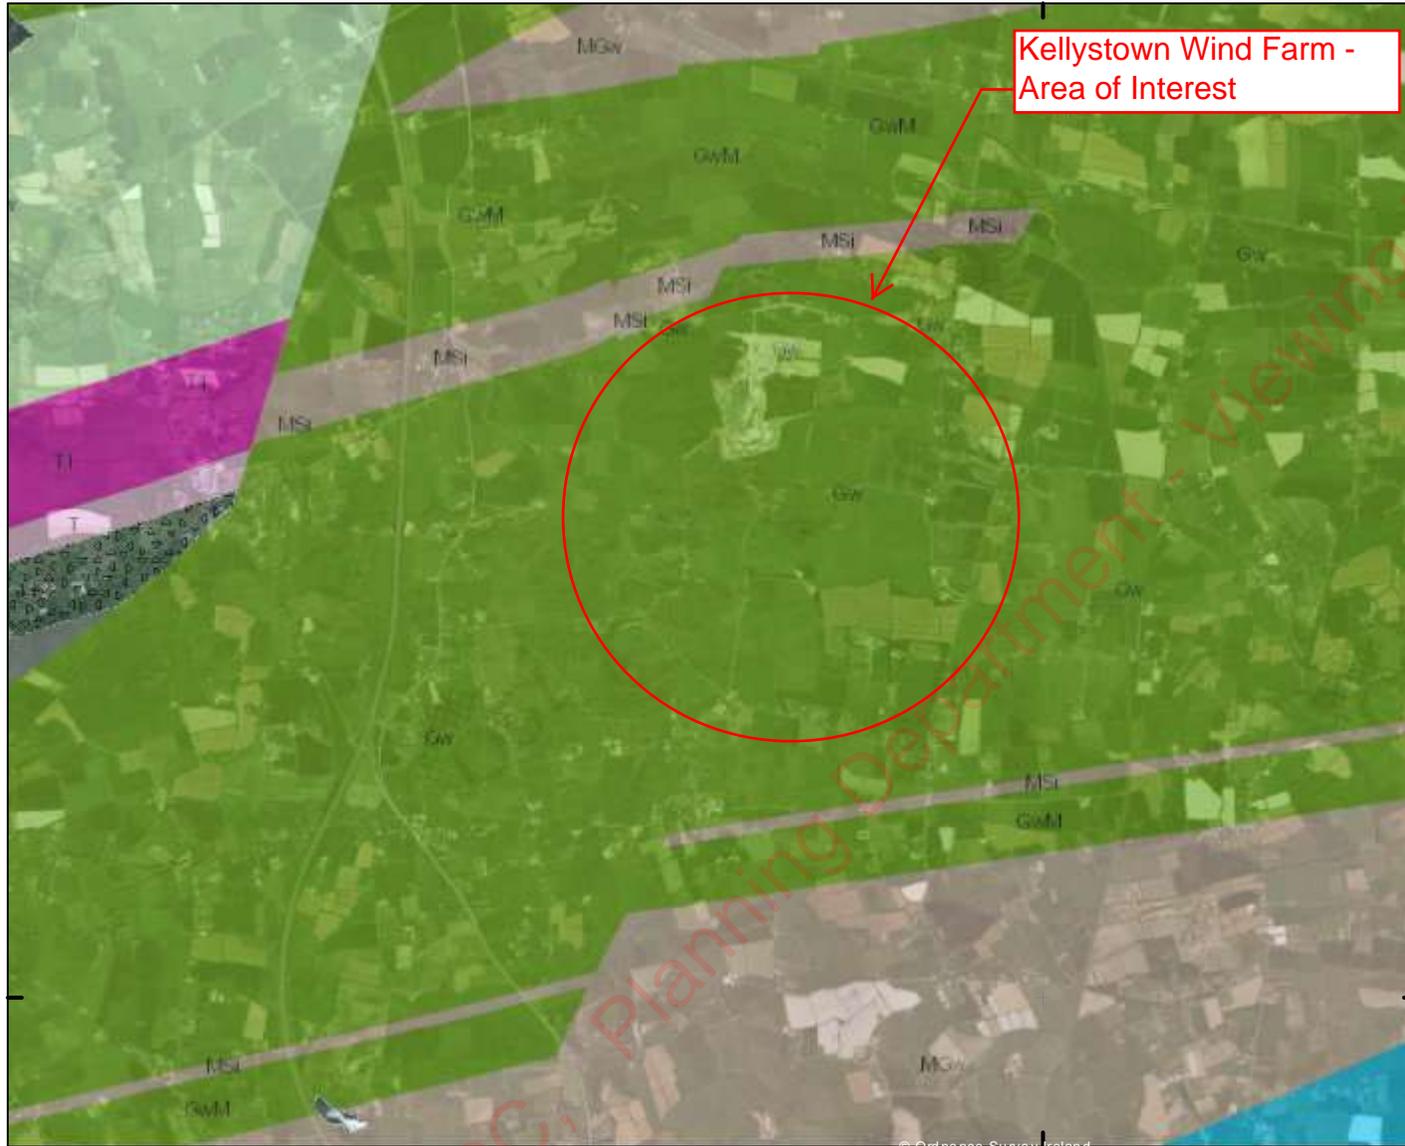
GSI Mapping - Aggregate Bedrock Scores

Kellystown Wind Farm -
Area of Interest

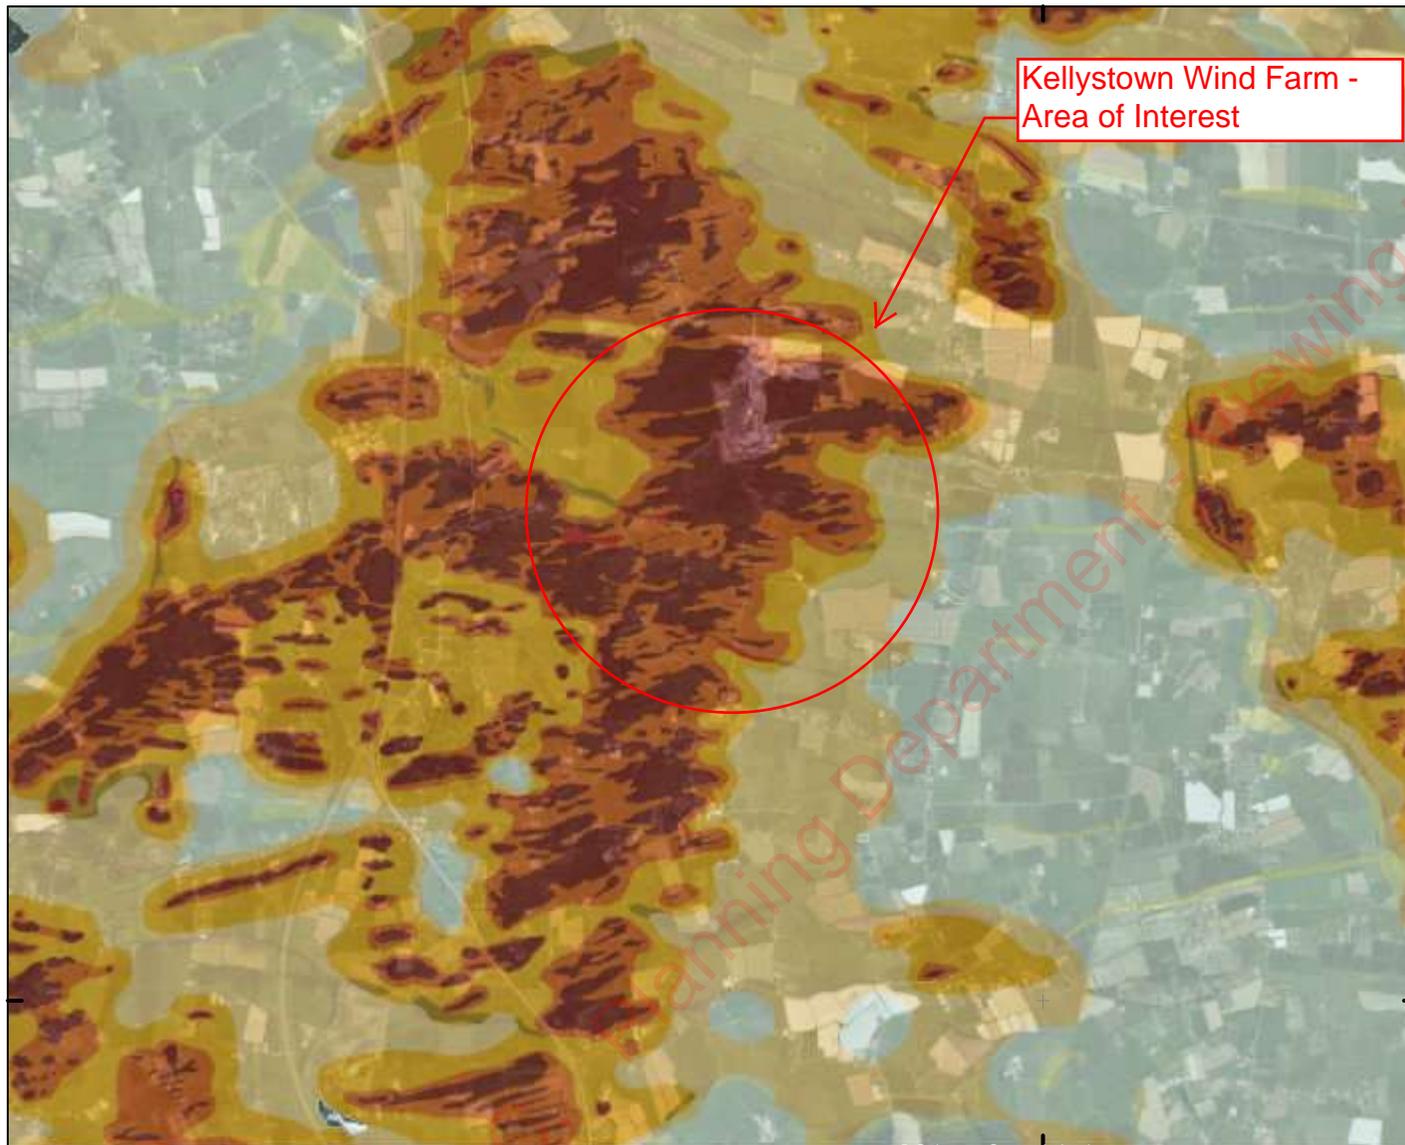
Legend

- Overburden Scores**
- 10 (minimal or no overburden)
 - 9
 - 8
 - 7
 - 6
 - 5
 - 4
 - 3
 - 2
 - 1 (thick overburden)
 - 0 (overburden)
 - inferred, below water

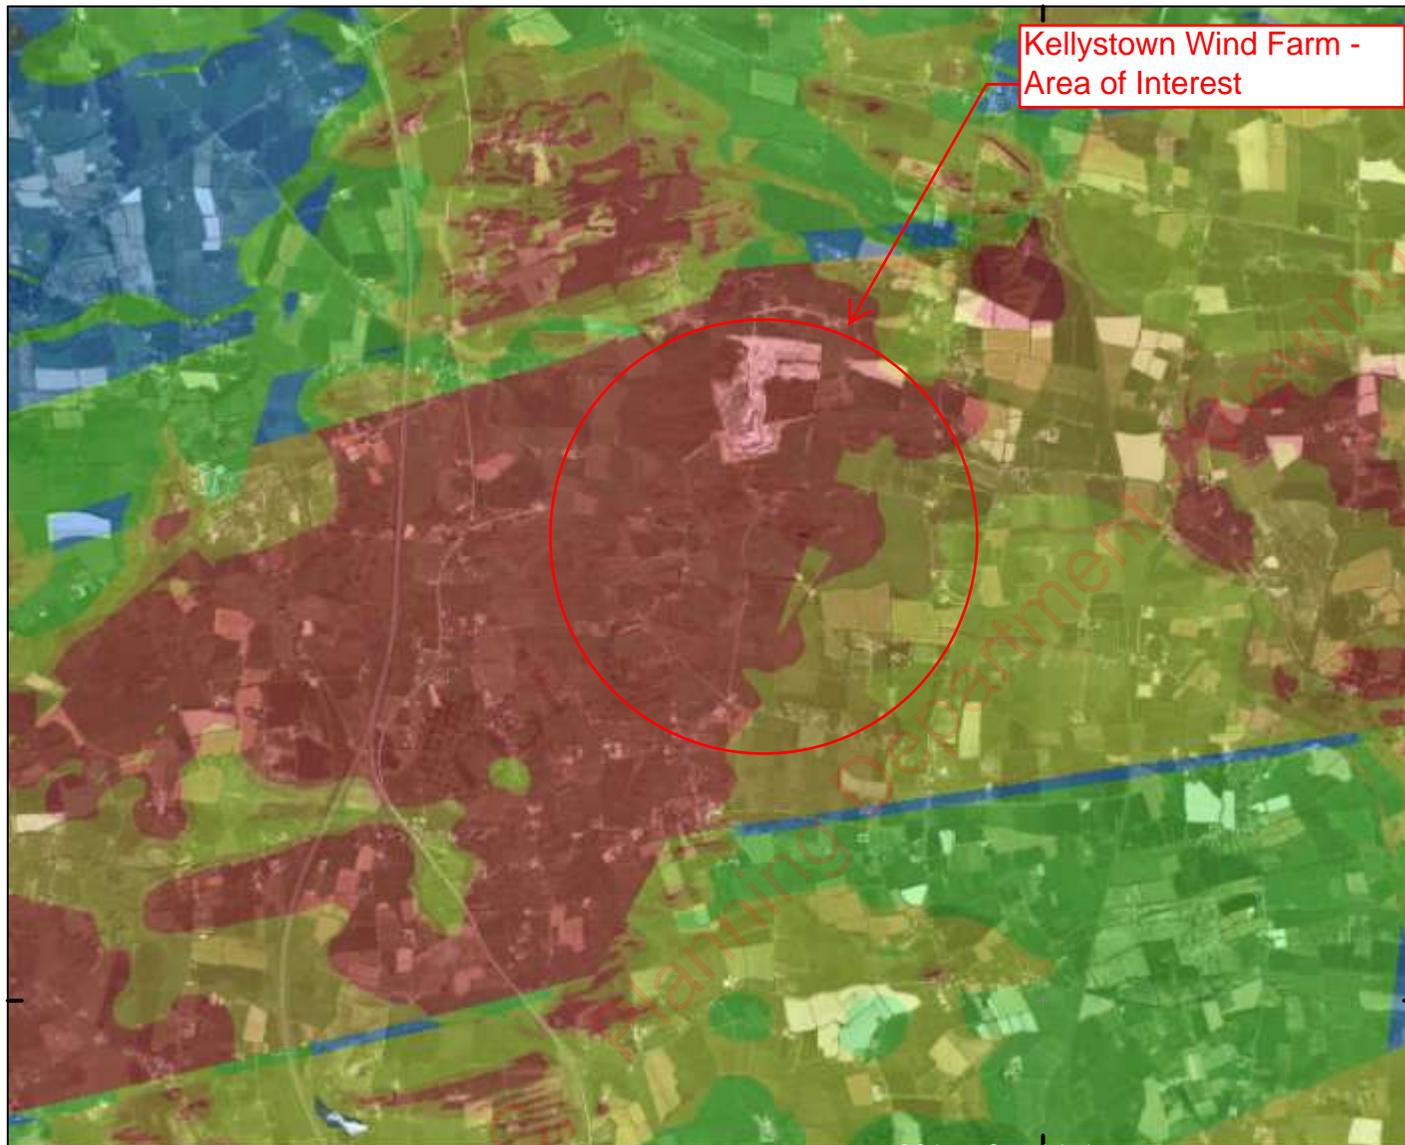
Crushed Rock Aggregate Potential

- Very High potential
- High potential
- Moderate potential
- Low potential
- Very Low potential

9	Predicted Performance as a construction aggregate	Only Medium Strong SILTSTONE rock strata (or better) has potential. This material was not encountered during the SI campaign, but believed to be present at depths > 3.50m below existing ground level. This material can be expected to produce significantly less fine content than the weathered strata that has been identified in the majority of the trial holes.

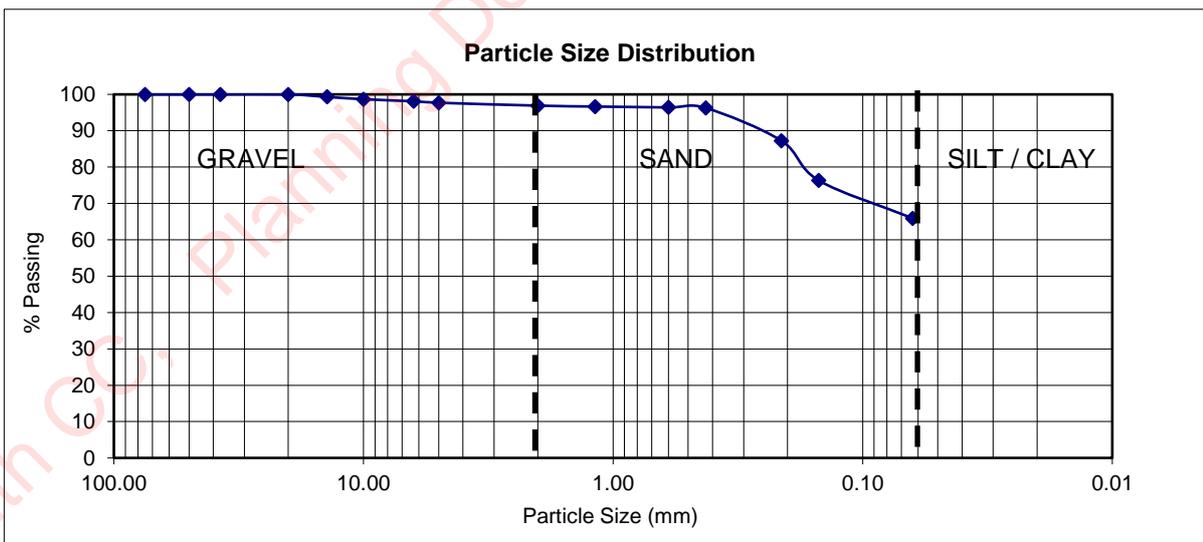
Location: Kellystown WF		Job ref:	2200-23	
Soil description: Sandy, SILT / CLAY		Borehole:	TP-A	
		Pit no.		
Test method BS 1377-2:1990:9.2/9.3/9.4/9.5*		Sample no.	1-50	
		Depth		
Initial dry mass (m1)		1847.10		
Mass of receiver (g)				
BS test sieve (mm)	Mass of dry soil + receiver (g)	Mass of dry soil retained (m2) (g)	Percentage retained (m2/m1)100	Cumulative percentage passing
75		0.00	0.00	100.00
50		0.00	0.00	100.00
37.5		0.00	0.00	100.00
20		0.00	0.00	100.00
14		12.90	0.70	99.30
10		11.70	0.63	98.67
6.3		10.70	0.58	98.09
5		7.20	0.39	97.70
2		14.80	0.80	96.90
1.18		4.50	0.24	96.65
0.6		4.50	0.24	96.41
0.425		2.90	0.16	96.25
0.212		166.00	8.99	87.27
0.15		202.30	10.95	76.31
0.063		191.90	10.39	65.92
Bottom tray		1217.70	65.92	0.00

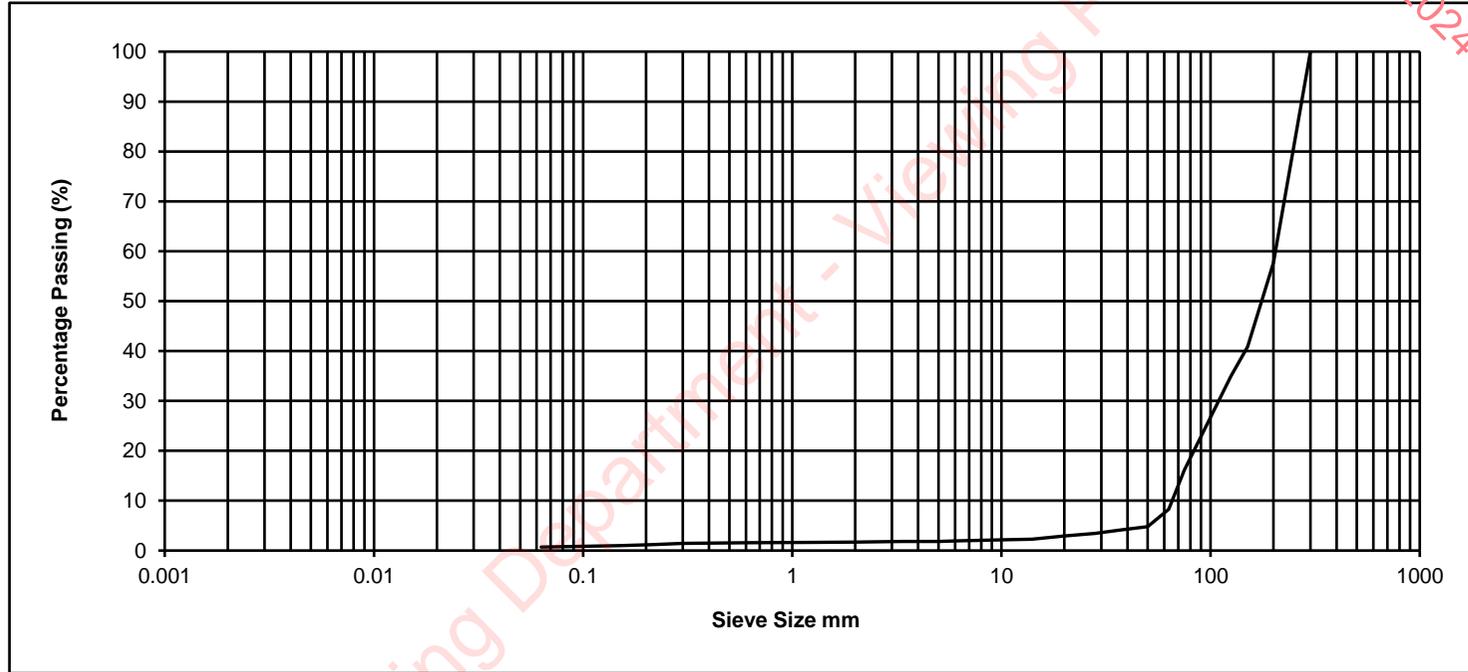
Sieve	%
Size mm	Passing
300.000	100
200.000	57.6535197
150.000	40.8487269
125.000	35.0
75.000	16.1
63.000	8.3
50.000	4.8
37.500	4.2
28.000	3.4
20.000	2.9
14.000	2.3
10.000	2.2
6.300	1.9
5.000	1.8
3.350	1.8
2.000	1.7
1.180	1.7
0.600	1.6
0.425	1.5
0.300	1.4
0.212	1.2
0.150	1.0
0.063	0.7

Percentage Particle Size											
Clay	Fine	Medium	Coarse	Fine	Medium	Coarse	Fine	Medium	Coarse	Cobbles	Boulder
	Silt			Sand			Gravel			91.7	0.0
	0.7			1.0			6.6

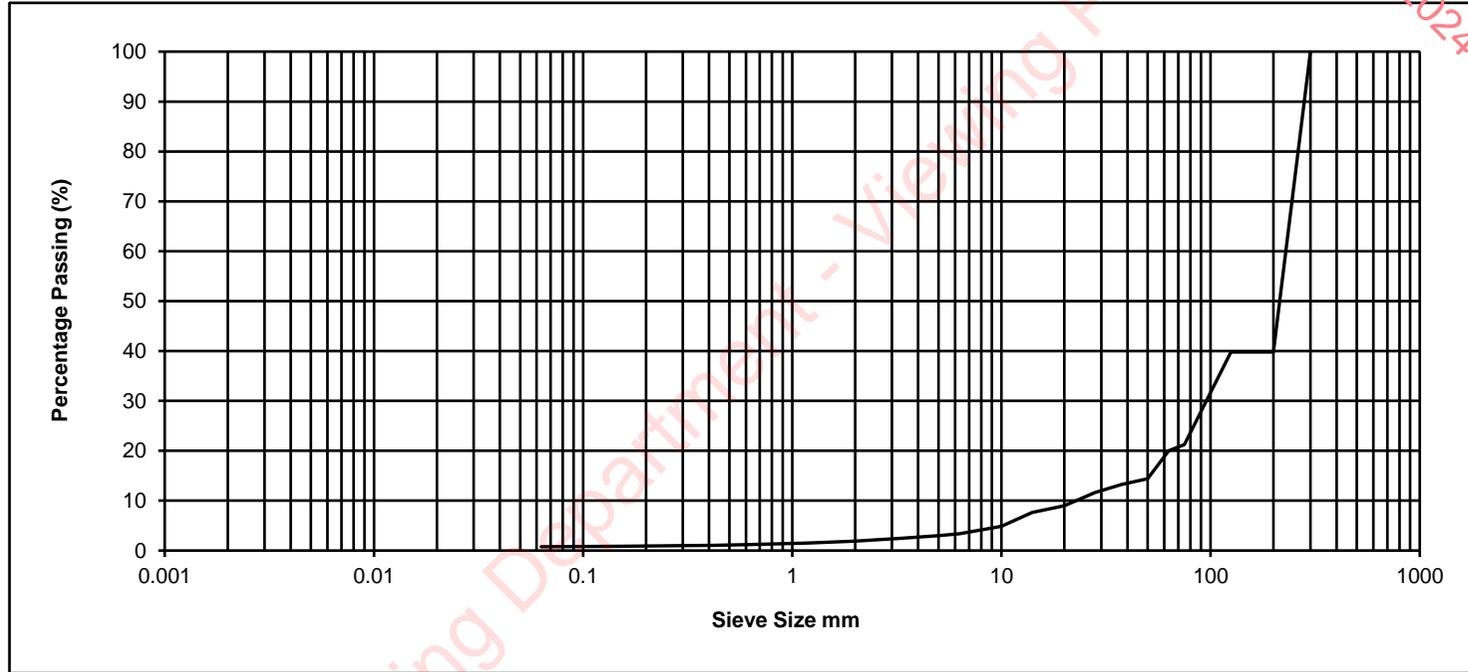
Sieve	%
Size mm	Passing
300.000	100
200.000	39.7827903
150.000	39.7827903
125.000	39.8
75.000	21.2
63.000	20.0
50.000	14.4
37.500	13.3
28.000	11.6
20.000	9.0
14.000	7.6
10.000	4.8
6.300	3.4
5.000	3.0
3.350	2.5
2.000	1.9
1.180	1.5
0.600	1.2
0.425	1.1
0.300	1.0
0.212	0.9
0.150	0.9
0.063	0.8

Percentage Particle Size											
Clay	Fine	Medium	Coarse	Fine	Medium	Coarse	Fine	Medium	Coarse	Cobbles	Boulder
	Silt			Sand			Gravel				
	0.8			1.1			18.1			80.0	0.0

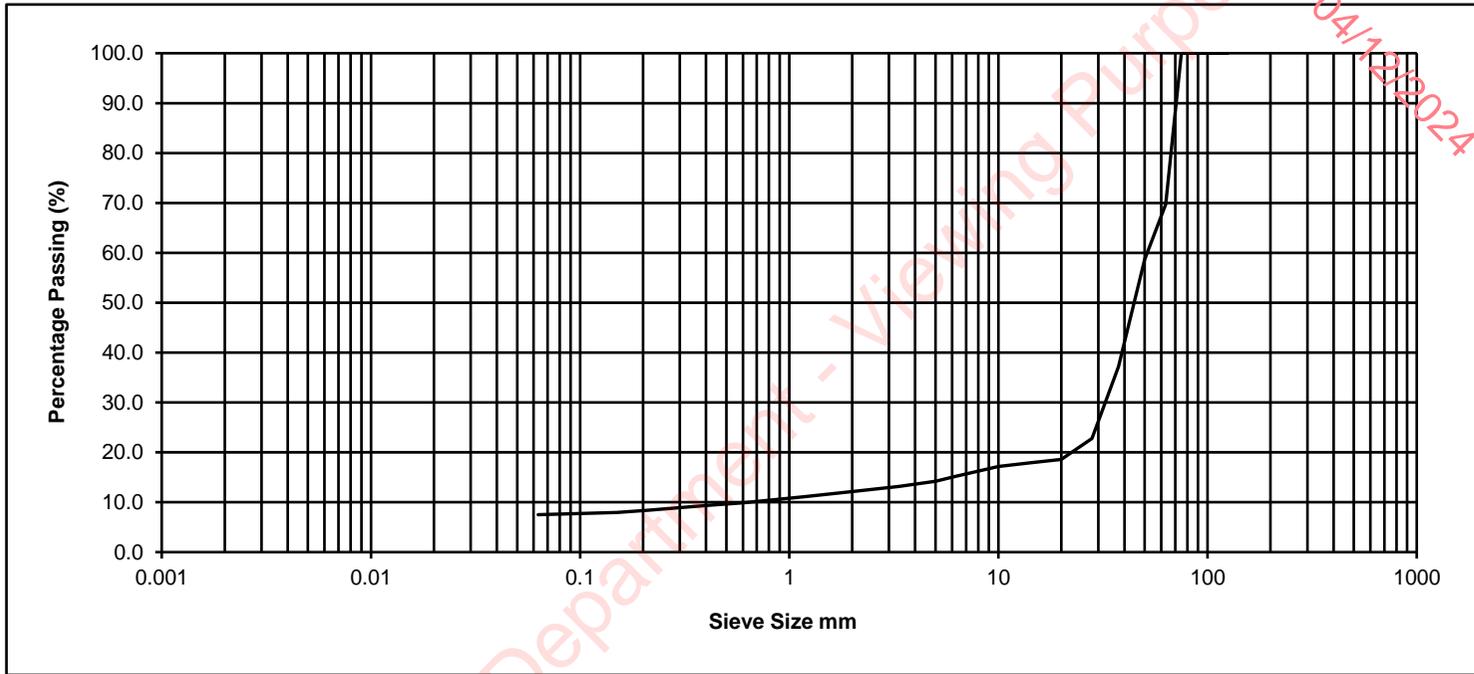
Determination of Particle Size Distribution
BS 1377 : 1990 : Part 2 : Clauses 9.2 & 9.5

Percentage Particle Size											
Clay	Fine	Medium	Coarse	Fine	Medium	Coarse	Fine	Medium	Coarse	Cobbles	Boulder
	Silt			Sand			Gravel			30.3	0.0
	7.5			4.6			57.6

Sample Description Silty sandy GRAVEL cont Cobbles

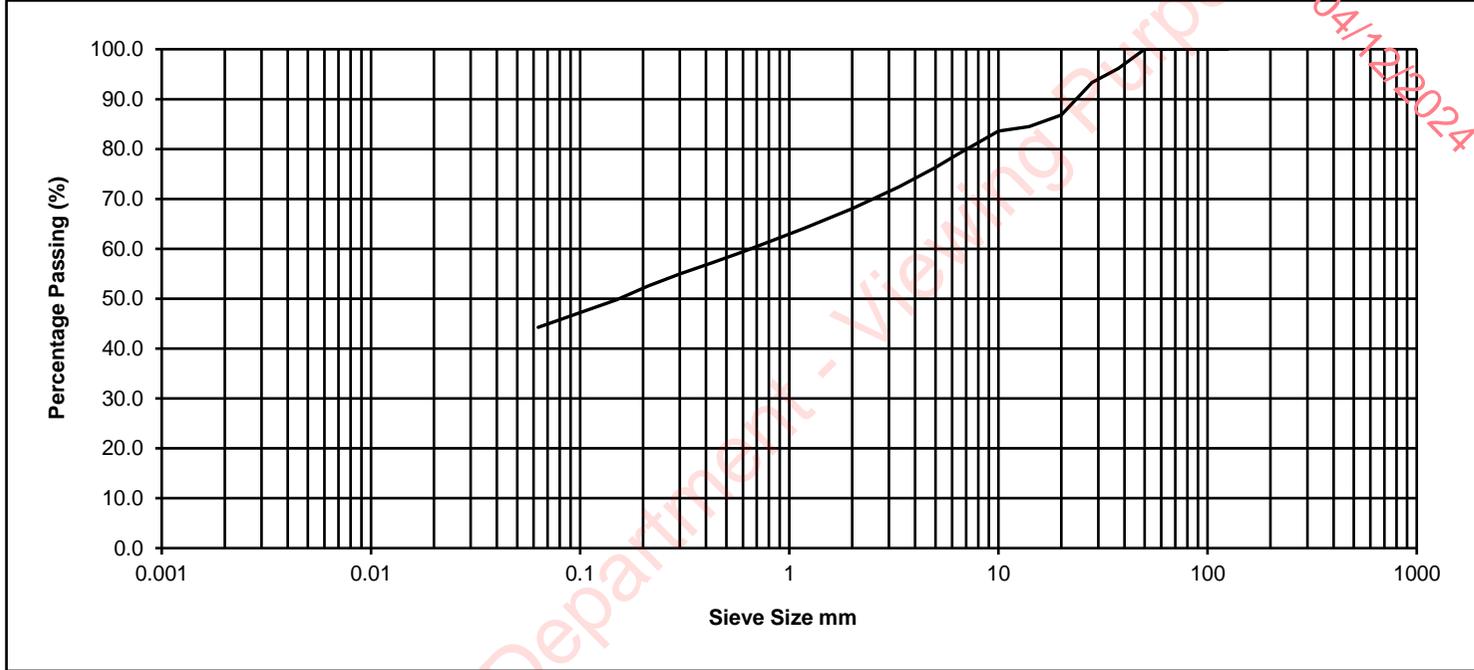
Determination of Particle Size Distribution
BS 1377 : 1990 : Part 2 : Clauses 9.2 & 9.5

Percentage Particle Size											
Clay	Fine	Medium	Coarse	Fine	Medium	Coarse	Fine	Medium	Coarse	Cobbles	Boulder
	Silt			Sand			Gravel				
	44.2			23.8			32.0			0.0	0.0

Sample Description Gravelly sandy SILT
