## 9 AQUATIC ECOLOGY

Please refer to **Chapter 2 (Description of the Proposed Development)** for a comprehensive overview of the site and the Development description. The project site, hereafter referred to as “the Site” is located approximately 9 km inland from Clogher Head, 2.5 km west of the village of Kellystown in Co. Louth. The proposal for the Site is mapped in Figure 9.1. The wider Development includes the Turbine Delivery Route (TDR) and Grid Connection Route (GCR), which are also considered in this chapter.

Figure 9.1. Kellystown Site Layout and Aquatic Ecology Survey Sites

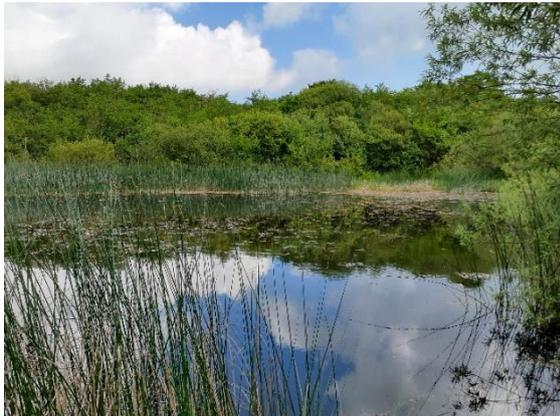
Plate 1. Drumshallon Lough, water quality location

Drumshallon Lough and its outflow stream (Sites 1 and 2 respectively) showed low taxonomic diversity and Q value scores, indicating moderate pollution. Though, the water chemistry here did not highlight any specific water quality issues, except for low DO at Site 2, the Q-value score indicates an absence of sensitive macroinvertebrates and suggests it also has water quality issues. The Q-value results from Piperstown Stream (Site 3) indicated moderate ecological pollution, corroborating the water chemistry results showing nutrient pollution from nitrogen/nitrates.

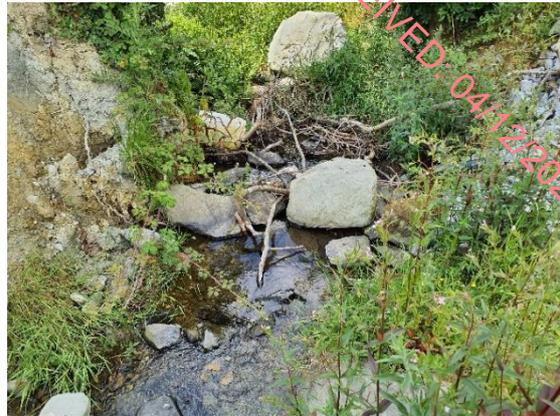
Plate 2. Site 2 water quality and kick sample location, photo facing upstream

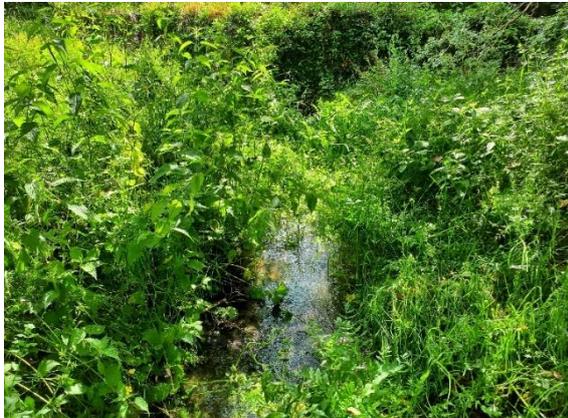
Plate 3. Site 3 water quality and kick sample location, facing downstream

Ammonia and Nitrogen concentrations were low across the sites. Total Oxidised Nitrogen (TON) as N was high at Site 3, but otherwise low. Total Nitrogen followed a similar trend, high levels at Site 3 and lowest at Sites 5 and 8; however, the highest concentration was found at Site 7.

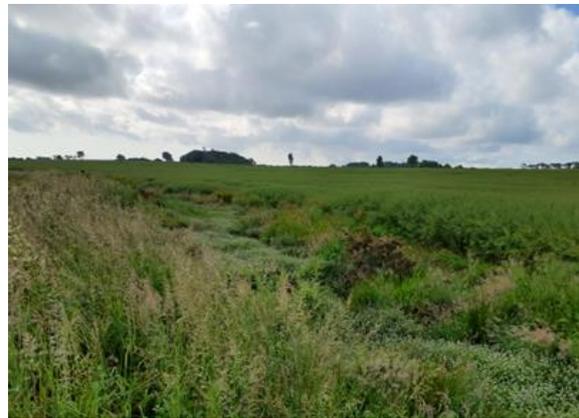
Plate 4. Site 4 unsuitable for water quality or kick sampling

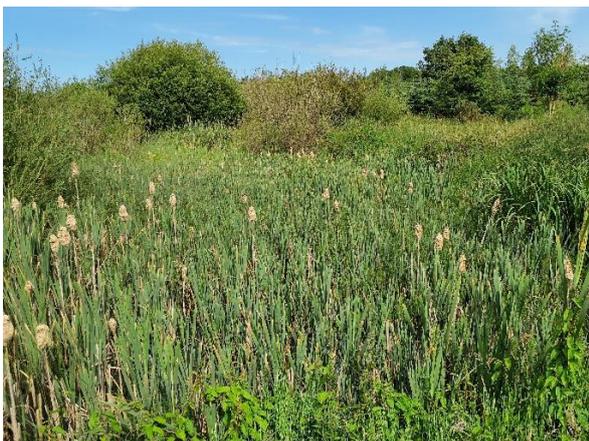
Plate 5. Site 5 water quality location, unsuitable for kick sampling

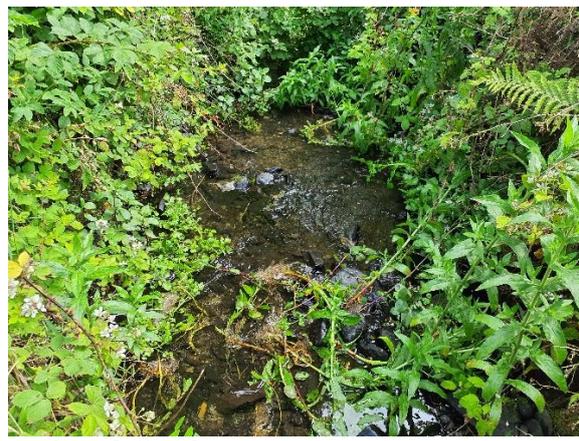
Plate 6. Site 6 water quality and kick sample location, facing downstream

All Sites were classified as Q3, indicating moderate pollution (and representing poor ecological status). The greatest taxa richness was found at Site 6.

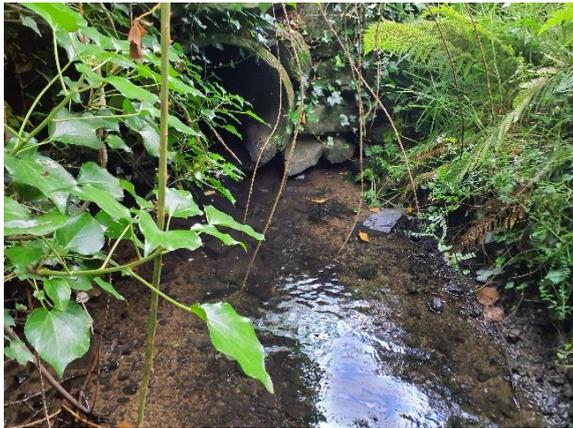
**Plate 7. Site 7 water quality and kick sample location, facing downstream**

Site 7 on the Slieveboy stream displayed the worst macroinvertebrate metrics and the water quality results, with strong evidence of nutrient pollution (in the form of nitrogen/ nitrates) in its water chemistry, consistent with its macroinvertebrate results. Further investigations of the Slieveboy Stream, upstream of the quarry, may provide a greater understanding of the baseline water quality of the Slieveboy Stream, which would allow separation of any potential impacts on water quality caused by windfarm construction from those caused by the quarry. Further water quality sampling (and laboratory analysis) should be completed prior to, during and post construction, to inform the assessment of the potential impact from the windfarm construction.

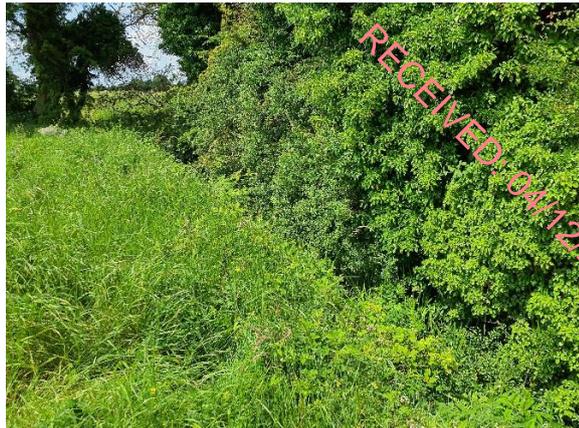
**Plate 8. Site 8 water quality location, unsuitable for kick sampling**
