GEOTECHNICAL AND PEAT STABILITY REPORT

GEOTECHNICAL & PEAT STABILITY REPORT

CURRAGLASS WIND FARM

Prepared for: MKO Ltd

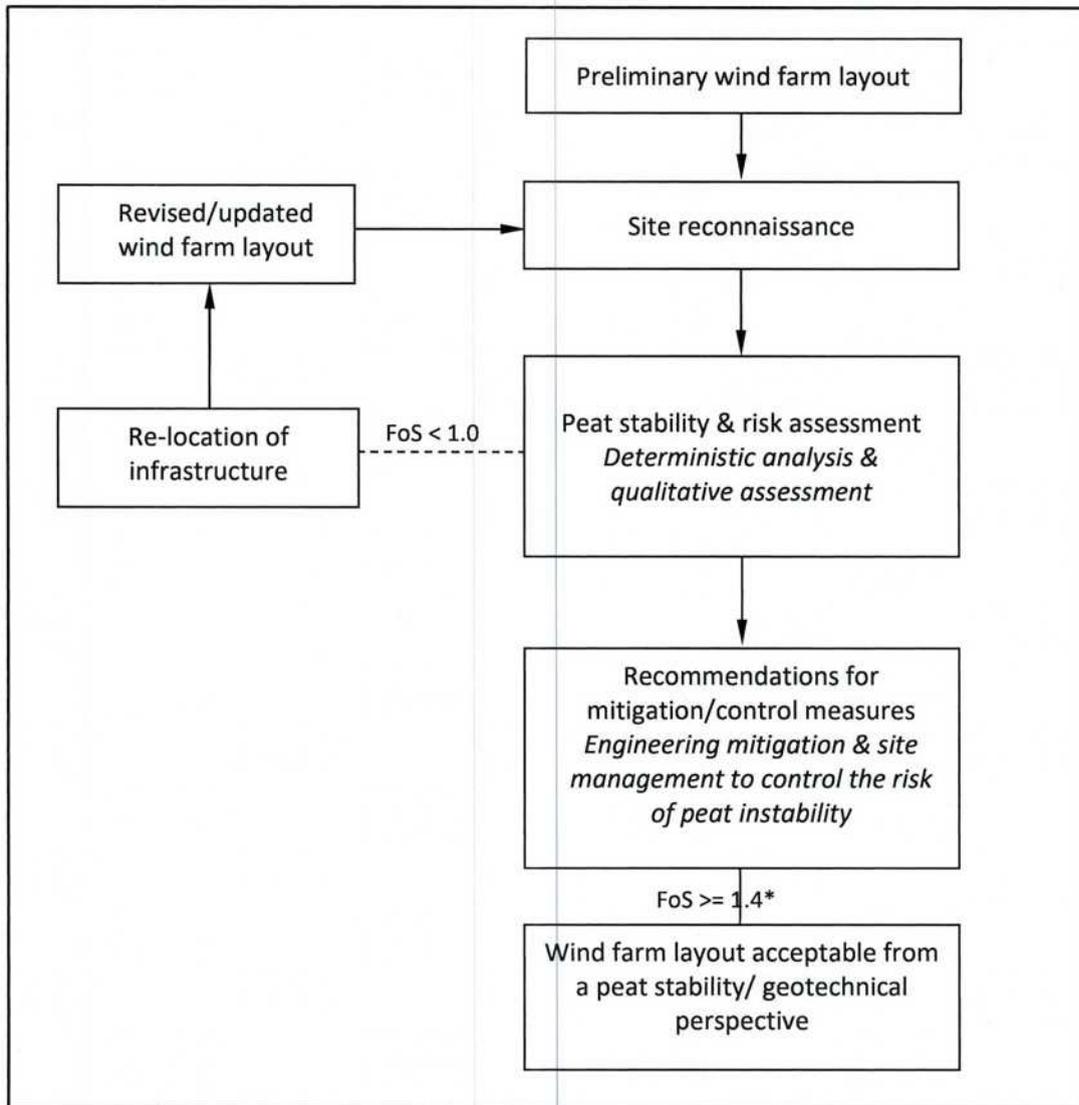
Figure 2.1: Methodology for Peat Stability Assessment

*An FoS of between 1.0 and 1.4 does not mean that a failure will occur, but that the area requires attention. Mitigation measures can be provided for areas with an FoS of between 1.0 and 1.4 to reduce the risk of failure.

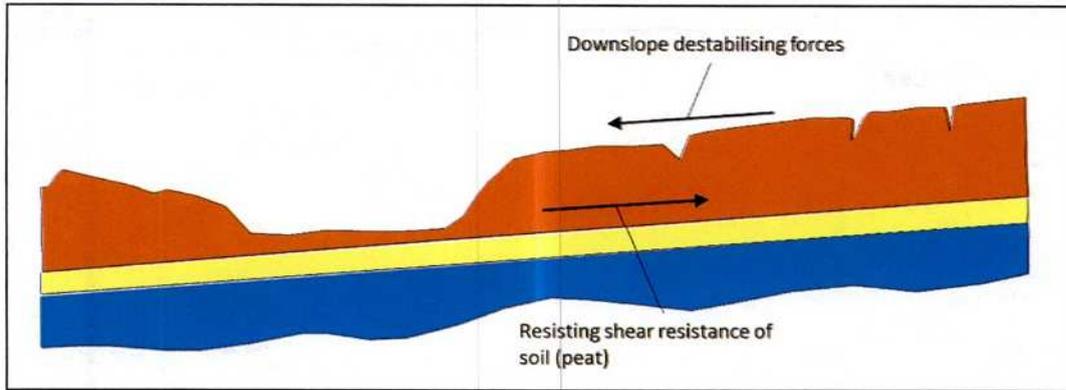
Figure 2.2: Peat Slope Showing Balance of Forces to Maintain Stability

The factor of safety is a measure of the stability of a particular slope. For any slope, the degree of stability depends on the balance of forces between the weight of the soil/peat working downslope (destabilising force) and the inherent strength of the peat/soil (shear resistance) to resist the downslope weight, see Figure 2.2.

The factor of safety provides a direct measure of the degree of stability of a slope and is the ratio of the shear resistance over the downslope destabilising force. Provided the available shear resistance is greater than the downslope destabilising force then the factor of safety will be greater than 1.0 and the slope will remain stable. If the factor of safety is less than 1.0 the slope is unstable and liable to fail. The acceptable range for factor of safety is typically from 1.3 to 1.4 (BS6031, 1981). A FoS of 1.4 is taken as indicative of sufficient stability within this report, which would be deemed a conservative approach.

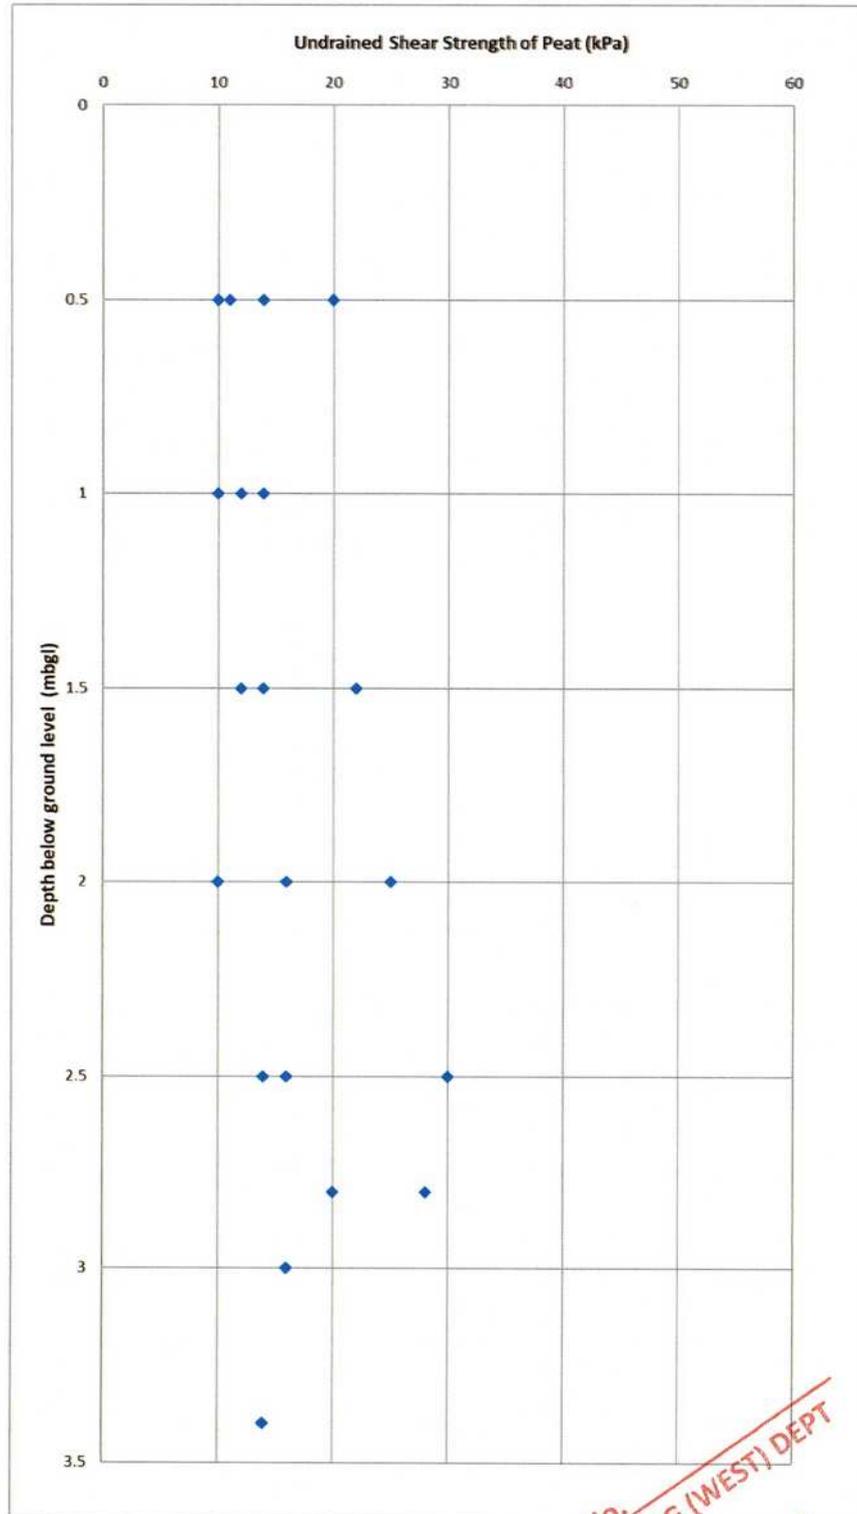
Figure 6.1: Undrained Shear Strength (c_u) Profile for Peat with Depth

Peat strength at sites of known peat failures (assuming undrained loading failure) are generally very low. For example the undrained shear strength at the Derrybrien failure (AGEC, 2004) as derived from back-analysis, was estimated at 2.5kPa. The recorded undrained strength at the Site is greater than the lower bound values for Derrybrien, indicating that there is no close correlation to the peat conditions at the Derrybrien site and that there is less likelihood of failure on the Site

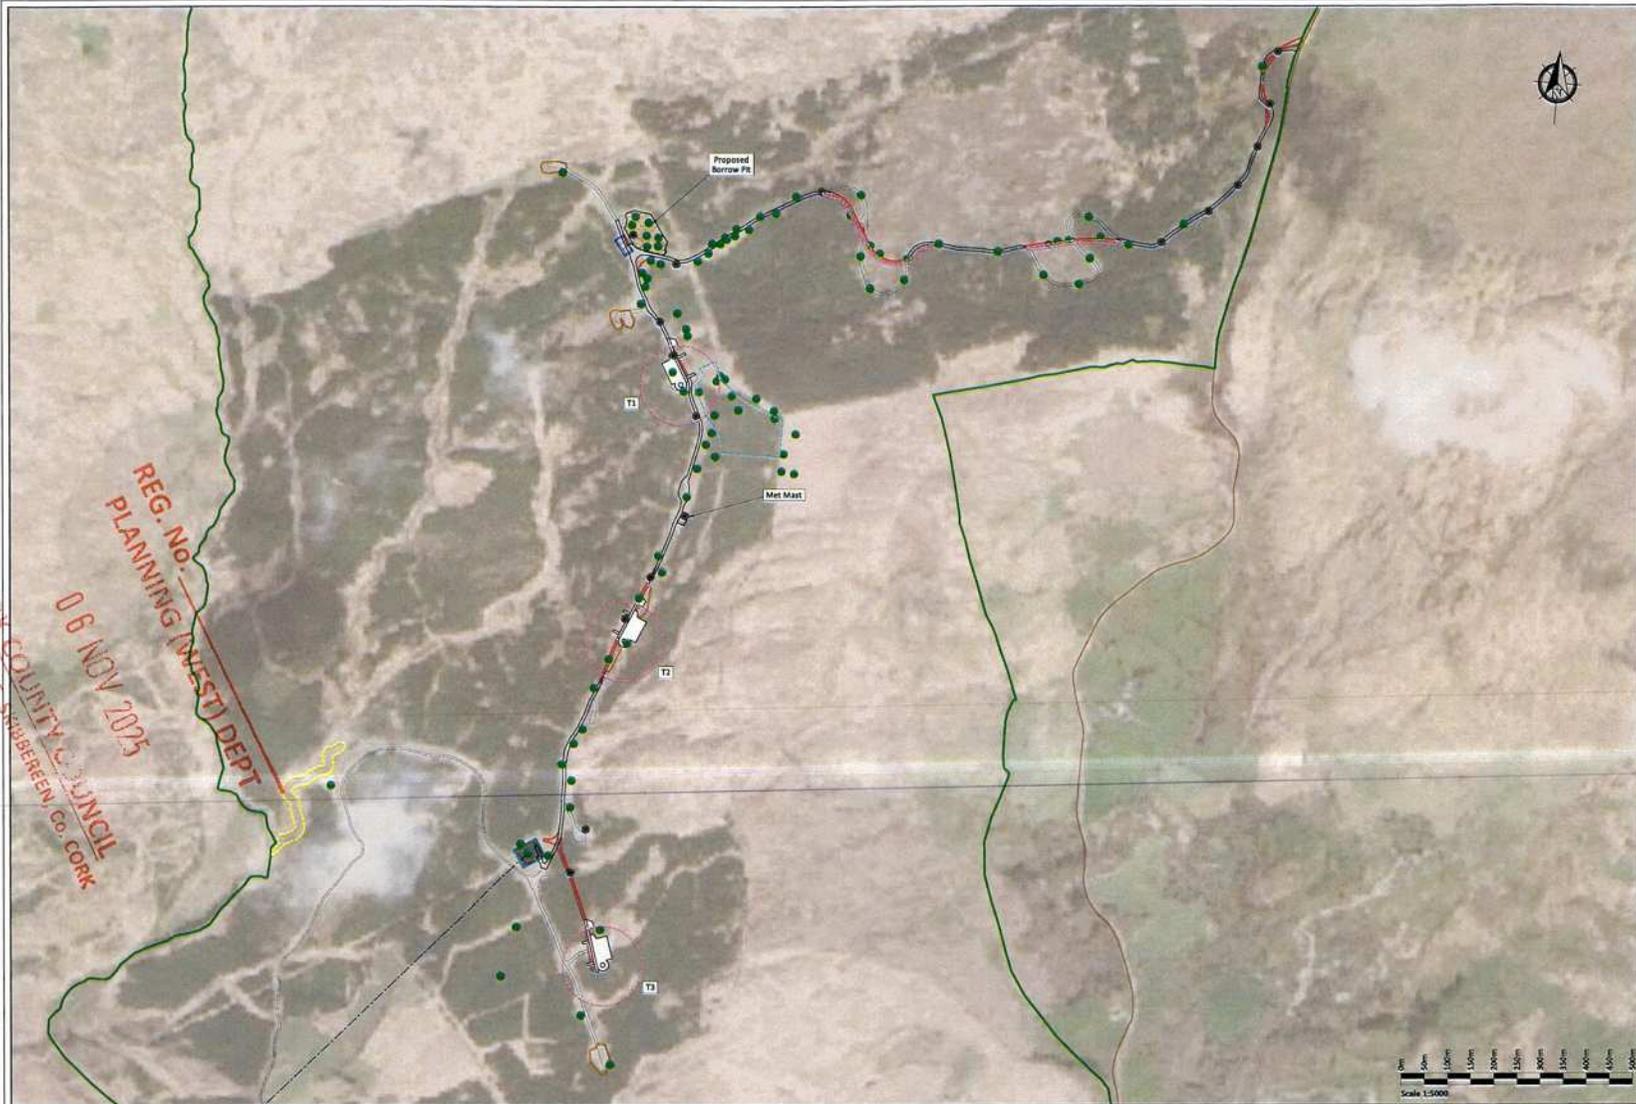
- Factor of Safety Legend:**
- 0 < 1.0
 - ≥ 1.0 < 1.3
 - ≥ 1.3
 - No Peat Recorded At This Location
- Assigned Direction ↓

- (5) Factor of safety plan – compiled for the short-term critical condition (undrained) for 92 no. FoS points analysed along the proposed infrastructure envelope on the Site.

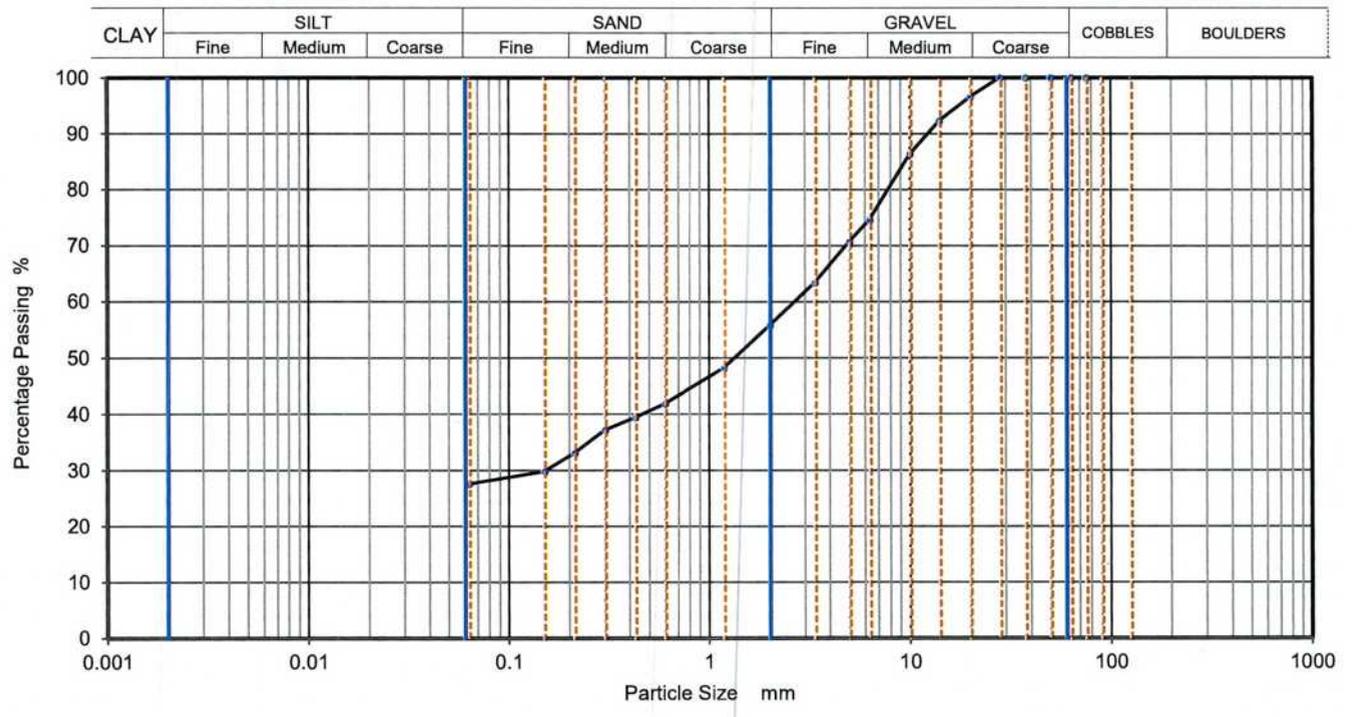
PARTICLE SIZE DISTRIBUTION

| | | | | | |
|--|---|---|--|---|---|
| JOB REF 2024C111 | | Borehole/Pit No. TP-T02 | | | |
| | | | | Site Name Curraglas Wind Farm | |
| Soil Description Light greyish-brown very silty very sandy fine and medium GRAVEL. | | Sample No. 3 | | | |
| Depth, m 2.50 | | Specimen Reference <table border="1" style="width: 100%; border-collapse: collapse;"> <tr> <td style="width: 50%;">Specimen Depth</td> <td style="width: 50%; text-align: center;">m</td> </tr> </table> | | Specimen Depth | m |
| Specimen Depth | m | | | | |
| Sample Type B | | Test Method BS1377:Part 2:1990, clause 9.2 | | | |
| KeyLAB ID IDL12025013020 | | | | | |

Based on the results of the particle size distribution (PSD) tests, the descriptions on the final trial pit logs have been updated. PSD results indicate that the gravel have a fines content of between 20 and 30%. Moisture content testing on samples of the gravel recorded results to 10 to 21%.

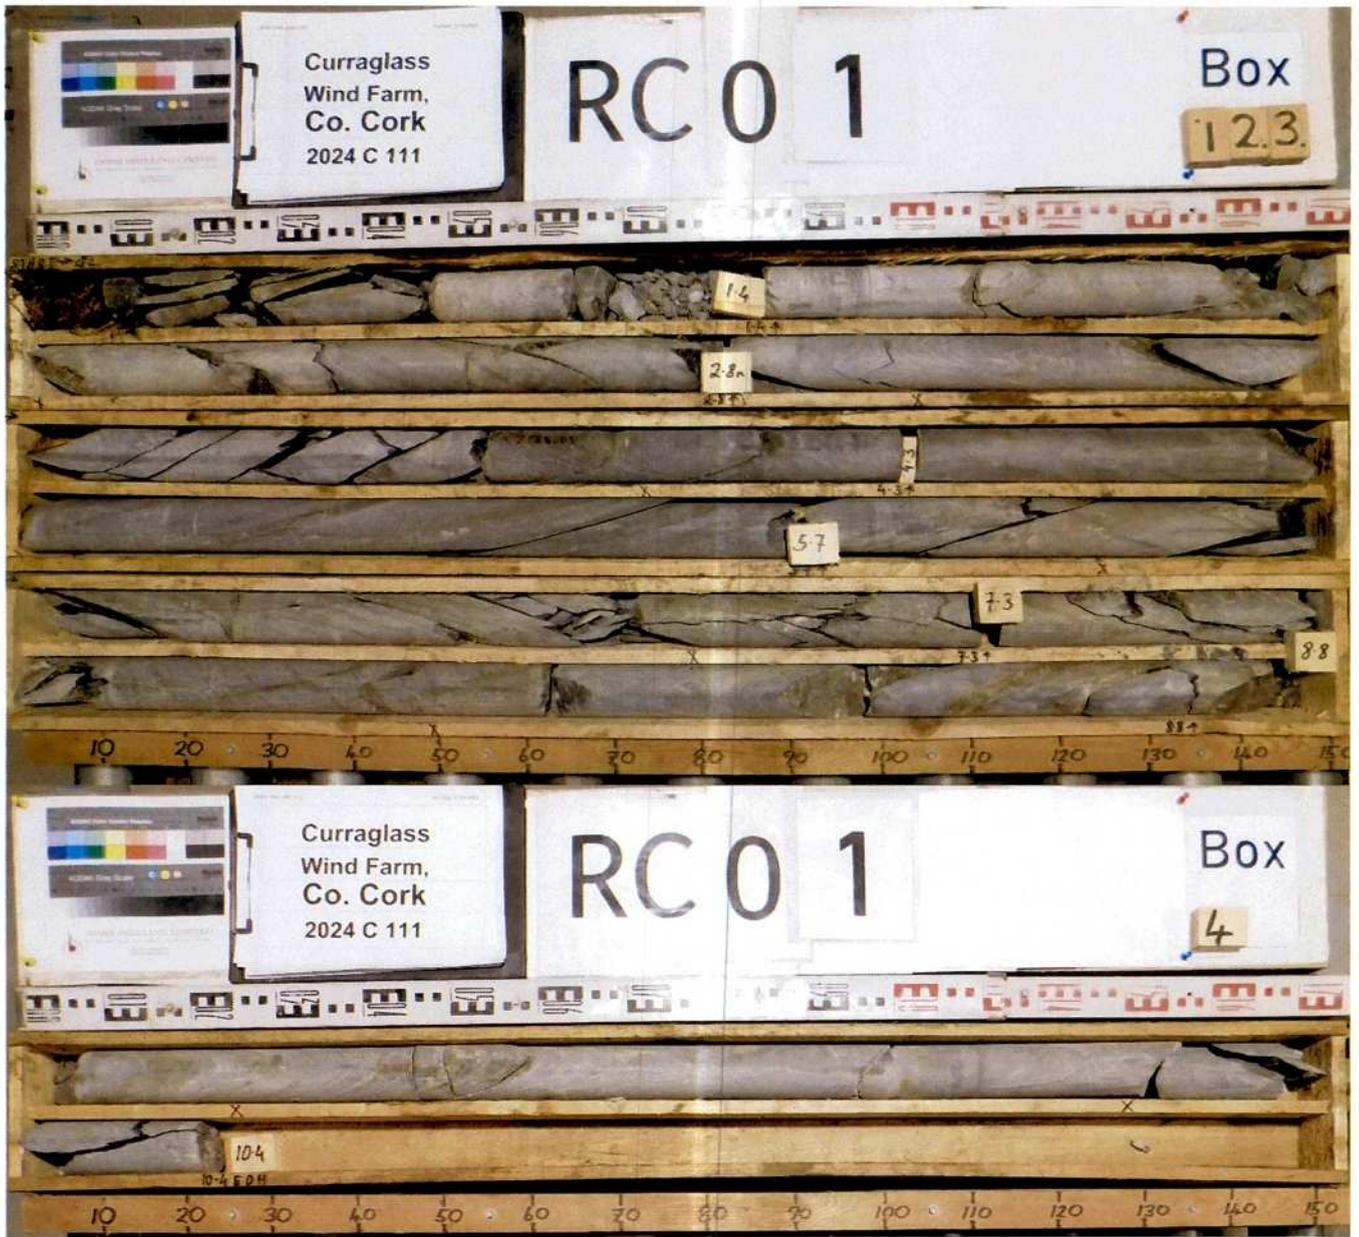
Irish Drilling Ltd: Core Photos:

One rotary core borehole was carried out to establish overburden conditions and rockhead and to establish the nature and integrity of the underlying rock.
