Environmental Impact Assessment (‘EIAR’) Volume 3 – Appendices

Continuance of Use & Extension to Ballyburn Pit

Dan Morrissey & Co. (Plazamount Ltd)

**Ballyburn Upper, Gortenvacan,
Knockbane, Castledermot, Co.
Kildare**

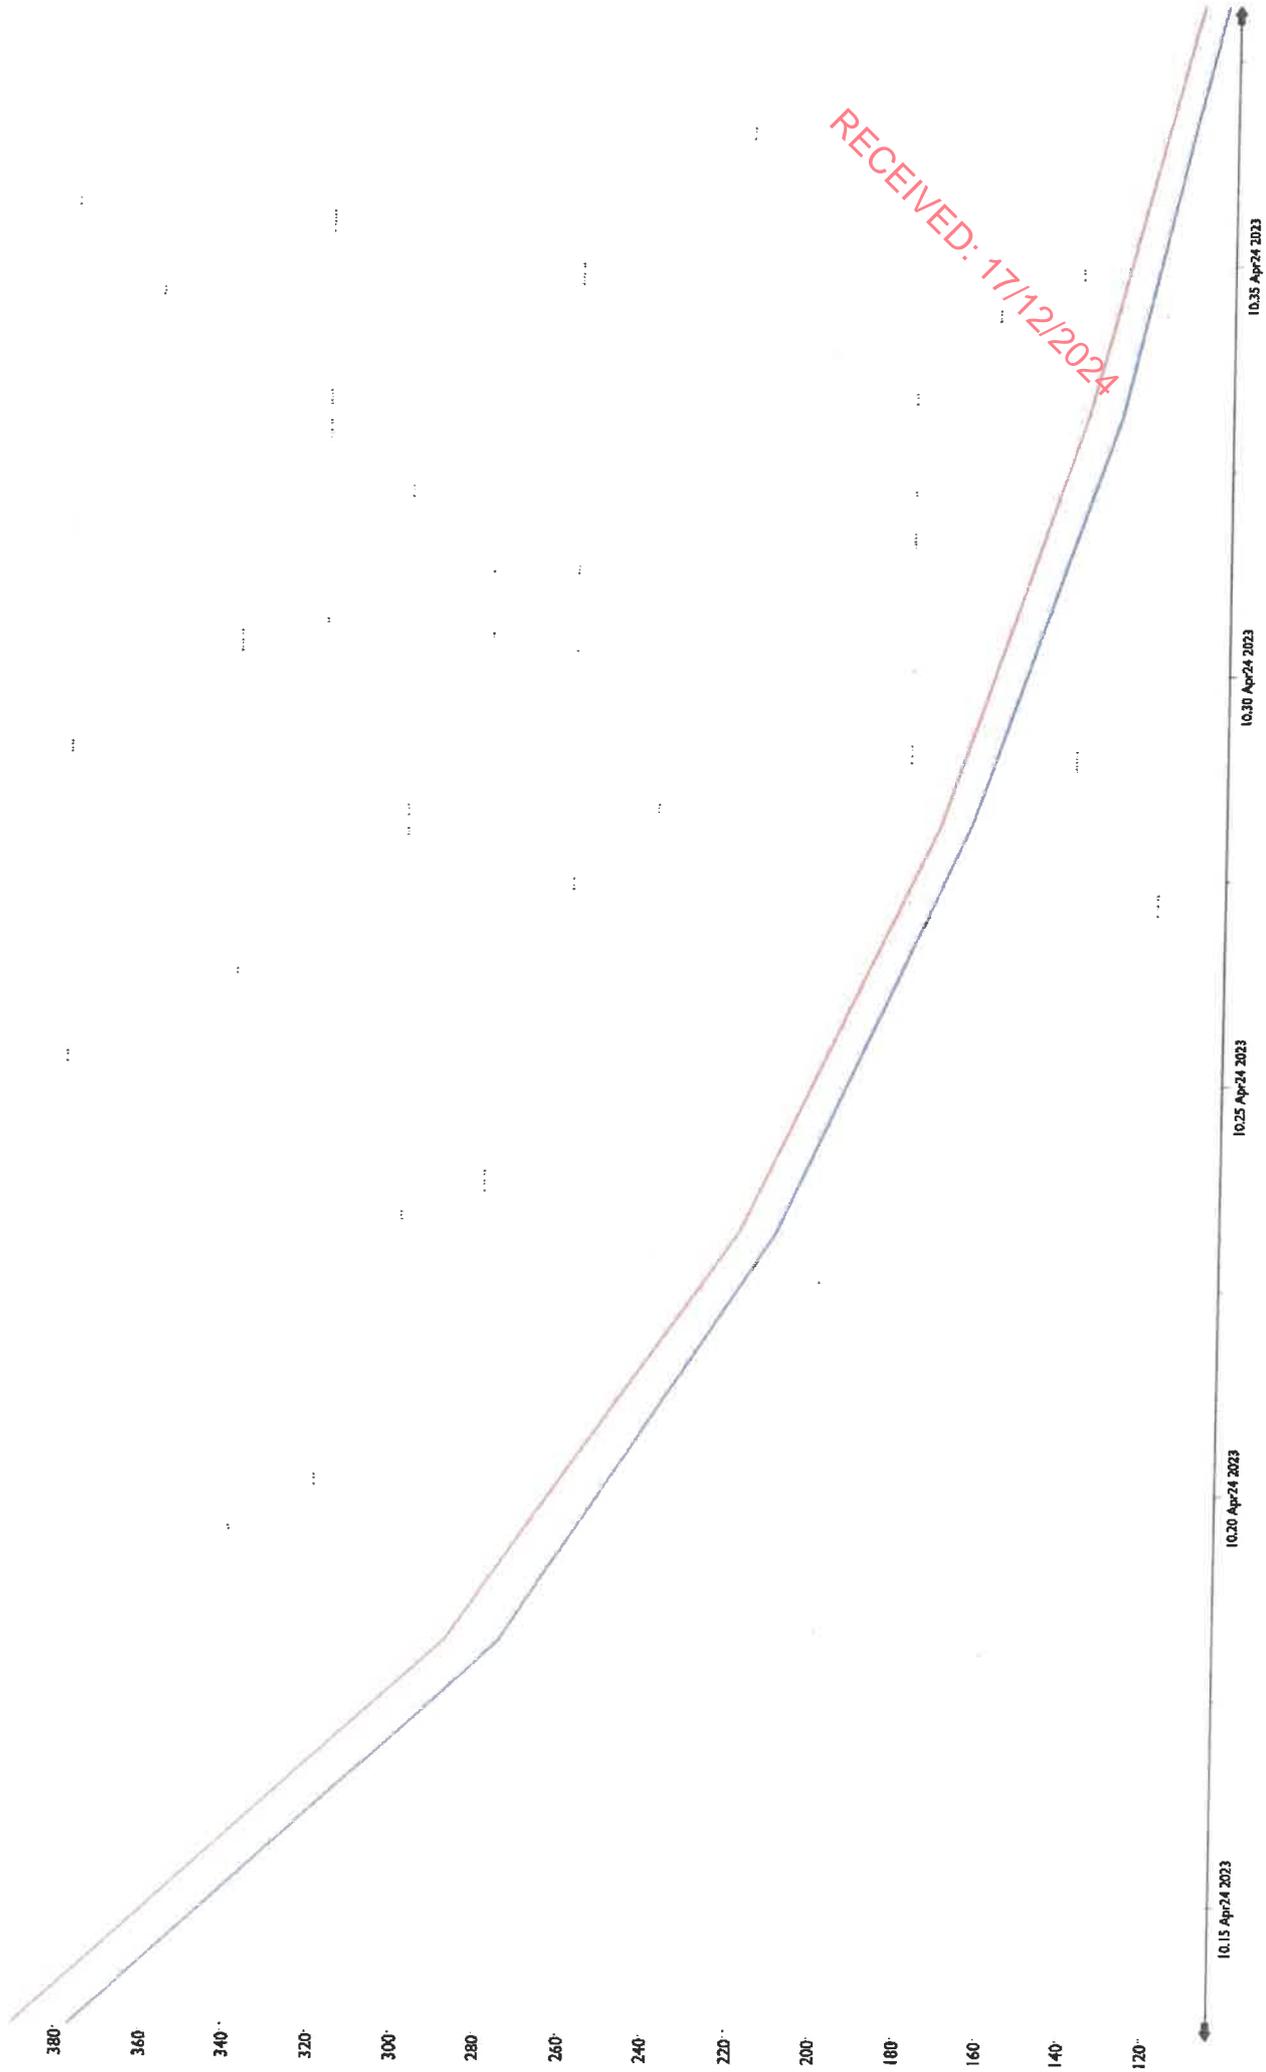
PM10: TNO2135/T3000089 — PM10: TNO436/T3000086
µg/m³

Instrument Calibration against Reference Instrument				
reading is with new calibration factor applied				
Fraction	Zero	Reading	Reference	New Cal. Factor
TSP	0.0 µg/m ³	227.2 µg/m ³	242.4 µg/m ³	1
PM10	0.0 µg/m ³	211.7 µg/m ³	221.1 µg/m ³	1
PM2.5	0.00 µg/m ³	194.65 µg/m ³	204.34 µg/m ³	1
PM1.0	0.00 µg/m ³	118.06 µg/m ³	116.31 µg/m ³	1
Reference Instrument: TNO2135		Date Reference Calibrated: 15/05/2023
