Archaeological Impact Assessment: Test Excavation Report Shelburne Energy Farm, Nash, Co. Wexford

Licence Number: 26E0034

Deirdre Murphy
March 2026
Report Status: Final

Project	Shelburne Energy Farm, Nash, Co. Wexford
Report Type	Archaeological Test Excavation
Licence No.	26E0034
Detection Device Licence No.	26R0054
Townlands	Cloonagh, Ballygarvan, Nash
RMP/SMR No.	WX040-002----, WX035-049001-, WX035-049002-
RPS Id./NIAH Reg. No.	N/A
ITM Ref.	677600, 619300
Consultant	Archaeological Consultancy Services Unit, 21 Boyne Business Park, Greenhills, Drogheda, County Louth
Archaeologist	Deirdre Murphy
Report Author(s)	Deirdre Murphy
Report Status	Final
Report Date	March 2026
ACSU Ref.	24122

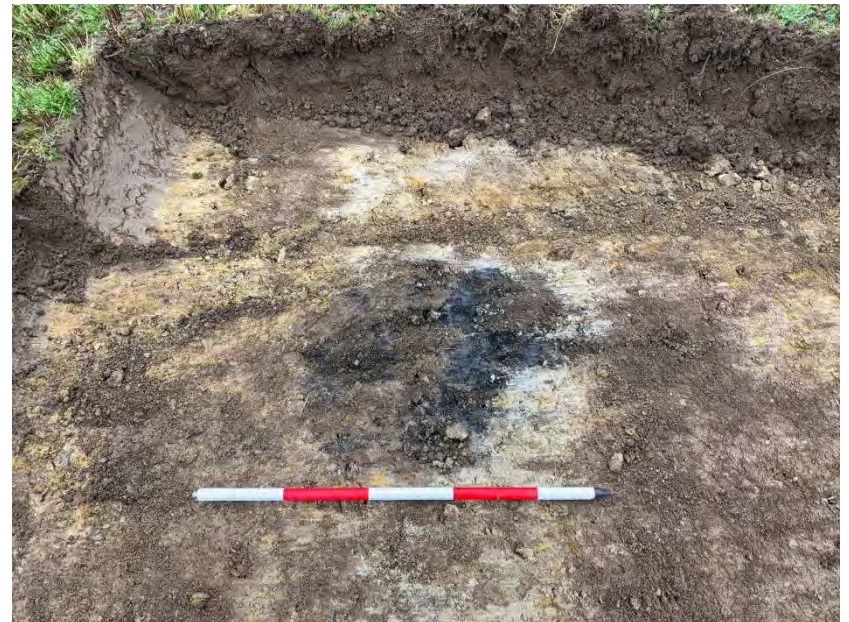
Plate 4: C301 facing north

Context	L(m)	W(m)	D(m)	Basic Description
				dark brownish black sandy clay (plate 4). A fragment of barbed wire recovered from the fill indicated it to be modern in date.
C1101	2.00m	1.00m	NA	A NW-SE linear 1.00m wide that ran for 2m before going beyond the limit of excavation. Located approximately midway along the trench (plate 13). Aligns with a modern field boundary shown on the 25-inch OS map.
C1201	3.20m	1.6m		At the NE end of trench 12, a significant area of burning, C1201, was noted. It measures measured 3.20m L x 1.6m W. Burning of the natural was also present sporadically throughout the length of trench (plate 14). A body sherd of modern ceramic was recovered from the fill.
C5001	1.2m	1.8m		A large shallow burnt spread measuring 1.2m w x 1.8m consisting of mid blackish grey sandy clay. Likely to be non-archaeological due to depth less than 5cm and presence of root activity and loose stone. (plate 54).

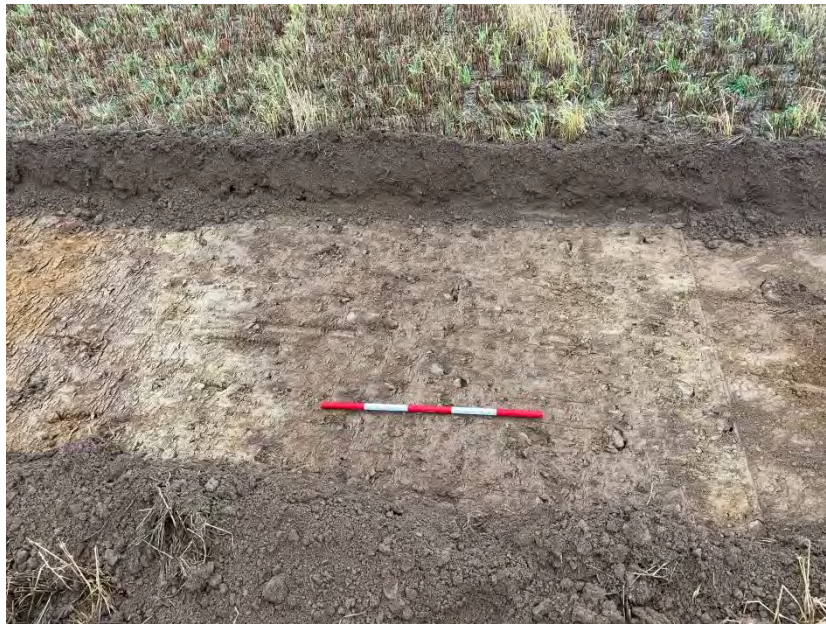
Plate 13: C1101 facing northwest

In trench 11 (Plate 13), a 1.00 m wide northwest-southeast linear was observed approximately mid way along the trench, filled with a mid grey silty clay. It was aligned with a modern field boundary shown on the 25 inch OS map (Figure 4). A large area of scorched earth, C1201 (Plate 14), comprised of a reddish grey silty clay, was noted at the southwestern end of trench 12. C1201 measured 3.20m L x 1.6m W and contained some body sherds of white ceramic pottery.

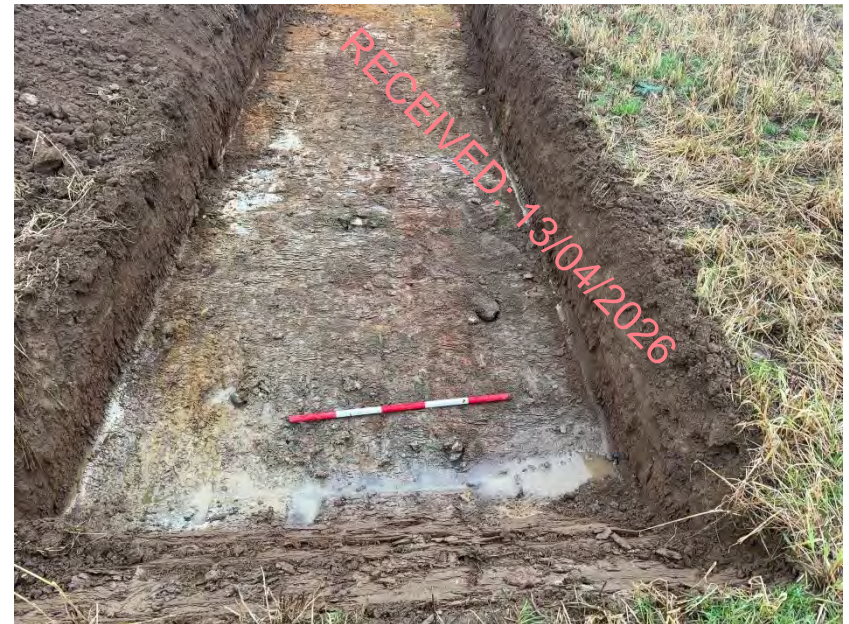
Plate 14: C1201 facing northeast

12	50	0.3-0.7	Trench aligned northeast to southwest. Located at the base of NE-SW slope causing topsoil to be deeper at SW end. Topsoil varied between 0.3-0.7m onto a yellowish orange sandy boulder clay. A spread of burnt earth C1201 was recorded, along with sporadic burning of the natural noted along the

Context	Find Number	Basic Description
C1201	26E0034:1201:1	A body sherd of modern ceramic was recovered from the fill of an area of burning C1201.
C6701	26E0034:6701:1	A fragment of bottle glass was recovered from a small, isolated, burnt pit.

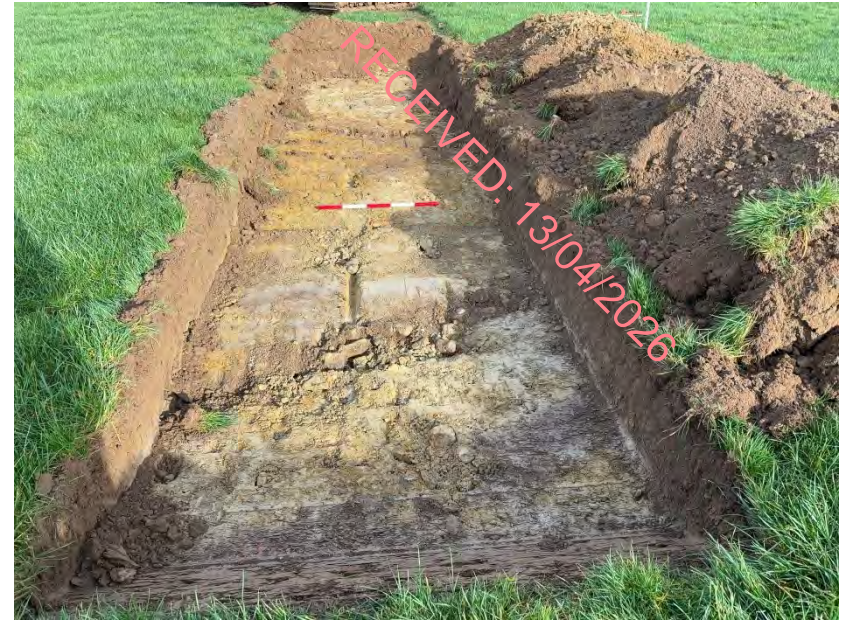
Plate 49: Trench 90 facing southwest

89	10	0.2	Trench aligned northeast to southwest. No archaeological features or deposits. 0.2m topsoil onto a greyish yellow sandy boulder clay. Area of manganese staining noted at end of trench. A NW-SE running stone drain was noted running through the trench.
90	10	0.2	Trench aligned northeast to southwest. No archaeological features or deposits. 0.2m topsoil onto a brownish yellow sandy boulder clay. A noticeable area of manganese staining throughout the trench (plate 49).

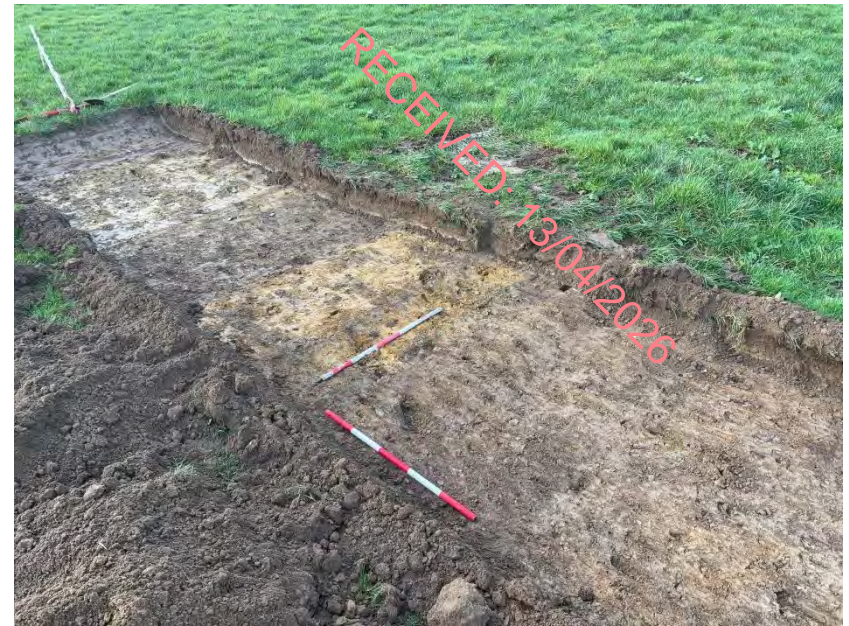
Plate 62: C5701 & 5702 facing northeast

Two parallel linears were noted in Trench 57 (Plate 62) These two linears aligned with linears noted during the geophysical surveys and on previous OS maps that showed previously known modern field boundary ditches. The first of the two parallel linears C5701 measured 1.00m W and ran for 2.00m was located c1.5m north of the second linear C5702 which also measured 1.00m W and ran for 2.00m.

C5701	2.00m	1.00		1st of 2 parallel linears in trench 57 1.0m W and 2.0m L. Two parallel shallow linears 5701 and 5702 aligning with former field boundaries shown in geophysics (plate 62) and OS mapping.
C5702	2.00	1.00		2nd of 2 parallel linears. Two parallel shallow linears 5701 and 5702 aligning with former field boundaries shown in geophysics and OS mapping. Measuring 1.0m W. and 2.0m L (plate 62).
C6701	0.65	0.3		Small isolated burnt pit measuring 0.65m l x 0.3w. Located 1.2m up from N from trench edge, 0.6m back from E from trench side (plate 73). A fragment of bottle glass was recovered.

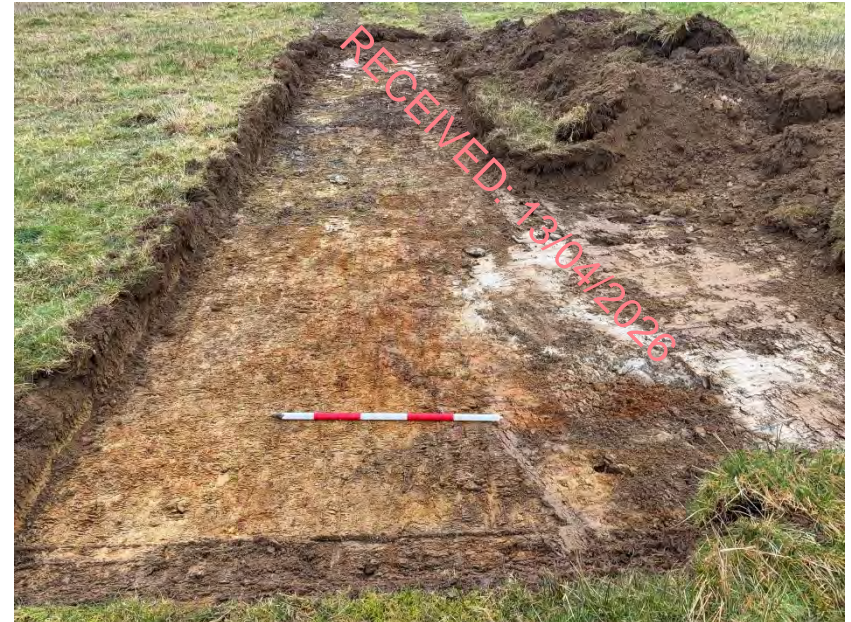
Plate 73: C6701 facing southwest

In trench 67, C6701 (Plate 73) a small isolated burnt pit measuring 0.65m L x 0.3m W was noted filled with a mid-greyish black sandy clay with flecks of charcoal and small sub angular pebbles. A fragment of bottle glass was recovered indicating the feature was of modern origin.
