## Illeunbaun Wind Farm - Environmental Impact Assessment Report

### Appendix A09-02: Peat Stability Risk Assessment (PSRA)

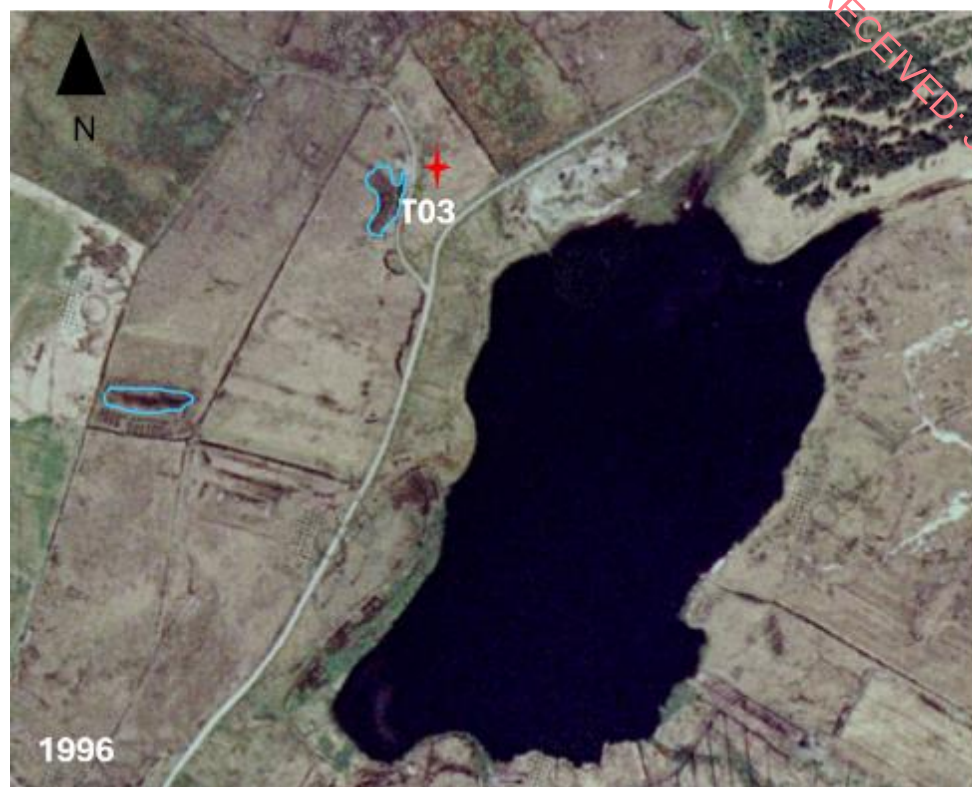
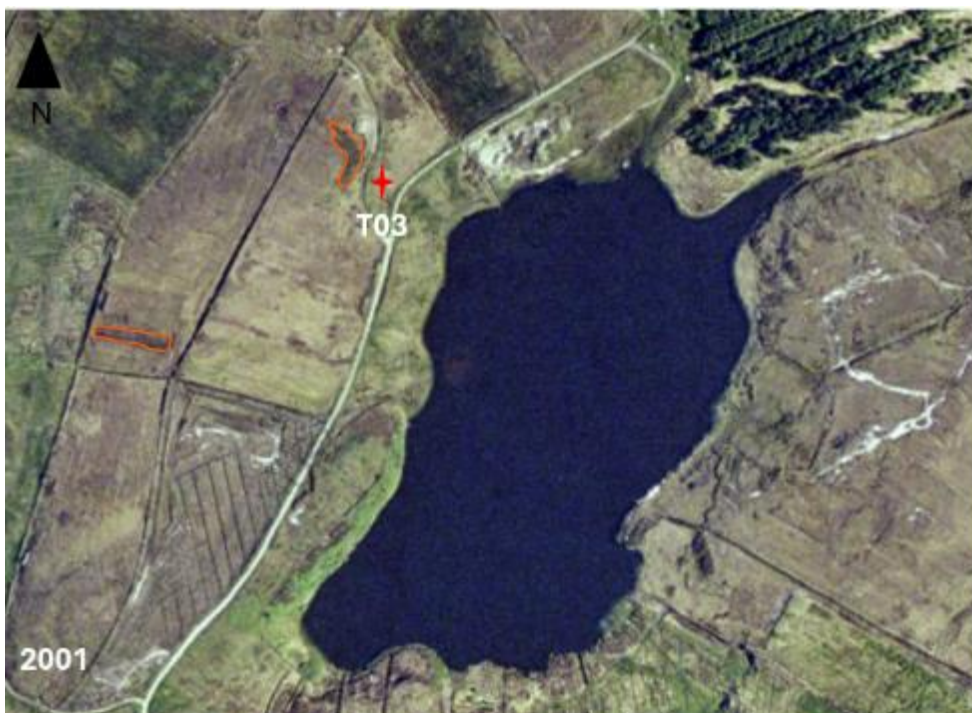
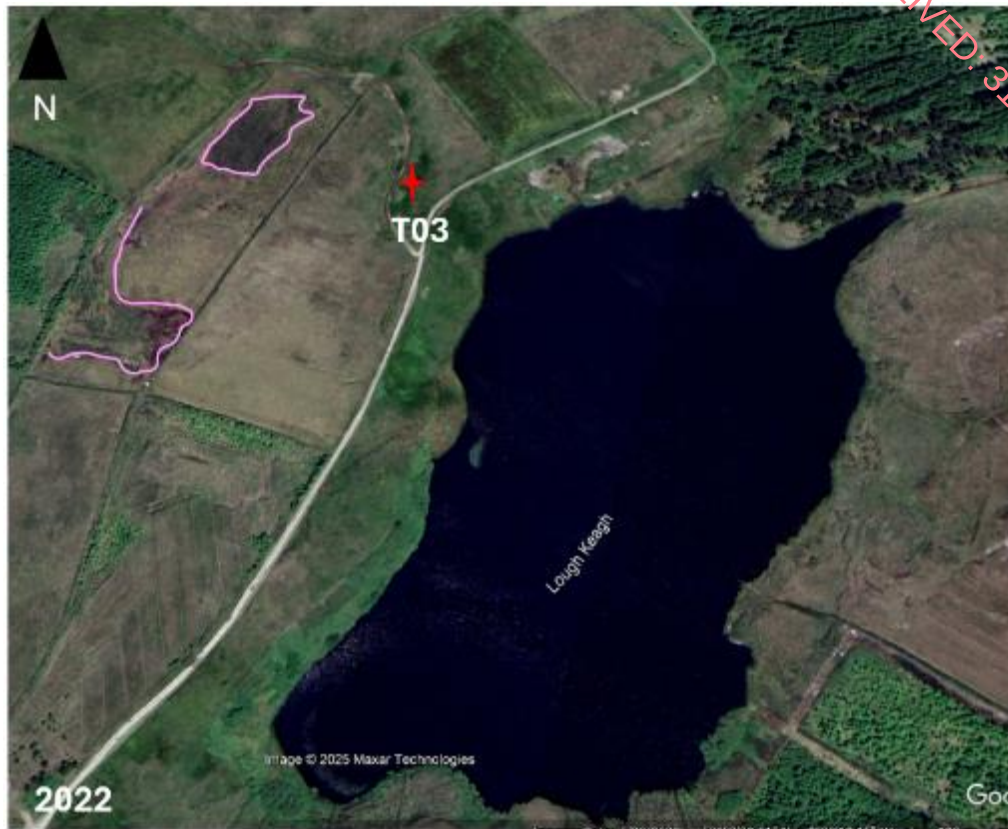
**Figure 2-1: Peat cuts and harvesting of peat to the west of T03, Ordnance Survey Ireland (OSI) aerial imagery, (1996-2013), Google Earth (2017-2022)**

A review of satellite imagery spanning the period from 1996 to 2022 revealed evidence of peat harvesting (marked across the satellite imagery in Figure 2-1) which was only observed in a small area to the northwest and southwest of T03, approximately about 90m northwest and 160m southwest of the turbine location. However, it is noted that the locations of turbines T2 and T5 are situated within a forestry plot that has undergone changes in tree density over this time.

Peat harvesting to the west of T03 was observed to progress at a slow rate until 2006, after which the intensity of harvesting notably increased. Despite this, the overall rate of harvesting is considered to be relatively low. This factor has been incorporated into the factor of safety analysis, with considerations made for section cuttings as part of the peat stability risk assessment

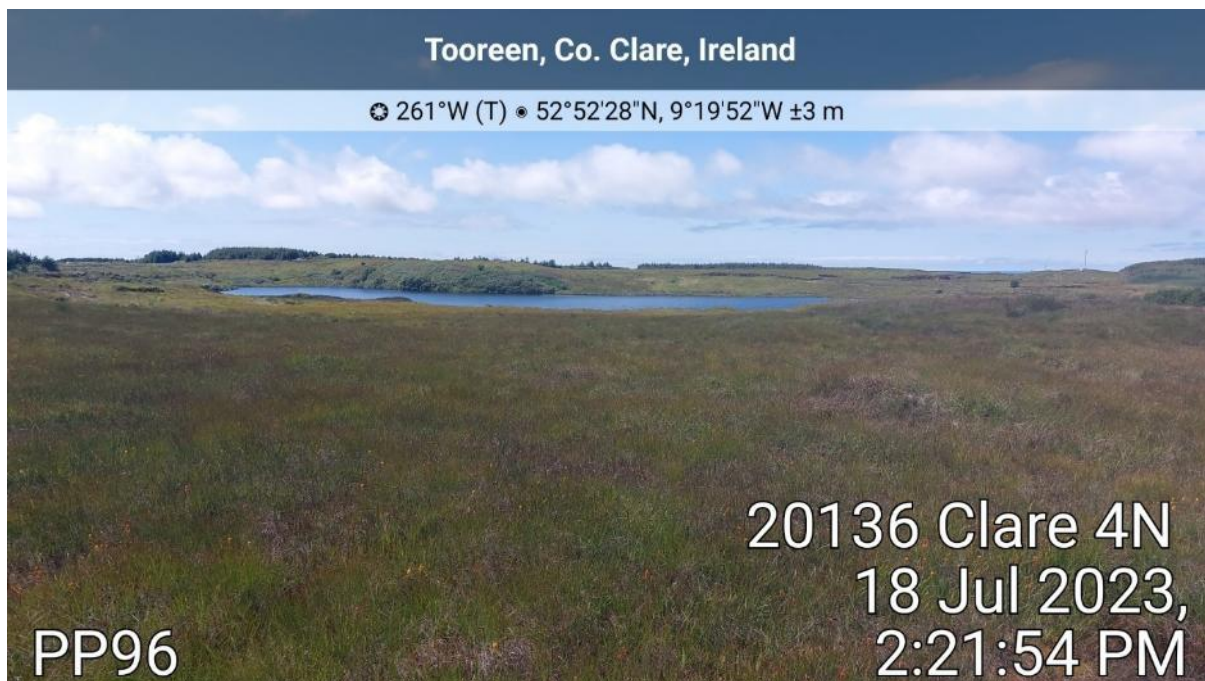
**Figure 3-1: View of Lough Keagh from PRA3, looking west across the T6 hardstand. Open cut-over blanket peat.**

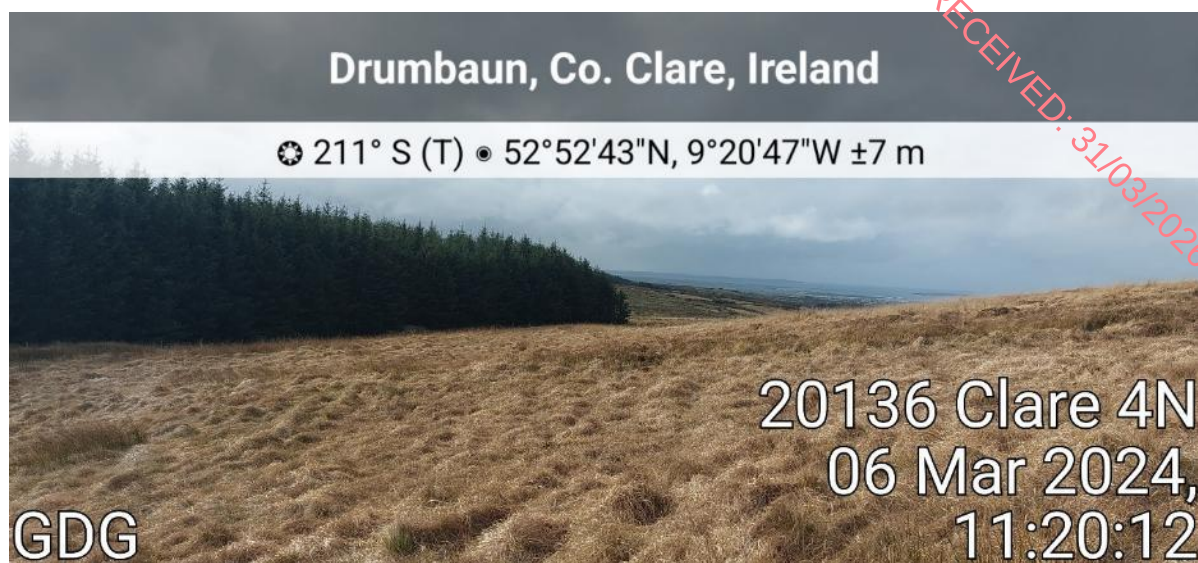
**Figure 3-2: T1 Location. Open blanket peat.**

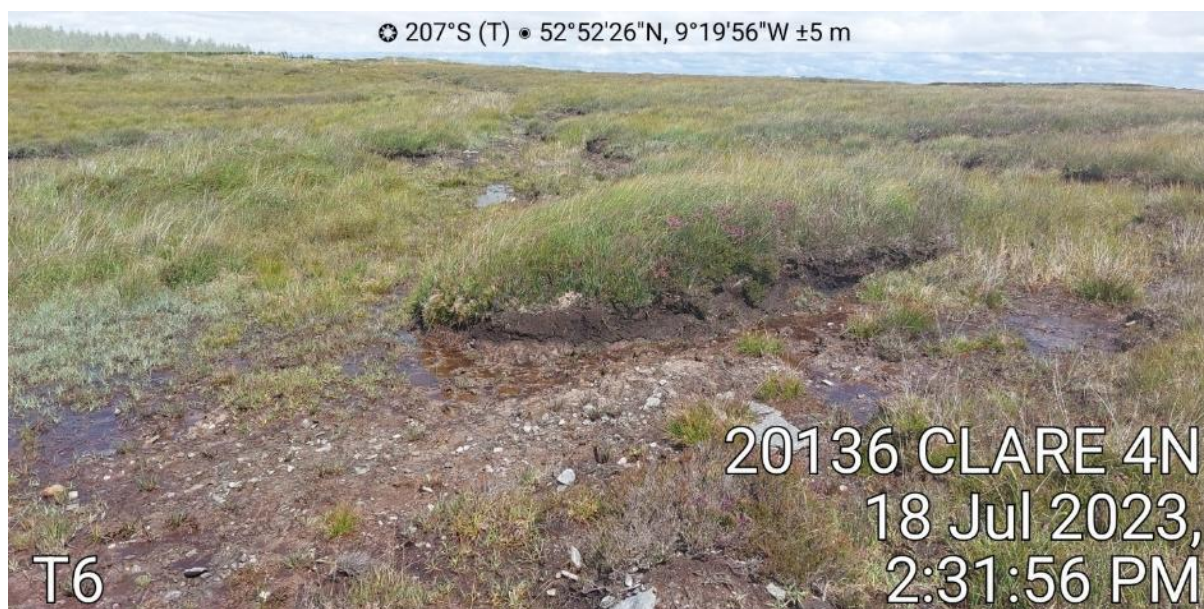
**Figure 3-3: Eroding peat hag at the T6 location.**

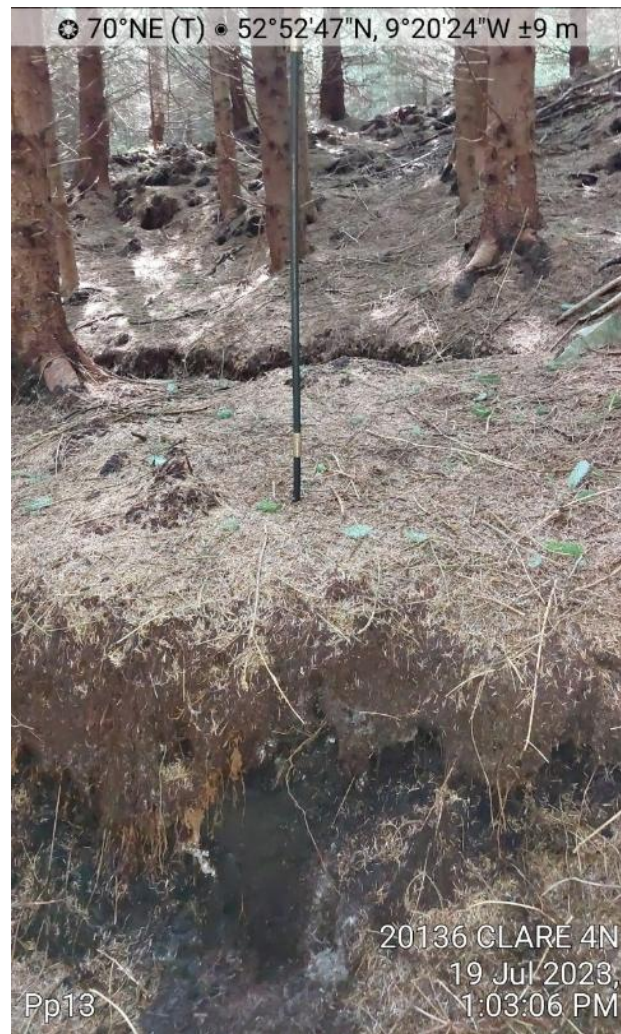
**Figure 3-4: Afforested blanket peat close to T5.**

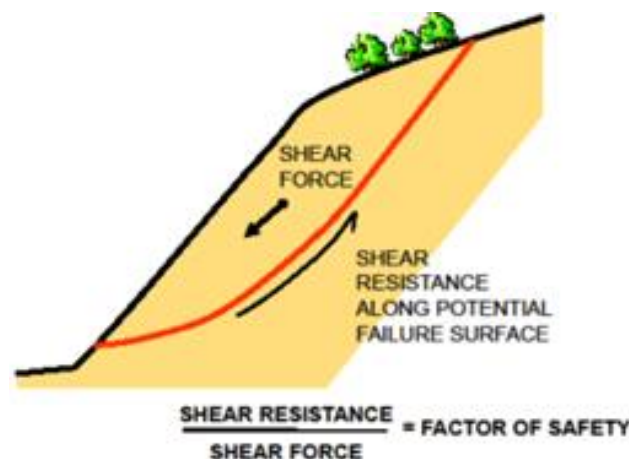
The FoS is a measure of the stability of a slope. For any slope, the degree of stability depends on the balance between the landslide driving forces (weight of the slope) and its inherent shear strength, illustrated in Figure 4-1.

Figure 4-1: Balance of forces in a slope (Scottish Executive, 2017).

Therefore, the FoS provides a direct measure of the degree of stability of a slope by the ratio of the shear resistance along a potential surface of failure and the landslide driving forces acting on such a surface. Multiple potential surfaces of failure are possible, but the FoS assigned to a slope is that of the surface of failure with the lowest value of FoS.

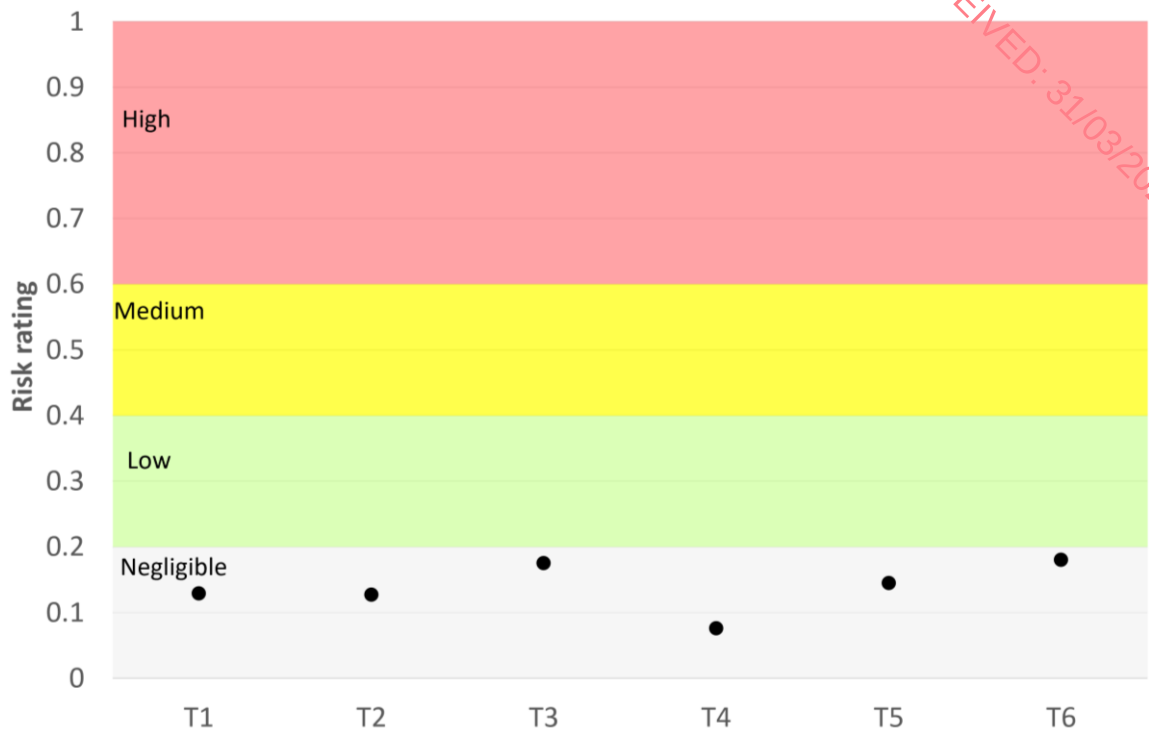
Figure 5-1: Risk ratings at the proposed turbine locations.

Risk in each wind farm infrastructure element is calculated in accordance with Equation 5.1-1, by multiplying the hazard scores and the consequences scores. The risk rating ranges between 0 and 1, and the following levels of risk rating have been distinguished (Figure 5-1 and Figure 5-2):

- High (0.6 to 1): Avoid project development at these locations. Mitigation is generally not feasible.
- Medium (0.4 to 0.6): The project should not proceed unless risk can be avoided or mitigated at these locations without significant environmental impact to reduce risk ranking to low or negligible.
- Low (0.2 to 0.4): Project may proceed pending further investigation to refine assessment and mitigate hazard through relocation or re-design at these locations.
- Negligible (0 to 0.2): The project should proceed with monitoring and mitigating peat landslide hazards at these locations as appropriate.

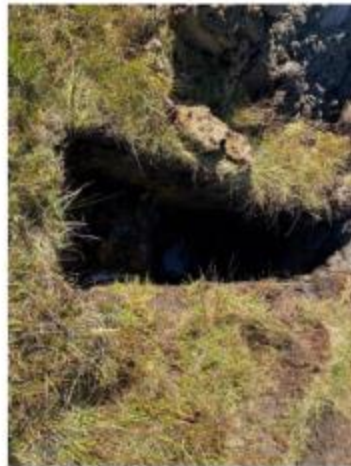
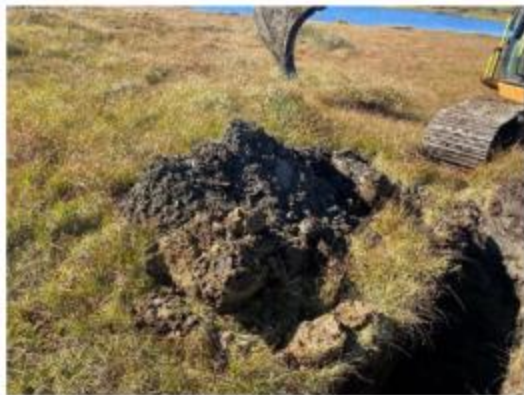
| <div>Description</div> <div>Date of the satellite images: January, 2025. [Maxar/Esri].</div> <div>Date of the ground-based pictures: July 2023. [GDG].And Photographs clicked during GI Campaign of IDL.</div> <div>Geomorphology: Topography is flat Peat is underlain by glacial till.</div> <div>Peat: Peat depth at T06 is 0.32m, with a slope angle of 3.0 degrees.</div> <div>Instability evidence: No.</div> | <div></div> <div>Figure 7 H:\2024\24CE108 Clare 4N\Trial Pit Pictures\TP-104 (1).JPG</div> | <div></div> <div>Figure 8 H:\2024\24CE108 Clare 4N\Trial Pit Pictures\TP-104 (2).JPG</div> |

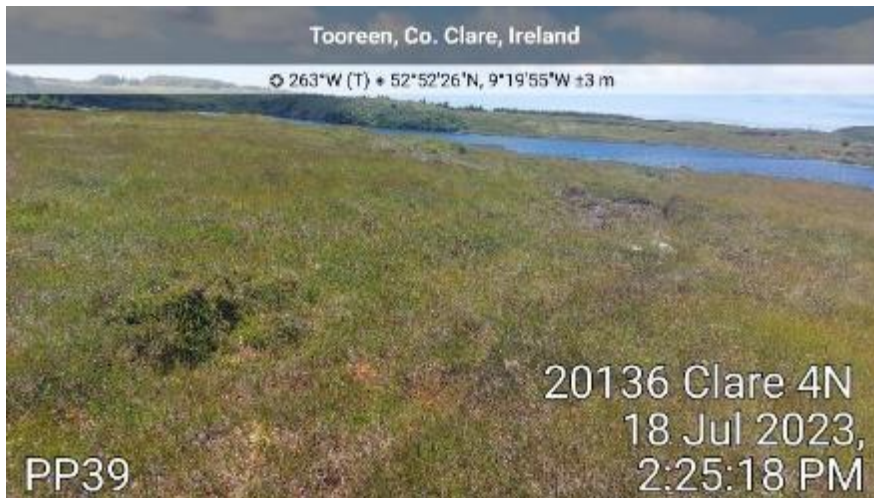
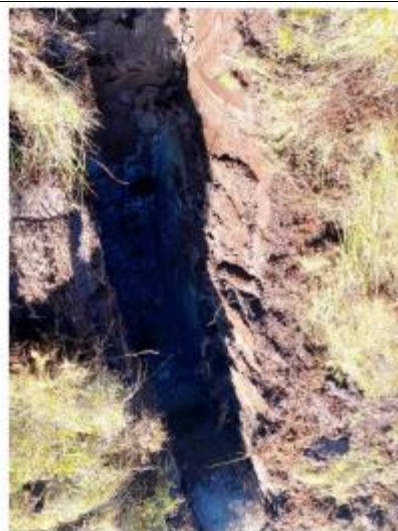
| <div>Description</div> <div>Date of the satellite images: January 2025. [Maxar/Esri].</div> <div>Date of the ground-based pictures July 2023 [GDG]</div> <div>Geomorphology: Topography is generally flat , underlain by peat and bedrock outcrops</div> <div>Peat: Peat depth is 0.88m, with a slope angle of 1.8 degrees.</div> <div>Instability evidence: No.</div> | <div><div></div></div> | <div><div></div><div>Figure 29 H:\2024\24CE108 Clare 4N\Trial Pit Pictures\TP-116 (1).JPG</div></div> |

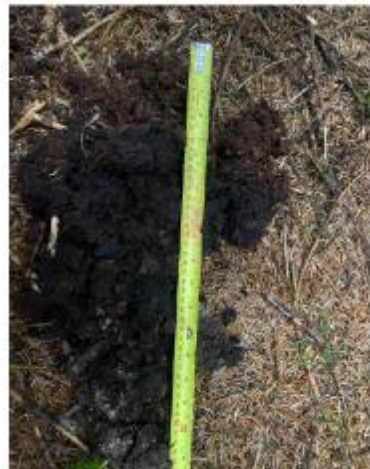
| <div>Description</div> <div><div>Date of the satellite images: January 2025. [Maxar/Esri].</div><div>Date of the ground-based pictures: July 2023[GDG]. And photographs clicked during IDL GI campaign</div><div>Geomorphology: The Topography at the site is mostly flat, cut over peat bog. Peat cuts are set back from the site, and there are drains perpendicular to contour lines.</div><div>Peat: Peat depth is 0.48m, with a slope angle of 3.8 degrees.</div><div>Instability evidence: No.</div></div> | <div><div>RCG101 (E 509852.064) (N 681654.47) (0.174-603m 0.0) Reduced level may be incorrect due to heavy tree cover.</div><div>GI-0.30m-Firm black H4.B2.F2.R2.W0.TV1.Th1.A0.P1 PEAT</div><div>0.30-0.40- Grey sandy GRAVEL</div><div>0.40- Possible rock</div><div></div></div> | |

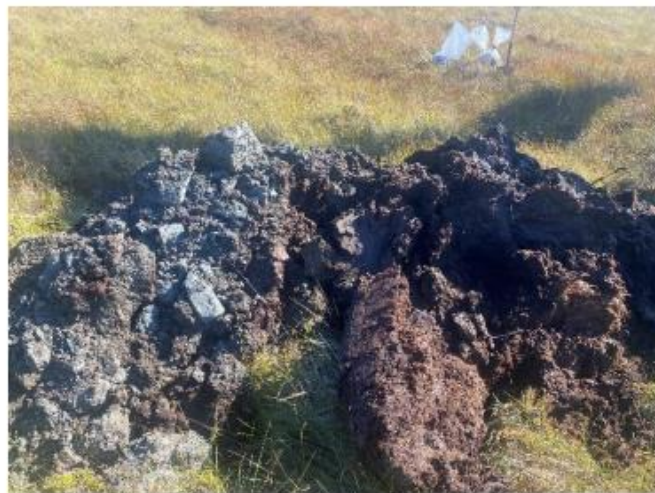
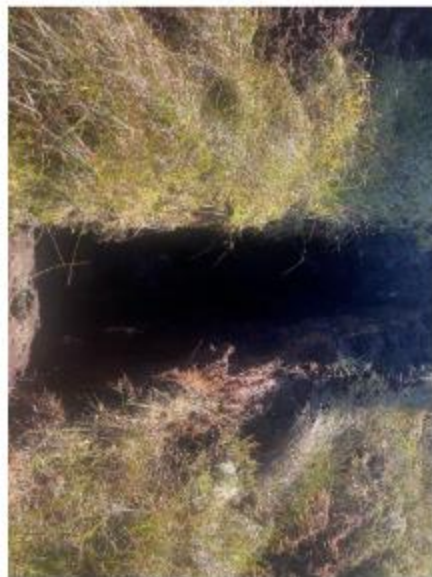
| <div>Description</div> <div>Date of the satellite images: January 2025. [Maxar/Esri].</div> <div>Date of the ground-based pictures July 2023[GDG]. And photographs clicked during IDL GI campaign</div> <div>Geomorphology: The Topography at the site is mostly flat, cut over peat bog. Peat cuts are set back from the site and there are drains perpendicular to contour lines.</div> <div>Peat: Peat depth is 1.37m, with a slope angle of 0.4 degrees.</div> <div>Instability evidence: No.</div> | <div></div> <div>Figure 33 H:\2024\24CE108 Clare 4N\Trial Pit Pictures\TP-117 (2).JPG</div> | <div></div> <div>Figure 32 H:\2024\24CE108 Clare 4N\Trial Pit Pictures\TP-117 (1).JPG</div> |

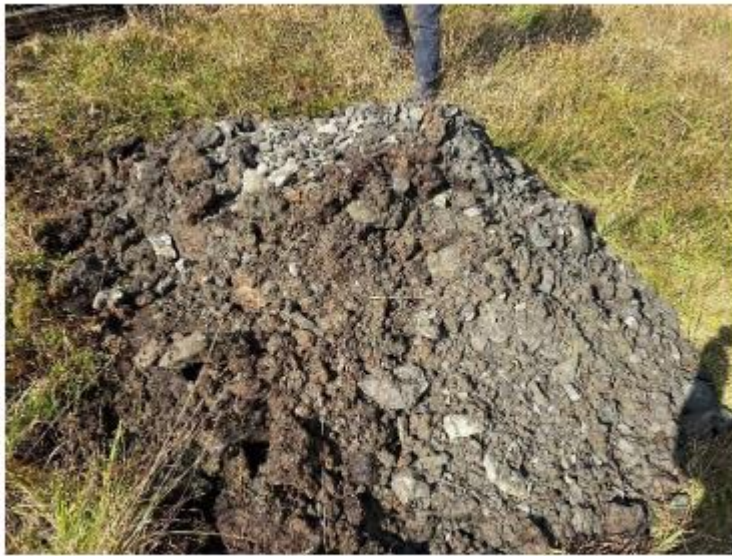
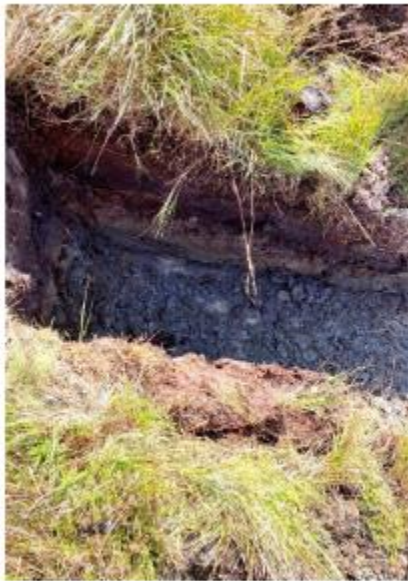
| <div>Description</div> <div>Date of the satellite images: January 2025. [Maxar/Esri].</div> <div>Date of the ground-based pictures: July 2023[GDG]. And photographs clicked during IDL GI campaign</div> <div>Geomorphology: The Topography at site is mostly flat with bedrock outcrops</div> <div>Peat: Peat depth is 0.32m, with a slope angle of 3.8 degrees.</div> <div>Instability evidence: No.</div> | <div></div> <div>Figure 14 H:\2024\24CE108 Clare 4N\Trial Pit Pictures\TP-107 (2).JPG</div> | <div></div> <div>Figure 13 H:\2024\24CE108 Clare 4N\Trial Pit Pictures\TP-107</div> |

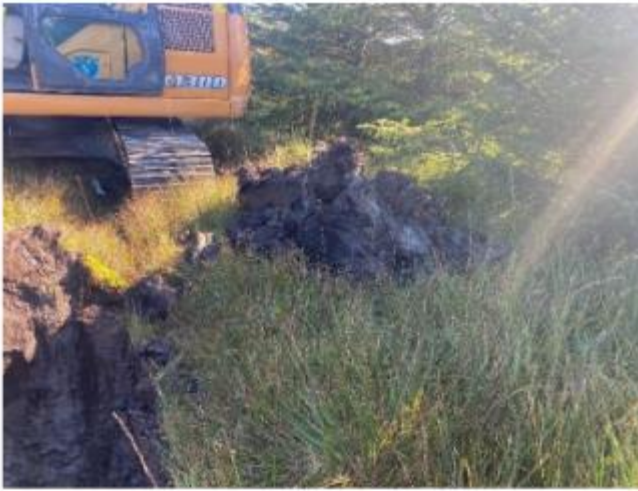
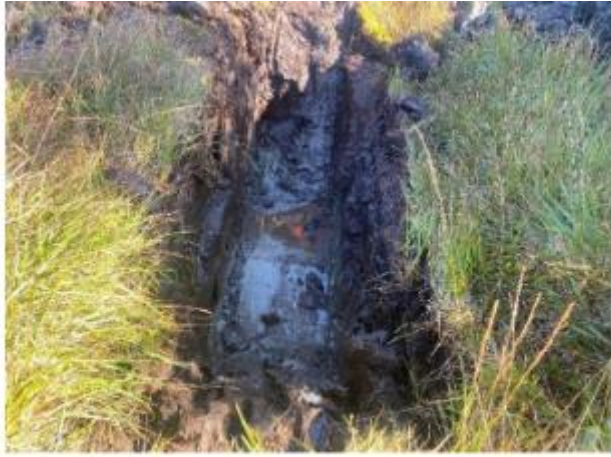
| <div>Description</div> <div><div>Date of the satellite images: January 2025. [Maxar/Esri].</div><div>Date of the ground-based pictures photographs clicked during IDL GI campaign</div><div>Geomorphology: Topography at site is mostly flat with bedrock outcrops</div><div>Peat: Peat depth is 0.72m, with a slope angle of 3.8 degrees.</div><div>Instability evidence: No.</div></div> | <div><div></div><div>Figure 10 H:\2024\24CE108 Clare 4N\Trial Pit Pictures\TP-105 (2).JPG</div></div> | <div><div></div><div>Figure 9 H:\2024\24CE108 Clare 4N\Trial Pit Pictures\TP-105 (1).JPG</div></div> |
