Suggested generic section profile for a Soil Polishing Filter construction installed at ground level  
(Check site Engineer's instructions for final construction details).

Title: 90m<sup>2</sup> above ground soil polishing filter

Drg. no.: SPF-AG-90-100719

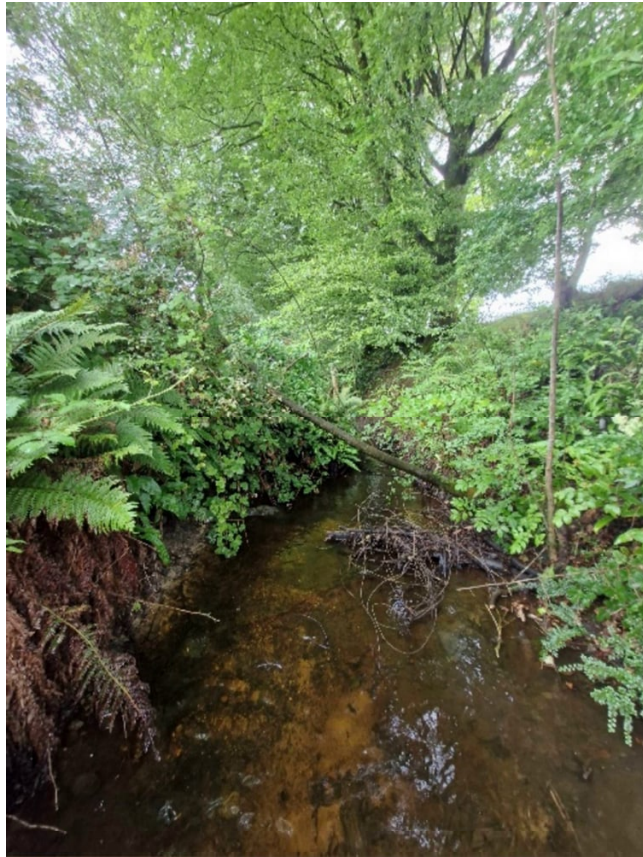
Plate 3 SW1 sampling location habitat

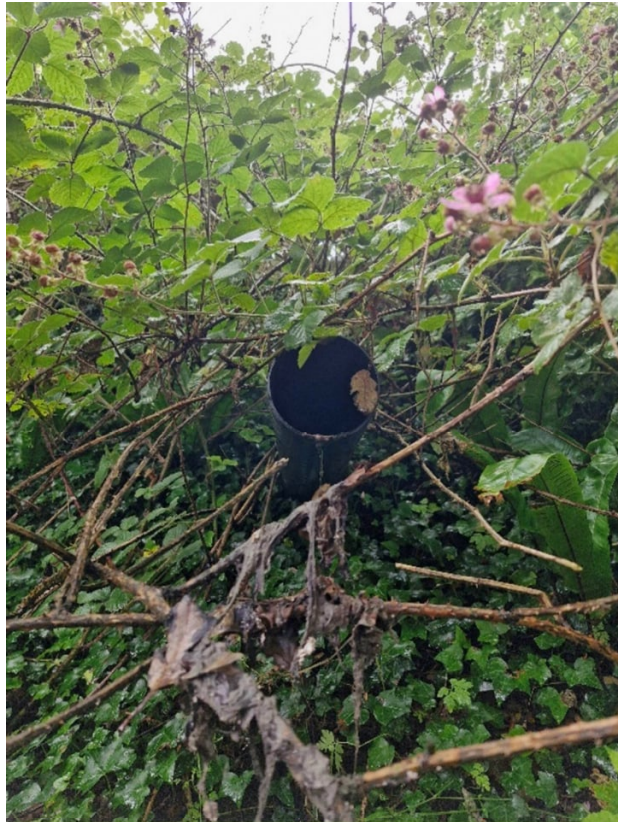
Plate 4 Pipe outflow at SW1 sampling location

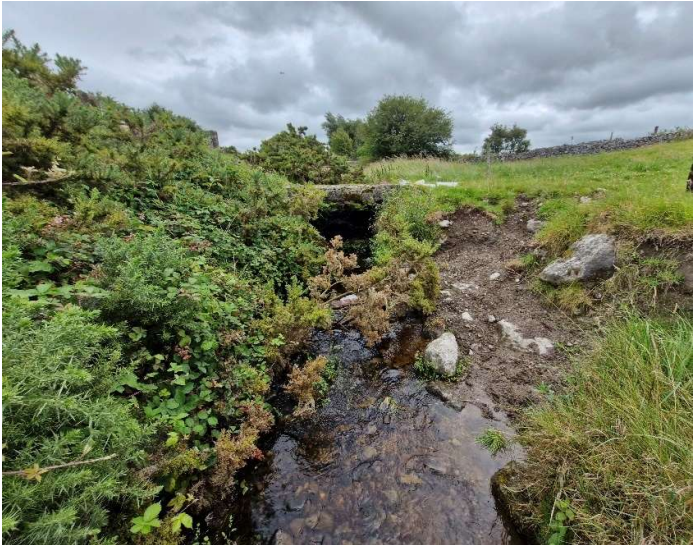
| Monitoring Site | Description |
|---|---|
| <p>Plate 7 Banks of SW2 damaged by livestock trampling</p> | |
