**NOVEMBER 2020 PEATSLIDE
ENVIRONMENTAL REPORT**

November 2020 Peat Slide
at Meenbog Wind Farm, Co.
Donegal and subsequent
Restoration and
Remediation Works

Document Title: **Environmental Report**

Prepared By: **MKO
Tuam Road
Galway
Ireland
H91 VW84**

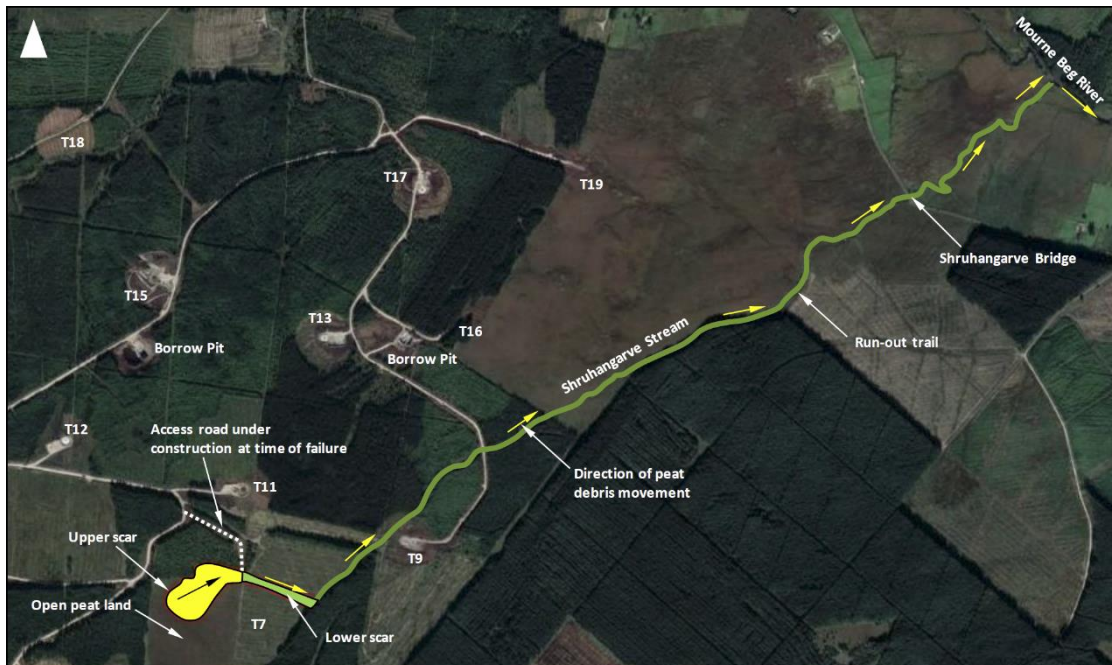
Figure 1 Extent of peat failure of 12 November 2020

The three distinct parts of the peat failure are shown in Figure 3.1, which should be viewed when reading the description below.

1. *Upper scar. This comprised the primary source area of the failed material. The upper scar was about 260m long by up to about 120m wide. The head of the failure scar was within open peat land. The southern part of the scar was also within open peat land. The northern part of the scar was within forestry plantation.*

2. *Lower scar. This comprised a secondary source area of the failed material. The lower scar is rectilinear and essentially follows the slope gradient (Figure 3.2). The lower scar was about 260m long by about 43m wide. The head of the lower scar is taken at the downslope mouth of the upper scar and essentially coincides with the upslope boundary of a recently felled forestry plantation. The lateral perimeter of the scar essentially follows the existing forestry furrows. The estimated total area of the lower scar is about 1.18ha.*

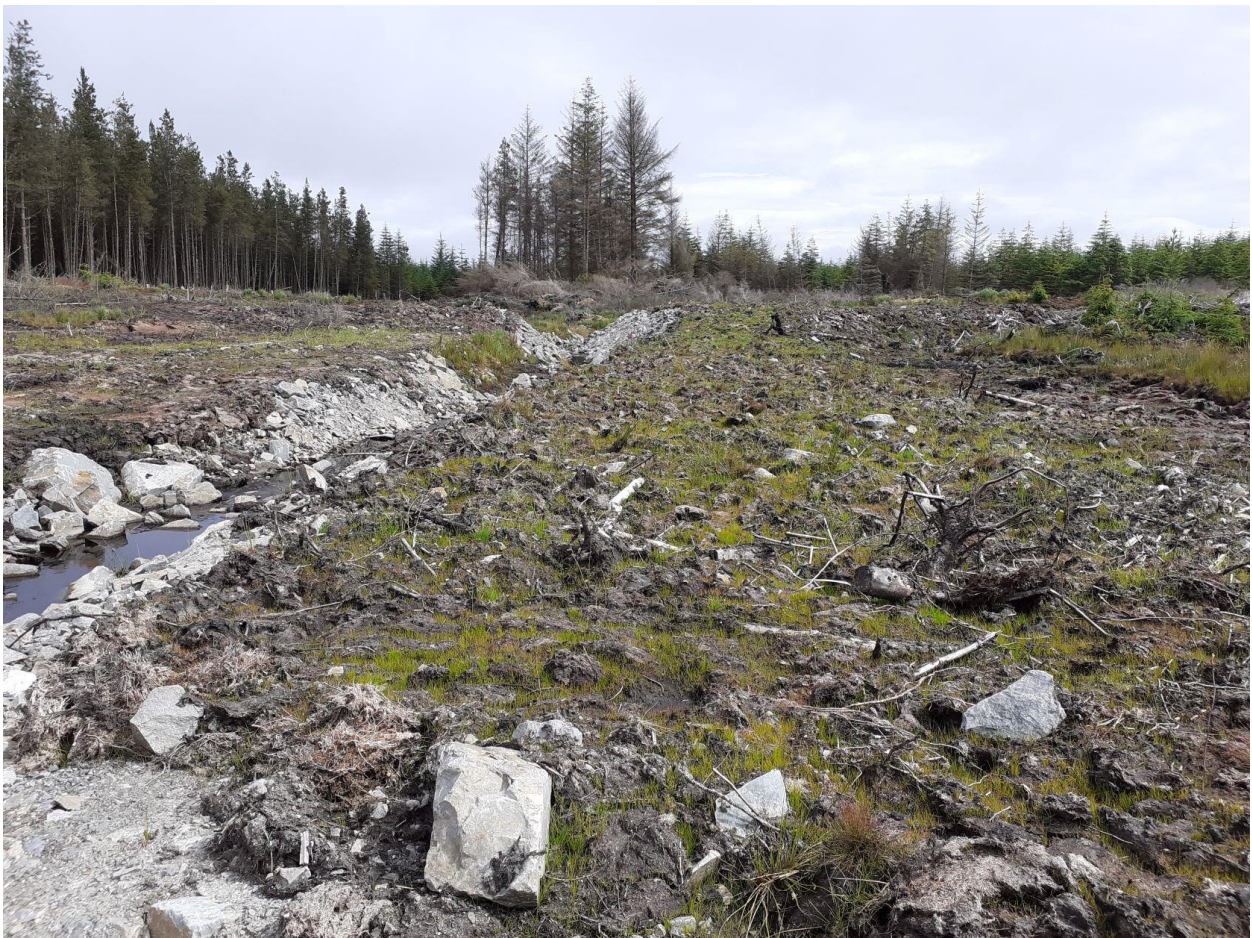
Photo 1- area where Wall 2 was located, showing new vegetation growth, 8/7/22

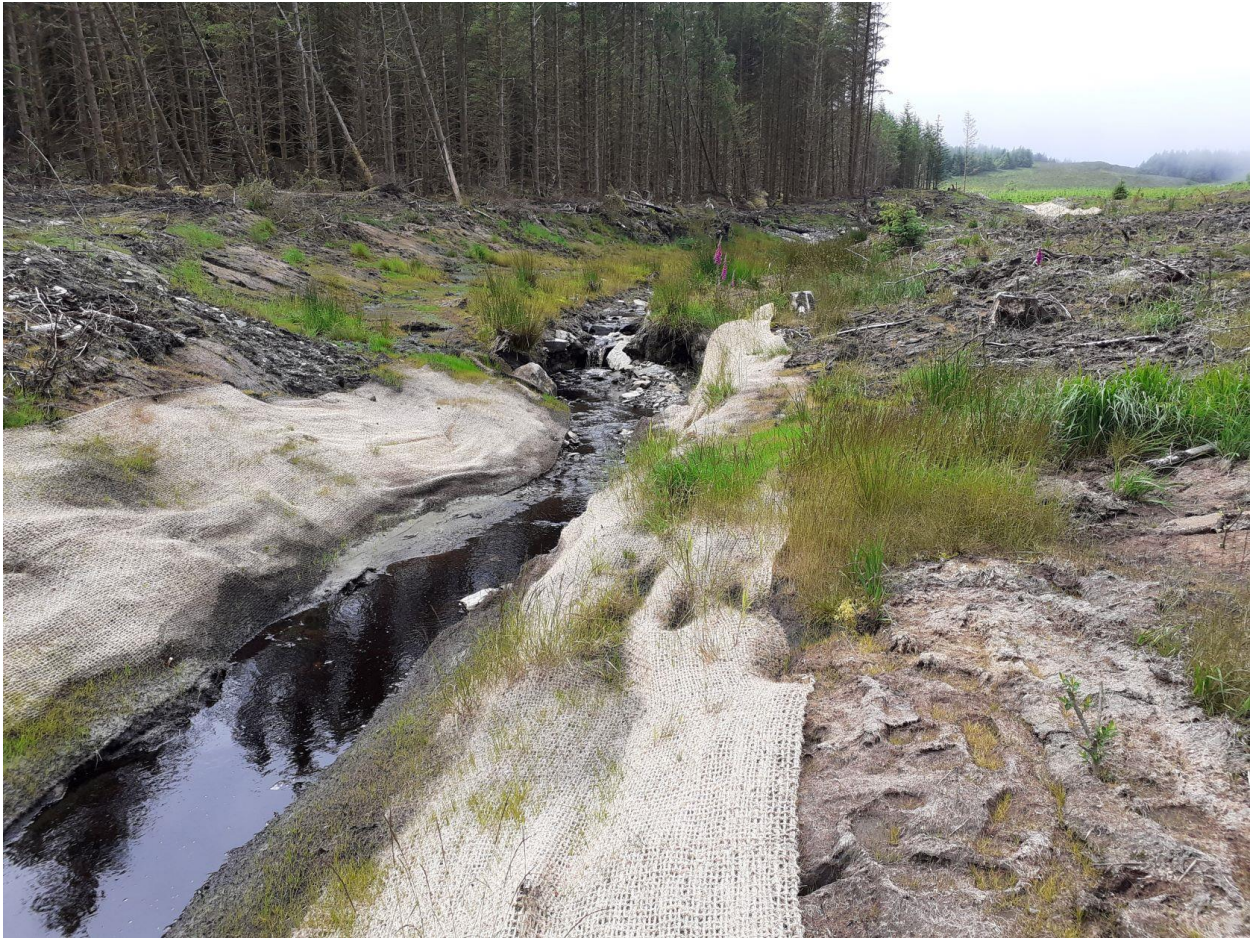
Photo 2 - area upstream of Wall 2 was located, showing grass growth in coir matting, 8/7/22

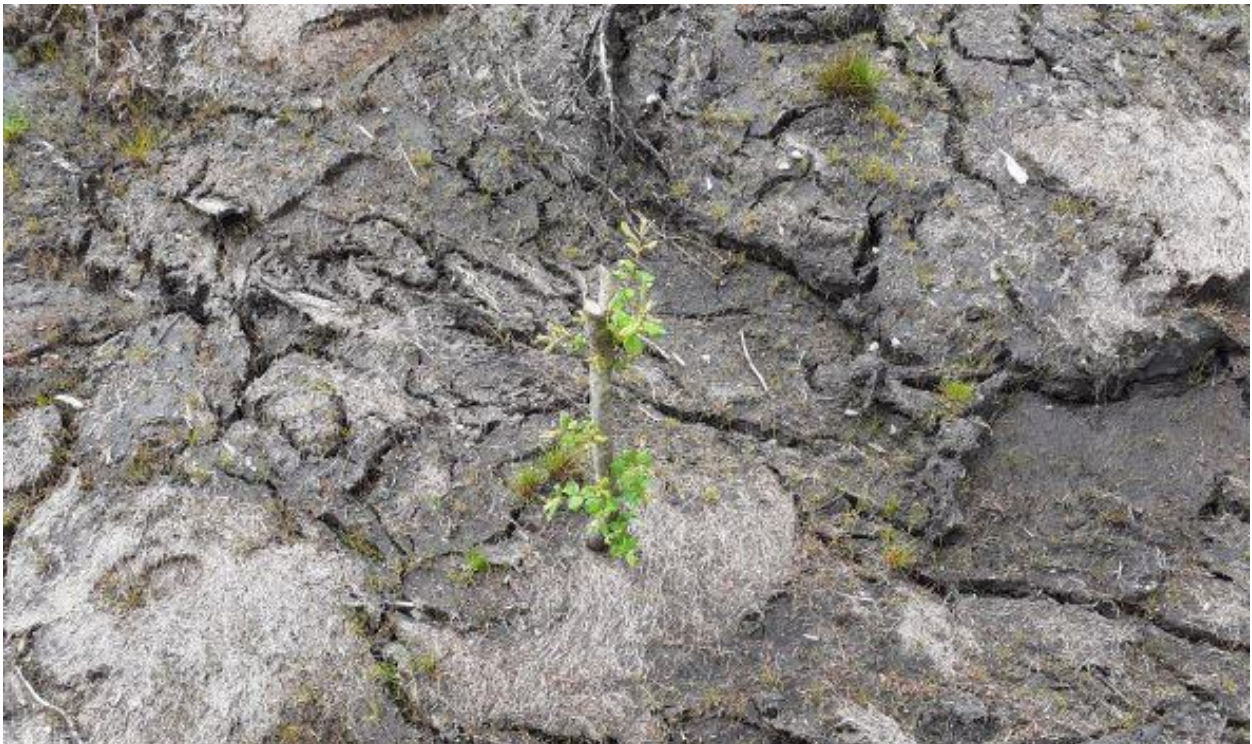
Photo 3 – sapling growing in area where wall 2 was located, 8/7/22

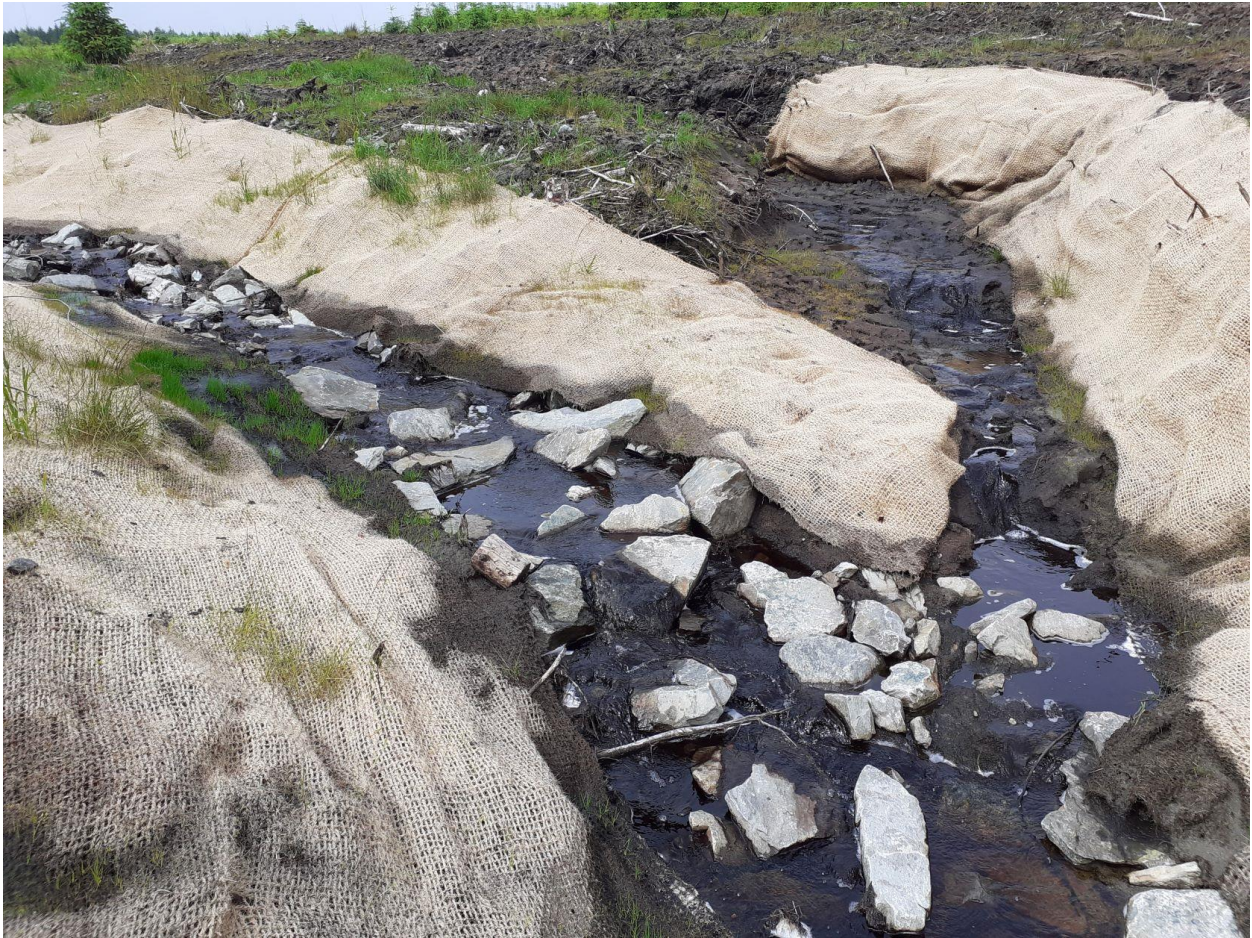
Photo 4- confluence of stream from Wall 3 & Sruhingarve stream, 8/7/22

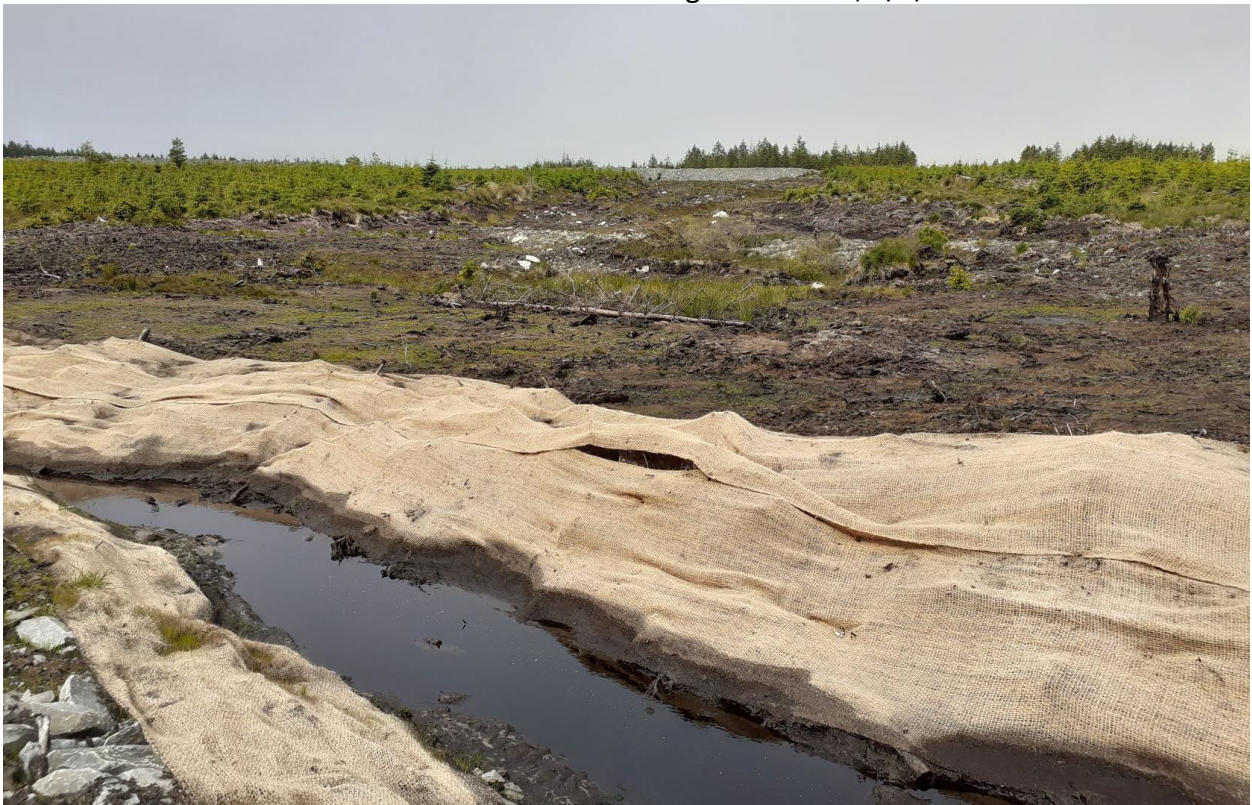
Photo 5 - Sruhingarve stream, looking up towards Wall 3, 8/7/22

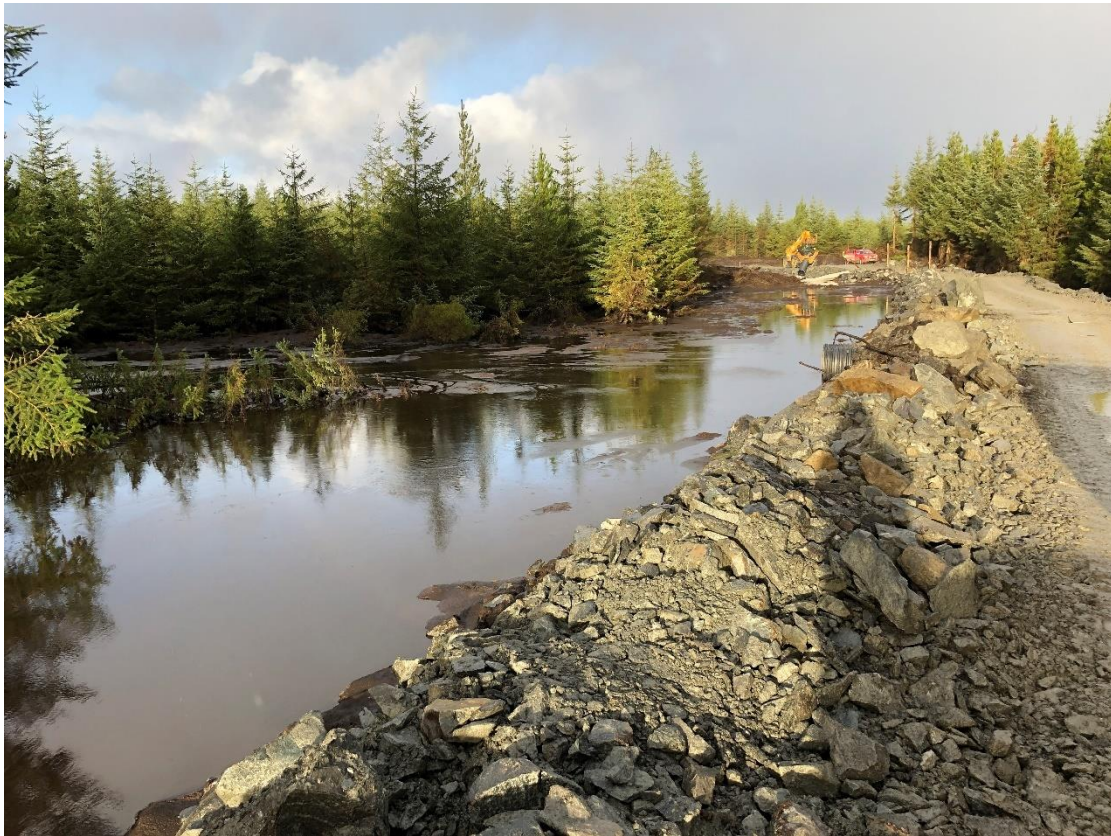
Large volumes of sediment have been successfully impounded behind Wall 1 and prevented from entering downstream watercourses, as evident in Figures 5.2 and 5.3 below. The volumetric measurement of these sediment volumes is presently underway and will be reported in future iterations of the Action Plan. Approximately 79% of water flows entering the Shruhingarve catchment upstream of Wall 1 have been intercepted upstream of the impounded sediment and diverted away from the sediment impounded behind Wall 1, thereby minimising the re-mobilisation of the impounded sediment, but larger volumes of water are likely to continue to reach the upstream side of Wall 1 in periods of heavier and prolonged rainfall.

Figure 5.2 Water and sediment impoundment area upstream of Wall 1 showing stabilised situation and deposits of peat up to surface of water

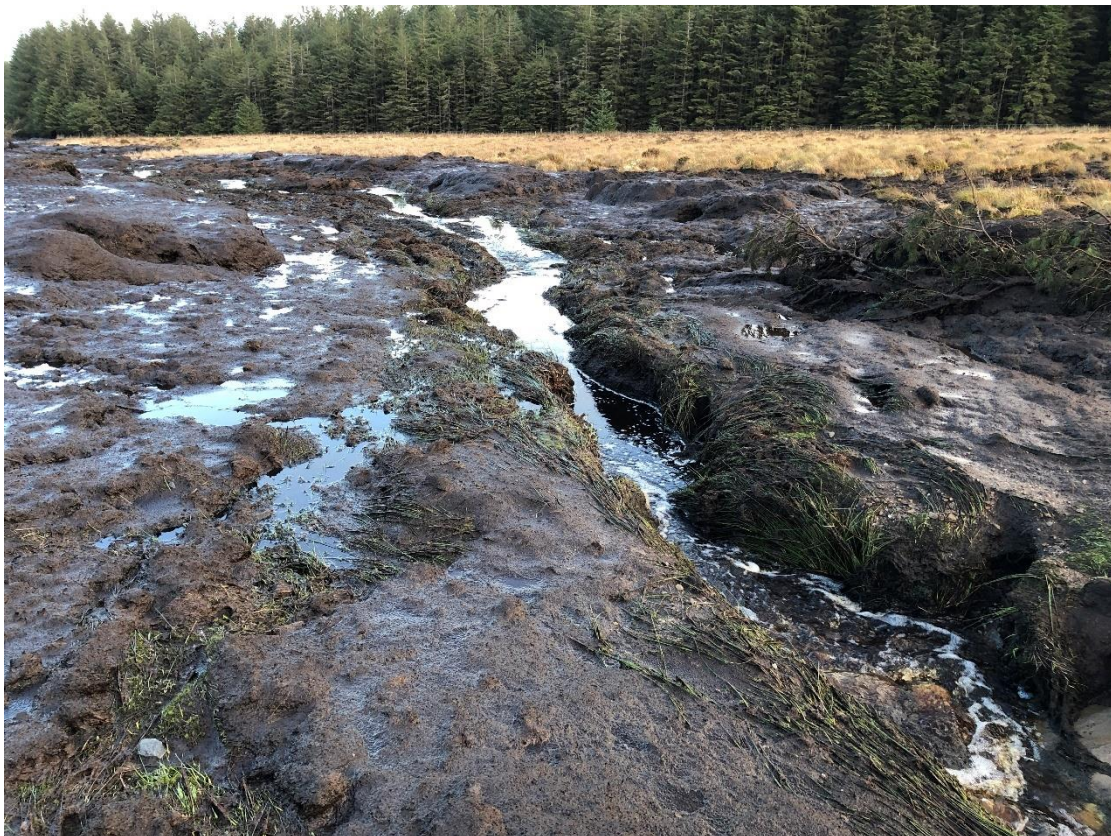
Figure 5.6 Peat deposited on stream bank downstream of Wall 1, with intact vegetation partially visible and larger deposits of peat further back from stream edge

The Shruhengarve stream downstream of Wall 1 continues to flow within the original natural stream channel, but larger flows during and after large rainfall events have caused some secondary mobilisation of the peat that would have been originally deposited on the stream banks. While the majority of the streambank peat deposits appear relatively stable, overland flows from the adjacent bog habitat towards the stream have caused some further mobilisation of the deposited peat in particular locations. It is not considered justifiable to leave the peat deposits in place without mitigation, as to do so would result in further secondary mobilisation of the deposited peat into the adjacent stream.

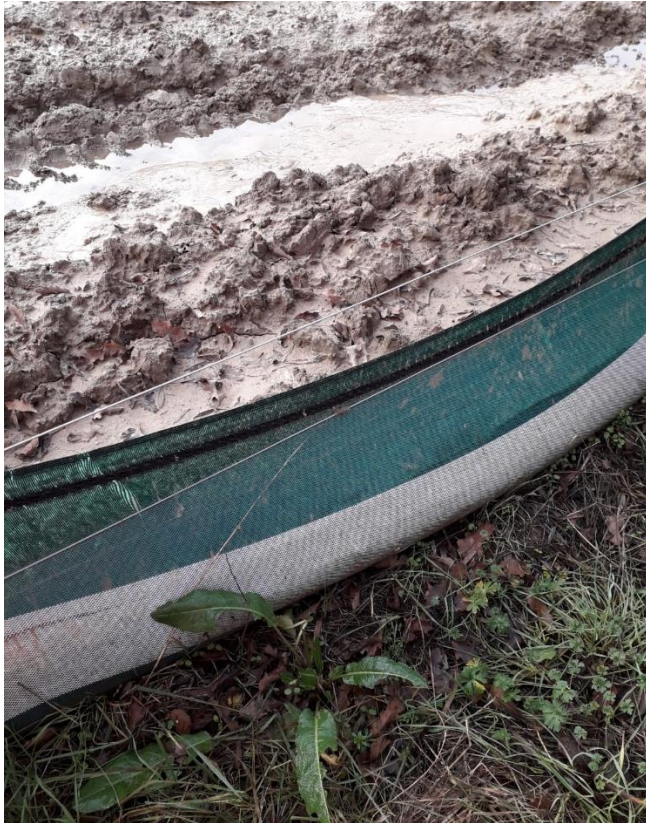
Figure 5.7 Terrastop silt fence properly buried into ground surface acting as effective silt barrier

15. Maintain silt fence in place for as long as necessary until all bare peat had reseeded and demonstrated to have well-establish root system of surface vegetation, capable of binding material together. Silt fence only to be removed with approval of supervising ecologist.

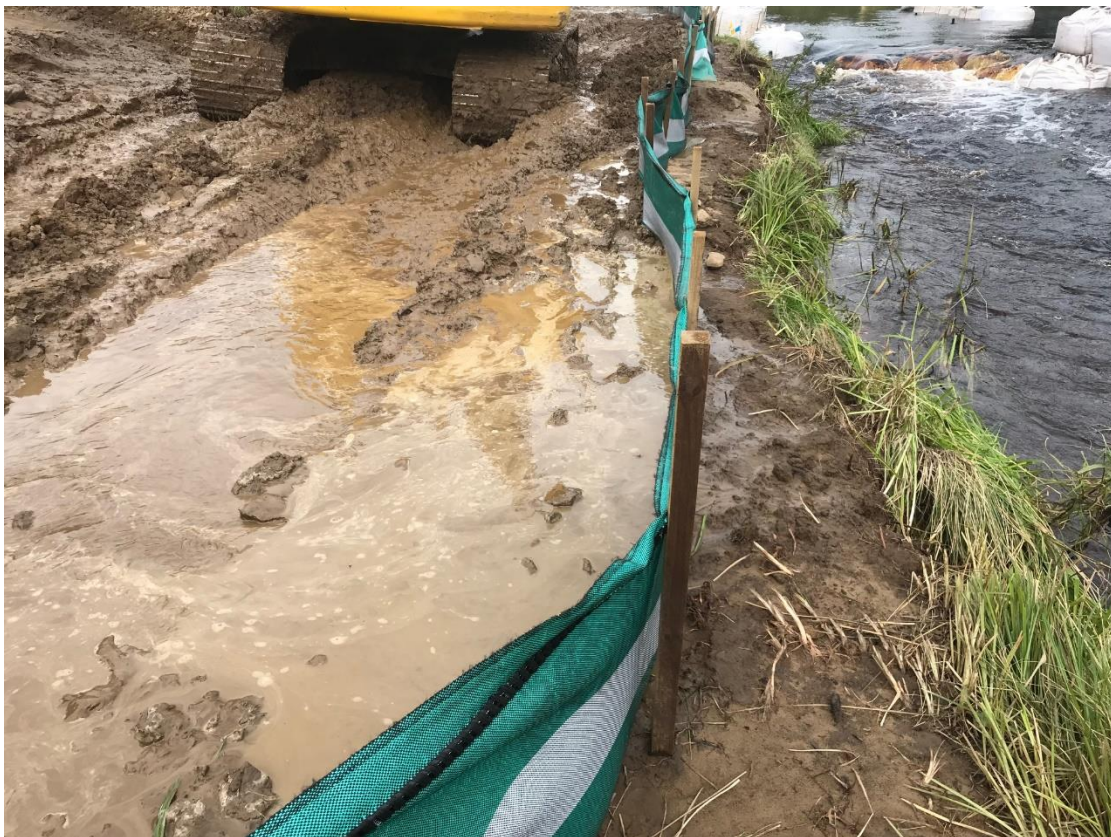
Figure 5.8 Terrastop silt fence installed on a riverbank preventing silt and soiled water reaching watercourse

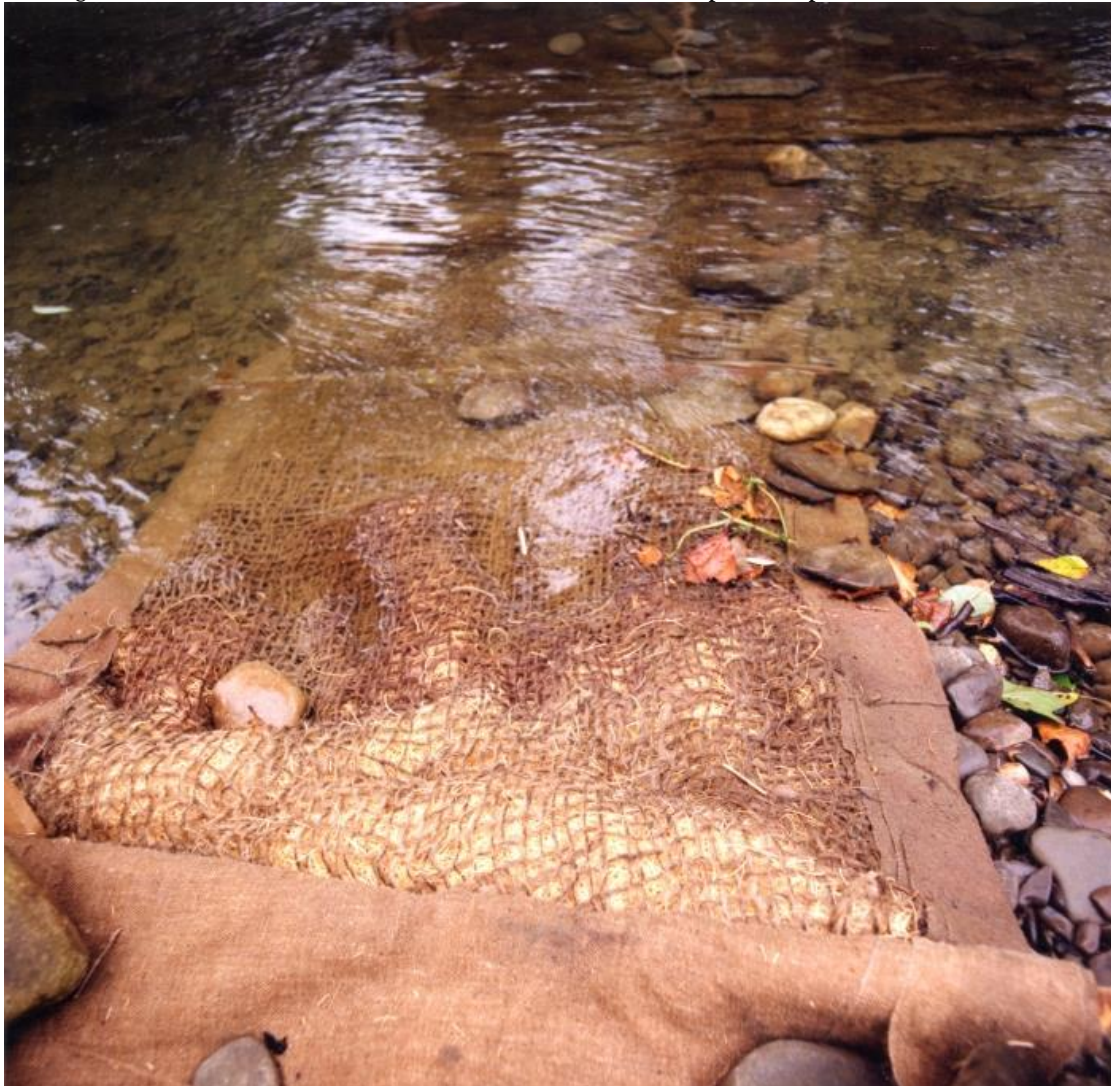
Figure 5.11 Sedimat installed on stream bed to trap suspended sediment through upper layer of jute mesh and lower layers of wood wool.

The effectiveness of the proposed Sedimats cannot be guaranteed, and therefore this recommendation is being made on a trial basis, with the trial to be extended and repeated if proven to be effective.

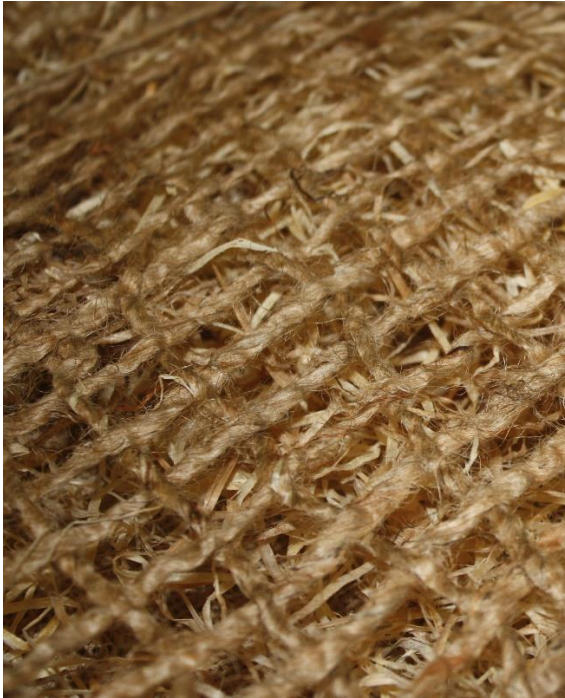
Figure 5.12 Narrow view of Sedimat with layered jute mesh and wood wool

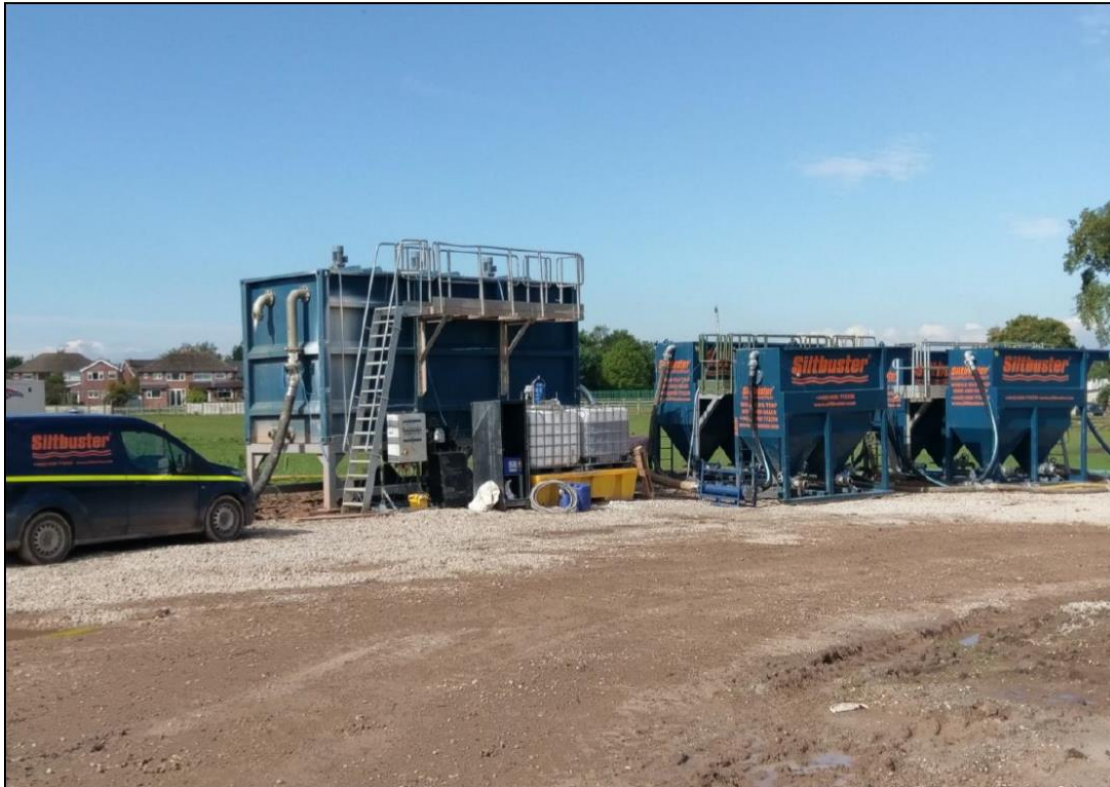
A photographic example of the system layout is shown in Figure 5.14 below. The total plan area of the core water treatment system is approximately 50-60 m².

- MT30 – 3.5mW x 6.1mL = 21.35m²
- HB50 – 1.7mW x 3.8mL x 4 no. = 25.84m²

Figure 5.14: MT30 Chemical Pre-Treatment system with 4 No Lamella clarifiers

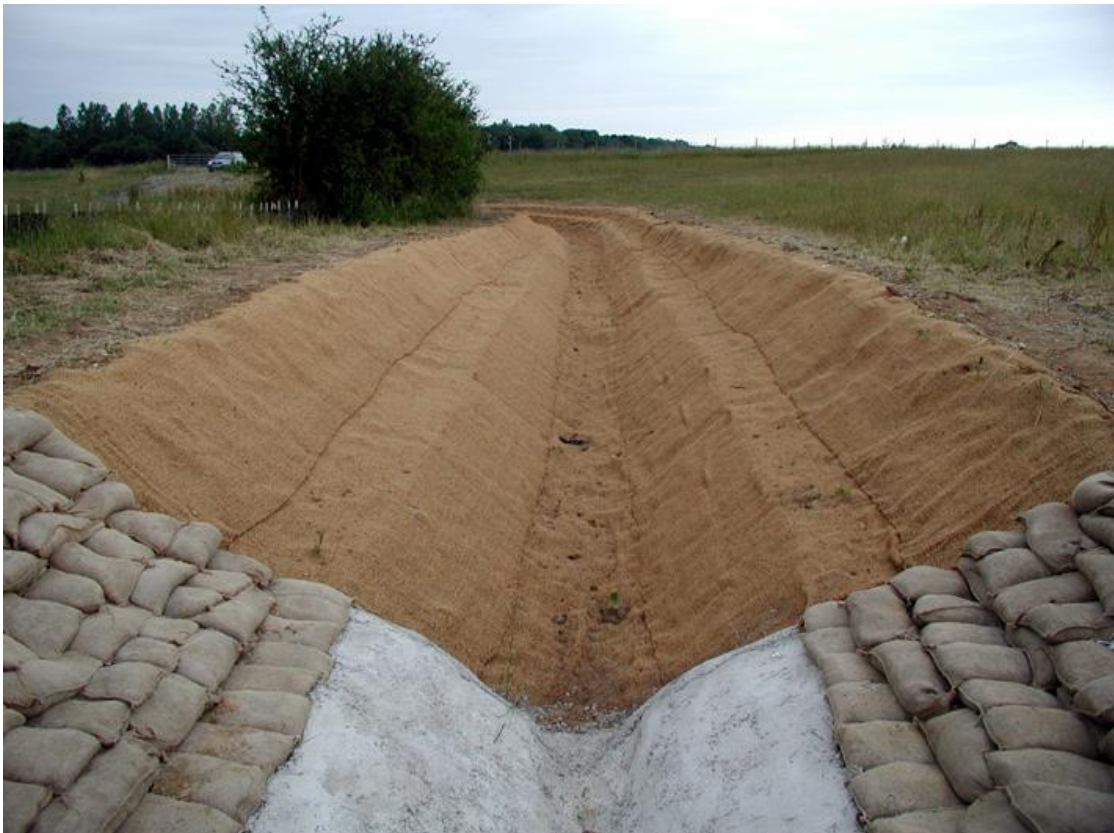
Plate 5.17 Large-scale use of CoriMesh to establish vegetated surfaces on drainage channel embankments

6. After all recoverable peat has been removed from the area upstream of Wall 1, the remaining peat deposits and unvegetated surface will be stabilised using soil erosion prevention materials, such as CoirMesh prior to reseeded, as shown in Figures 5.16 and 5.17 below.

6. Divide works areas into sections and assign installation crews to sections.
7. After the depth of all reachable areas of deposited peat have reduced, the remaining peat deposits and unvegetated surface will be stabilised using soil erosion prevention materials, such as CoirMesh prior to reseeded, as shown in Figures 5.16 and 5.17 above.

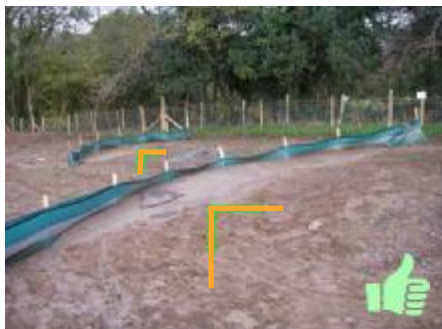
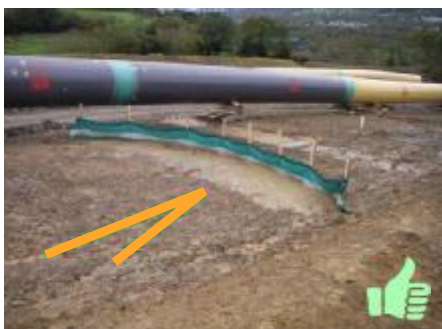
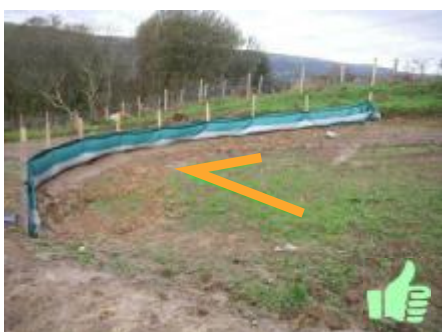
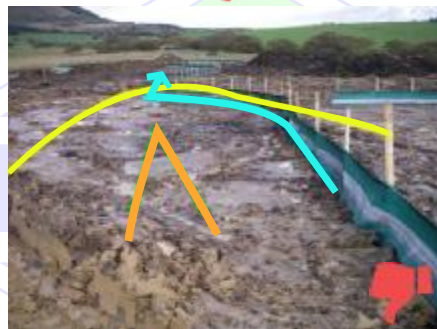
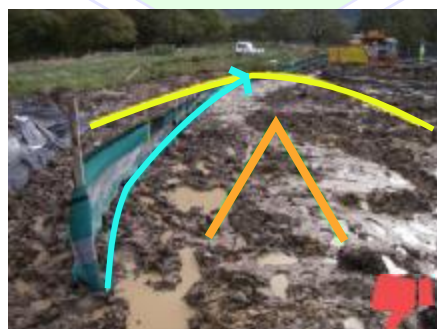
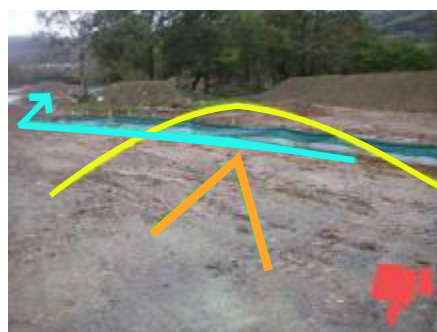
Fence is centred and at right angles to flow.

Orange lines highlight the slope direction.

Runoff follows the fence line making erosion worse.

Yellow line depicts the correct positioning.

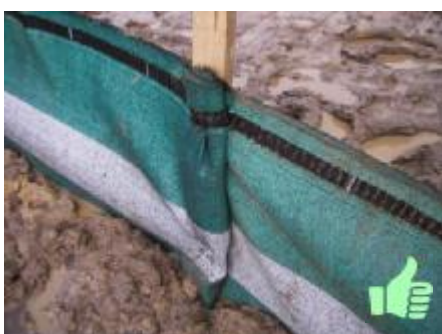
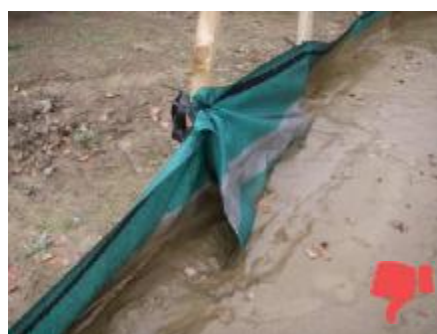
Fold edges on one another several times & then fixed.

Gaps allow sediment to pass through.

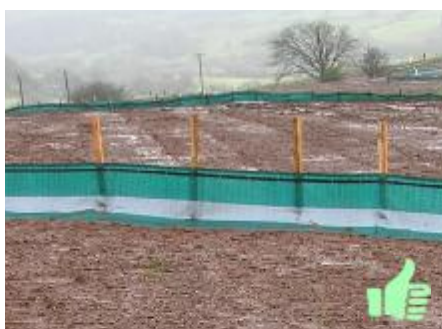
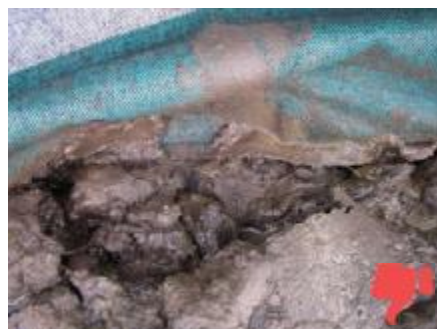
Bottom buried up to red line & backfill firmly compacted.

Not buried deep enough & ground poorly compacted.

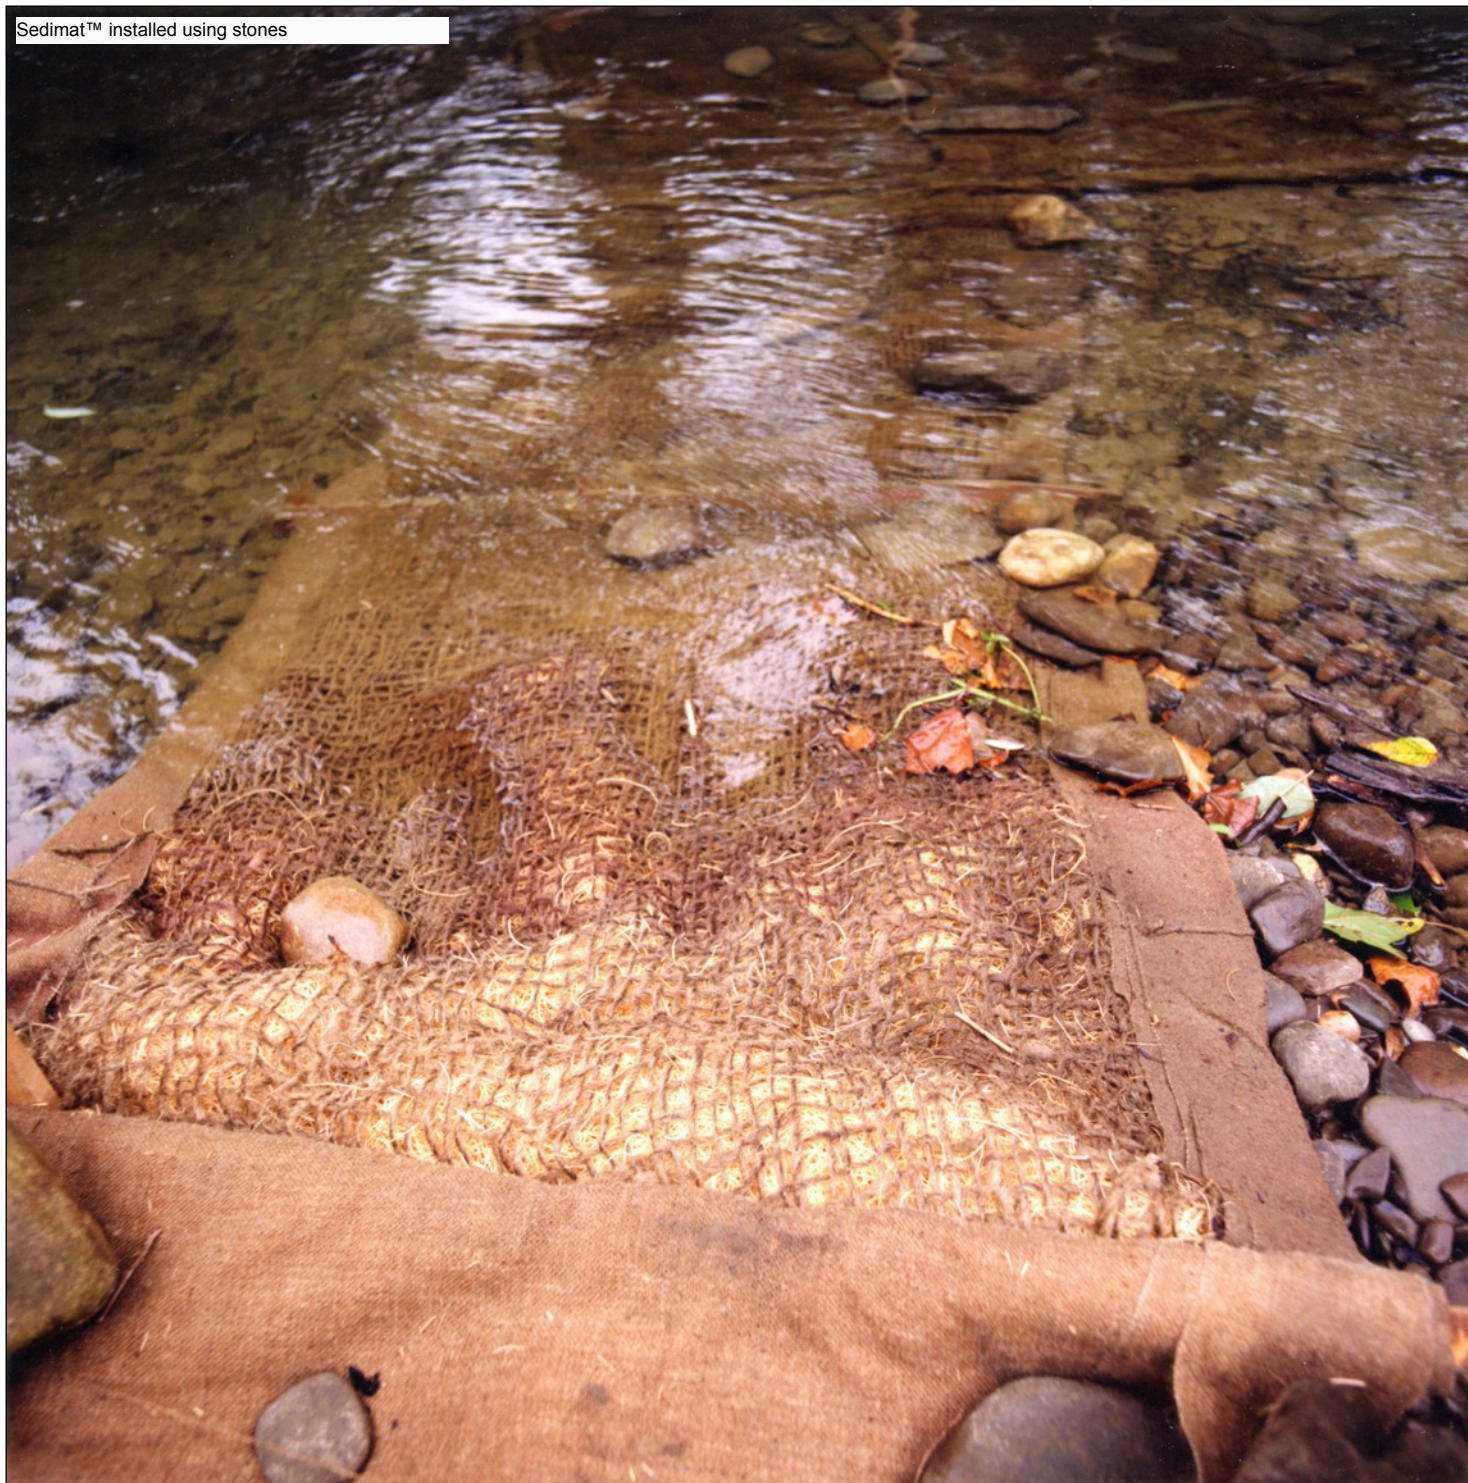
Sedimat™ installed using stones

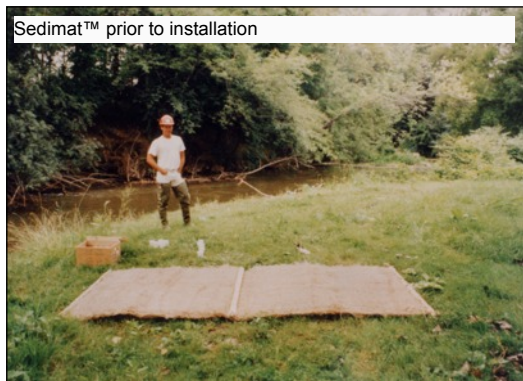
Sedimat™ prior to installation

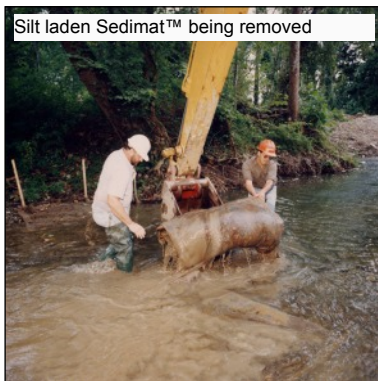
Silt laden Sedimat™ being removed

The fully biodegradable, sediment laden mats can then be unrolled, fixed to the embankment and seeded to provide instant bank stabilisation, a rich seedbed for vegetation restoration, and avoid disposal problems.

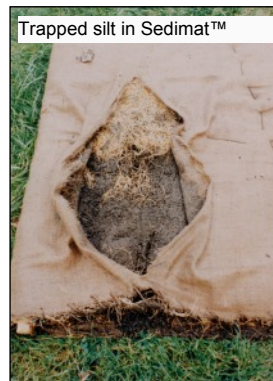
Trapped silt in Sedimat™

Each Sedimat™ is capable of trapping in excess of 250kg of sediment. Because they lay flat on the bed the mats are not affected by the current and do not cause back up of water.

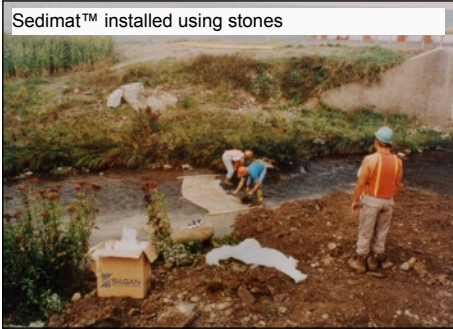
Sedimat™ installed using stones

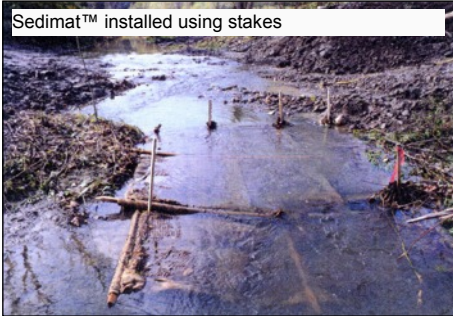
Sedimat™ installed using stakes

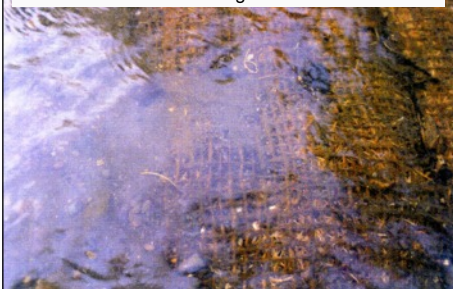
Disturbed sediment entering Sedimat™

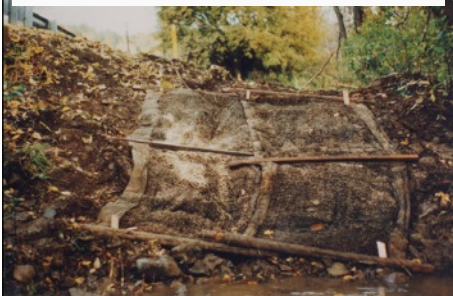
Used Sedimats™ fixed to bank

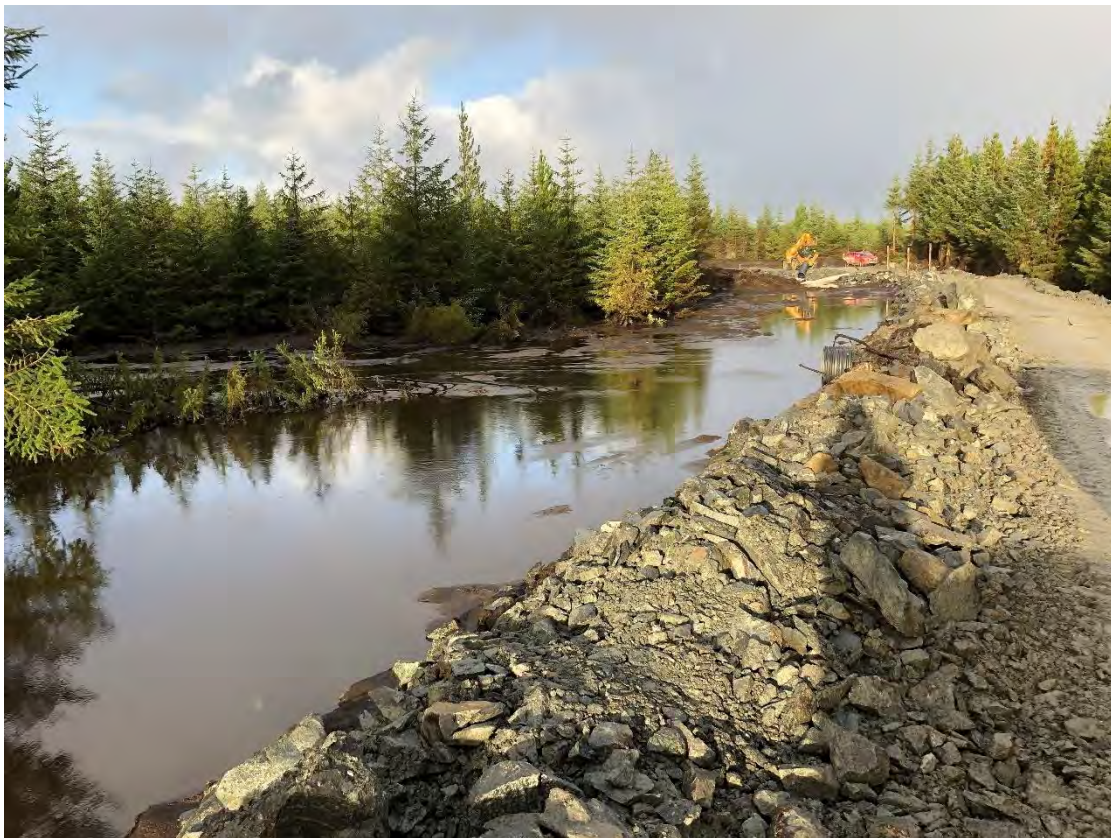
Figure 2.1 Water and sediment impoundment area upstream of Wall 1 showing stabilised situation and deposits of peat up to surface of water

Large volumes of sediment have been successfully impounded behind Wall 1 and prevented from entering downstream watercourses, as evident in Figures 2.1 and 2.2 below. The volumetric measurement of these sediment volumes is presently underway and will be reported in future iterations of the Action Plan. Approximately 79% of water flows entering the Shruhingarve catchment upstream of Wall 1 have been intercepted upstream of the impounded sediment and diverted away from the sediment impounded behind Wall 1, thereby minimising the re-mobilisation of the impounded sediment, but larger volumes of water are likely to continue to reach the upstream side of Wall 1 in periods of heavier and prolonged rainfall.

There currently appears to be minimal seepage of water through Wall 1, likely because any void spaces have become plugged with suspended peat and the bypass flows already in place around Wall 1.

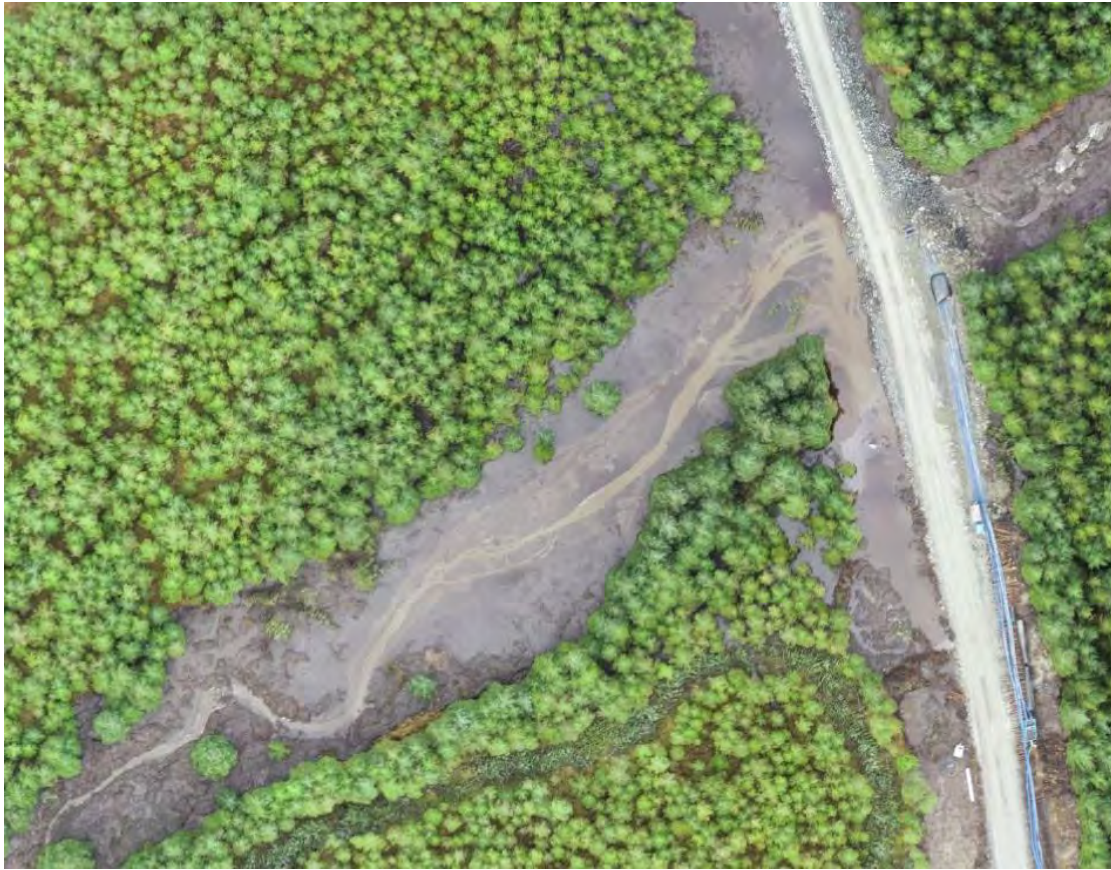
Figure 2.2 Aerial image of water and peat impoundment area upstream of Wall 1 showing large volumes of impounded peat and clearly identifiable channel for water reaching Wall 1

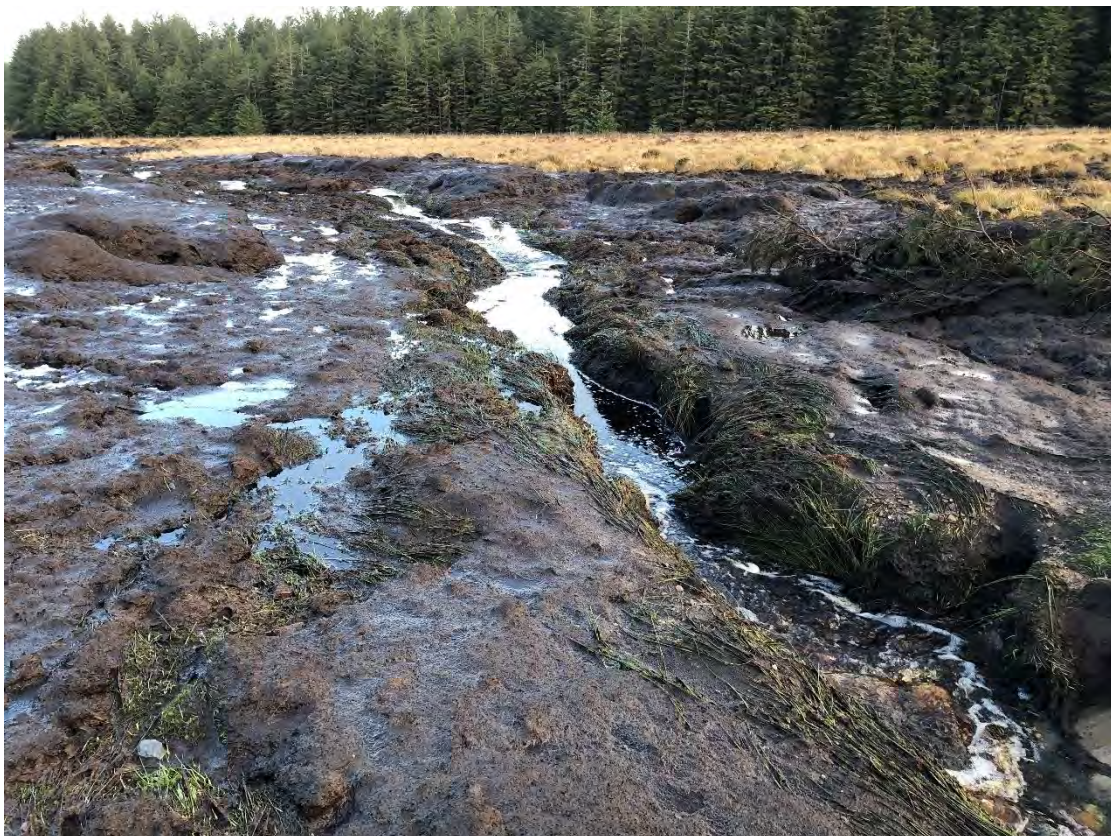
Figure 5.2 Peat deposited on stream bank downstream of Wall 1, with intact vegetation partially visible and larger deposits of peat further back from stream edge

The Shruhengarve stream downstream of Wall 1 continues to flow within the original natural stream channel, but larger flows during and after large rainfall events have caused some secondary mobilisation of the peat that would have been originally deposited on the stream banks. While the majority of the streambank peat deposits appear relatively stable, overland flows from the adjacent bog habitat towards the stream have caused some further mobilisation of the deposited peat in particular locations. It is not considered justifiable to leave the peat deposits in place without taking action to minimise run off, as to do so would result in further secondary mobilisation of the deposited peat into the adjacent stream. The Shruhengarve Stream with associated peat deposits is shown in Figure 5.2
