**NOVEMBER 2020 PEATSLIDE
ENVIRONMENTAL REPORT**

November 2020 Peat Slide
at Meenbog Wind Farm, Co.
Donegal and subsequent
Restoration and
Remediation Works

Document Title: **Environmental Report**

Prepared By: **MKO
Tuam Road
Galway
Ireland
H91 VW84**

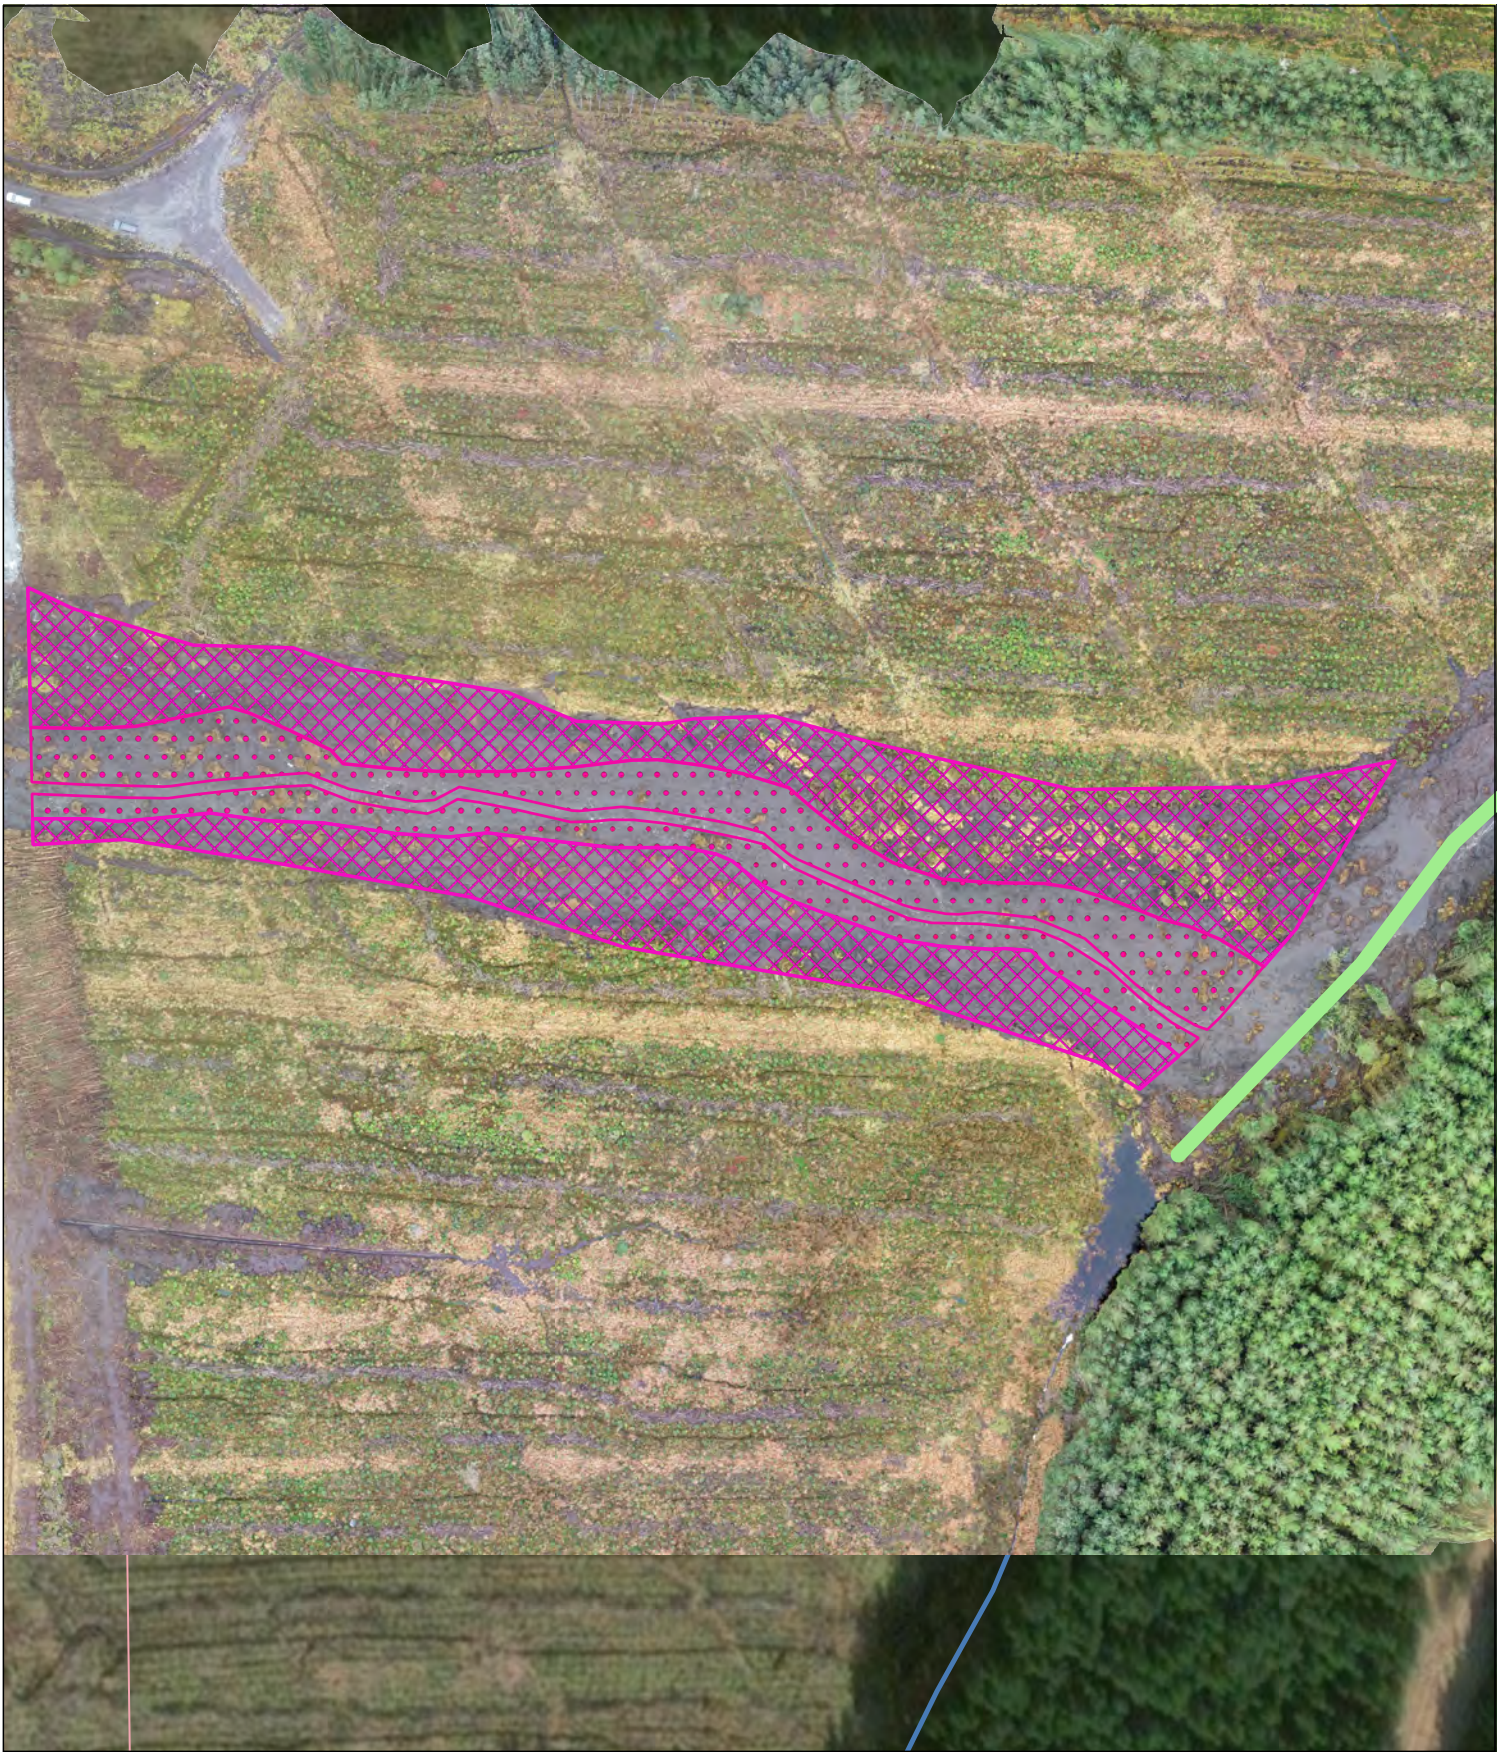
Drawing No.
Figure 5.3

- Zone 1 comprises of wetter areas immediately adjacent to the discharge channel and has an area of approximately 3,575 m².
- Zone 2 comprises the remainder of the slip scar outside of Zone 1 and has an area of approximately 7,765 m².

Slip Planting Plan

See Figure 5.3 below for the location of the Planting Zones 1 and 2. Proposed seeding and planting rates for Zones 1 and 2 are provided in Tables 5.1 and 5.2 below.

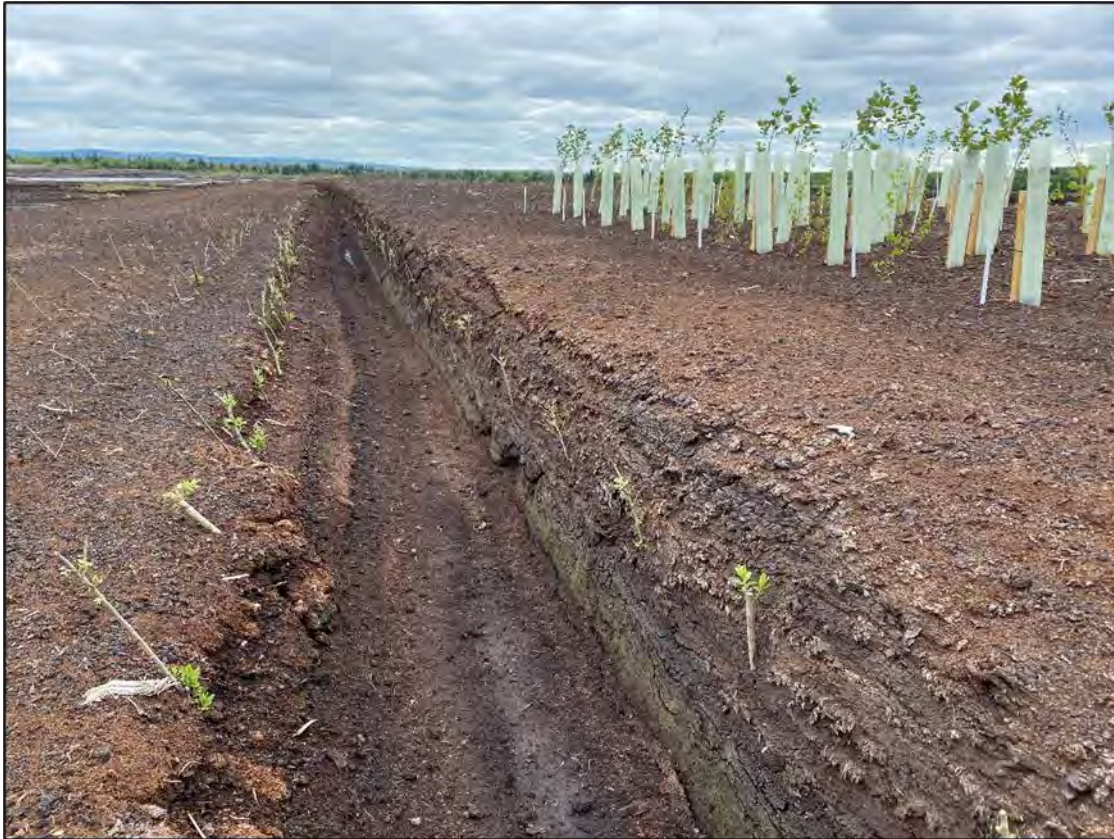
Figure 5.4 Example of live cutting along drain in planting trial on deep peat.

- Between 20%-30% and two buds (or pruned, lateral branch locations) on the cutting shall be above the ground surface
 - Split or otherwise damaged cuttings shall not be used.

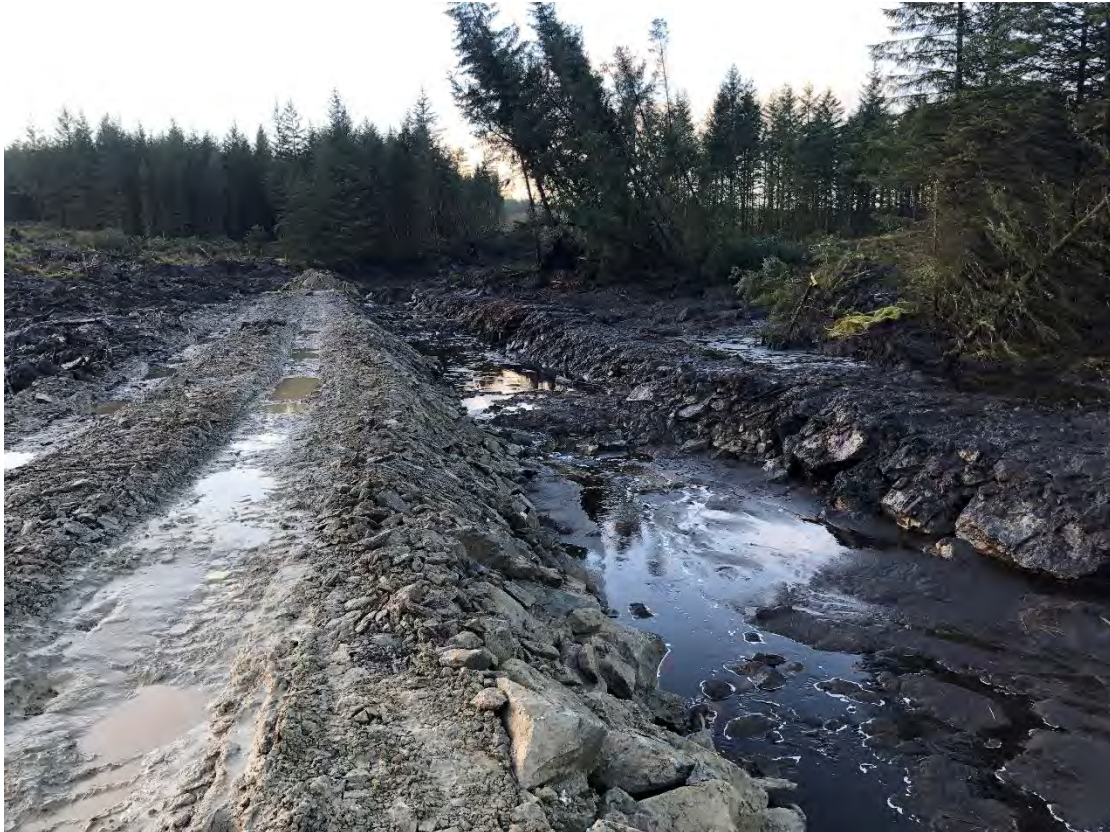
Figure 5.7 View of peat deposits at Reach 1, facing upstream.

This stream reach is approximately 390 metres in length. There is significant peat deposition throughout the reach and the original stream channel has been extensively damaged by the peat slide (Figure 5.7). A full restoration of this reach will be required and will be detailed in later phases of this action plan. For the purposes of Phase 1A of this action plan it is proposed to seed all bare peat areas adjacent to Stream Reach 1. This is intended as a temporary measure to promote stability and minimise loss of peat while further design and analysis work is undertaken. There are no in-stream works proposed at this time.

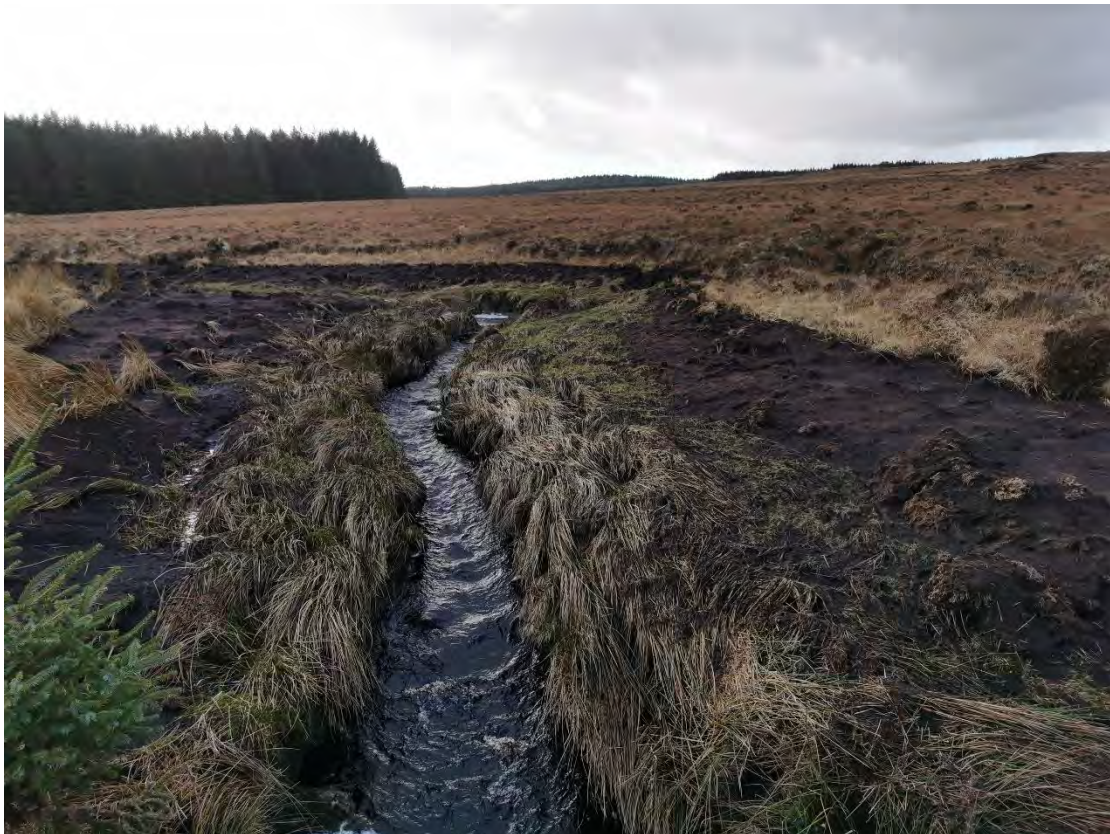
Figure 5.8 Riparian vegetation recovering in Reach 4

The levels of peat deposition on the top of the stream banks in Reach 4 are variable, ranging from very light (<0.1m) to moderate (0.4 m) in discrete pockets. The total area of peat deposition in Reach 4 is approximately 3.83 hectares. There is evidence of vegetation recovery throughout this reach as shown in Figure 5.8 below. There is some evidence of some localised bank instability in the upper section of this reach, however this is not widespread and in general the channel geomorphology remains intact. A field inspection of this stream reach on 25th February 2021 revealed a number of blockages in the stream channel in the upper section of this reach. Where debris is encountered in the channel this shall be removed by hand if possible.

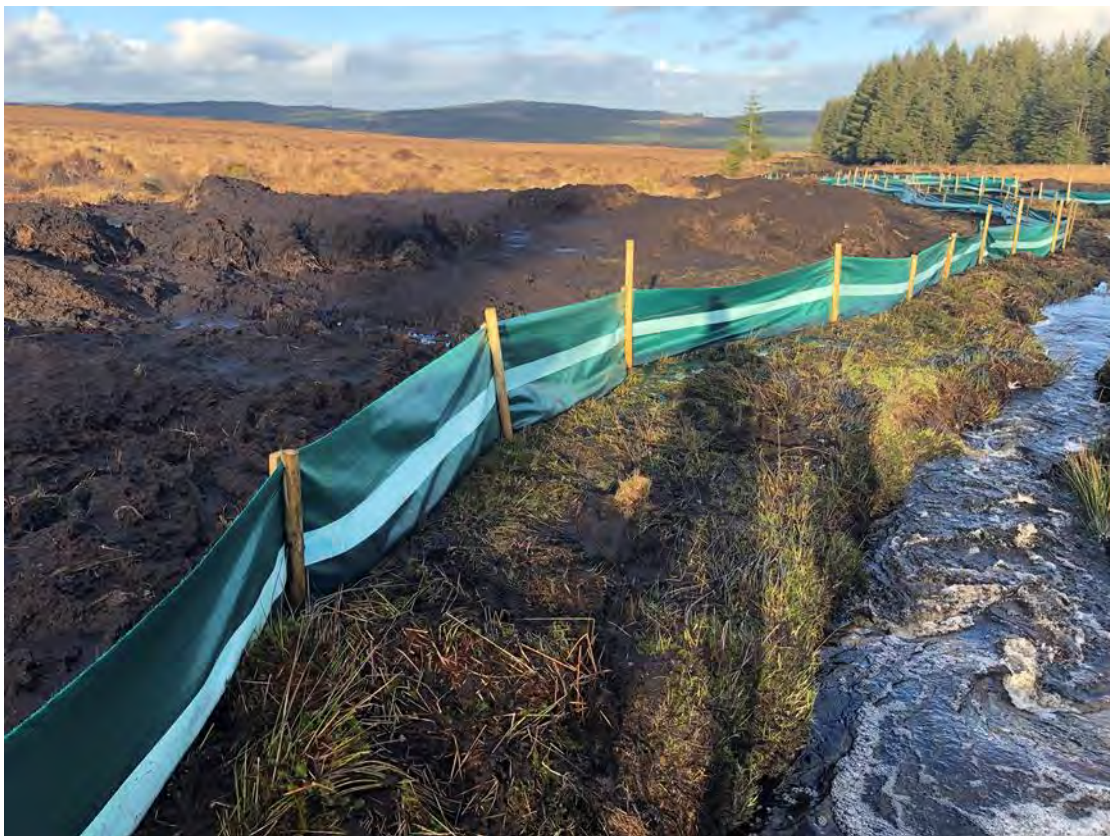
Figure 5.10 Silt fence Installed on Reach 4

- Install silt fencing along cleared path on stream bank, taking care to follow manufacture's specifications and ensure bottom of fence is properly buried into ground surfer and adequate fencing stakes are installed at regular intervals to support fence and the silt that will build up behind it. Specification for Terrastop silt fencing is included in Appendix 3.

- Maintain silt fence in place for as long as necessary until all bare peat has reseeded and demonstrated to have well-establish root system of surface vegetation, capable of binding material together. Silt fence only to be removed with approval of supervising ecologist.

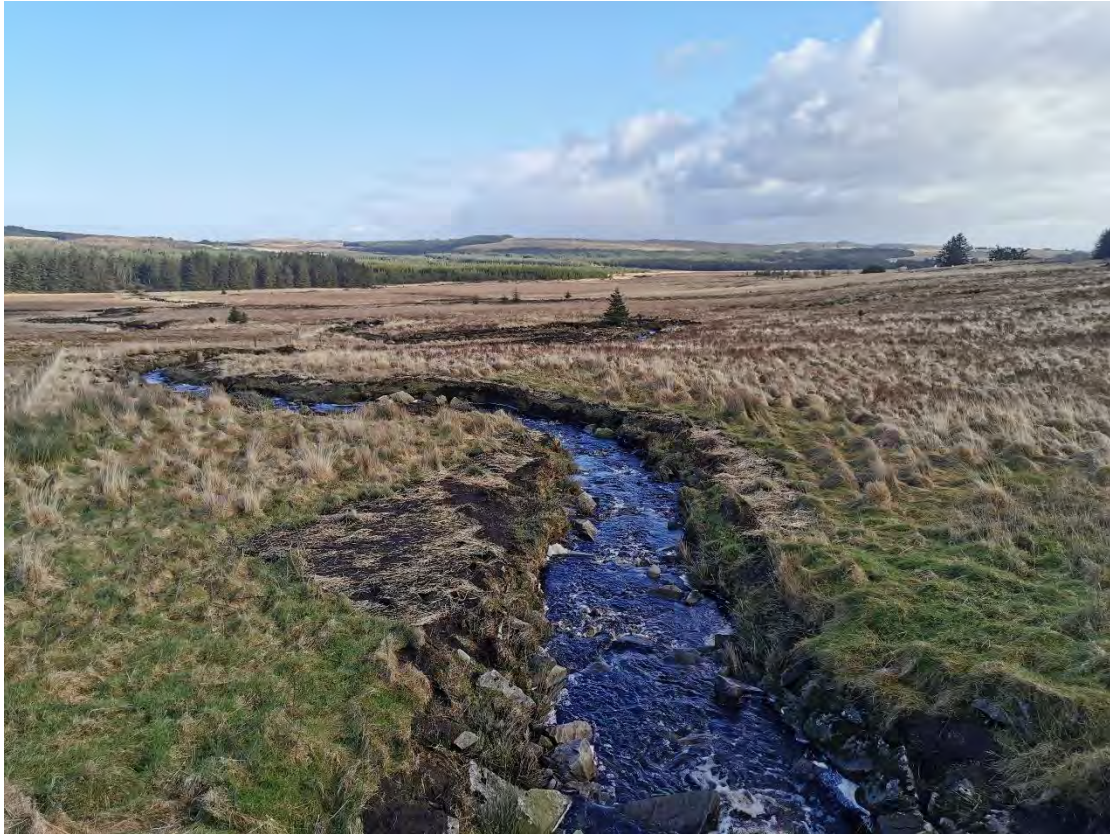
Figure 5.11 View of typical peat deposits in Reach 5, facing downstream.

A field inspection of this stream reach on 25th February 2021 revealed no blockages in the stream channel and relatively light levels of peat deposition on the top of the stream banks. The Shruhengarve stream is generally more incised in this reach than further upstream and this, in conjunction with the greater distance from the original peat slide, may have contributed to generally lighter levels of peat deposition. There is evidence of vegetation recovery throughout this reach as shown in Figure 5.11 below. Furthermore, there is no evidence of extensive channel instability in this reach.

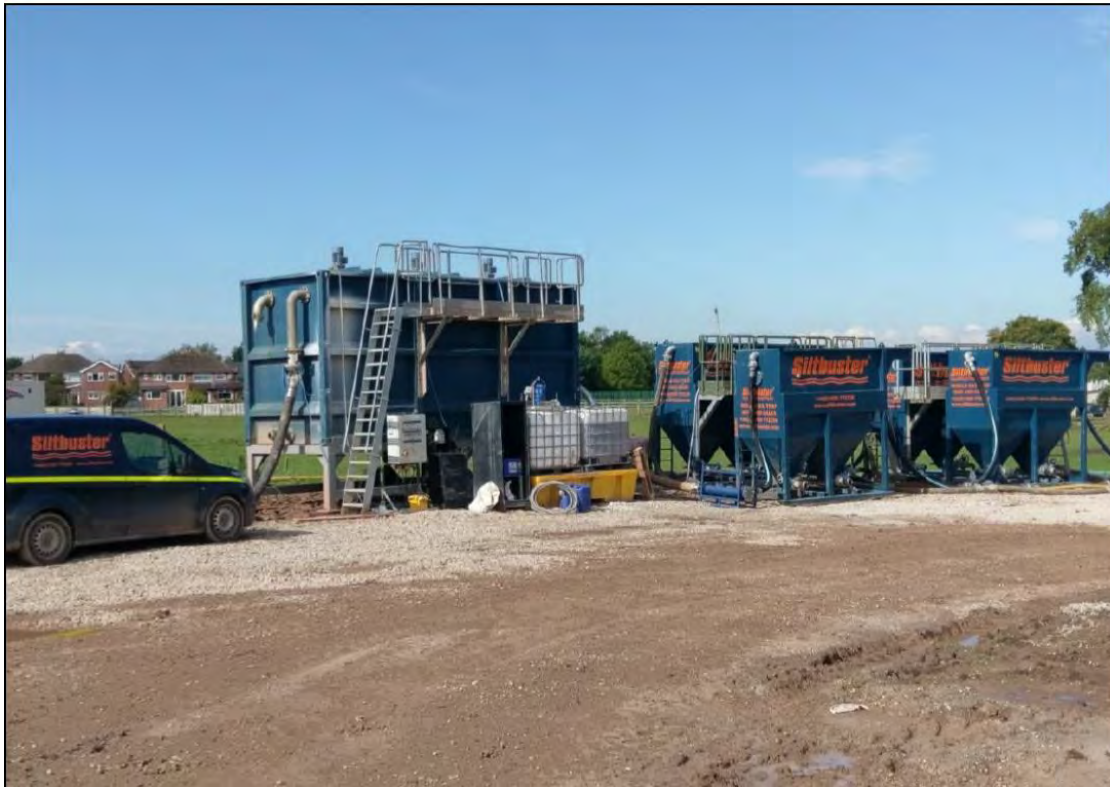
Figure 5.12: MT30 Chemical Pre-Treatment system with 4 No Lamella clarifiers

A photographic example of the system layout is shown in Figure 5.12 below. The total plan area of the core water treatment system is approximately 50-60 m².

- > MT30 – 3.5mW x 6.1mL = 21.35m²
- > HB50 – 1.7mW x 3.8mL x 4 no. = 25.84m²

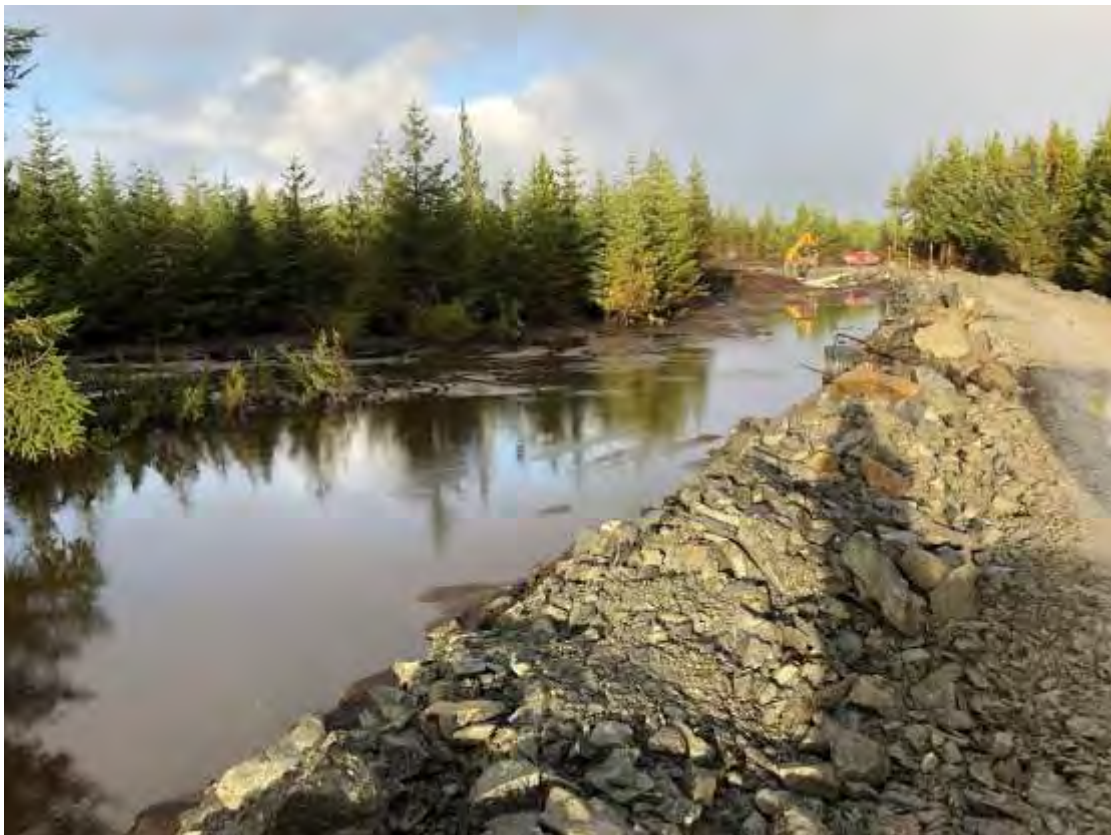
Figure 2.2 Water and sediment impoundment area upstream of Wall 1 showing stabilised situation and deposits of peat up to surface of water

Large volumes of sediment have been successfully impounded behind Wall 1 and prevented from entering downstream watercourses, as evident in Figures 2.2 and 2.3 below. The volumetric measurement of these sediment volumes is presently underway and will be reported in future iterations of the Action Plan. Approximately 79% of water flows entering the Shruhingarve catchment upstream of Wall 1 have been intercepted upstream of the impounded sediment and diverted away from the sediment impounded behind Wall 1, thereby minimising the re-mobilisation of the impounded sediment, but larger volumes of water are likely to continue to reach the upstream side of Wall 1 in periods of heavier and prolonged rainfall.

There currently appears to be minimal seepage of water through Wall 1, likely because any void spaces have become plugged with suspended peat and the bypass flows already in place around Wall 1.

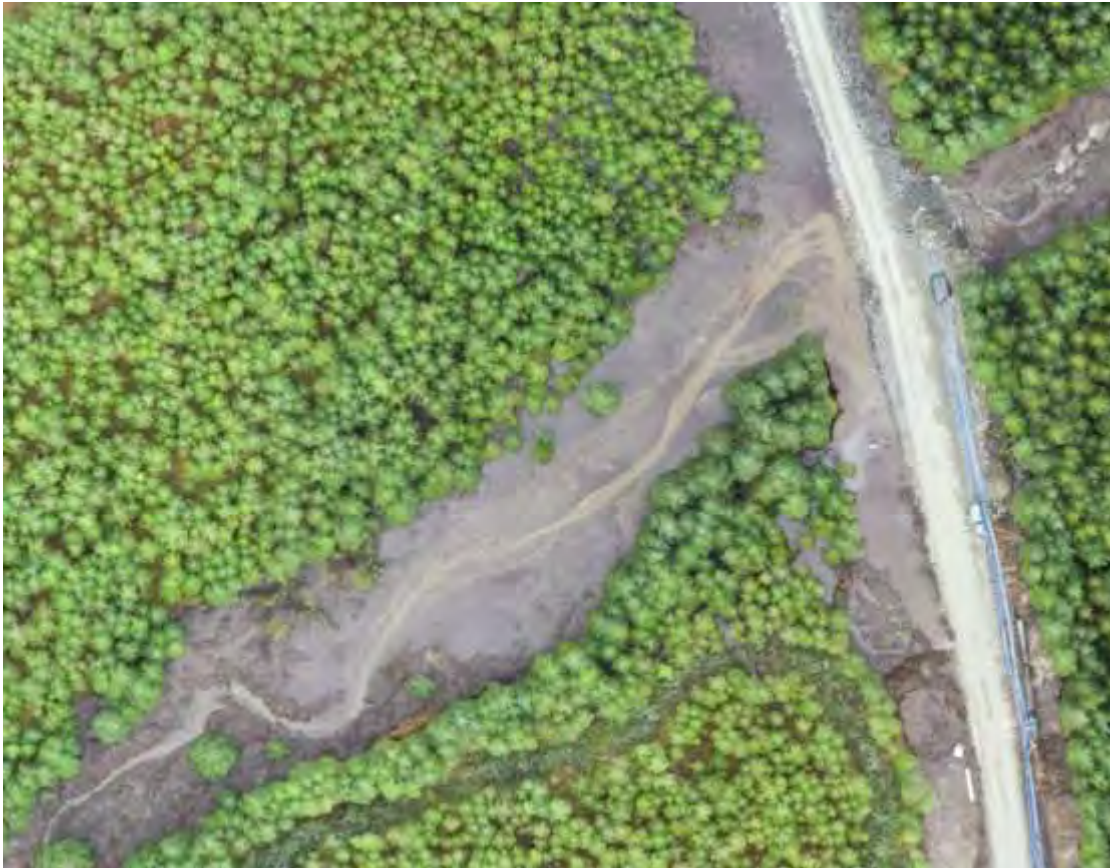
Figure 2.3 Aerial image of water and peat impoundment area upstream of Wall 1 showing large volumes of impounded peat and clearly identifiable channel for water reaching Wall 1

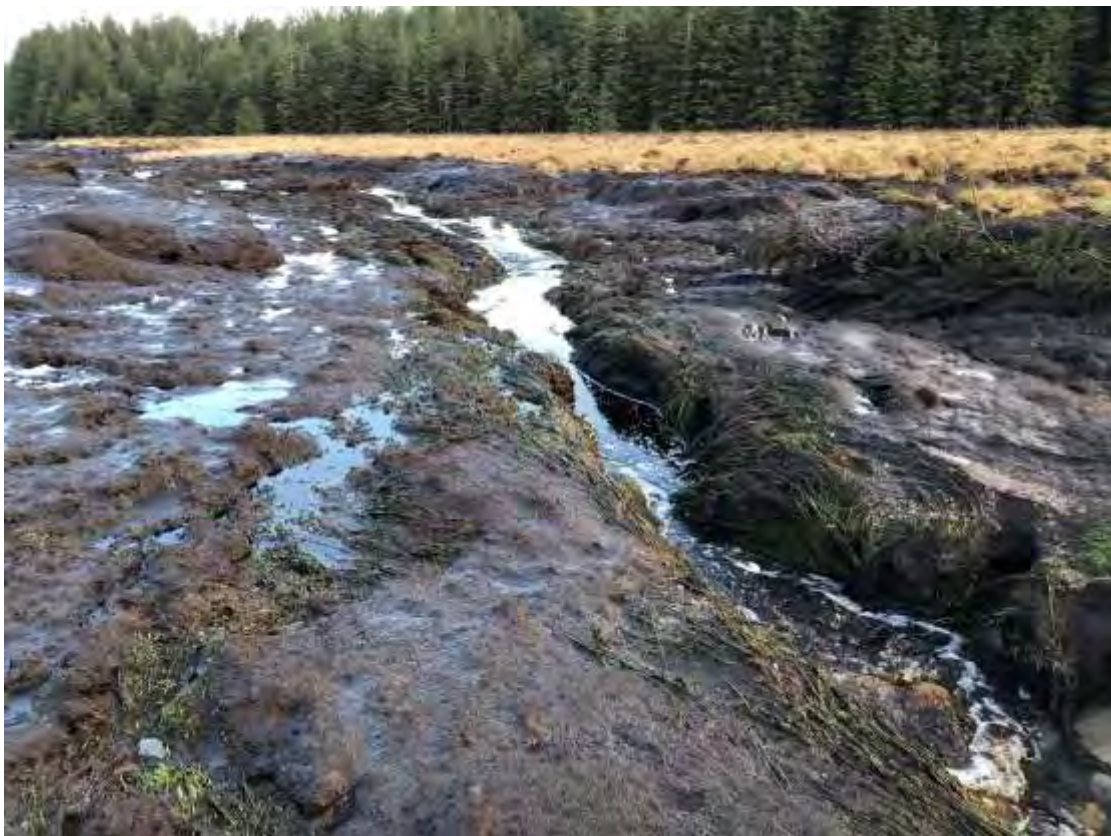
Figure 5.2 Peat deposited on stream bank downstream of Wall 1, with intact vegetation partially visible and larger deposits of peat further back from stream edge

The Shruhengarve stream downstream of Wall 1 continues to flow within the original natural stream channel, but larger flows during and after large rainfall events have caused some secondary mobilisation of the peat that would have been originally deposited on the stream banks. While the majority of the streambank peat deposits appear relatively stable, overland flows from the adjacent bog habitat towards the stream have caused some further mobilisation of the deposited peat in particular locations. It is not considered justifiable to leave the peat deposits in place without taking action to minimise run off, as to do so would result in further secondary mobilisation of the deposited peat into the adjacent stream. The Shruhengarve Stream with associated peat deposits is shown in Figure 5.2

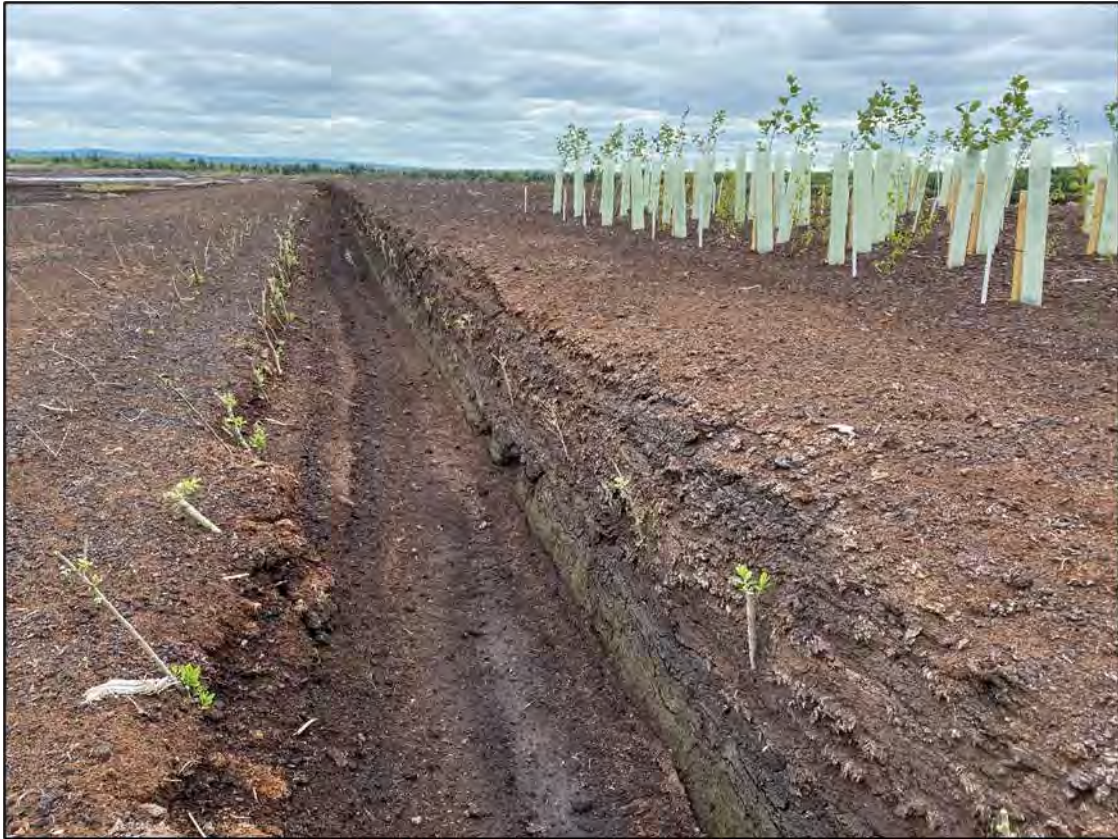
Figure 5.4 Example of live cutting along drain in planting trial on deep peat.

- Peat shall be firmly packed around the hole after installation, where required.
 - Cuttings shall be tamped in at a right angle to the ground with between 70%-80% of the stake installed below the ground surface.

- Between 20%-30% and two buds (or pruned, lateral branch locations) on the cutting shall be above the ground surface
 - Split or otherwise damaged cuttings shall not be used.

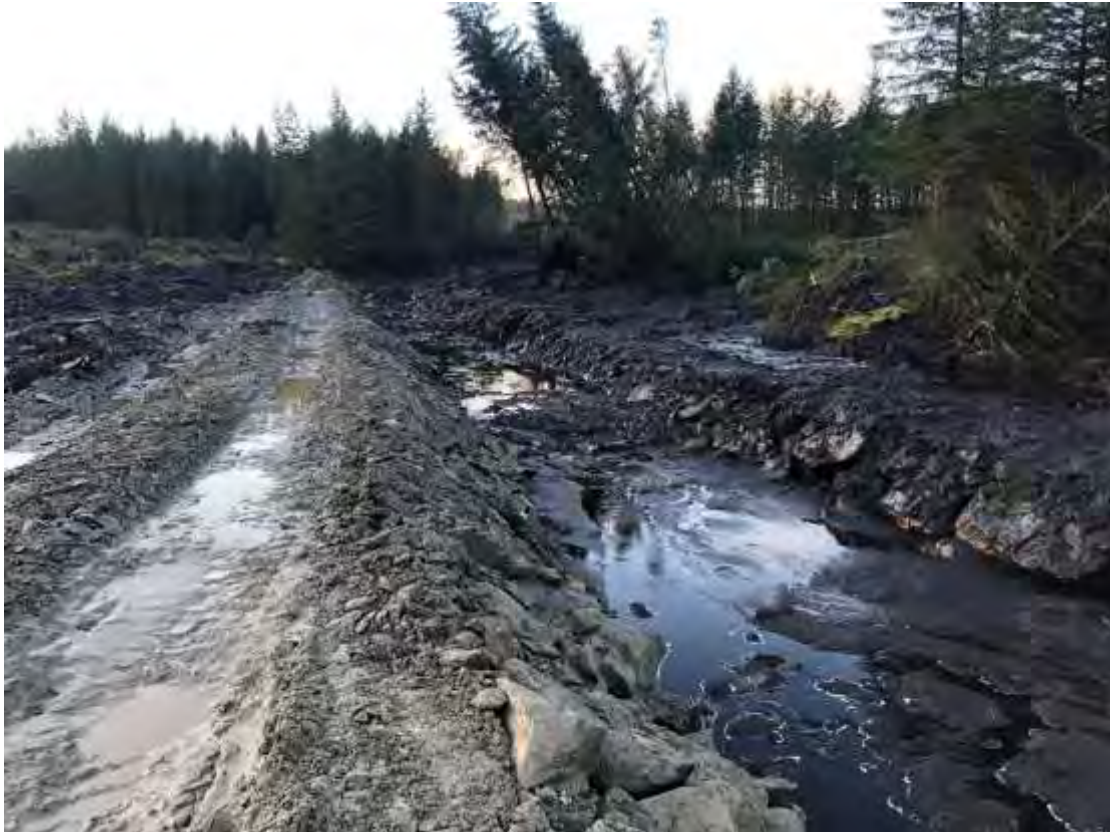
Figure 5.7 View of peat deposits at Reach 1, facing upstream.

This stream reach is approximately 390 metres in length. There is significant peat deposition throughout the reach and the original stream channel has been extensively damaged by the peat slide (Figure 5.7). A full restoration of this reach will be required and will be detailed in later phases of this action plan. For the purposes of Phase 1A of this action plan it is proposed to seed all bare peat areas adjacent to Stream Reach 1. This is intended as a temporary measure to promote stability and minimise loss of peat while further design and analysis work is undertaken. There are no in-stream works proposed at this time.

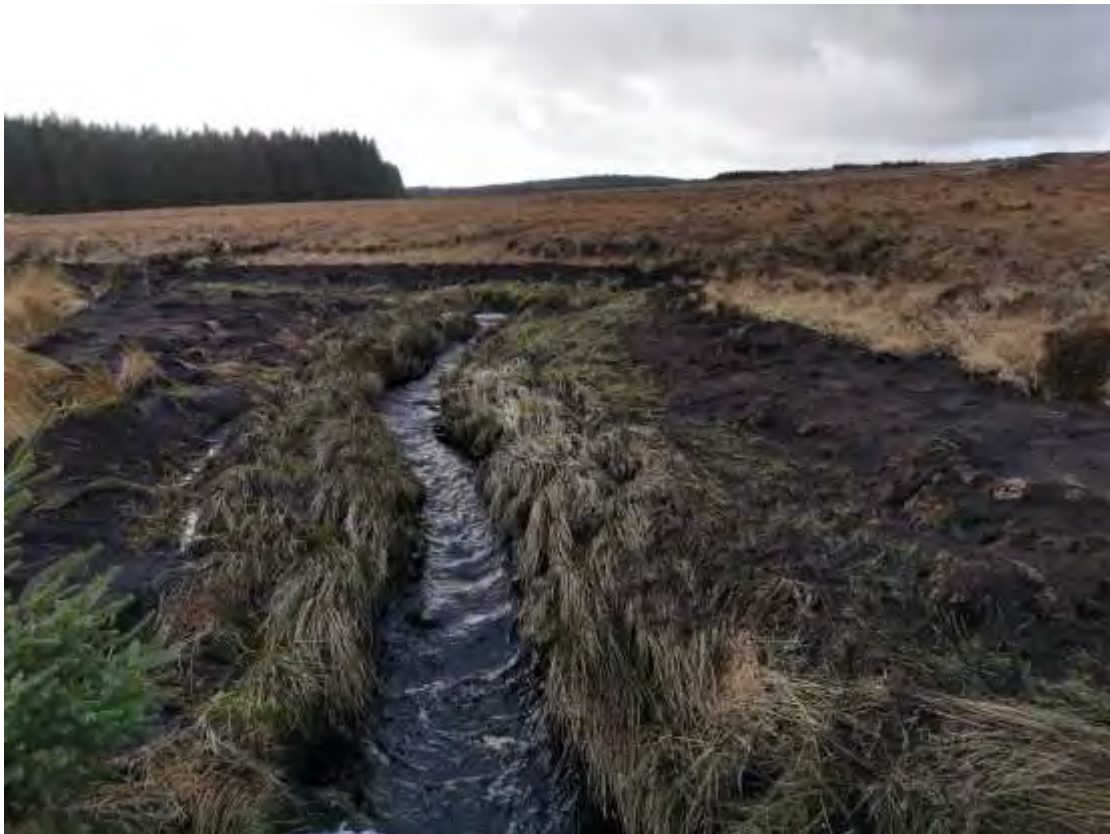
Figure 5.8 Riparian vegetation recovering in Reach 4

The levels of peat deposition on the top of the stream banks in Reach 4 are variable, ranging from very light (<0.1m) to moderate (0.4 m) in discrete pockets. The total area of peat deposition in Reach 4 is approximately 3.83 hectares. There is evidence of vegetation recovery throughout this reach as shown in Figure 5.8 below. There is some evidence of some localised bank instability in the upper section of this reach, however this is not widespread and in general the channel geomorphology remains intact. A field inspection of this stream reach on 25th February 2021 revealed a number of blockages in the stream channel in the upper section of this reach. Where debris is encountered in the channel this shall be removed by hand if possible.

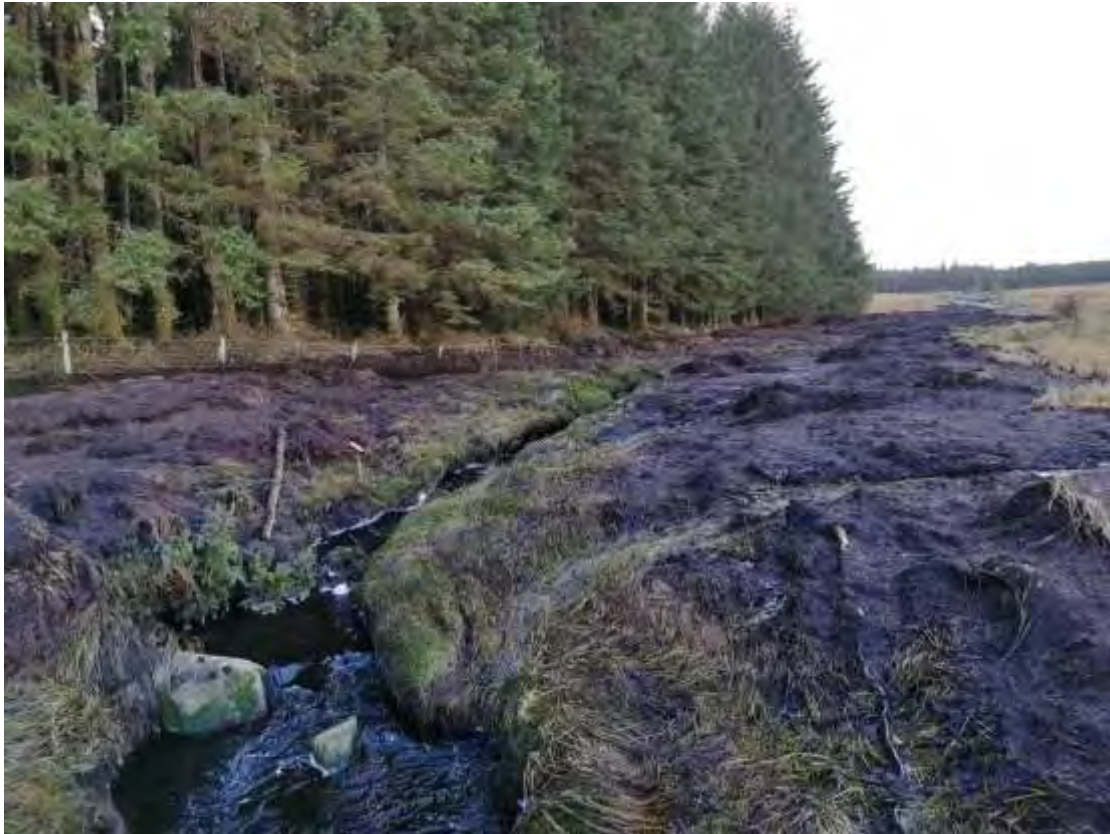
Figure 5.9 Area of heavier peat deposits in Reach 4 (facing upstream) where temporary silt fencing is recommended. Immediate streamside zone is largely free of peat.

Taking into account the conditions discussed above, the following measures are recommended for this reach:

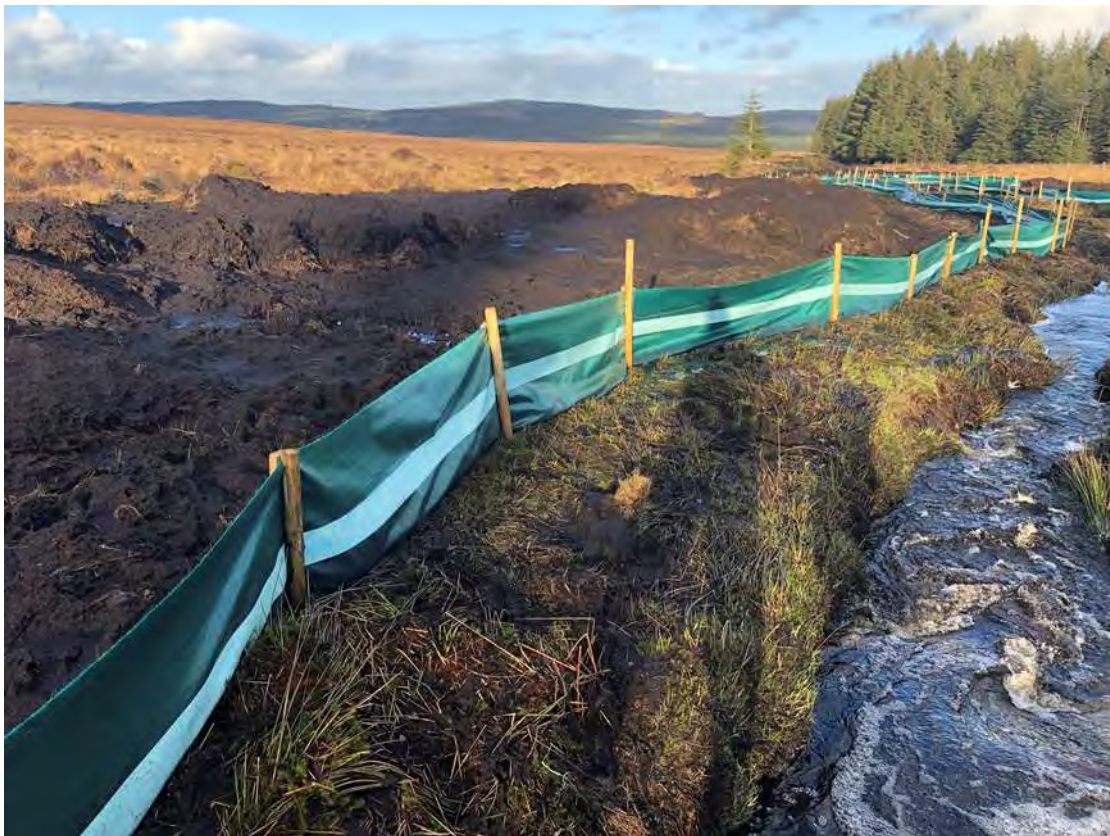
Figure 5.10 Silt fence Installed on Reach 4

- Install silt fencing along cleared path on stream bank, taking care to follow manufacture’s specifications and ensure bottom of fence is properly buried into ground surfer and adequate fencing stakes are installed at regular intervals to support fence and the silt that will build up behind it. Specification for Terrastop silt fencing is included in Appendix 3.

- Maintain silt fence in place for as long as necessary until all bare peat has reseeded and demonstrated to have well-establish root system of surface vegetation, capable of binding material together. Silt fence only to be removed with approval of supervising ecologist.

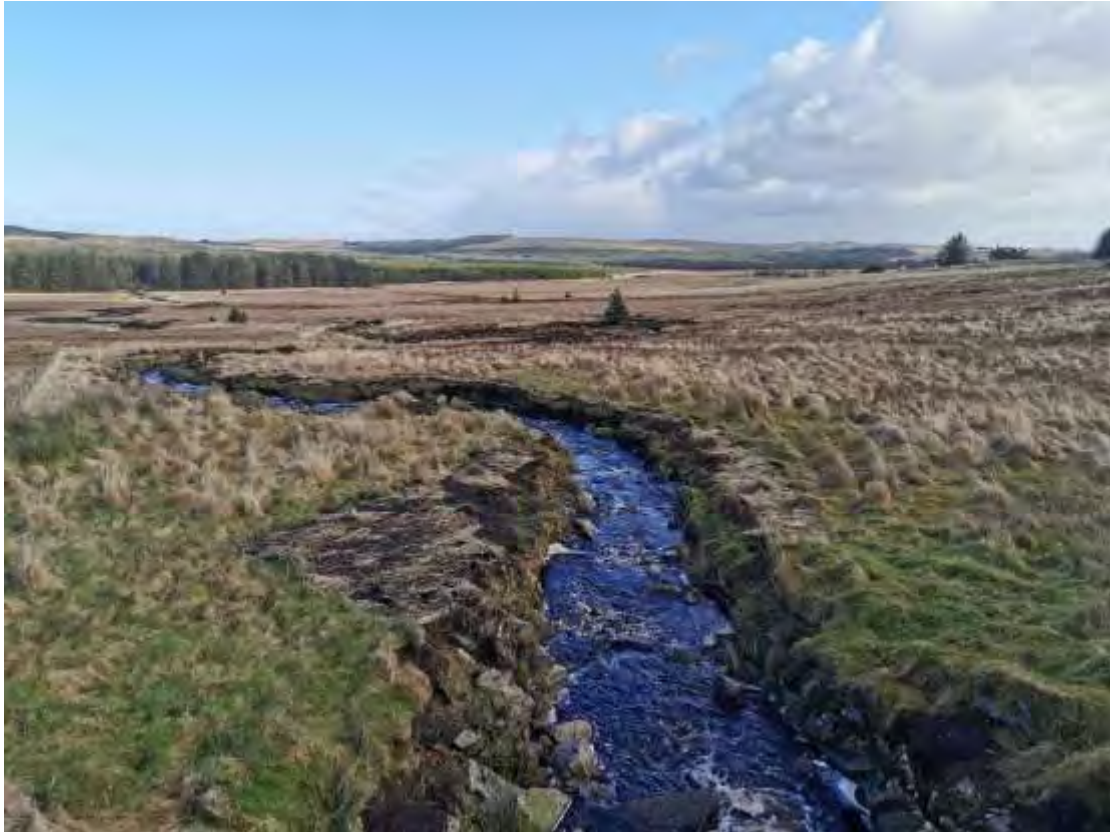
Figure 5.11 View of typical peat deposits in Reach 5, facing downstream.

A field inspection of this stream reach on 25th February 2021 revealed no blockages in the stream channel and relatively light levels of peat deposition on the top of the stream banks. The Shruhengarve stream is generally more incised in this reach than further upstream and this, in conjunction with the greater distance from the original peat slide, may have contributed to generally lighter levels of peat deposition. There is evidence of vegetation recovery throughout this reach as shown in Figure 5.11 below. Furthermore, there is no evidence of extensive channel instability in this reach.

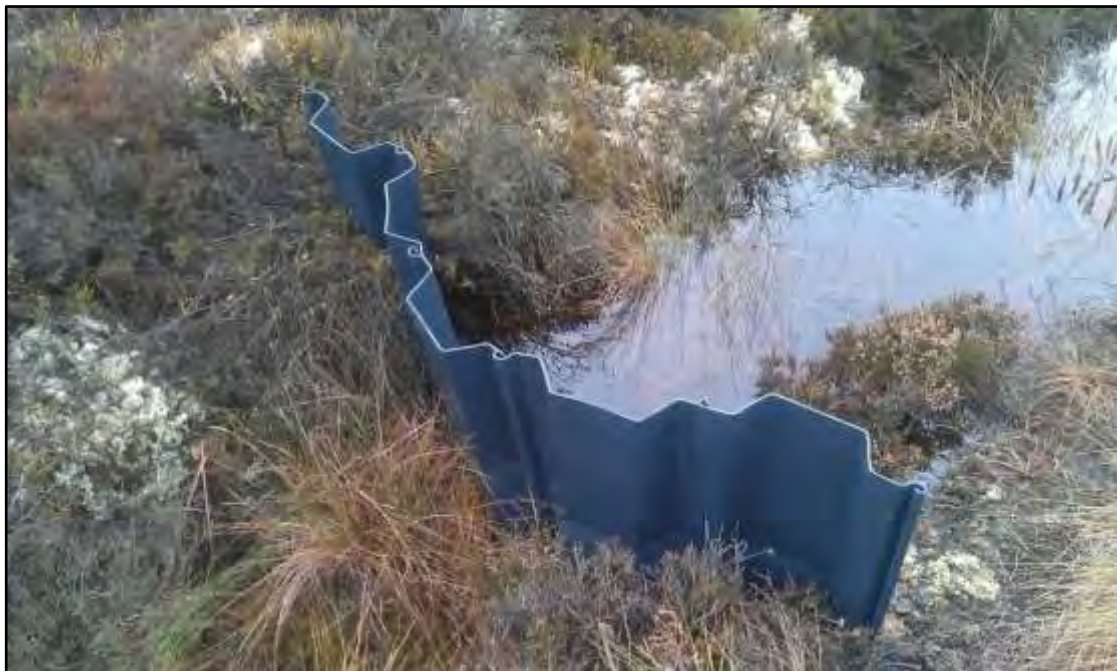
Figure 5.12 Example of plastic dams to be used for on-site drain blocking.

Existing/historic drainage channels occurring within the wider area to the south of the area where the peat slide occurred provide some surface contribution to the affected area. Therefore, following advice from the project hydrologist Michael Gill, a number of plastic dams will be installed at a number of targeted areas to slow the rate of flow entering the area of the peat slide following periods of heavy rainfall. This will assist in avoiding or reducing erosion during periods of heavy rainfall by decreasing through flow. Therefore, the dams will be installed within the drains partly below the surface level. This will allow surface water runoff to continue to discharge from this small catchment at a controlled rate without creating any significant water retention at this location. Drains will be blocked, where appropriate, using plastic dams, see Plate 5.12. These will be installed by hand with no vehicular access permitted to the area at any stage of the works. The indicative location of the dams is provided in Figure 3.2 of the Peatland Restoration Plan (Appendix 4, attached). The methodology for dam installation is also set out in Mackin et, al., (2017).

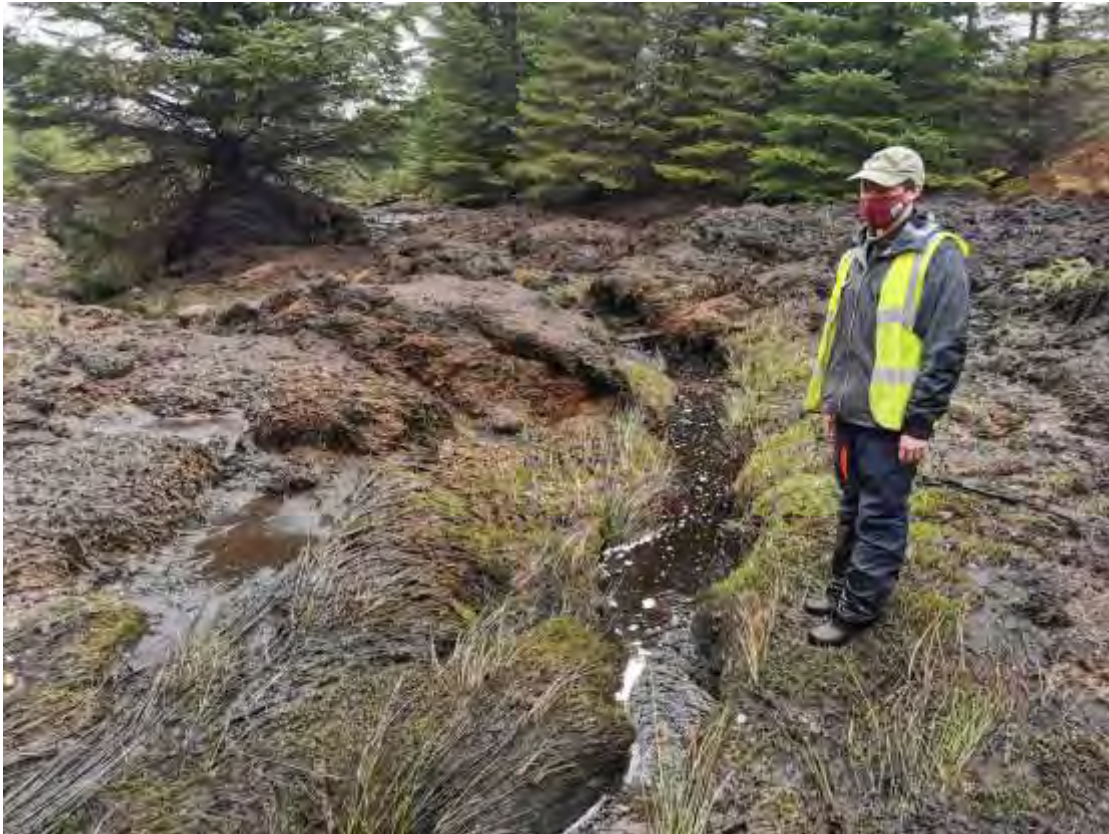
Figure 5.13 Area of heavier peat deposits in Reach 4 (facing upstream) where temporary silt fencing is recommended. Immediate streamside zone is largely free of peat.

Drone inspections and a field visit on the 30th of March 2021 have identified an approximately 100 metre section of Stream Reach 2 immediately upstream of the impounded area where the original stream channel is intact and largely free of obstructions. The levels of peat deposition on the top of the stream banks immediately adjacent to the stream in this section are generally light (0.1 to 0.2 m) and natural riparian vegetation is evident. However, there are several areas where large sections of brown, fibrous peat has been deposited in the riparian area. Figure 5.13 is representative of typical conditions within this section of Reach 2.

Taking into account the conditions discussed above it is proposed to use hand tools to clear heavy deposits from a 2 metre wide strip on either side of the stream. Silt fence will then be installed along both sides of the stream at 2 metres from the top of bank. All exposed residual peat with will be seeded with a native seed mix to promote revegetation. The following methods will be utilised:

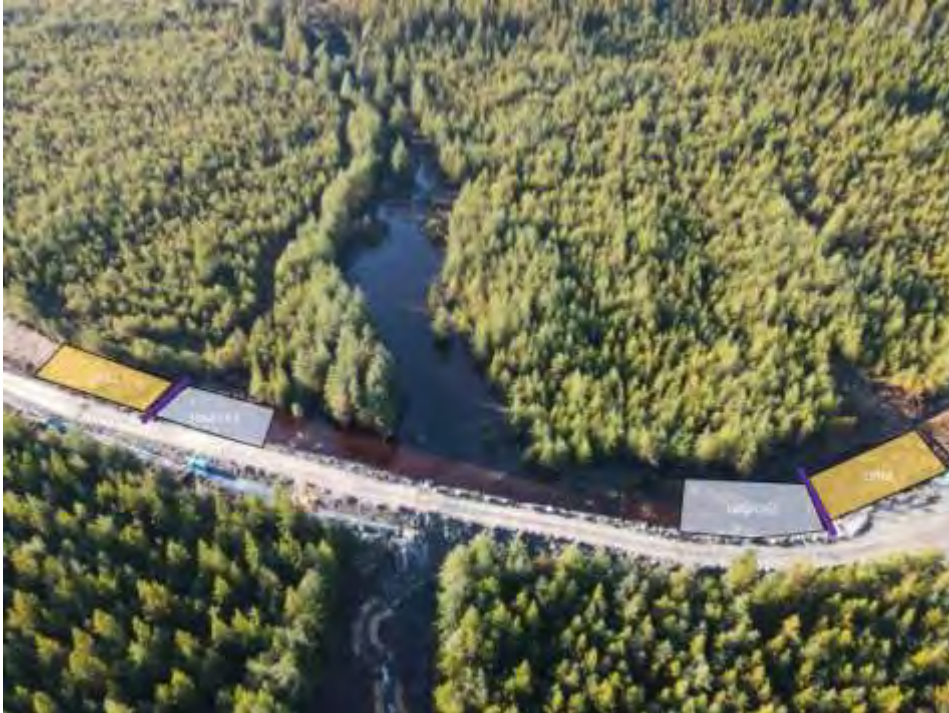
Figure 5.14 Creation of outer drying cells

Creation of outer drying cells (refer to Figure 5.14)

- Create vertical barriers/berm on pond side of Cell 1 and Cell 2 using rock.
- Dig peat material from Cell 1 and Cell 2 and remove to peat storage area
- Fill empty Cell 1 and Cell 2 with material from source 1 and source 2 areas
- Allow material in Cell 1 and Cell 2 to dry
- Once dry, remove material in Cell 1 and Cell 2 to authorised on-site peat storage area.
