**NOVEMBER 2020 PEATSLIDE
ENVIRONMENTAL REPORT**

November 2020 Peat Slide
at Meenbog Wind Farm, Co.
Donegal and subsequent
Restoration and
Remediation Works

Document Title: **Environmental Report**

Prepared By: **MKO
Tuam Road
Galway
Ireland
H91 VW84**

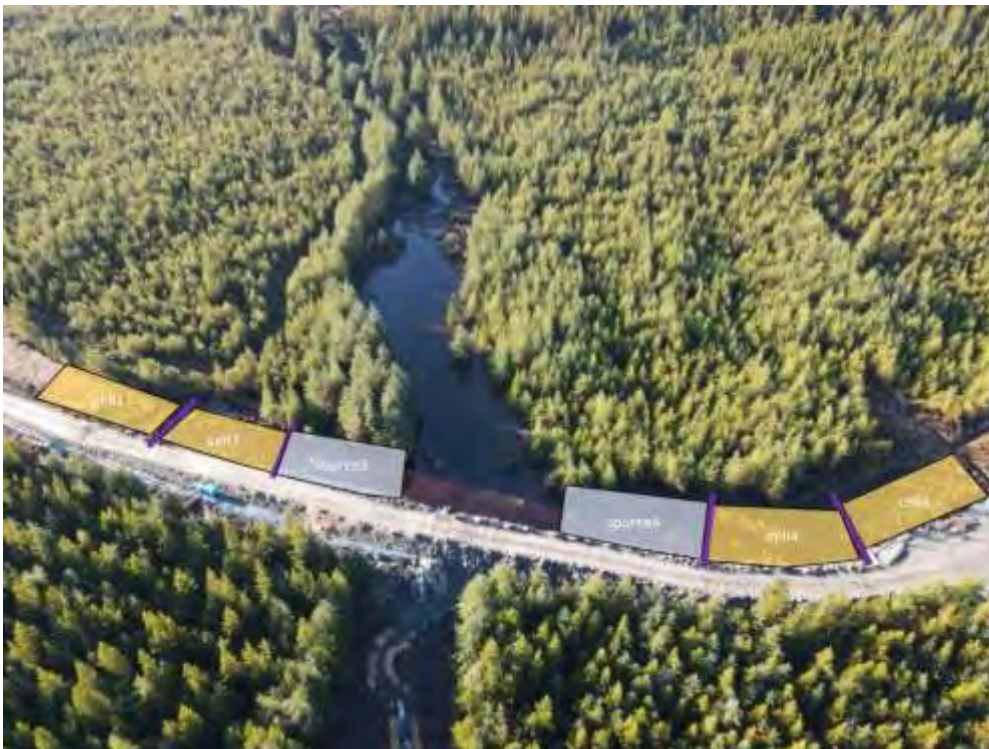
Figure 5.15 Creation of intermediate drying cells

Creation of intermediate drying cells (refer to Figure 5.15)

- > Create vertical barriers/berm on pond side of Cell 3 and Cell 4.
- > Fill the empty Cell 1/Cell 3 and Cell 2/Cell 4 with material from source 3 and source 4 areas
- > Allow material in Cell 1/Cell 3 and Cell 2/Cell 4 to dry
- > Once dry, remove material in Cell 1/Cell 3 and Cell 2/Cell 4 to authorised on-site peat storage area.

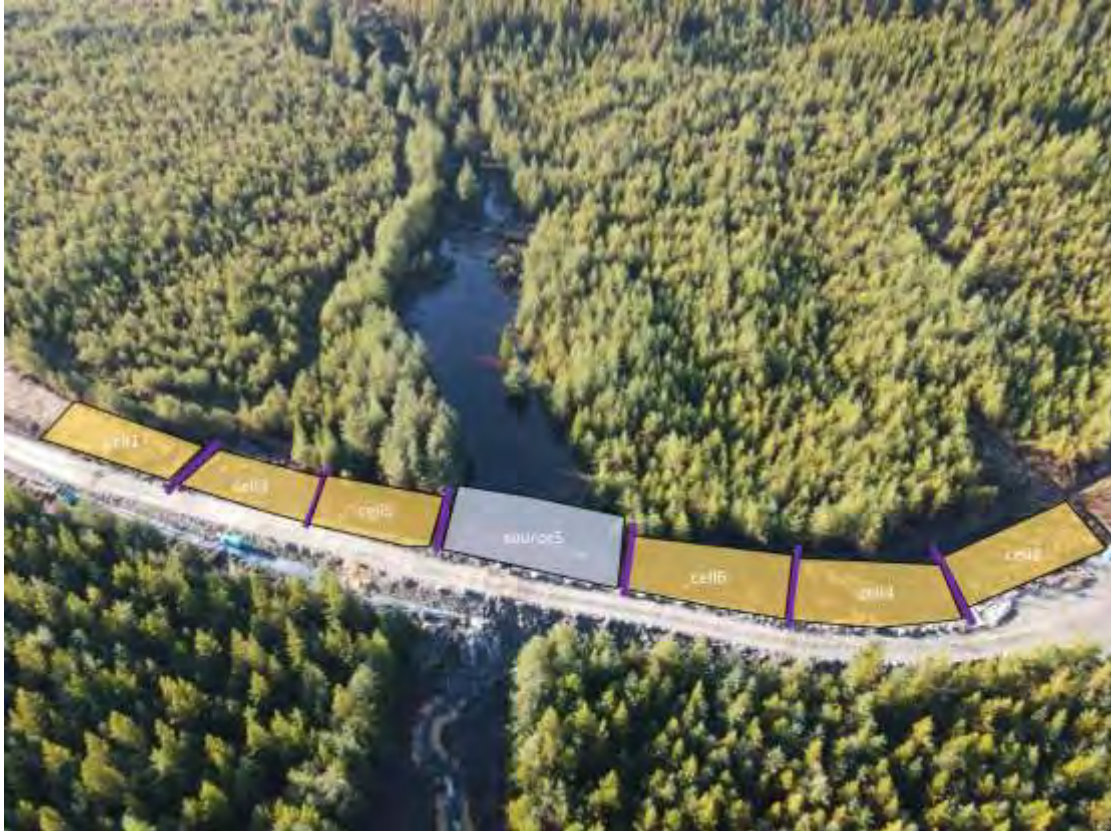
Figure 5.16 Creation of Inner drying cells

Creation of Inner drying cells (refer to Figure 5.16)

- > Create vertical barriers/berm on pond side of Cell 5 and Cell 6.
- > Fill the empty Cell 1/Cell 3/Cell 5 and Cell 2/Cell 4/Cell 6 with material from source 5 area.
- > Once material in all cells is dry, remove material in Cell 1/Cell 3/Cell 5 and Cell 2/Cell 4/Cell 6 to authorised on-site peat storage area.
- > Repeat this process until all material in Source Area 5 is removed.

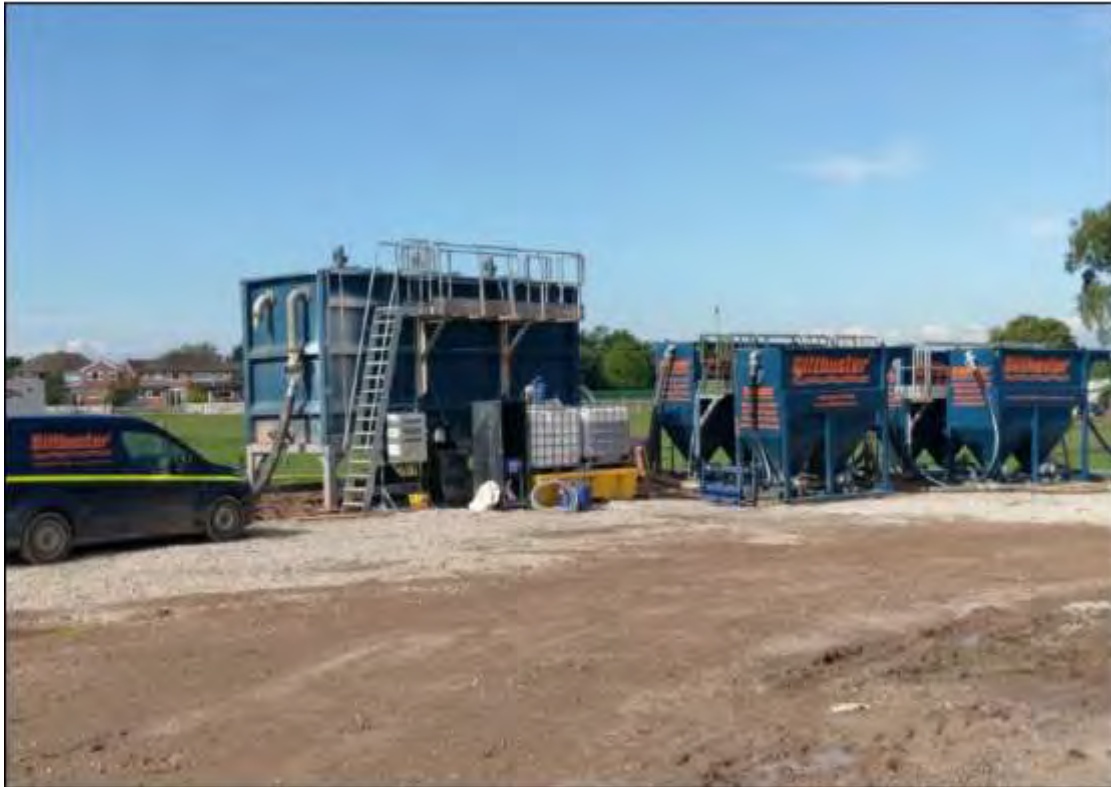
A photographic example of the system layout is shown in Figure 5.17 below. The total plan area of the core water treatment system is approximately 50-60 m².

- MT30 – 3.5mW x 6.1mL = 21.35m²
- HB50 – 1.7mW x 3.8mL x 4 no. = 25.84m²

Figure 5.17: MT30 Chemical Pre-Treatment system with 4 No Lamella clarifiers

Power requirements include a minimum 20KVA generator, 3-phase, 415V earth plus neutral, adjustable earth leakage or minimum 300 mA RCD.

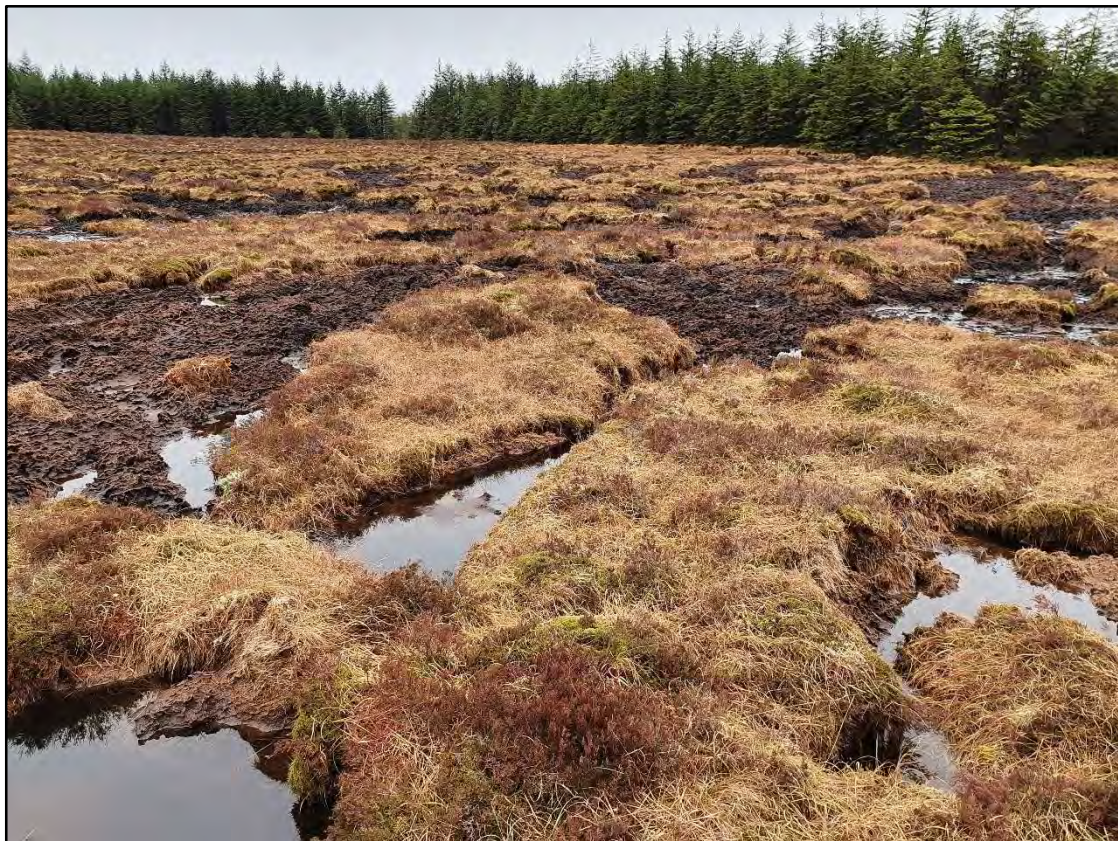
Plate 1.1 Example of the fragmented blanket bog habitat occurring where the slip occurred.

As shown in Plate 1.1, the area where the peat slide occurred now comprises some areas of exposed peat. In order to estimate the area of bare peat and bare peat areas now retaining surface water within the peat slide, the study area was surveyed using a drone. The imagery was then used to produce contour data and high-resolution imagery from which the following areas for each feature within the peat slide have been determined:

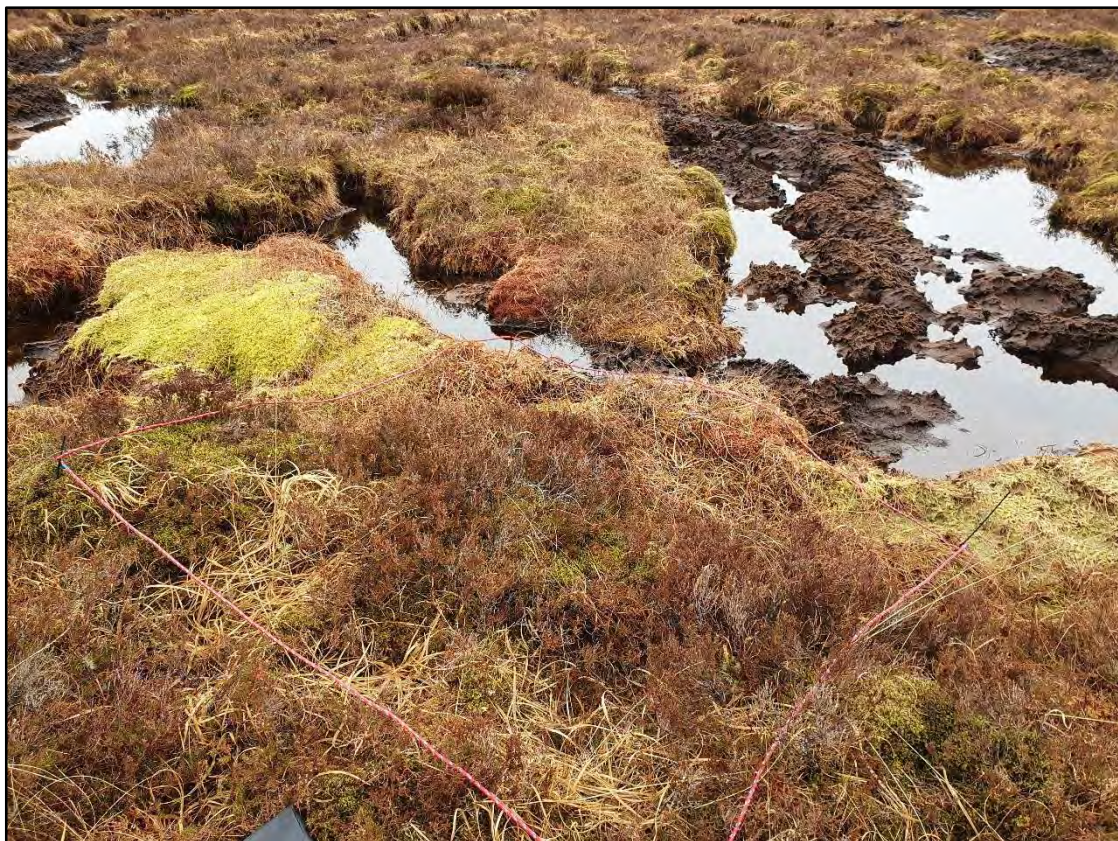
Plate 2.2 Example of the fragmented blanket bog habitat occurring within the area where the slip occurred. Note the amount of surface water retention within the newly formed “bog pools”, providing suitable features for Sphagnum moss establishment.

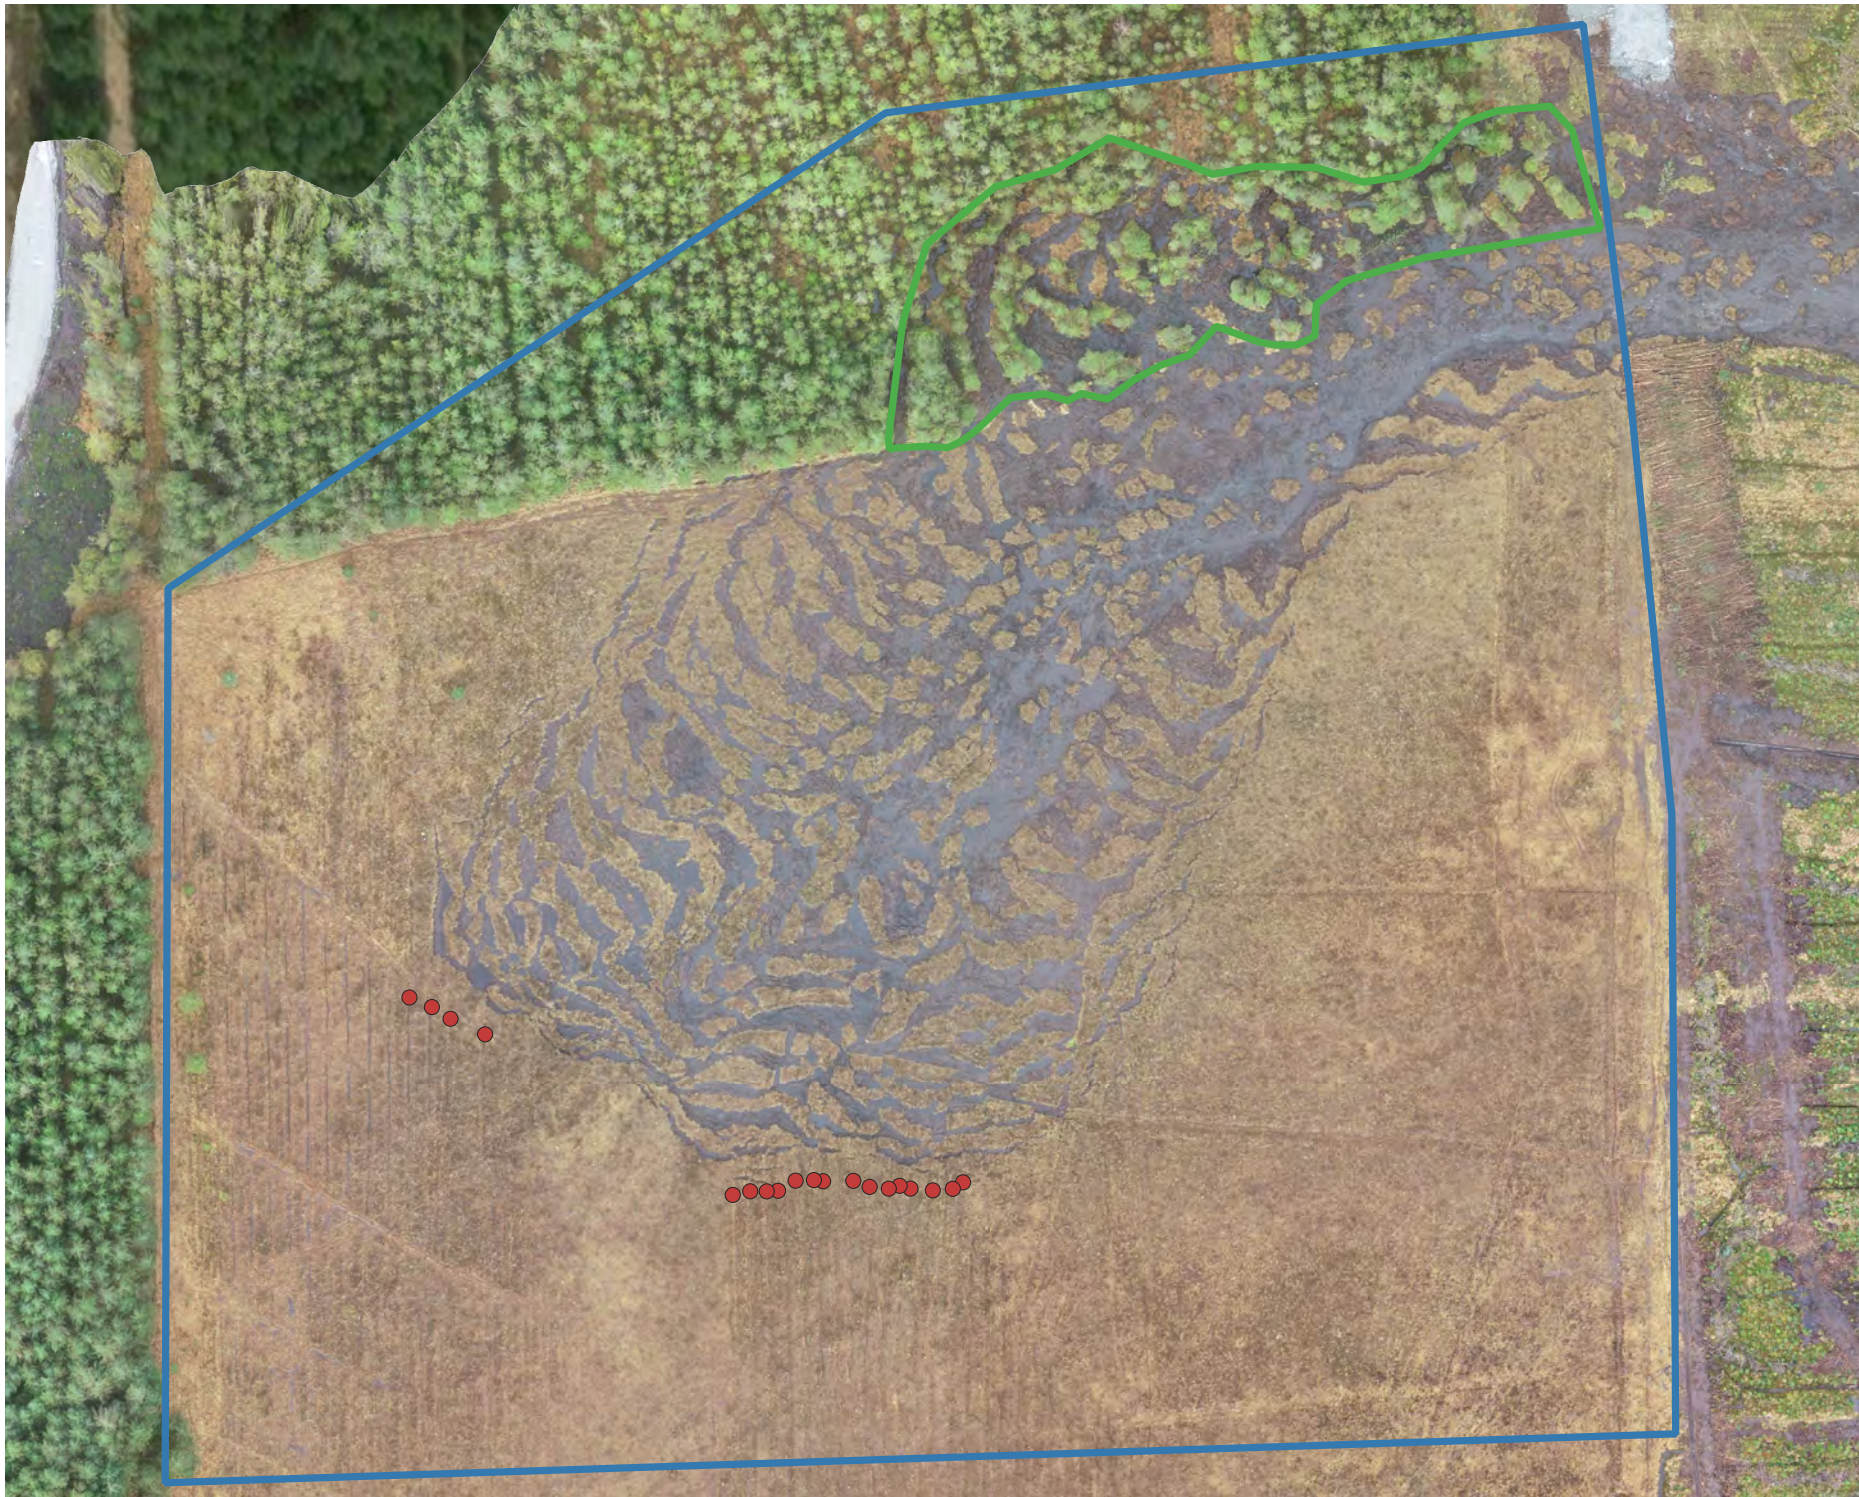
Drawing Title	
Management Actions	
Project Title	
Meenbog Peatland Restoration Plan	
Drawn By	Checked By
DMN	PR
Project No.	Drawing No.
201174	Figure 3.2
Scale	Date
1:1450	12.04.2021

- Proposed drain blocking locations
- Proposed tree removal area
- Wall 3
- Study area

As described above, existing/historic drainage channels occurring within the wider area to the south of the area where the peat slide occurred provide some surface contribution to the affected area. Therefore, following advice with the project hydrologist Michael Gill, a number of plastic dams will be installed at a number of targeted areas to slow the rate of flow entering the area of the peat slide following periods of heavy rainfall. This will assist in avoiding or reducing erosion during periods of heavy rainfall by decreasing through flow. Therefore, the dams will be installed within the drains partly below the surface level. This will allow surface water runoff to continue to discharge from this small catchment at a controlled rate without creating any significant water retention at this location. Drains will be blocked, where appropriate, using plastic dams, see Plate 3.1. These will be installed by hand with no vehicular access permitted to the area at any stage of the works. The indicative location of the dams is provided in Figure 3.2. The methodology for dam installation is also set out in Mackin et al., (2017).

The area where the peat slide occurred (above Wall Three) encompasses a number of trees that currently located on isolated raised sections of peat i.e. “peat rafts”, held together by the root system. In this area, the surrounding peat has lowered in elevation, see Plate 3.2 and Figure 3.2.

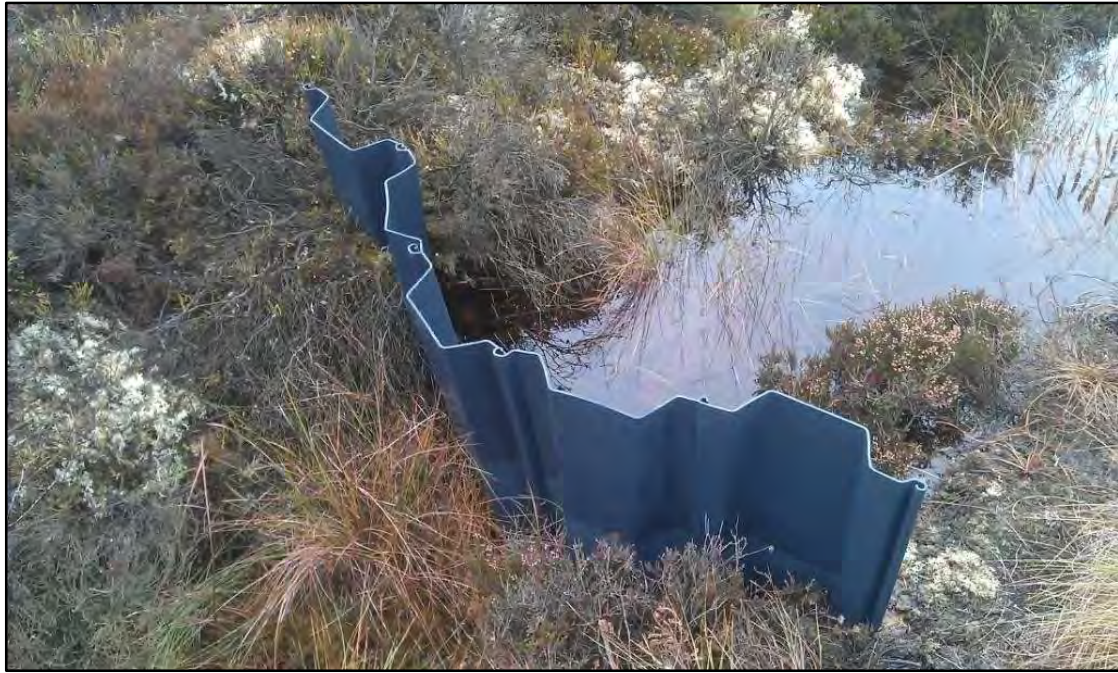
Plate 3.1 Example of plastic dams to be used for on-site drain blocking.

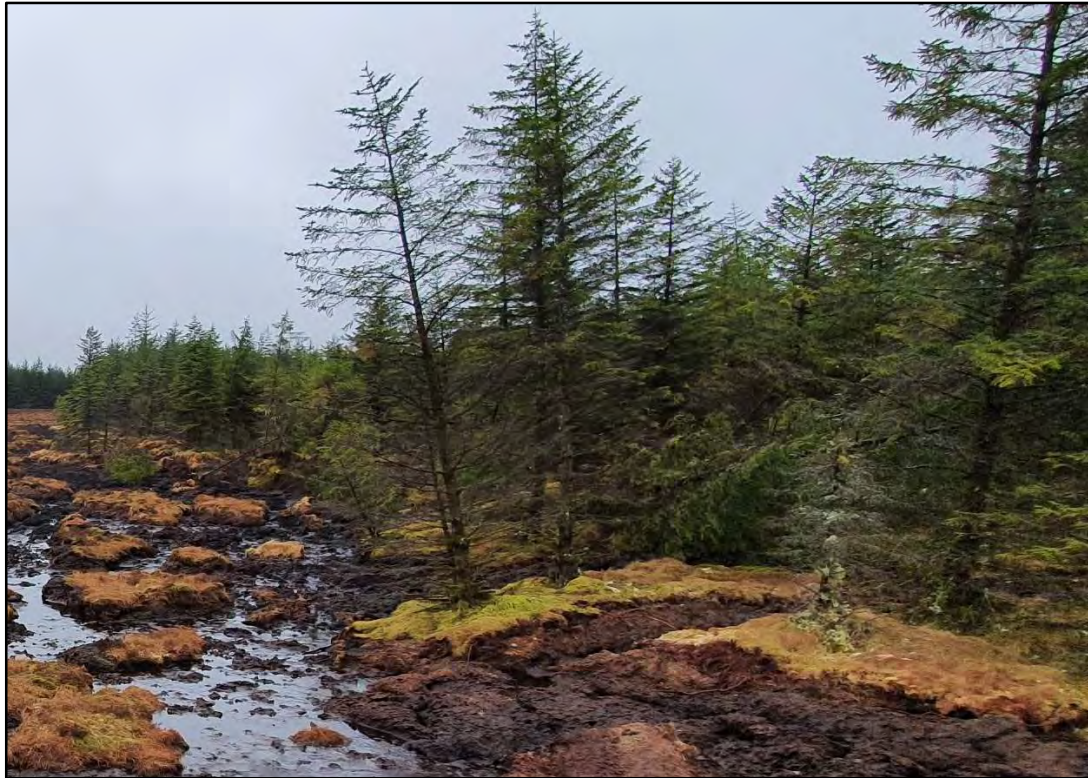
Plate 3.2 Example of forestry occurring at the northern extent of the study area with notable peat rafts.

As part of the monitoring programme, the trees within this area will be subject to monitoring to see if there are any signs that they may be knocked over during high winds (known as windblow). If the trees do fall and result in any additional vegetation disturbance, it is proposed to fell these individual trees by hand. Any such vegetation clearance will be undertaken under the provisions of the Wildlife Acts 1976 to 2018.

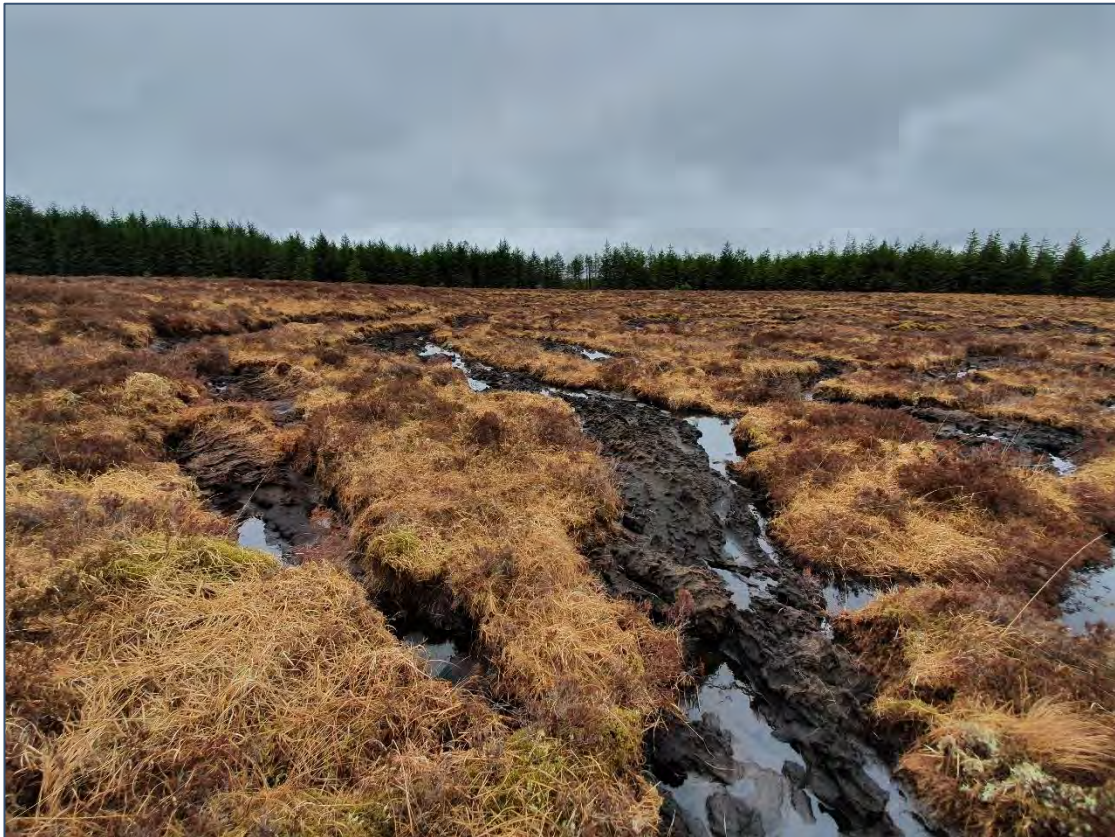
Plate 2-1 Eroding gullies formed within the blanket bog habitat.

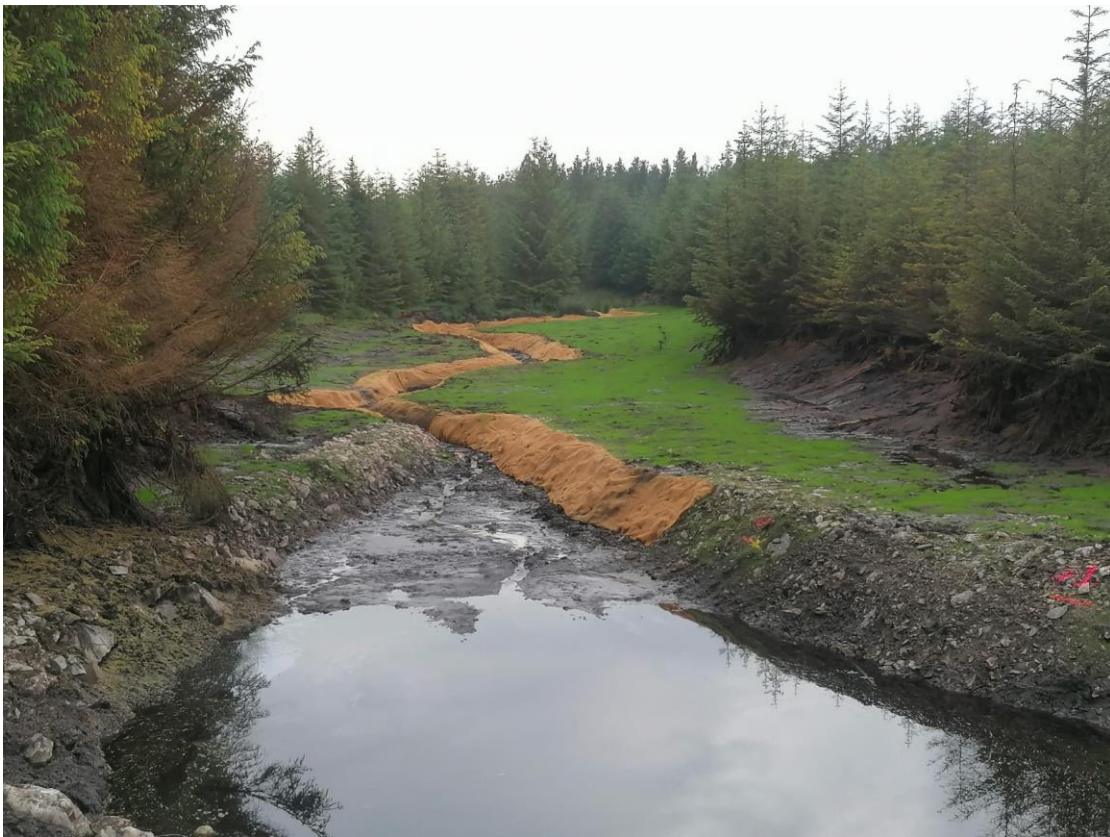
Plate 2.5 View of impounded area following sediment removal works, taken from Wall 1, facing upstream

All significant peat deposits have now been removed from the lower portion of Reach 2 down to the level of the native ground. The area has been seeded with a native grass seed mix to provide surface protection from erosion. An area approximately 30 metres long by 15 metres wide, immediately upstream of Wall 1 has been left to provide attenuation for high flows and to continue to act as a silt trap to prevent any sediment that might arise from upstream works from proceeding further downstream. This area will remain in this condition until all upstream works are completed. Plates 2.5 and 2.6 are representative of the current condition of this reach

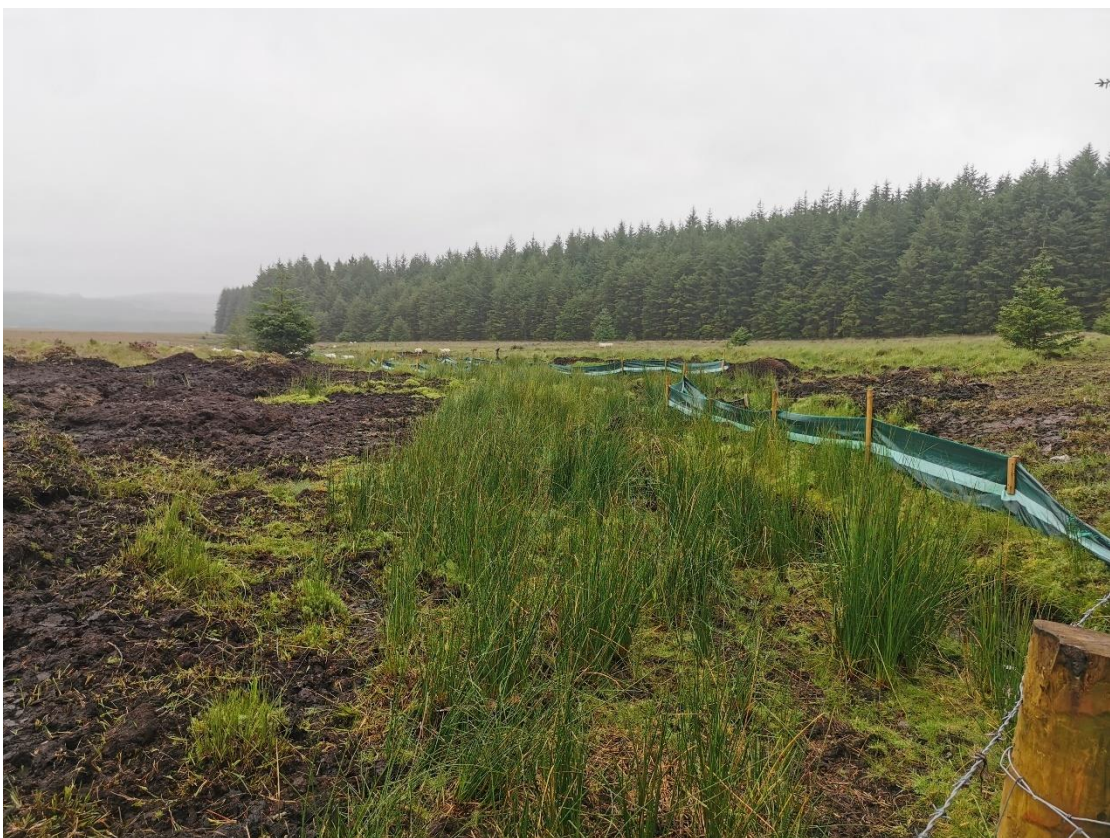
Plate 2.9 Riparian vegetation recovering in upper portion of Reach 4, facing downstream

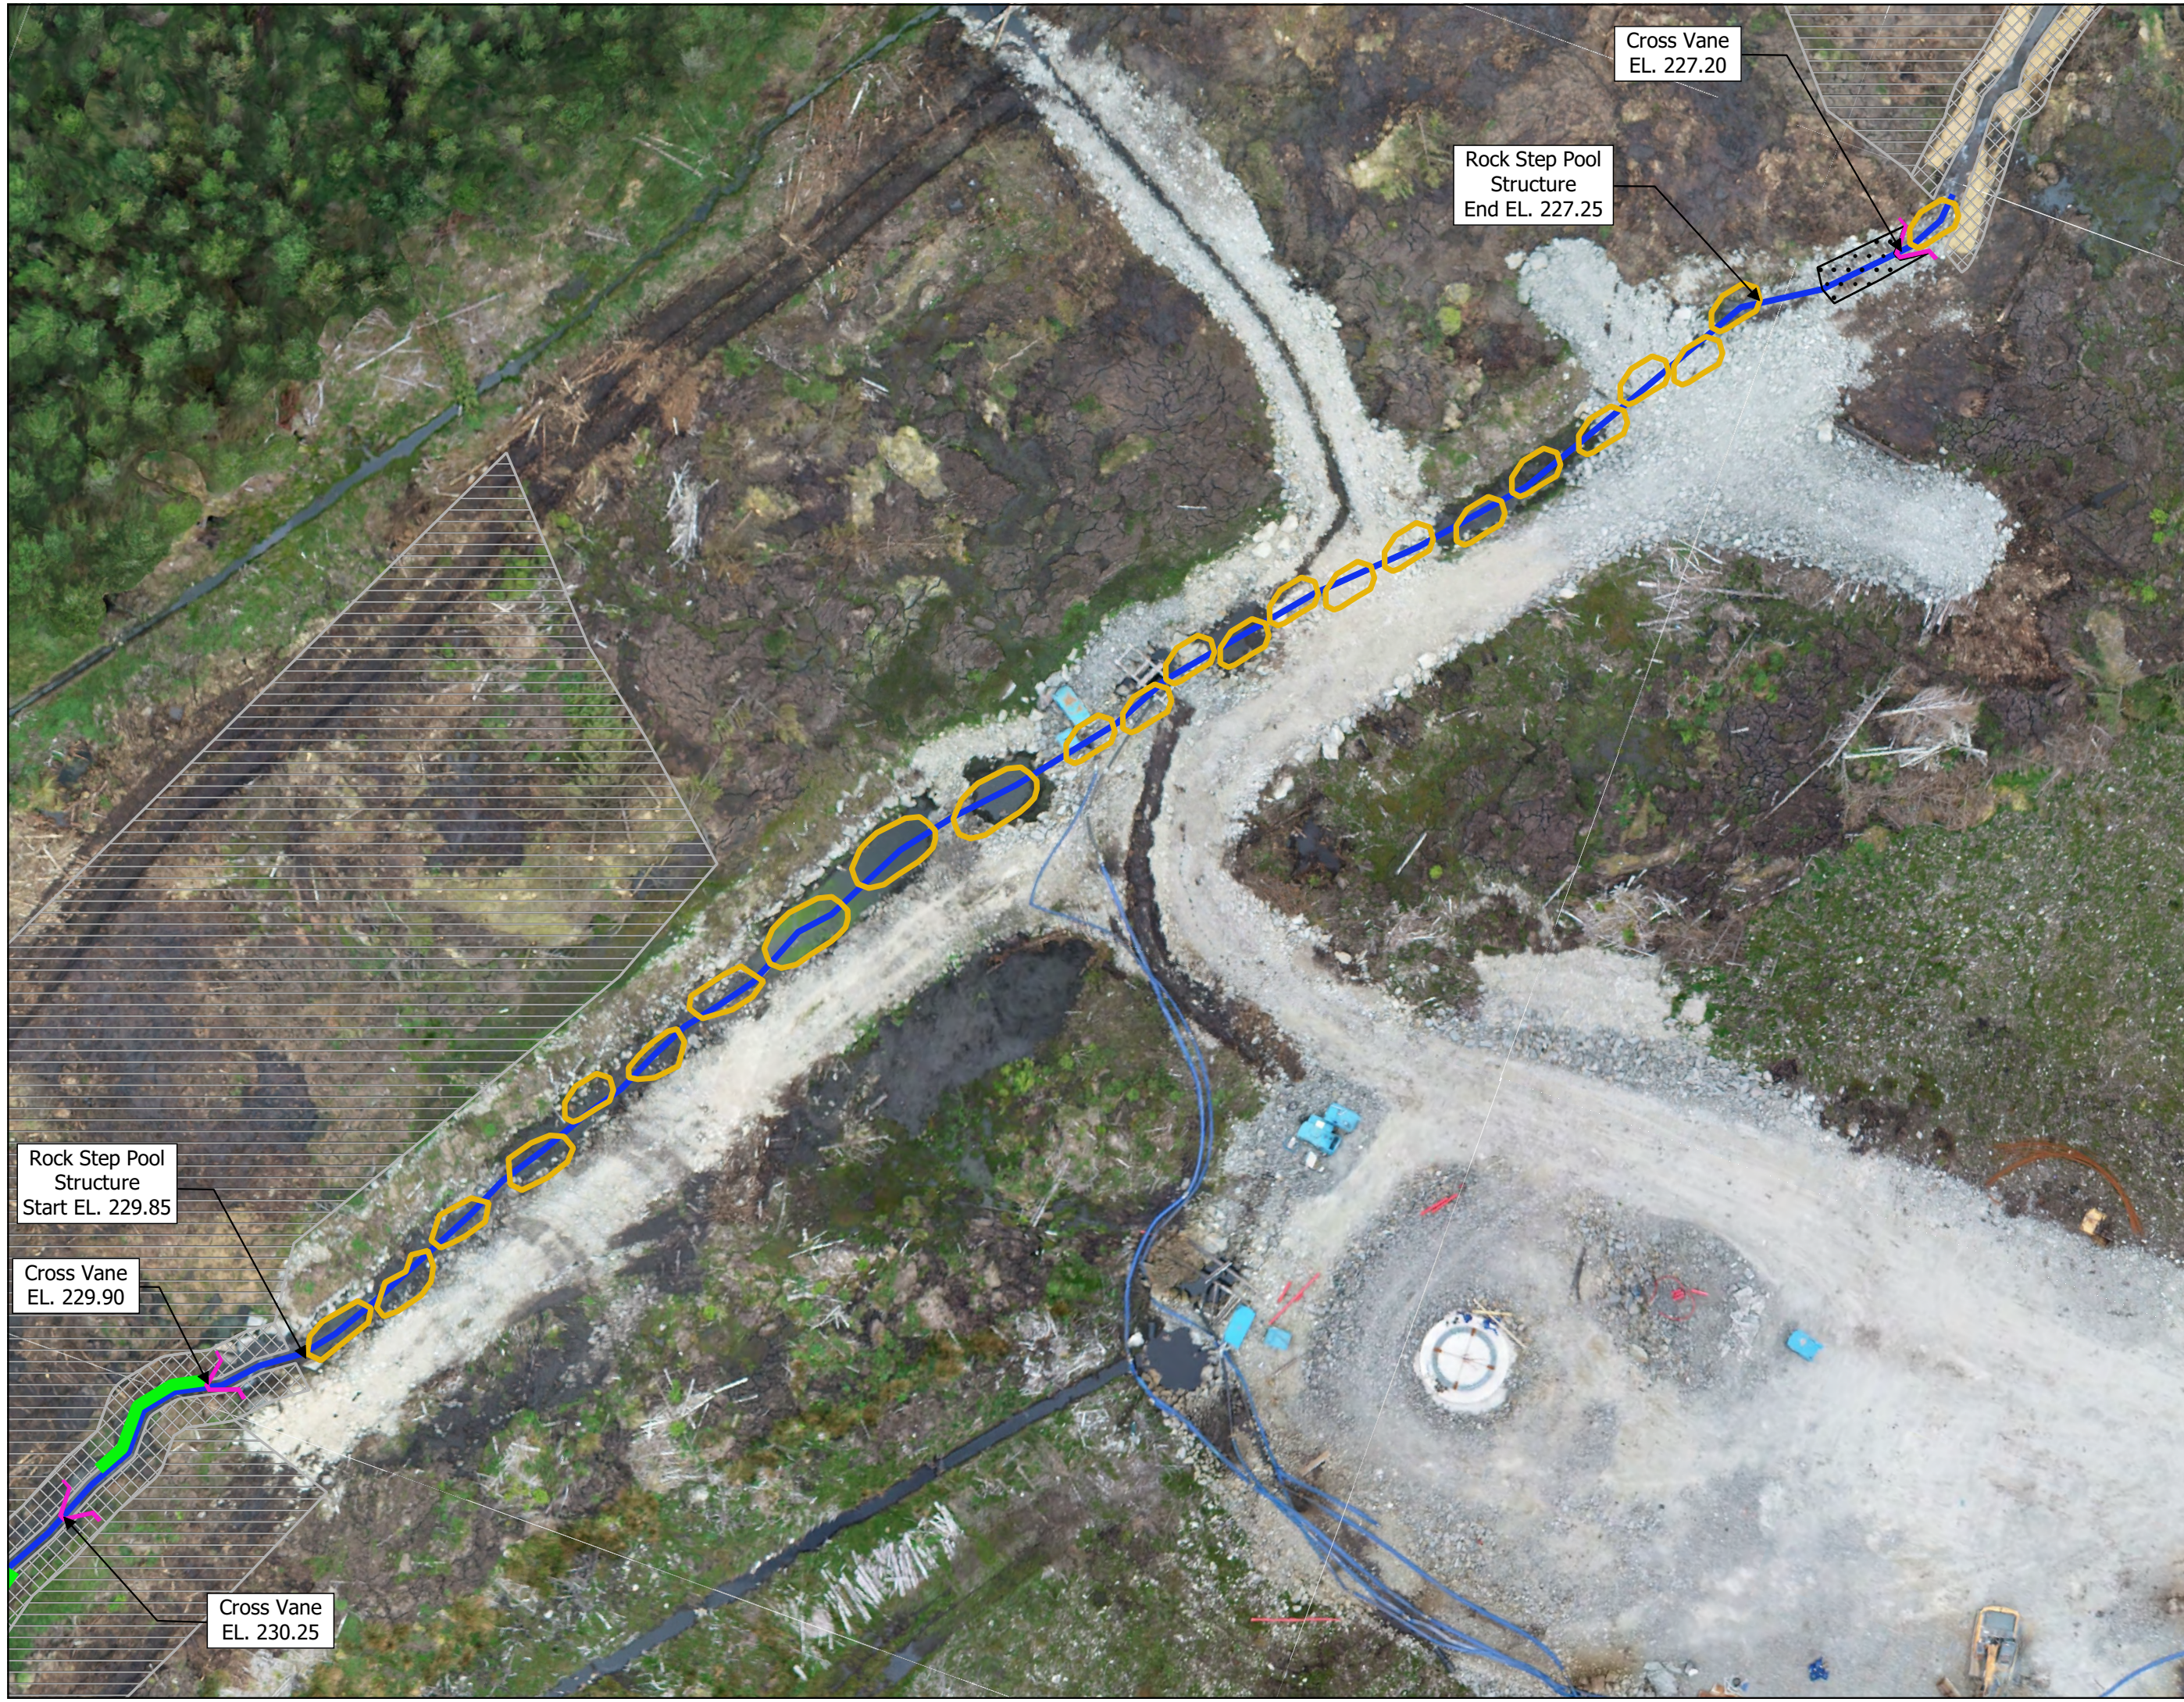
- Reach 1 - Proposed Centreline
- Instream Structures
 - Cross-Vane
 - Rock Step Pool
 - Live Fascine
 - Constructed Riffle
- Planting Zones
 - Zone 1
 - Zone 2

The locations of the various proposed measures are shown on Figures 3.4 to 3.8. Given the variability inherent in natural systems it is highly likely that field adjustments in the location and elevation of proposed structures and measures. The stream designer will have the flexibility to make changes in the field as conditions dictate within the overall intent of the proposed plan. Once the restoration of the stream channel has been completed flow will be restored to the new channel. Any residual sediment will be washed out of the channel and captured at Wall 2 and Wall 1 to protect downstream water quality.

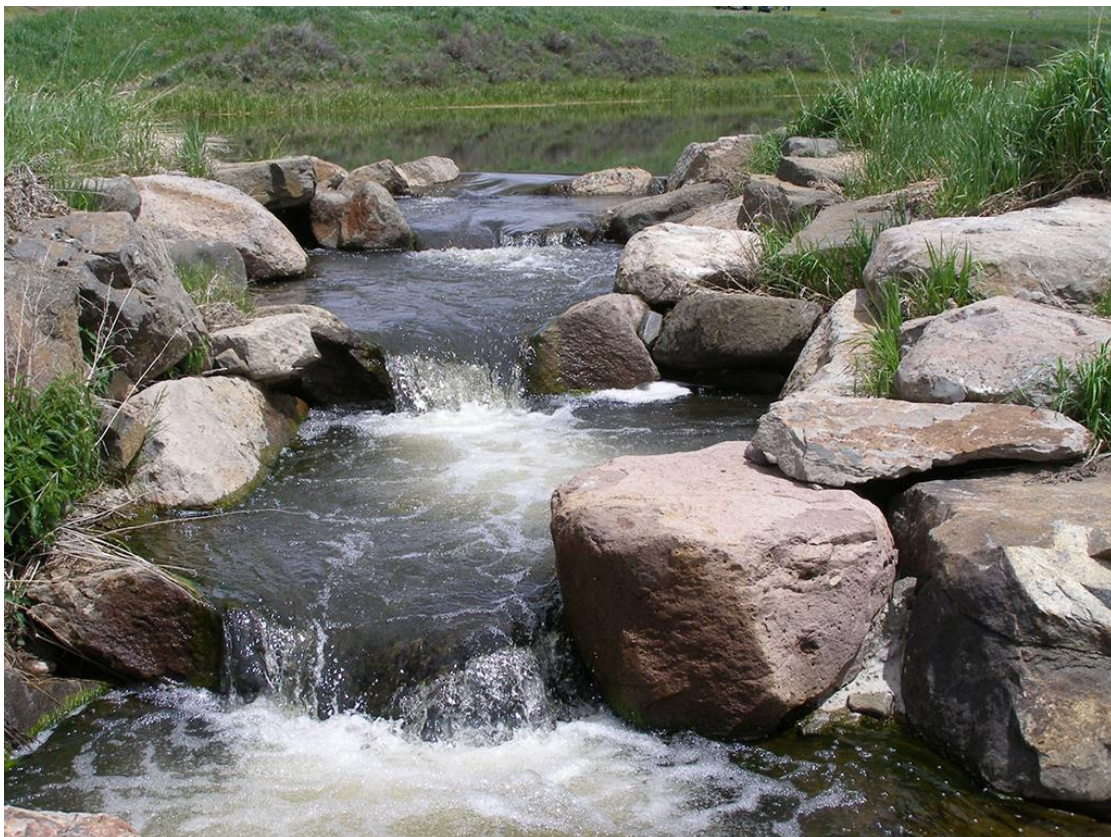
Plate 3.1 Example of Rock Step Pool Structure

From Wall 2 upstream for approximately 140 metres the stream channel will be restored using a series of rock step pools (Figure 3.6). The existing rock berms on either side of this section of stream channel will remain in-situ as they provide protection against potential slumping of the adjacent peat material. The top of the berms will be lowered to match the grade of the adjacent ground, covered with a thin layer of soil, and seeded with native peatland grass seed. The rock step pools will provide a good mix of in-stream habitat (pools and cascades) and will help in providing oxygenation to the stream. Although the existing channel is not particularly steep in this section, the horizontal constraints limit the ability to re-establish natural sinuosity to the channel. Therefore, the channel design for this section was focused on energy dissipation and habitat creation through the creation of rock step pools.

Rock step pools will also be used as drop structures at three additional locations in Reach 1 where there is potential for vertical instability due to the slop of the channel. The locations of these drop structures are shown on Figures 3.4 and 3.5. Plate 3.1 provides an example of a constructed rock step pool structure.

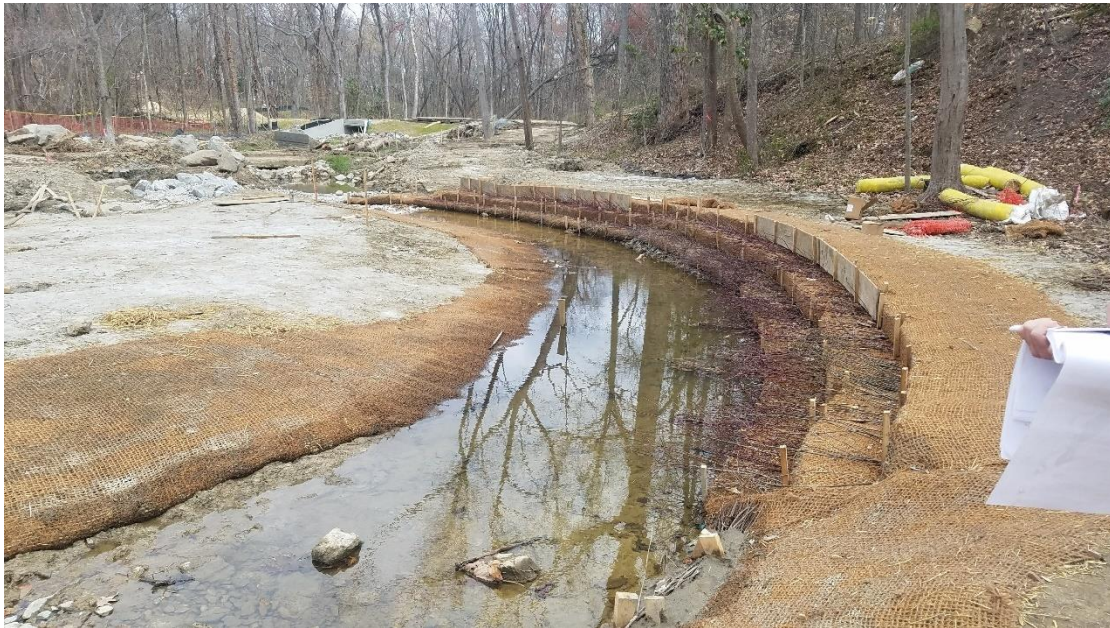
There are a number of areas where the original stream bank on one or both sides of the channel has been washed away. In these areas the stream bank will be reconstructed using vegetated geogrids. The vegetated geogrid consists of live cuttings of willow placed between soil lifts wrapped with coir fibre matting. The matting provides short term surface protection from erosion, while the roots that will develop from the willow cuttings will provide long term stability. Plate 3.2 below shows an example of a vegetated geogrid under construction. The locations where vegetated geogrids are proposed are shown on Figures 3.4 and 3.5.

Plate 3.2 Example of Vegetated Geogrid

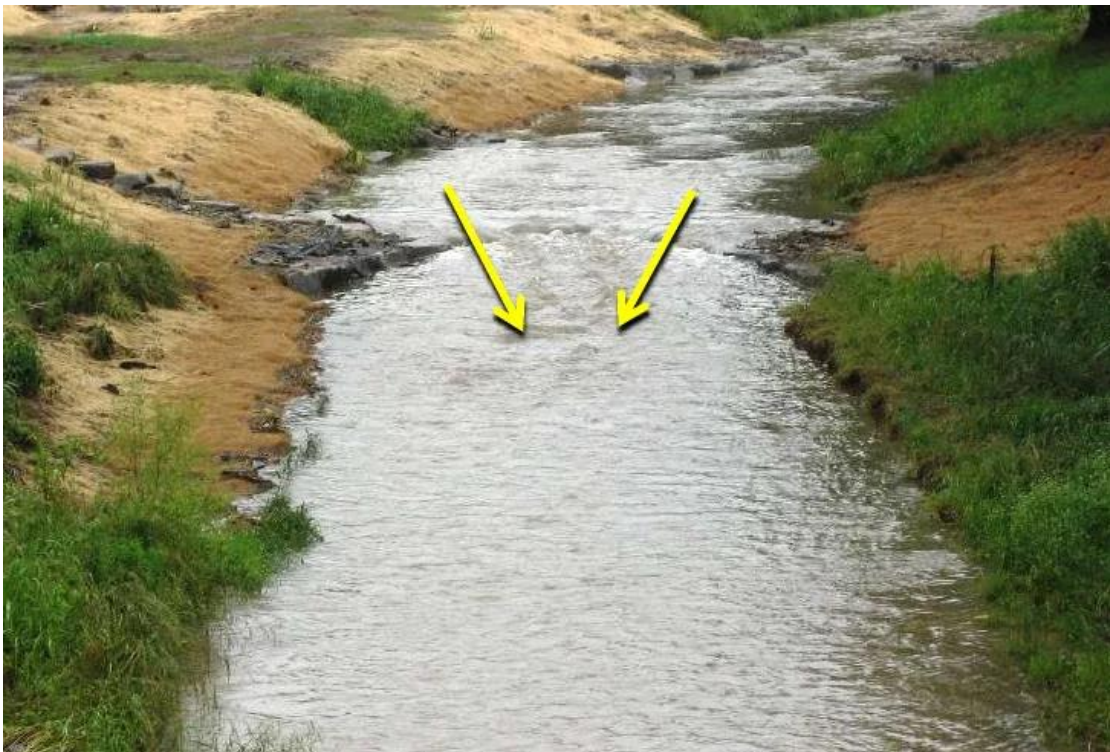
The purpose of the cross vane is to protect the banks downstream of the vane and to provide grade control to reduce the potential for headcutting in the channel. Cross vanes are proposed for two locations in Reach 1 (Figures 3.4 and 3.5).

Plate 3.3 Example of cross vane on a restored stream

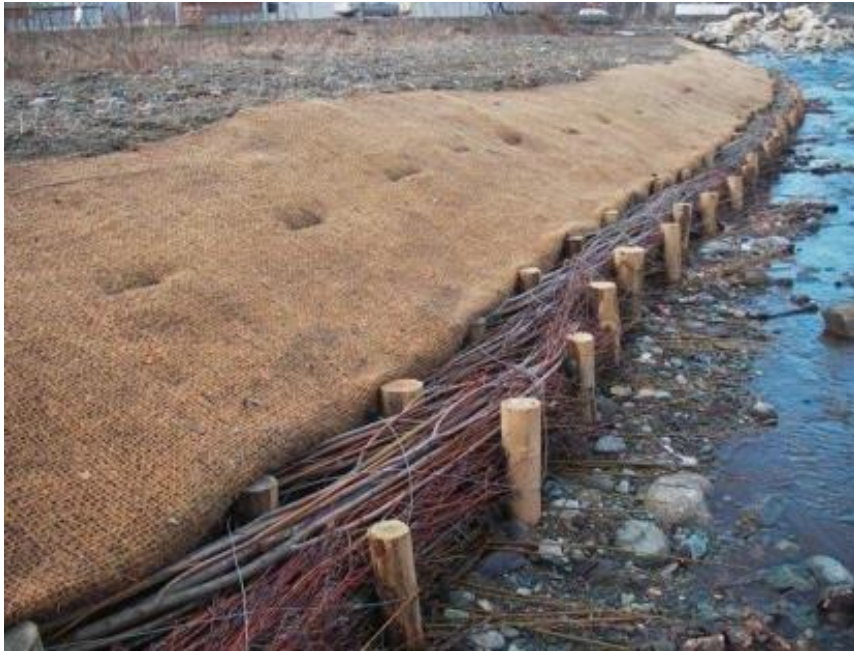
Plate 3.4 Live willow fascine installed at toe of bank.

Plate 3.4 shows an example of a live willow fascine installed on a stream bank.

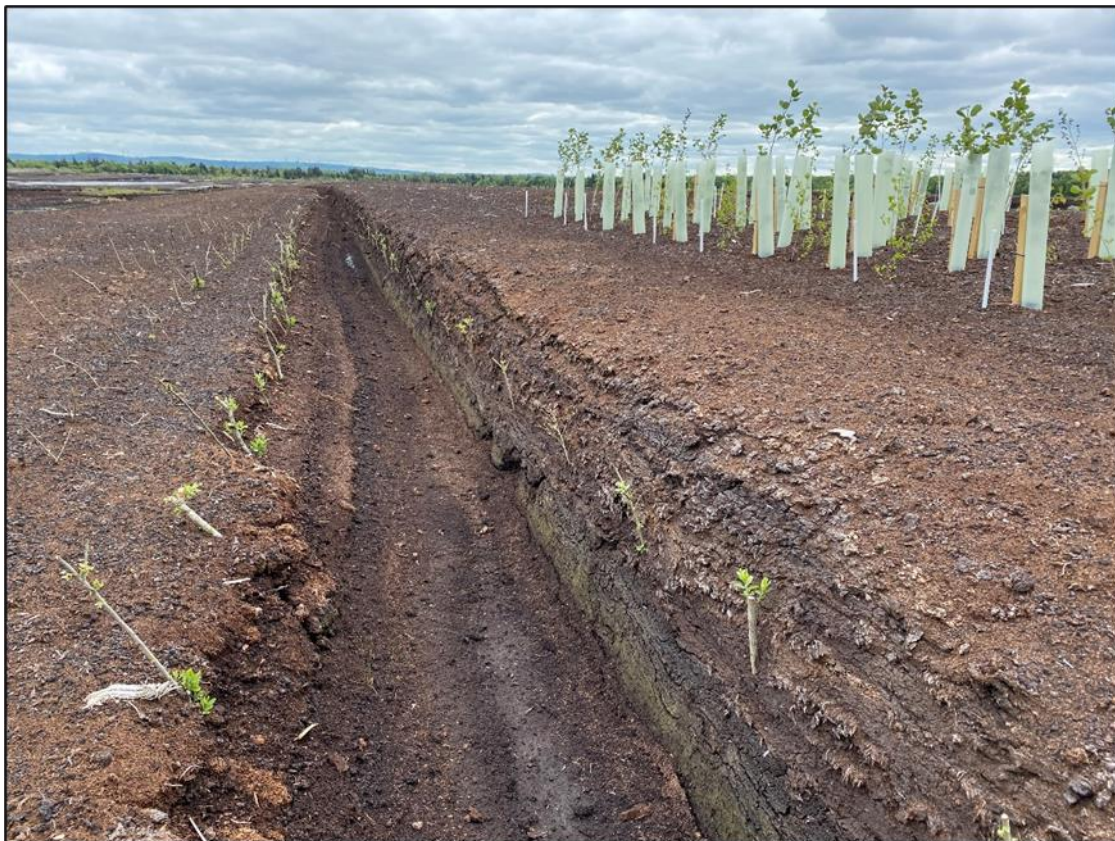
Figure 3.10 Example of live cutting along drain in planting trial on deep peat.

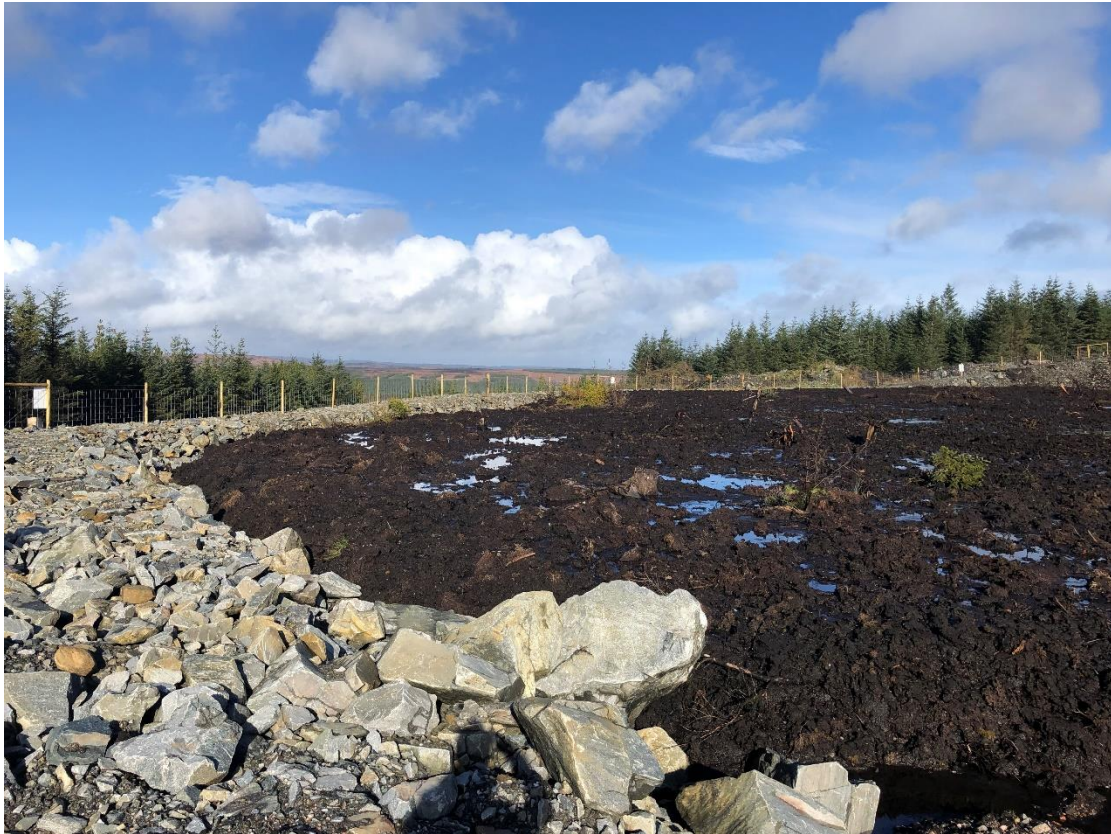
Plate 2.2 Completed peat cell at borrow pit southwest of T12

Plate 2.1 below shows the borrow pit southwest of T12. This borrow pit has been partially restored with peat. Plate 2.2 shows a peat cell at the same borrow pit that has been filled with peat. The peat surface of the completed peat cells will be allowed to revegetate naturally. Typical cross sections of borrow pits and peat cells are included as Figures 2.1 and 2.2 respectively.
