**2020 PRELIMINARY
WATERCOURSE, OTTER,
AND
MACRO-INVERTEBRATE
ASSESSMENT**

Preliminary Watercourse, Otter and Macro-Invertebrate Assessment

Environs of the Meenbog Wind
Farm, Shruhanganve Stream
and Mourne Beg River, Co.
Donegal

Following a peat slide at the site of the Meenbog Wind Farm on or around the 12th November 2020, a large volume of peat entered the Shruhingarve Stream and from there entered the Mourne Beg River.

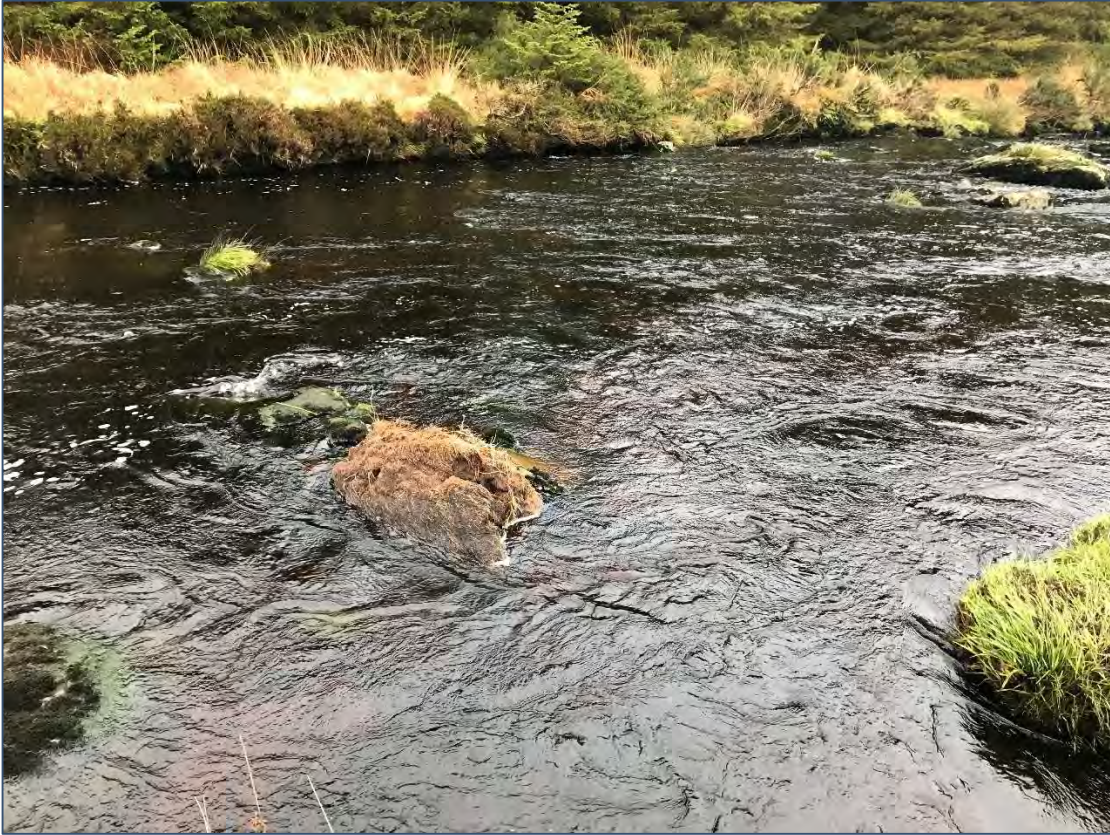
Plate 3-4. Section of bog/bankside habitat that was washed into the stream upstream of the Shruhanganve and not associated with the peat slide.

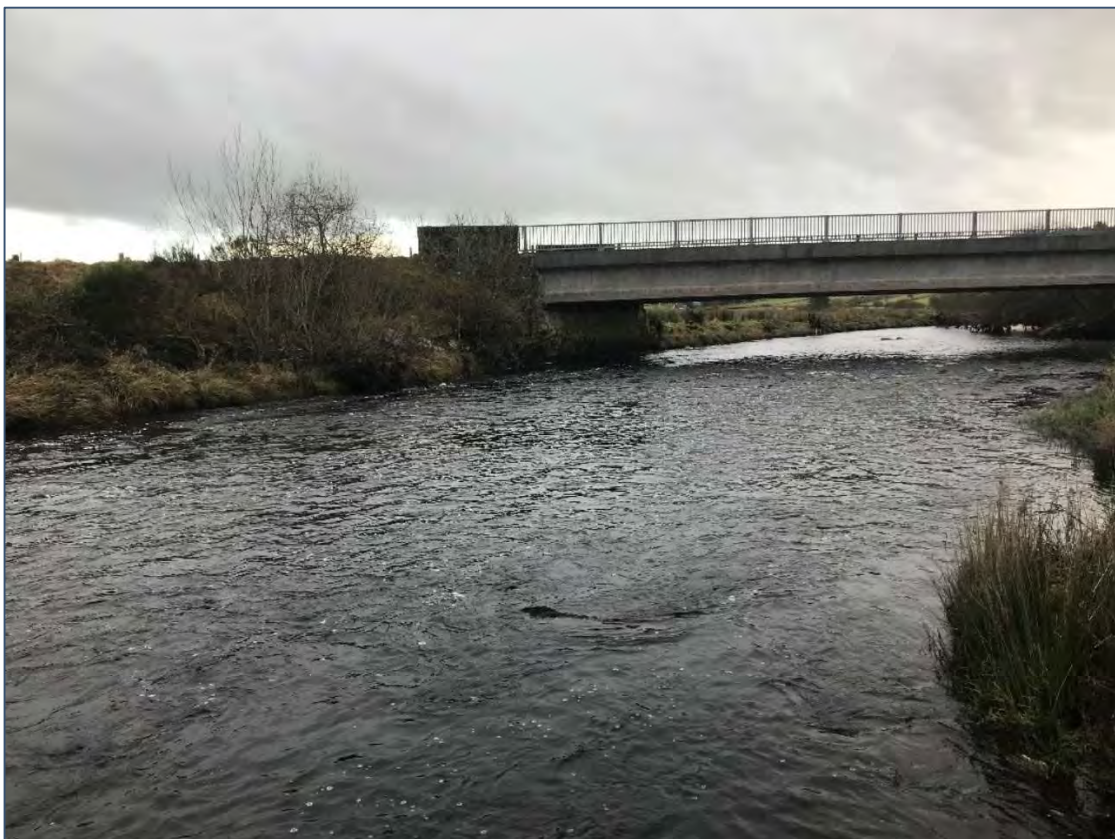
The habitats alongside the river at this location were dominated by wet grasslands that included species such as soft rush (*Juncus effuses*) and creeping bent (*Agrostis stolonifera*). There were sporadic bankside trees including ash (*Fraxinus excelsior*) and grey willow (*Salix cinerea oleifolia*). There were signs of recent high water including the deposition of vegetation and sediments. However, these were consistent with similar features recorded upstream of the Shruhangerve and no impacts of the peat slide on the bankside habitats were evident during the walkover survey. This section is shown in Plate 3-7.

Plate 3-7. Mourne Beg River at Survey Section Three

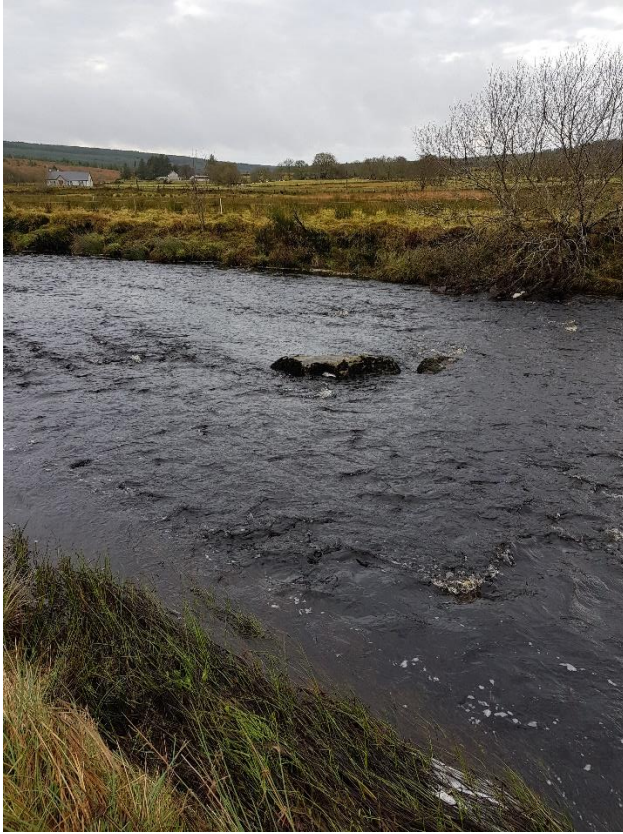
Photo 3. Downstream Mourne Beg RS01M010420

General Description	Water chemistry
<p>Moderately fast flowing stretch of river, approximately 10m wide with a substrate dominated by gravel and some cobble with some accumulations of peat observed on the bankside. Slight water colour observed due to peat in the catchment. Good salmonid spawning habitat observed (although noted this may not be usable habitat due to increase fines)</p>	<p>Dissolved oxygen DO %-100.1% 12.21mg/l Temperature 6.8°C Conductivity 35 µs/cm pH 5.72</p>

The macroinvertebrate fauna at the downstream site (RS01M010420) (3.2km downstream from the Shruhanagarve confluence) on the Mourne Beg was indicative of Q3-4* (* denotes impact by siltation) indicating moderate ecological condition. There was a noticeable difference in the biological community upstream and downstream of the Shruhanagarve confluence. Similar Group A taxa were recorded at the downstream site, but they occurred in low numbers (either as singletons or few). More group C taxa were recorded here which include taxa that are more tolerant to water

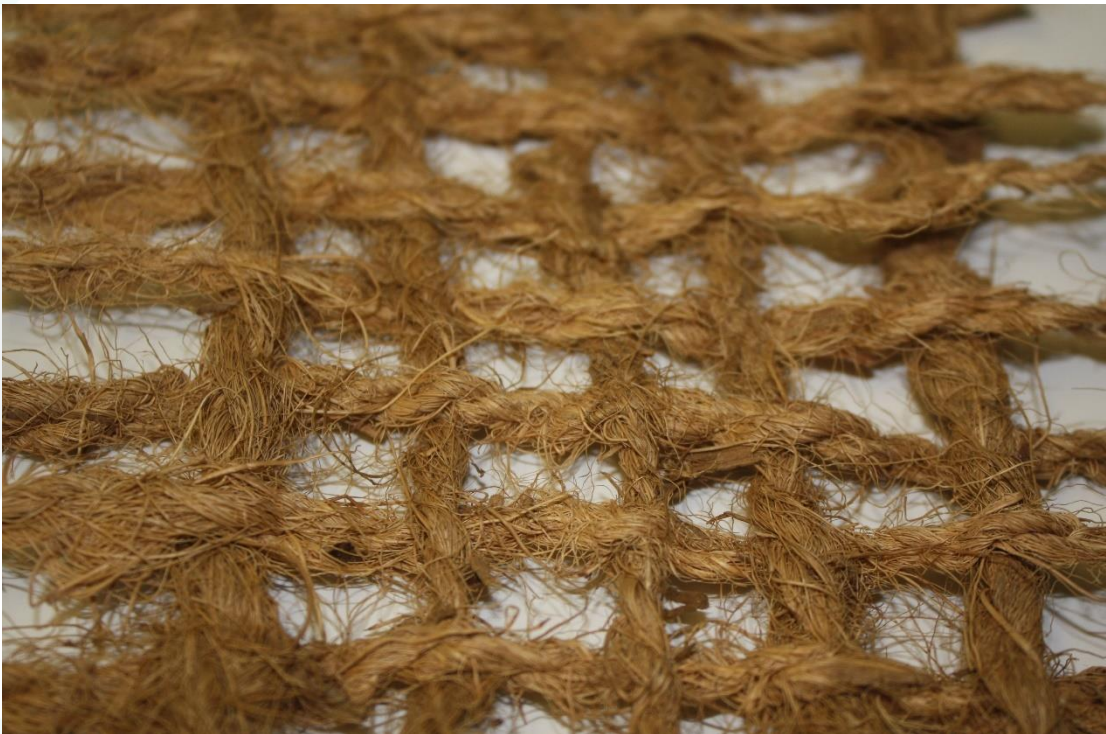
Plate 2 CoriMesh biodegradable woven coconut fibre used on bare surfaces to prevent erosion and promote revegetation

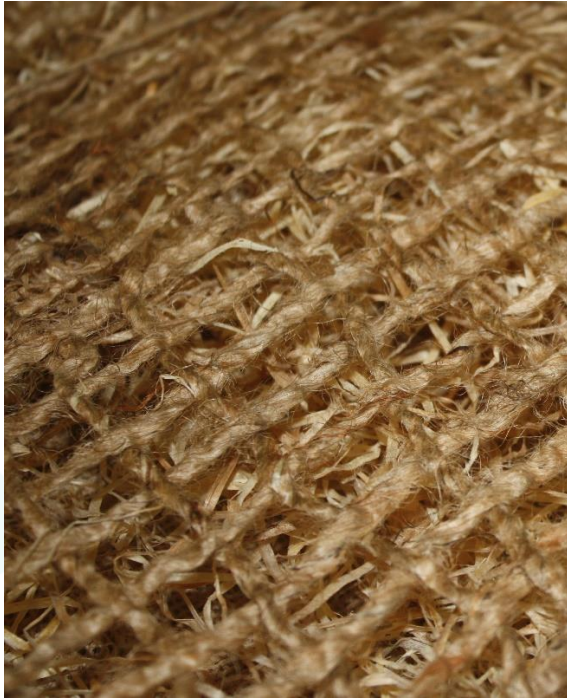
Plate 5 Narrow view of Sedimat with layered jute mesh and wood wool

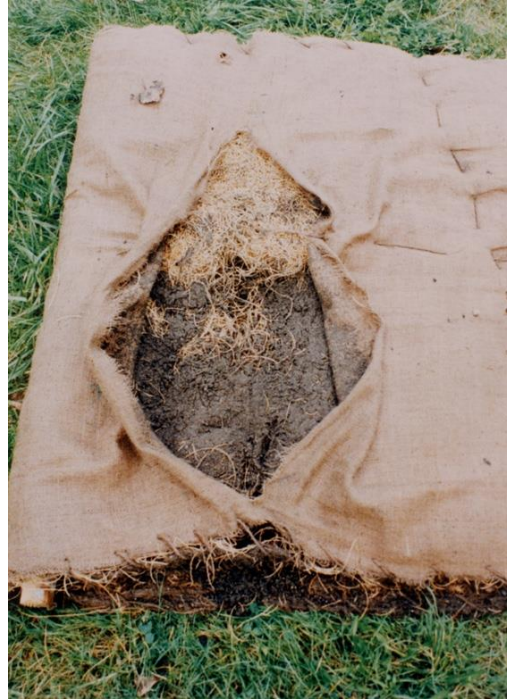
Plate 6 "Full" Sedimat after having been removed from stream bed
