Appendix 13.1

Wading and Metal Detection
Survey, June 2016

Wading and Metal Detection Survey
at
Ballybrack Stream, Ardarrig, Ballybrack & Douglas, Douglas;
Grange Stream, Grange & Castletreasure, Douglas;
Tramore River, Lehenagh More, Deanrock and Doughcloyne, Togher

Licence Number 16D0048 & 16R0065

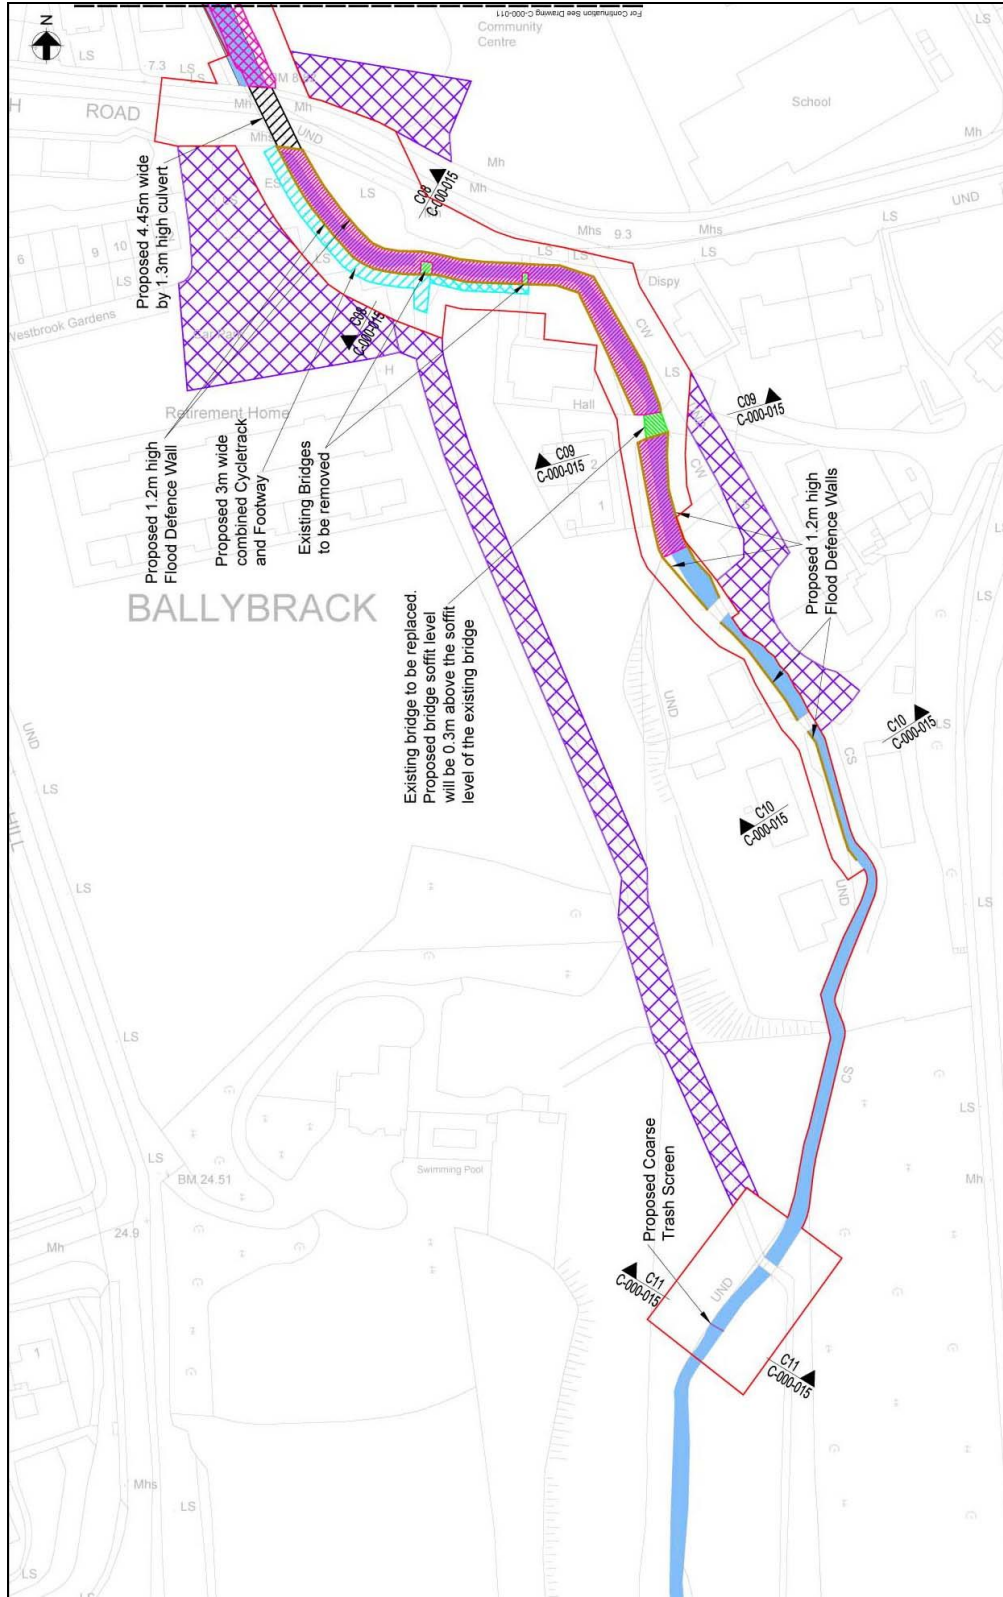
Figure 5: Proposed works to Ballybrack Stream, Ravensdale and Ballybrack Woods, Douglas (after Arup)

- *Ballybrack Stream: Ravensdale, Douglas, in in Ardarrig and Ballybrack townlands (chainage 310 – 467) (Fig. 5)*

Works will comprise widening the existing channel by 2m and construction of a 1.2m high flood defence walls along both banks. The existing bridge at the ICA hall at chainage 374m will be removed and the existing Ravensdale Lower Bridge at chainage 422m to be replaced by a bridge with soffit level 0.3m above the soffit level of the existing bridge.

- *Ballybrack Stream: Ravensdale, Douglas, in Ardarrig and Ballybrack townlands (chainage 467 – 530) (Fig. 5)*

Work will comprise the construction of a new 1.2m high flood defence wall along the left (west) bank.

- *Ballybrack Stream: Ballybrack Woods, Douglas in Ardarrig and Ballybrack townland (chainage 623) (Fig. 5)*

Works will comprise the replacement of the existing bridge and installation of a larger course trash screen.

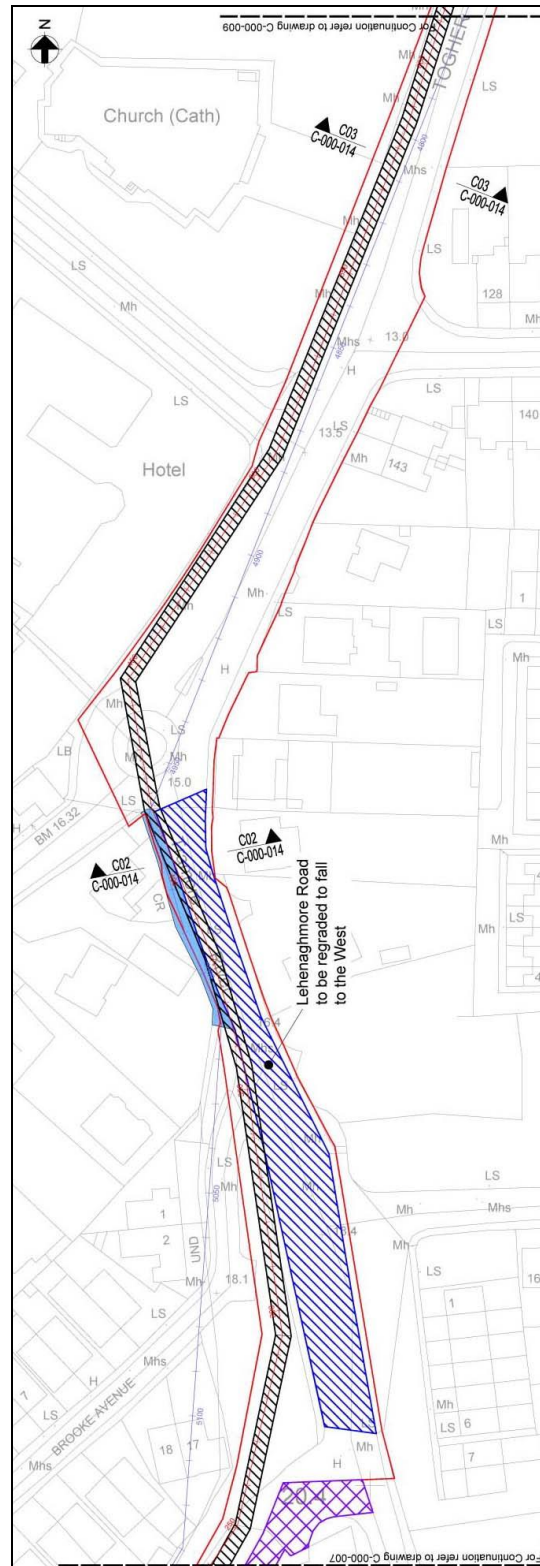
Figure 7: Proposed works to Tramore River, upstream of Togher Road Roundabout, Togher (after Arup)

- *Tramore River: upstream of Togher Road Roundabout, Togher, in Doughcloyne and Lehenagh More townlands (chainage 5013 – 4962) (Fig. 7)*

Works will comprise the construction of a new 3m wide by 1.4m high concrete culvert to replace the existing 2.5m wide by 0.9m high open channel. In addition, Lehenaghmore Road will be regraded to fall to the west.

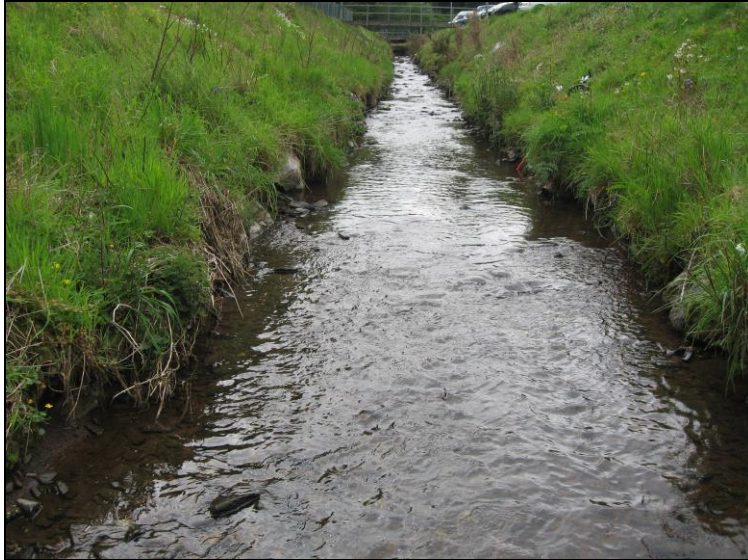
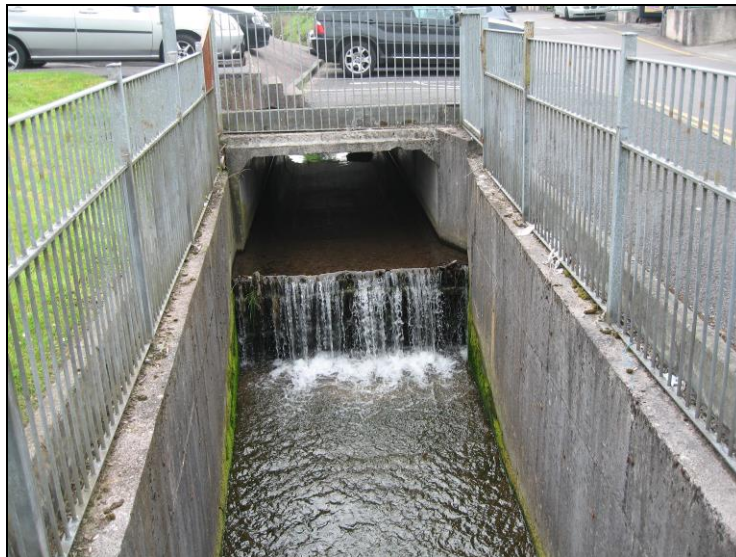
The stream at this location runs within a modified channel separated into two over-ground sections by a culverted portion approximately 12m long. The western open section runs within a sloping earth-cut channel with large boulders along both banks at water level and smaller stones along the stream bed. Above the banks the sides of the channel slope steeply and are grass-covered. The surrounding grounds are laid out as an access road and car parking for the commercial park and a range of modern buildings suggest significant amounts of ground disturbance have been undertaken in the recent past. The upstanding building of the milling complex lie approximately 100m to the east of the proposed works area. The eastern open section is a stepped concrete channel which was visually inspected but not accessed or metal detected. The channels were both very clean and no features were apparent. No metal objects were detected.

Plate 1: Grange Stream western open section in Donnybrook Commercial Park, looking west

Plate 2: Grange Stream eastern stepped section emerging from culvert in Donnybrook Commercial Park, looking west

- 5.4 Due to the disturbed nature of the channel in which the Grange Stream, (Grange and Castletreasure townlands in Donnybrook Commercial Park, Douglas (chainage 252m – 262m and 277m – 292m)) now runs and the likely disturbance to the adjoining ground

intermittent archaeological monitoring/inspections of subsurface disturbance is recommended based on the low archaeological potential of such ground.

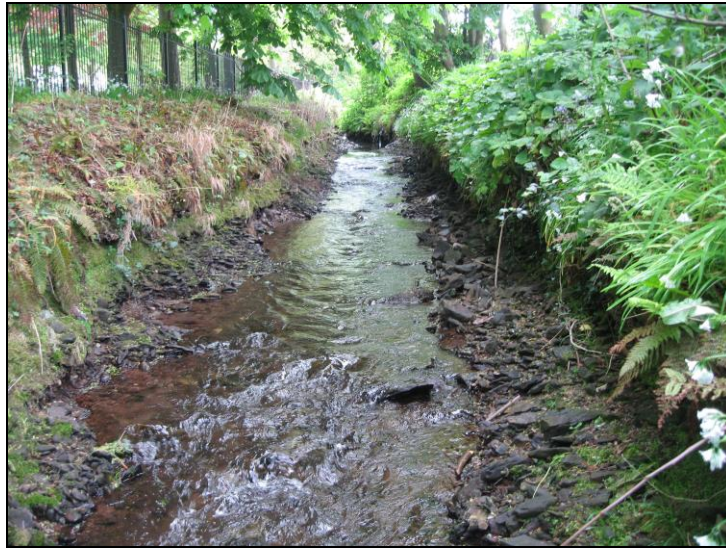
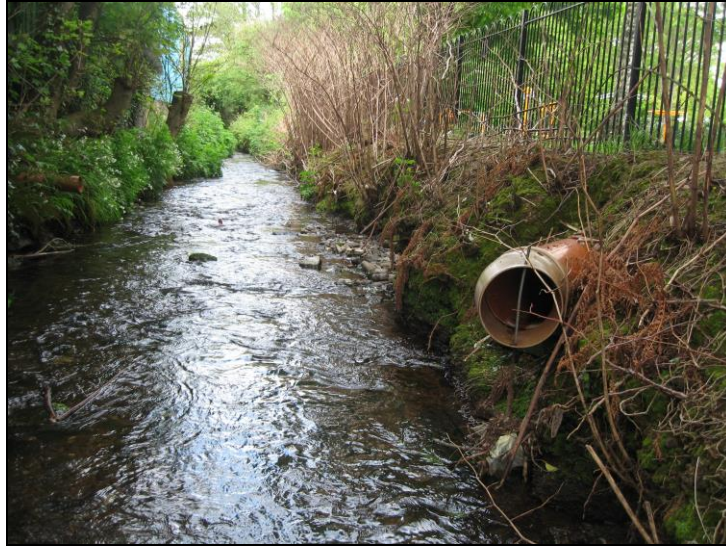
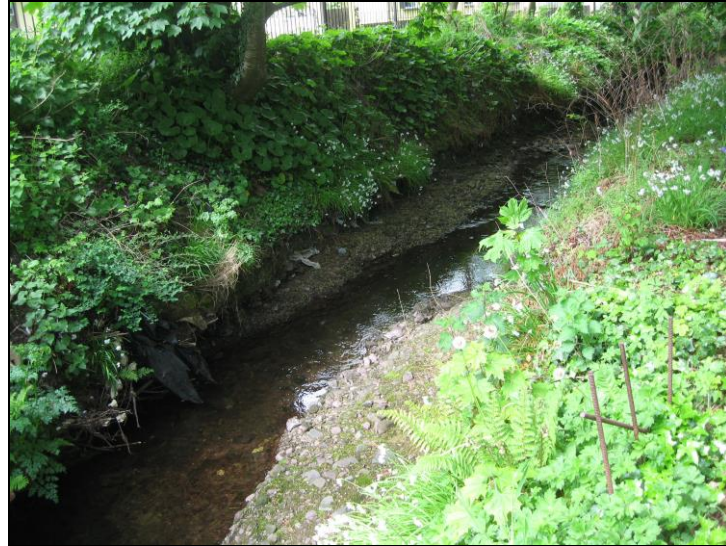
The stream runs along the western boundary of Douglas Community Park within a fenced area. The stream runs in an earth-cut channel with a stoney bed and occasional stones protrude above water level. Above the water level the banks are quite steep. The bank and the bed are heavily eroded in places with a narrow, deeper channel cut along

parts of the bed. The stream is quite fast flowing. At the southern end of the park the stream channel is lined in concrete which adjoins the culvert which carries the stream under Church Street. Stone gabions extend southwards along the western bank for a short distance from the concrete channel. A small number of pipes cross the stream and there are three outfall pipes discharging into it. Towards the southern end of the park a warehouse lies along the western bank of the stream and a concrete wall forms the western bank here. Elsewhere the bank is generally covered in low vegetation with some mature trees and tree stumps. At the southern end of the park the stream is again concrete-lined before entering a concrete culvert running under Church Road.

The channel was relatively clean with no large amounts of material present and according to local authority personnel it has been cleaned and maintained as such in recent times. No features associated with the nearby milling activity or other features of archaeological potential were noted. A number of metal objects were detected, all were modern in nature and of no archaeological significance. A number of individual properties lie on the eastern bank of the stream and there is no visible trace of the mill pond shown on the 1842 OS map in the area of these properties.

Plate 3: Ballybrack Stream, Douglas Community Park, looking south

Plate 4: Ballybrack Stream, Douglas Community Park, looking north

Plate 5: Ballybrack Stream, Douglas Community Park, looking north

- Ballybrack Stream, Douglas townland, in Douglas Community Park (chainage 0 – 292m).
 - Ballybrack Stream in Ardarrig and Ballybrack townlands, Ravensdale, Douglas (chainage 310 – 623).

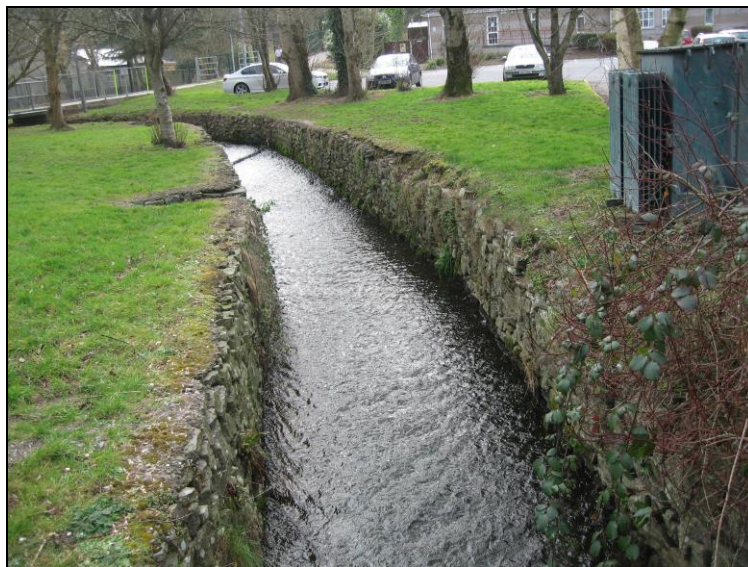
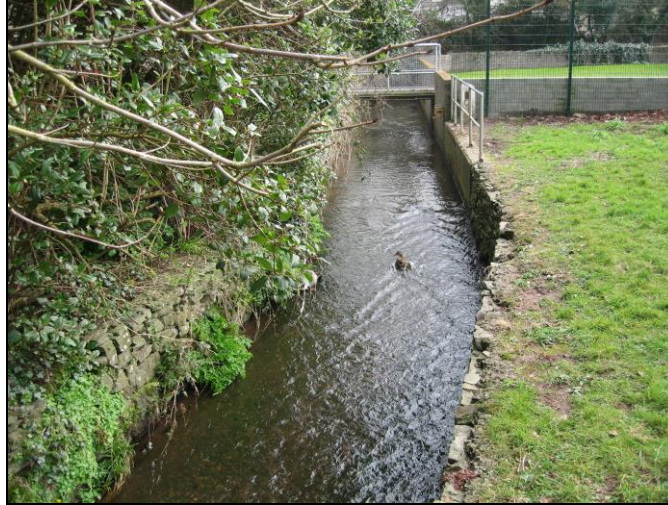
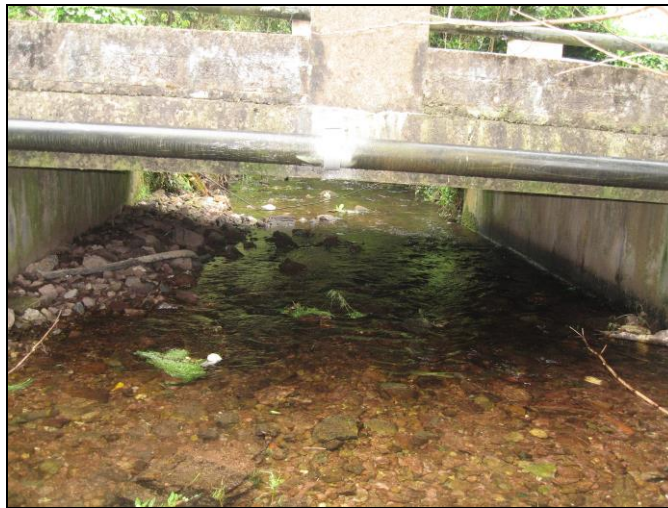
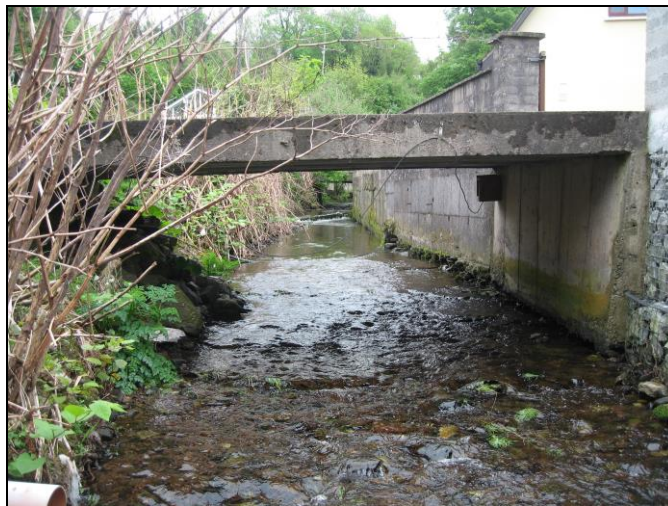
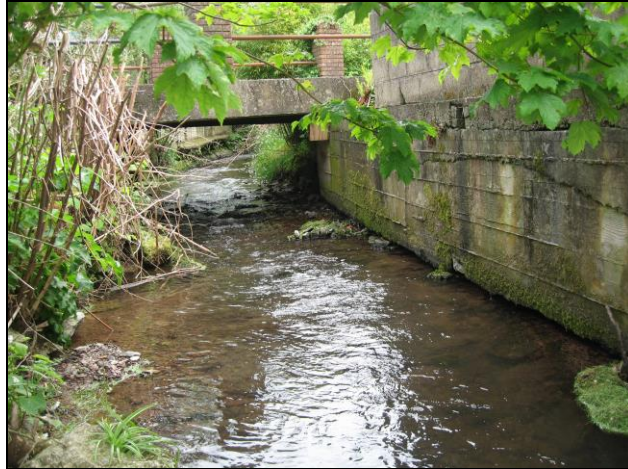
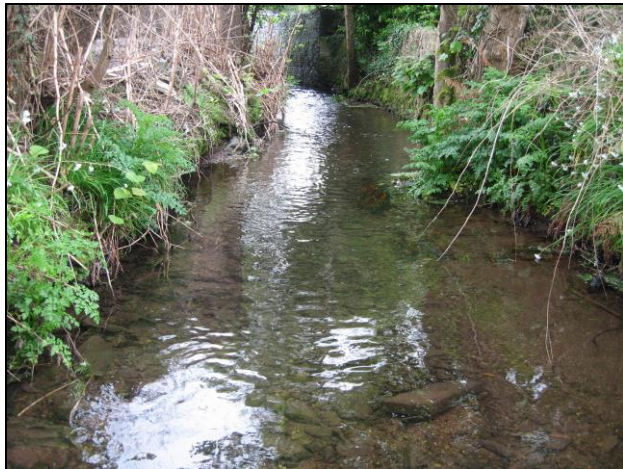
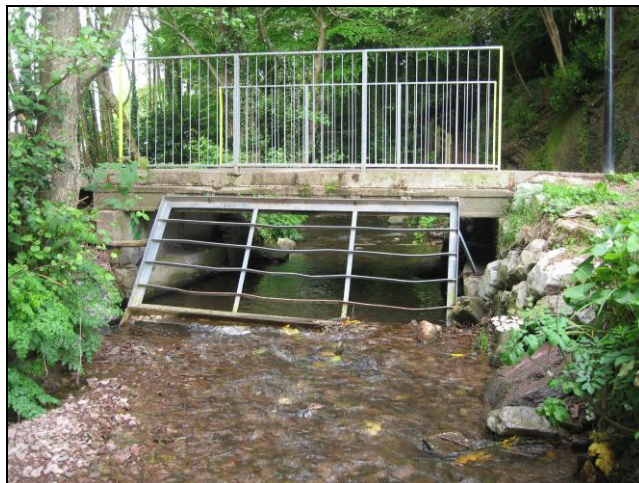
On the southern side of the Church Road culvert the stream flows east within a stone and concrete lined channel for approximately 80m. Two modern bridges cross the stream, both opening from Church Road; the western one forms part of a recreational track south to Ballybrack Woods and the eastern one provides access to the ICA Hall. The stream was waded and visually inspected along this section but the concrete bed made the metal detector inoperable.

The stream turns south through Ravensdale where it appears to run in its original channel. The bed is stoney with some silty patches and the banks are generally earth-cut. There are, however, sections of wall along the banks and a small run of gabions supporting the western bank. A section of concrete path runs along the wall along the upper stretches of the eastern bank. The stream runs mainly along property boundaries with a public road along the eastern side, although at one point a warehouse/workshop lies along its eastern bank. The eastern bank is generally covered in low vegetation with some semi-mature trees where the concrete walls have not been constructed. The stream is crossed by three modern bridges (Lower, Middle and Upper Ravensdale Bridges) which provide access to the dwelling houses on the western bank and a large pipe crosses the stream bed between the middle and upper bridges.

The southern end of this section of stream, in Ballybrack Woods, is an earth cut channel crossed by a modern bridge with a trash screen below.

The stream is relatively clean along its course. No features associated with the nearby Ravensdale Mill shown on the 1842 OS map or other features of archaeological potential were noted. A number of metal objects, particularly pipes, were detected, none of which were considered to be of archaeological significance.

Plate 6: Ballybrack Stream, looking southeast with bridge to Ballybrack Woods in background

Plate 7: ICA Bridge on Ballybrack Stream eastern elevation

Plate 8: Lower Ravensdale Bridge on Ballybrack Stream, southern elevation

Plate 9: Middle Ravensdale Bridge on Ballybrack Stream, southern elevation

Plate 10: Upper Ravensdale Bridge on Ballybrack Stream, northern elevation

Plate 11: Ballybrack Stream in Ravensdale, looking south

Plate 12: Ballybrack Stream showing bridge and trash screen in Ballybrack Woods, looking south

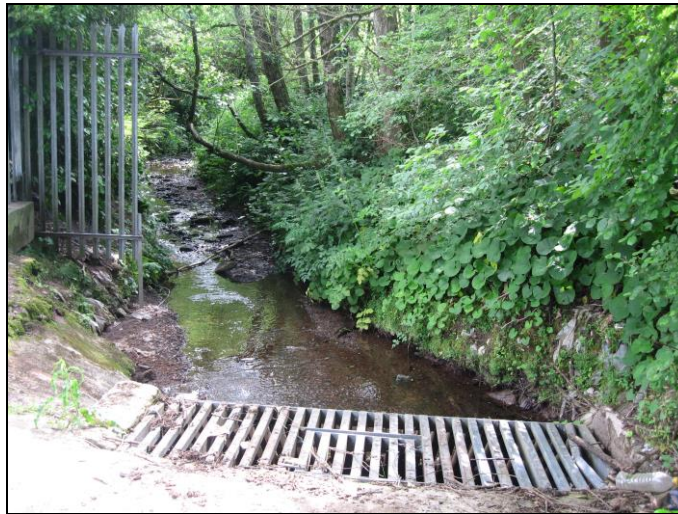
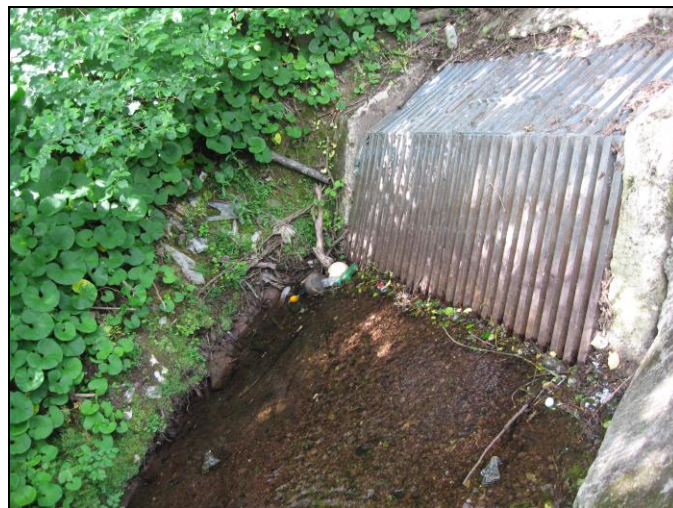
The river runs in a shallow, earth-cut channel with a stoney bed. The banks are overgrown with low vegetation and some mature trees. To the northeast the rivers runs into a concrete culvert closed by a large trash screen.

The river is quite clean with small amounts of rubbish caught in the trash screen. No features of archaeological potential were noted. A small number of modern metal objects were detected, none of which were considered to be of archaeological significance.

Plate 13: Tramore River at Lehenaghmore Industrial Estate, looking west

Plate 14: Existing trash screen Tramore River, Lehenaghmore Industrial Estate, looking east

- Tramore River at Doughcloyne and Lehenagh More townlands, Lehenaghmore Industrial Estate (chainage 5326m – 5306m).
 - Tramore River at Doughcloyne and Lehenagh More townlands upstream of Togher Road Roundabout, Togher (chainage 5013m – 4962m).

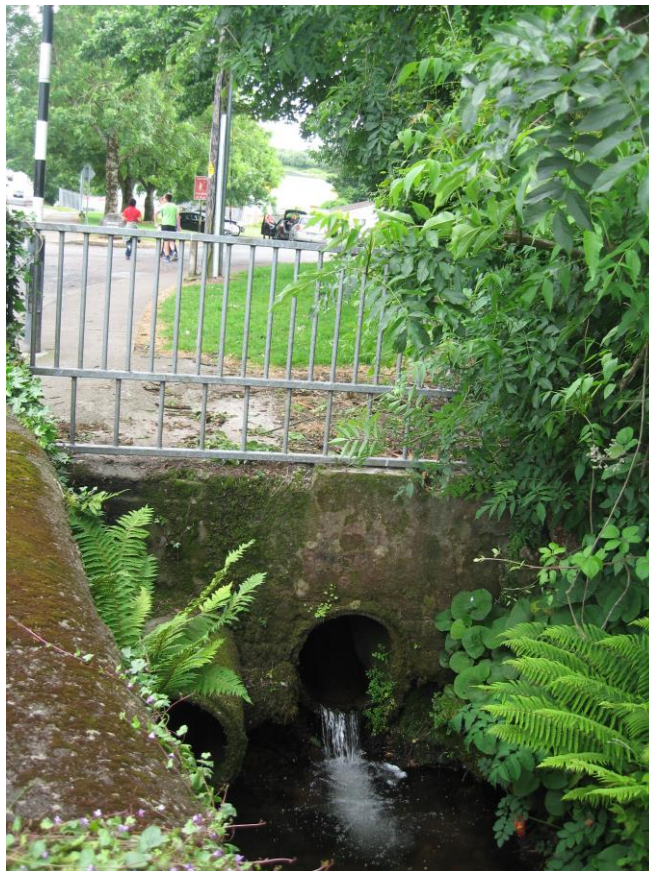
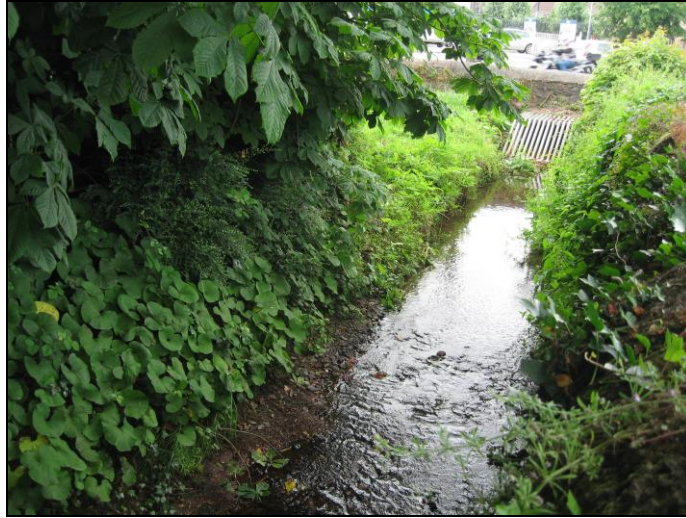
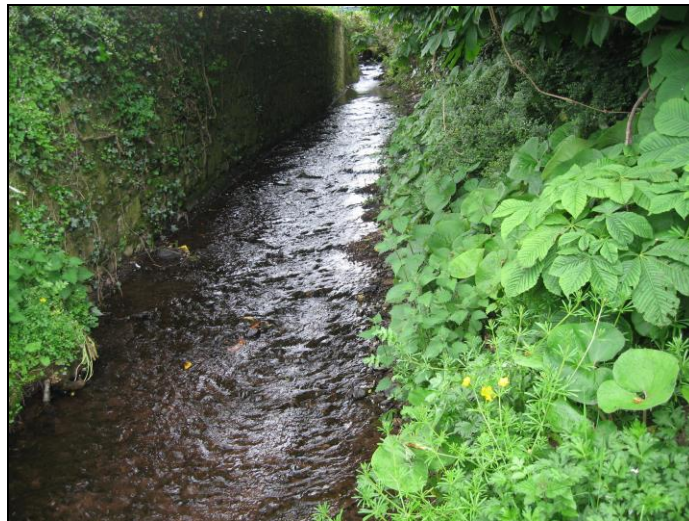
The river emerges from a culvert under Brook Avenue and flows north in a relatively narrow channel along the western side of Lehenaghmore Road. A random rubble wall along the eastern bank of the river separates it from the road. The western bank is heavily overgrown and some occasional patches of random rubble wall were visible behind the undergrowth. Some erosion of the western bank is also apparent. The river bed is generally stoney with some silt. At the northern end of this stretch the river runs into a culvert, under the Togher Roundabout, which is closed with a large trash screen. The culvert runs along the western side of Togher Road.

This small open stretch of river is quite clean. No features of archaeological potential were noted. A small number of modern metal objects were detected, none of which were considered to be of archaeological significance.

Plate 15: Tramore River emerging from culvert under Brook Avenue, looking south

Plate 16: Tramore River beside Lehenaghmore Road, looking north

Plate 17: Tramore River beside Lehenaghmore Road, looking south

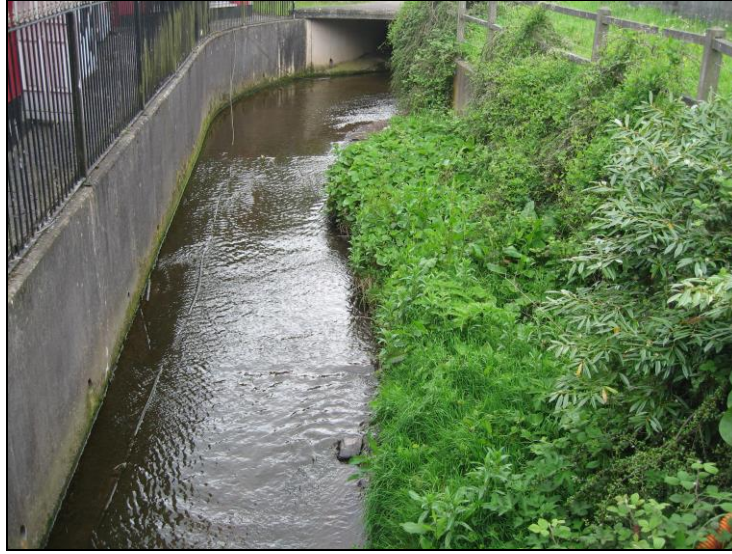
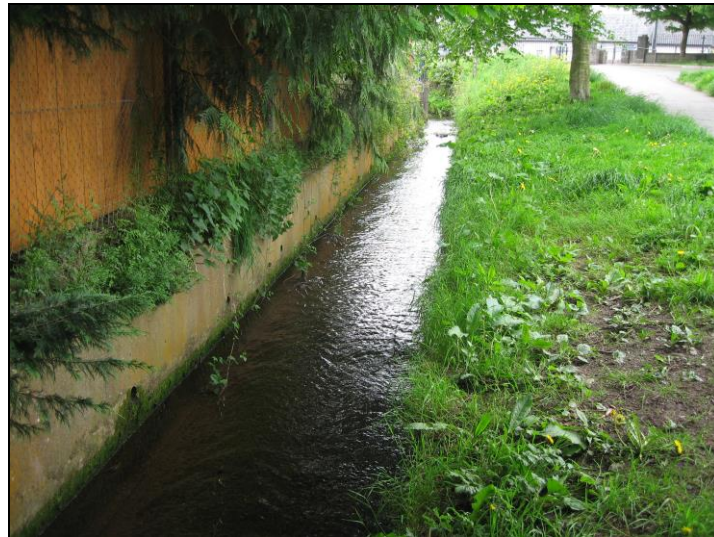
The river emerges from a culvert under the Togher Road and runs east in a concrete channel to the north (rear) of the houses in Greenwood Estate. Individual property boundaries line the southern river bank and there is a path and park along the northern bank.

The river is quite clean here. It was inspected and waded but the concrete bed made the metal detector inoperable. No features of archaeological potential were noted.

Plate 18: Tramore River emerging from culvert under Togher Road behind Greenwood Estate,
looking west

Plate 19: Tramore River, behind Greenwood Estate, looking west
