### **Fish Survey Report**

project title **Fish Stock survey of the Tramore River  
for the Douglas Flood Relief Scheme**

client ARUP Consulting Engineers

date 12th November, 2014

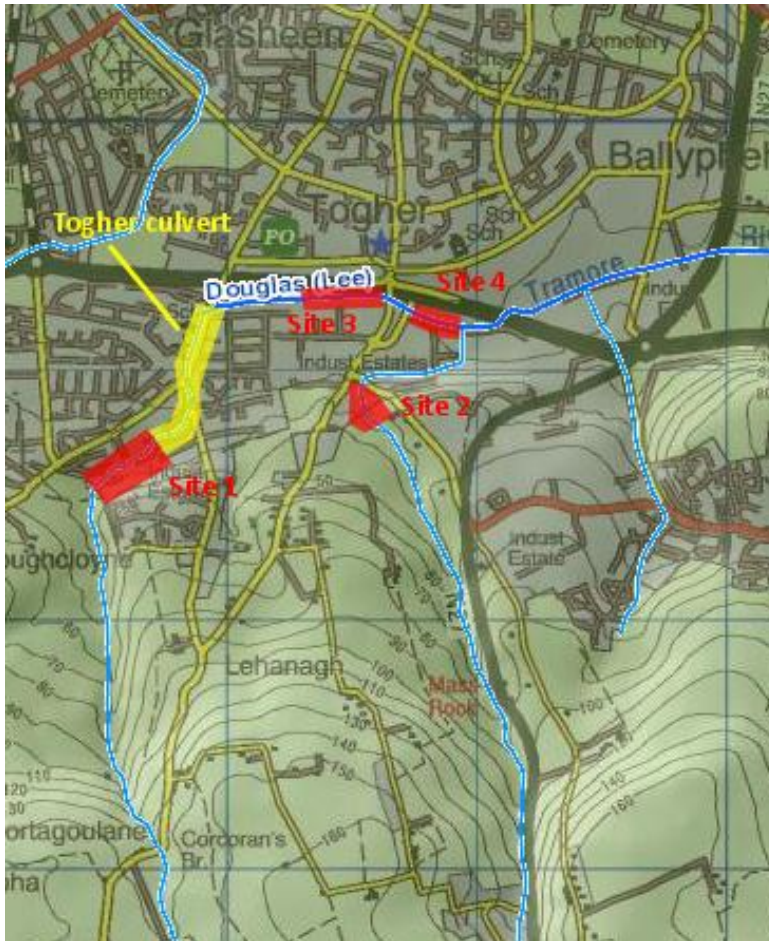
Figure 2. Survey sites in relation to the Togher Culvert.

Surveys were carried out on the main channel of the Tramore River and on two tributaries which flow southward from higher ground to the north. The characteristics of the survey areas are detailed below in **Table 1** and results are included in **Table 2**. The survey sites are shown below on **Figure 2**. Photographs are included in **Appendix 1**.

The Togher culvert, including the grill at its upstream end, creates a significant barrier to fish migration and no trout were recorded upstream of this culvert (Site 1). A pipe at the upstream end of Site 1 also creates a significant barrier to fish movement. A small number of eels were recorded in isolated pockets of deeper water including the plunge pool at the upstream end of the site.

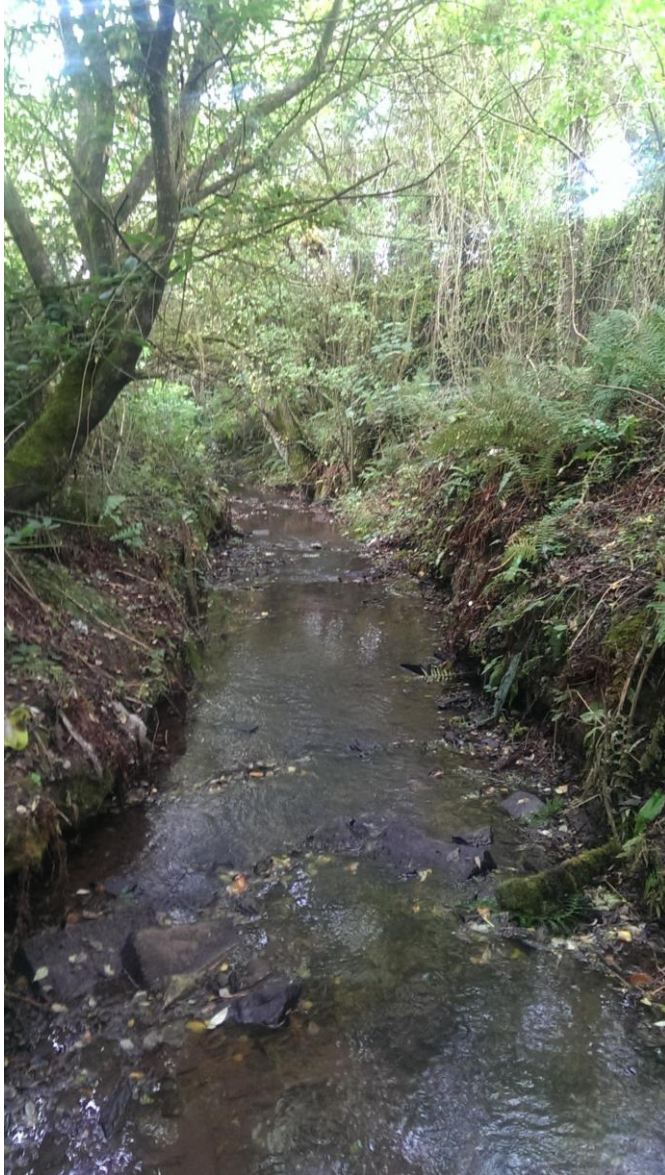
<b>Site 1</b>	<p>Upstream of the Togher culvert. The survey section is defined by a metal grill at the downstream end. At the upstream end, the river is piped and falls a considerable distance into a deep plunge pool. The drop from this pipe creates an additional barrier to fish movement. This section of the stream is heavily shaded and generally shallow with the exception of some small pools and the larger plunge pool which was approximately 1.5m in depth at the time of the survey. Upstream of this plunge pool the river flows through gardens and from there drops rapidly in size. No suitable habitat for juvenile lamprey was recorded within this section of the stream; however, some potential habitat for brown trout and eel was noted.</p>
<b>Site 2</b>	<p>Small stream which flows parallel to the N27 through agricultural land. Site 2 itself was heavily shaded with deep banks and a mixture of riffle and shallow pool habitat. Some potential eel and brown trout habitat was recorded.</p> <p>An examination of the stream found that flow in the stream is low and no potential sites with enough depth for an effective survey were located upstream of site 2. Due to low flows, the value of the upper sections of this stream for eels and brown trout and is minimal. Lamprey species are unlikely to occur.</p>

**Photo 1 Stream heavily shaded and shallow at Site 1**

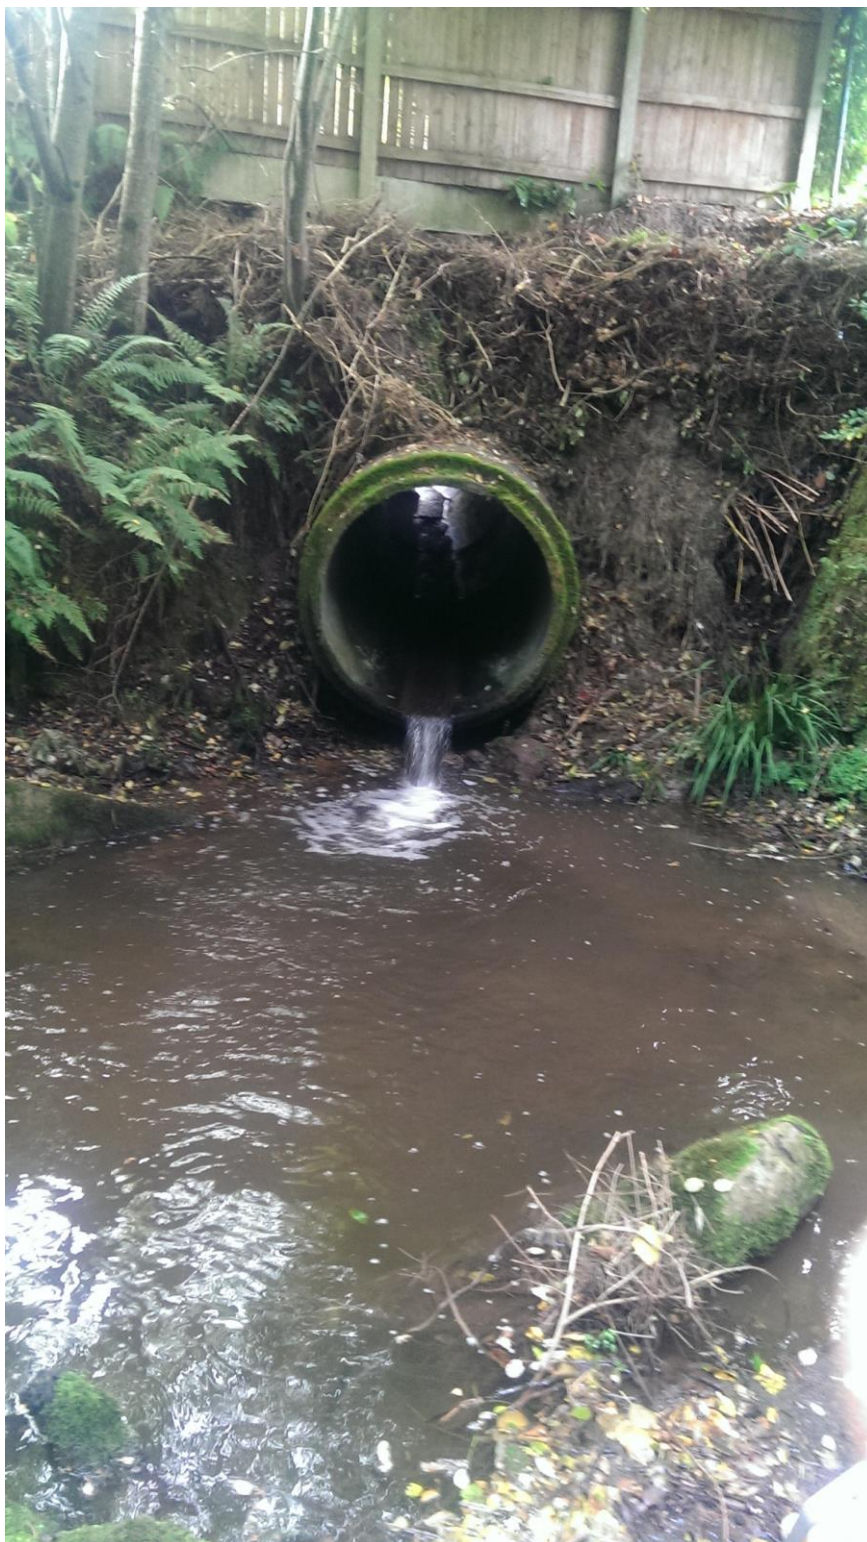
**Photo 2. Plunge pool and pipe which forms a further barrier to fish movement at the upstream end of Site 1.**

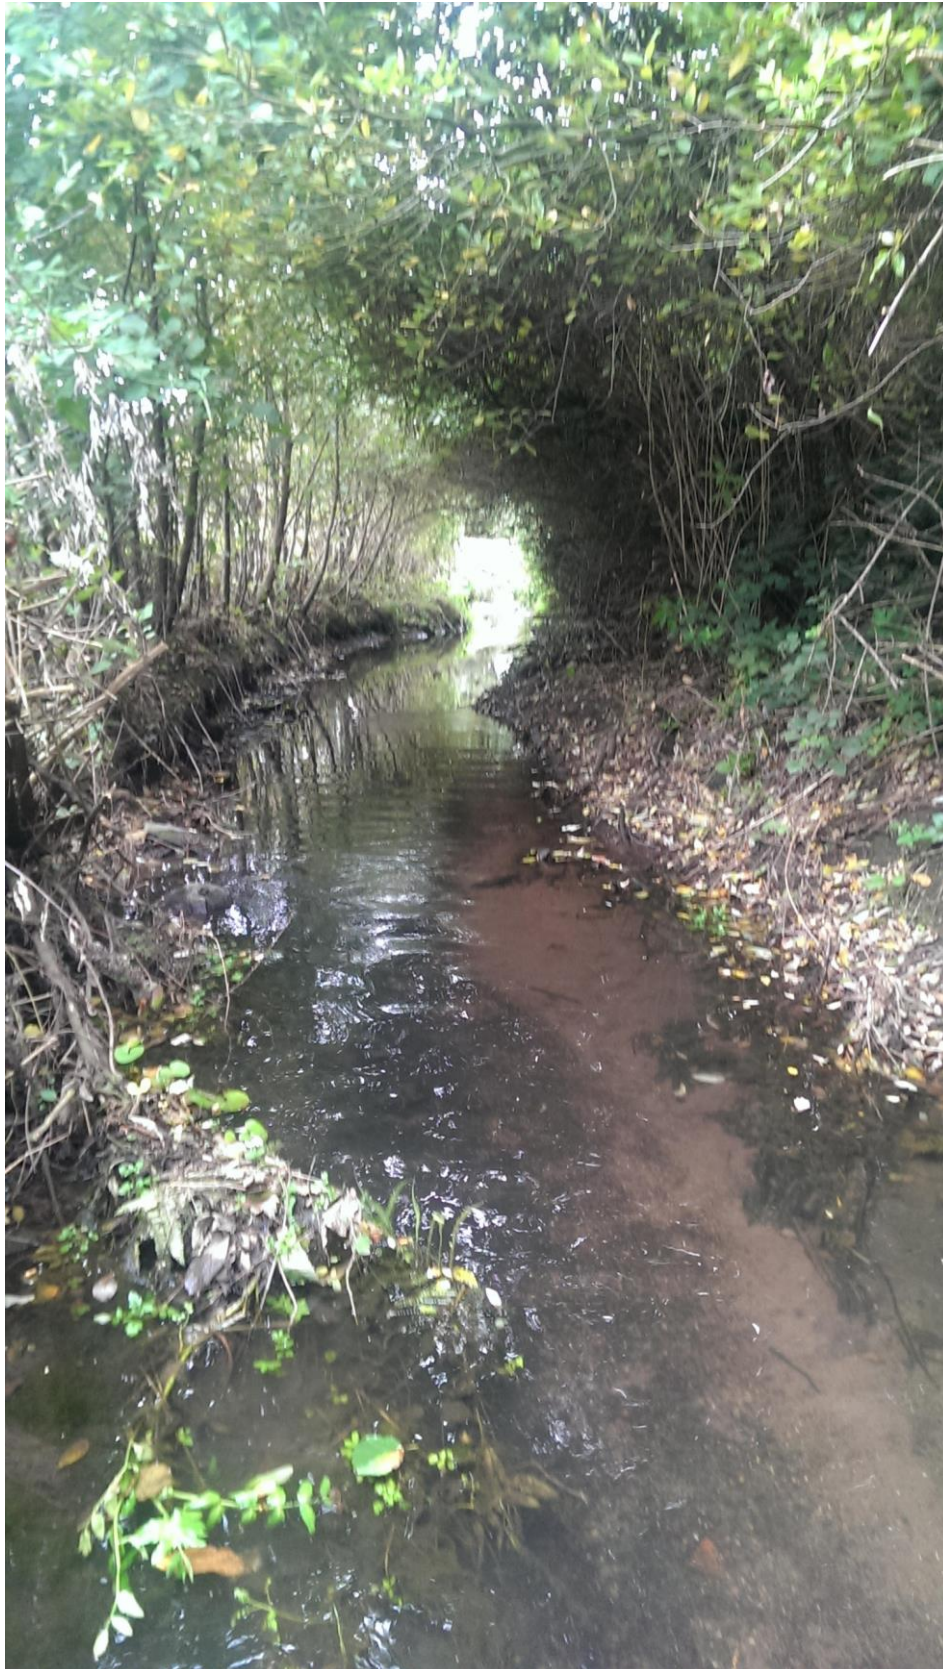
<b>Site 3</b>	<p>Located on the main channel of the Tramore River. Site 3 is dominated by riffle glide and is slightly deeper due to the presence of a weir. Cover from overhanging vegetation provides some cover for fish species and for trout in particular. Some suitable habitat for brown trout and eel was recorded. No habitat suitable for lamprey species was recorded.</p>
<b>Site 4</b>	<p>Site 4 is characterised by deep silt in places, slow flows and only small areas of suitable cover for trout. Some water quality impairment noted. Some suitable habitat for eel and lamprey was recorded</p>

The main channel of the Tramore River (Sites 3 and 4) was found to support trout, eel and stickleback. Eels were recorded in moderate numbers and high numbers of stickleback, which can provide food for other piscivorous species, were also recorded. Although water quality varies in this river, vegetative cover was the determining factor in relation to trout distribution. Moderate numbers were recorded where there was sufficient bankside cover; however long sections which were open and shallow were largely devoid of trout. Although areas of silt suitable for juvenile lamprey were noted, no lamprey was recorded during the survey.

**Photo 3. Main channel of Tramore at site 3 with high silt levels and patchy cover for fish**

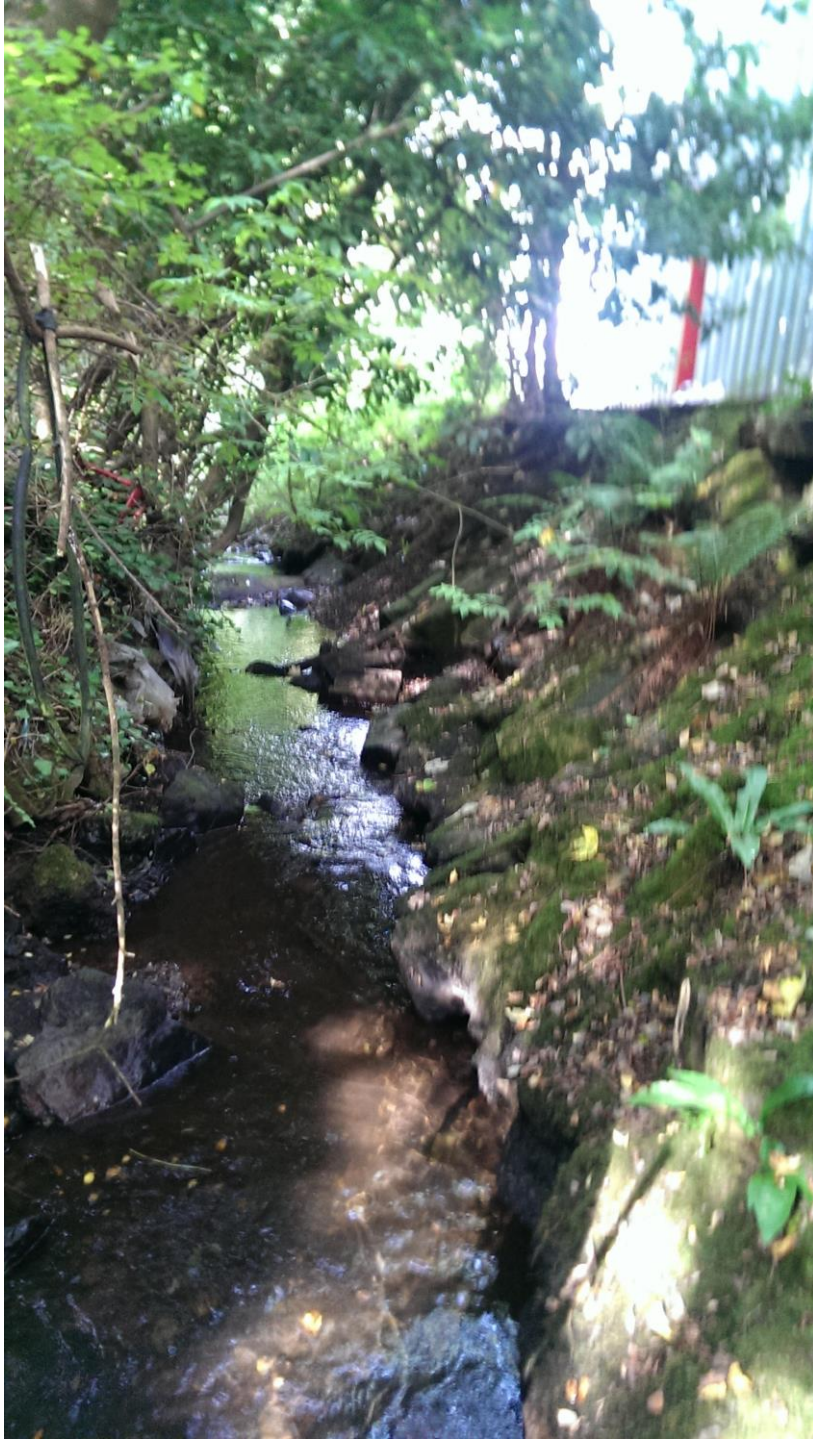
Only two large eel were recorded at Site 2 and upstream of this site, the stream was generally too shallow to effectively survey. There are culverts in place downstream of Site 2 which probably prevent trout from accessing suitable habitat on this tributary.

**Photo 4. Site 2- shallow channel with large areas of bedrock. Heavily shaded.**
