# Appendix G

## Geology & Slope Stability

### MAIGHNE WIND FARM - WINDMILL CLUSTER

### PEAT STABILITY ASSESSMENT

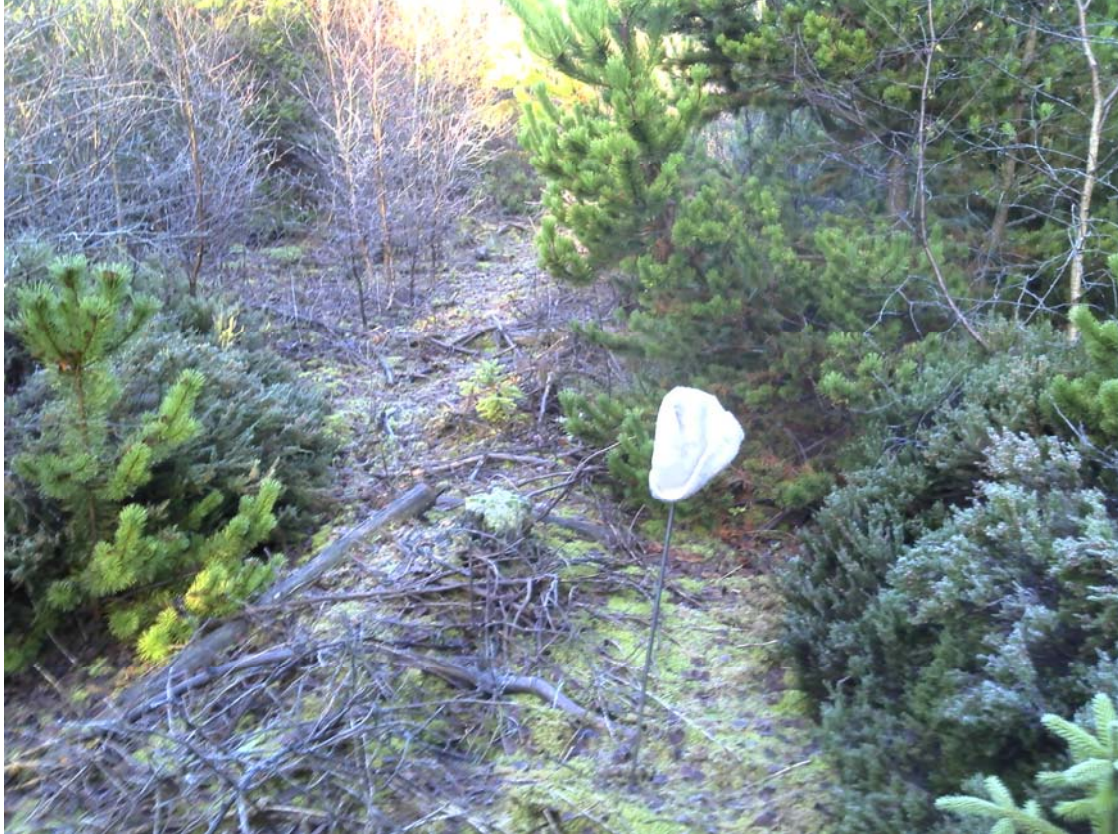
<b>Site: Drehid Substation</b>	<b>Job No: LE14-731-04</b>
<b>Client: Element Power</b>	<b>Weather: Dry</b>
<b>Position ID: Substation</b>	<b>Date: 2/12/14</b>

<b>Topography:</b> Flat lying.	
<b>Vegetation:</b> Semi-mature mixed forestry.	
<b>Peat Thickness:</b> 3m.	
<b>Features:</b> Soft brown pseudo-fibrous peat over soft to firm silt.	
<b>Von Post Classification:</b> H7 B4	
<b>Uncorrected Shear Strength:</b> 20kPa @ 0.5m, 20 kPa @ 1.0m, 30kPa @ 1.5m, 30kPa @ 2.0m.	
<b>Water Courses/Drainage:</b> Numerous dry drainage ditches E-W at 10 to 20m spacing	
<b>Assessed Peat Slide Risk:</b> Low	
<b>Created By:</b> AG	<b>Checked By:</b> TPR

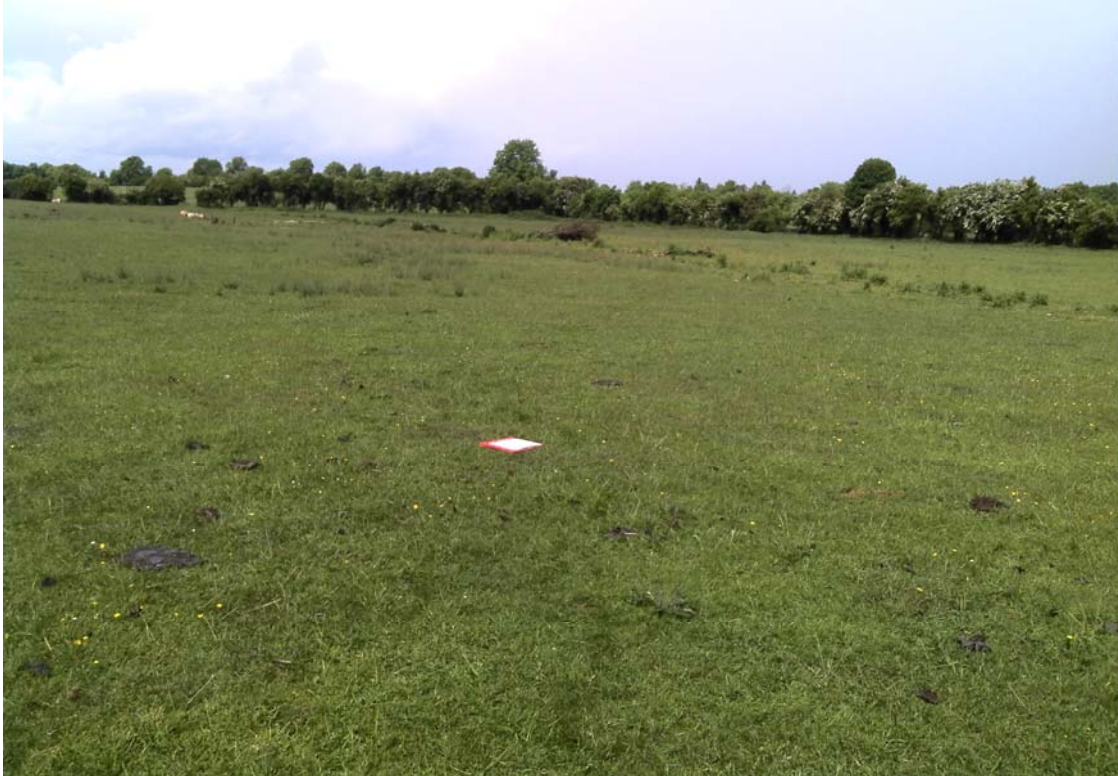
<b>Site: Ballynakill</b>	<b>Job No: LE14-731-04</b>
<b>Client: Element Power</b>	<b>Weather: Heavy Showers</b>
<b>Position ID: Turbine 1</b>	<b>Date: 11/6/13</b>

**Topography:** Flat to slightly undulating terrain

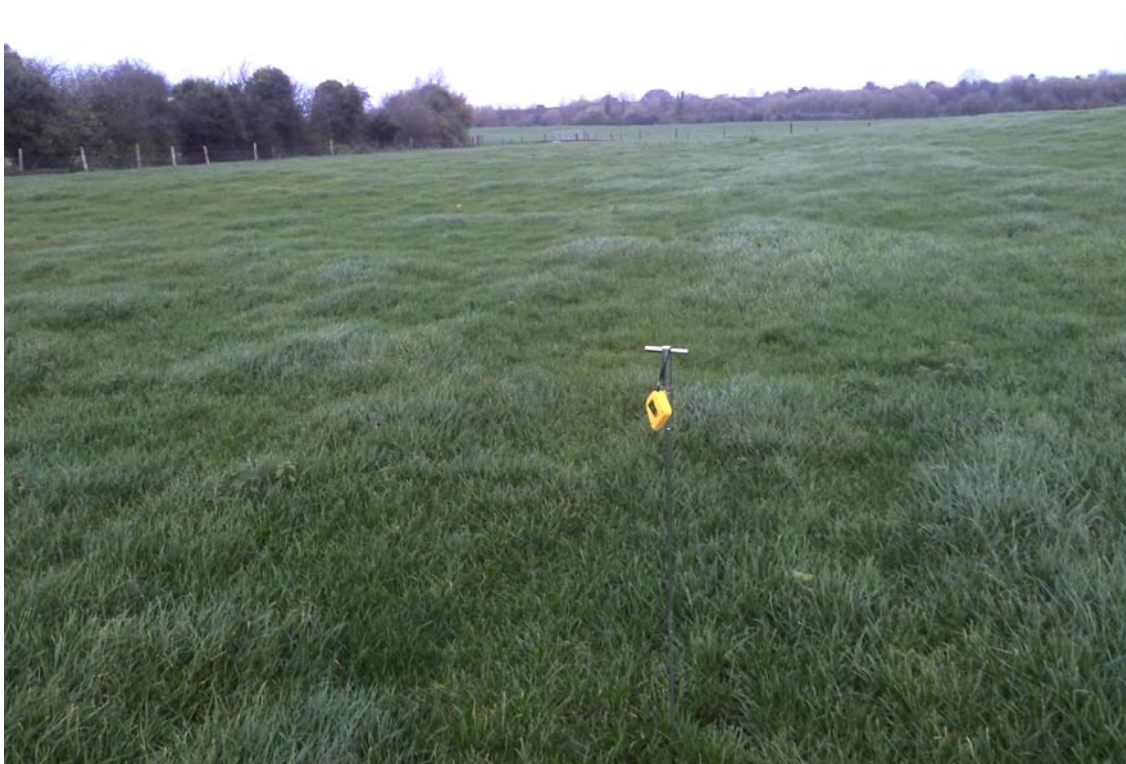
<b>Site: Ballynakill</b>	<b>Job No: LE14-731-04</b>
<b>Client: Element Power</b>	<b>Weather: Fine</b>
<b>Position ID: Turbine 2</b>	<b>Date: 31/10/14</b>

**Topography:** Slightly undulating Terrain with 1° N slope at the turbine location.

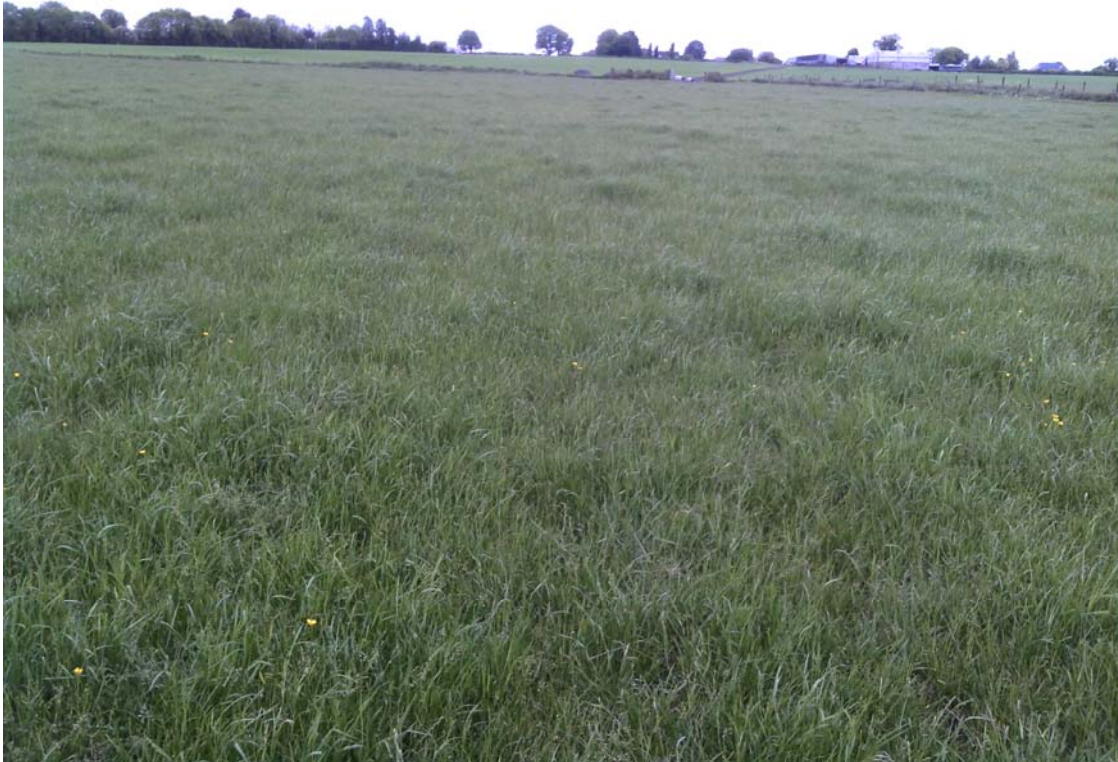
<b>Site: Ballynakill</b>	<b>Job No: LE14-731-04</b>
<b>Client: Element Power</b>	<b>Weather: Heavy Showers</b>
<b>Position ID: Turbine 3</b>	<b>Date: 11/6/13</b>

**Topography:** Flat terrain

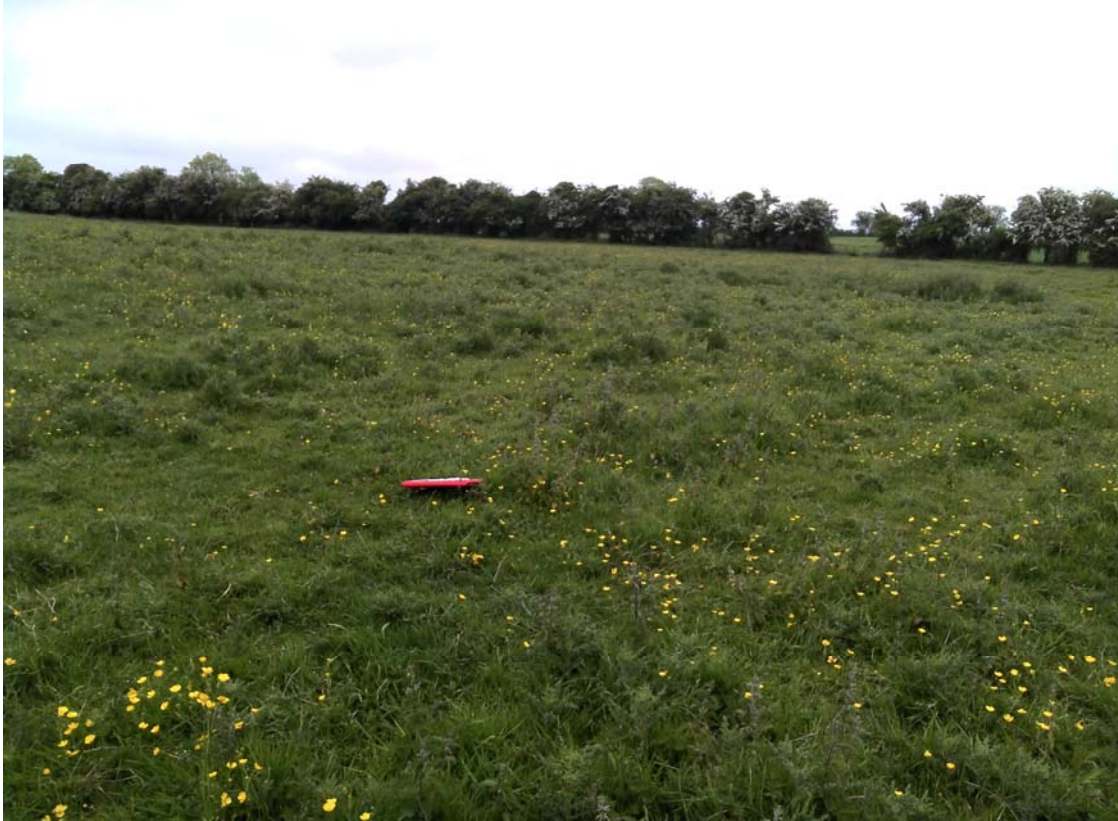
<b>Site: Greenwire Longwood Extension</b>	<b>Job No: LE11-731-09</b>
<b>Client: Element Power</b>	<b>Weather: Heavy Showers</b>
<b>Position ID: Turbine 4</b>	<b>Date: 11/6/13</b>

<p><b>Topography:</b> Flat Terrain</p> <p><b>Vegetation:</b> Grassland</p> <p><b>Peat Thickness:</b> None present</p> <p><b>Features:</b> Firm underfoot</p> <p><b>Von Post Classification:</b> Not Applicable</p> <p><b>Uncorrected Shear Strength:</b> Not Applicable</p> <p><b>Water Courses/Drainage:</b> No drainage features identified close to turbine location.</p> <p><b>Assessed Peat Slide Risk:</b> Not Applicable</p>
---

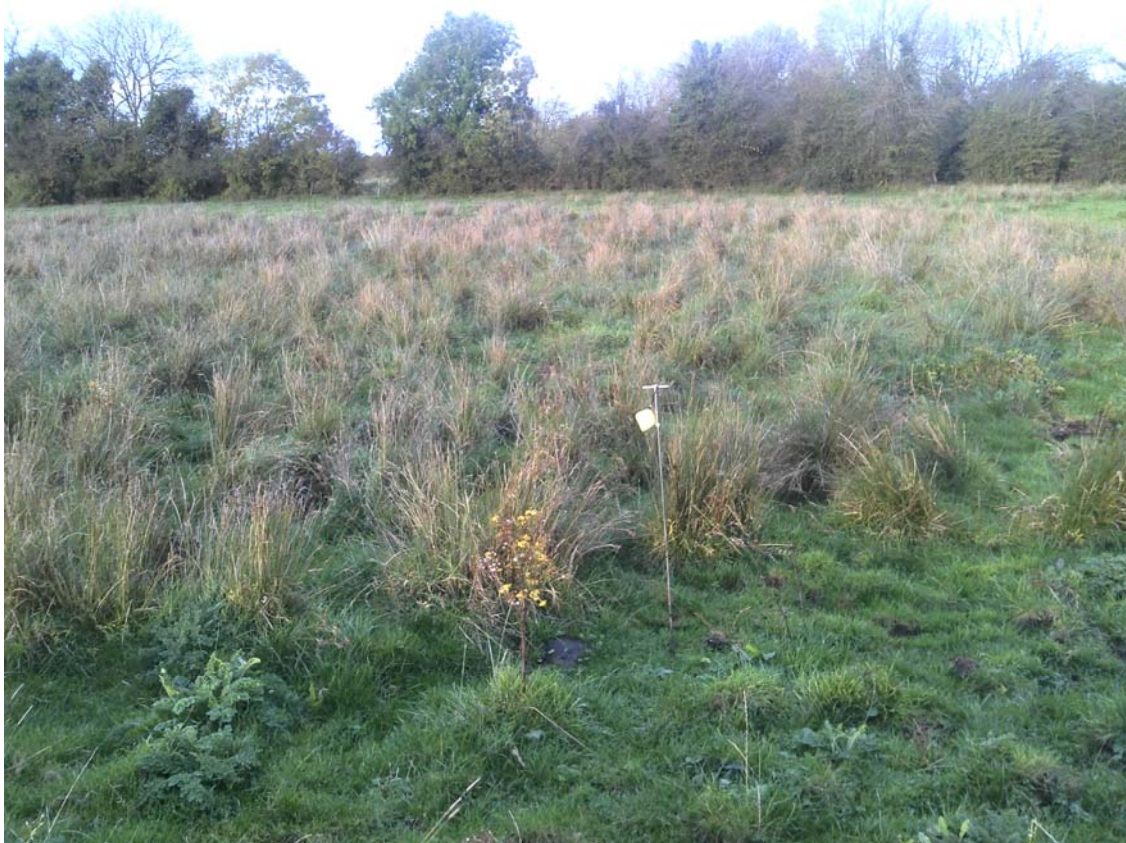
<b>Site: Ballynakill</b>	<b>Job No: LE14-731-04</b>
<b>Client: Element Power</b>	<b>Weather: Fine</b>
<b>Position ID: Turbine 5</b>	<b>Date: 30/10/14</b>

<p><b>Topography:</b> Gently undulating terrain with 2° east slope at turbine location.</p> <p><b>Vegetation:</b> Grassland with abundant rushes at lowest point in poorly drained field.</p> <p><b>Peat Thickness:</b> None present. 0.5m peaty topsoil.</p> <p><b>Features:</b> Soft underfoot (Topsoil only). Firm below 0.20m BGL</p> <p><b>Von Post Classification:</b> Not Applicable</p> <p><b>Uncorrected Shear Strength:</b> 50kPa at 0.5m</p> <p><b>Water Courses/Drainage:</b> Drainage ditches in surrounding field boundaries.</p> <p><b>Assessed Peat Slide Risk:</b> Not Applicable</p>
--

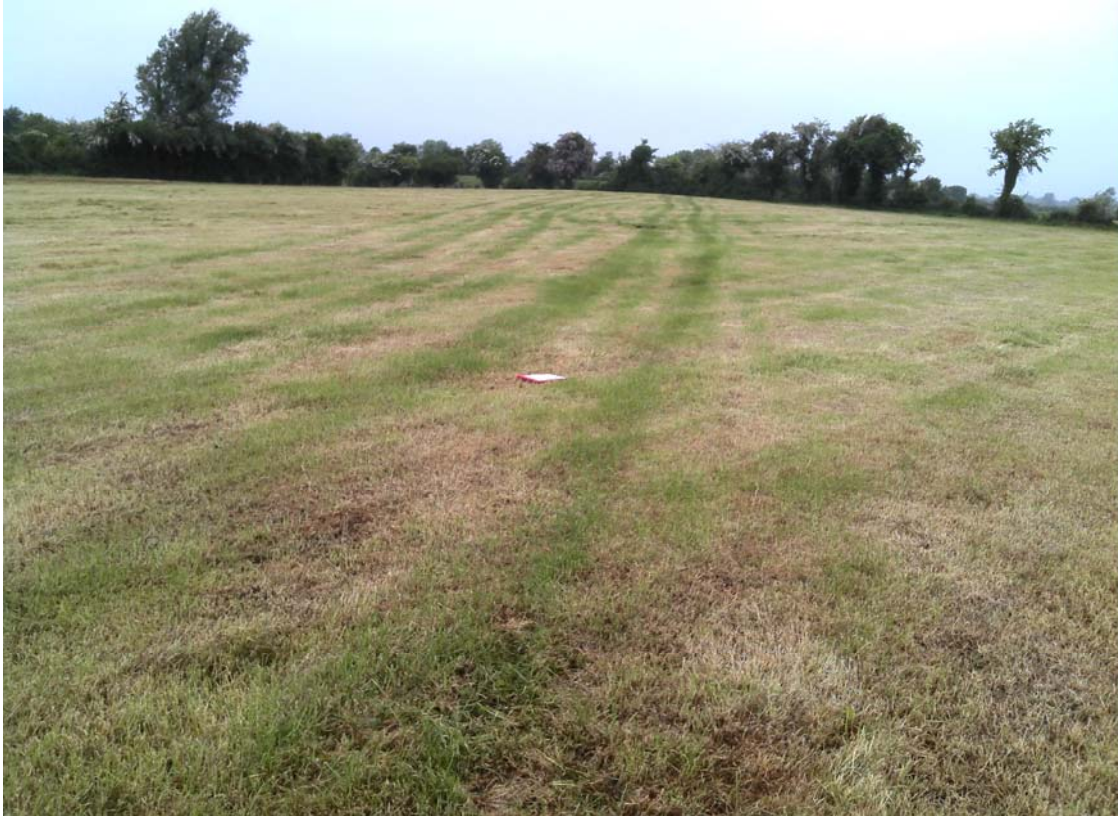
<b>Site: Greenwire Longwood Extension</b>	<b>Job No: LE11-731-09</b>
<b>Client: Element Power</b>	<b>Weather: Heavy Showers</b>
<b>Position ID: Turbine 6</b>	<b>Date: 11/6/13</b>

<p><b>Topography:</b> Flat Terrain</p> <p><b>Vegetation:</b> Grassland</p> <p><b>Peat Thickness:</b> None present</p> <p><b>Features:</b> Firm underfoot</p> <p><b>Von Post Classification:</b> Not Applicable</p> <p><b>Uncorrected Shear Strength:</b> Not Applicable</p> <p><b>Water Courses/Drainage:</b> Deep drains in surrounding field boundaries.</p> <p><b>Assessed Peat Slide Risk:</b> Not Applicable</p>
---

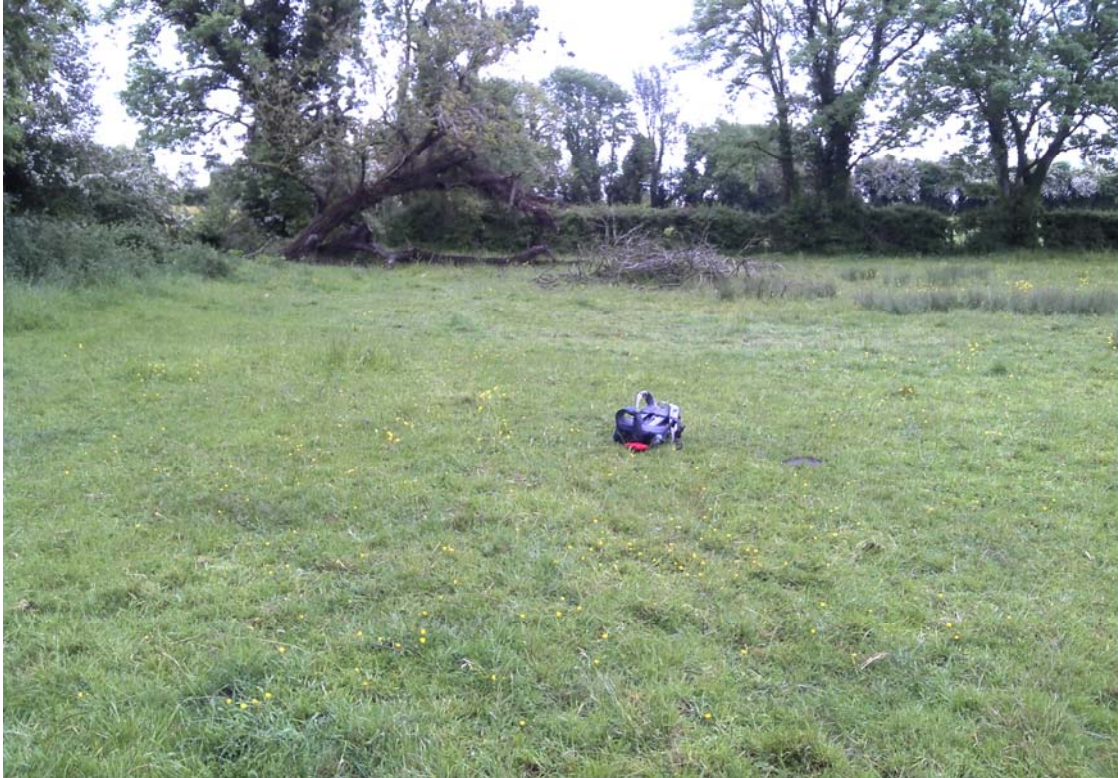
<b>Site: Ballynakill</b>	<b>Job No: LE14-731-04</b>
<b>Client: Element Power</b>	<b>Weather: Heavy Showers</b>
<b>Position ID: Turbine 7</b>	<b>Date: 11/6/13</b>

<p><b>Topography:</b> Flat Terrain</p> <p><b>Vegetation:</b> Grassland</p> <p><b>Peat Thickness:</b> None present</p> <p><b>Features:</b> Firm underfoot</p> <p><b>Von Post Classification:</b> Not Applicable</p> <p><b>Uncorrected Shear Strength:</b> Not Applicable</p> <p><b>Water Courses/Drainage:</b> No drainage features identified close to turbine location. Royal Canal 250m northeast of turbine location</p> <p><b>Assessed Peat Slide Risk:</b> Not Applicable</p>
--

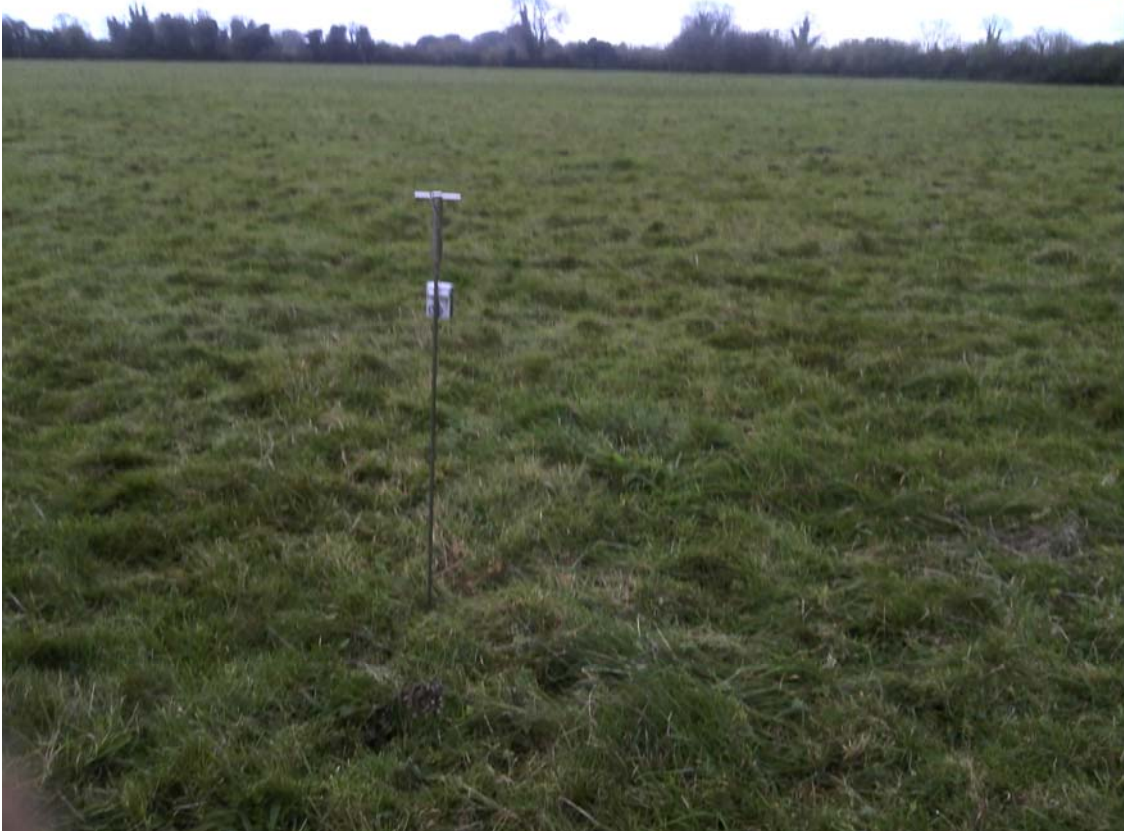
<b>Site: Ballynakill</b>	<b>Job No: LE14-731-04</b>
<b>Client: Element Power</b>	<b>Weather: Fine</b>
<b>Position ID: Turbine 8</b>	<b>Date: 31/10/14</b>

**Topography:** Flat Terrain

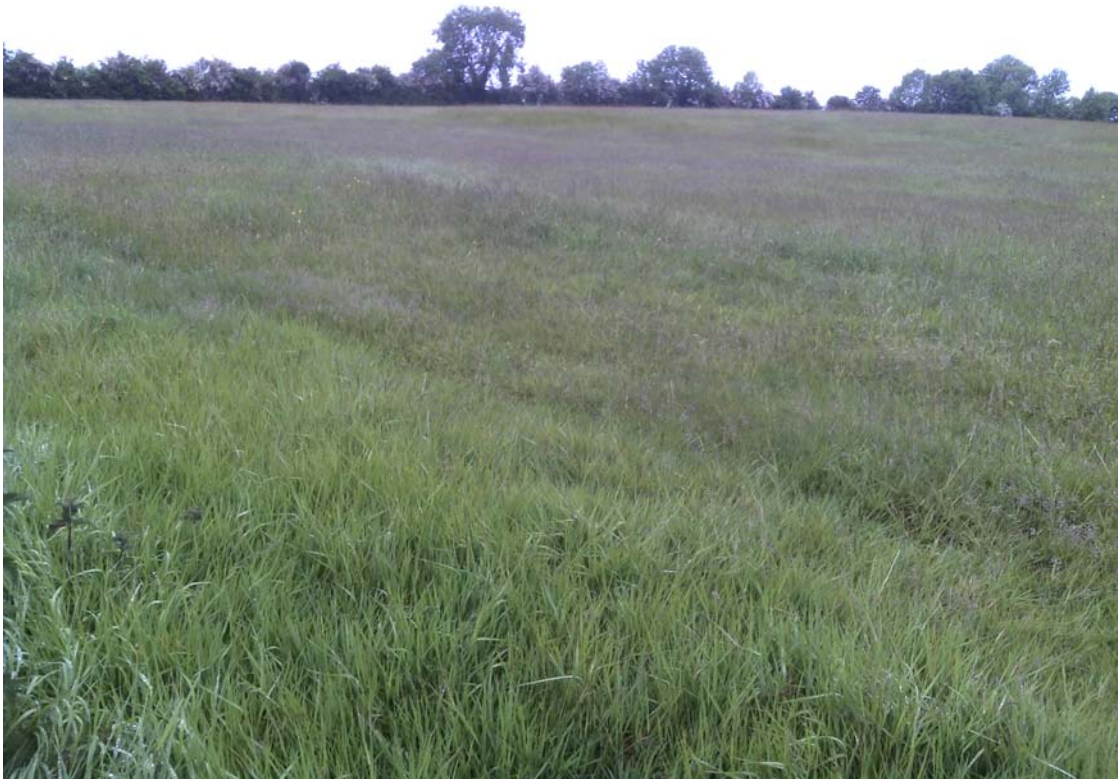
<b>Site: Ballynakill</b>	<b>Job No: LE14-731-04</b>
<b>Client: Element Power</b>	<b>Weather: Heavy Showers</b>
<b>Position ID: Turbine 9</b>	<b>Date: 11/6/13</b>

**Topography:** Flat Terrain

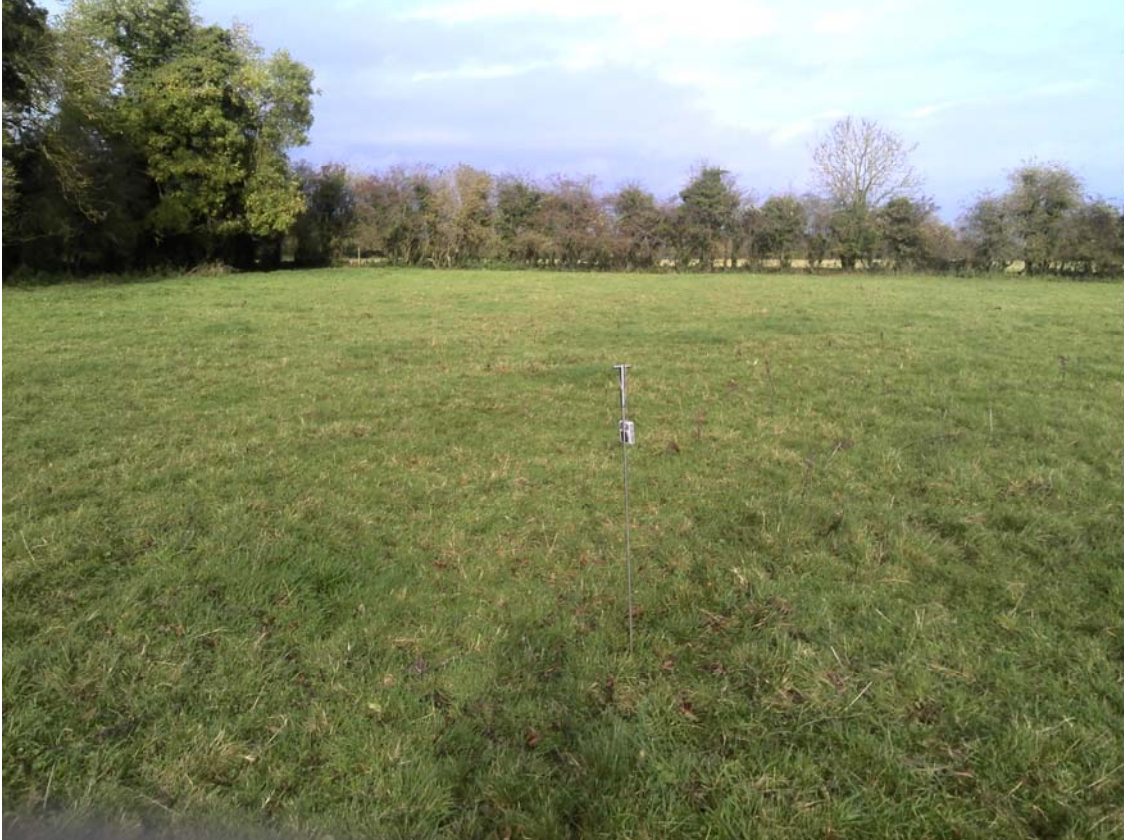
<b>Site: Ballynakill</b>	<b>Job No: LE14-731-04</b>
<b>Client: Element Power</b>	<b>Weather: Fine</b>
<b>Position ID: Turbine 10</b>	<b>Date: 31/10/14</b>

**Topography:** Flat Terrain

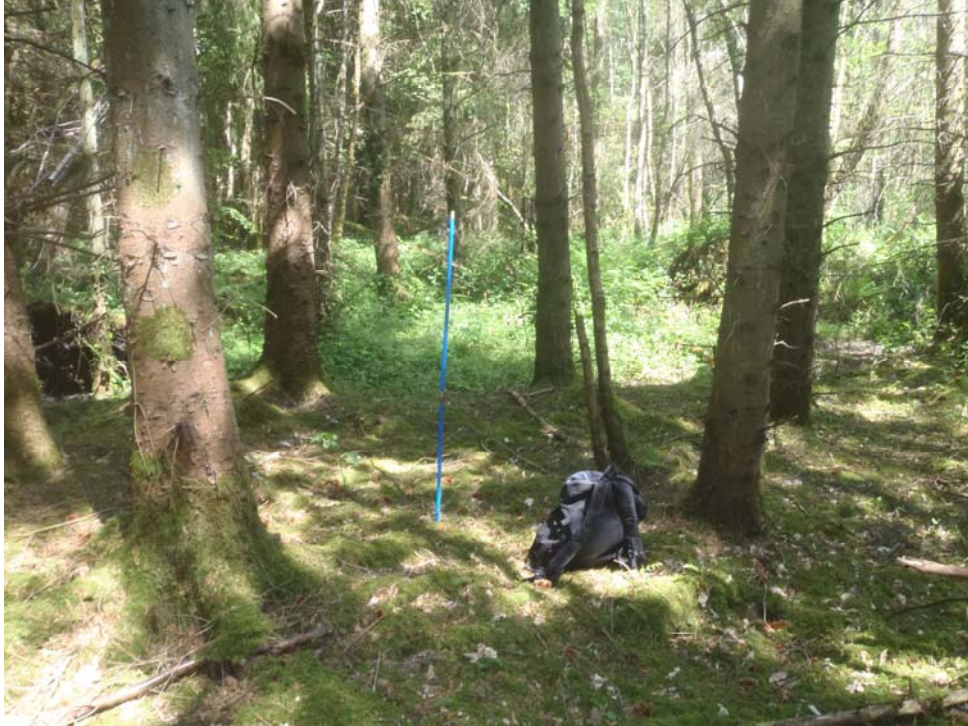
<b>Site:</b> Drehid	<b>Job No:</b> LE14-731-04
<b>Client:</b> Element Power	<b>Weather:</b> Dry
<b>Position ID:</b> Turbine 11	<b>Date:</b> 7-6-2013 & 25-11-14

**Topography:** The ground gently slopes 1° SW.

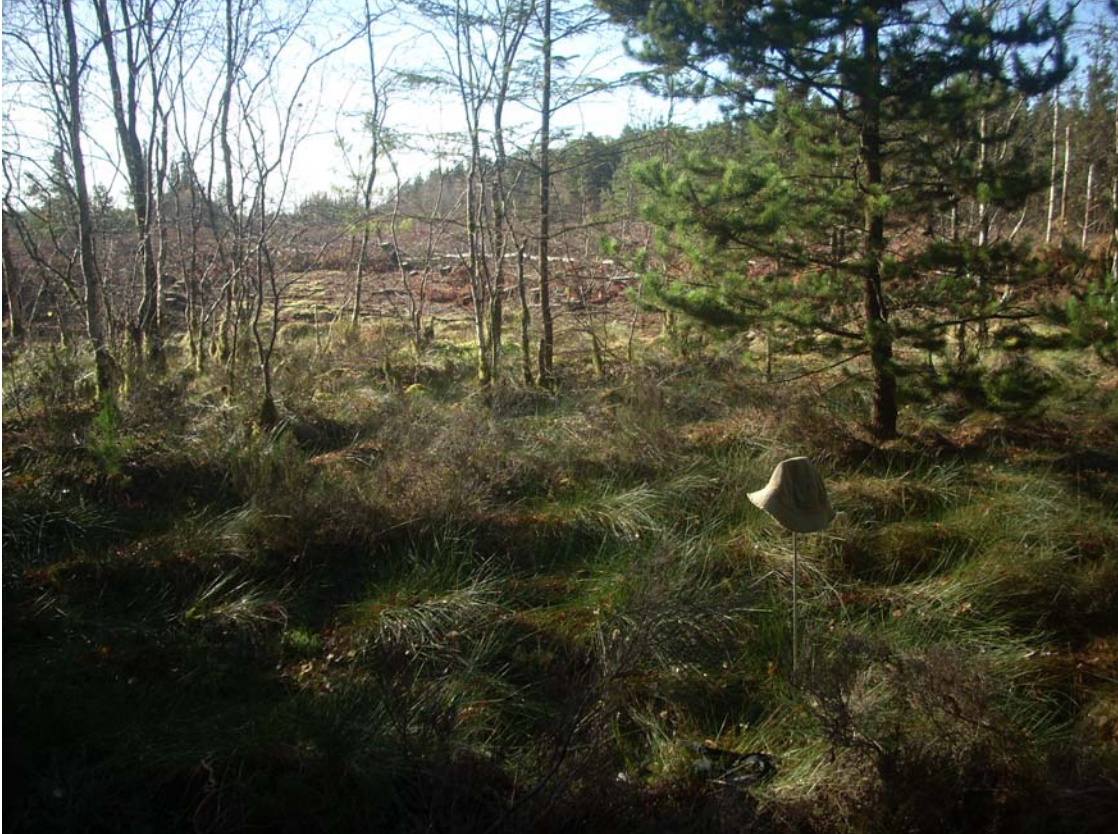
<b>Site:</b> Drehid	<b>Job No:</b> LE14-731-04
<b>Client:</b> Element Power	<b>Weather:</b> Dry
<b>Position ID:</b> Turbine 12	<b>Date:</b> 5/11/14

**Topography:** Flat lying, boggy ground.

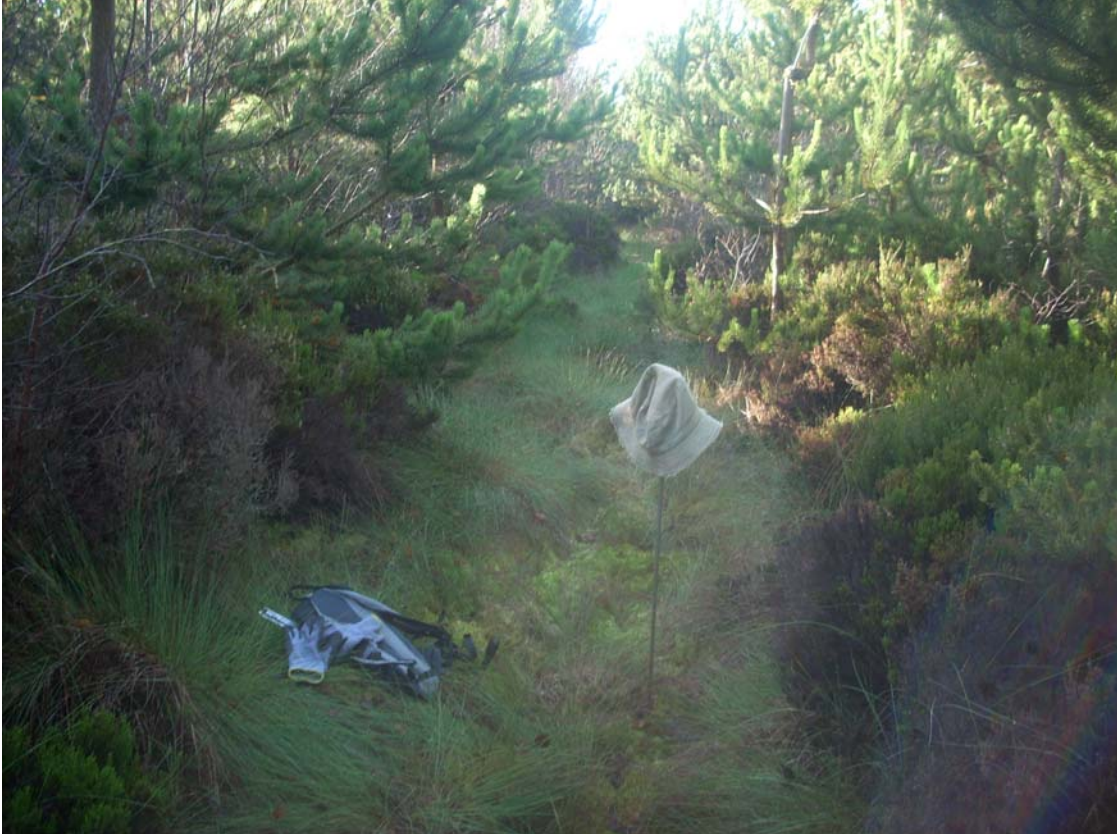
<b>Site:</b> Drehid	<b>Job No:</b> LE14-731-04
<b>Client:</b> Element Power	<b>Weather:</b> Dry
<b>Position ID:</b> Turbine 13	<b>Date:</b> 05/11/14

**Topography:** The ground gently slopes 1° N max.

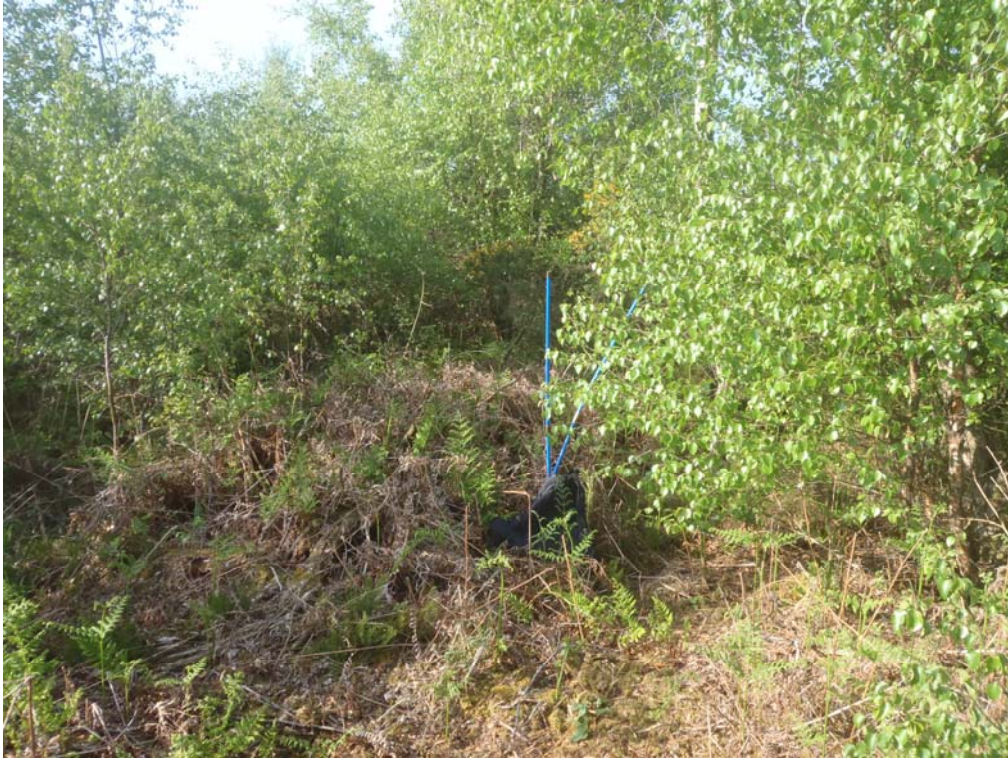
<b>Site: Drehid</b>	<b>Job No: LE14-731-04</b>
<b>Client: Element Power</b>	<b>Weather: Dry</b>
<b>Position ID: Turbine 14</b>	<b>Date: 7-6-2013</b>

<b>Topography:</b> The ground gently slopes 2°W.	
<b>Vegetation:</b> Harvested forestry replanted with deciduous trees overlying peat.	
<b>Peat Thickness:</b> 0.80m probe peat.	
<b>Features:</b> Soft brown spongy fibrous peat.	
<b>Von Post Classification:</b> H6 B2	
<b>Uncorrected Shear Strength:</b> 32KPa at 0.25m, 36KPa at 0.5m.	
<b>Water Courses/Drainage:</b> Drainage ditches evident 10-20m spacing.	
<b>Assessed Peat Slide Risk:</b> Very Low	
<b>Created By:</b> Andrew Jaworski	<b>Checked By:</b> AG

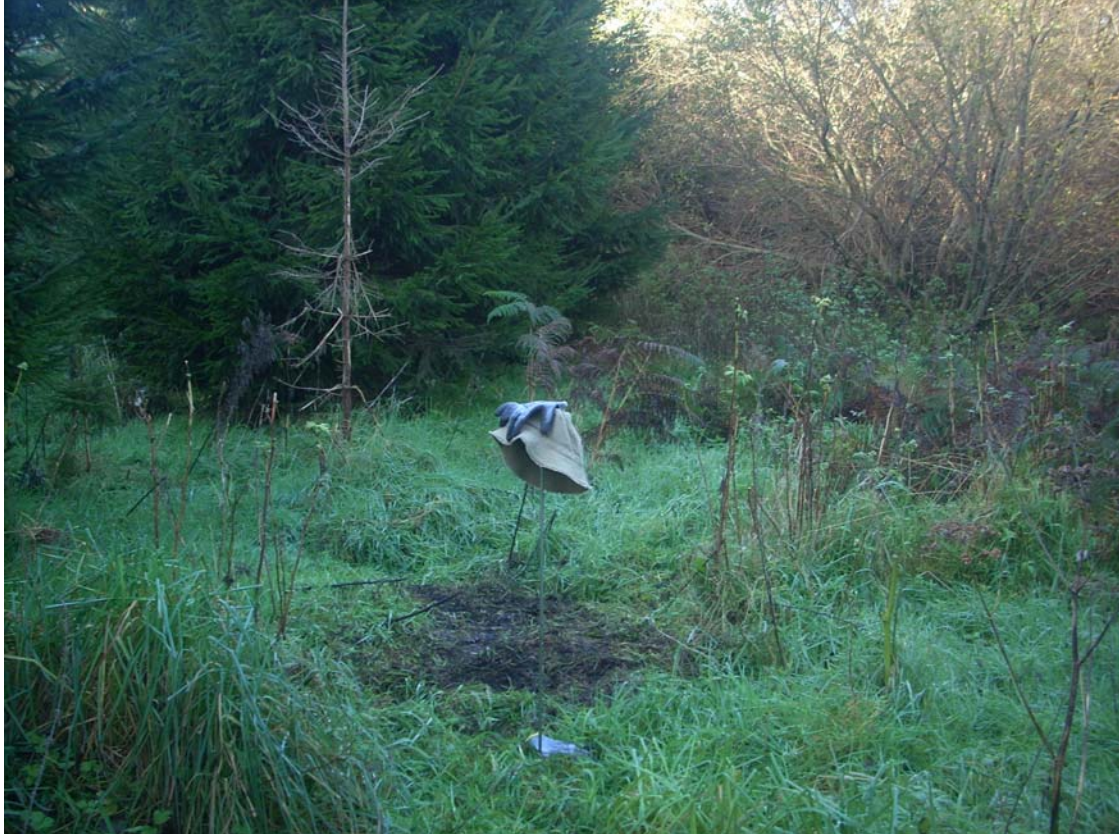
<b>Site:</b> Drehid	<b>Job No:</b> LE14-731-04
<b>Client:</b> Element Power	<b>Weather:</b> Dry
<b>Position ID:</b> Turbine 15	<b>Date:</b> 5/11/14

<b>Topography:</b> The ground gently slopes 1° N .	
<b>Vegetation:</b> Semi-mature mixed forestry over Peat.	
<b>Peat Thickness:</b> 0.5m peat.	
<b>Features:</b> Soft brown spongy fibrous peat.	
<b>Von Post Classification:</b> H6 B3	
<b>Uncorrected Shear Strength:</b> 20KPa at 0.25m	
<b>Water Courses/Drainage:</b> drainage ditches evident 10-20m spacing.	
<b>Assessed Peat Slide Risk:</b> Very Low	
<b>Created By:</b> AG	<b>Checked By:</b> TPR

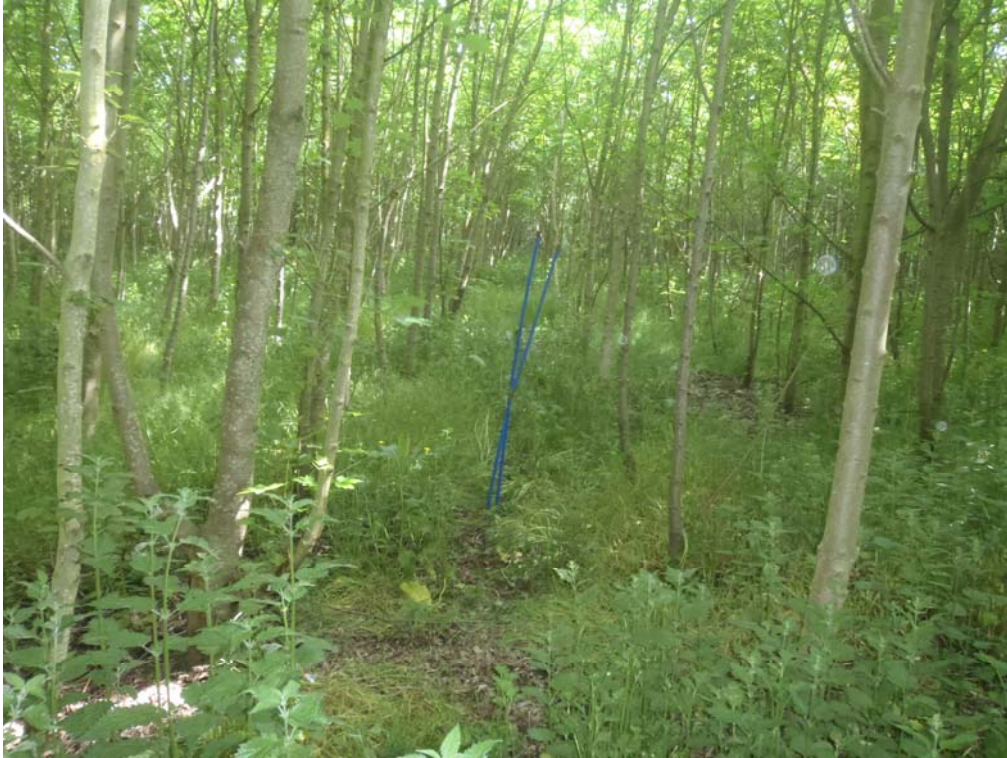
<b>Site: Drehid</b>	<b>Job No: LE14-731-04</b>
<b>Client: Element Power</b>	<b>Weather: Dry</b>
<b>Position ID: Turbine 16</b>	<b>Date: 7-6-2013</b>

**Topography:** The ground gently slopes 2° S.

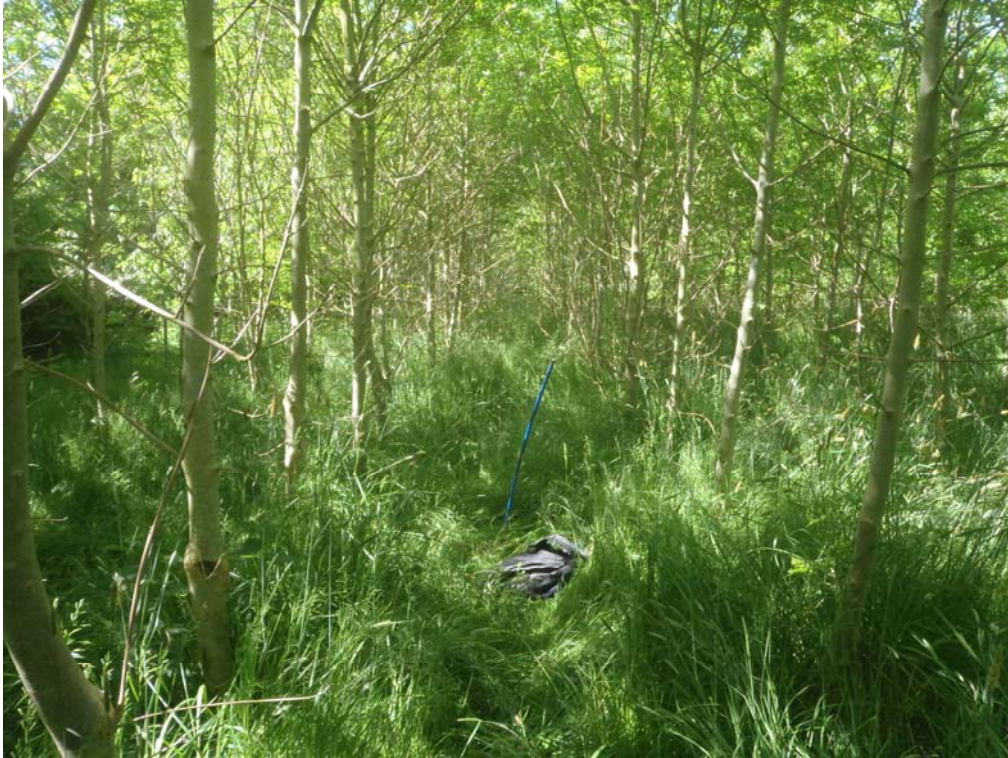
<b>Site: Drehid</b>	<b>Job No: LE14-731-04</b>
<b>Client: Element Power</b>	<b>Weather: Dry</b>
<b>Position ID: Turbine 17</b>	<b>Date: 7-6-2013</b>

**Topography:** The ground gently slopes 3° S.

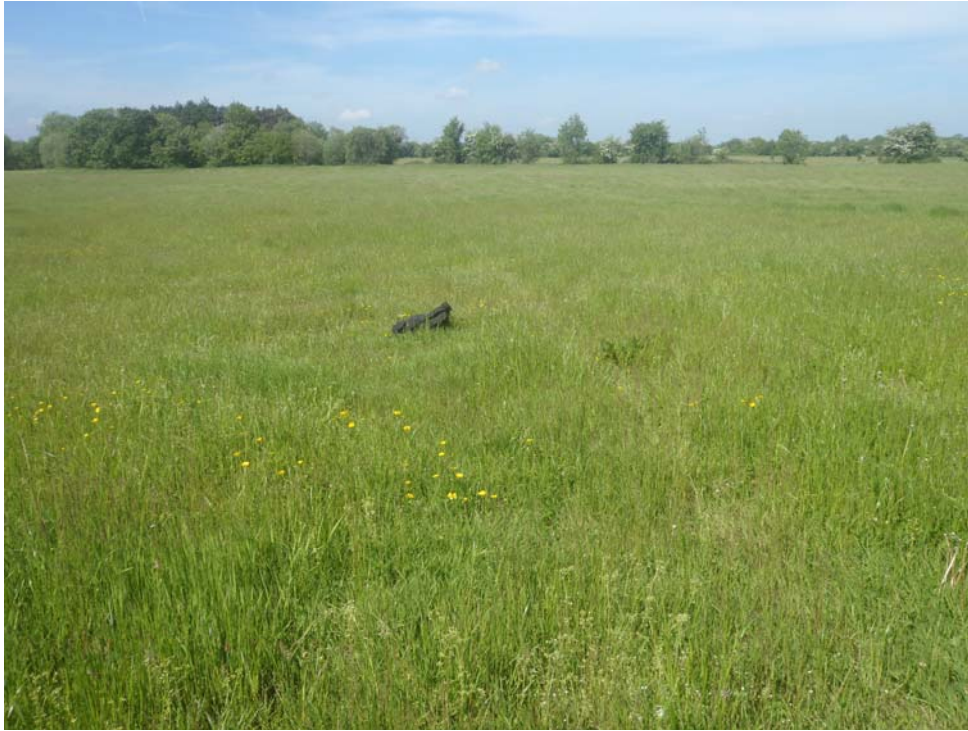
<b>Site: Drehid</b>	<b>Job No: LE14-731-04</b>
<b>Client: Element Power</b>	<b>Weather: Dry</b>
<b>Position ID: Turbine 18</b>	<b>Date: 7-6-2013</b>

**Topography:** The ground gently slopes 2° E.

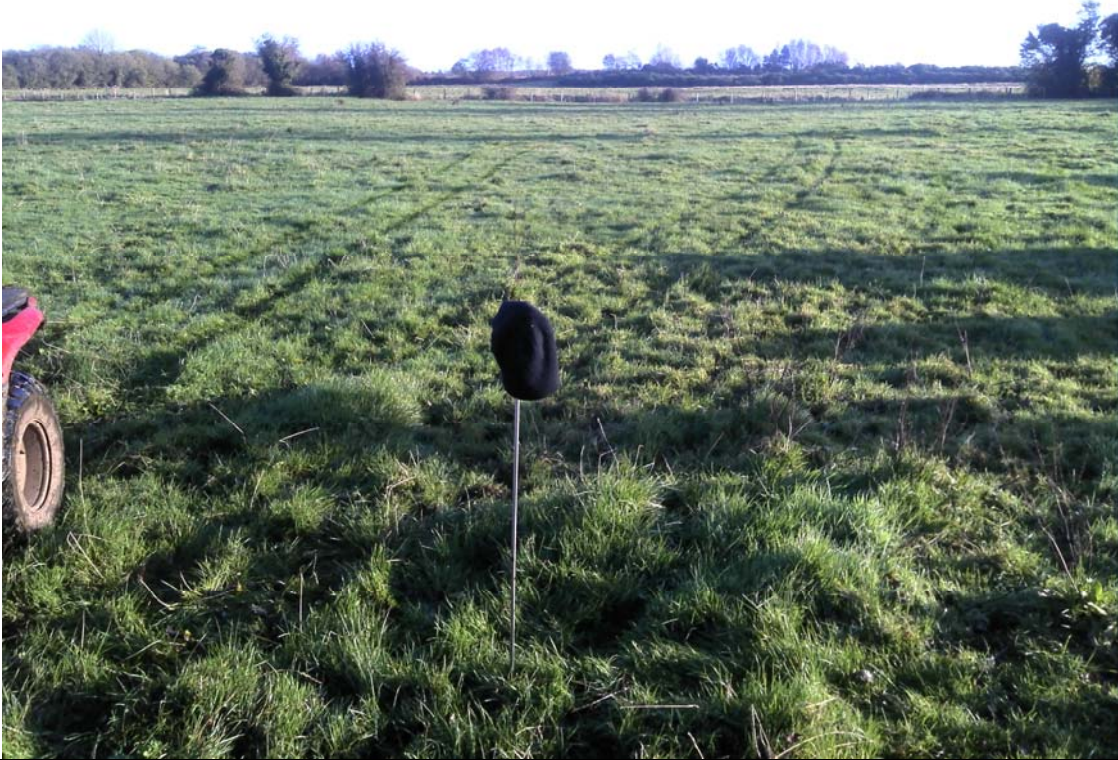
<b>Site:</b> Drehid	<b>Job No:</b> LE14-731-04
<b>Client:</b> Element Power	<b>Weather:</b> Dry
<b>Position ID:</b> Turbine 19	<b>Date:</b> 05/11/14

**Topography:** The ground gently slopes 1° N.

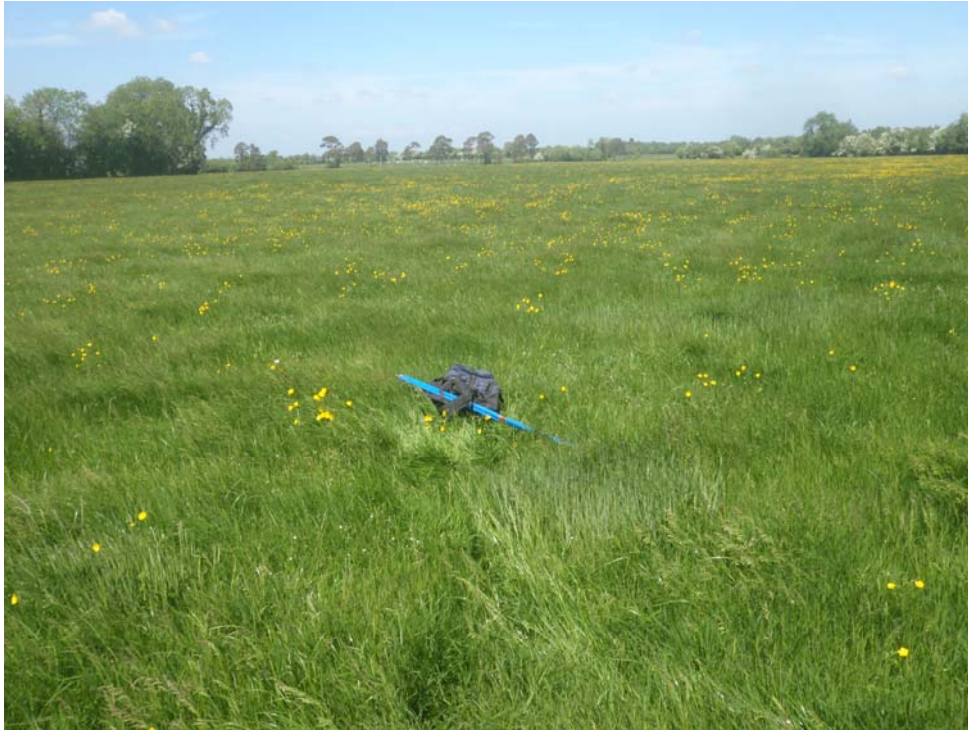
<b>Site:</b> Drehid	<b>Job No:</b> LE14-731-04
<b>Client:</b> Element Power	<b>Weather:</b> Dry
<b>Position ID:</b> Turbine 20	<b>Date:</b> 6-6-2013

**Topography:** The ground gently slopes 2° SW.

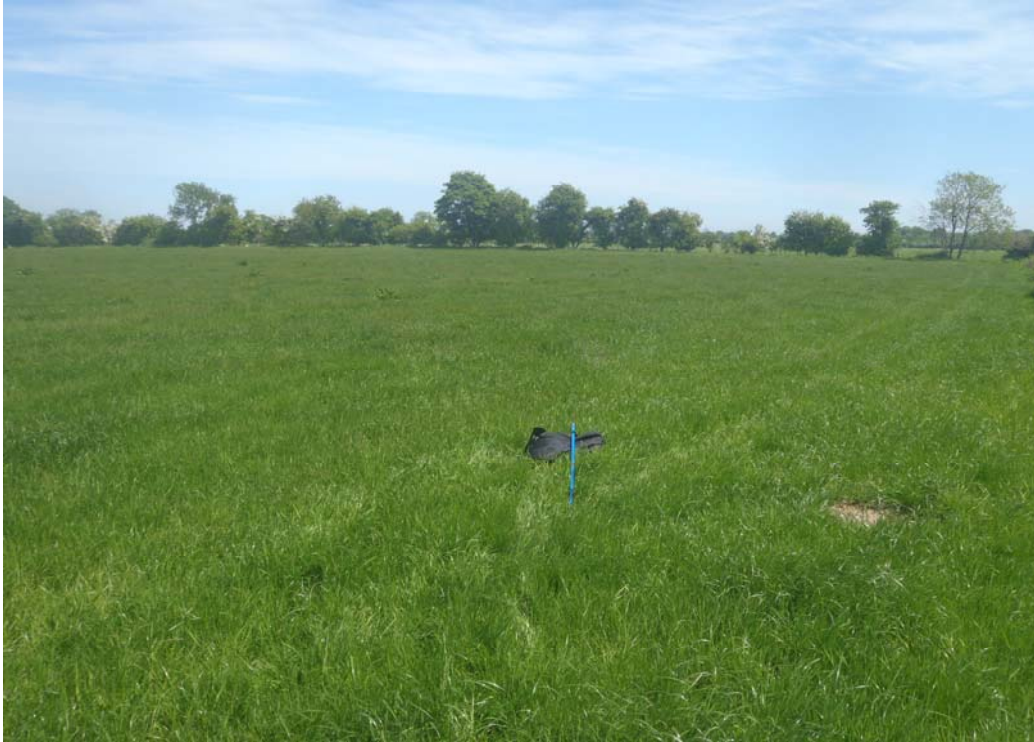
<b>Site:</b> Drehid	<b>Job No:</b> LE14-731-04
<b>Client:</b> Element Power	<b>Weather:</b> Dry
<b>Position ID:</b> Turbine 21	<b>Date:</b> 6-6-2013

<b>Topography:</b> The ground gently slopes up to 2° SW	
<b>Vegetation:</b> Firm Grassland	
<b>Peat Thickness:</b> None Present.	
<b>Features:</b> gently sloping grassland over brown topsoil.	
<b>Von Post Classification:</b> Not Applicable	
<b>Uncorrected Shear Strength:</b> No Penetration	
<b>Water Courses/Drainage:</b> None Visible.	
<b>Assessed Peat Slide Risk:</b> Not Applicable.	
<b>Created By:</b> Andrew Jaworski	<b>Checked By:</b> AG

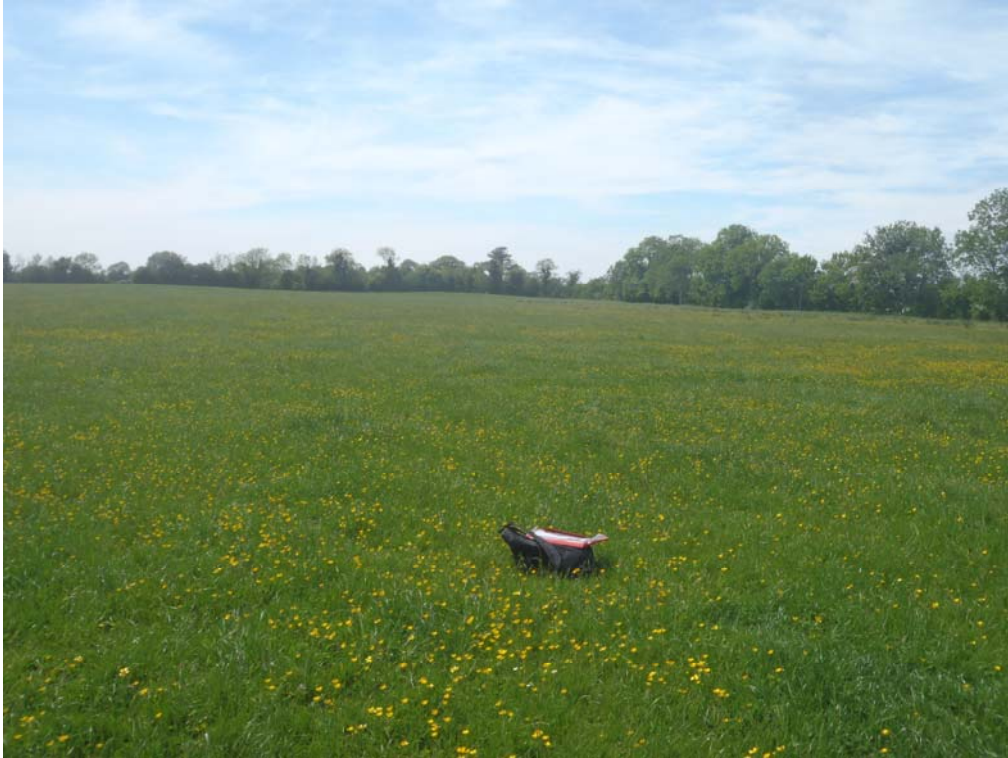
<b>Site: Drehid</b>	<b>Job No: LE14-731-04</b>
<b>Client: Element Power</b>	<b>Weather: Dry</b>
<b>Position ID: Turbine 22</b>	<b>Date: 6-6-2013</b>

<b>Topography:</b> The ground gently slopes 3° S.	
<b>Vegetation:</b> Firm Grassland	
<b>Peat Thickness:</b> None Present.	
<b>Features:</b> gently sloping grassland over brown topsoil.	
<b>Von Post Classification:</b> Not Applicable	
<b>Uncorrected Shear Strength:</b> No Penetration	
<b>Water Courses/Drainage:</b> None Visible.	
<b>Assessed Peat Slide Risk:</b> Not Applicable.	
<b>Created By:</b> Andrew Jaworski	<b>Checked By:</b> AG

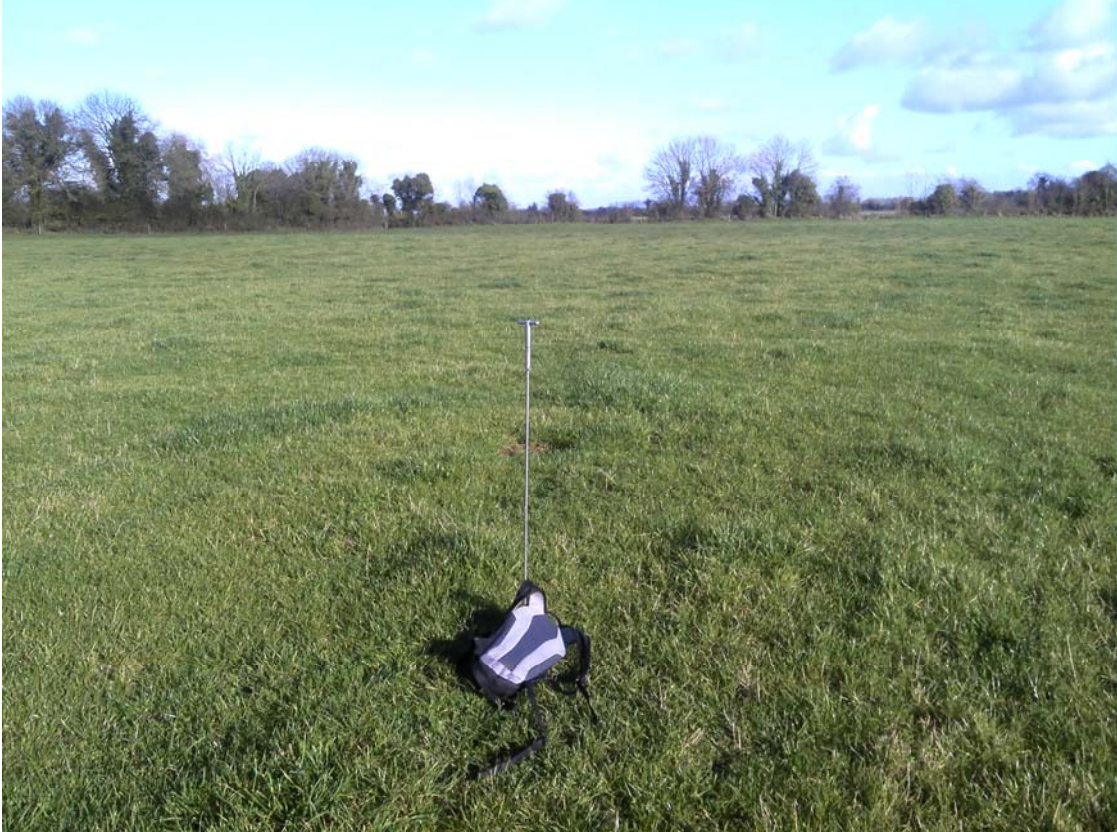
<b>Site:</b> Drehid	<b>Job No:</b> LE14-731-04
<b>Client:</b> Element Power	<b>Weather:</b> Dry
<b>Position ID:</b> Turbine 23	<b>Date:</b> 5/11/14

**Topography:** The ground gently slopes 1° S.
