# Appendix G

## Geology & Slope Stability

### MAIGHNE WIND FARM - WINDMILL CLUSTER

### PEAT STABILITY ASSESSMENT

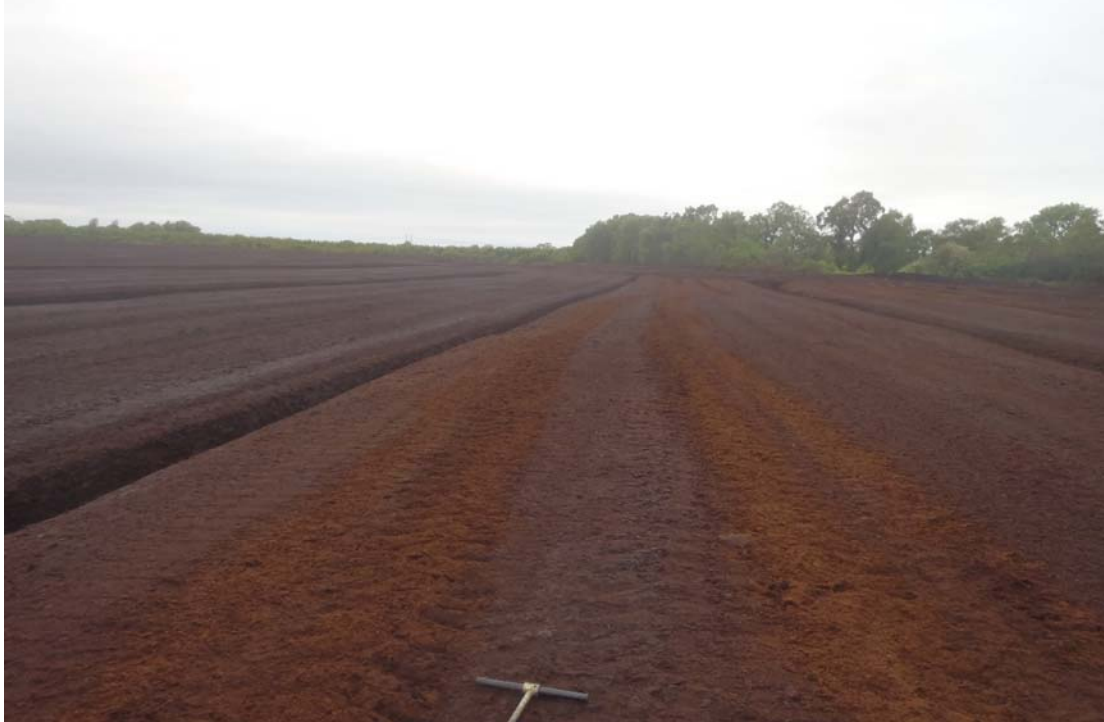
<b>Site:</b> Windmill	<b>Job No:</b> LE14-731-04
<b>Client:</b> Element Power	<b>Weather:</b> Wet Overcast
<b>Position ID:</b> Turbine T24	<b>Date:</b> 11-6-2013 & 18-11-2014

**Topography:** Site Slope <math><1^\circ</math> E-W.

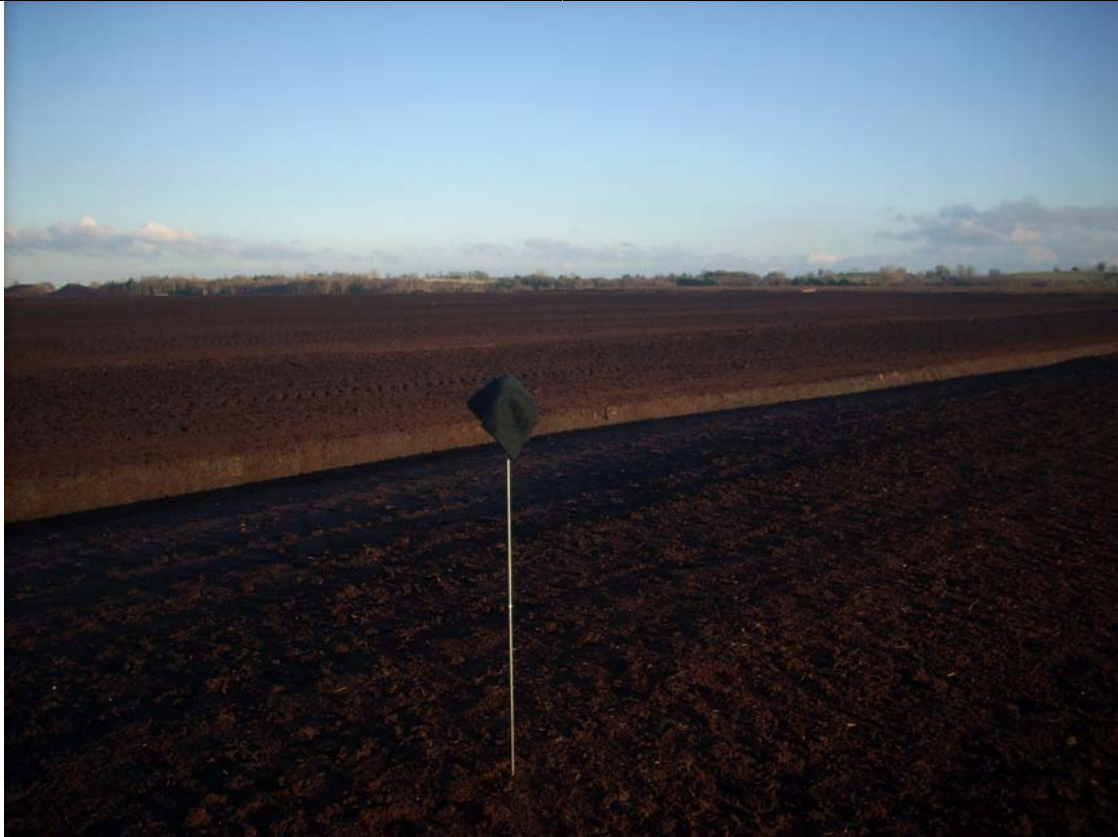
<b>Site:</b> Windmill	<b>Job No:</b> LE14-731-04
<b>Client:</b> Element Power	<b>Weather:</b> Dry
<b>Position ID:</b> Turbine T25	<b>Date:</b> 18-04-14

**Topography:** Site Slope  $<1^\circ$  S.

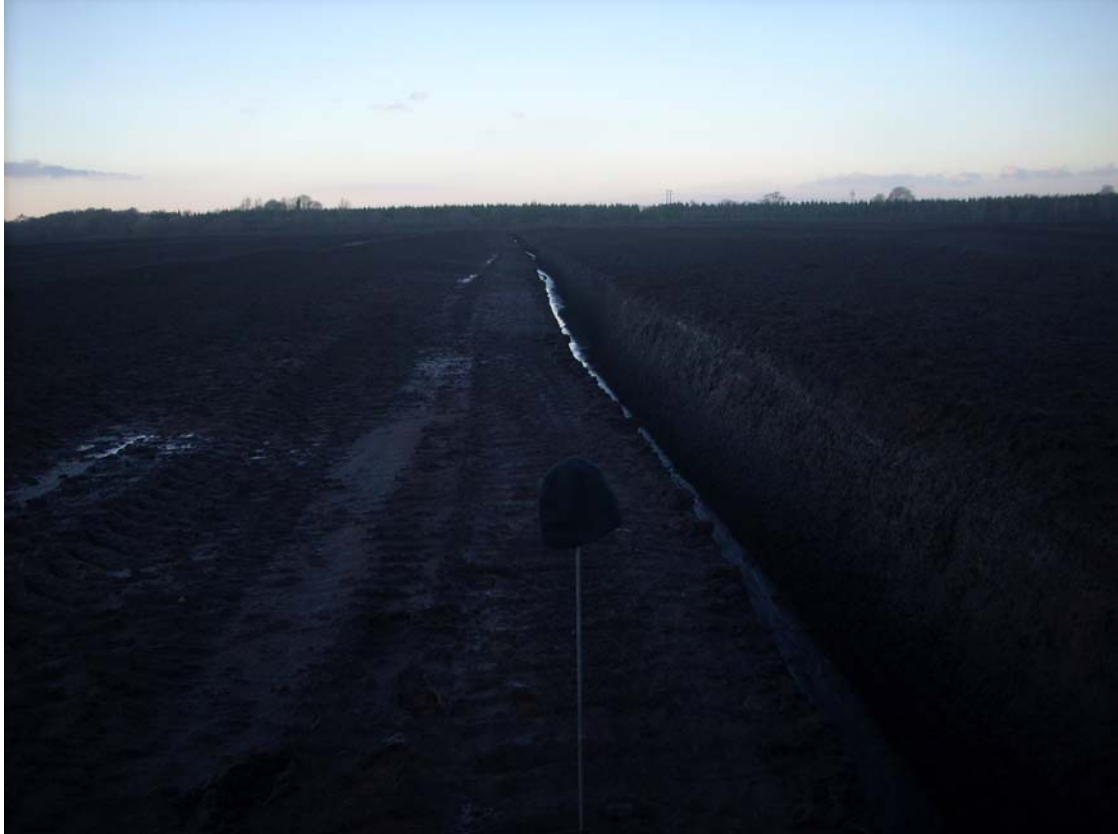
**Topography:** Site Slope <math><1^\circ</math> N-S.

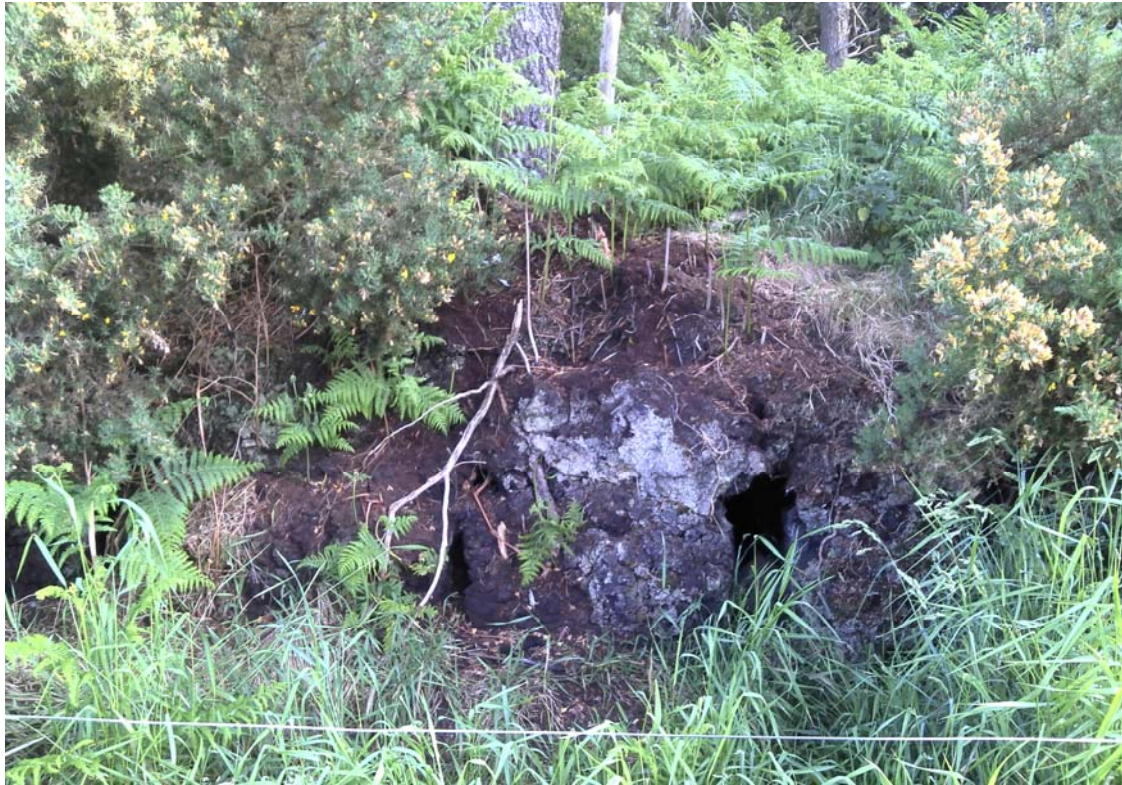
<b>Topography:</b> Elevated, flat peat bank surrounded by tillage fields	
<b>Vegetation:</b> Woodland on Peat	
<b>Peat Thickness:</b> 0.5m	
<b>Features:</b> Dark brown pseudo-fibrous Peat	
<b>Von Post Classification:</b> H5, B2	
<b>Uncorrected Shear Strength:</b> 63kPa @ 0.5m	
<b>Water Courses/Drainage:</b> Peat cracked in numerous places.	
<b>Assessed Peat Slide Risk:</b> Extremely Low	
<b>Created By:</b> Neil Sandes	<b>Checked By:</b> AG

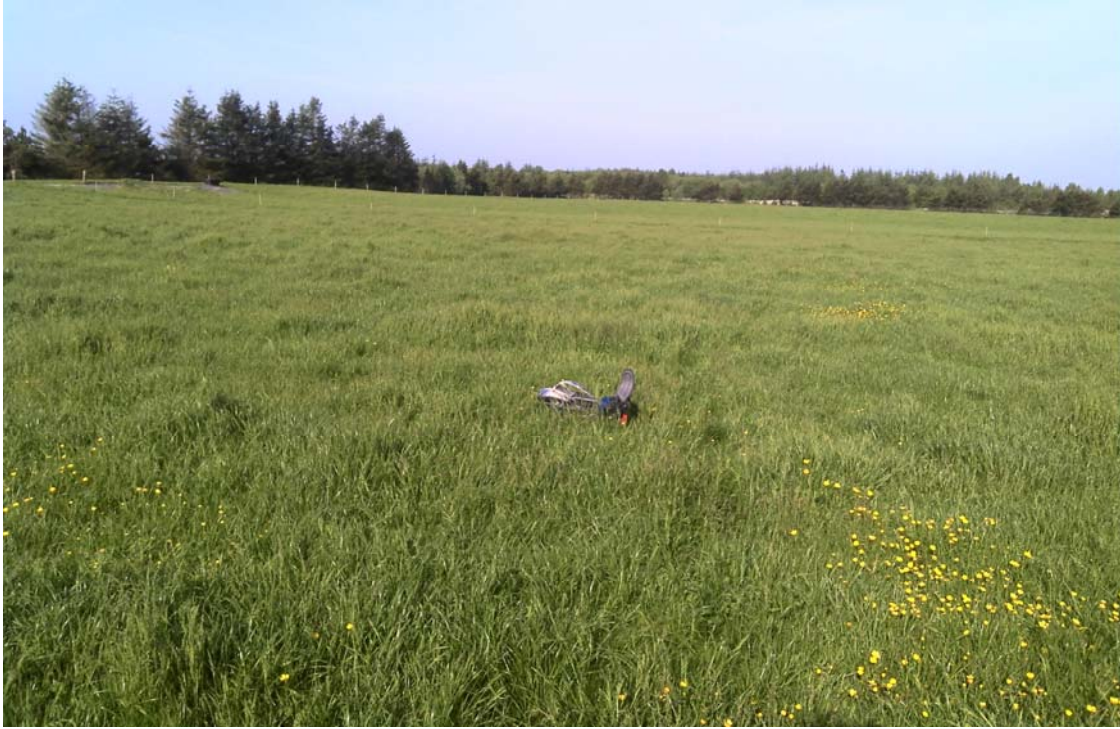
<p><b>Topography:</b> Very slight (1°) east to west slope</p> <p><b>Vegetation:</b> Grassland</p> <p><b>Peat Thickness:</b> 0.3m</p> <p><b>Features:</b> Peaty Topsoil</p> <p><b>Von Post Classification:</b> Not Sampled</p> <p><b>Uncorrected Shear Strength:</b> 50kPa @ 0.3m BGL</p> <p><b>Water Courses/Drainage:</b> No drainage features identified close to turbine location.</p> <p><b>Assessed Peat Slide Risk:</b> Not Applicable</p>
--

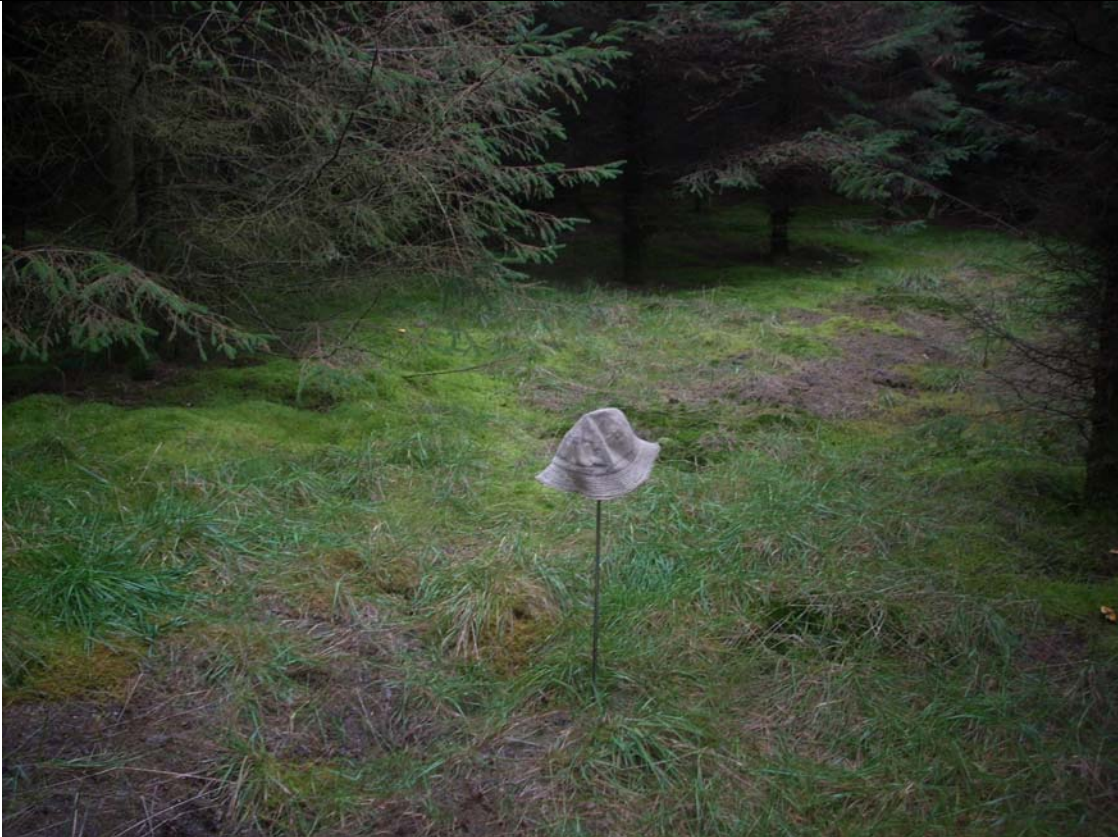
<b>Topography:</b> Flat Terrain	
<b>Vegetation:</b> Mature forestry	
<b>Peat Thickness:</b> 1.75m.	
<b>Features:</b> Moist light brown Peat	
<b>Von Post Classification:</b> H6, B3	
<b>Uncorrected Shear Strength:</b> 30kPa @0.5m, 25kPa @1m, 30kPa @ 1.5m	
<b>Water Courses/Drainage:</b> Moderate drainage. 5m spaced blocked drains.	
<b>Assessed Peat Slide Risk:</b> Low	
<b>Created By:</b> Neil Sandes	<b>Checked By:</b> AG

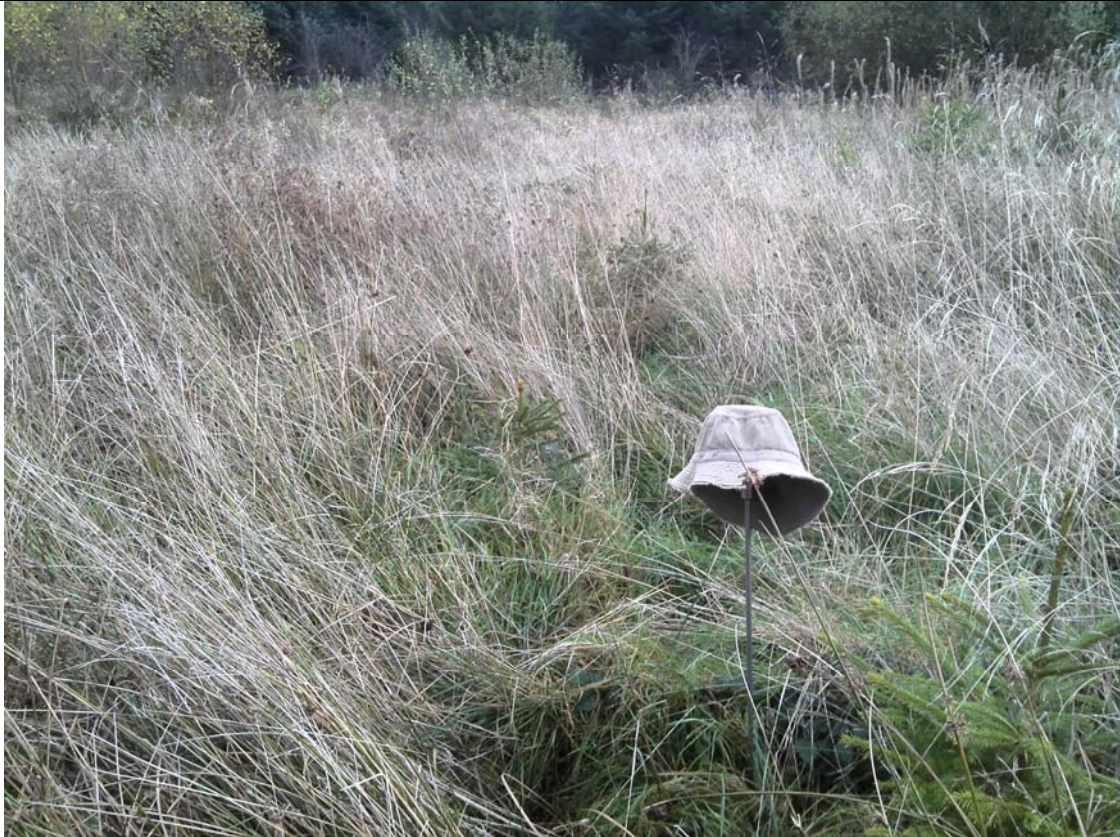
<b>Topography:</b> Flat boggy terrain	
<b>Vegetation:</b> Sedge grasses and newly planted forestry in clearfelled area	
<b>Peat Thickness:</b> 0.3m.	
<b>Features:</b> Boggy underfoot	
<b>Von Post Classification:</b> Not applicable	
<b>Uncorrected Shear Strength:</b> Not tested	
<b>Water Courses/Drainage:</b> 20m from nearest drain. Poor drainage.	
<b>Assessed Peat Slide Risk:</b> Negligible	
<b>Created By:</b> Neil Sandes	<b>Checked By:</b> AG

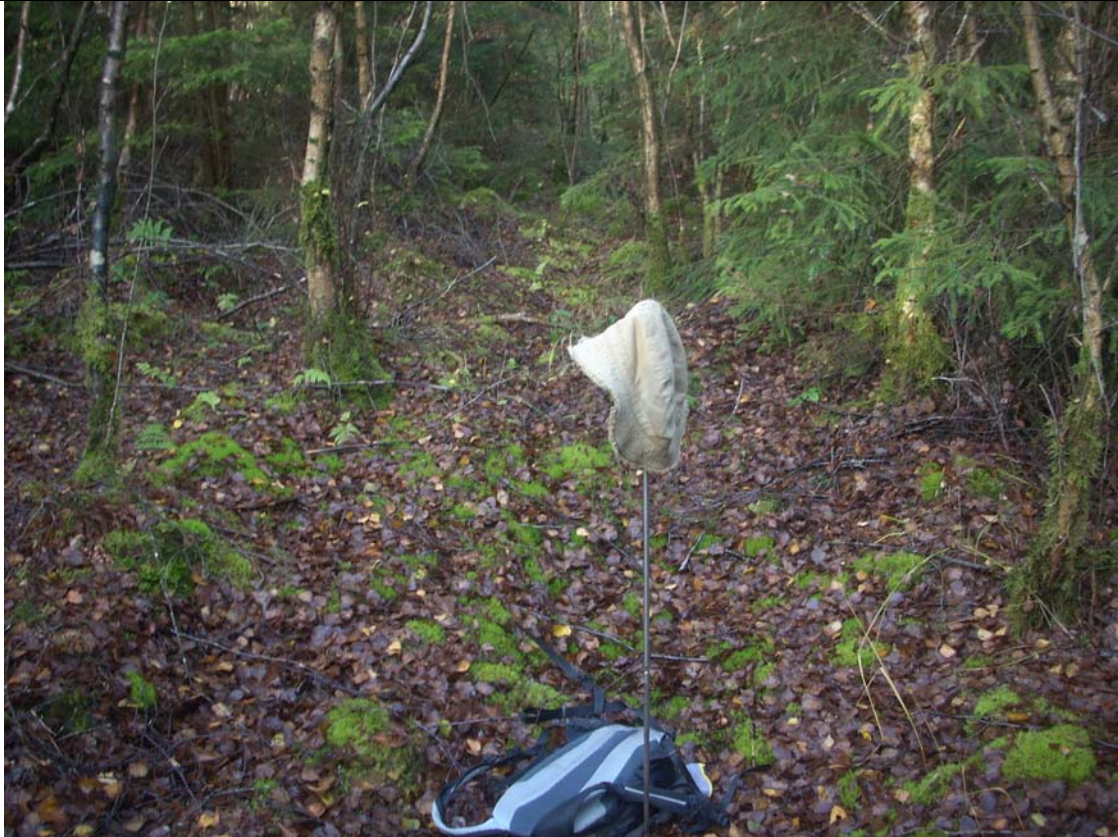
<b>Topography:</b> Flat Terrain. Max 1°N	
<b>Vegetation:</b> Semi-mature mixed forestry on Peat	
<b>Peat Thickness:</b> 3.7m.	
<b>Features:</b> Slightly moist dark brown amorphous Peat	
<b>Von Post Classification:</b> H6, B2	
<b>Uncorrected Shear Strength:</b> 30kPa @ 0.5m BGL, 30kPa @ 1m BGL, 35kPa @ 1.5m BGL, 35kPa @ 2.0m BGL, 50kPa @ 2.5m BGL, 60kPa @ 3.0m BGL, 60kPa @ 3.5m BGL,	
<b>Water Courses/Drainage:</b> Forest drains throughout. 5m spacing. Well drained.	
<b>Assessed Peat Slide Risk:</b> Very Low	
<b>Created By:</b> Neil Sandes	<b>Checked By:</b> AG

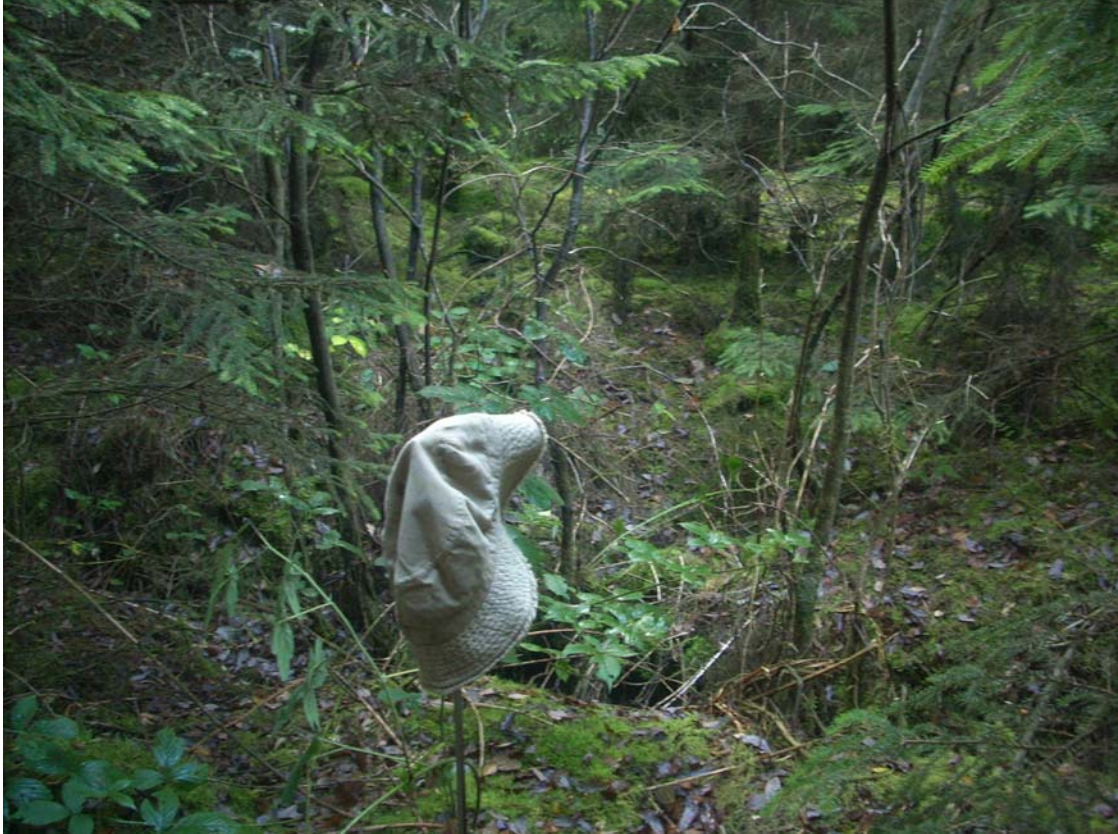
**Topography:** Flat Terrain. Max slope 1° S

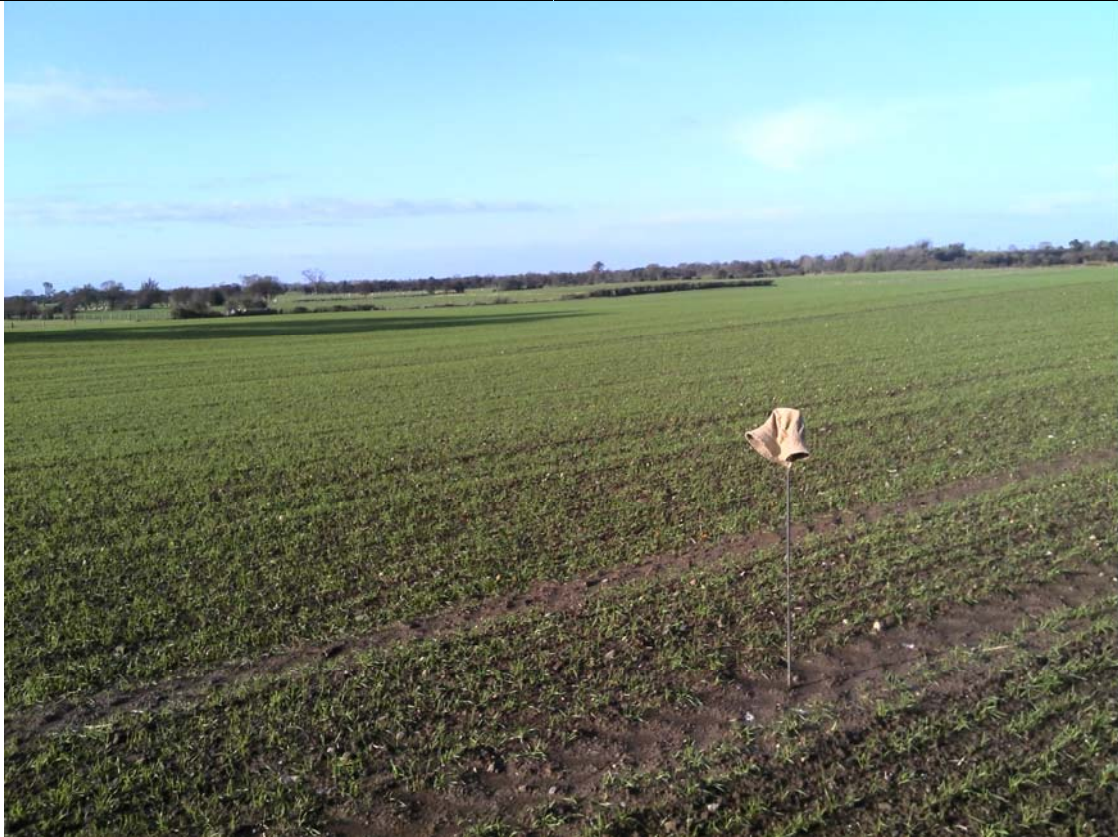
<b>Topography:</b> Gentle slope 1° S	
<b>Vegetation:</b> Tillage Field	
<b>Peat Thickness:</b> None present. Probe 0.3m.	
<b>Features:</b> Firm underfoot. Possible ring fort located 50m southeast of turbine	
<b>Von Post Classification:</b> Not Applicable	
<b>Uncorrected Shear Strength:</b> Not Applicable	
<b>Water Courses/Drainage:</b> Drainage ditches located on field boundaries. Slate River 220m north of turbine location	
<b>Assessed Peat Slide Risk:</b> Not Applicable	
<b>Created By:</b> Neil Sandes	<b>Checked By:</b> AG

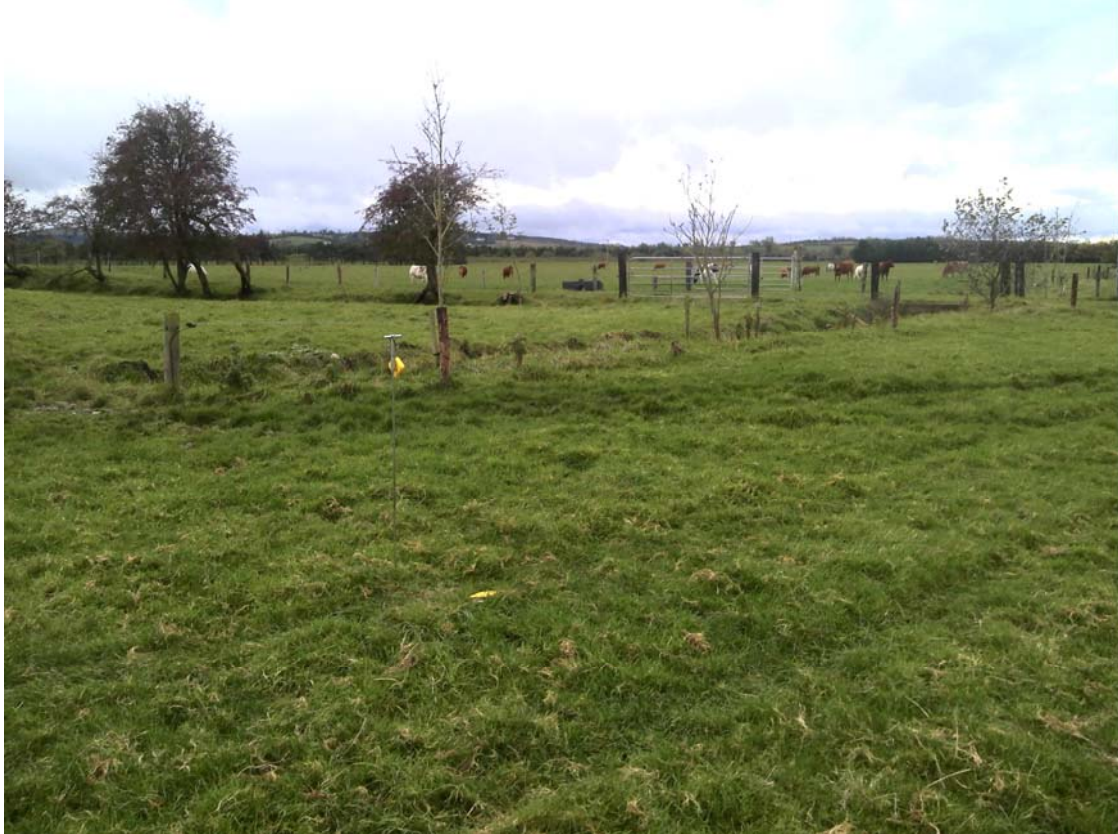
<b>Topography:</b> Flat Terrain	
<b>Vegetation:</b> Grassland	
<b>Peat Thickness:</b> No peat. 0.5m peaty topsoil over possible boulder clay	
<b>Features:</b> Soft to Firm underfoot	
<b>Von Post Classification:</b> Not Sampled	
<b>Uncorrected Shear Strength:</b> 50kPa @ 0.3m BGL	
<b>Water Courses/Drainage:</b> Field drain approximately 20m from turbine.	
<b>Assessed Peat Slide Risk:</b> Not applicable	
<b>Created By:</b> Neil Sandes	<b>Checked By:</b> AG

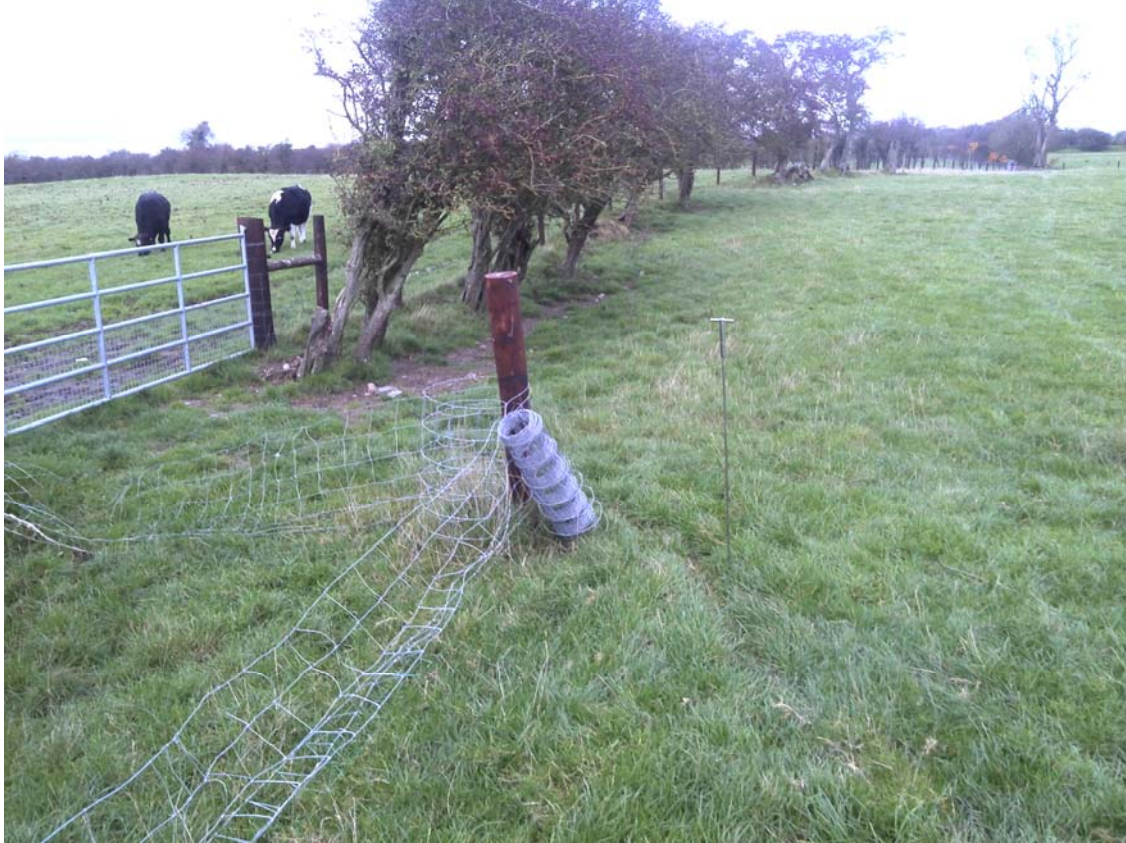
<b>Topography:</b> Flat Terrain. Max slope 1°S.	
<b>Vegetation:</b> Grassland	
<b>Peat Thickness:</b> None present. Probe 0.1m	
<b>Features:</b> Firm underfoot	
<b>Von Post Classification:</b> Not Applicable	
<b>Uncorrected Shear Strength:</b> Not Applicable	
<b>Water Courses/Drainage:</b> Drainage ditches located on field boundaries. River Slate 170m northwest of turbine location.	
<b>Assessed Peat Slide Risk:</b> Not Applicable	
<b>Created By:</b> Neil Sandes	<b>Checked By:</b> AG

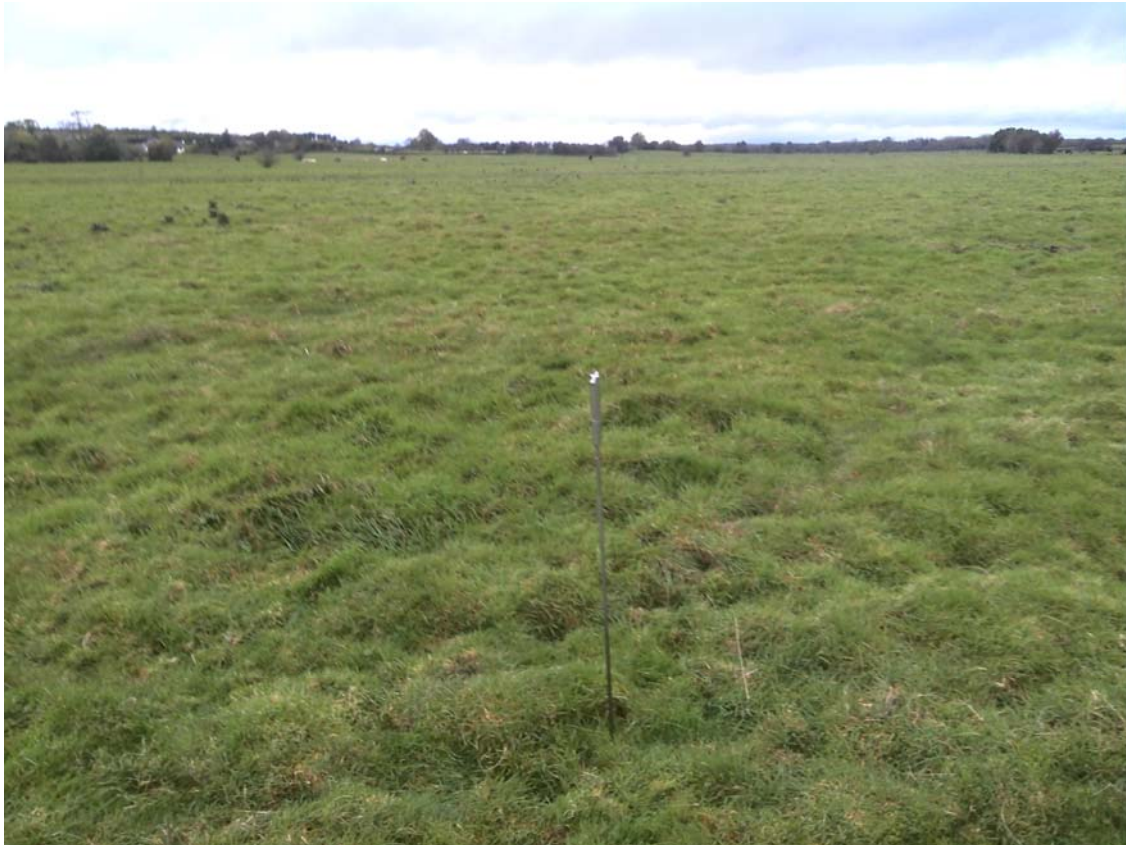
<b>Topography:</b> Flat Terrain	
<b>Vegetation:</b> Grassland	
<b>Peat Thickness:</b> Peaty topsoil 1m deep. Hard refusal	
<b>Features:</b> Soft to firm underfoot.	
<b>Von Post Classification:</b> Not Applicable	
<b>Uncorrected Shear Strength:</b> 30kpa at 0.5m	
<b>Water Courses/Drainage:</b> Drainage ditches located about 50m from turbine.	
<b>Assessed Peat Slide Risk:</b> Not Applicable	
<b>Created By:</b> Neil Sandes	<b>Checked By:</b> AG

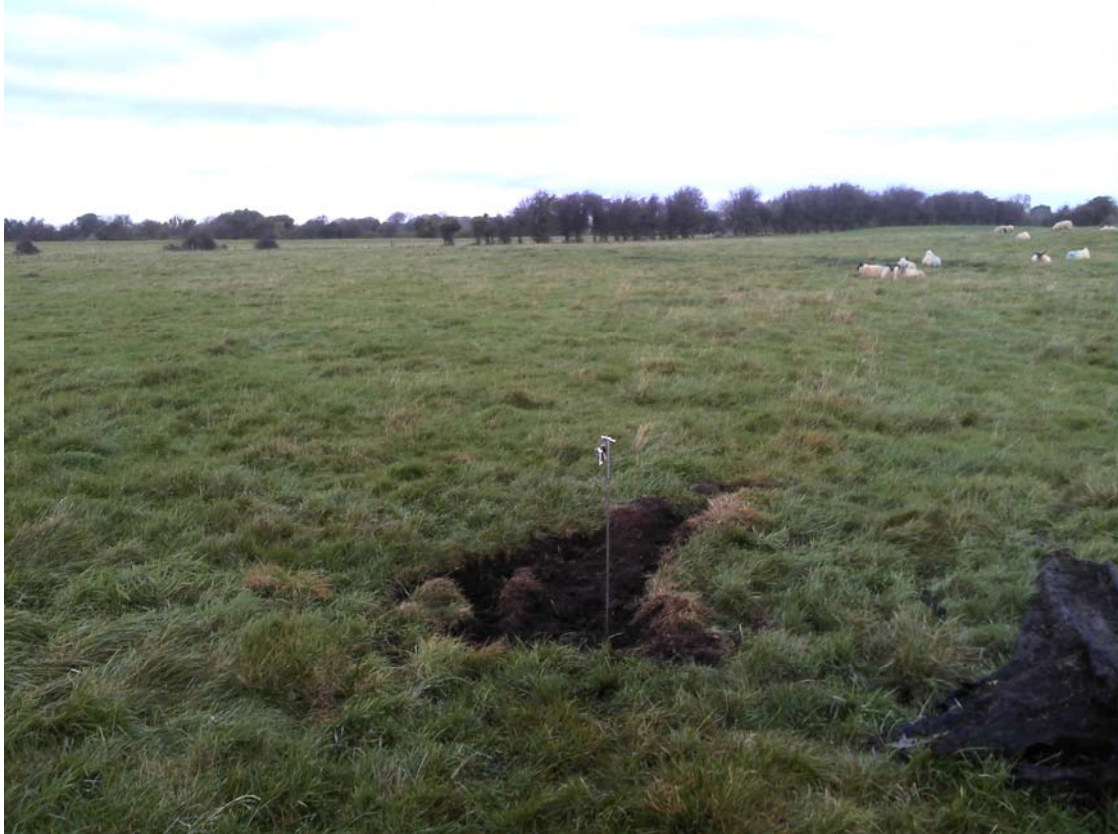
<b>Topography:</b> Flat Terrain. Max slope 1° S	
<b>Vegetation:</b> Grassland	
<b>Peat Thickness:</b> Peaty topsoil to 0.5m BGL over grey sandy gravelly silt (seen in nearby recently excavated drain)	
<b>Features:</b> Firm – No penetration with probe.	
<b>Von Post Classification:</b> Not Applicable	
<b>Uncorrected Shear Strength:</b> 30kPa @ 0.4m	
<b>Water Courses/Drainage:</b> Deep drainage ditch located 20m south Slate River located 300m northwest.	
<b>Assessed Peat Slide Risk:</b> Not Applicable	
<b>Created By:</b> Neil Sandes	<b>Checked By:</b> AG

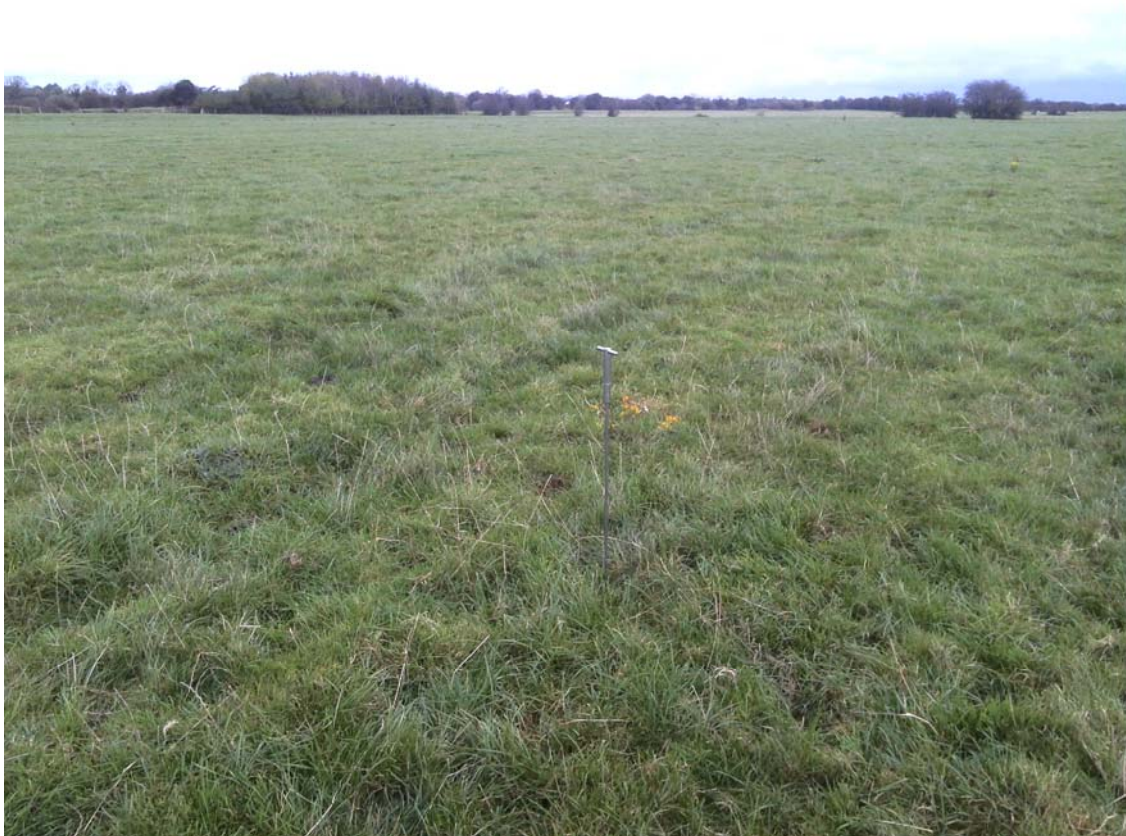
<b>Topography:</b> Flat Terrain	
<b>Vegetation:</b> Grassland with abundant rushes.	
<b>Peat Thickness:</b> Peaty topsoil to 0.5m BGL	
<b>Features:</b> Soft underfoot. Brown peaty clay.	
<b>Von Post Classification:</b> Not Applicable	
<b>Uncorrected Shear Strength:</b> 55kPa @ 0.3mBGL, 150kPa @ 0.5m	
<b>Water Courses/Drainage:</b> Deep drainage ditch located 30m north of turbine location. Slate River located 200m northwest.	
<b>Assessed Peat Slide Risk:</b> Not Applicable	
<b>Created By:</b> Neil Sandes	<b>Checked By:</b> AG

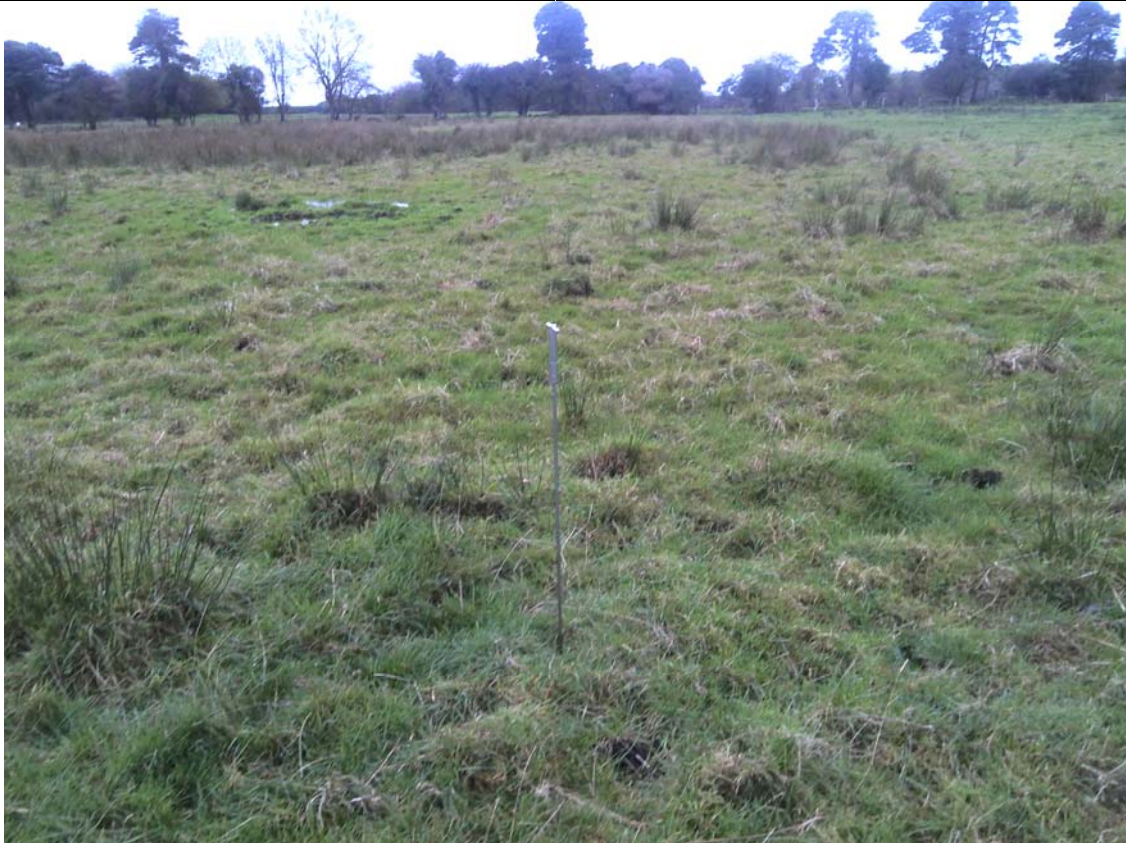
<b>Topography:</b> Flat Terrain. Max 1°S	
<b>Vegetation:</b> Boggy grassland with occasional rushes.	
<b>Peat Thickness:</b> Peaty topsoil to 0.5m BGL	
<b>Features:</b> Soft underfoot. Brown peaty clay.	
<b>Von Post Classification:</b> Not Applicable	
<b>Uncorrected Shear Strength:</b> Not applicable	
<b>Water Courses/Drainage:</b> 50m from field drain	
<b>Assessed Peat Slide Risk:</b> Not Applicable	
<b>Created By:</b> Neil Sandes	<b>Checked By:</b> AG

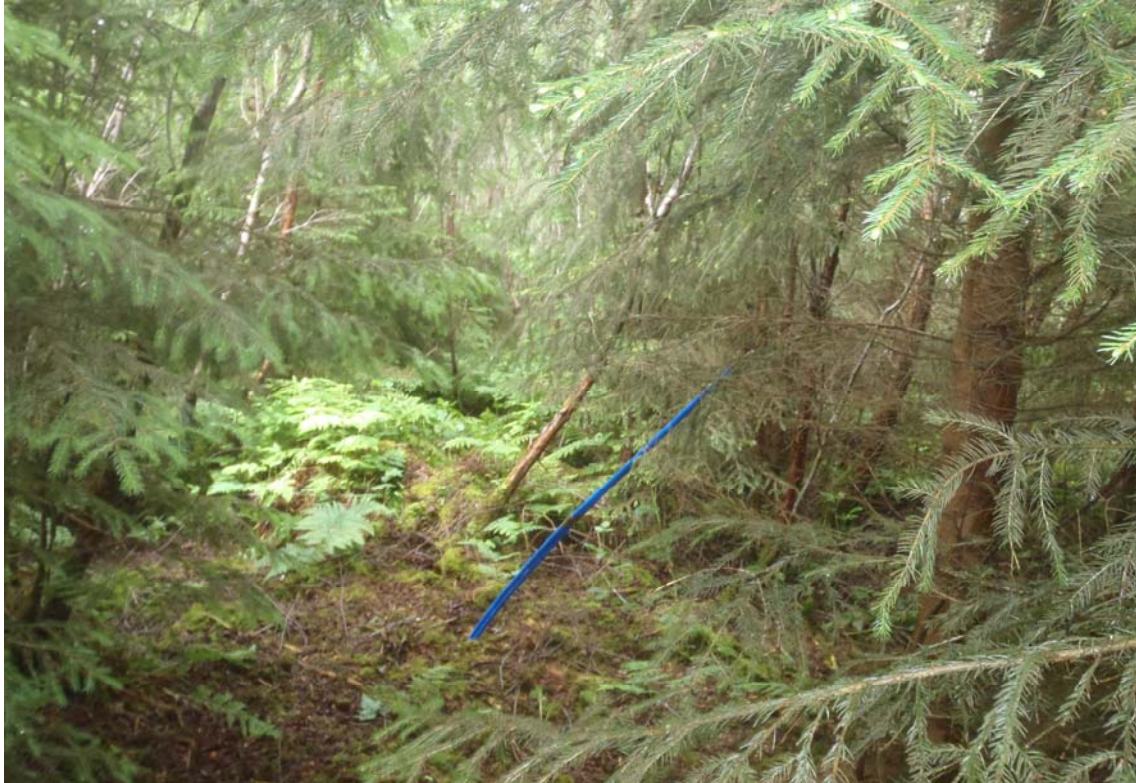
**Topography:** The ground slopes 2° N.

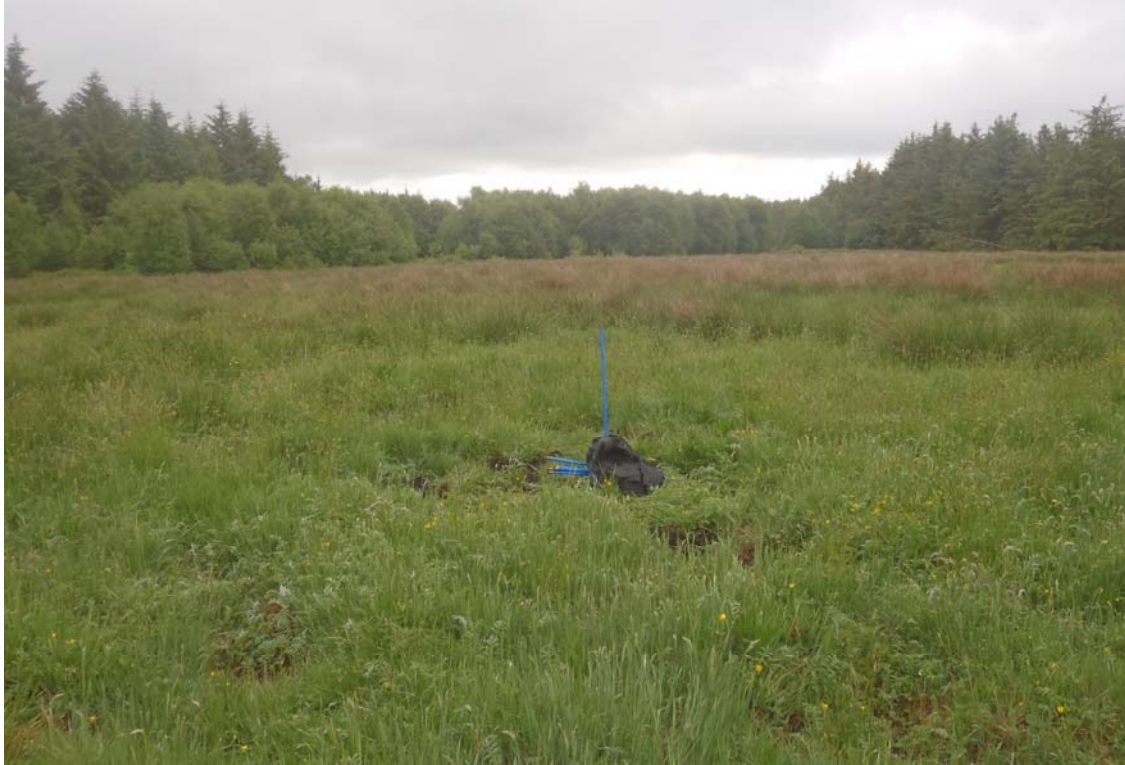
**Topography:** The ground slopes 3° NW.

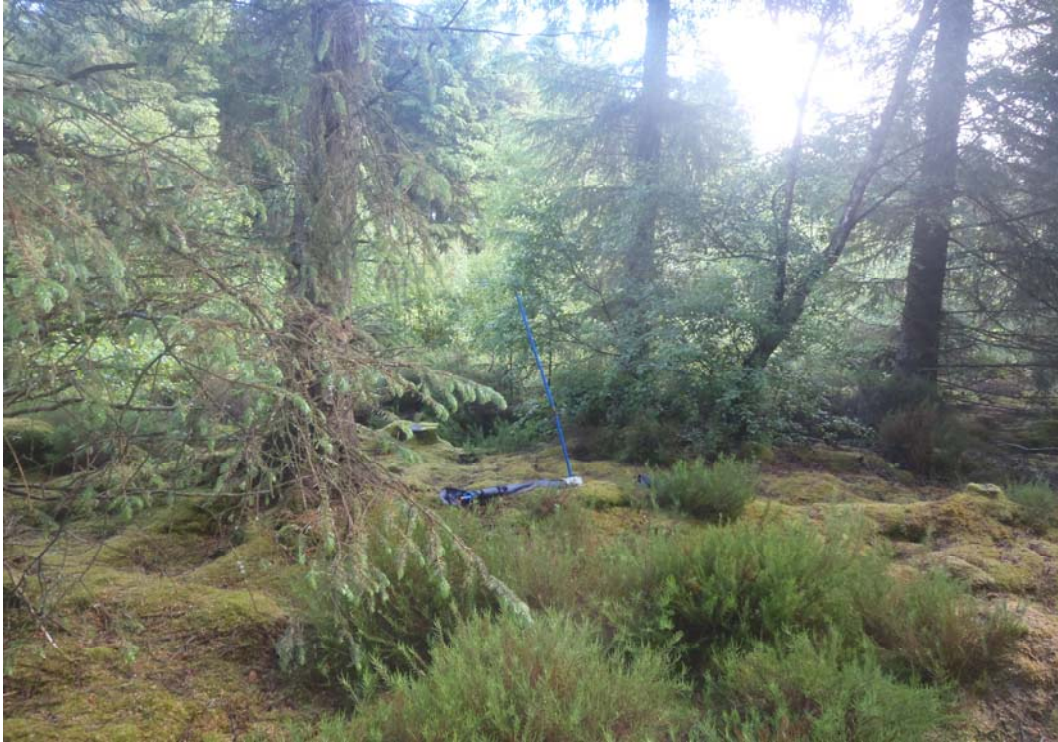
**Topography:** The ground slopes 3° E

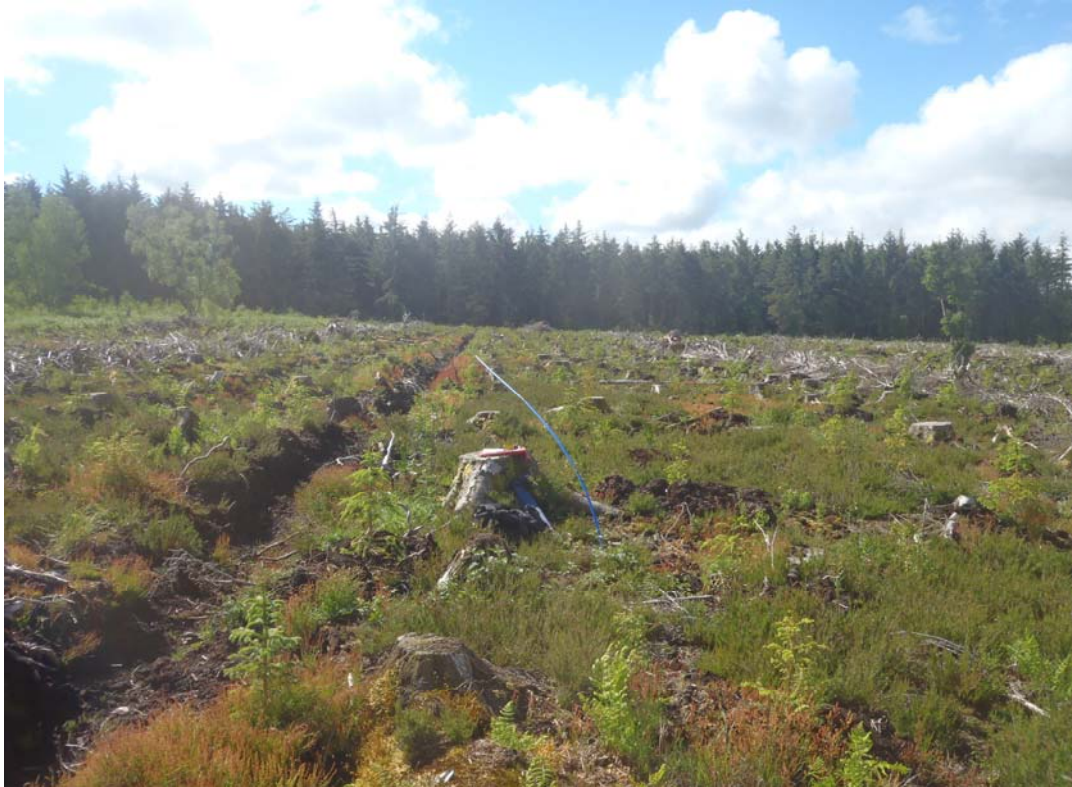
<p><b>Topography:</b> The ground slopes 2° SE.</p> <p><b>Vegetation:</b> Harvested forestry overlying soft brown pseudofibrous spongy peat. Peat</p> <p><b>Peat Thickness:</b> 0.90m. Soft brown fibrous peat</p> <p><b>Features:</b> Harvested forestry</p> <p><b>Von Post Classification:</b> H5 B2</p> <p><b>Uncorrected Shear Strength:</b> 40KPa at 0.50m, 45KPa at 0.90m</p> <p><b>Water Courses/Drainage:</b> Dry drainage ditches at 10m intervals.</p> <p><b>Assessed Peat Slide Risk:</b> Very Low.</p>	
<b>Created By:</b> Andrew Jaworski	<b>Checked By:</b> AG

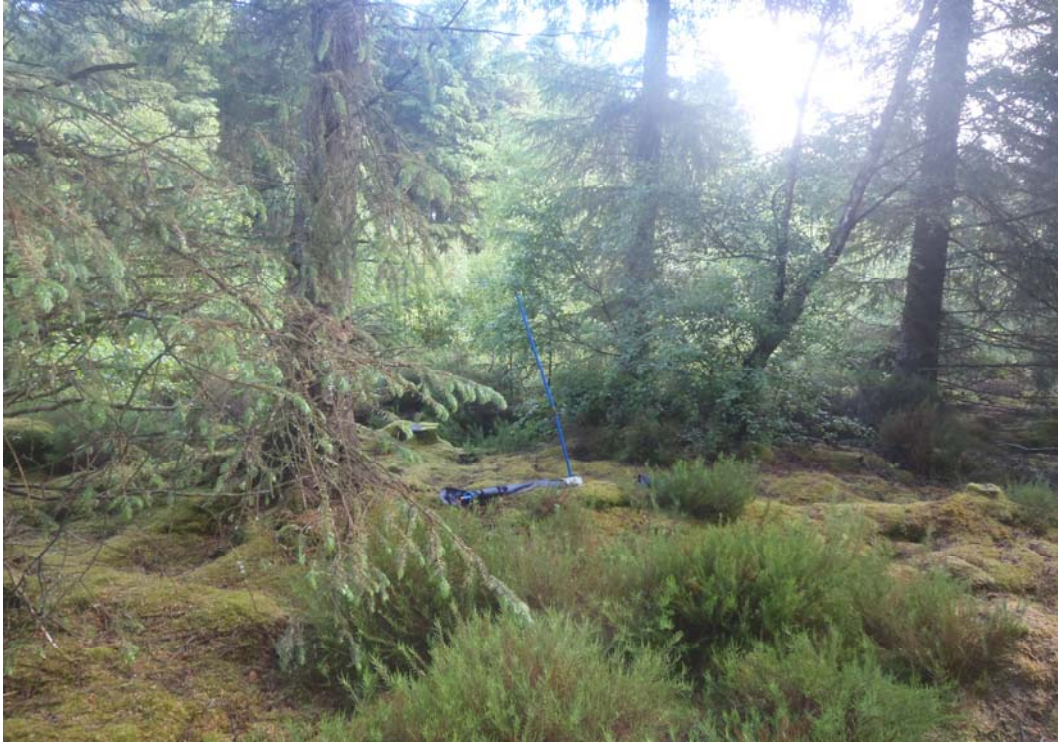
**Topography:** The ground slopes 3° E

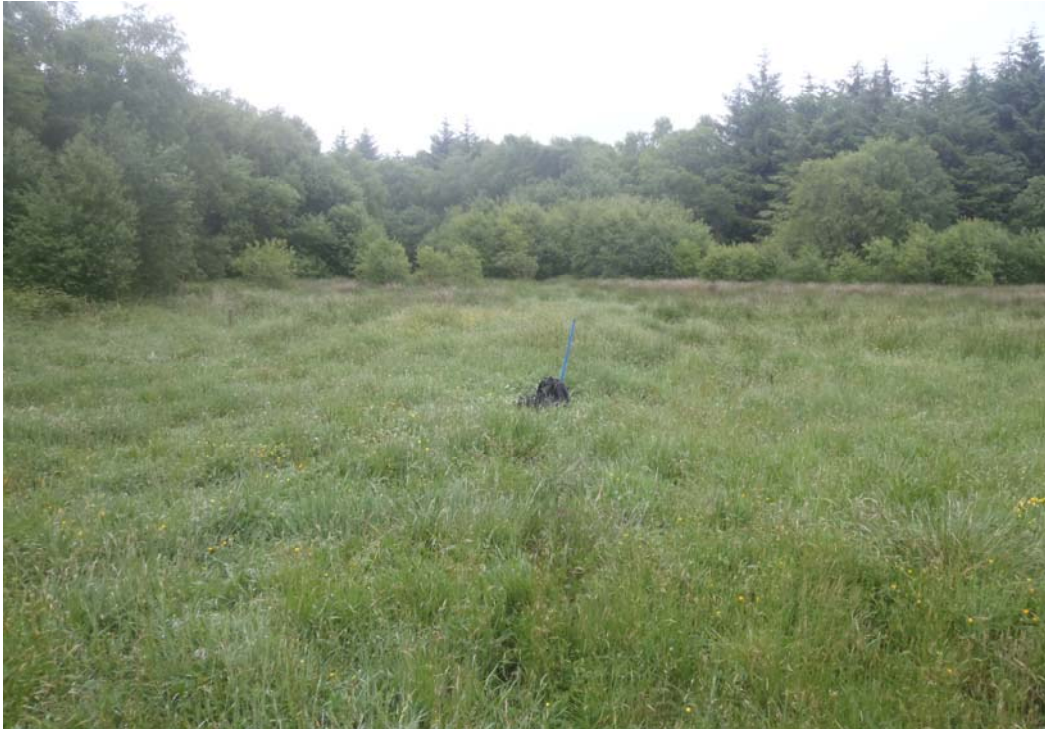
**Topography:** The ground gently slopes 2° S.

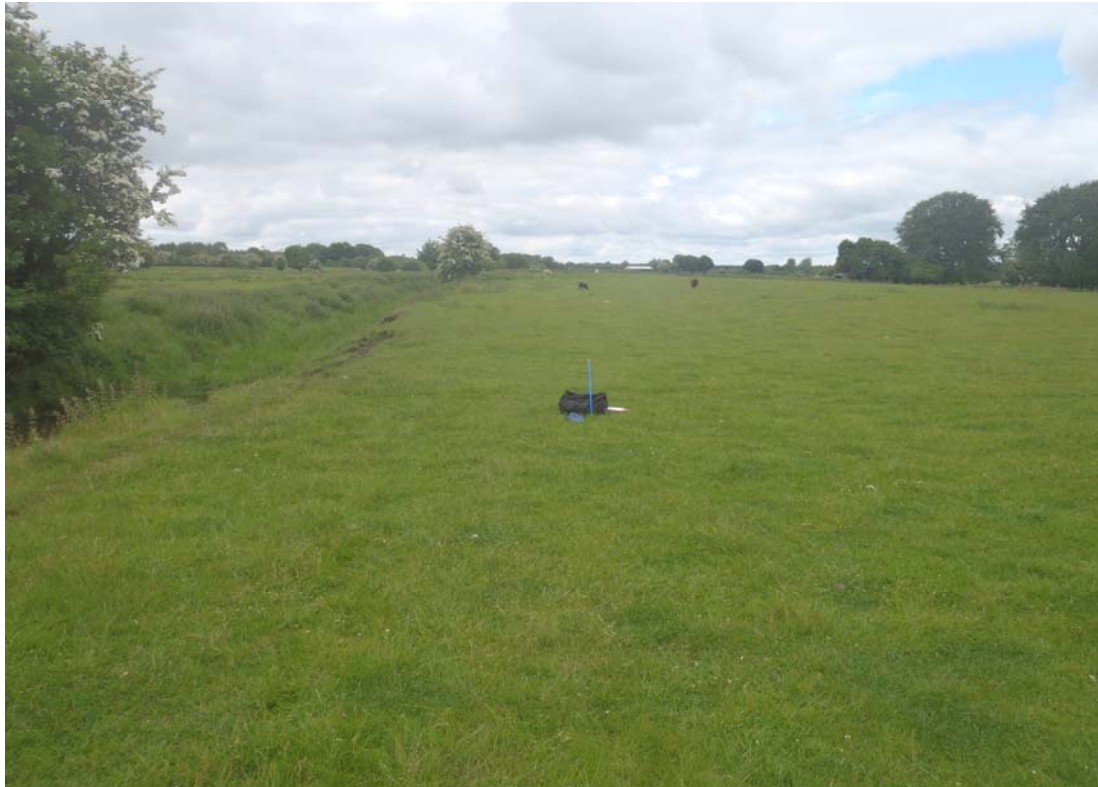
<b>Topography:</b> The ground gently slopes 1° S.	
<b>Vegetation:</b> Firm grassland	
<b>Peat Thickness:</b> None Present. Firm topsoil over brown slightly sandy gravelly clay.	
<b>Features:</b> Flat pastureland.	
<b>Von Post Classification:</b> Not Applicable	
<b>Uncorrected Shear Strength:</b> Not tested	
<b>Water Courses/Drainage:</b> Drainage ditch to SE within 10m of Turbine	
<b>Assessed Peat Slide Risk:</b> Not Applicable.	
<b>Created By:</b> Andrew Jaworski	<b>Checked By:</b> AG
