# Appendix G

## Geology & Slope Stability

### MAIGHNE WIND FARM - WINDMILL CLUSTER

### PEAT STABILITY ASSESSMENT

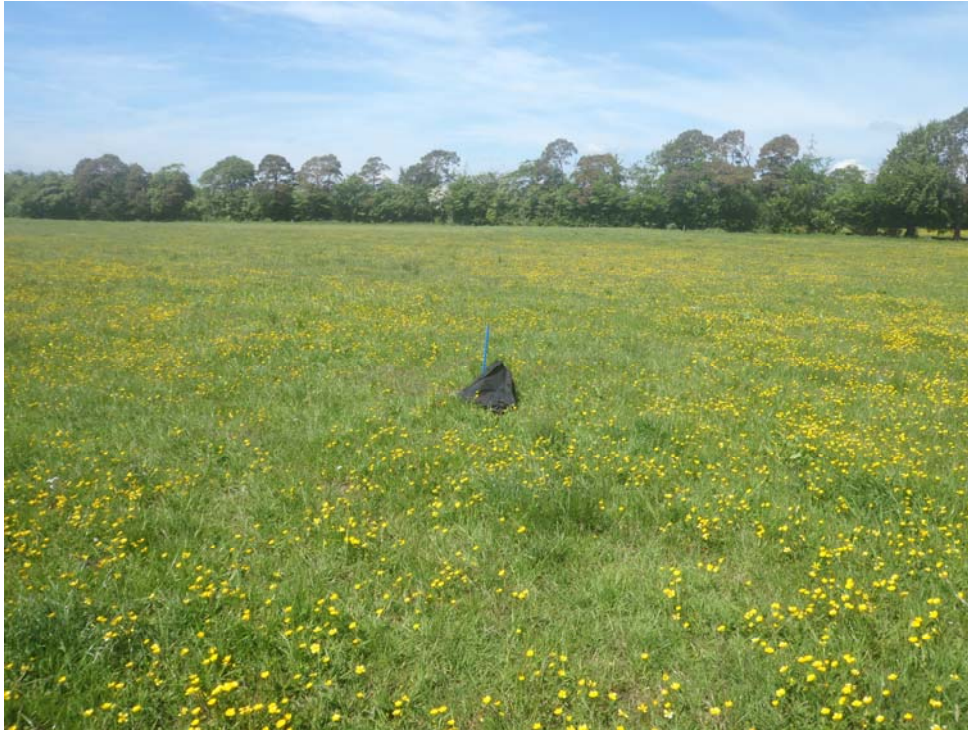
<p><b>Topography:</b> The ground gently slopes 3° E.</p> <p><b>Vegetation:</b> Firm Grassland (Evidence of being soft in Wet weather deep animal ruts)</p> <p><b>Peat Thickness:</b> None Present probe depth 0.20m.</p> <p><b>Features:</b> gently sloping grassland over brown topsoil.</p> <p><b>Von Post Classification:</b> Not Applicable</p> <p><b>Uncorrected Shear Strength:</b> No Penetration</p> <p><b>Water Courses/Drainage:</b> None Visible.</p> <p><b>Assessed Peat Slide Risk:</b> Not Applicable.</p>	
<b>Created By:</b> Andrew Jaworski	<b>Checked By:</b> AG
