Development for the further replacement of Fossil Fuel  
with Alternative Fuels and for use of Alternative Raw  
Materials  
Natura Impact Statement

Irish Cement Ltd.

25 July 2017

6144\_RP-NIS-01\_Natura Impact Statement

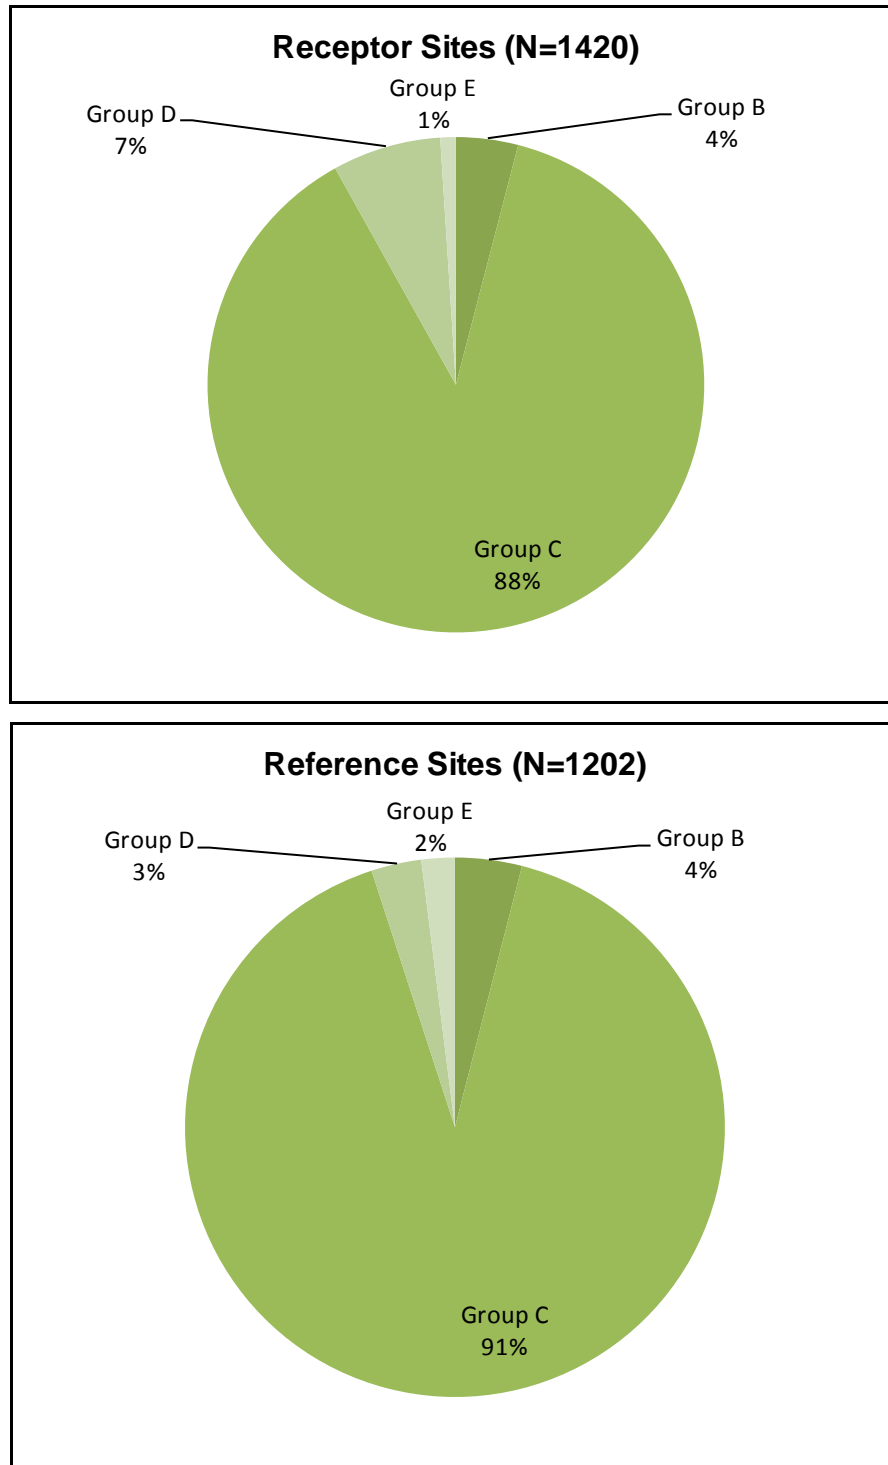
**Figure 4** Overall classification of macroinvertebrate species present in terms of their pollution sensitivity (EPA methods). Based on numbers of groups present collectively at the reference and receptor sites.

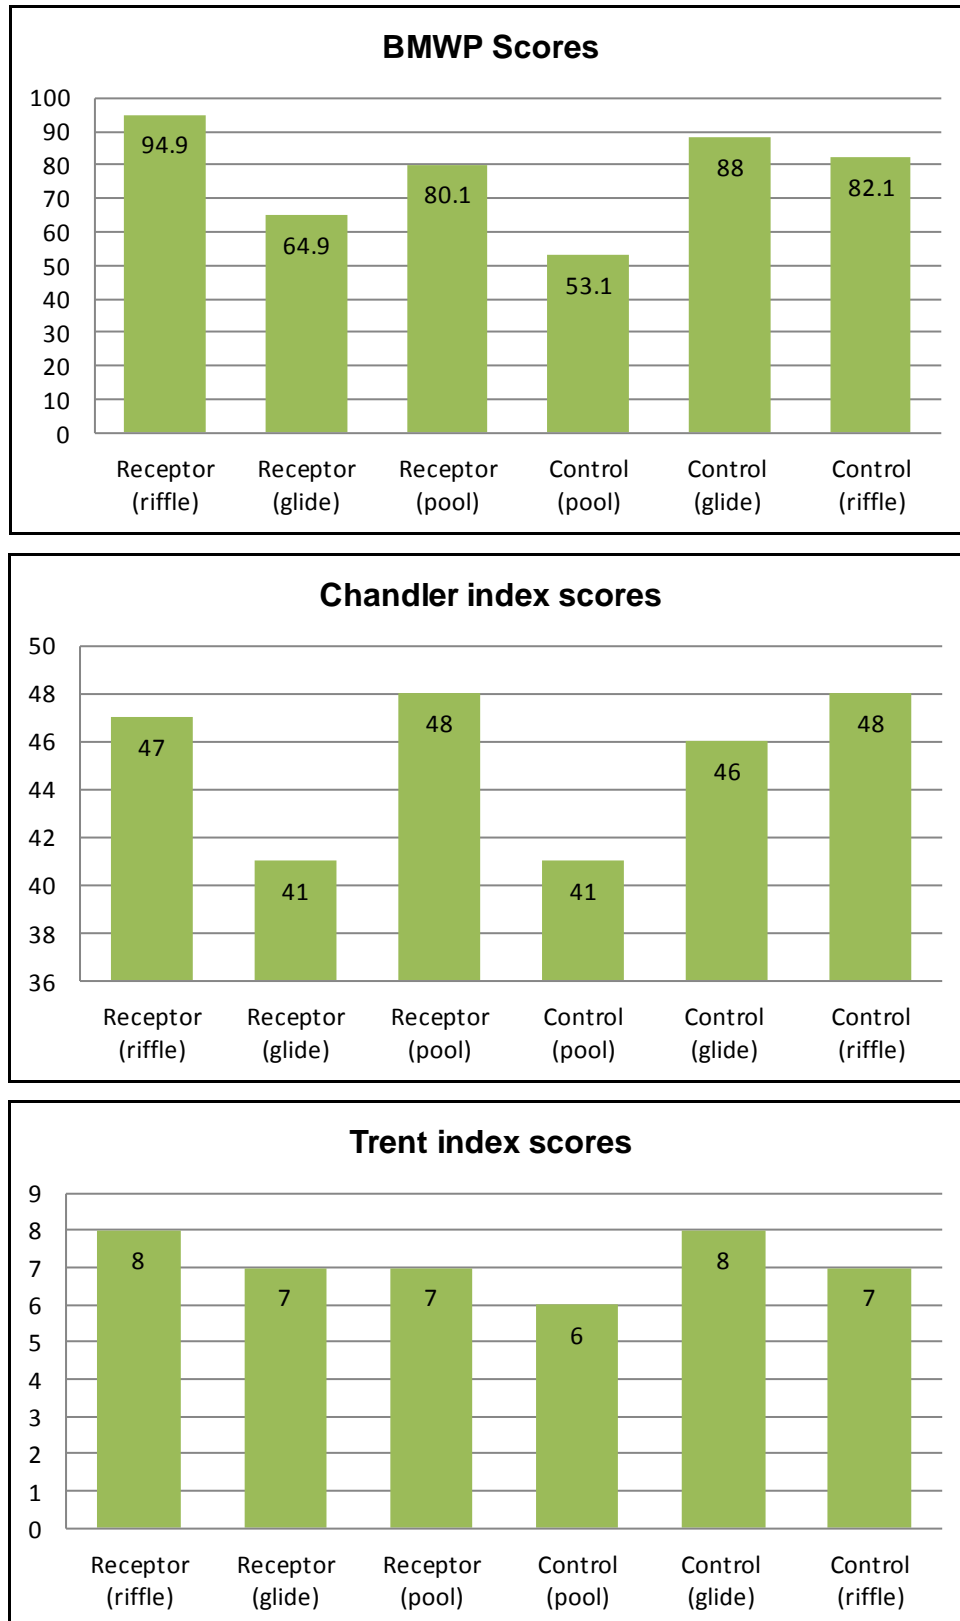
**Figure 5** Variation of the BMWP Score, Trent Biotic Index and Chandler Biotic Index at the six survey sites.

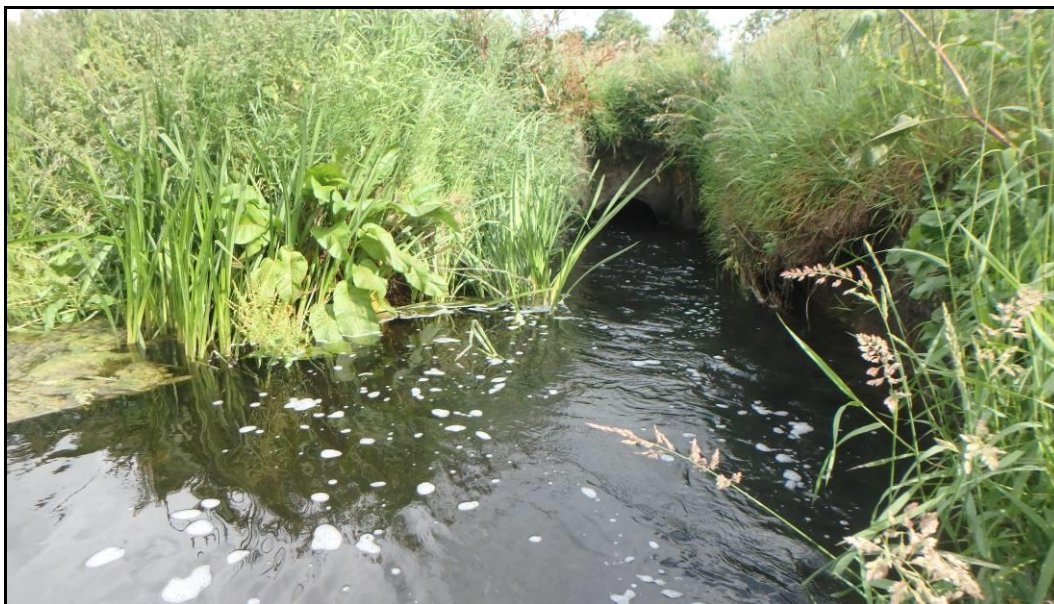
**Plate 8** Irish Cement trade effluent outfall to the River Nanny. Sampling of the effluent was undertaken at this location adjacent to the River Nanny (ca. 100 south of the R150).

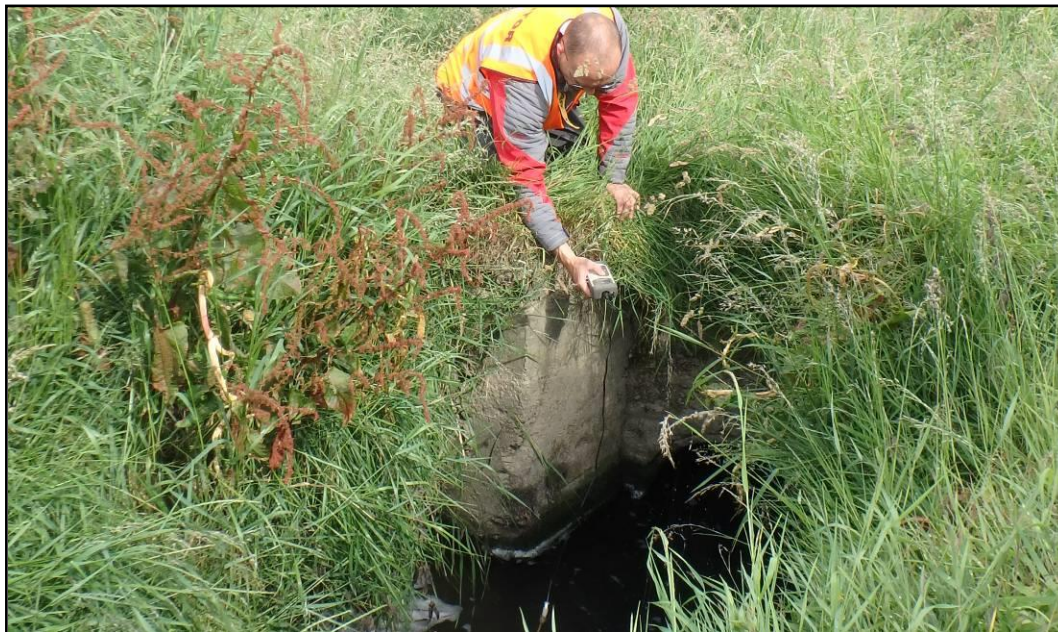
**Plate 12** Reading Conductivity of the discharge to the River Nanny.

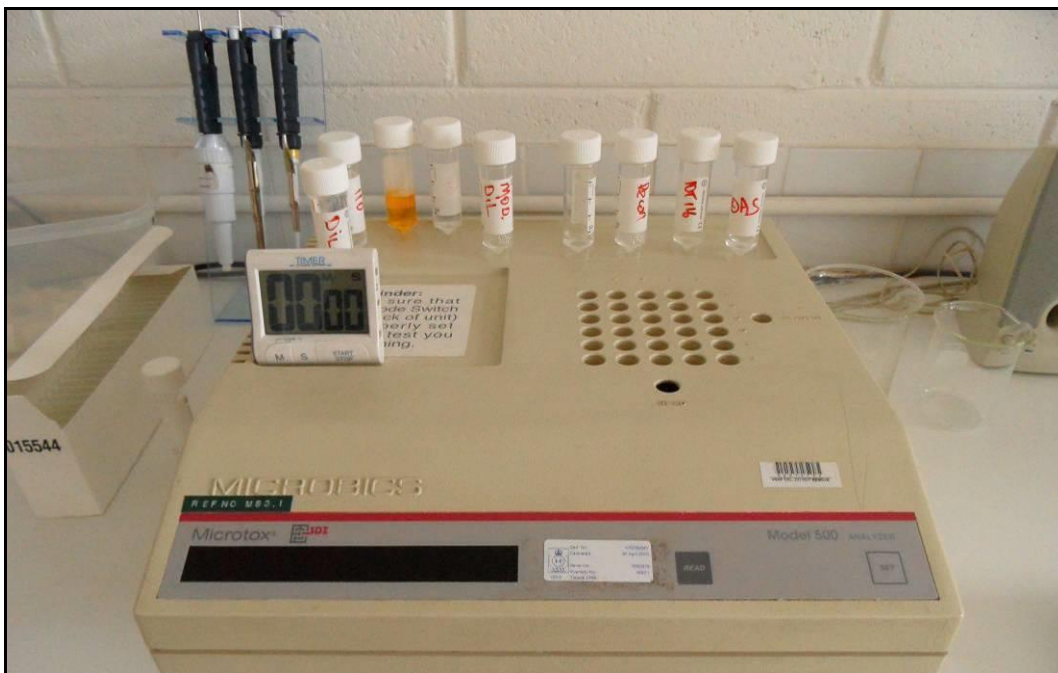
**Plate 18** Temperature controlled photometer apparatus used to test for bioluminescence of *Vibrio fischeri* in the 30 min EC<sub>50</sub> test.
