TEST REPORT

Test Specification: Noise Monitoring

Item: Noise survey at Noise Sensitive Locations at the Patton Brothers operation located at Gortletteragh, Stranolar, Co.Donegal.

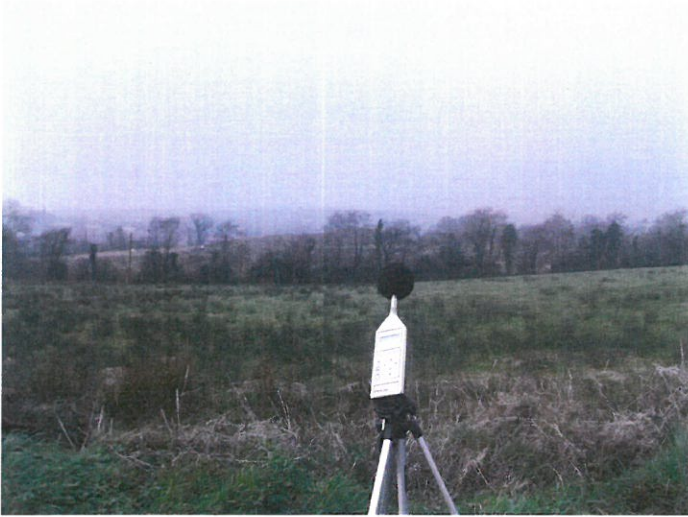
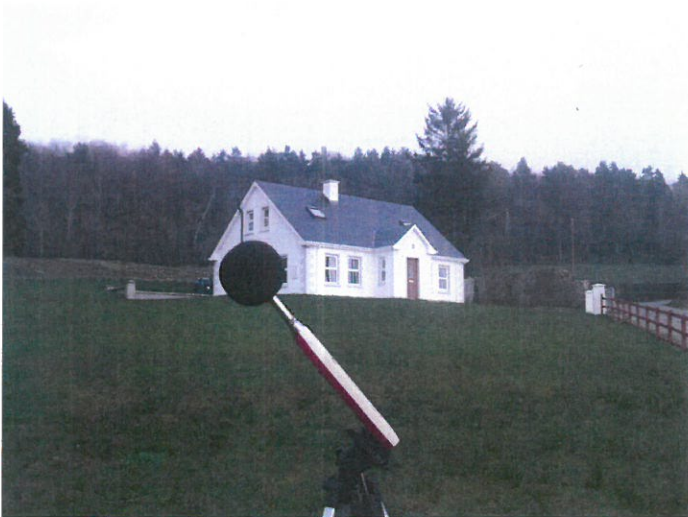
Noise monitoring equipment at Monitoring Location A

The image above illustrates the view as one looks towards the quarry location from the noise sensitive location while the image below illustrates the noise sensitive location.

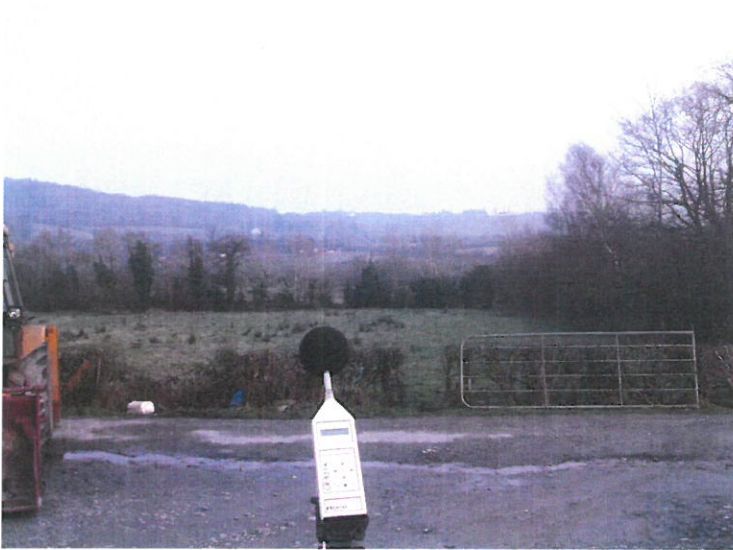
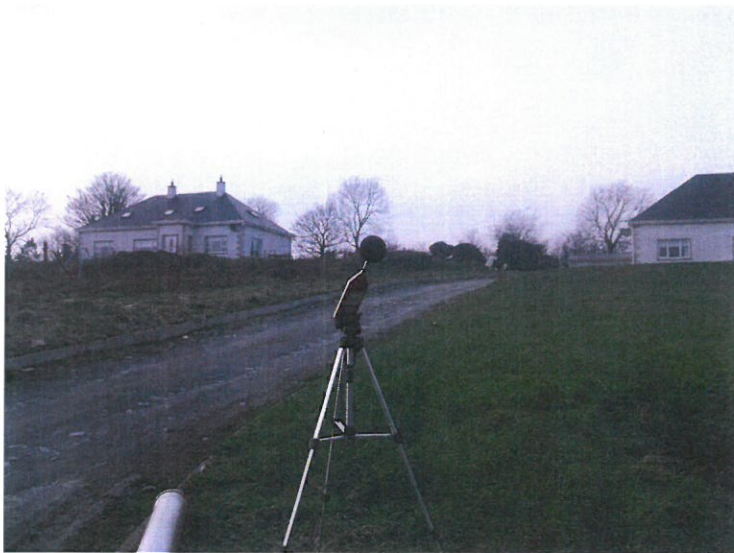
Noise monitoring equipment at Monitoring Location B

The image above illustrates the view as one looks towards the quarry location from the noise sensitive location while the image below illustrates the noise sensitive location.
