7. LANDSCAPE AND VISUAL IMPACT

This chapter presents the findings of a landscape and visual impact assessment that was conducted to assess the impact of Patton Bros. existing quarry development on the landscape and visual amenities of the surrounding area.

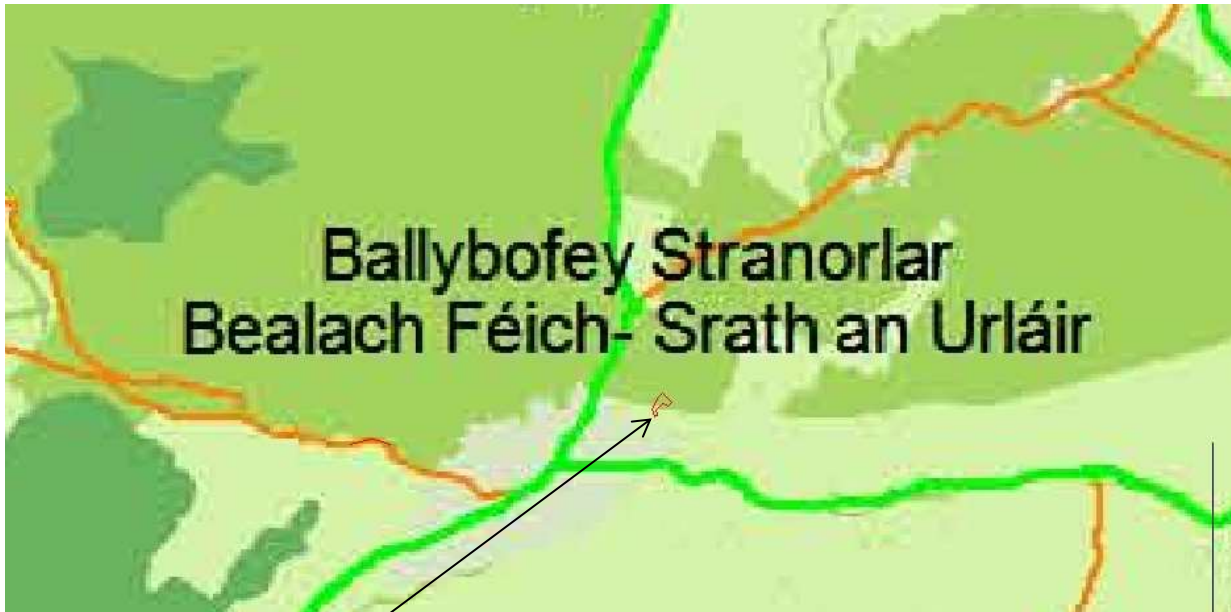
Figure 7.2 Areas of Scenic Amenity Source: Donegal County Development Plan 2012 - 2018

Following a review of the Draft County Development Plan, it is determined that the quarry lies on the border of two separate areas, being: -

- Areas of High Scenic Amenity (HAS)
- Areas of Moderate Scenic Amenity (MSA)

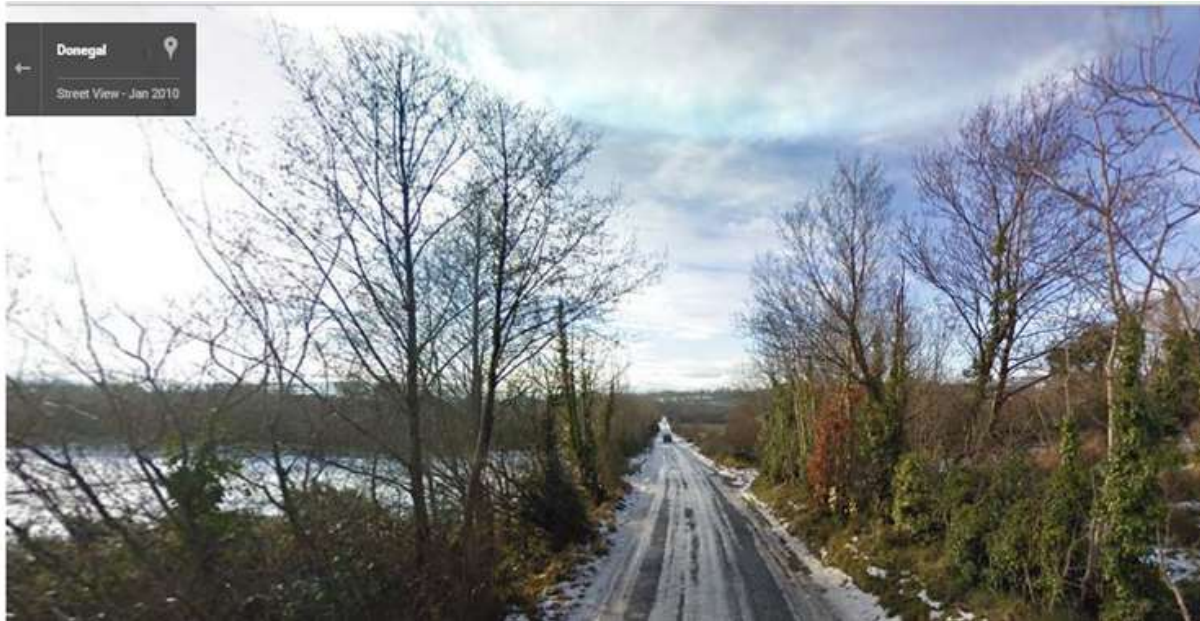
Plate 7.6 Approach towards quarry entrance on the right from Cooldawson to the east

Plate 7.6 is a view of the approach from the north east with the entrance to the quarry on the right side of the road in the middle of the photo. Even in mid-winter, the roadside tree cover restricts views into the quarry.

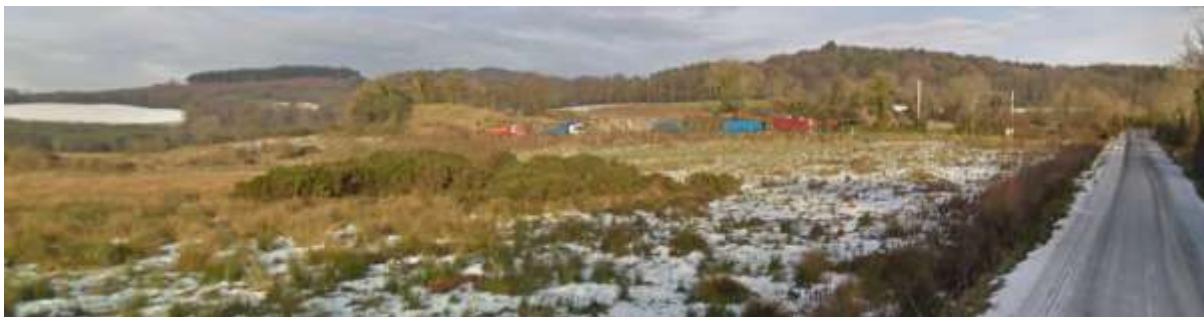
Plate 7.7 2010 view of quarry prior to planting of landscaped boundary from 150m west of quarry

Plates 7.7 and 7.8 below show images of the quarry from google earth in January 2010 before the perimeter planting has been carried out along the western boundary adjacent to the entrance while Plates 7.9 and 7.10 are images taken from the same locations as Plates 7.7 and 7.8 from the summer of 2017. They illustrate that the Leyland Cypress trees screen that has been planted along the western perimeter has significantly reduced the visual impact of the quarry from the main point where views of the quarry are available. The images also show the elevated topography to the north and east of the quarry that significantly reduces the visual envelope within which views are possible.

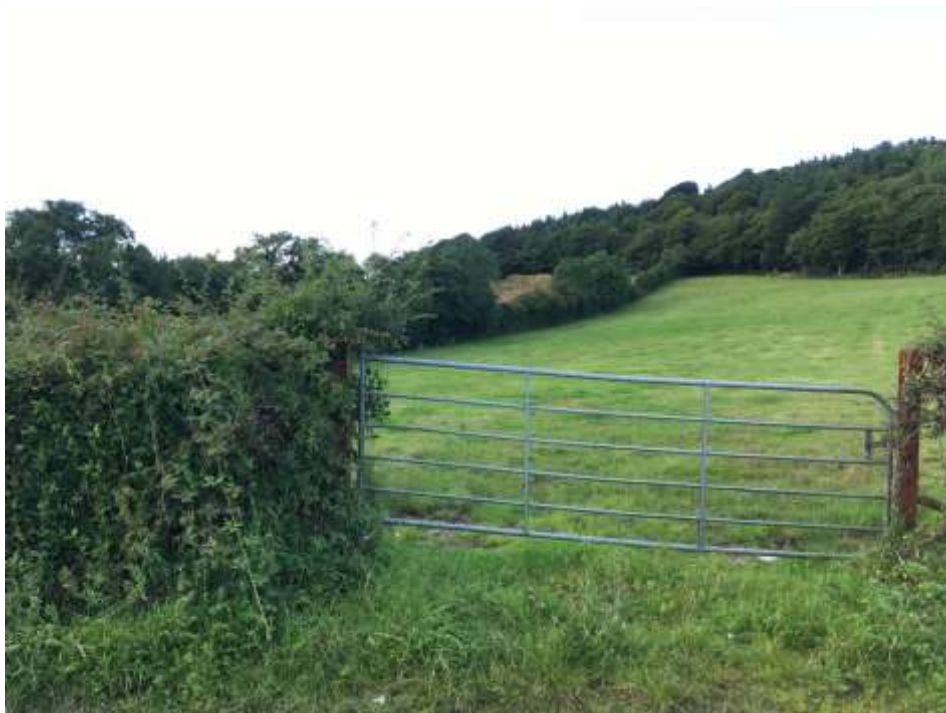
Plate 7.11 Limited view of earth bank behind quarry from 200m north of vehicular entrance

The nearest residential property is located c 300m from the nearest point of the quarry and an images taken along the public road close to the front of the house is shown below at Plate 7.11. It shows that the existing hedge and treeline have restricted the views into the quarry with only a small part of the embankment at the rear of the quarry visible form the road through a gated entrance to an adjoining field.

The construction of an additional berm along the eastern boundary of the working quarry closest to the nearest resident property and the application of additional vegetation of this boundary will further aid in the screening of the quarry from public view.
