**Archaeological Field Inspection,
Coolagh Townland, Galway**

Galway County Council

N6 Galway City Ring Road

Issue 1 | 14 October 2020

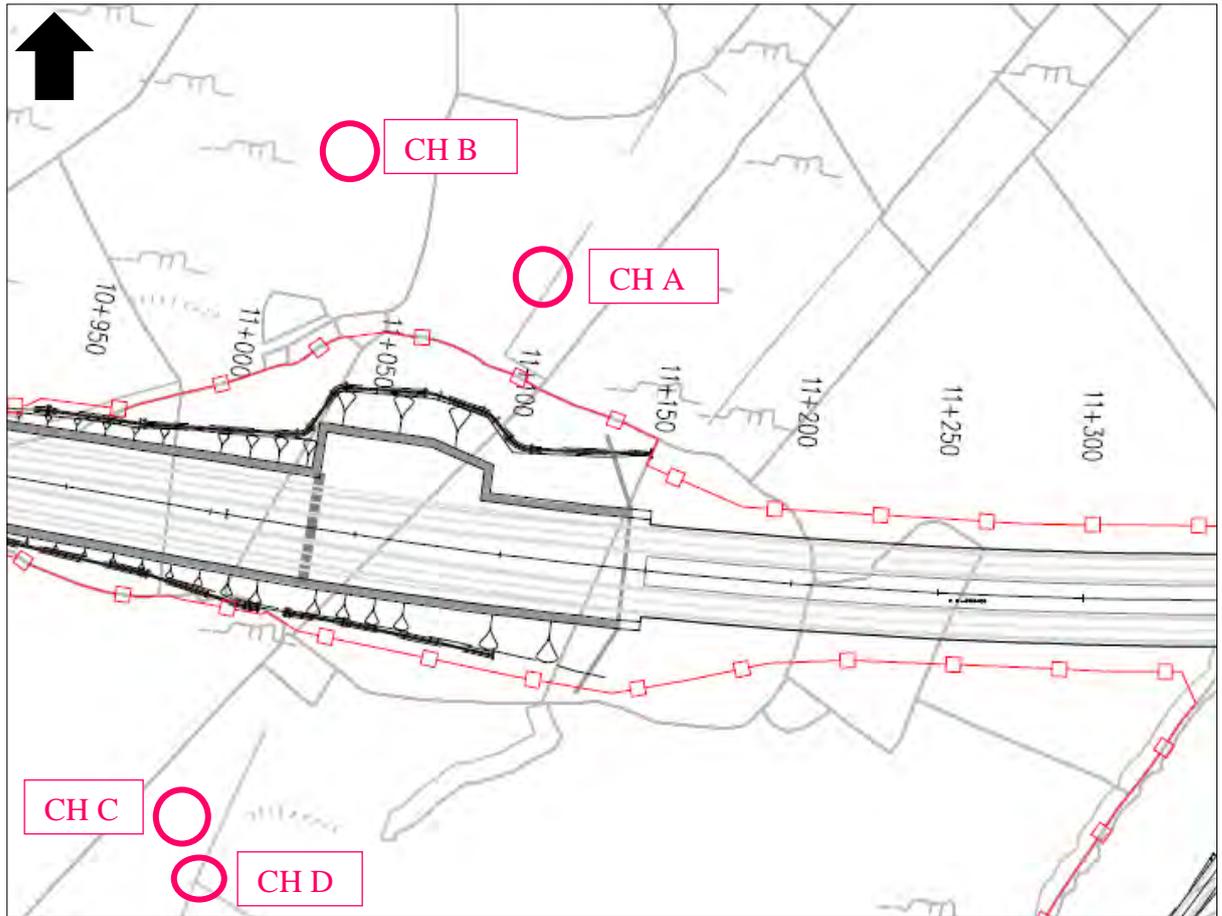
Mr McDonagh identified five sites of potential cultural heritage significance during the field inspection. The sites are described and illustrated below and have been designated as Cultural Heritage (CH) sites A-E. During the field inspection, it was possible to confirm that none of the five sites fall within the footprint of the proposed development boundary for the proposed N6 Galway City Ring Road. Figure 1 below shows the locations of sites CH A to D and Figure 2 in Section 2.5, the location of site CH E.

Figure 1: Location of CH A-D and the proposed N6 Galway City Ring Road

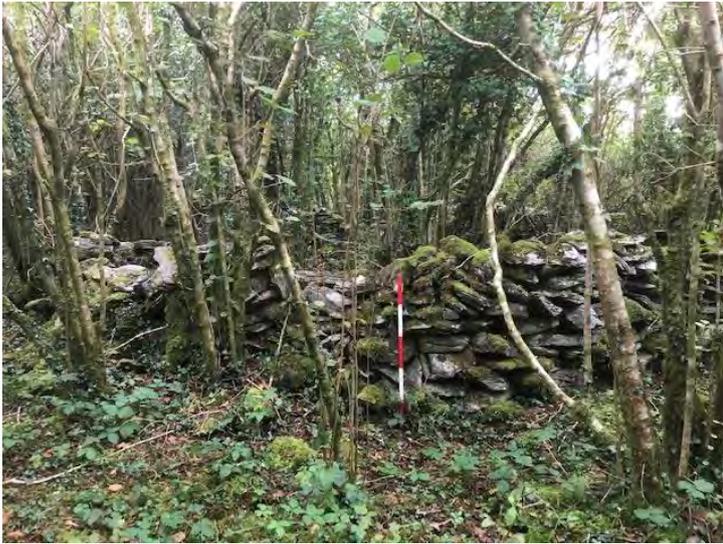
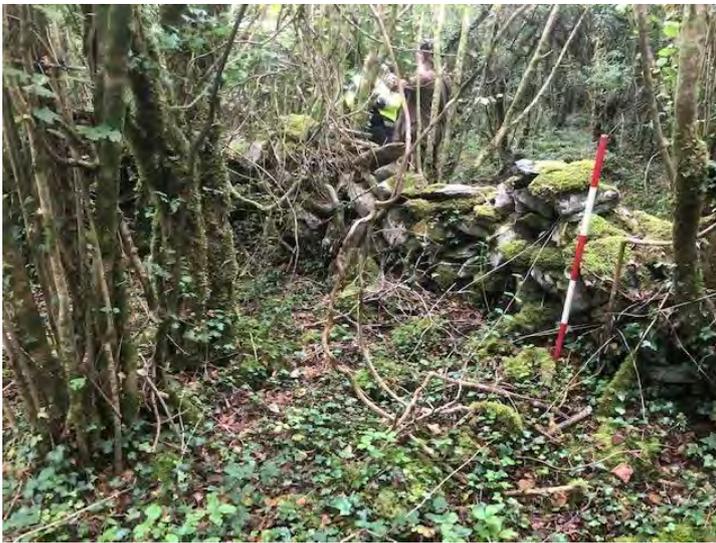
The site consists of a sub-circular 'D-shaped' enclosure that has been constructed adjacent to a stone field boundary that is aligned northeast-southwest. It measures c. 8m east-west by c. 10m north-south (Plates 1 and 2). The enclosure is formed by a roughly constructed dry stone wall and is situated in dense overgrowth c. 40m east of an old track and c. 75m east-northeast of a similar feature marked within the 1895-1900 historic Ordnance Survey map, which is no longer extant today (Figure 1). The walls vary in height from 1m – 1.25m in height and there is no obvious entrance to the enclosure, although some sections of the wall have collapsed.

The field boundary that the site abuts is not present on the first edition OS map of 1841, but is marked by the time of the 1895-1900 map. This suggests the earliest date of the feature is mid-19th century, although it is not marked on any of the historic mapping. It is possible that the enclosure represents the remains of a pen or enclosure for livestock, which were a common feature of the post medieval landscape, especially in marginal terrain, such as the environs surrounding the site, where stock may range a wide area.

Plate 1: CH A, facing northeast

Plate 2: CH A, facing southwest

The site will not be directly impacted by the proposed N6 GCRR, being 35m away from the proposed development boundary. Given the level of dense vegetation in the area, indirect negative impacts are not predicted. The level of predicted impact is deemed to be neutral and no further mitigation is required.

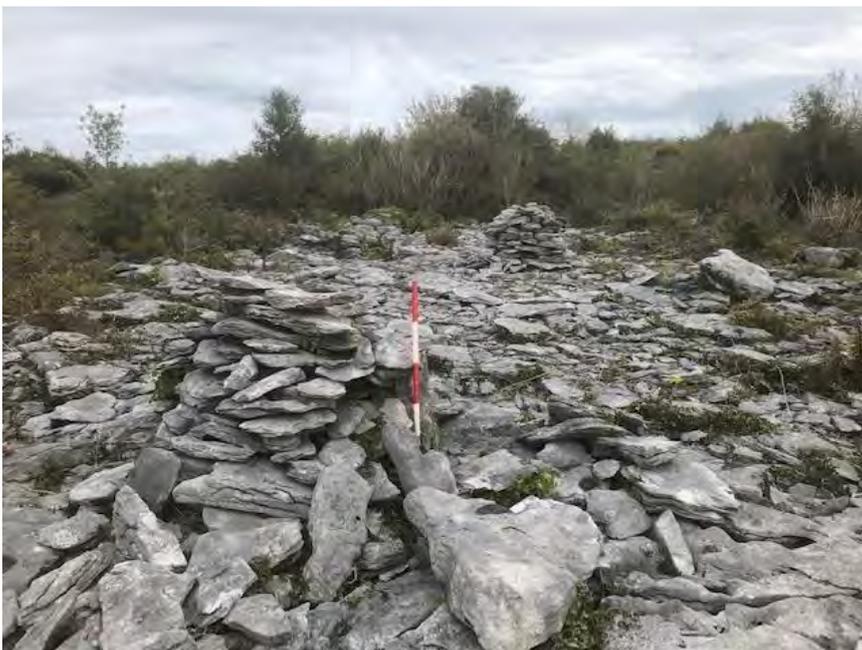
This site consists of two small cairns, both of which are approximately 1m high and c. 1.5-2m wide at the base (Figure 1, Plate 3). The features are located within an area of limestone pavement and, given the large amount of stone in the immediate surrounding landscape, they are unlikely to represent an effort to clear the landscape of stone. It is more probable that they represent a marker in the landscape, which may have been used to navigate across a marginal terrain characterised by areas of stone pavement and dense scrub, in order to forage or manage livestock. The features have been roughly constructed from dry stone and it is not possible to date them. Whilst the features are not marked within the historic OS maps, they are likely to be post medieval or more modern in origin.

Plate 3: CH B, facing north

The site will not be directly impacted by the proposed N6 GCRR, being 65m away from the proposed development boundary. Given the distance of the site from the proposed N6 GCRR and vegetation that lies in between, indirect negative impacts are not predicted. The level of predicted impact is deemed to be neutral and no further mitigation is required.

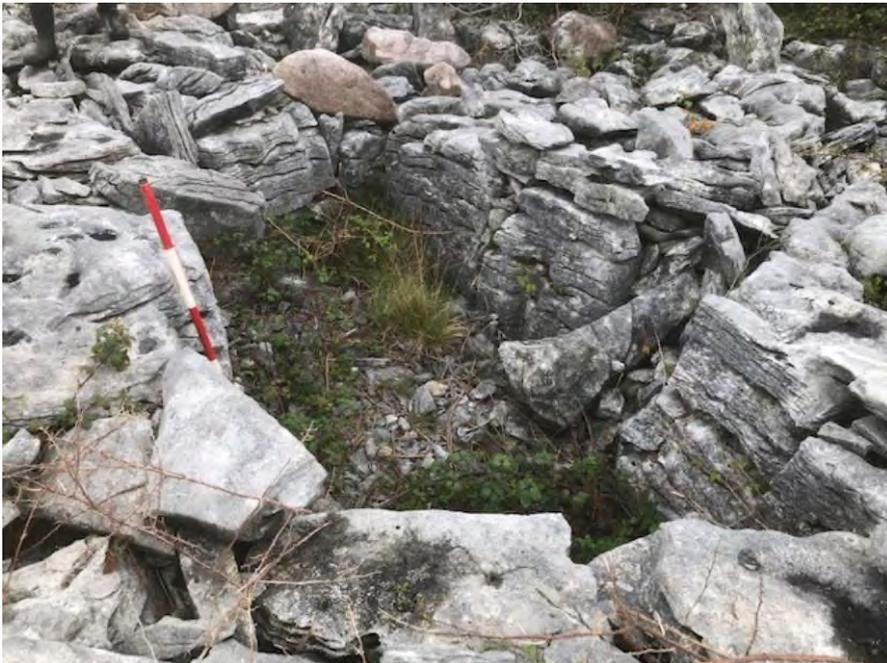
This feature may represent the remains of a rock cut feature, which is sub-rectangular in plan and c. 04-06m deep (Figure 1, Plate 4). The function is unclear as the feature is located within an area of limestone pavement and, due to the fractured nature of the rock, would not have held water or liquid without some form of liner. It is possible that the feature represents the remains of localised quarrying, although this seems unlikely given the amount of loose stone that lies on the ground in the area. It remains possible that this is a natural feature caused by weathering and water run-off.

Plate 4: CH C, facing southwest

The site will not be directly impacted by the proposed N6 GCRR, being 72m away from the proposed development boundary. Given the level of dense vegetation in the area between the feature and proposed N6 GCRR, indirect negative impacts are not predicted. The level of predicted impact is deemed to be neutral and no further mitigation is required.

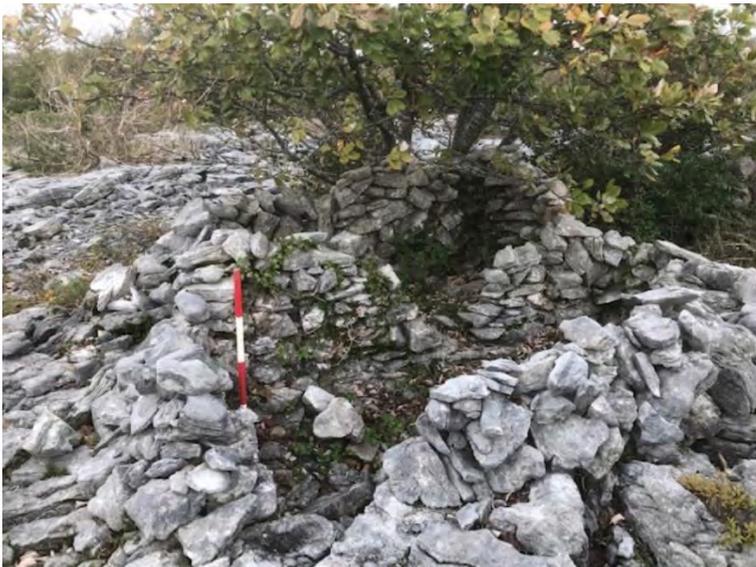
This small built feature is located c. 92m southwest of the proposed road scheme within an area of limestone pavement. The feature comprises two small rectangular areas defined by roughly constructed drystone walls (Figure 1, Plate 5). The upstanding walls stand to a height of c. 1m and the walls abut a stone field boundary wall, which is first marked on the 1928-29 OS map. This indicates that the feature was constructed between 1895 and 1929. The function of this feature is not clear, but it may have been used as a booley hut or similar small shelter, in use whilst animals were being tended in a marginal landscape.

Plate 5: CH D, facing northwest

The site will not be directly impacted by the proposed project, being 92m away from the edge of the lands required for the scheme. Given the level of dense vegetation in the area between the feature and proposed project, indirect negative impacts are not predicted. The level of predicted impact is deemed to be neutral and no further mitigation is required.

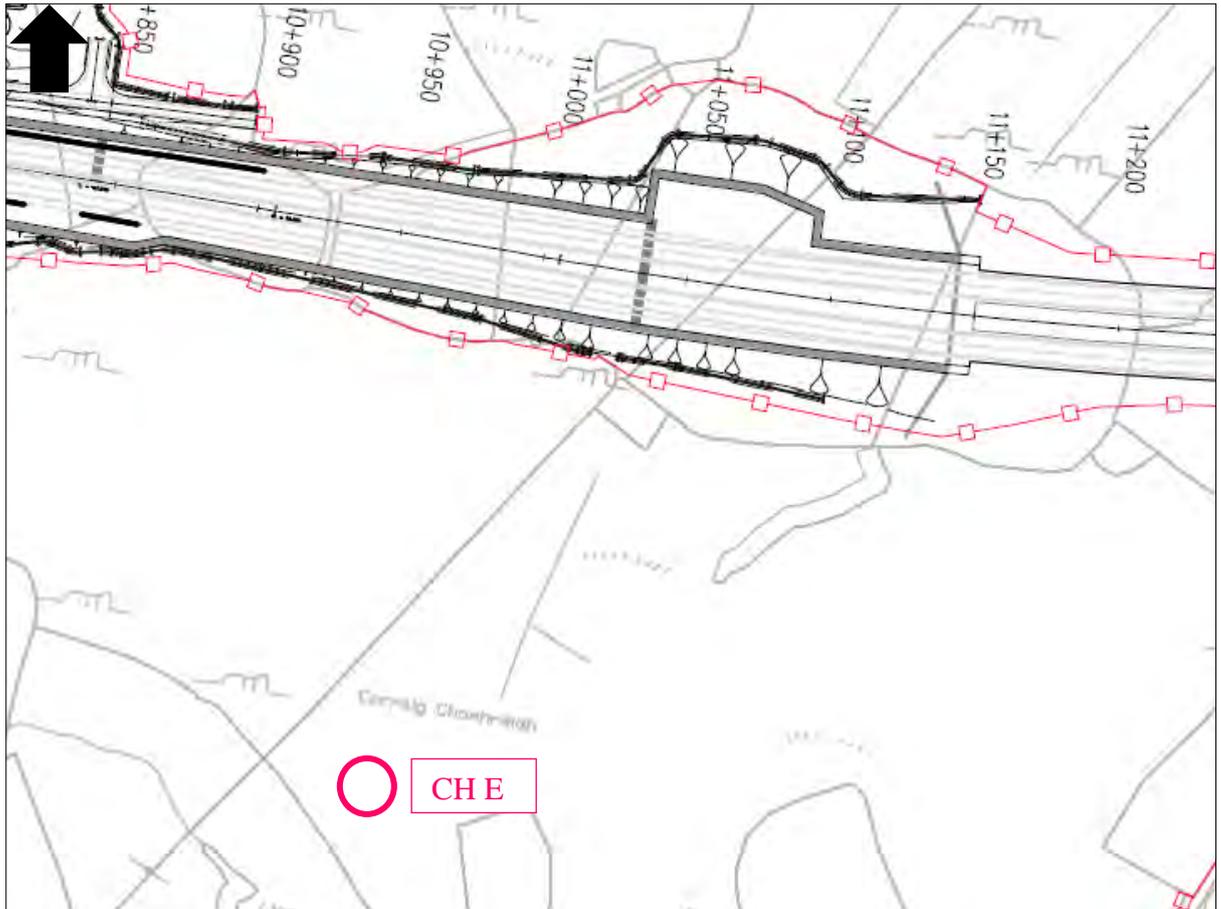
Figure 2: Location of CH E and the proposed N6 GCR

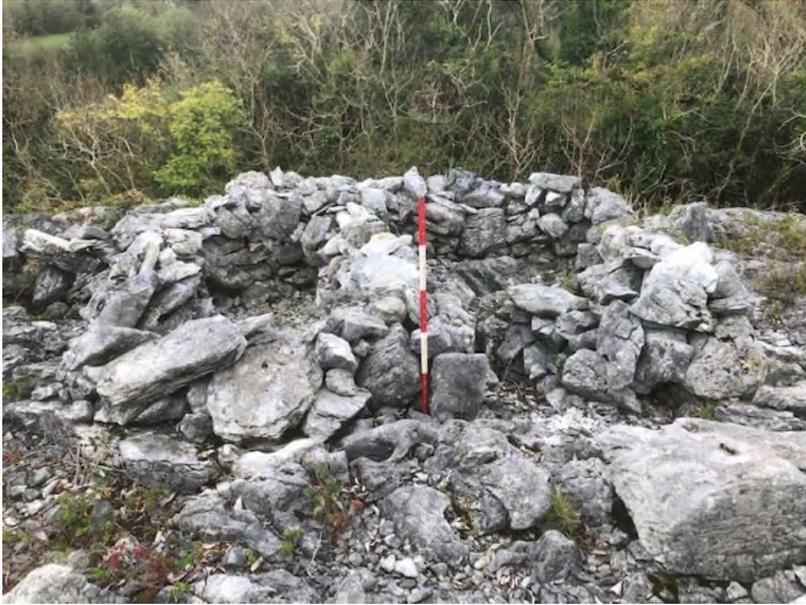
This small built feature is located c. 166m southwest of the proposed N6 GCR within an area of limestone pavement. It is situated 77m southwest of CH D, which is similar in form. The feature comprises two small rectangular areas defined by roughly constructed drystone walls (Plate 6, Figure 2). The upstanding walls stand to a height of c. 0.5m and similar to CH D, the walls abut a stone field boundary wall, which is first marked on the 1895-1900 OS map. The function of this feature is not clear, but it may have been used as a booley hut or small shelter whilst animals were being tended in a marginal landscape, or may represent a feature for storage. It is probable that CH D and CH E are connected to one another, given their proximity in a marginal landscape.

Plate 6: CH E, facing southwest

The site will not be directly impacted by the proposed N6 GCRR, being 166m away from the proposed development boundary. Given the distance between the feature and proposed N6 GCRR, indirect negative impacts are not predicted. The level of predicted impact is deemed to be neutral and no further mitigation is required.
