Appendix A.8.27

Compensatory Habitat Management Plans

Project title N6 Galway City Ring Road
Document title Updated Environmental Impact Assessment Report
Job number 233985-00
Document ref Appendix A.8.27 Compensatory Habitat Management Plans
File reference

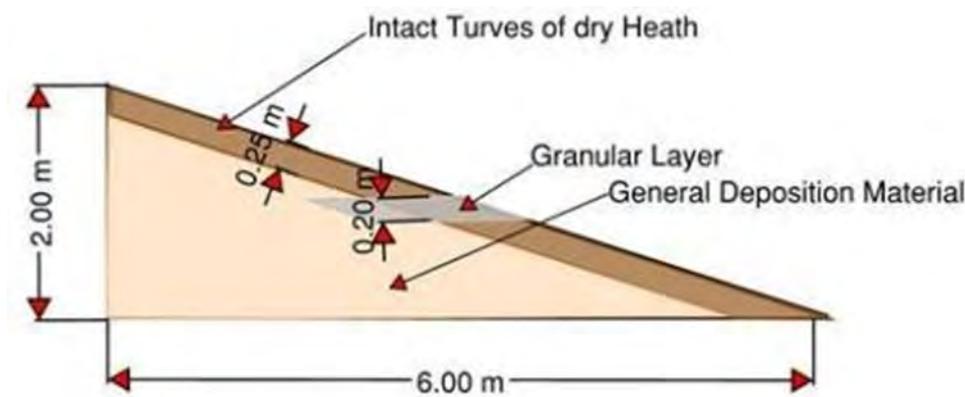
Plate 1 Example illustration of MDA side slope

In the case of the receptor sites that are also Material Deposition Areas (MDA), the following measures will also be implemented to ensure the successful creation of 4030. The placement of a compatible layer of material, such as a granular material with a high permeability, on the slopes of the MDA, to allow water to freely drain and to provide slope and surface stability. On top of the granular layer, intact habitat turves may be placed (as described in Section 2.4.3). The root depth for some heathland plants may extend up to 500mm and therefore there may be interaction between the root zone of the dry heath habitat and the core of the MDA area. It can be confirmed that the pH of the top 400mm layer of the MDA material (where it directly underlies areas proposed for dry heath habitat creation) will be below 6.5. The habitat layer will include a minimum 100mm depth of translocated soil/peat depth and/or turves. Therefore, there will be a minimum of 500mm depth of material with a pH compatible with dry heath habitat. See Plate 1 below for an example illustration of granular layer of the side slope of a MDA in the context of where the intact turves would be placed and Plate 2 for a typical cross section of MDAs with dry heath. Details of MDA sites on top of which dry heath habitat will be created are outlined in Table 1.

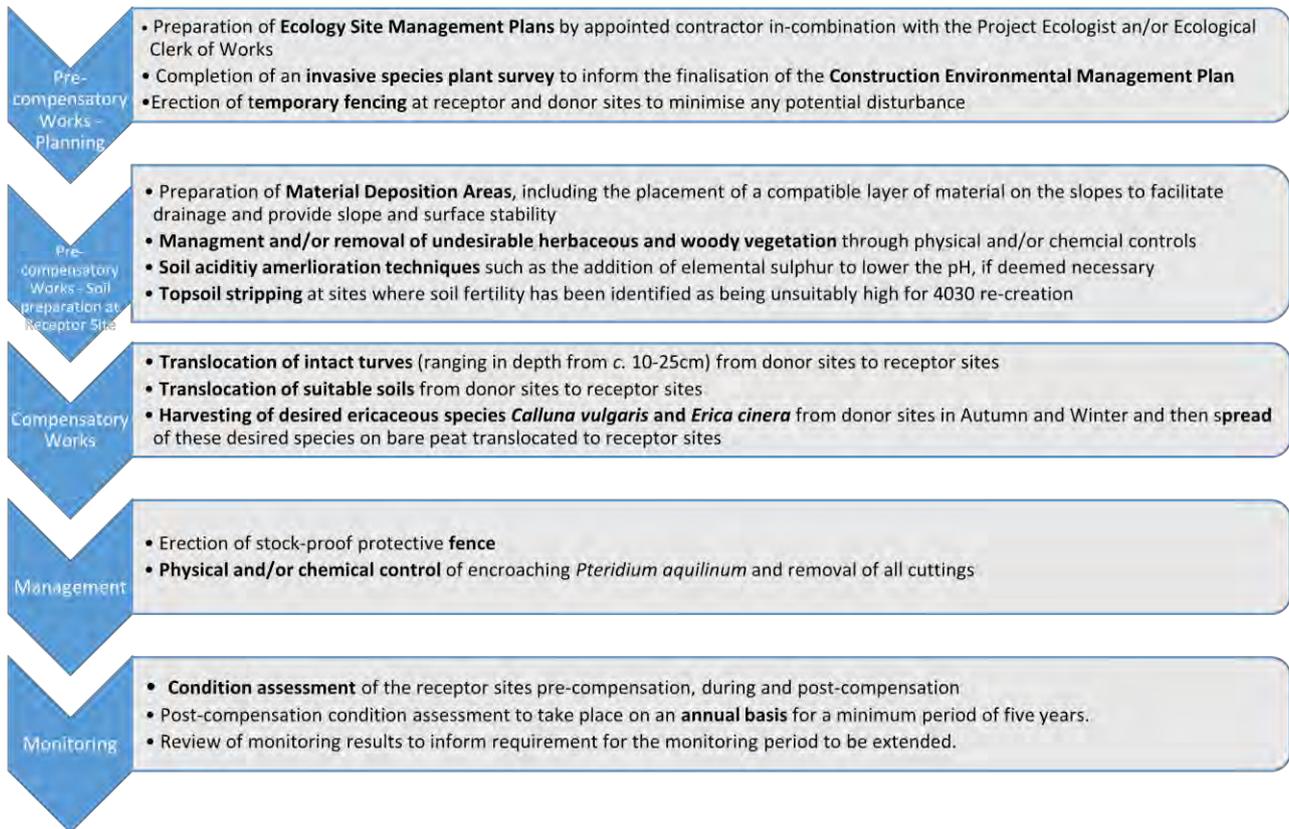
Plate 3 Flow chart of steps involved in the creation of 4030

The measures outlined in this section will compensate for the significant residual effect on 4030 habitat by ensuring that there will be no net permanent loss of this habitat type as a consequence of the proposed N6 GCRR and a biodiversity gain for peatland habitats. A total area of c.4.08ha (c.129% of the combined losses of: 4030 and mosaics containing 4030) will be created as part of the proposed compensatory works. The steps outlined in this section are presented below as a flow chart.

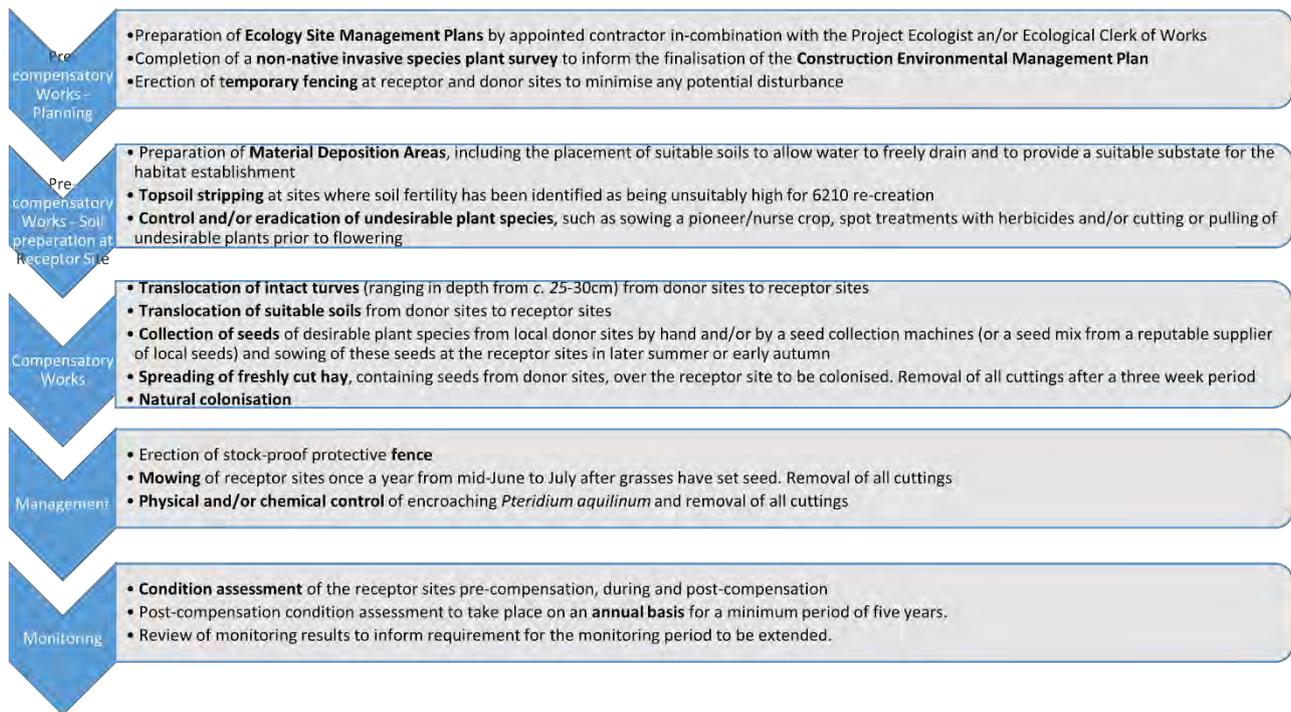
Plate 4 Flow cart of steps involved in the creation of 6210

The measures outlined in this section will compensate for the significant residual effect on 6210 habitat by ensuring that there will be no net permanent loss of this habitat type as a consequence of the proposed N6 GCRR. A total area of c.7.98ha (*i.e.* c.3,192% of the area of 6210 lost) will be created as part of the proposed compensatory works. The steps outlined in this section are presented below as a flow chart. The steps outlined in this section are presented below as a flow chart.

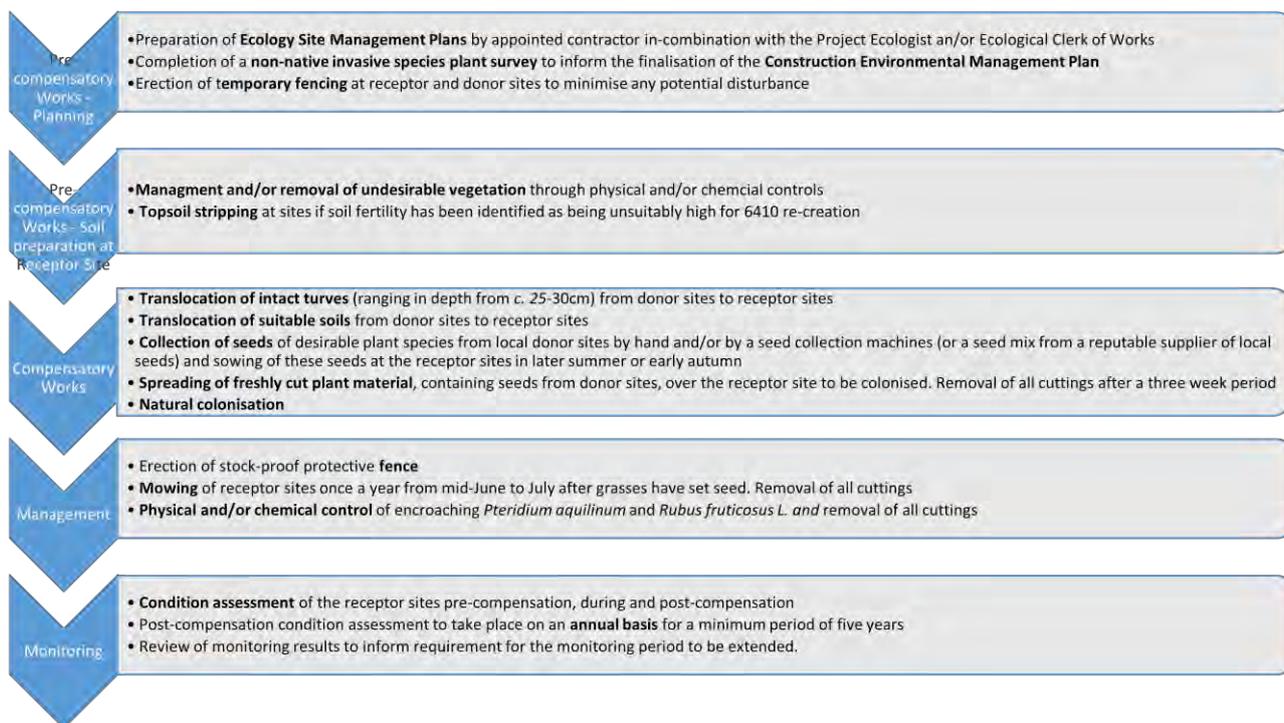
Plate 5 Flow chart of steps involved in the creation of 6410

The measures outlined in this section will compensate for the significant residual effect on 6410 habitat by ensuring that there will be no net permanent loss of this habitat type as a consequence of the proposed N6 GRR. A total area of c.0.49ha (*i.e.* c.170% of the area of 6410 lost) will be created as part of the proposed compensatory works. The steps outlined in this section are presented below as a flow chart.

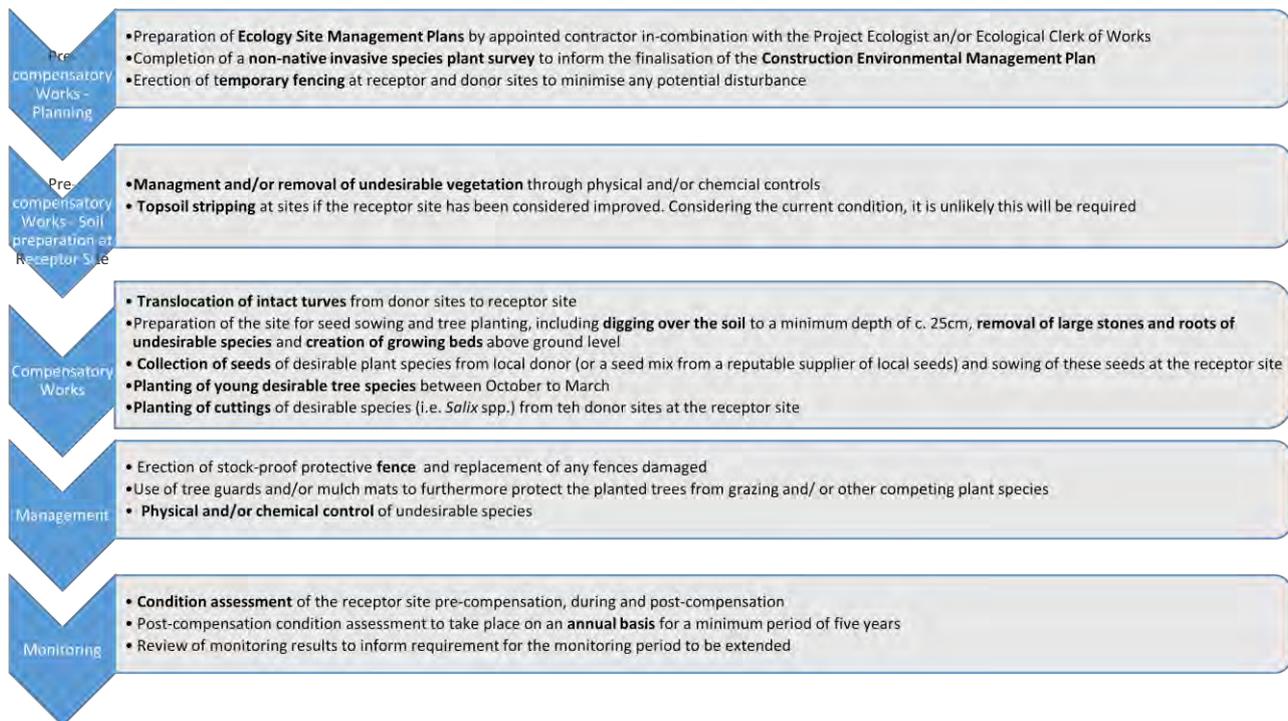
Plate 6 Flow chart of steps involved in the creation of *91E0

The measures outlined in this section will compensate for the significant residual effect on *91E0 habitat by ensuring that there will be no net permanent loss of this habitat type as a consequence of the proposed N6 GCRR. A total area of c.0.17ha (*i.e.* c.121% of the area of *91E0 lost will be compensated for) will be created as part of the proposed compensatory works. The steps outlined in this section are presented below as a flow chart.

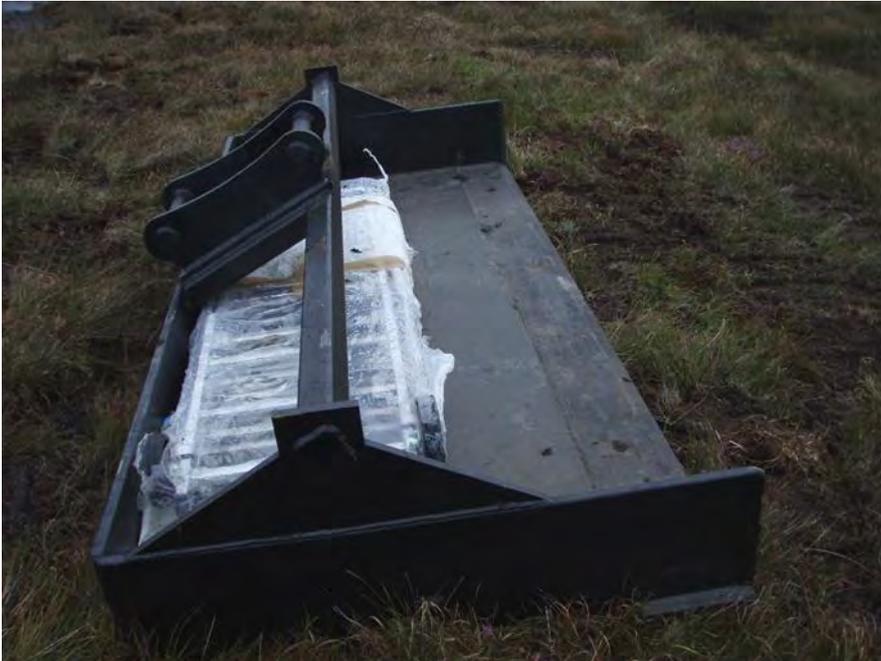
1. Bespoke bucket used to lift surface vegetation turves (3m x 1m x 0.3 deep)

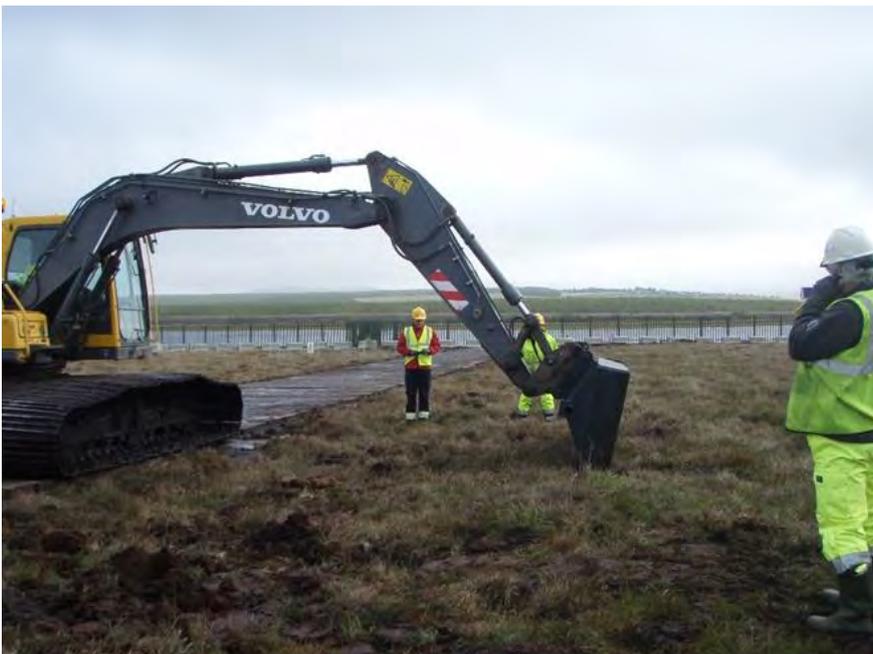
2a. Lifting turve

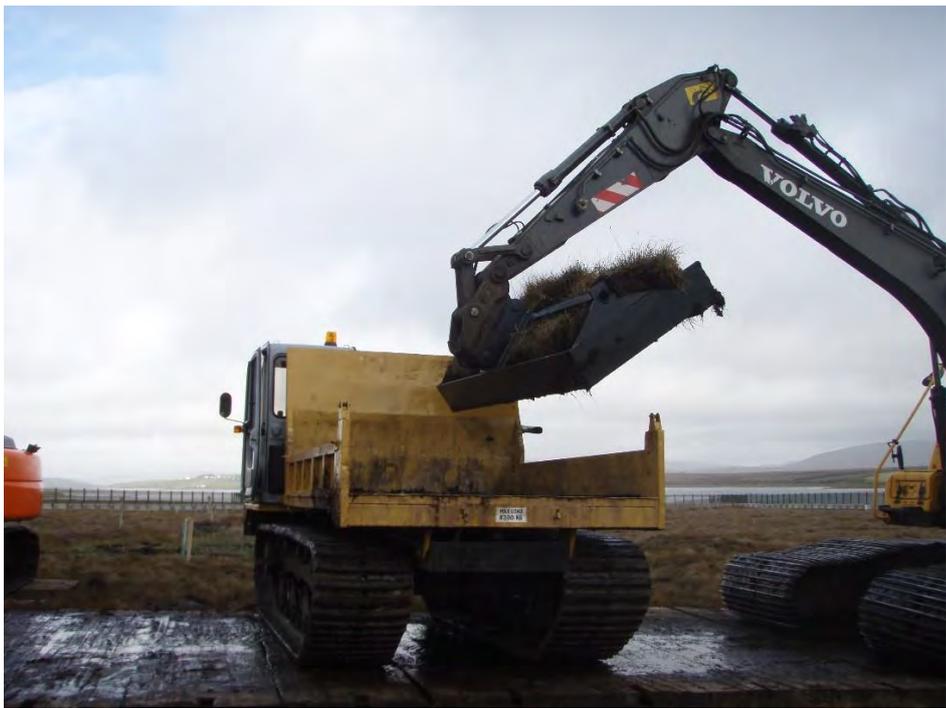
2b. Transfer bucket + turve to back of low impact truck

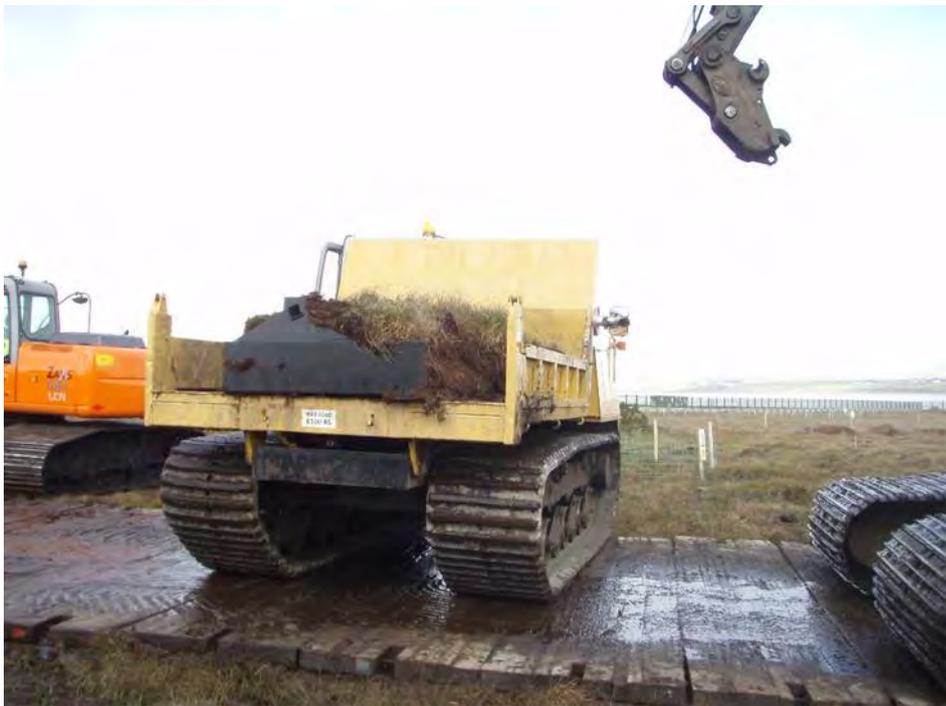
2c. Transport to peat storage area

2d. Lift bucket + truve off back of truck and place on turve storage area

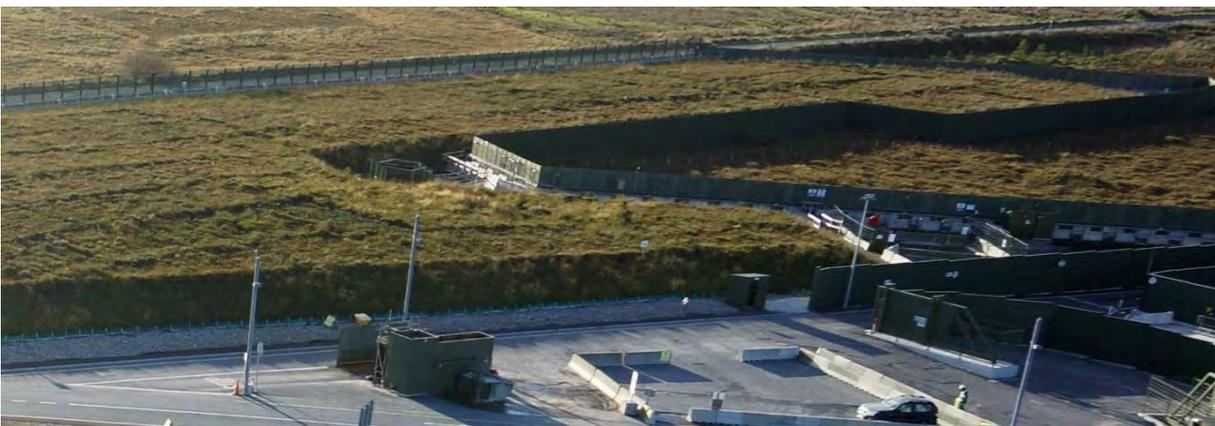
3b. One of the peat storage areas – with turves growing on top and on sloping sides (after 1 year)

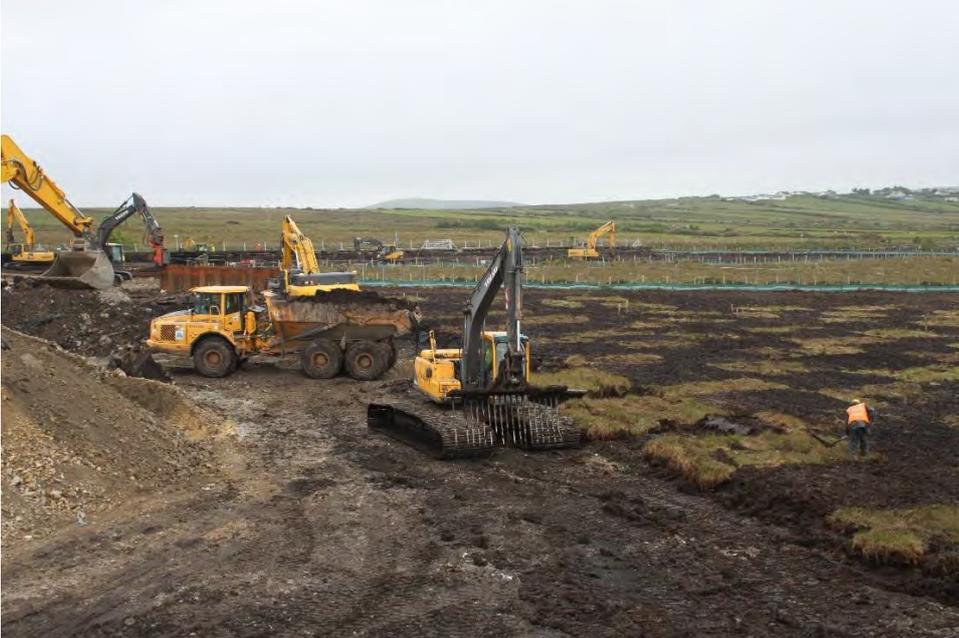
Effectively reverse the process, lifting turves from the storage areas with turving bucket but used large multiforked bespoke 'bucket' to lift them from back of truck and placed carefully into position. Three turves placed together to form matrix of 3 x 3m and the interstices filled with stored peat up to the level of the replaced turves.

4a. To show forking bucket

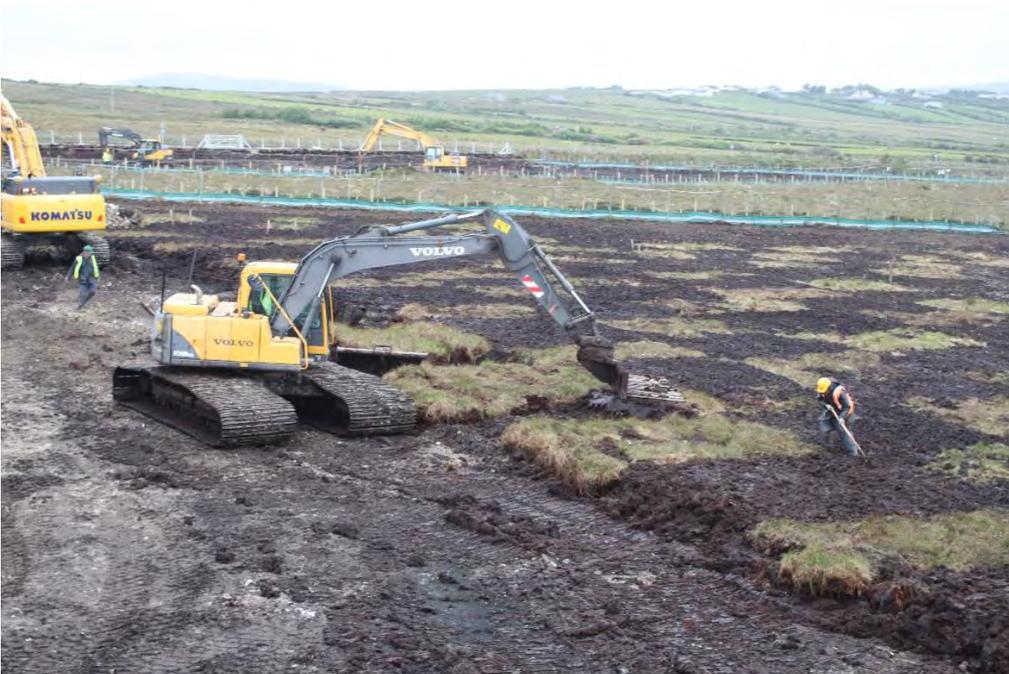
4b. Placement

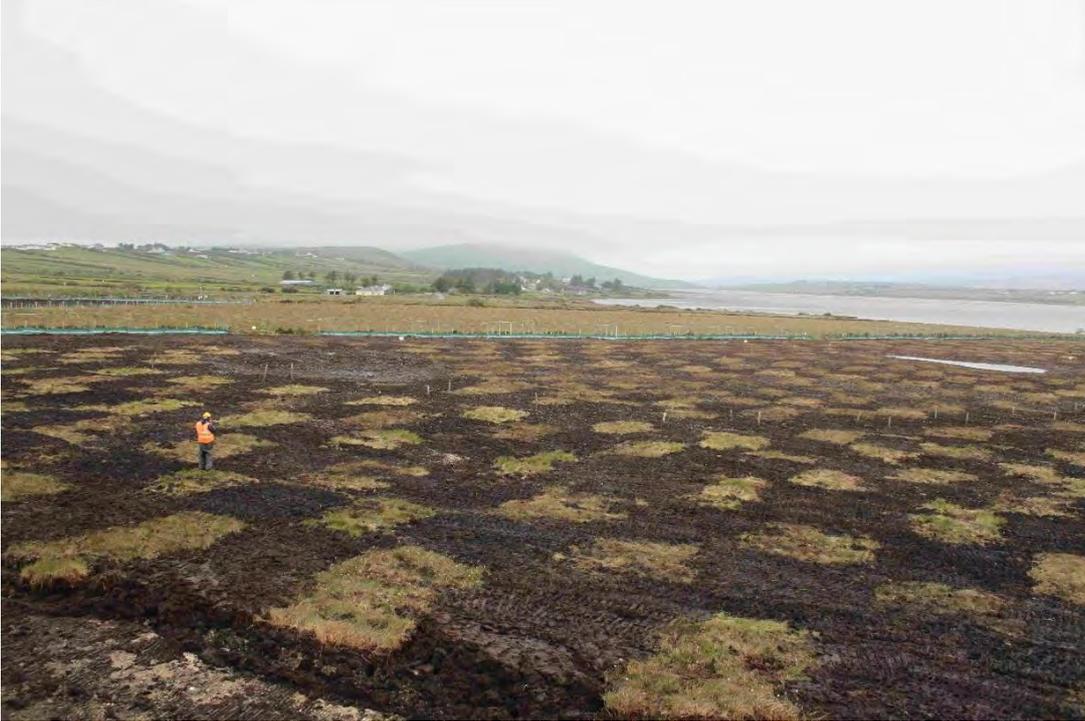
4c. The end result. Bare peat interstices were planted with *Eriophorum angustifolium* plantlets (64,000 in total) and seeded with locally collected ericaceous seed.

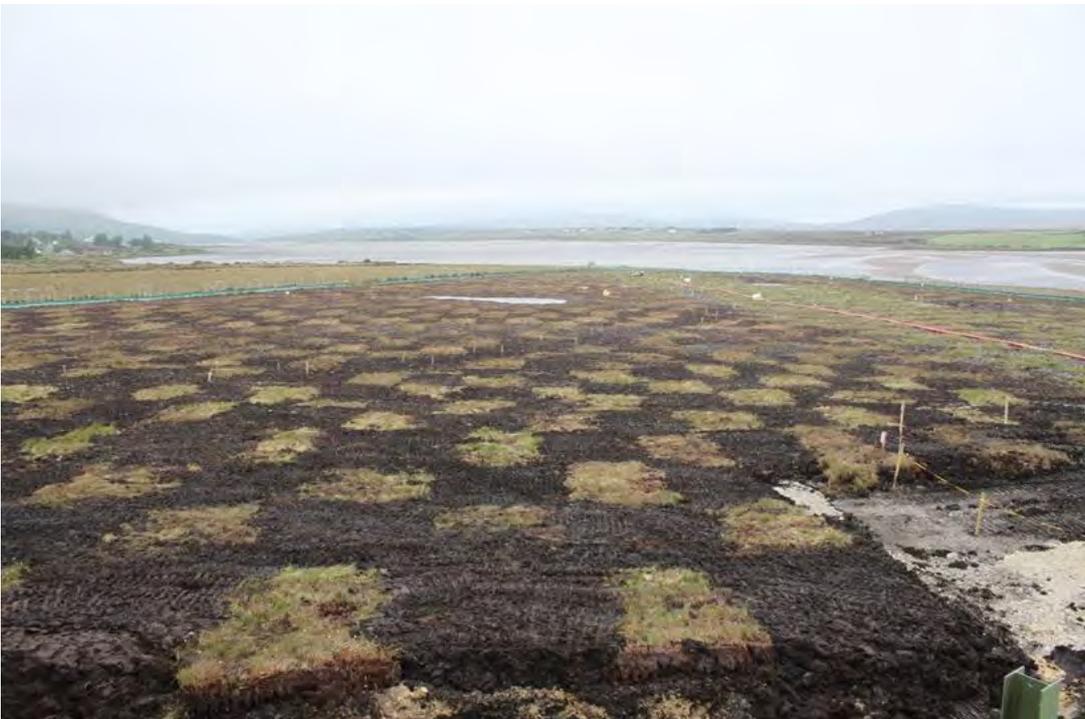
4d. Working edge visible, also newly created wetland (in peat) Sruwaddacon Bay in the background

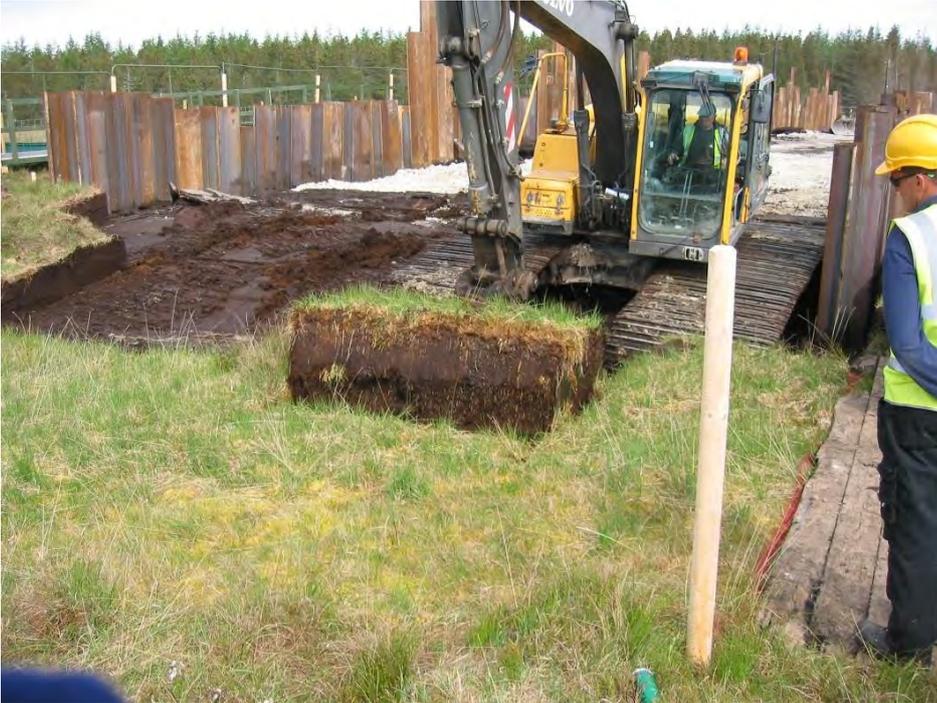
i. Used bespoke bucket: 2m x 1m x 0.5 deep

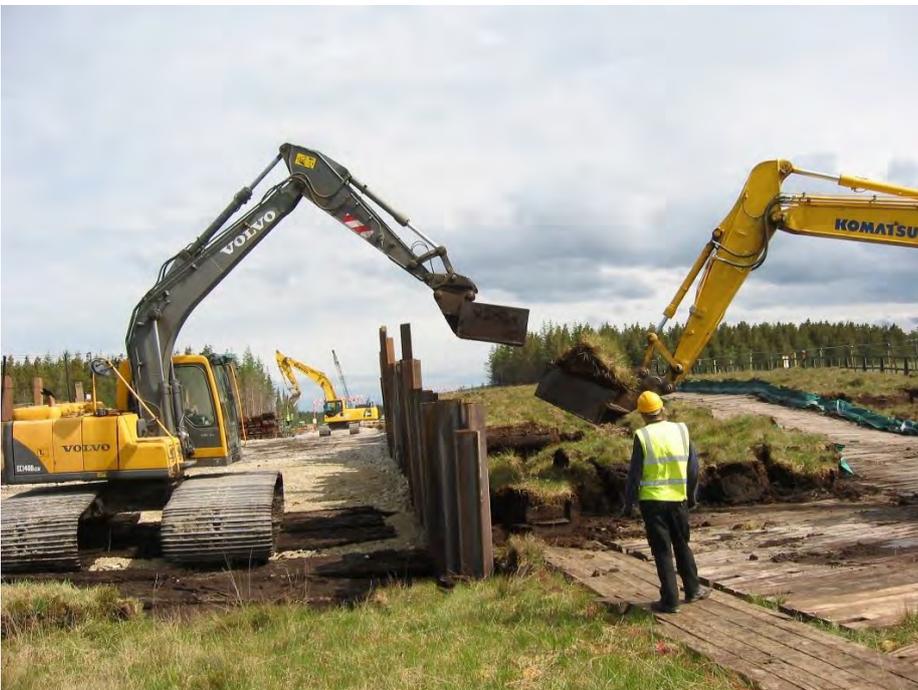
ii. Then transferred from the ‘lifting’ machine’s bucket to the machine placing turves on bogmats in the adjacent storage area – required excellent driver coordination and care

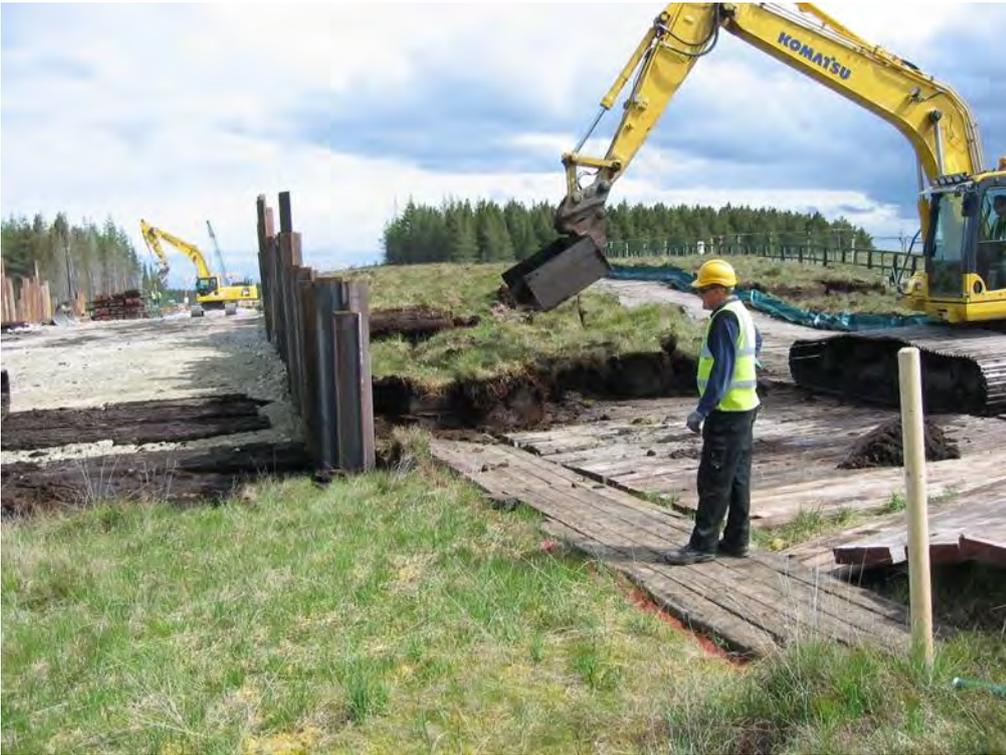
iii. Turve storage on bogmats (on RHS of sheet piled haul road and trench section on left)

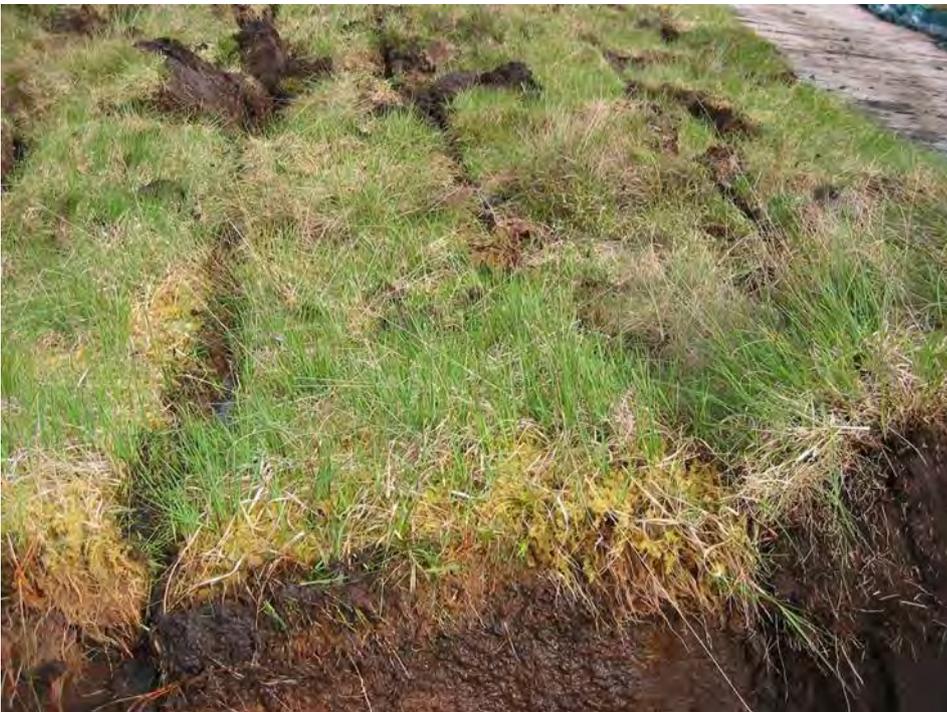
iv. Turves after lifting

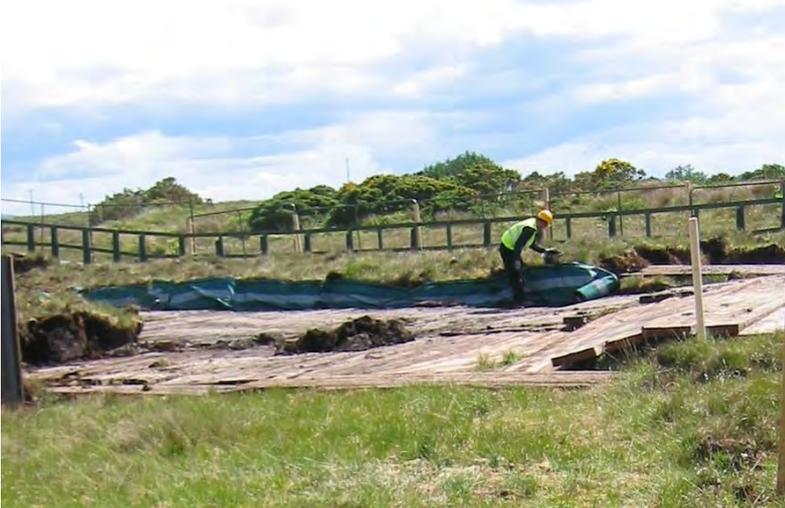
v. Exposed edges firmly wrapped in silt fencing to prevent drying and erosion while in storage

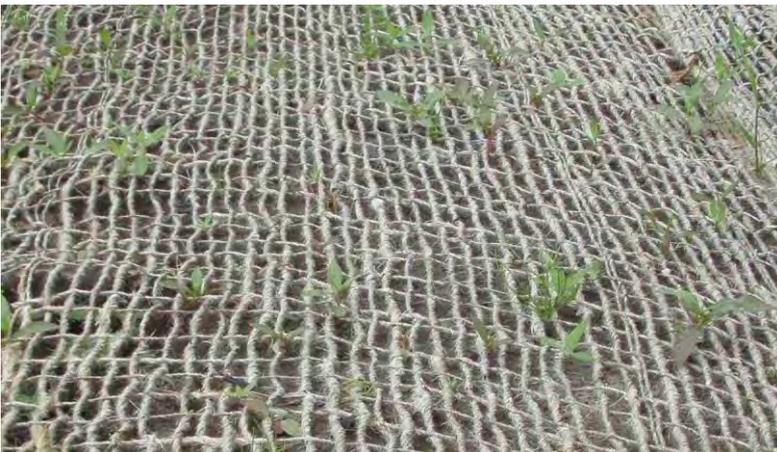
i. Use of Geocoir with vegetation establishing on Landfall Valve Installation

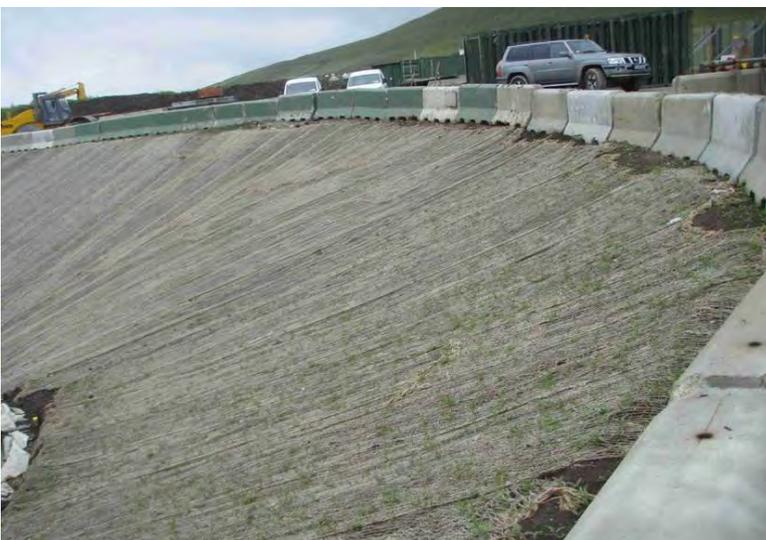
ii. Use of Geojute with vegetation establishing on Landfall Valve Installation side slopes
