N6 Galway City Ring Road

**Lackagh Tunnel: Geotechnical and
Hydrogeological Appraisal**

GCOB-4.03-4.16

Issue 4 | 28 March 2025

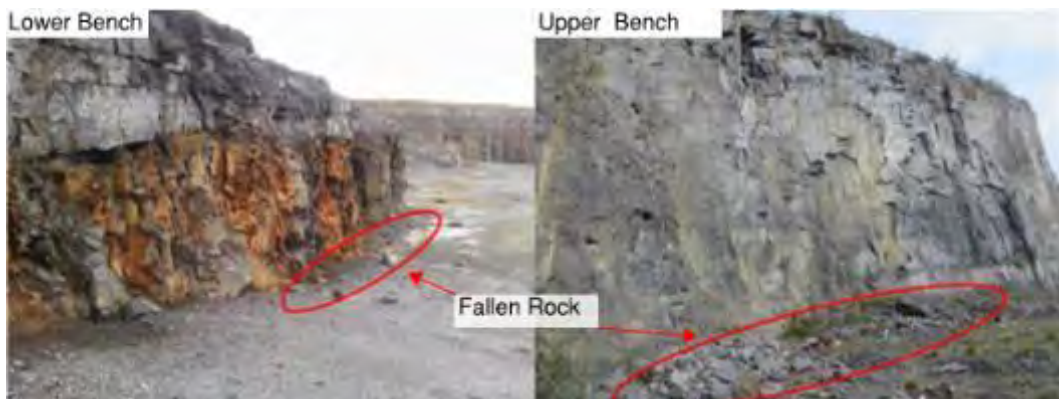
Figure 3.5: Face instability on the lower and upper bench

Some instability in the rock face is evident predominantly from blast damage during the operation of the quarry, with open discontinuities (joints and fractures), loose rock and the accumulation of debris resulting from spalling and failures present at the base of the lower and upper benches, see Figure 3.5 below.

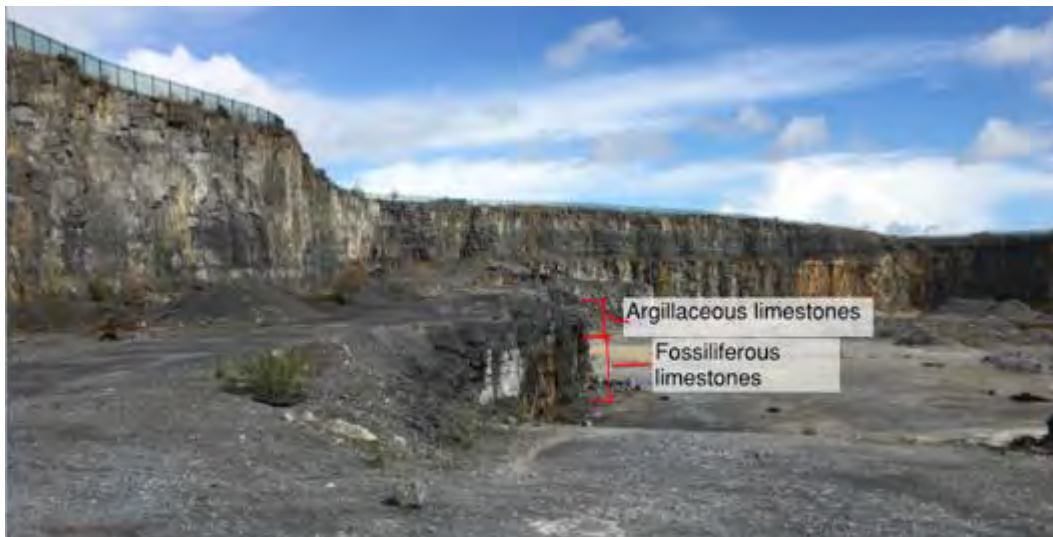
Figure 3.15: Cyclical sequence of Limestones at Lackagh Quarry

Ground conditions at the western face of Lackagh Quarry comprise a cyclical sequence of carboniferous limestones (see Figure 3.15). Each cycle is between 10m and 15m thick and is characterised by thinly bedded, dark mud-rich (argillaceous) limestones which pass upward into thicker bedded, paler non-argillaceous limestones. The darker limestone marks the beginning of the upper bench at the western face, and is generally considered to be stronger than the paler limestones.

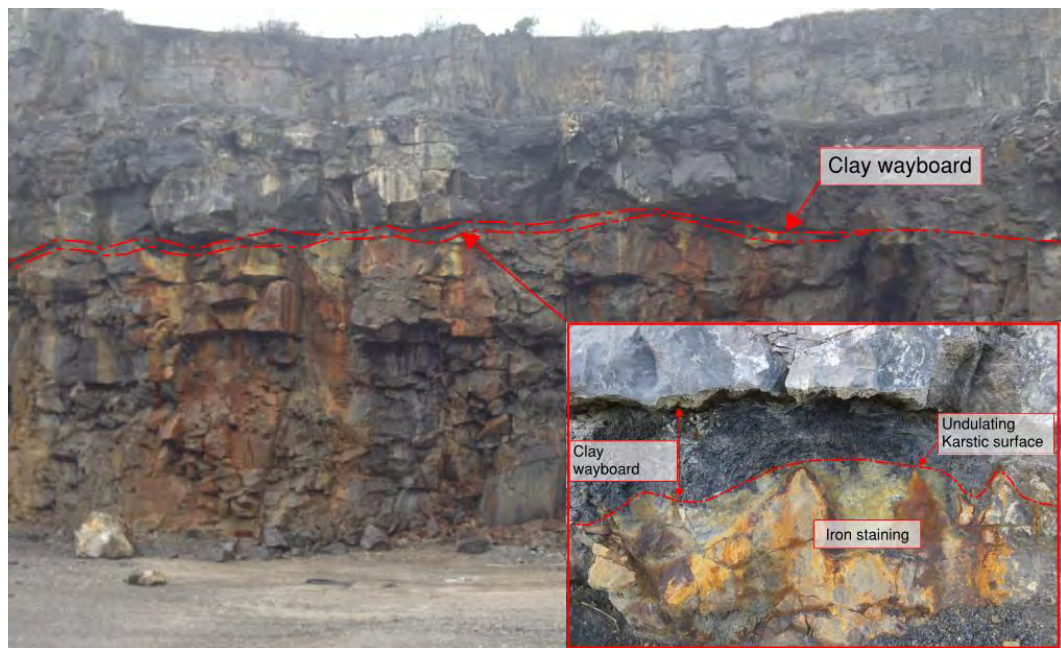
Figure 3.16: Clay wayboard on the quarry face at Lackagh Quarry

A clay wayboard of varying thicknesses from ~30cm to absent is evident on all faces of Lackagh Quarry, refer to Figure 3.16. A thin 20cm band of laminated mudstone, which compares favourably with the material observed on the quarry face, was encountered in BH04, however it is unknown whether this is a continuous layer or a cavity infill. BH04 and BH05 encountered several cavities, some not filled, and some infilled with clay.

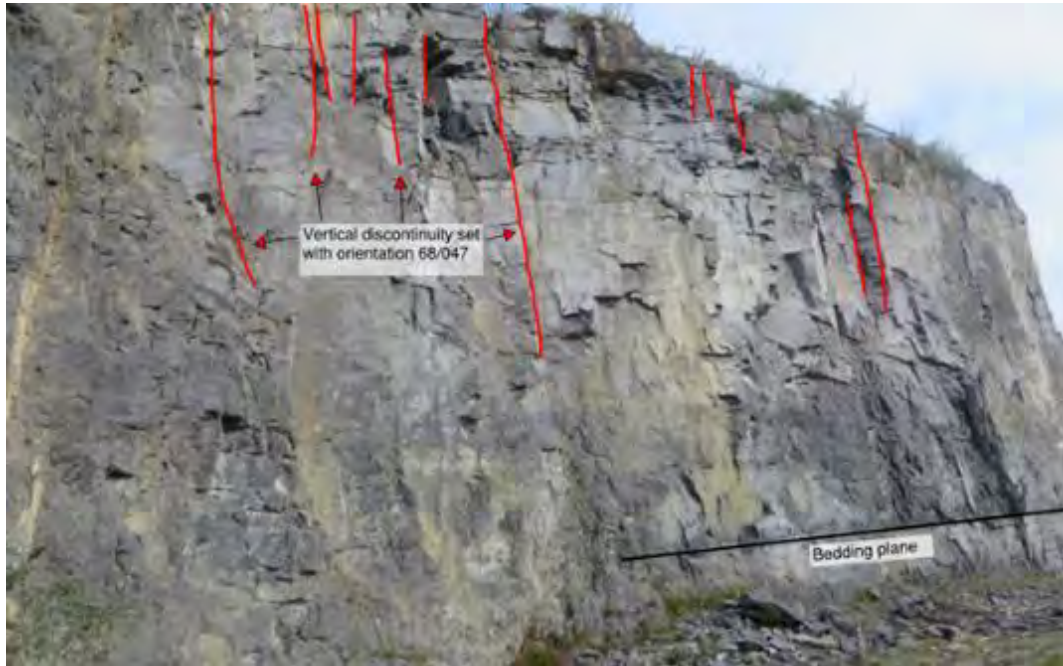
Figure 3.17: Exposed discontinuities on the upper bench

The vertical and horizontal discontinuities are visible on the exposed quarry face and are more evident in the upper bench wall, as the lower bench wall has been heavily affected by blast induced fractures.

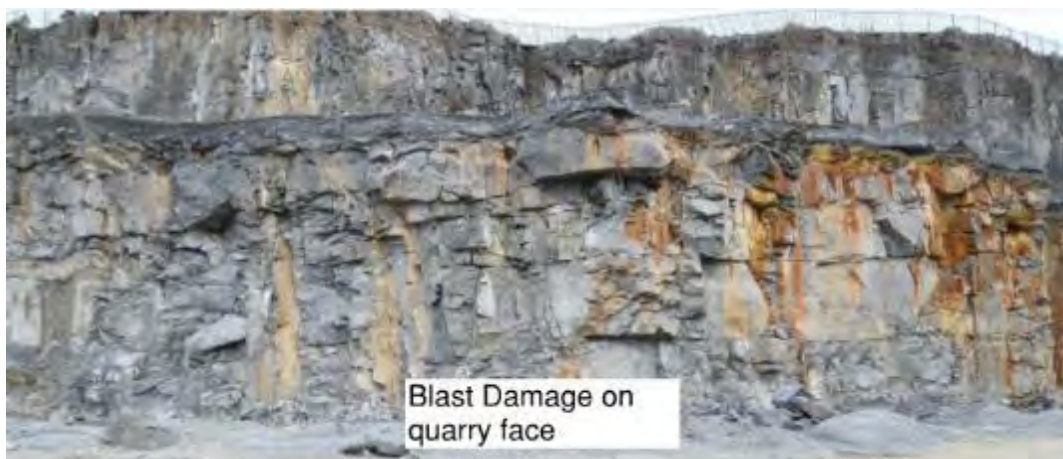
Figure 3.18: Blast damage on quarry face

The western face has been left unprotected since the closure of the quarry in 2010 and has gradually deteriorated over time. Previous quarry workings have resulted in a heavily fractured rock face, both natural and blast induced (Figure 3.18), and unsafe overhangs and loose rock are present in the area of the proposed tunnel portal.

Given the nature of the fracturing and the evidence of failures, the angle at which the current rock face stands is too steep in parts, suggesting that this unprotected face, if left in its present state will continue to erode and may potentially impact the overlying Limestone pavement if a deep seated slope failure was to occur.

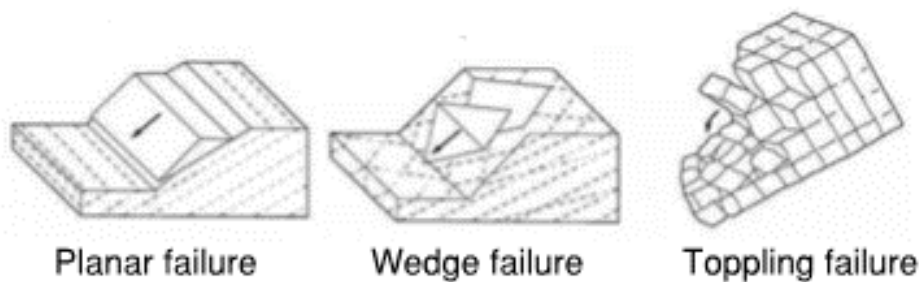
Figure 5.1: Schematic of potential failure mechanisms, Planar, Wedge and Toppling⁵

The three principal failure mechanisms which occur in a rock mass are discussed below and illustrated as schematics in Figure 5.1. The principal rock mass failure mechanisms are:

- Planar Failure
 - In order for a rock mass to undergo planar failure, the dip of the rock face must exceed the dip of the potential slip plane
 - The potential slip plane must be visible on the rock face
- Wedge Failure
 - Occurs when the dip of the rock face exceeds the dip of the line of intersection between two discontinuity planes
 - The line of intersection of the two discontinuity planes must daylight on the rock face
- Toppling Failure (Direct toppling)
 - Two sets of discontinuity planes whose intersections must dip into the rock face
 - Another set of discontinuity planes which daylight on the rock face and dip at a shallow angle

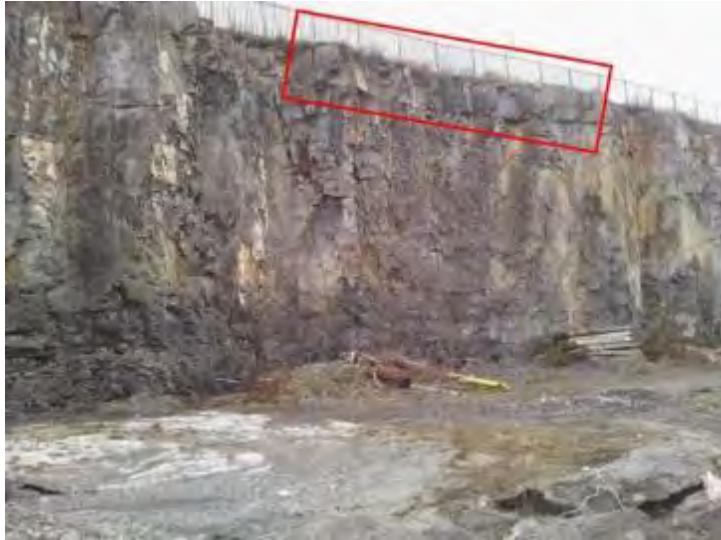
Figure 5.2: Wedge failure in the upper bench

Following analysis of the site specific ground information and the discontinuity data, presented in Table 3.4 in Chapter 3, it was determined that the failure most likely to occur within the rock mass and impact upon the structural integrity of the Limestone pavement is wedge failure and toppling. Wedge failures are seen in the upper section of the upper bench illustrated in Figure 5.2 below.

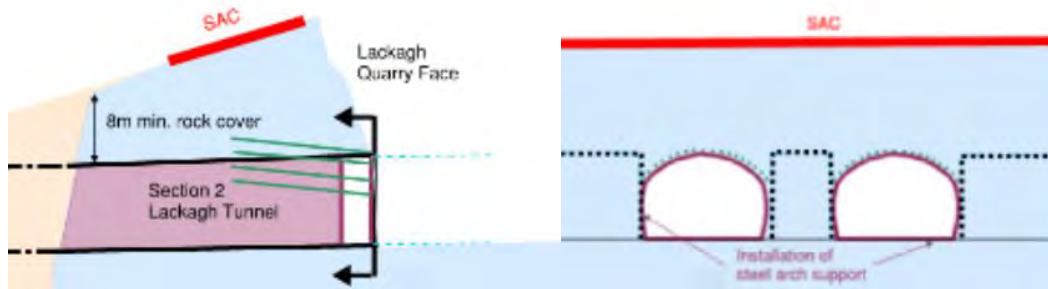
First advance of tunnel

Excavation will be then progressed for the tunnel in a cyclic manner with drilling, blasting, rock face mapping by a geotechnical expert, mucking out, probing for karst features, installation of support measures and then preparing for the next advance of the tunnel (Stages 5 and 6 in Figure 5.7). The excavation will be in short advances with steel arches and sprayed concrete implemented until the end of the pre-support zone.

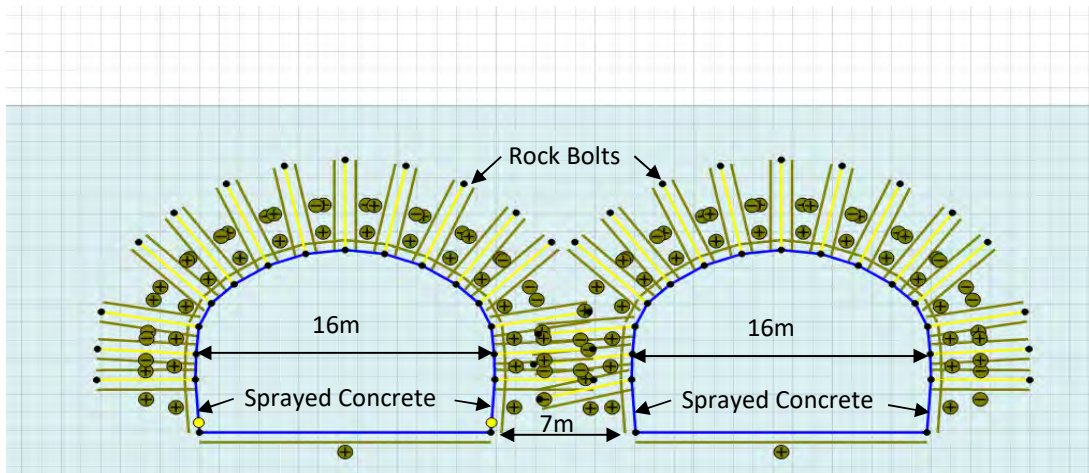
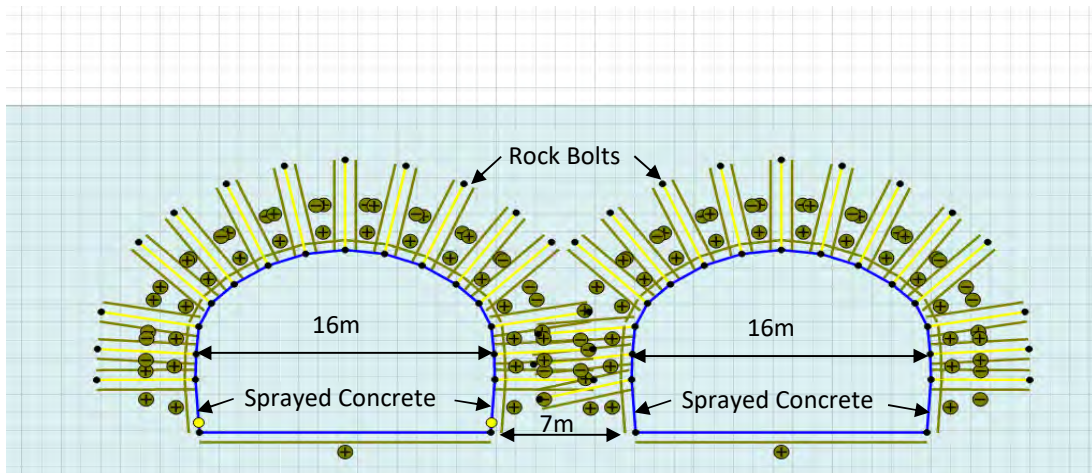
Standard practice for calculating rock cover is to set a minimum rock cover at half the tunnel span. Each tunnel bore at Lackagh Quarry is 13.6m wide. To account for potential resizing of the tunnel a conservative assumed width of 16m will be adopted for this calculation, therefore a minimum rock cover of 8m is used in the calculation.

Standard practice for calculating rock cover is to set a minimum rock cover at half the tunnel span. Each tunnel bore at Lackagh Quarry is 13.6m wide. To account for potential resizing of the tunnel a conservative assumed width of 16m will be adopted for this calculation, therefore a minimum rock cover of 8m is used in the calculation.

Figure C1: Model graphics showing twin bored tunnels with rock bolts installed around the lining.

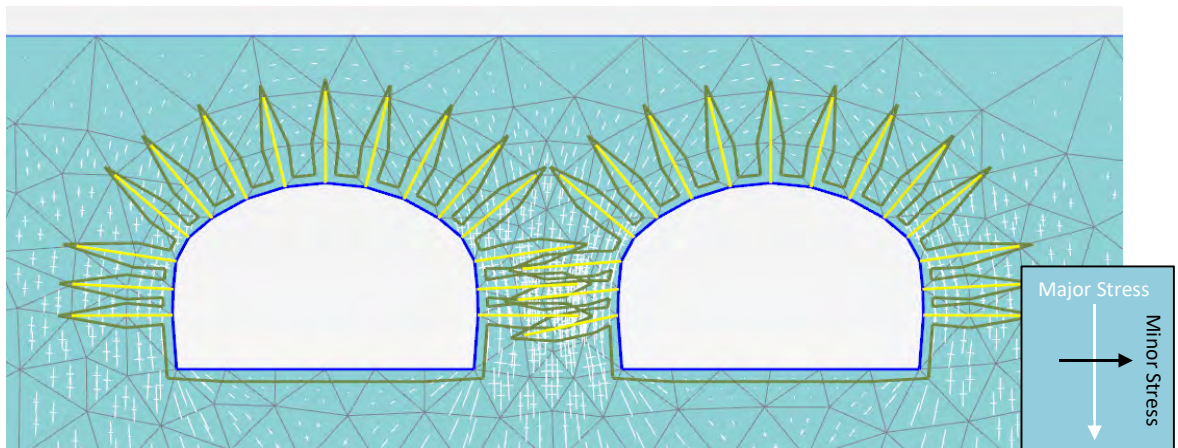
Figure C3 Principal stresses and stress directions in the limestone rock

The figure below shows the principal (major and minor) stresses and stress directions in the rock mass. The direction of the major stress indicates that the rock arch load is being transferred effectively into the rock pillar between the tunnels and the ground either side. This demonstrates that an effective rock arch is forming above the tunnels where the depth of rock is least (8m from ground level to the tunnel crown).

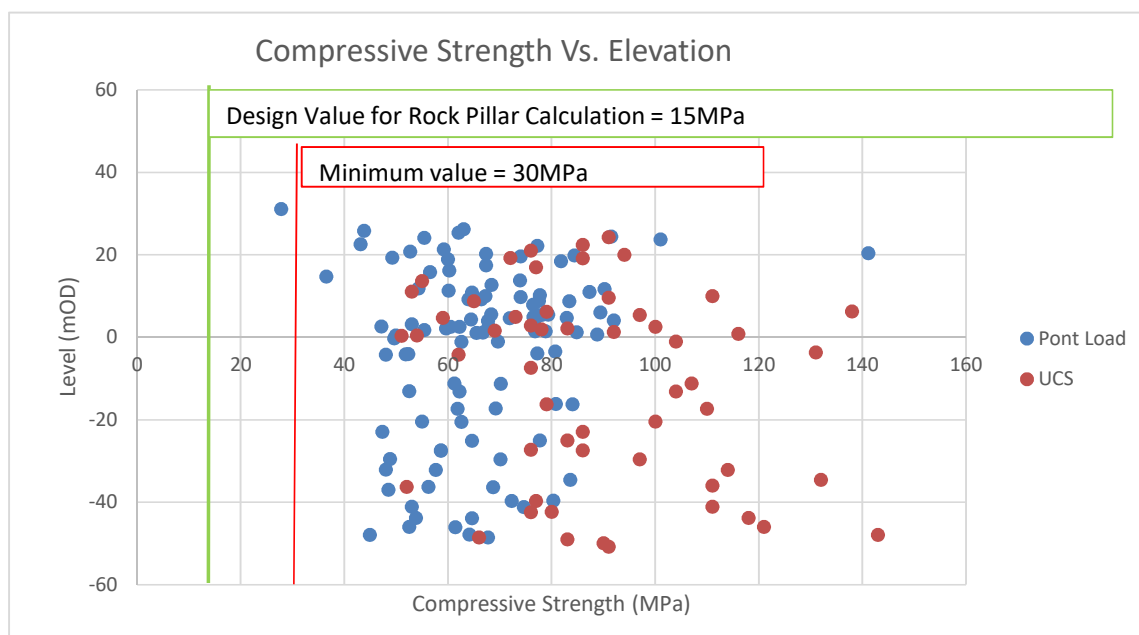
Figure D4 - Compressive strength of rock Vs. Sample level (mOD)

UCS and point load laboratory test results from 69 samples that were taken from the Lackagh Tunnel site specific ground investigation. Figure D5 illustrates a plot of the UCS strength values versus depth below ground level. Based on this information an unconfined compressive strength (UCS) of 15MPa is used in the calculation, this value is the lower bound UCS value.

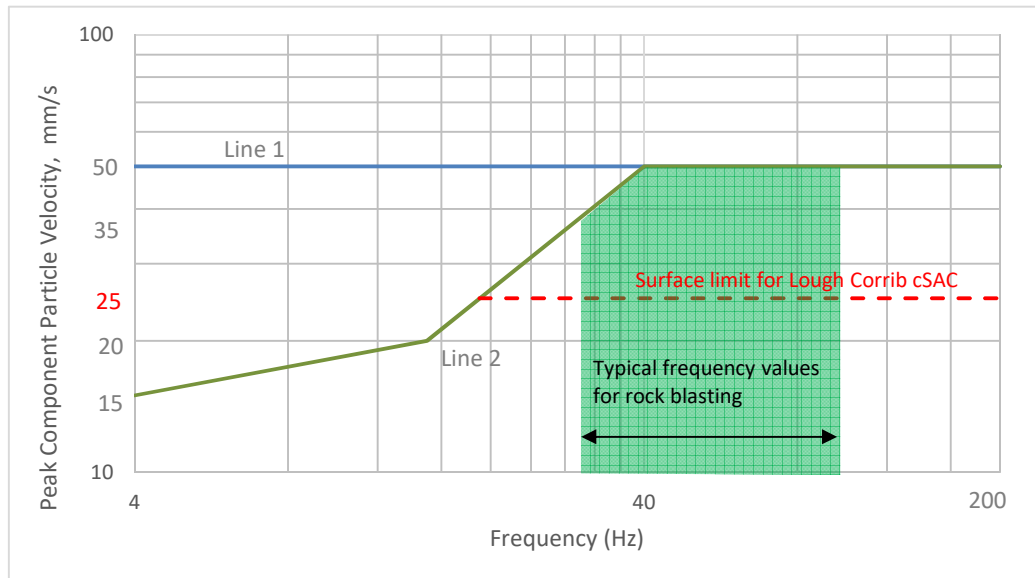
Figure E3 - (reproduced from BS7385: Figure 1 - Transient vibration guide values for cosmetic damage)
