Appendix 13.1

**Soil and Hydrogeological Investigation (K.T. Cullen & Co. Ltd) &
Hydrogeological Assessment for Hammond Lane Metal Company**

SOIL AND HYDROGEOLOGICAL INVESTIGATION

Greenfield Site,
Ringaskiddy,
Co. Cork,

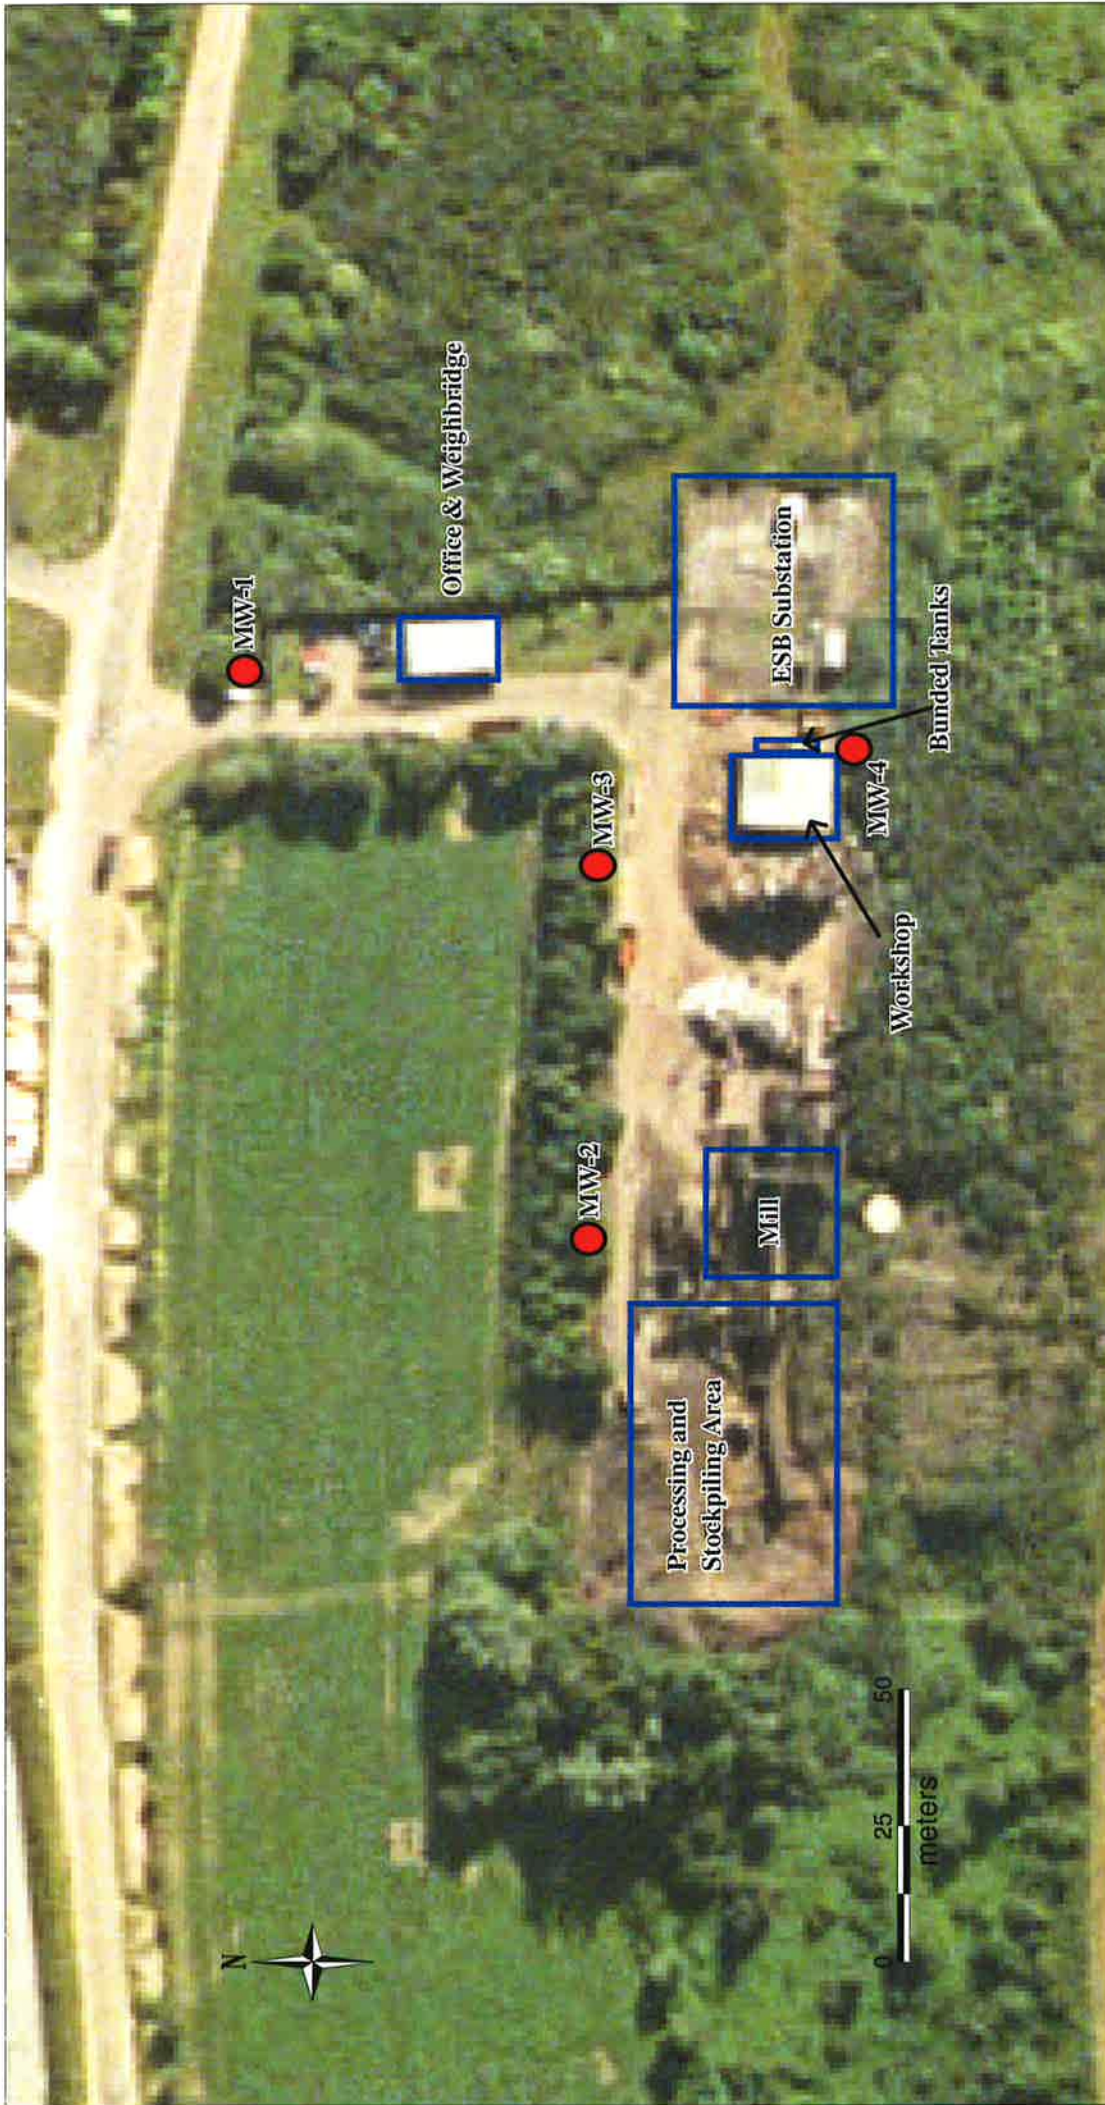
<p>CLIENT</p> <p>Hammond Lane Metal Co.</p>	<p>Legend</p> <p>● Groundwater Well</p>	<p>FIGURE No.</p> <p>2.2</p>
<p>TITLE</p> <p>Site Layout</p>	<p>SCALE</p>

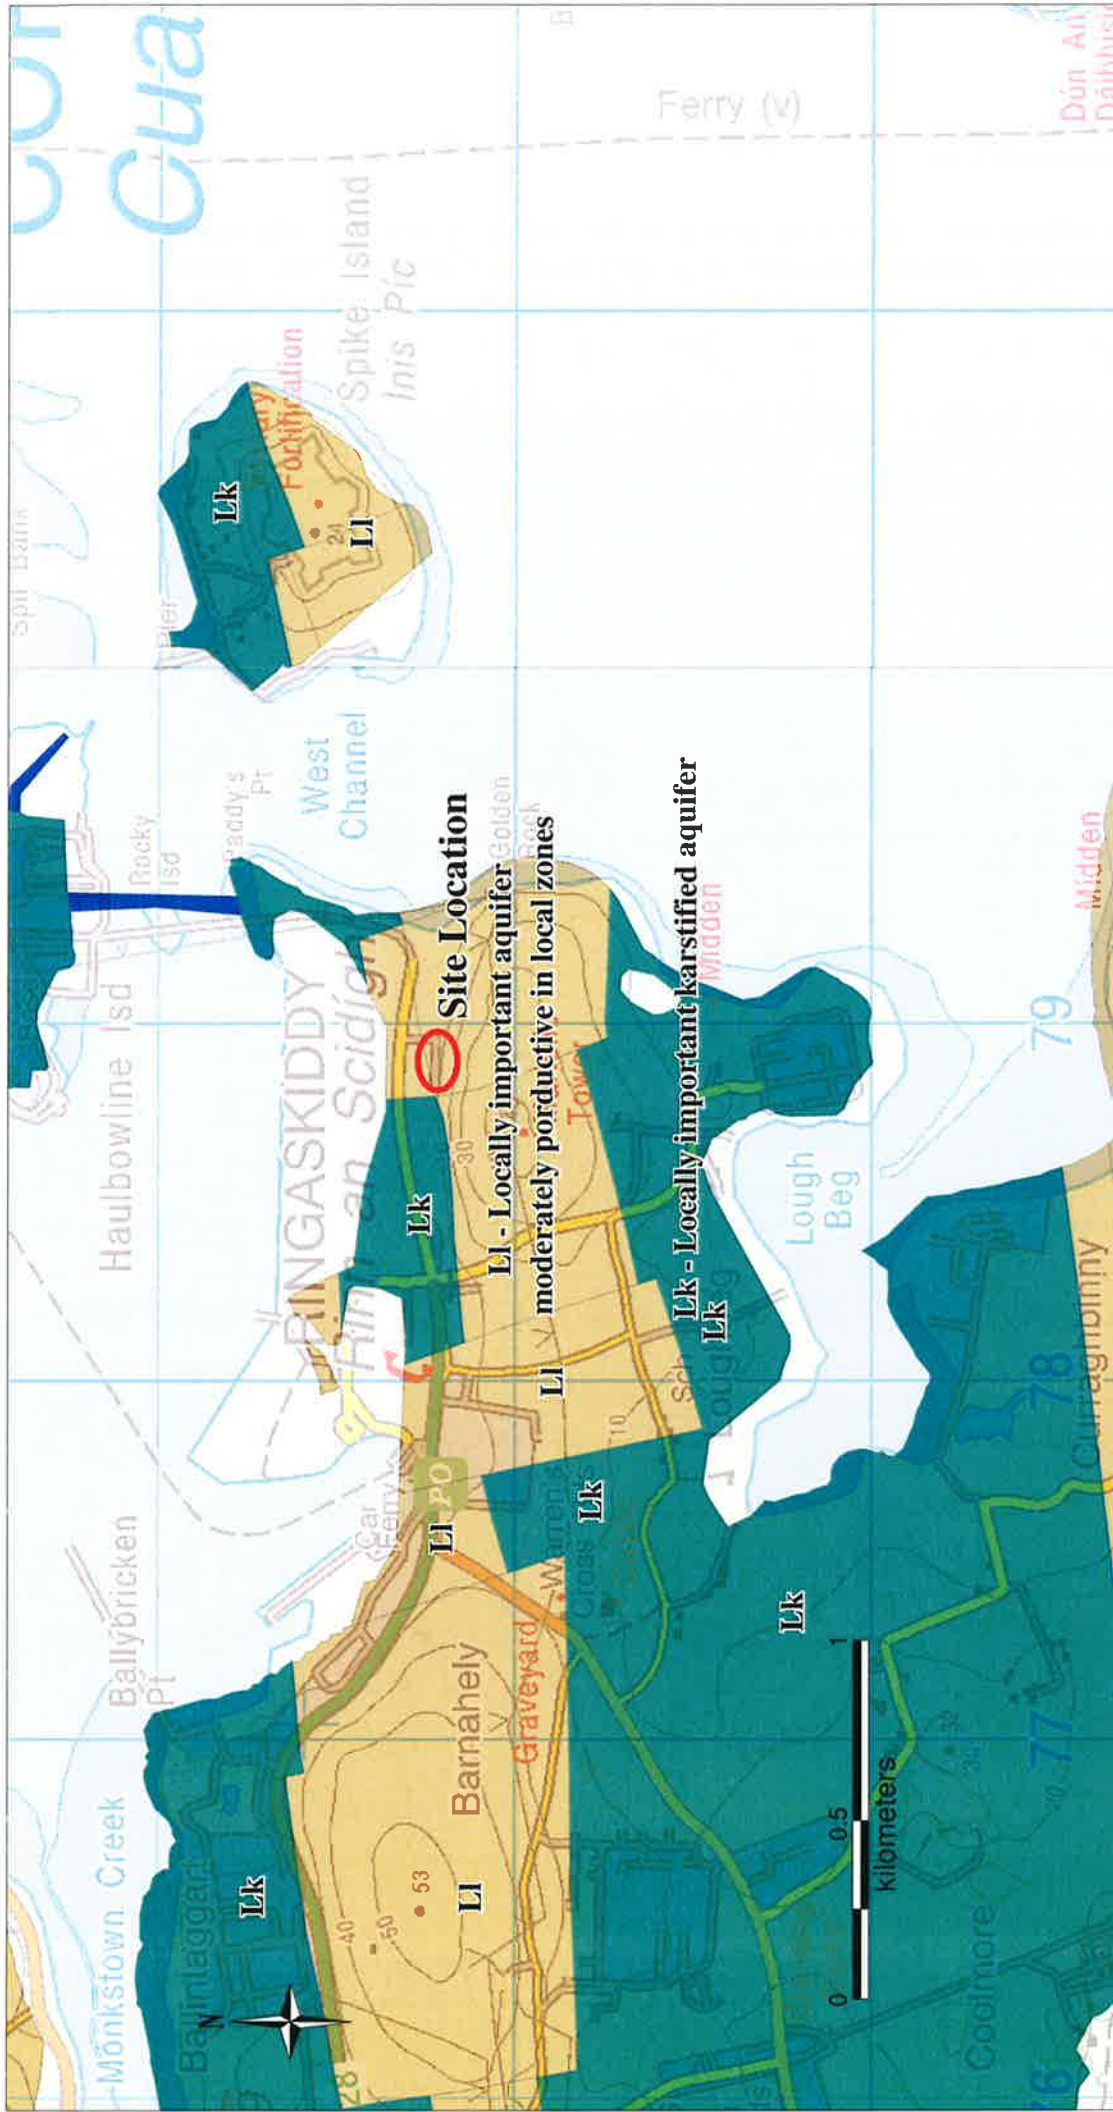
<p>O' Callaghan Moran & Associates. Granary House, Rutland Street, Cork, Ireland. Tel. (021) 4321521 Fax. (021) 4321522 email : info@ocallagh Moran.com</p> <p>environmental management for business</p>		CLIENT Hammond Lane Metal Co.		Legend Aquifer Classification <div><div>Lk</div><div>LI</div><div>Unclassified</div></div>	
<p>This drawing is the property of O'Callaghan Moran & Associates and shall not be used, reproduced or disclosed to anyone without the prior written permission of O'Callaghan Moran & Associates and shall be returned upon request.</p>		TITLE Aquifer Classification		FIGURE No. 2.5	
				SCALE

The GSI has developed a classification system for aquifers based on the value of the resource and the hydrogeological characteristics. The bedrock aquifer beneath the site is characterised by the GSI as a Locally Important Aquifer (**LI**), which is moderately productive in local zones. The aquifer classification is illustrated on Figure 2.5.
