## Coastal Erosion Study

# Ringaskiddy Resource Recovery Centre

## Environmental Impact Statement

Reference: 13.3 Coastal Erosion Study, Arup (2025)

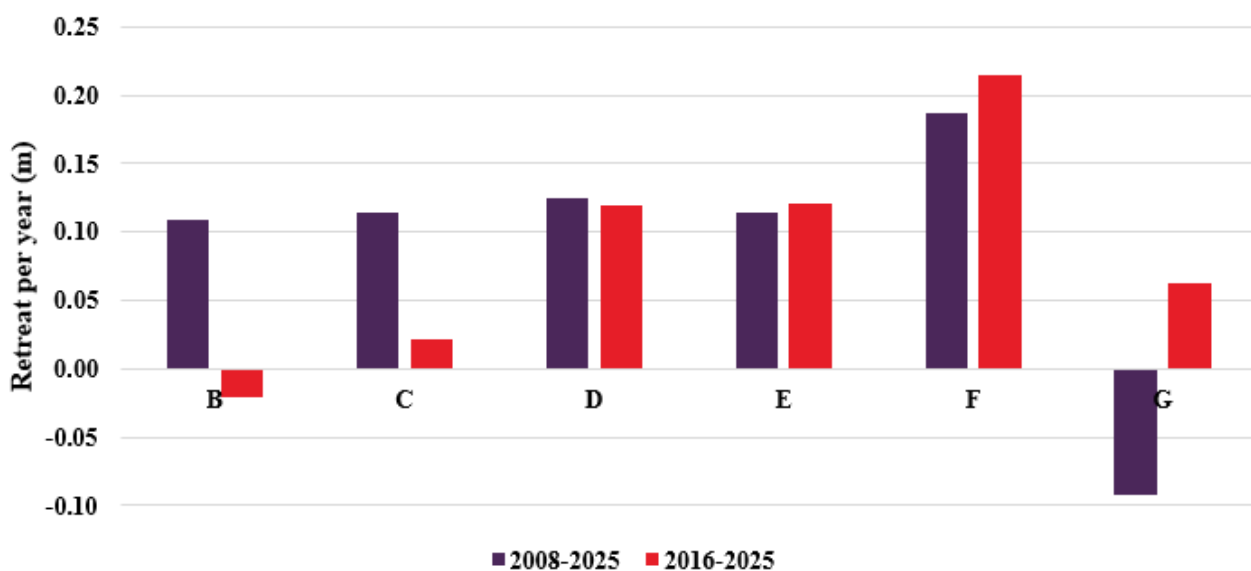
**Figure 3 Retreat per year of the toe of cliff line over the latest and global monitoring period**

A summary of the evolution of the cliff toe line is shown in **Table 2** and **Figure 3**.

Section	Retreat			
	2008 to 2025 (m)	Retreat per year 2008 to 2025 (m/year)	2016 to 2025 (m)	Retreat per year 2016 to 2025 (m/year)
<b>B</b>	1.86	0.11	-0.36	-0.02
<b>C</b>	1.93	0.11	0.36	0.02
<b>D</b>	2.13	0.13	2.02	0.12
<b>E</b>	1.93	0.11	2.06	0.12
<b>F</b>	3.18	0.19	3.66	0.22
<b>G</b>	-1.56	-0.09	1.06	0.06
<b>Average</b>	<b>1.58</b>	<b>0.09</b>	<b>1.47</b>	<b>0.09</b>

Note: (+) retreat represents erosion of the cliff toe while (-) retreat represents accretion

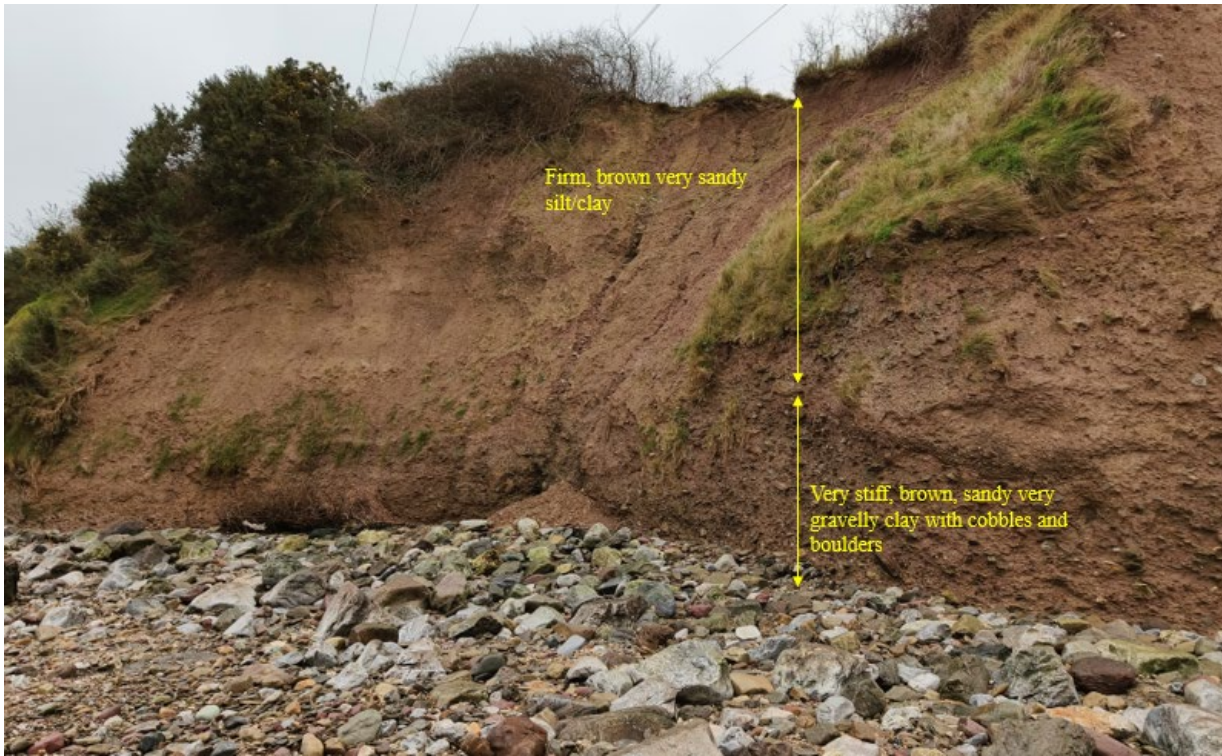
During the site walkover the cliff face was noted as having fresh unvegetated slumps and landslide features along the extent of the proposed development coastal boundary. Upon inspection of these features, it appeared that the slumped material and the material in the slope scarps is silty and sandy in consistency. The slump and landslide features become more substantial as the height of the cliff rises towards the southern boundary. A stiff/hard brown sandy very gravelly clay with cobbles and boulders was visible in areas at the toe of the slope where it was not covered by slumped material. The overlying material comprises of firm brown, very sandy silt/clay.

**Figure 5 Representative cross section of the stratigraphic profile of the eastern coastal cliff boundary**

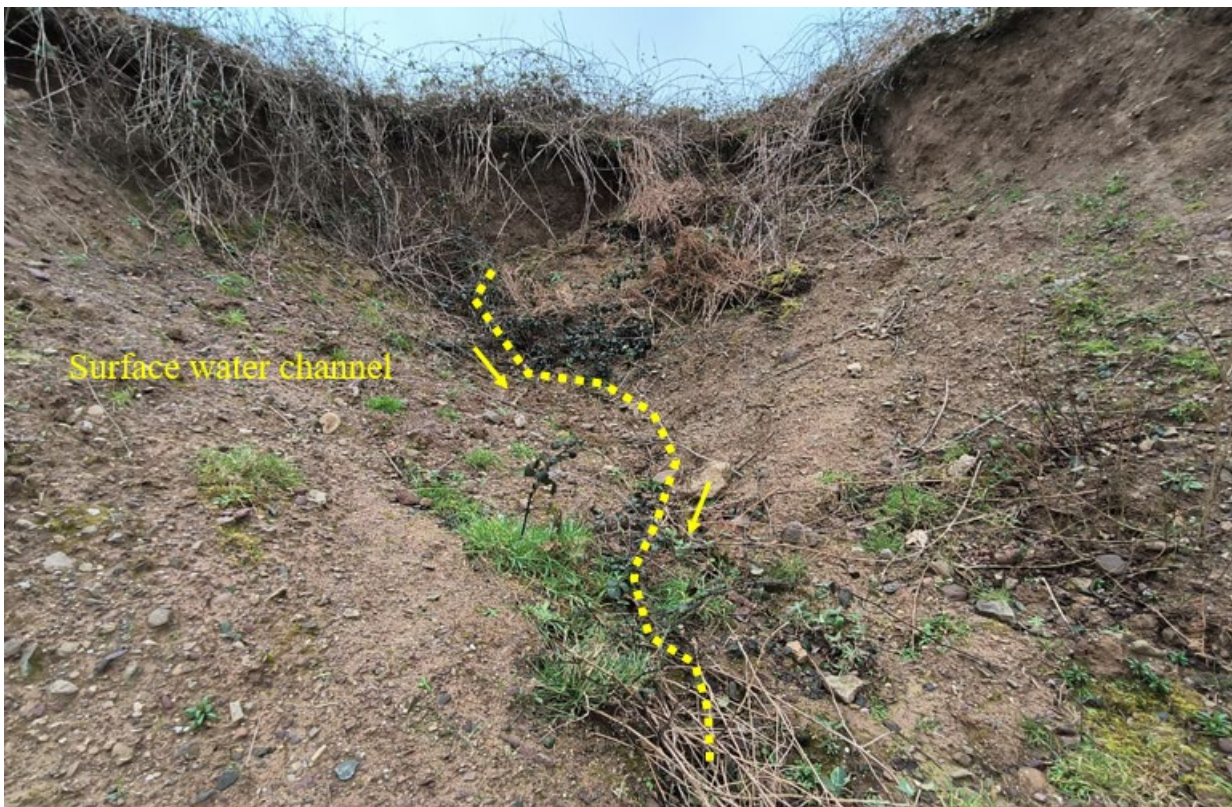
Erosion at the toe of the cliff face was noted and notching evident as outlined in **Figure 6**. There is evidence of overland water flow down the cliff face and is likely to contribute to slope failure. Surface water from the top of the cliff was recorded flowing through a landslide scarp and in other areas surface water channels are evident on the cliff face. Groundwater seepages were noted at the toe of the cliff slope.

**Figure 6 Surface water channel in a landslide scarp**

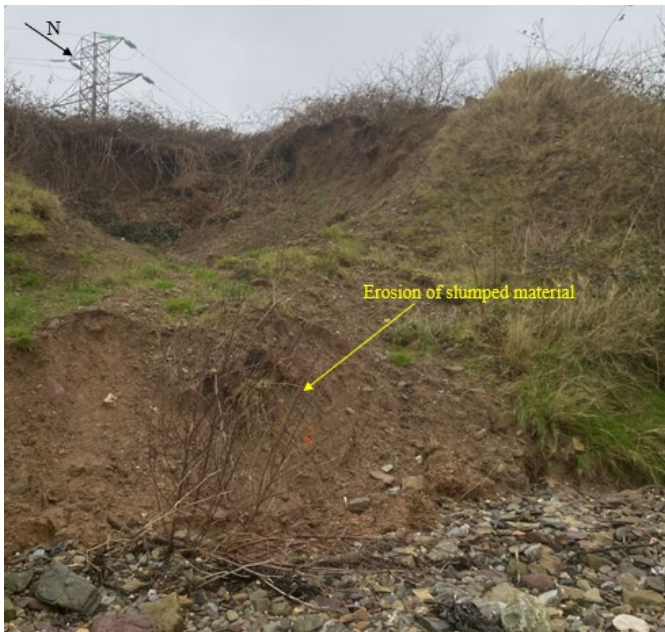
A larger landslide was recorded at the southern boundary of the site, which is the same failure that was recorded in 2016 between Section F and G. This landslide occurs at a 10m high cliff section and has a bowl like morphology with steepened side slopes. The landslide presents as a global slip of material. A surface water channel runs through the failure and the slumped material at the toe has been eroded.

**Figure 7 Landslide between Section F and G**

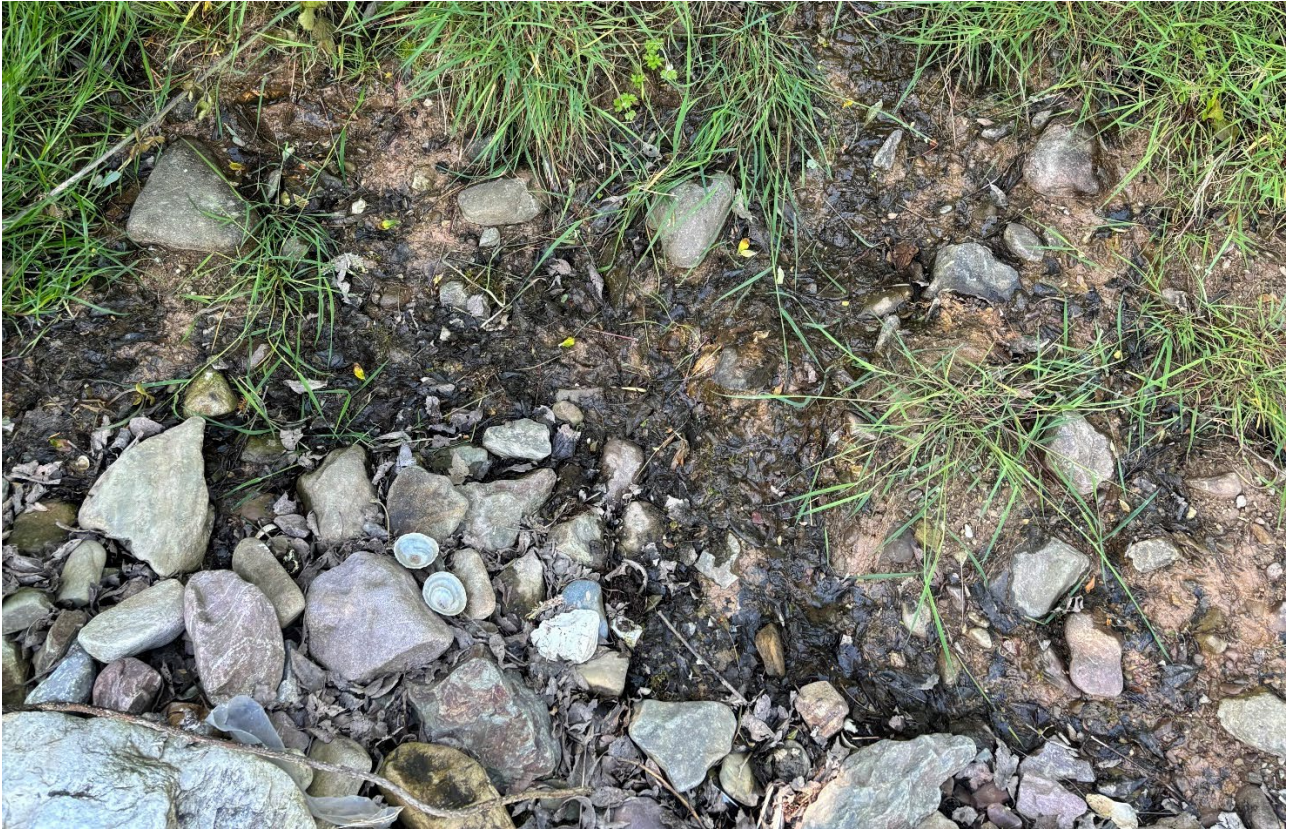
Despite the dry weather, the cliff toe appeared saturated at a number of locations along much of the beach, and a number of groundwater seepage springs were observed (see **Figure 8** as one example from the site visit report), indicating ongoing subsurface hydrological activity independent of the lack of rainfall.

**Figure 8 View of the seepage at the cliff toe mid-way between cross-sections E and F**

The findings of the 2016 site walkover, conducted after a season of intense rainfall and storms, along with the persistent groundwater seepage observed at the cliff toe during the 2025 walkover, despite prolonged dry conditions prior to the site walkover, seem to indicate that subsurface hydrological activity is ongoing through the cliff face. This seepage contributes to internal weakening of the slope, promoting instability even during dry weather periods, as observed in the 2025 site walkover.

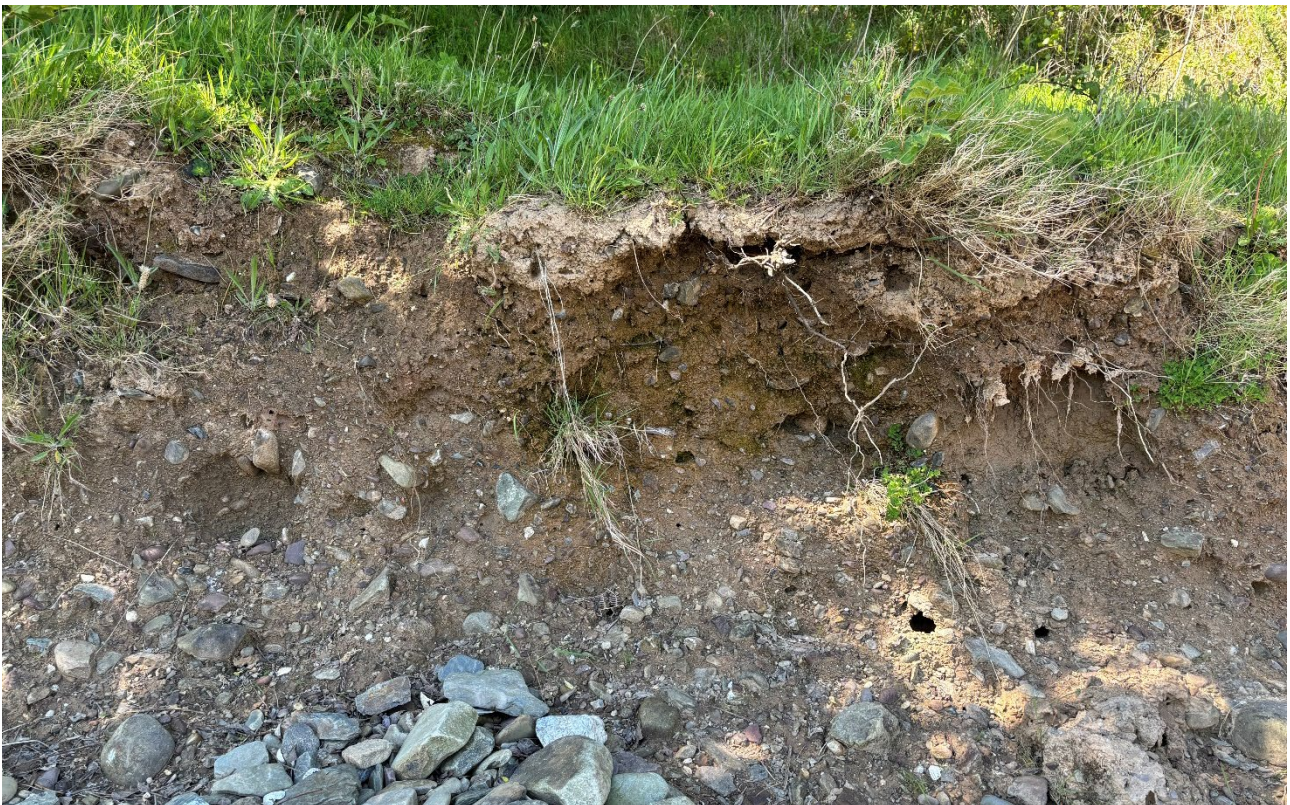
Several minor cliff failures were also observed, along with evidence of toe notching (see **Figure 9** as one example from the site visit report). Combined with the absence of vegetation at the cliff base, this suggests that the toe is periodically reached and influenced by tides and waves.

**Figure 9 View of cliff toe notching at cross-section D**

Furthermore, evidence of toe notching in the 2025 site walkover, combined with an absence of vegetation at the cliff base, suggests that wave action periodically reaches and erodes the cliff toe. This undercutting of the cliff face likely exacerbates slope instability and contributes to global cliff failures.

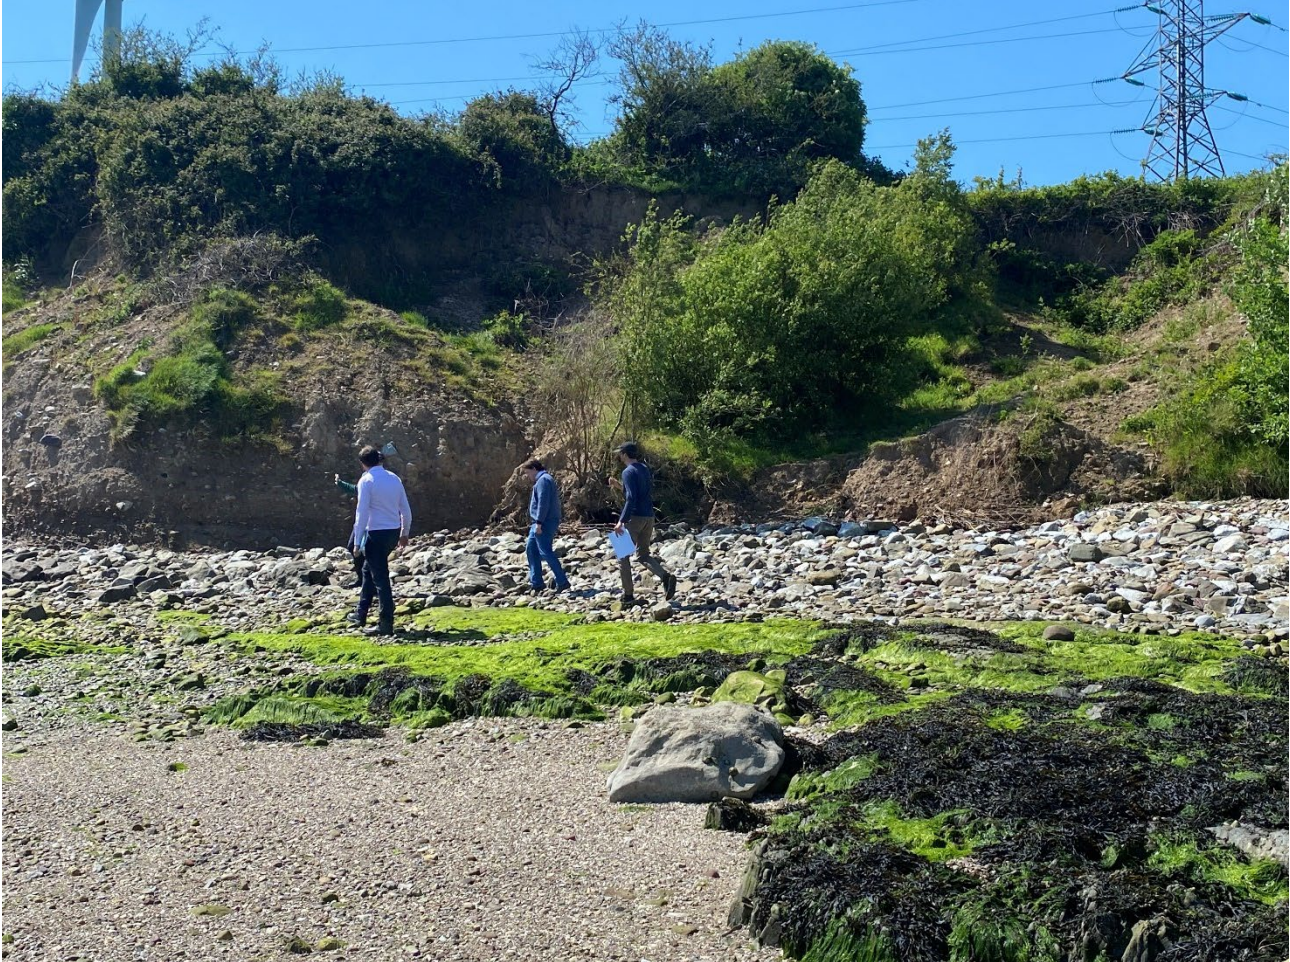
The significant cliff failure identified in the 2016 site walkover (refer to **Section 2.3.1**) and the topographic survey assessment (refer to **Section 2.2**), can be seen in **Figure 10**. Exposures of the underlying mudstone/sandstone bedrock (as identified in the GI for the area) were noted along the beach in this section.

**Figure 10 View of the cliff face between Sections F and G**

The apparent underlying mudstone/sandstone bedrock (as identified in the GI for the area) observed during the 2025 site walkover along the beach in front of the significant cliff failure between Sections F and G, is expected to limit the rate of future beach erosion along this section by limiting the impact of wave action.

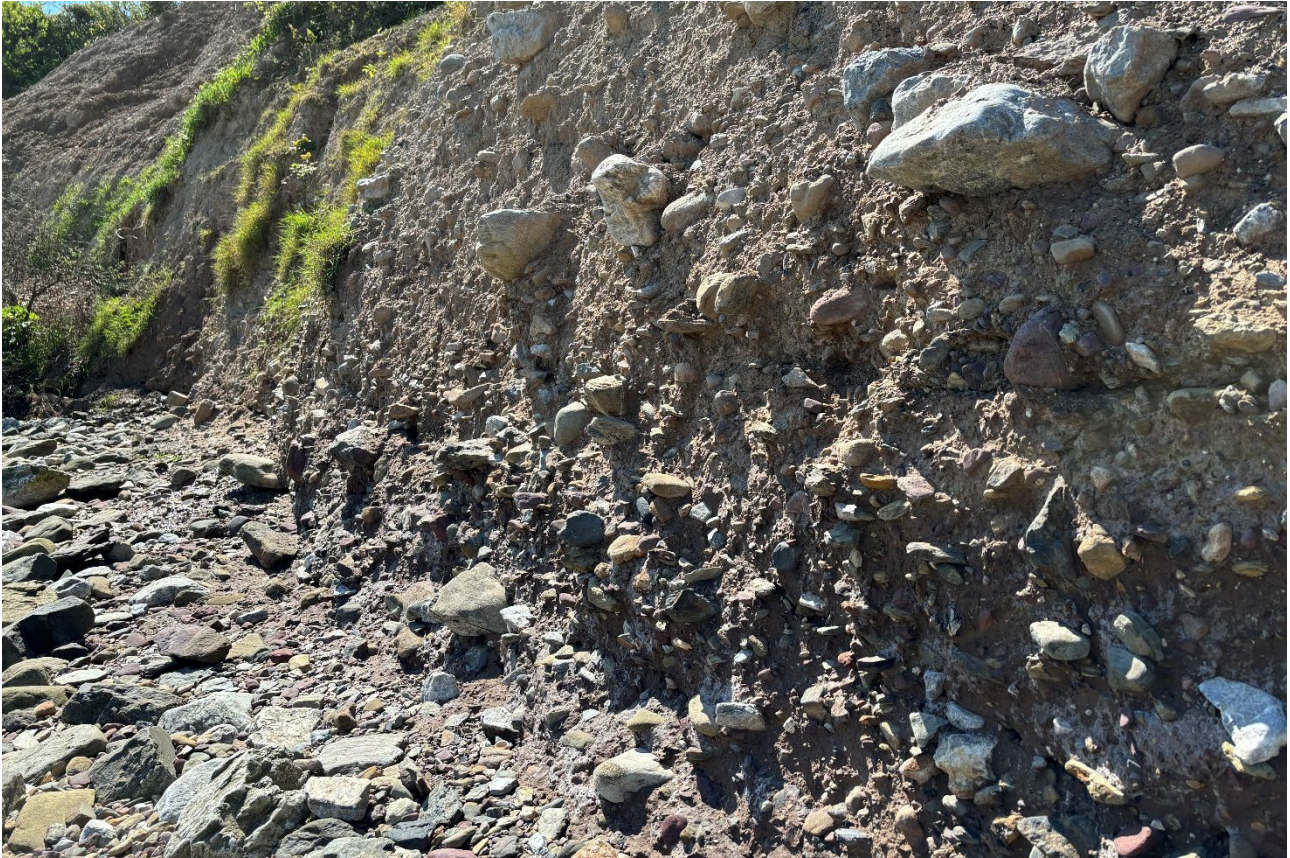
Just south of cross-section G, a distinct material change in the cliff face is observed. A very stiff/hard sandy very gravelly clay with many cobbles and occasional boulders extending approximately 1m above beach level was observed along the cliff toe, sloping gently downwards from south to north. This layer is an over consolidated glacial till and is significantly stiffer and more granular than the overlying strata (see **Figure 11**).

**Figure 11 View of the cliff face south of cross-section G**

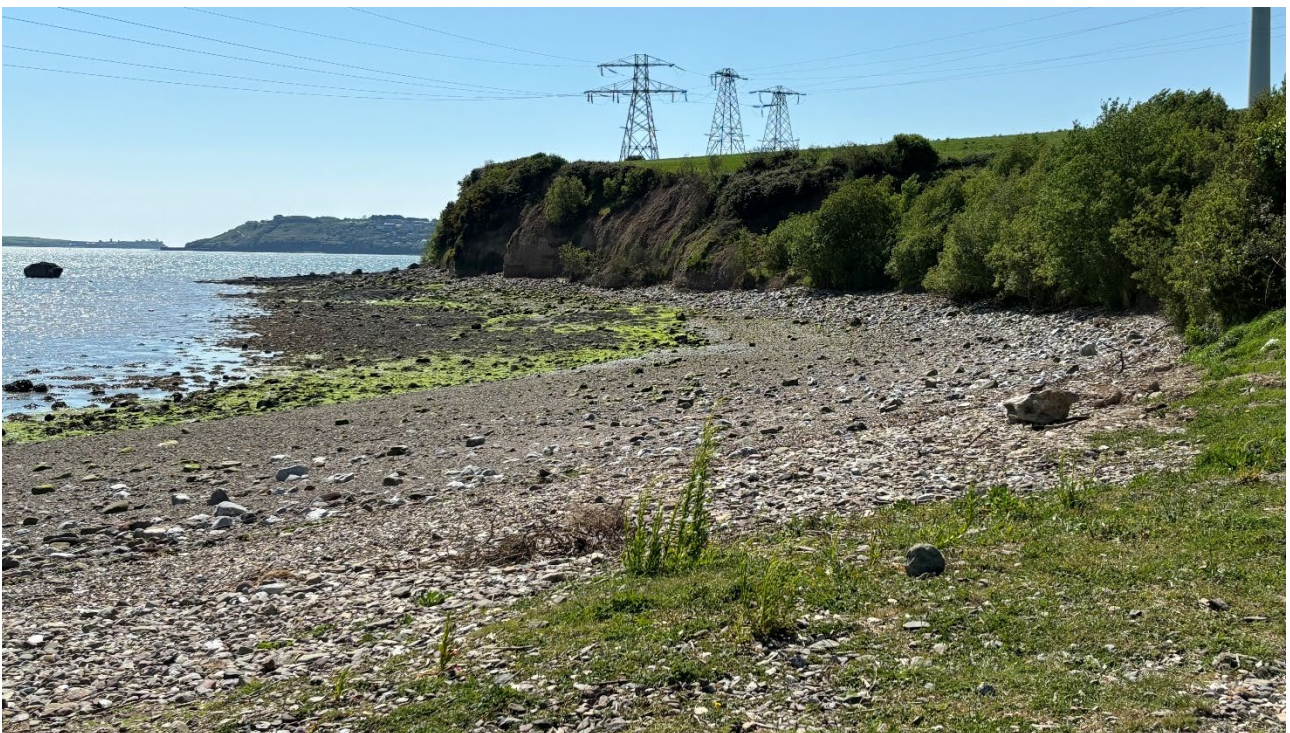
**Figure 12 View of Gobby Beach and cliffs, looking south from the car park beach access ramp**

Two distinct zones were identified in the superficial composition of Gobby Beach (see **Figure 10** and **Figure 12**). The upper section of the beach varies in width and is characterised by shingle, rocks, and boulders. In contrast, the lower section comprises predominantly shingle and silty sand with occasional rock outcrops. The beach profile exhibits a gentle lower slope and steeper upper slope at the toe of the cliff.

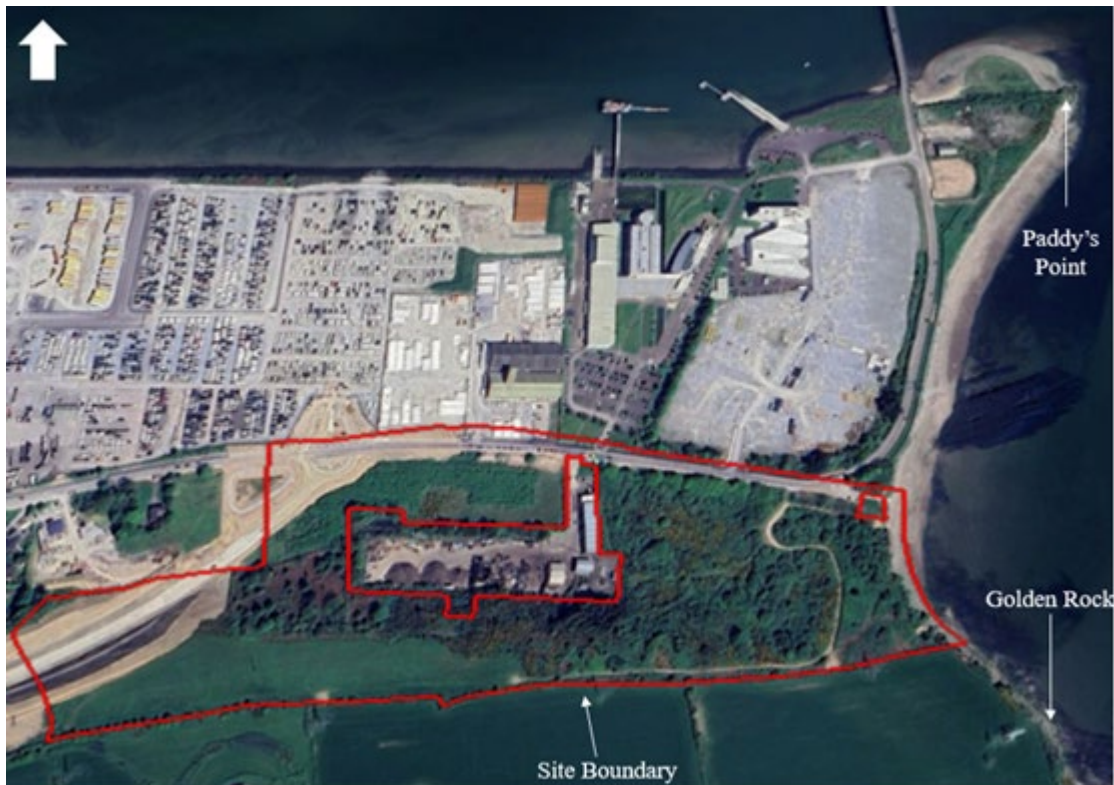
**Figure 14 Indaver Site Aerial Photo - Source: Google Maps. - ©2014 Google**

The coastal boundary of the Indaver site is a small area (approximately 150m in length) of a larger bay situated to the west of Cork Harbour located between Paddy’s Point and Golden Rock. In larger context this particular area is less likely to erode due to both its sheltered protection by rock outcrops (Paddy’s Point and Golden Rock) and its convex layout shape.

The eastern coastal boundary is formed by a glacial till slope. Based on the 2025 topographic survey, the toe of the slope varies from 2.7m OD at the northern end to 1.8m OD at the southern end. The top of the slope varies from 3.0m OD at the northern end to 11.6m OD at the southern end. There are rock outcrops to the north and south of the site. Mean High Water Springs (MHWS) is 1.62m OD (4.20m Chart Datum (CD)) at the site.

The site is sheltered from open sea waves but is fully exposed to wind generated waves from the second quadrant (from east to south) and a large proportion of wind generated waves from the first directional quadrant (from north to east).

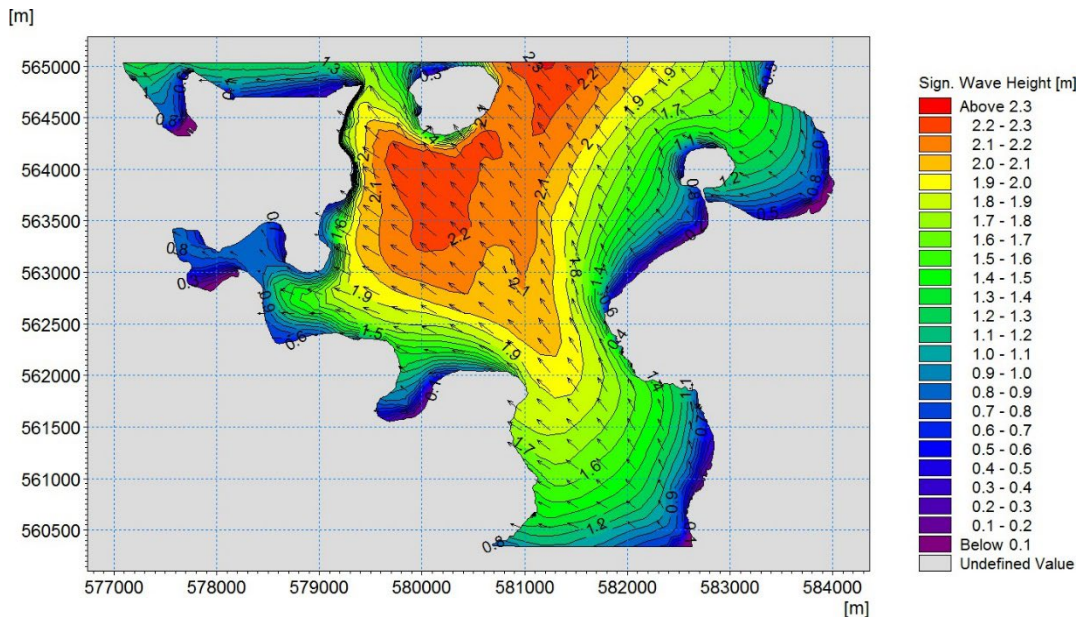
Direction	Case Number	Case	Wind Conditions		Nearshore Wave Conditions	
			Velocity (ms <sup>-1</sup> )	Duration (min)	Wave Height (m)	Period (s)
SE	2.1	MHWS + MRFS	28.3	10	1.0	4.1

**Figure 23 Offshore wave height distribution - Case 2.1 Waves from the SE**

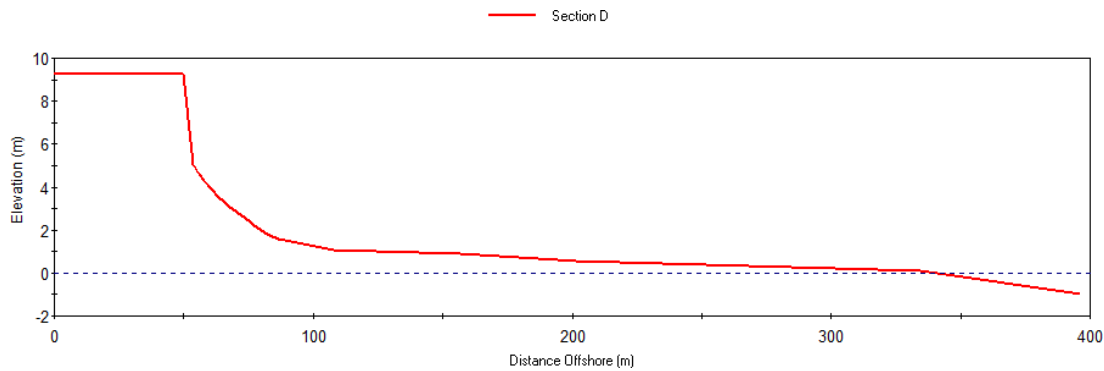
A section of coast derived from the November 2014 topographic survey was input into the SBEACH model as a reach. **Figure 34** shows a typical profile with MHWS conditions. **Figure 35** shows the reach profile for section D.

**Figure 35 Reach for Section D derived from Nov. 2014 survey**

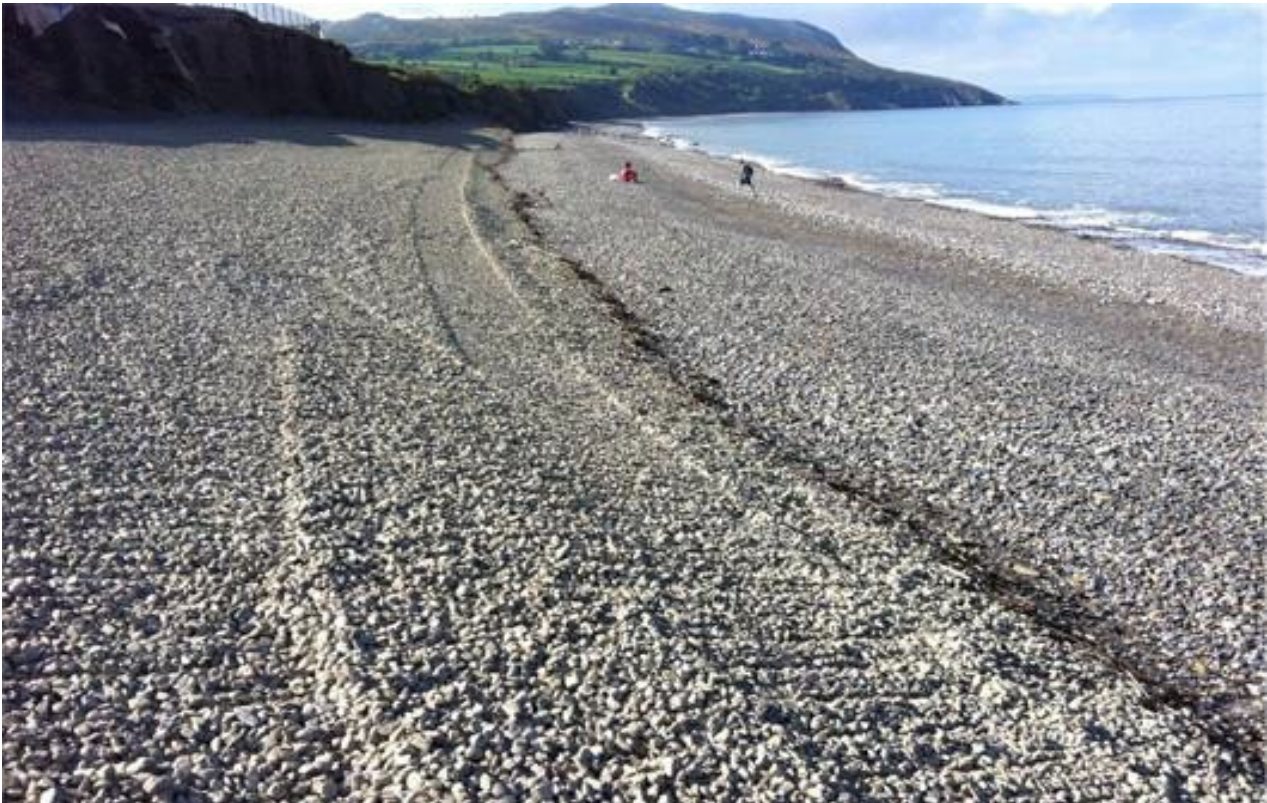
**Figure 41 Completed beach nourishment works at Greystones in the area between the revetment and the Gap Bridge. Site visit 25 May 2014**

A continuous monitoring and observation of natural evolution has been carried out at Greystones beach since 2008, when a previous beach nourishment campaign was undertaken. The monitoring campaign is ongoing

but early indications are that the additional material placed at the toe of the cliffs has been beneficial for the cliffs.

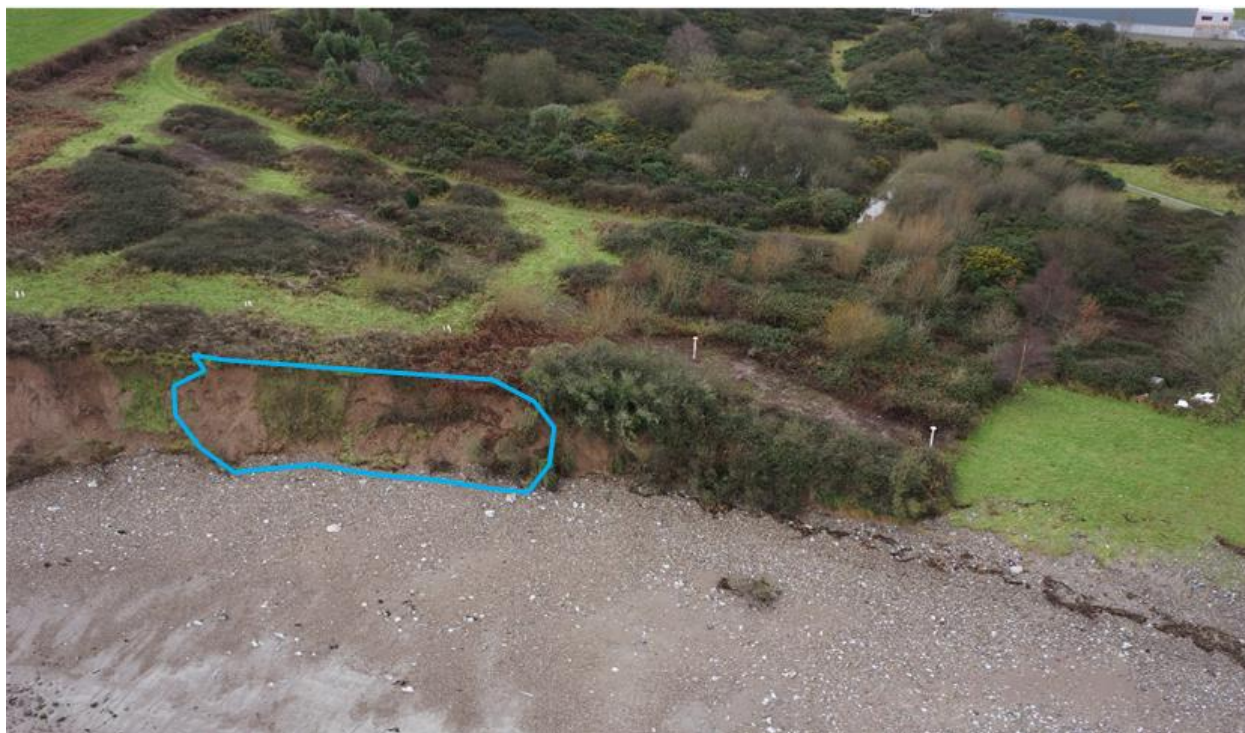
In January 2016 Indaver commissioned a drone survey of the coast adjacent to the proposed development site. **Figure 1** and **Figure 3** below show two areas where significant slope failures occurred. The first area shown in **Figure 1** (circled in blue) is approx. 20m long and cliff height is roughly 2 to 3m. This area is located approximately 50m south of the car park. The second area shown in **Figure 3** (circled in blue) is a further 20m south and is approximately 40m in length and cliff height is roughly 7 to 9m.

**Figure 1 Drone photography showing first area of slope failure and minimal damage to the beach north of this location**

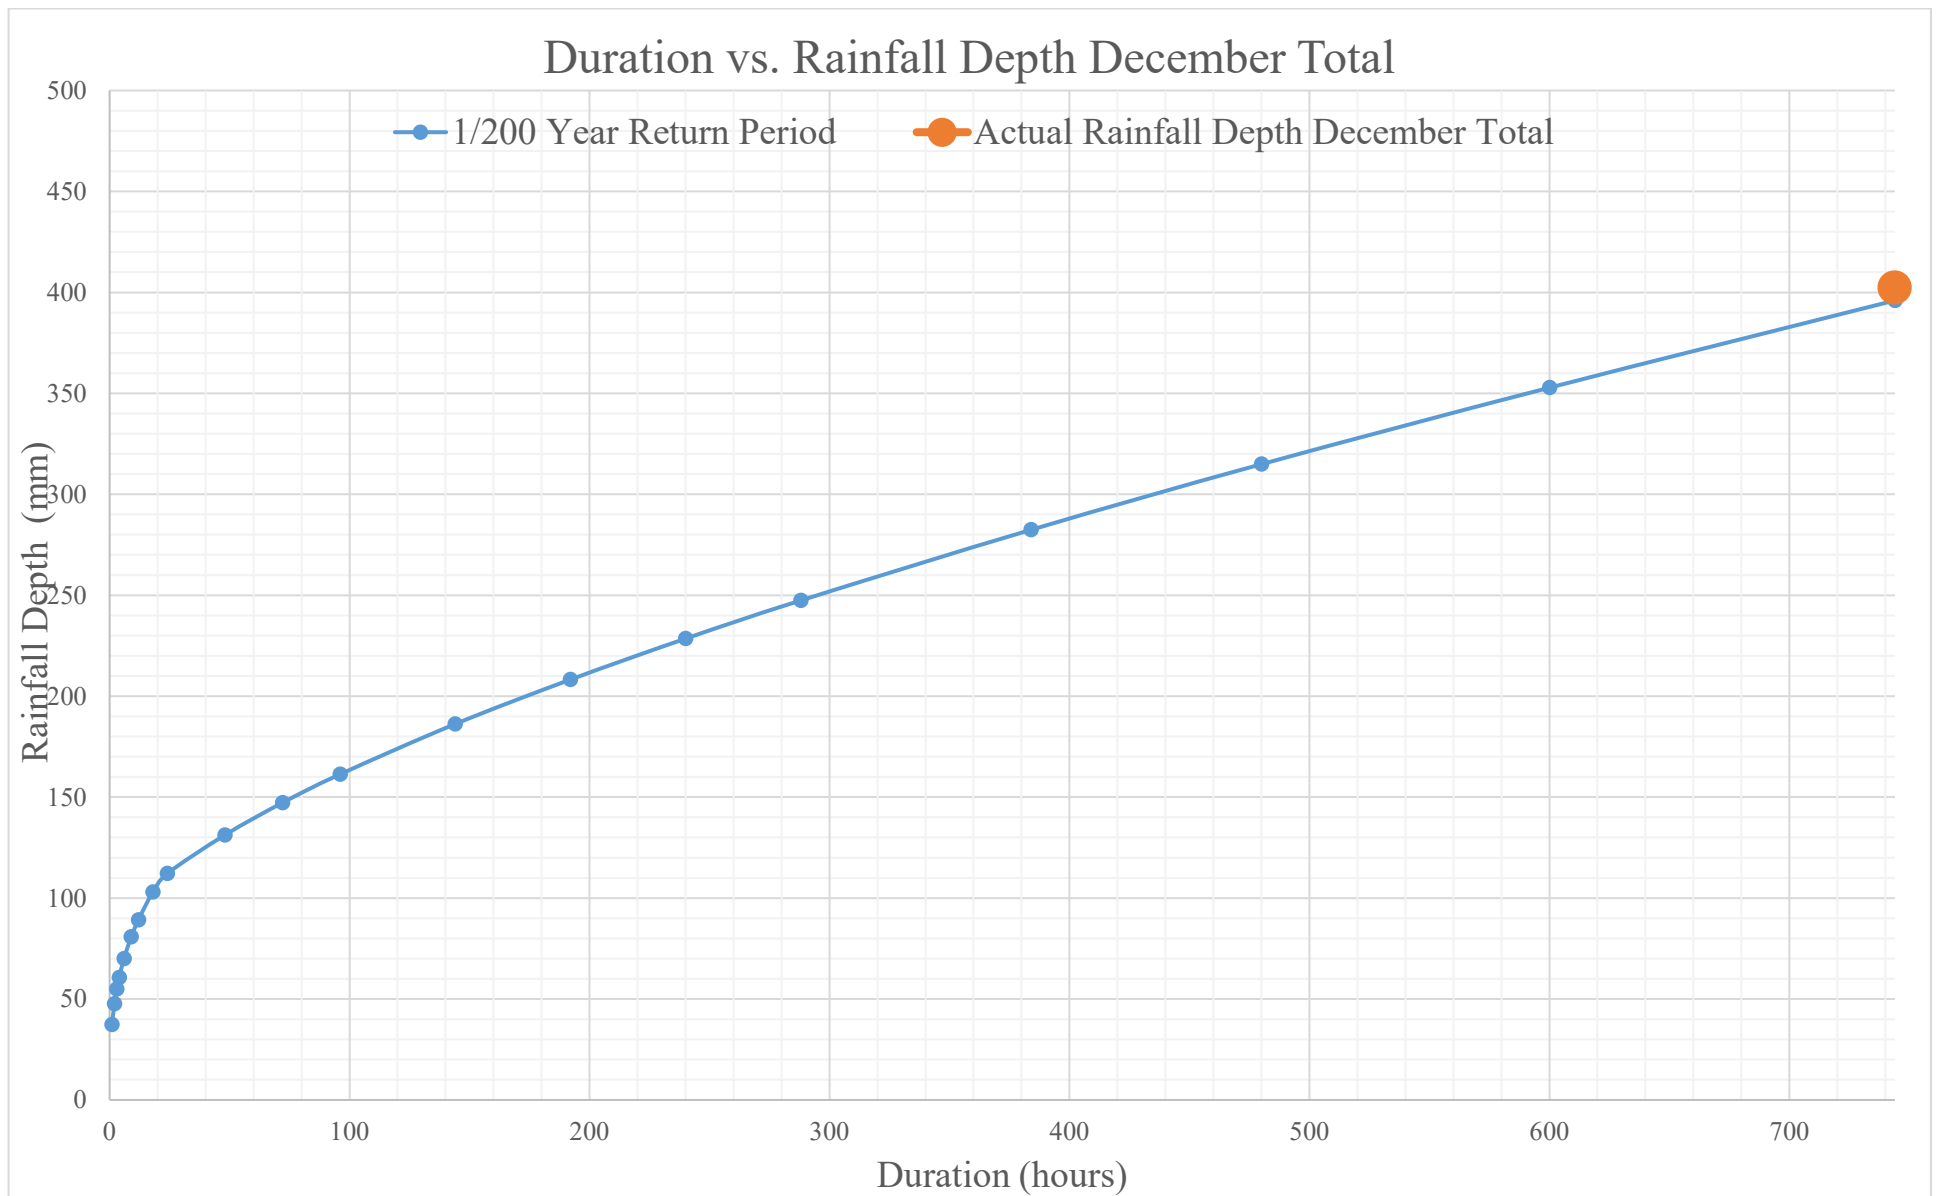
**Figure 2 Depth duration graph for 1 in 200 year rainfall event**

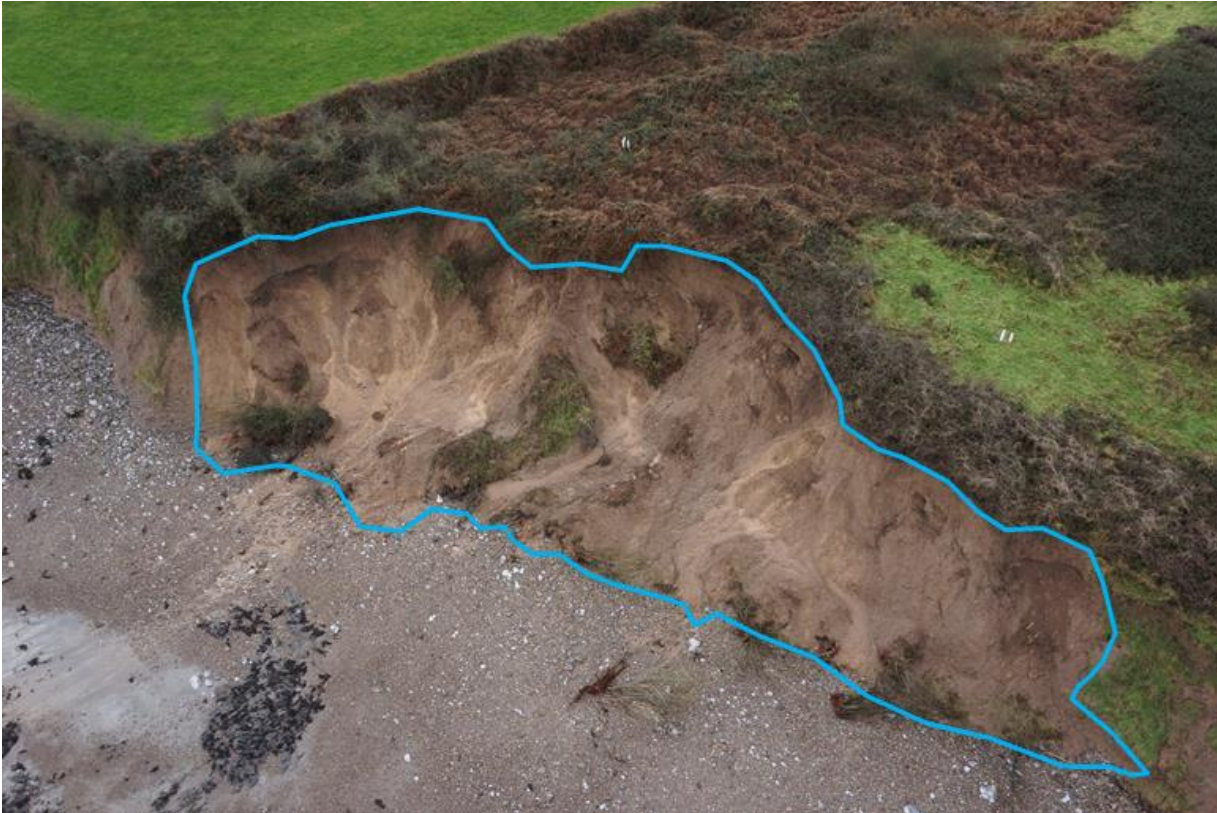
**Figure 3 Drone photography showing slope failure to the southern section**

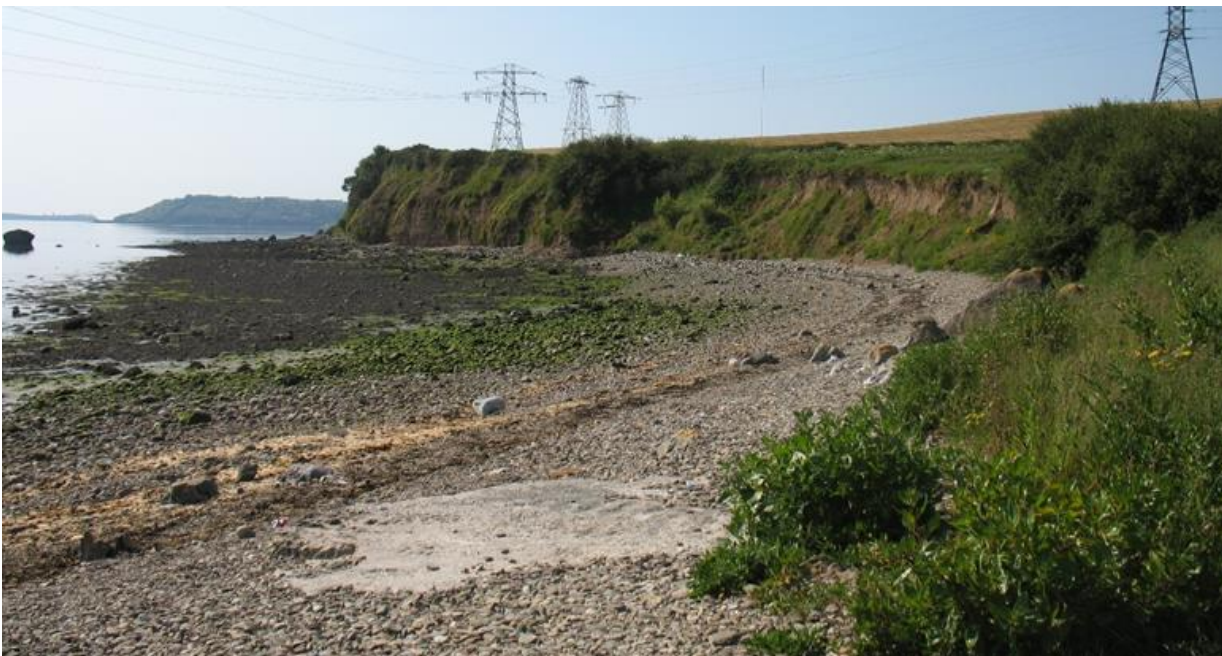
**Figure 4, Figure 5 and Figure 6** below show the affected area to the south of the beach as recorded in June 2009, September 2015 and December 2015. From the imagery it is clear that there has been localised slope failure between 2009 and 2016. Minor erosion occurred between June 2009 and June 2015 and a large slope failure occurred between September 2015 and December 2015. The nature and timeline of the failure will be discussed further in the following sections.

**Figure 4 Cliff adjacent to proposed development site, June 2009**

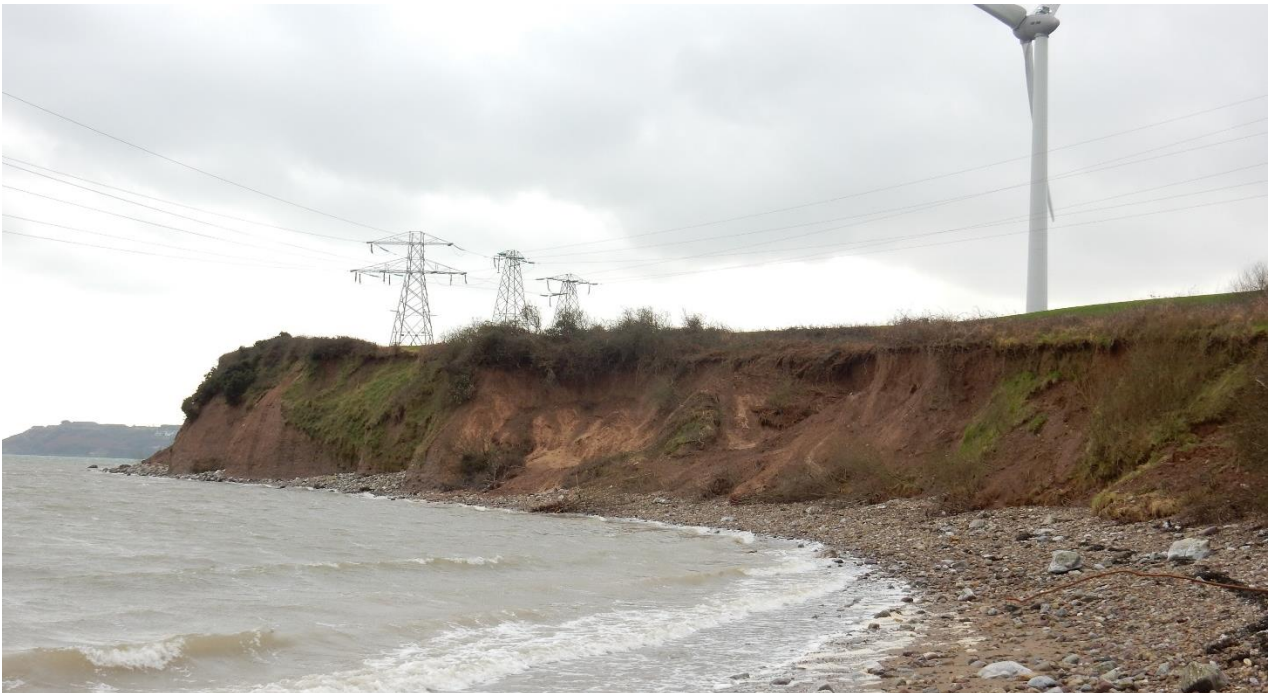
**Figure 6 Cliff adjacent to proposed development site, December 2016 following failure**

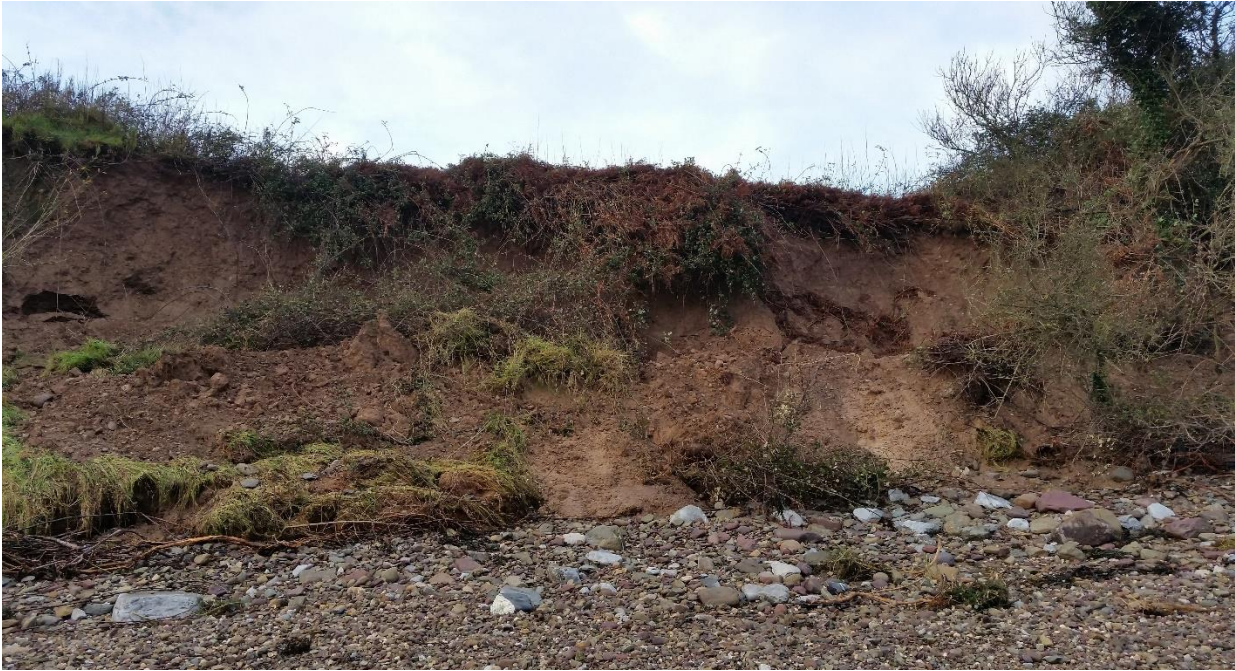
**Figure 7** and **Figure 8** below show the two areas of slope failure as described previously.

**Figure 7** First area of slope failure approximately 50m south of car park

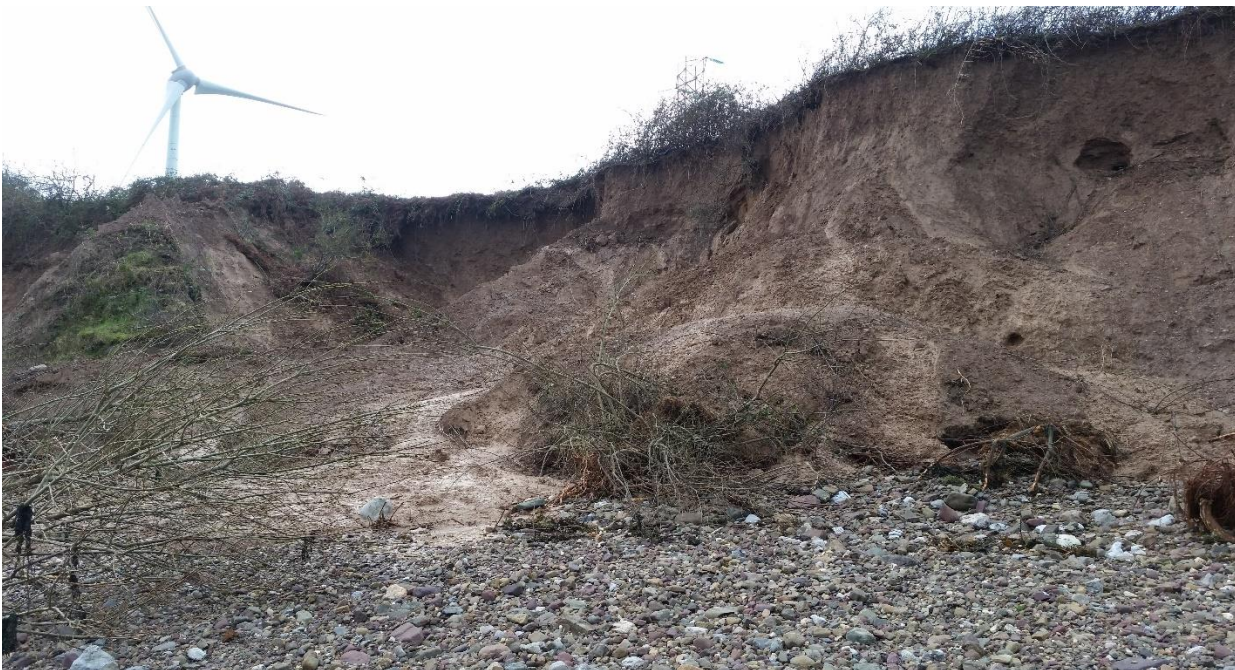
**Figure 8** Second area of slope failure further 20m south

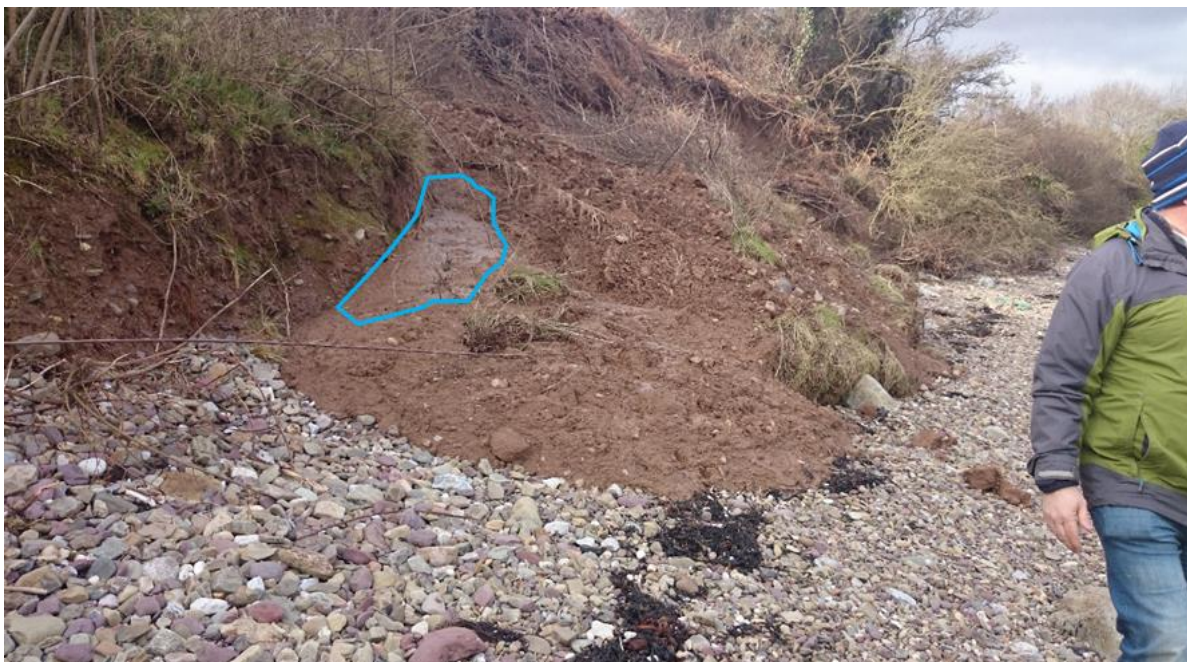
**Figure 9 Water running out of the slope failure**
