## Coastal Erosion Study

# Ringaskiddy Resource Recovery Centre

## Environmental Impact Statement

Reference: 13.3 Coastal Erosion Study, Arup (2025)

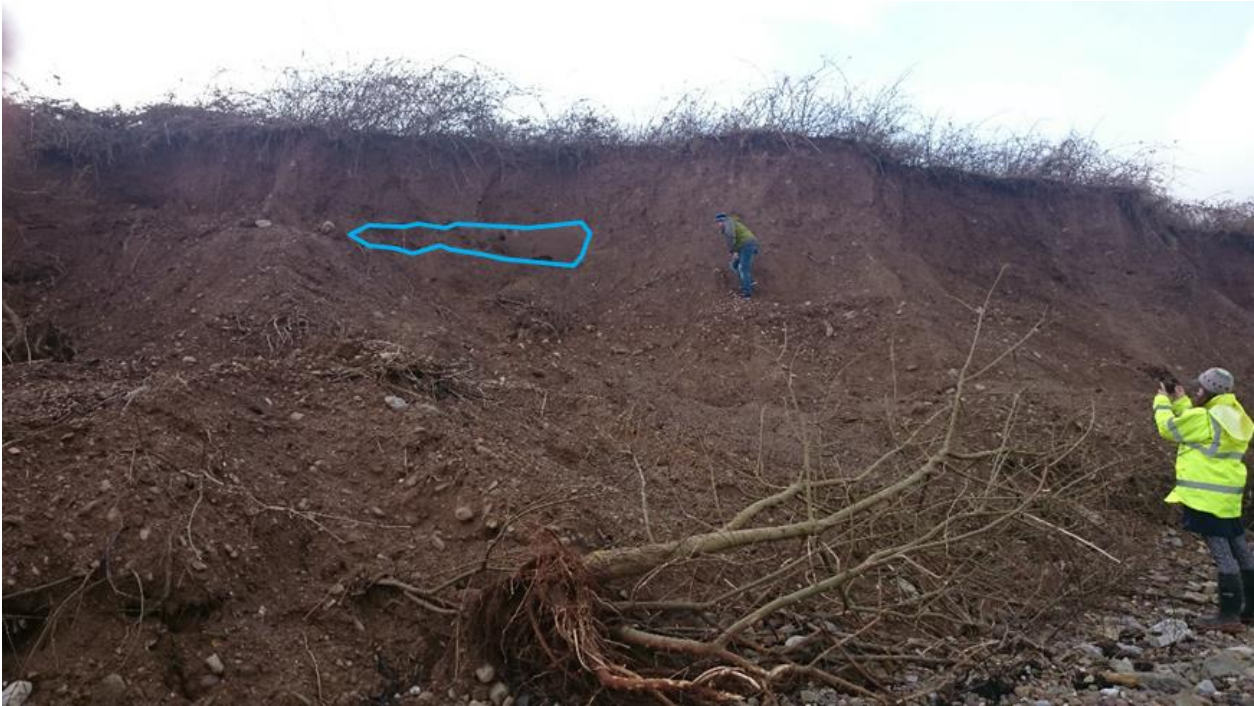
**Figure 10 Sand lens in the slope failure**

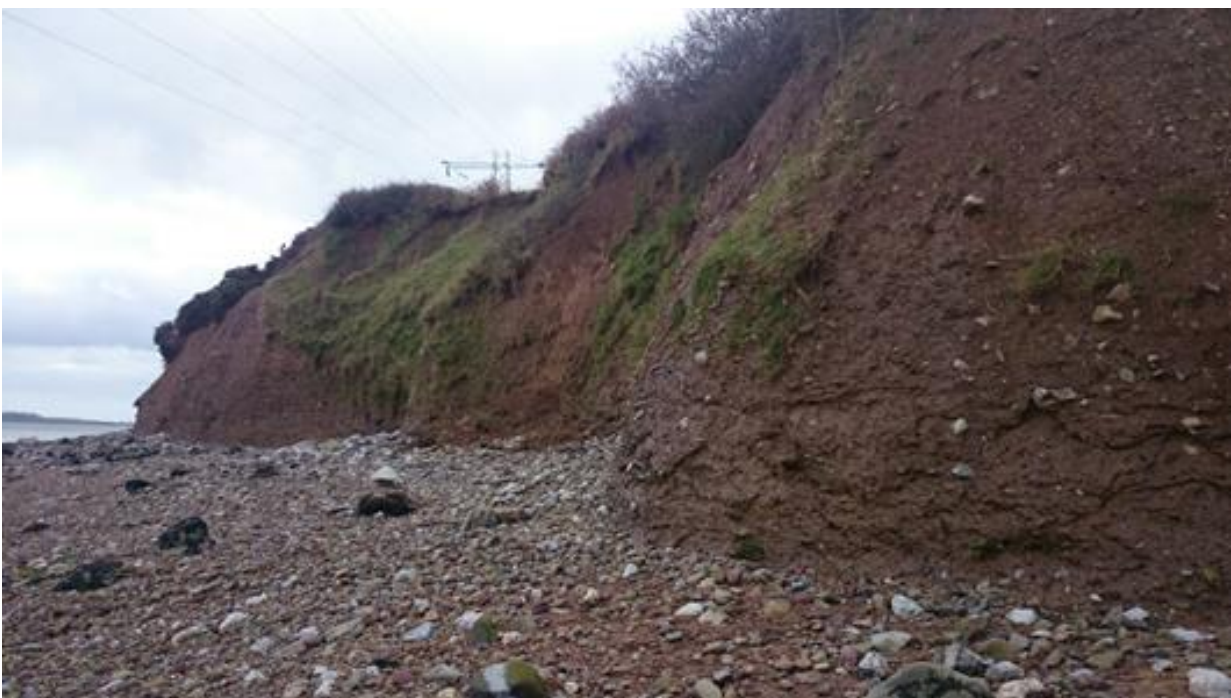
- There was no evidence of any significant coastal erosion at the bottom of the cliffs. They did not have a ‘notched’ shape at the bottom and overall the beach shingle was high up on the beach covering the toe of the cliff. (Refer to **Figure 11**)

**Figure 11 Currently no evidence of 'notching' at the bottom of these cliffs**

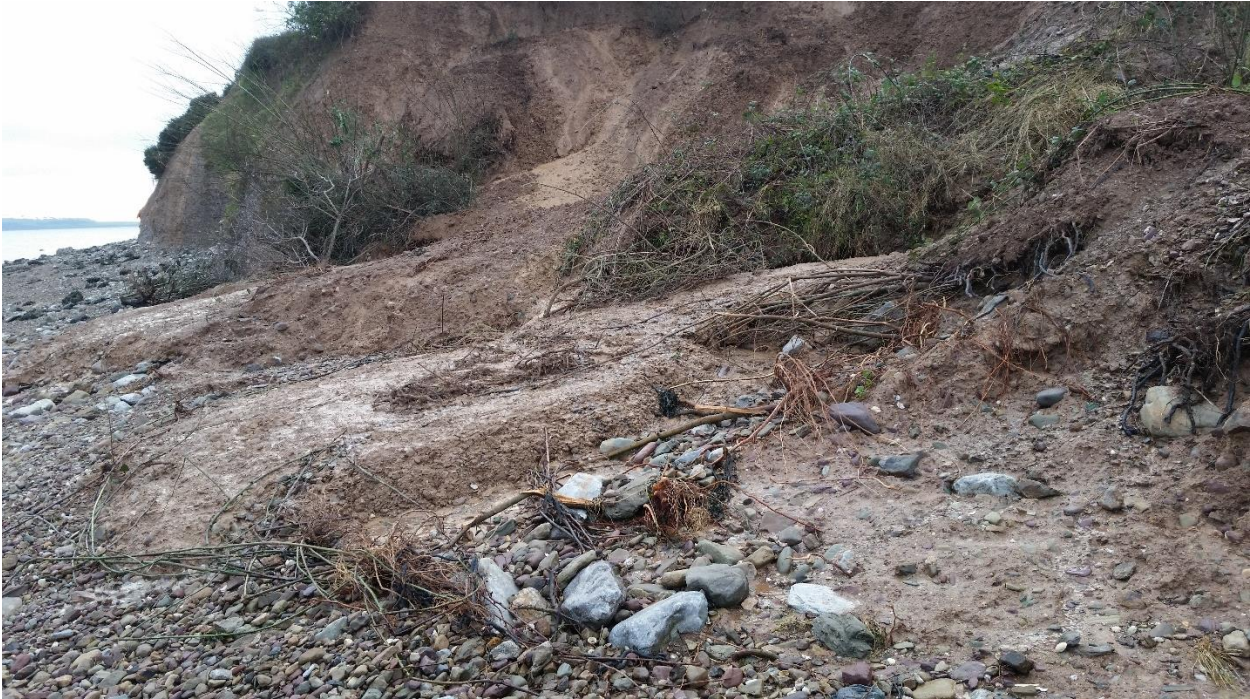
At this location there are local 'fluvio-glacial' deposits of sands and gravels within the boulder clay. These more granular deposits (lenses) are considerably more permeable than the surrounding boulder clays, and transmit water through the ground, and out through the face of the cliffs where exposed. Therefore, the surface water (rainfall) both (a) flows over the ground surface and down the cliff face, and (b) infiltrates into the ground and flows through these permeable lenses and channels out through the cliff face.

**Figure 12 Surface water (which has infiltrated the ground and flows through the permeable lenses) flowing out through cliff face**

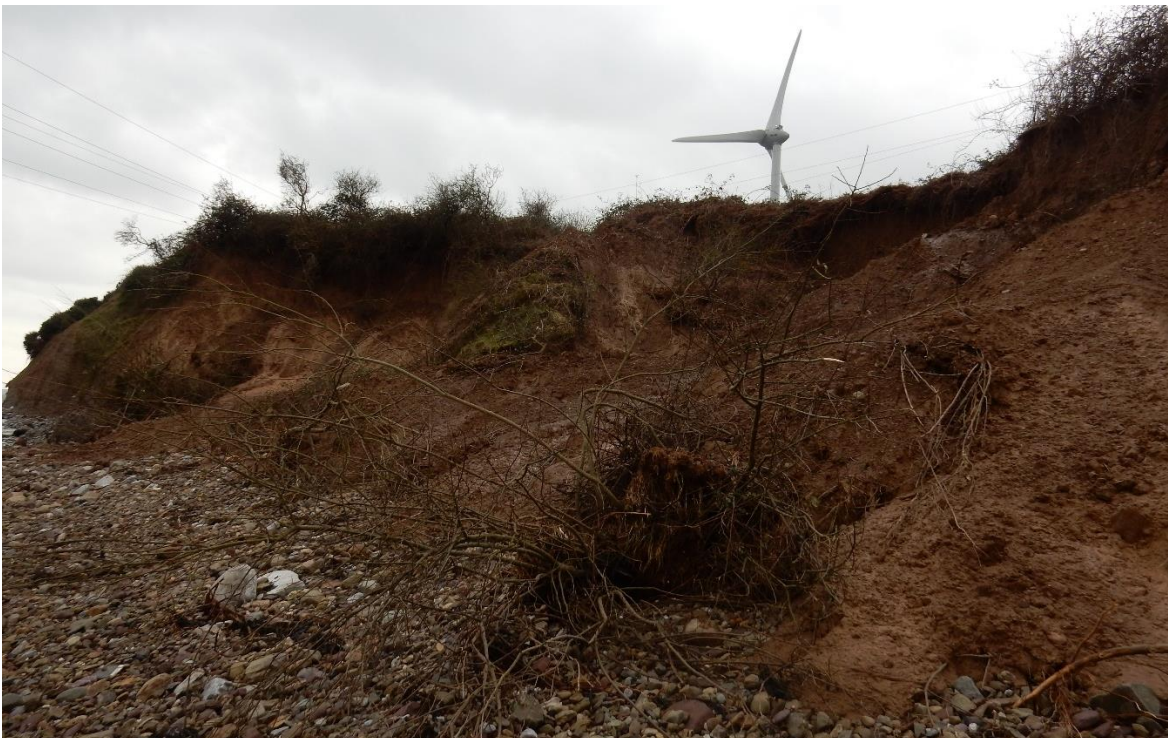
The evidence observed on site shows that the recent slope failures are due to the effects of the excessive rainfall over the month of December. While sea erosion is a contributing factor to erosion along this section of coast, the recent slips were triggered by water pressure and flow within the cliff material causing instability and slip failure.

**Figure 15 Area of collapse showing flatter slope**

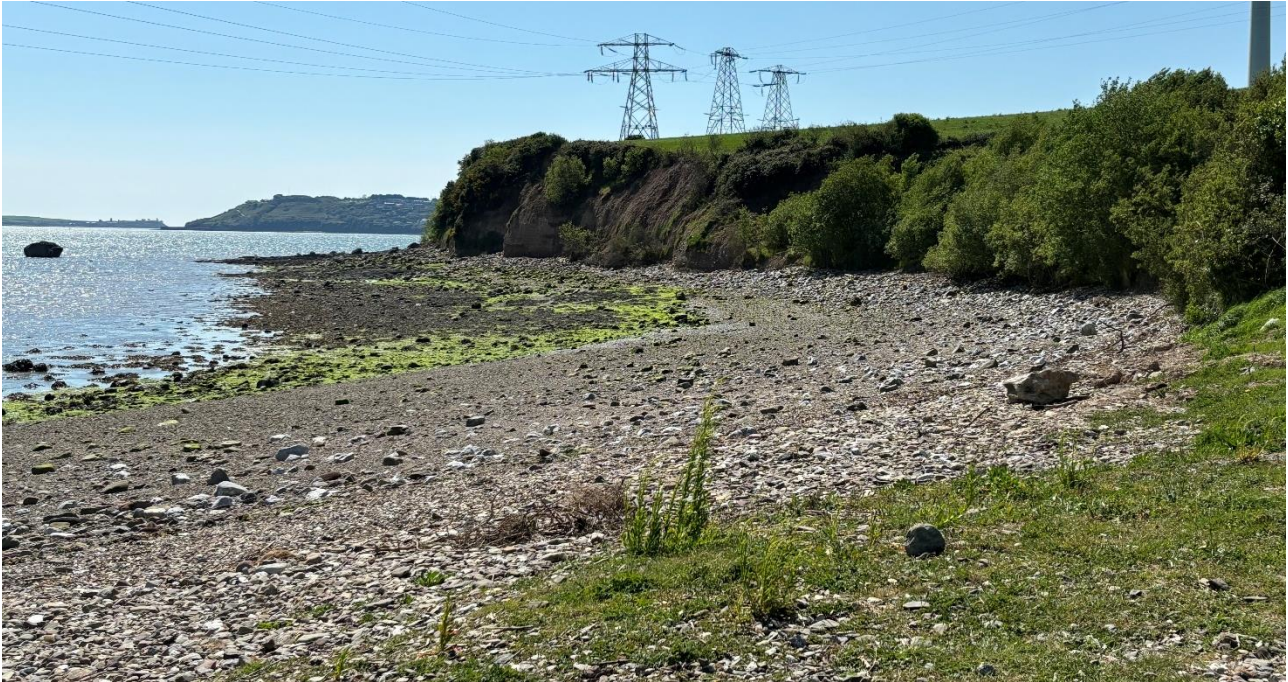
A distinct line of green seaweed visible on sections of lower beach see **Figure 2** and **Figure 3**.

**Figure 2 View of Gobby Beach and cliffs, looking south from the car park beach access ramp**

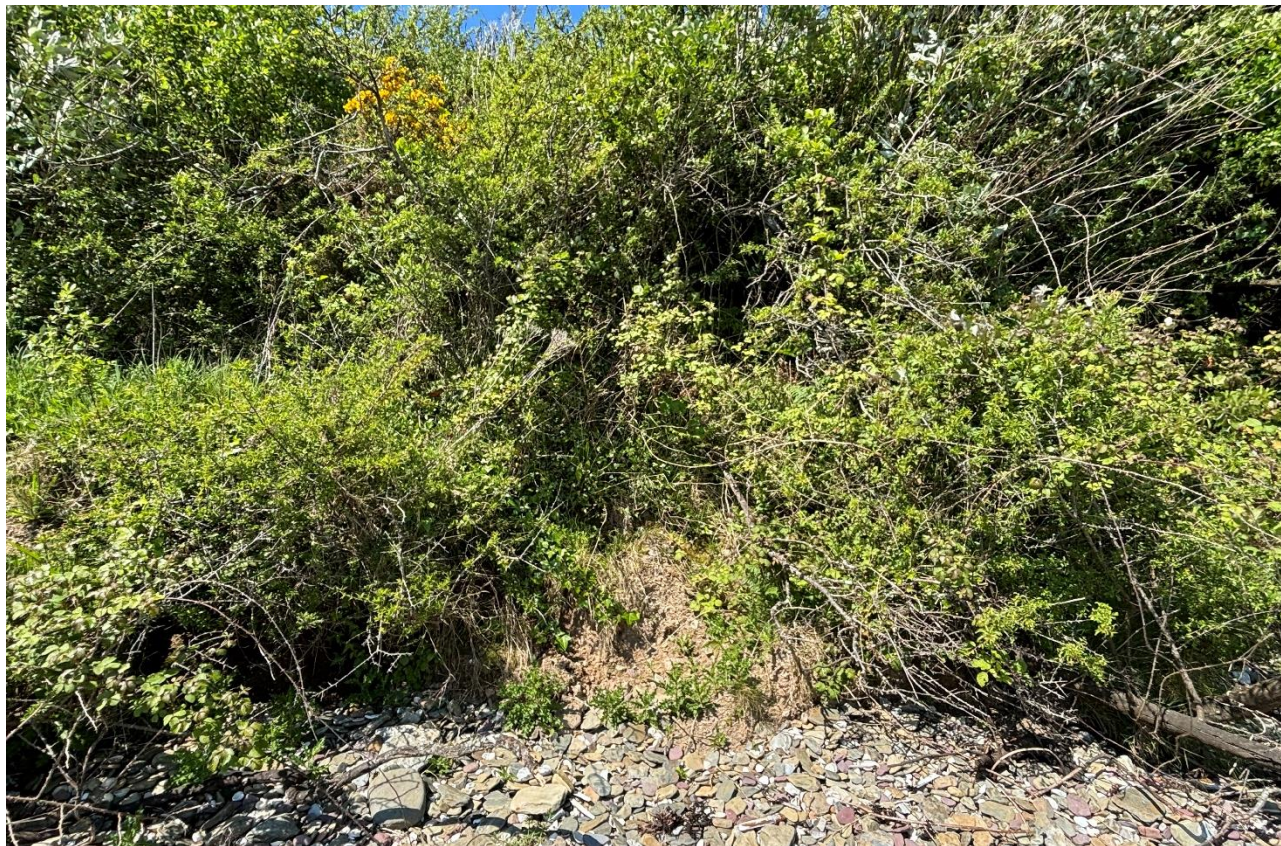
**Figure 6 View of the cliff face at cross-section B**

Along this stretch, the cliffs range in height from approximately 1.4m at cross-section A1 to 3.6m C.

Between cross-sections A2 and C, dense vegetation cover significantly limited visibility and hindered a comprehensive assessment of the cliff face conditions (see **Figure 6**). No evidence of toe notching was observed along this stretch during the site visit however a near vertical face of bare soil less than a metre high could be seen at the toe of the slope.

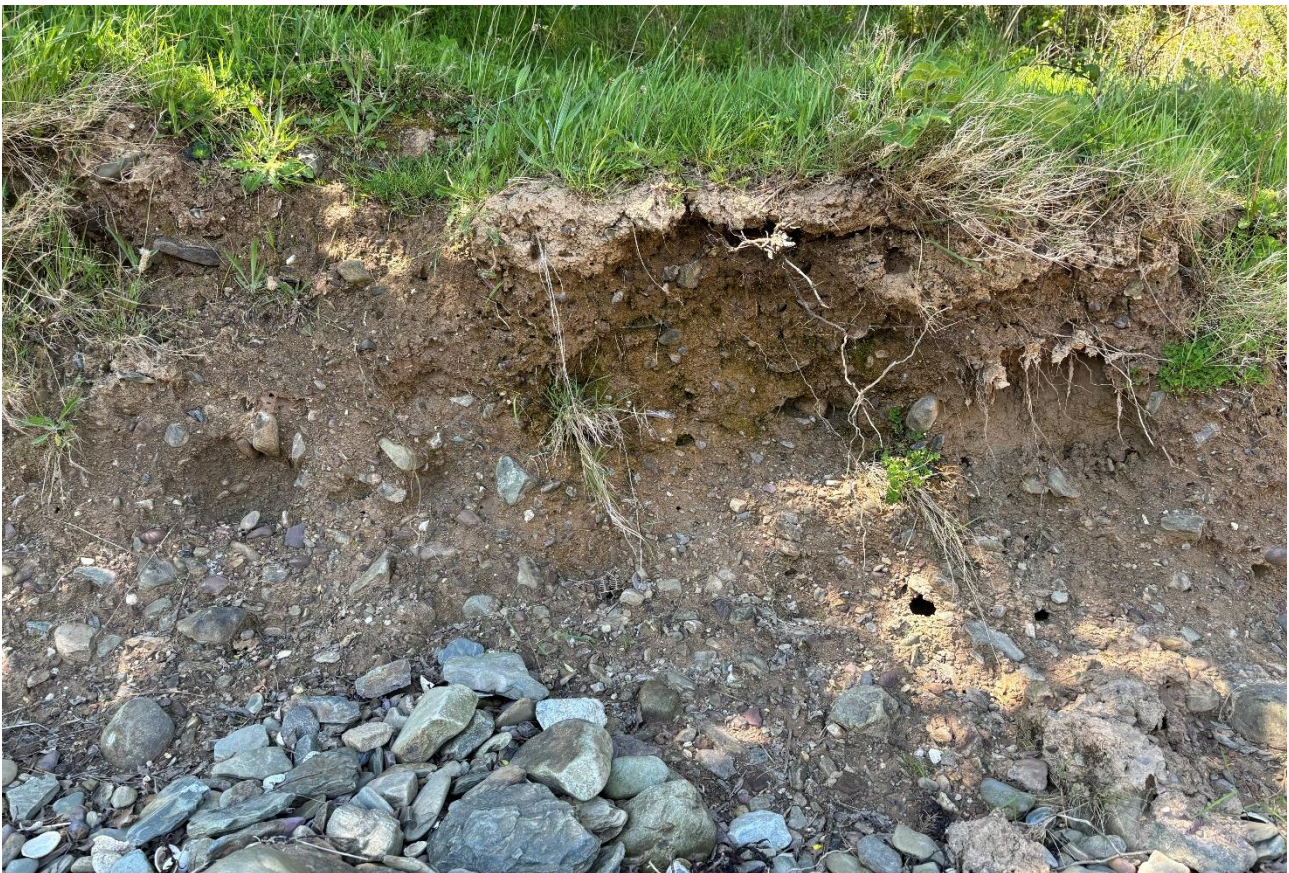
**Figure 10 View of cliff toe notching at cross-section D**

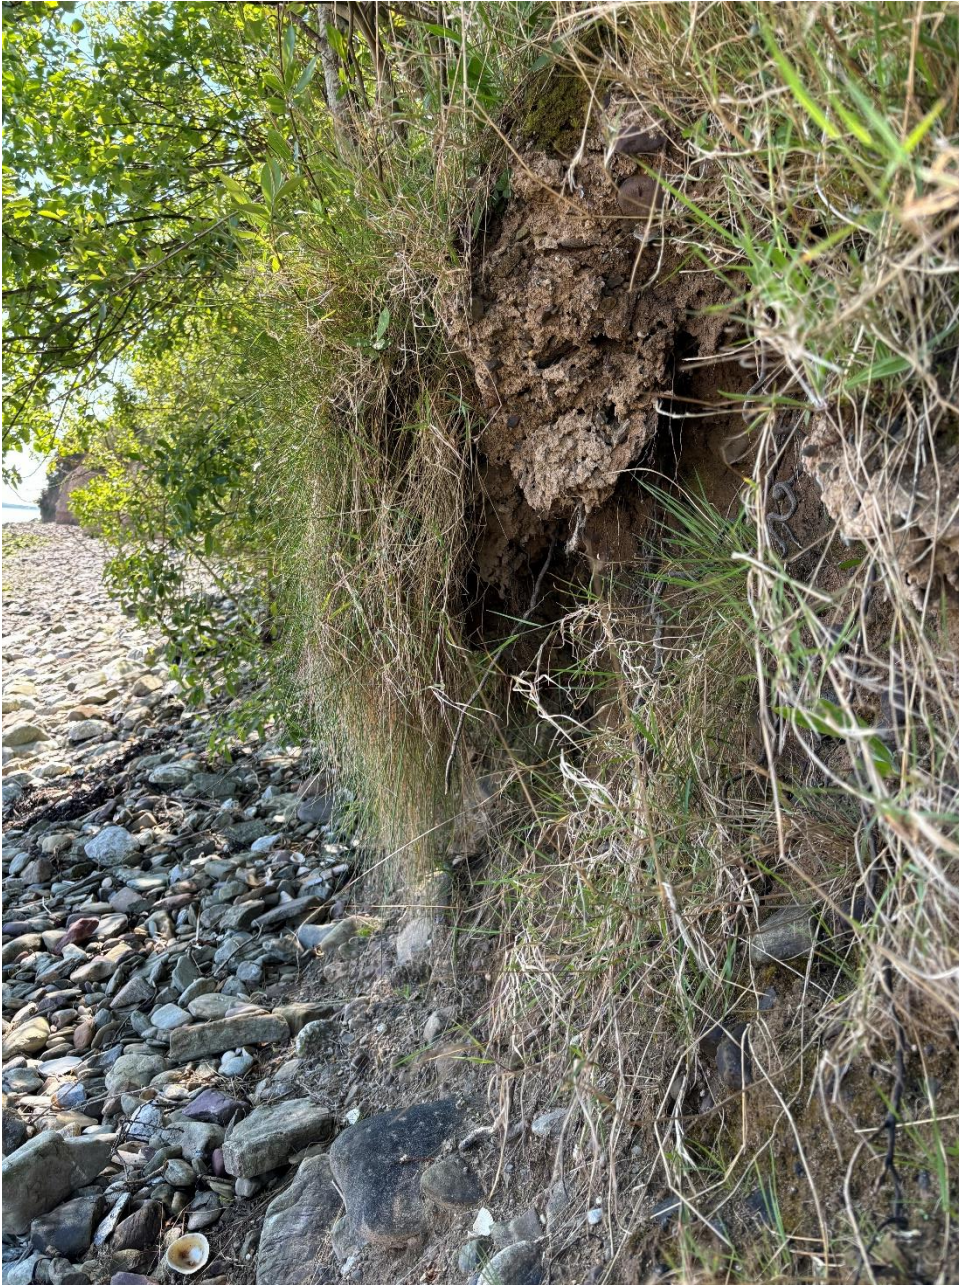
**Figure 11 View of cliff toe notching just south of cross-section D**

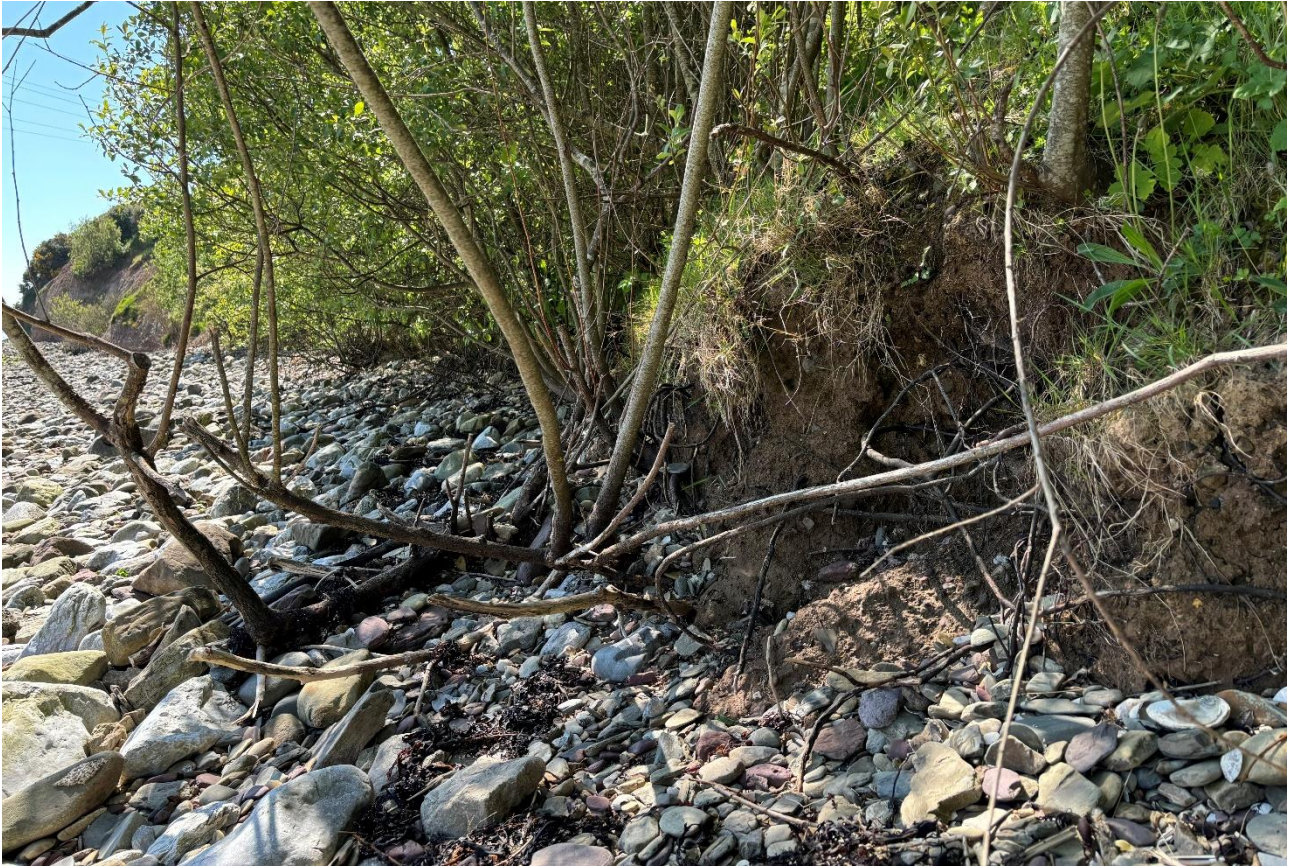
**Figure 12 View of the cliff toe between cross-sections D and E**

Dry seaweed was observed near the cliff base (see **Figure 12**). No significant waterlogging or wet conditions were observed at the time of inspection.

Additionally, dense vegetation cover was noted along portions of the cliff toe, which may obscure early signs of instability (also visible in **Figure 12**).

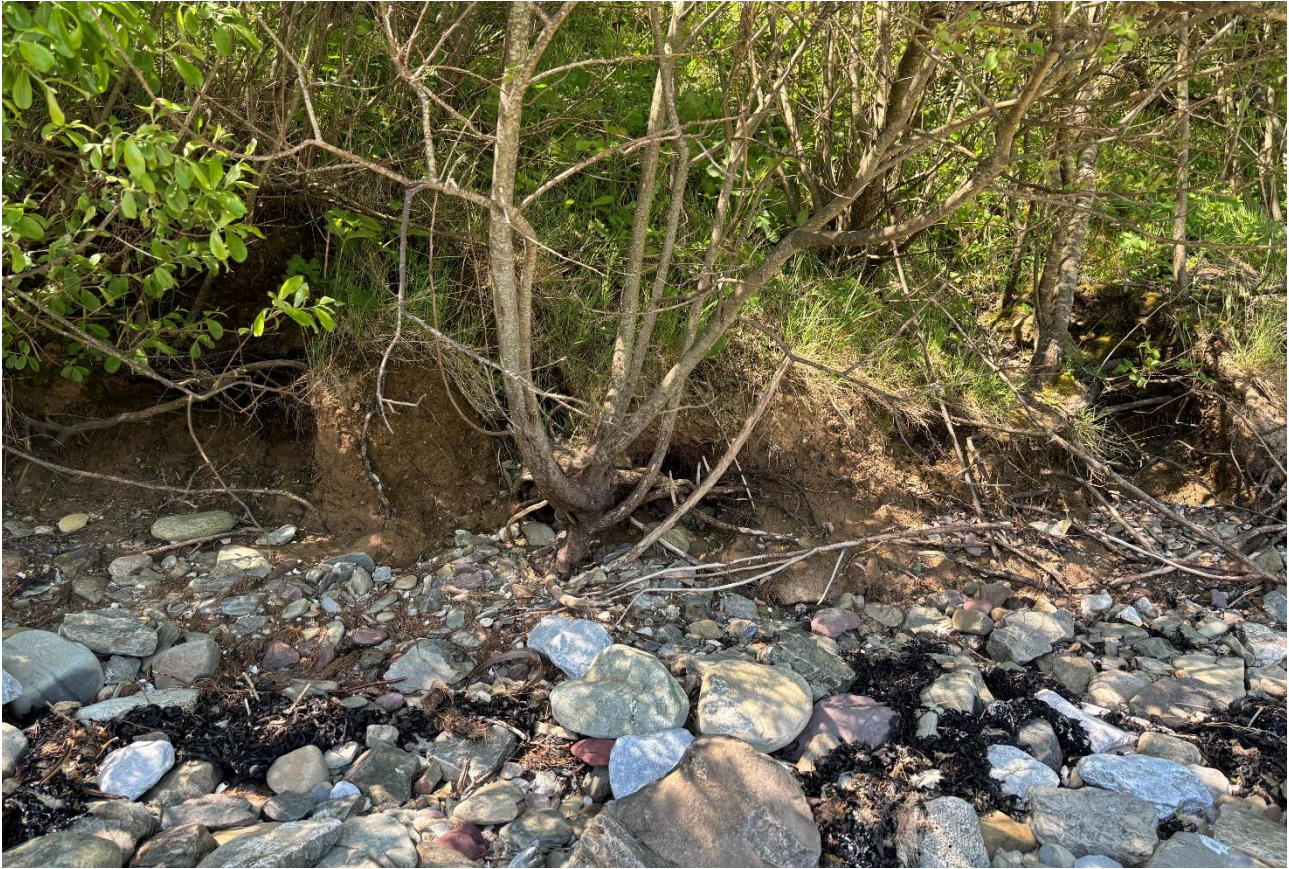
**Figure 13 View of cliff face just south of cross-section E**

Additionally, dry seaweed was observed at the base of the cliff (see **Figure 13**).

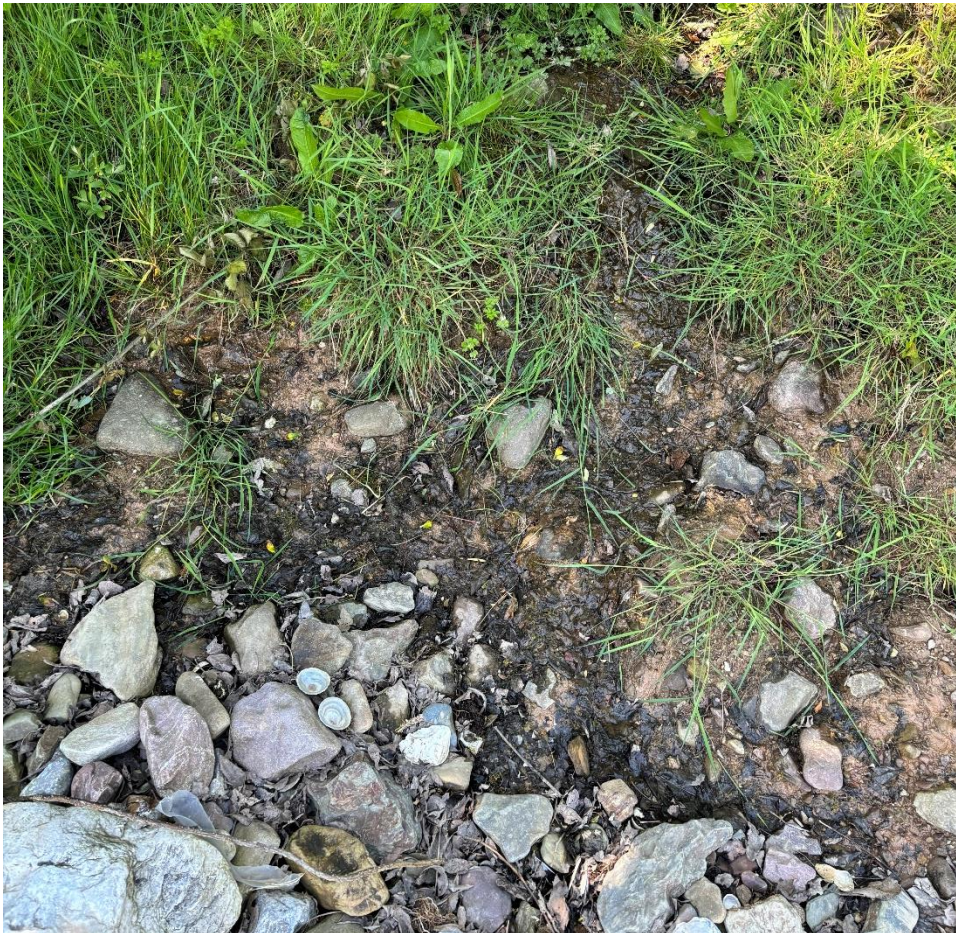
**Figure 18 View of the seepage at the cliff toe mid-way between cross-sections E and F**

The cliff toe was generally saturated, and multiple seepage springs were identified along this stretch, (**Figure 18**).

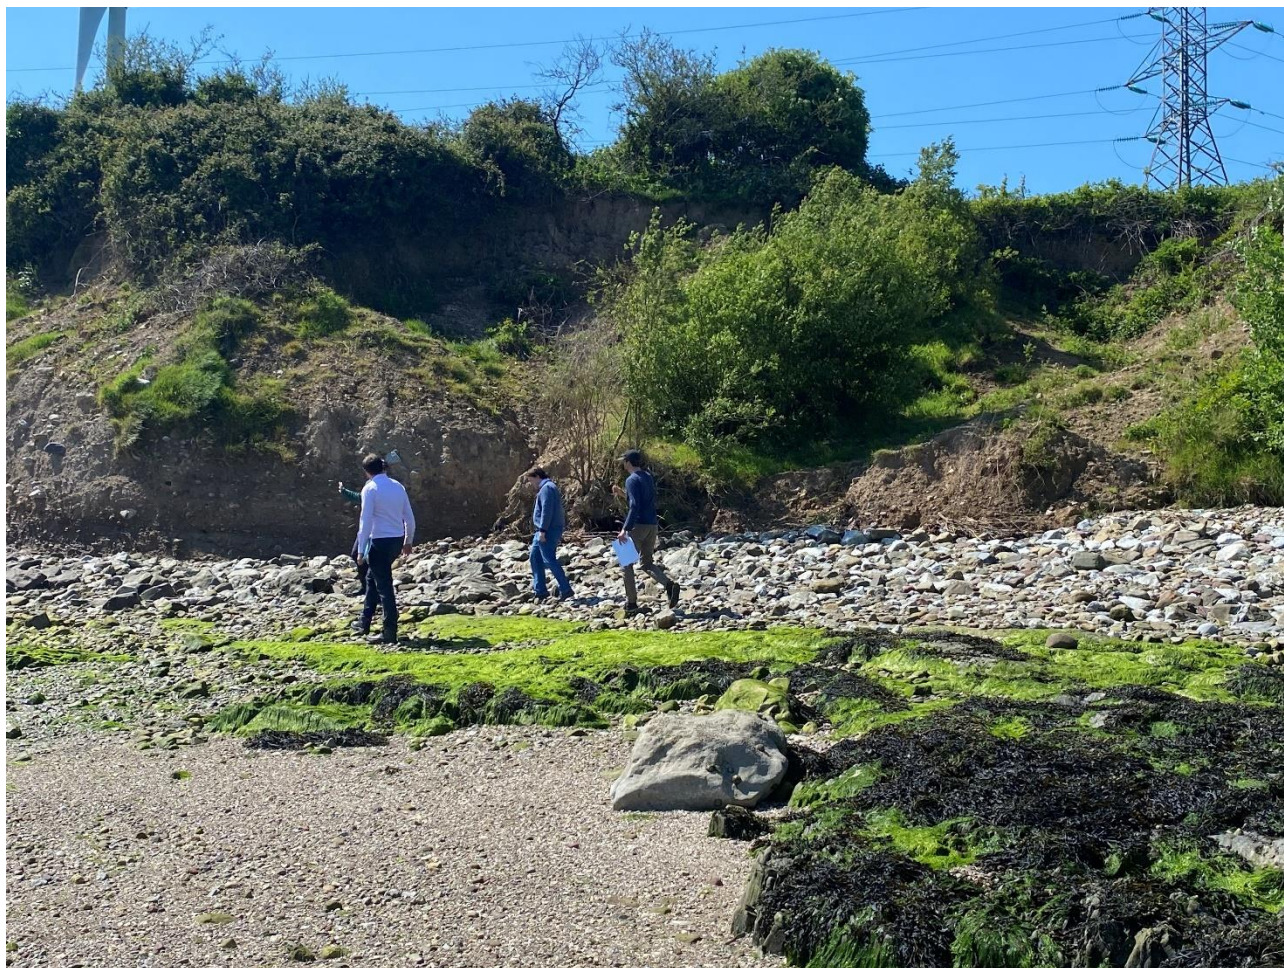
**Figure 19 View of the central and southern channels at sections F and G**

Exposures of the underlying mudstone layer (as identified in the GI for the area) were noted along the beach in this section (see **Figure 19** and **Figure 28**).

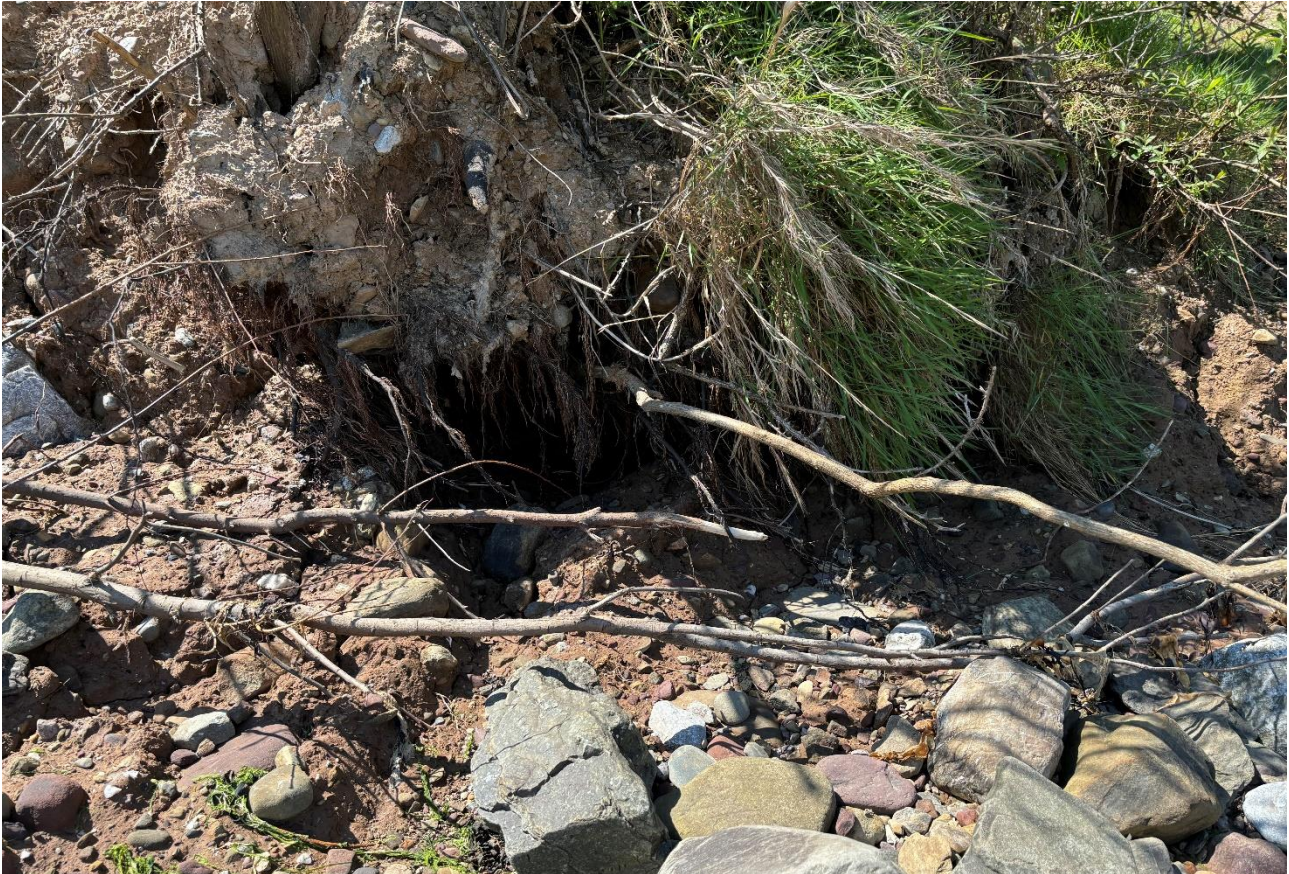
**Figure 23 View of cliff toe notching between cross-sections F and G**

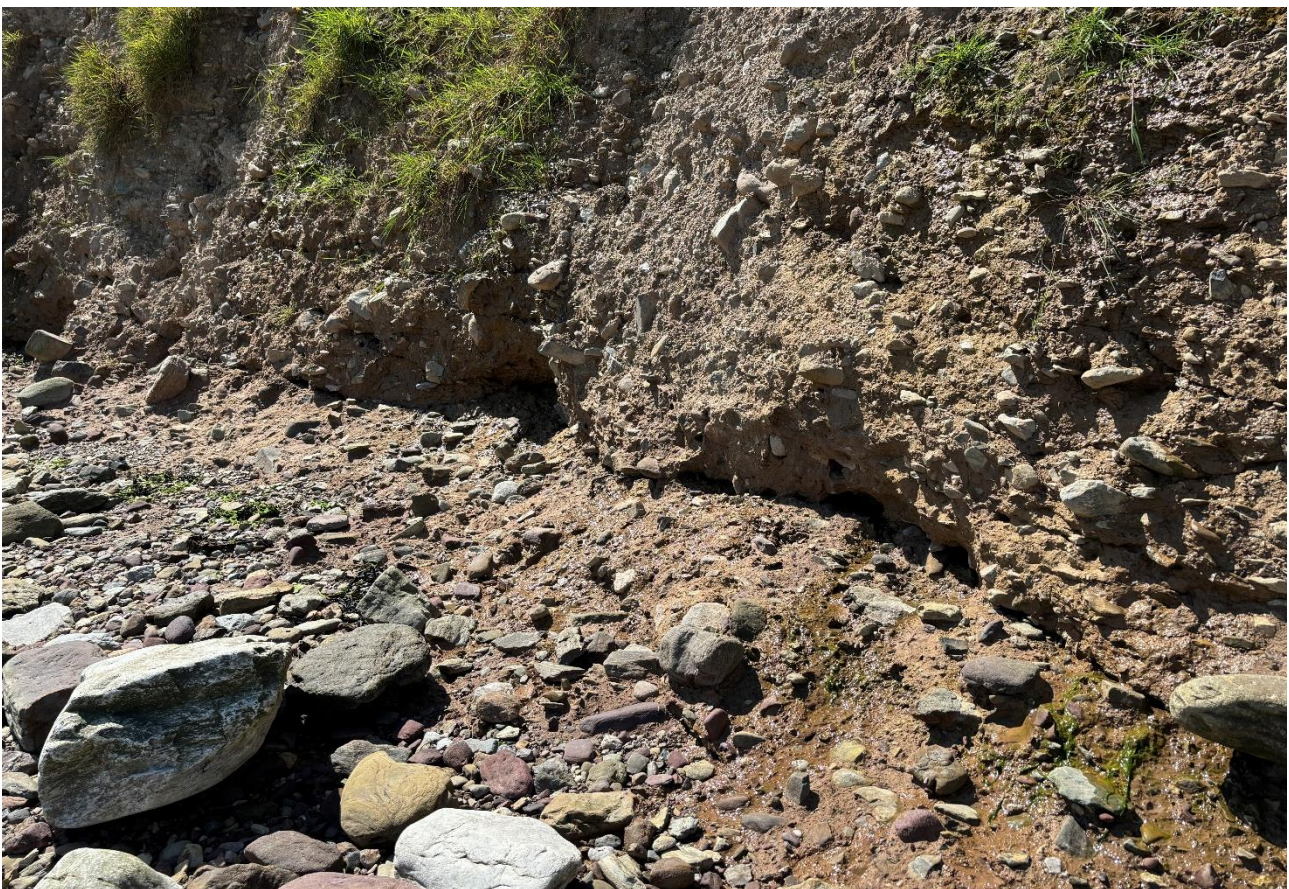
**Figure 24 View of cliff toe notching and seepage at the southern site boundary limit**

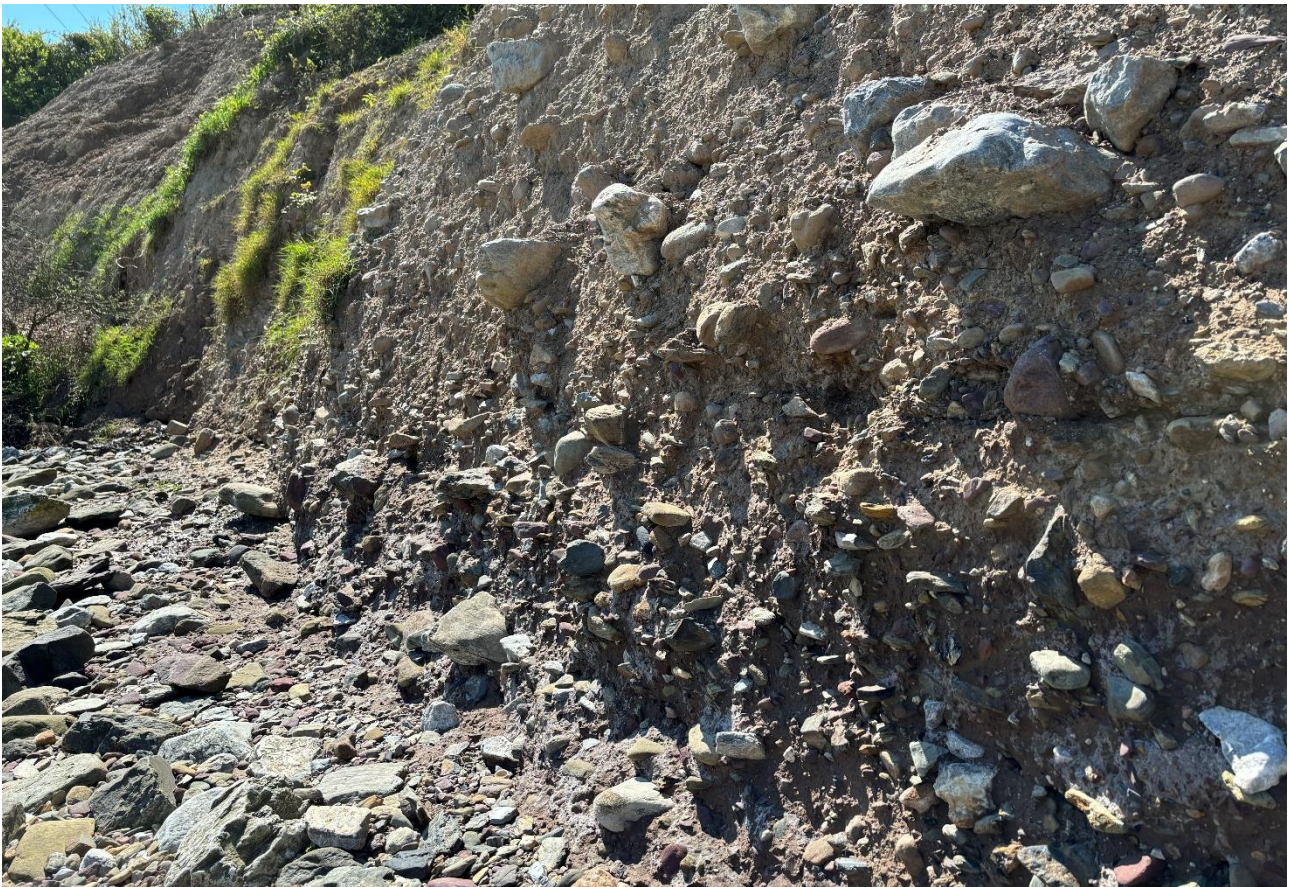
**Figure 26 View of the cliff face south of cross-section G**

Just south of cross-section G, a distinct material change in the cliff face could be observed. A band reaching approximately 1m above beach levels was observed along the cliff toe, sloping gently downwards from south to north. This layer appeared more cemented and cohesive than the overlying materials. It was firmer to the touch and contained a higher concentration of shingle-sized particles (see **Figure 26** and **Figure 27**).

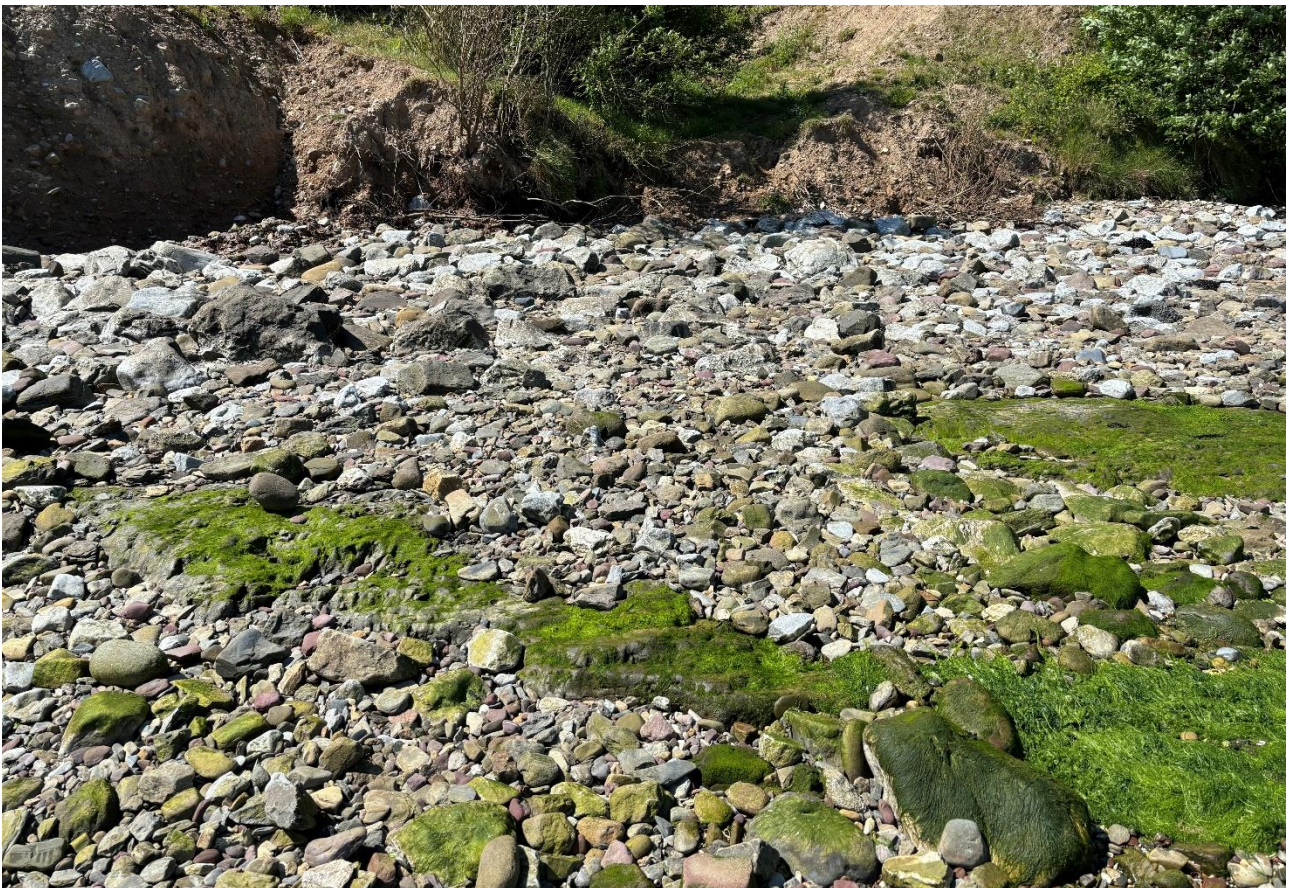
**Figure 28 View of mudstone rock outcrops on the beach at cross-section G**

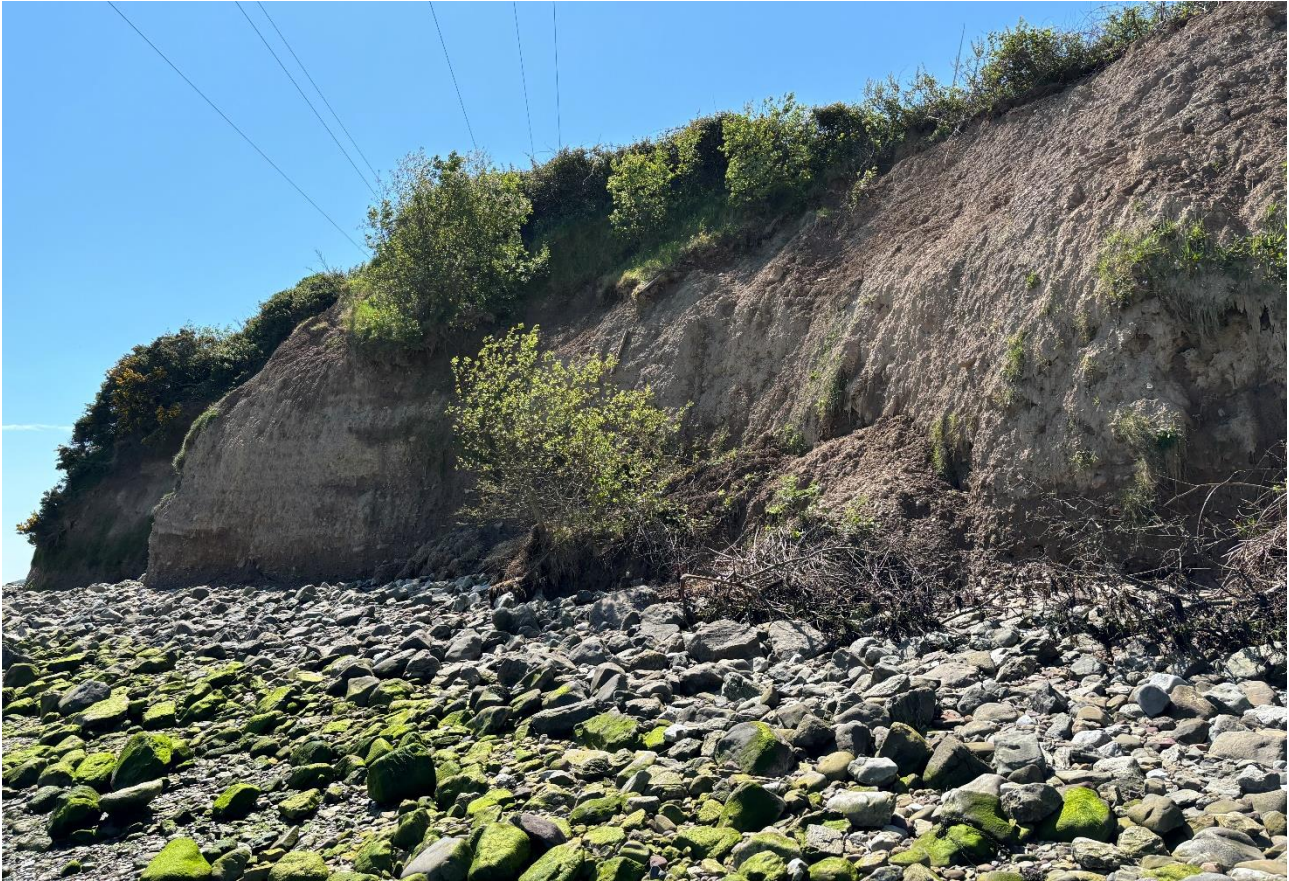
**Figure 30 View of the cliffs south of cross-section H**

Additionally, the green line of wet seaweed was observed to lie closer to the cliff toe in this southern section compared to the northern areas of the beach. This observation is supported by a comparison between **Figure 4** and **Figure 30**.

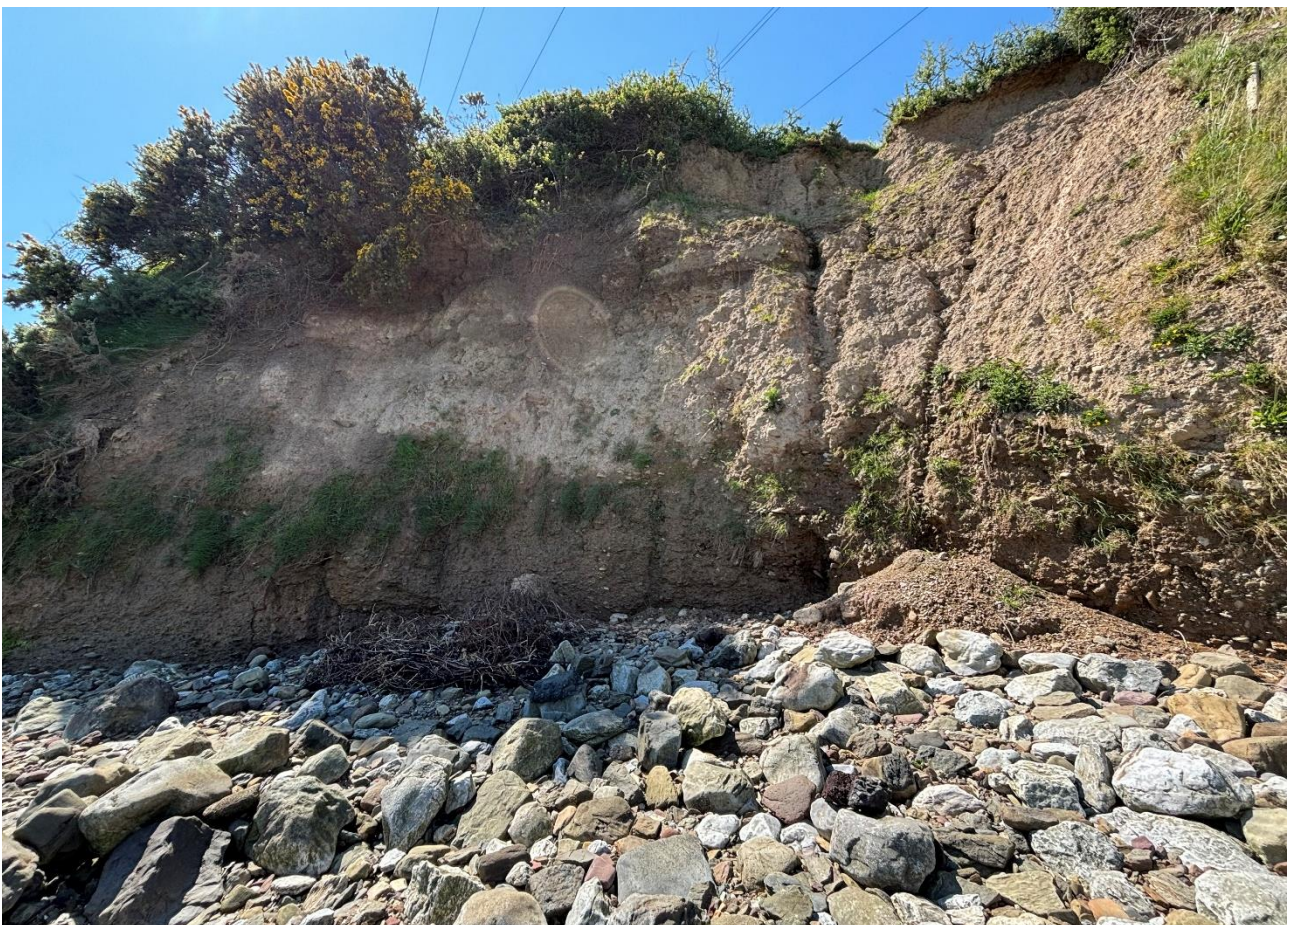
**Figure 31 View of the cliff face south of cross-section H**

The cliff face exhibited two distinct material layers, a darker, wetter lower layer and a lighter, drier upper layer (see **Figure 31**). The lower layer appeared to be saturated with groundwater, as indicated by its colour and moisture content.

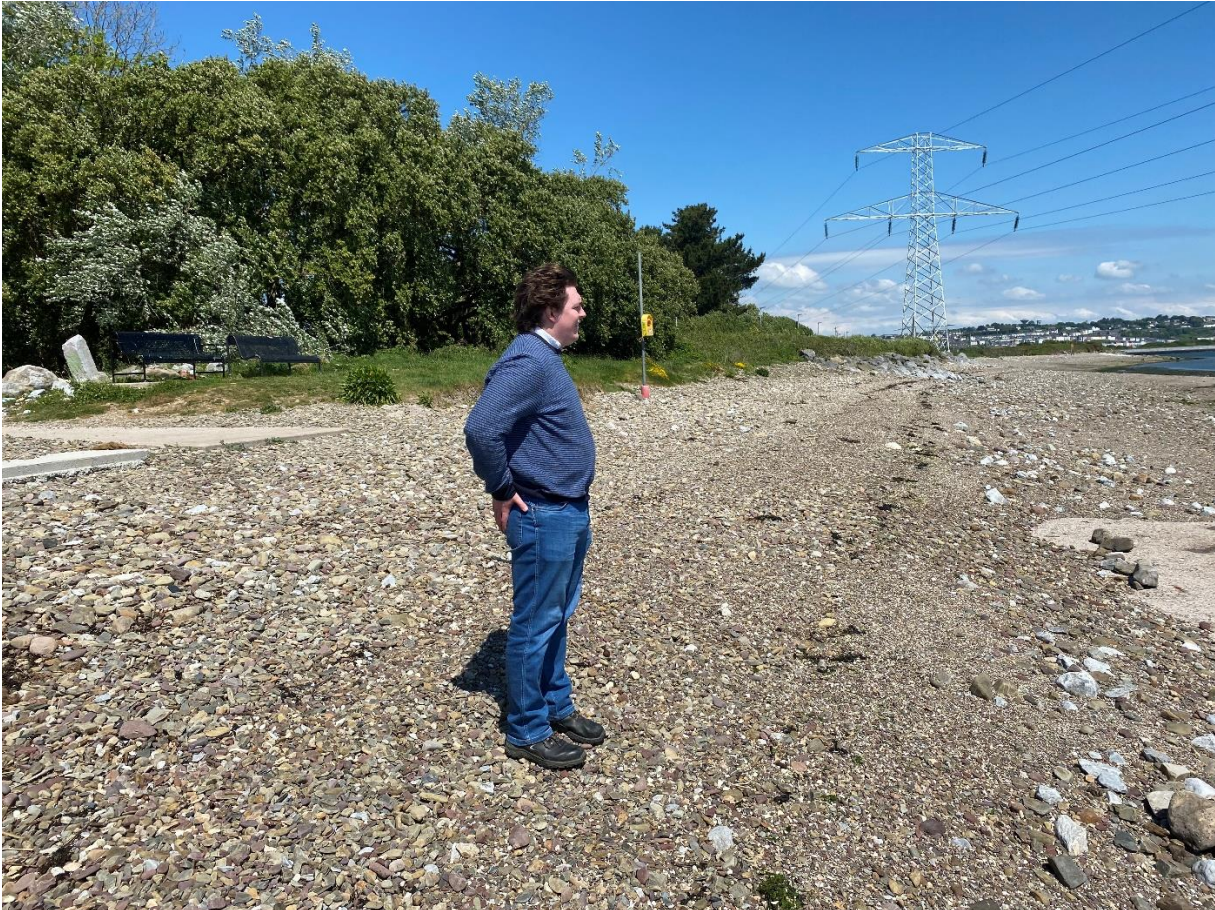
**Figure 32 View of the beach immediately north of the car park access ramp**

The upper beach shingle observed along this beach stretch is noticeably smaller in size than the material found along the upper section of the beach fronting the site.

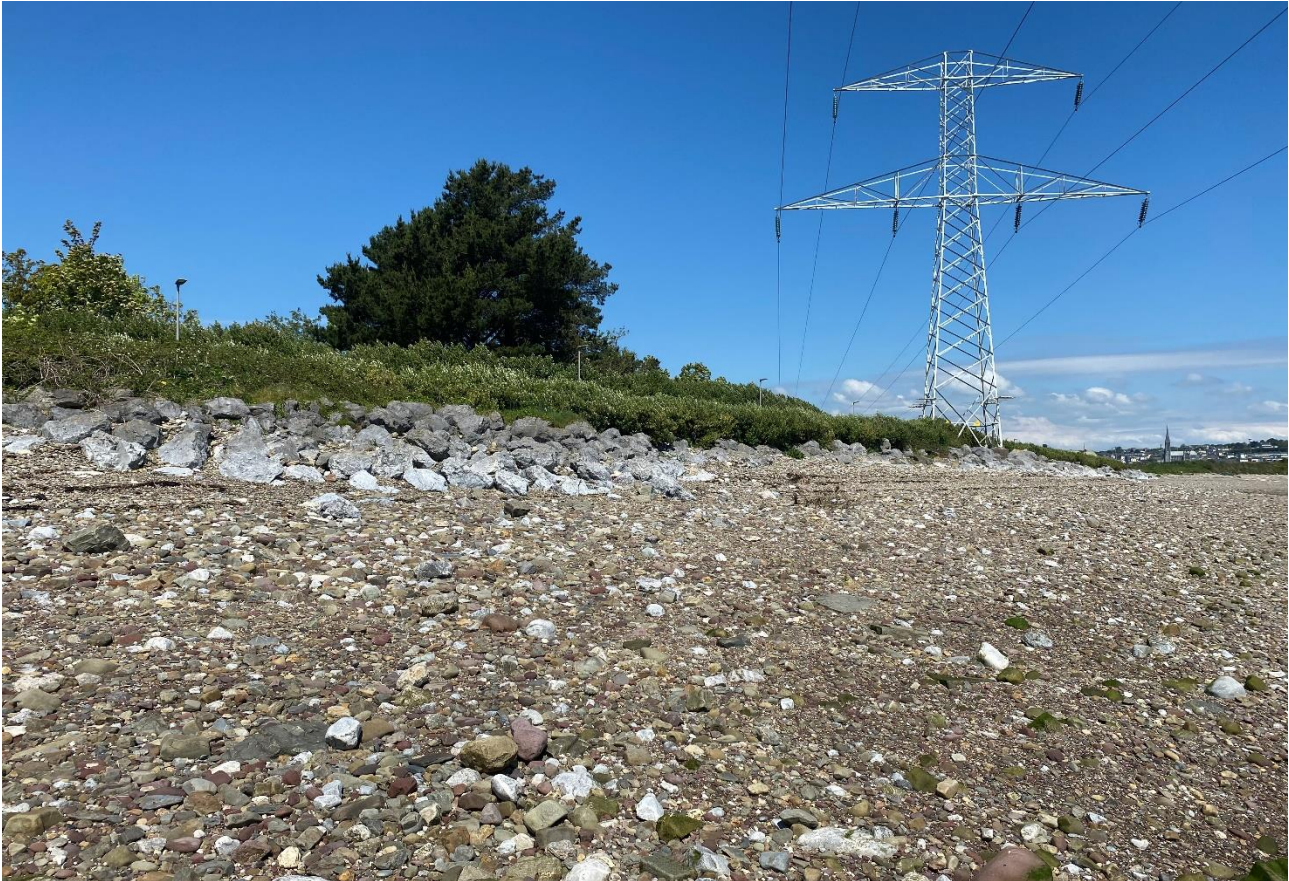
**Figure 33 View of the rock revetment along the bank north of the site**
