## Coastal Erosion Study

# Ringaskiddy Resource Recovery Centre

## Environmental Impact Statement

Reference: 13.3 Coastal Erosion Study, Arup (2025)

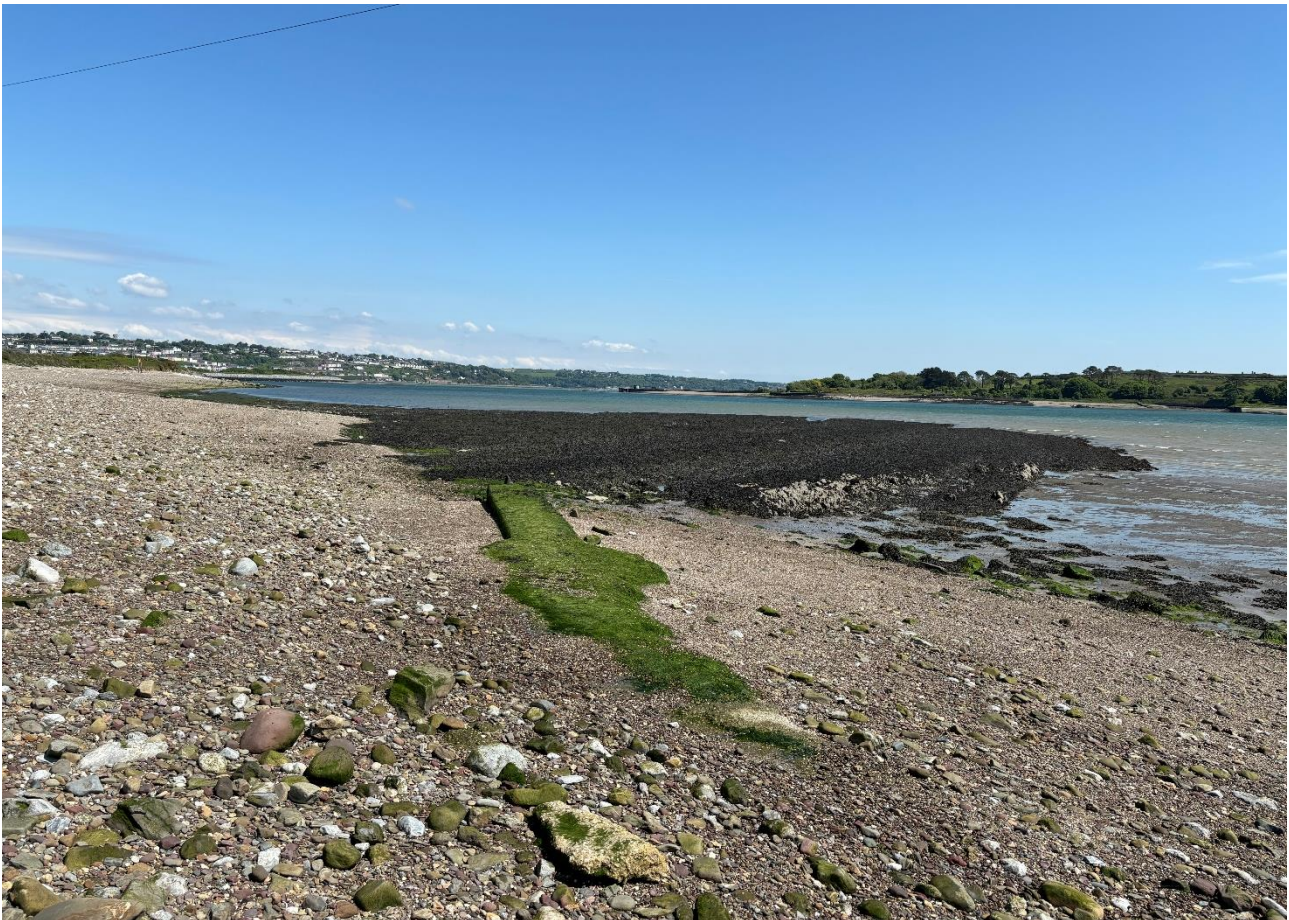
**Figure 34 Drainage network outfall**

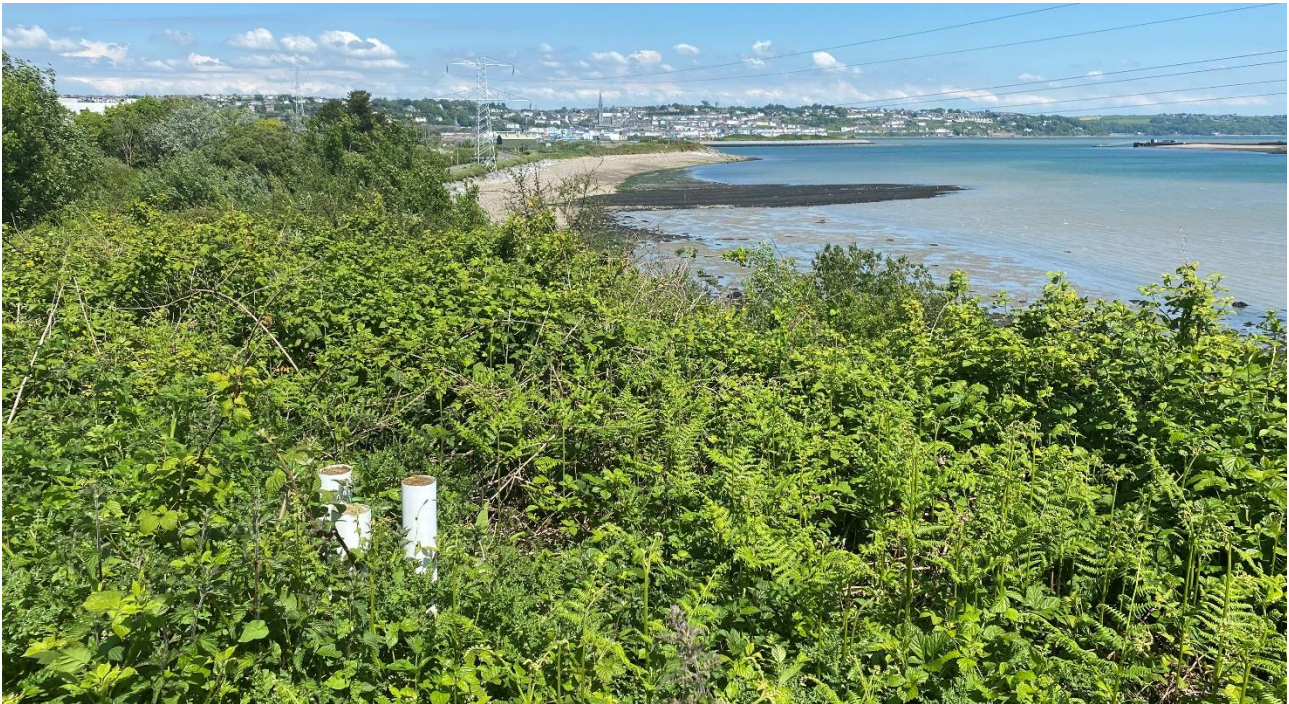
**Figure 35** View from the top of the cliff at cross-section E

The water table monitoring wells seen in **Figure 35** were observed to be within five metres of the cliff edge at the top of the central valley.

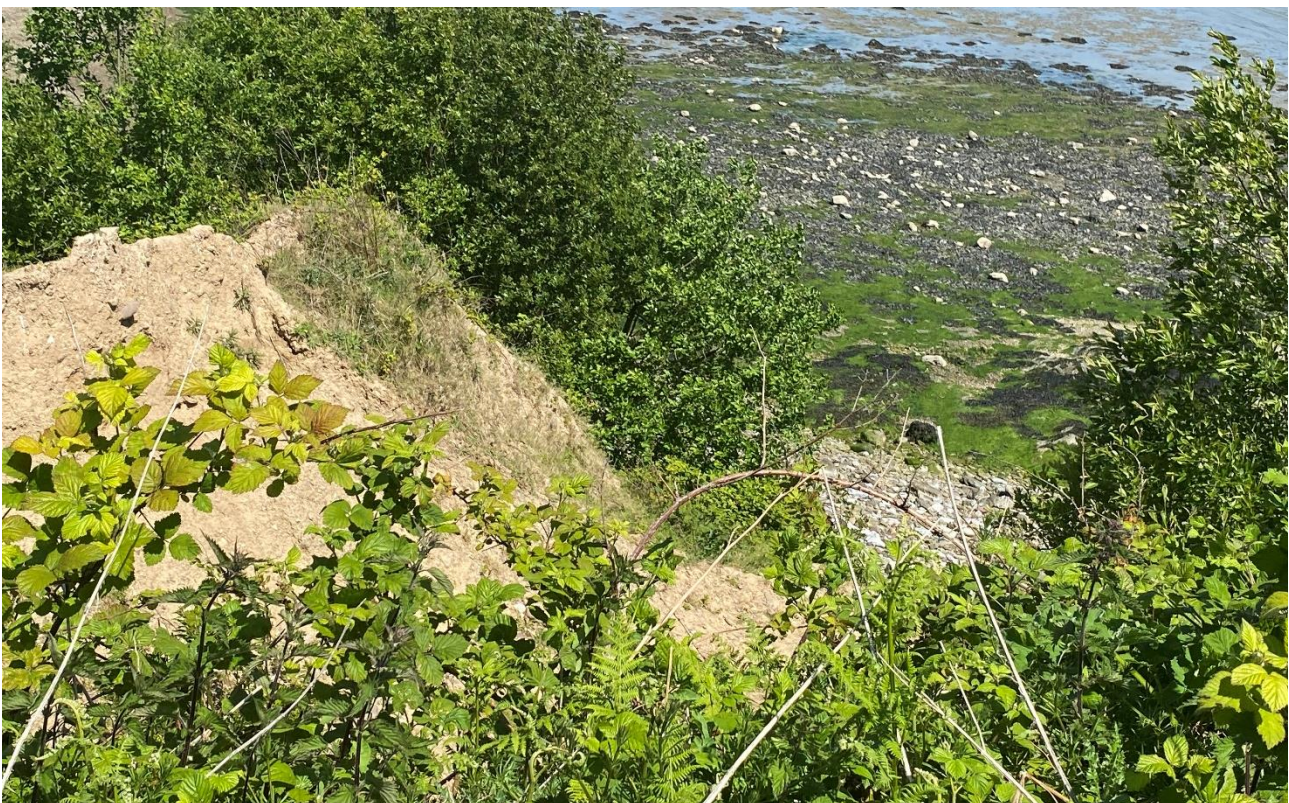
**Figure 36** View from the cliff top at cross-section G

The sharp ridge separating the northern and central valleys, as described in **Section 2.5**, was visible from this vantage point and is illustrated in **Figure 36**.
