ORIEL WIND FARM PROJECT

Environmental Impact Assessment Report - Addendum Appendix 15-3: Marine Geophysical Surveys 2022 - Archaeological Interpretation

MDR1520C
EIAR - Appendix 15-3
A1 C01
December 2025

Oriel Offshore Windfarm
Marine Geophysical Surveys 2022
Archaeological Interpretation
22R0220

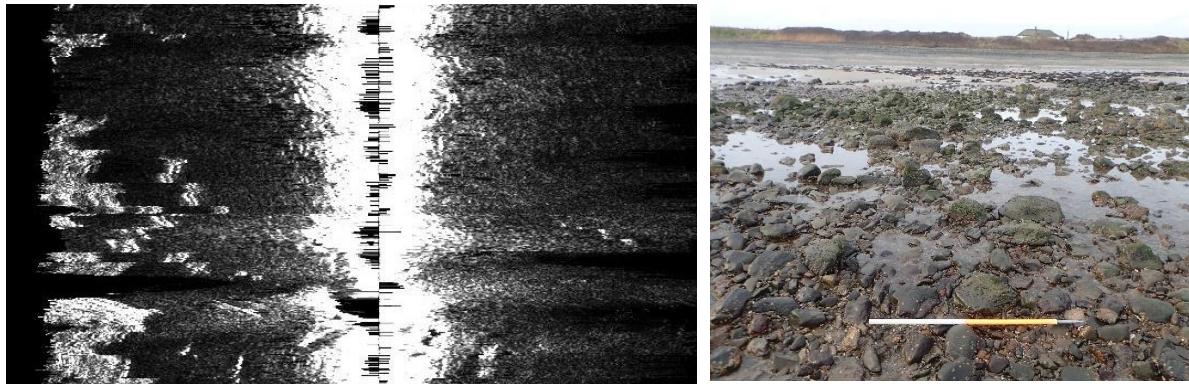
Plate 1: Side scan sonar trace at 681425E 597106N, proceeding from south to north on left, with photograph on right showing the same section of foreshore in January 2025 during the intertidal archaeology survey.

The eastern edge boulder field extruded in the photograph (looking west) is recorded along the left side of the sonar trace.

This resulted in clear overlap with the intertidal archaeology survey, and two examples of such overlap are presented in Plate 1. For the Oriel Windfarm project, it is concluded that there was no data gap in the survey coverage.
