ORIEL WIND FARM PROJECT

Environmental Impact Assessment Report - Addendum

Appendix 21-1 Addendum: Coastal Erosion Assessment Report

MDR1520C
EIAR Addendum – Appendix 21-1
A1 C01
December 2025

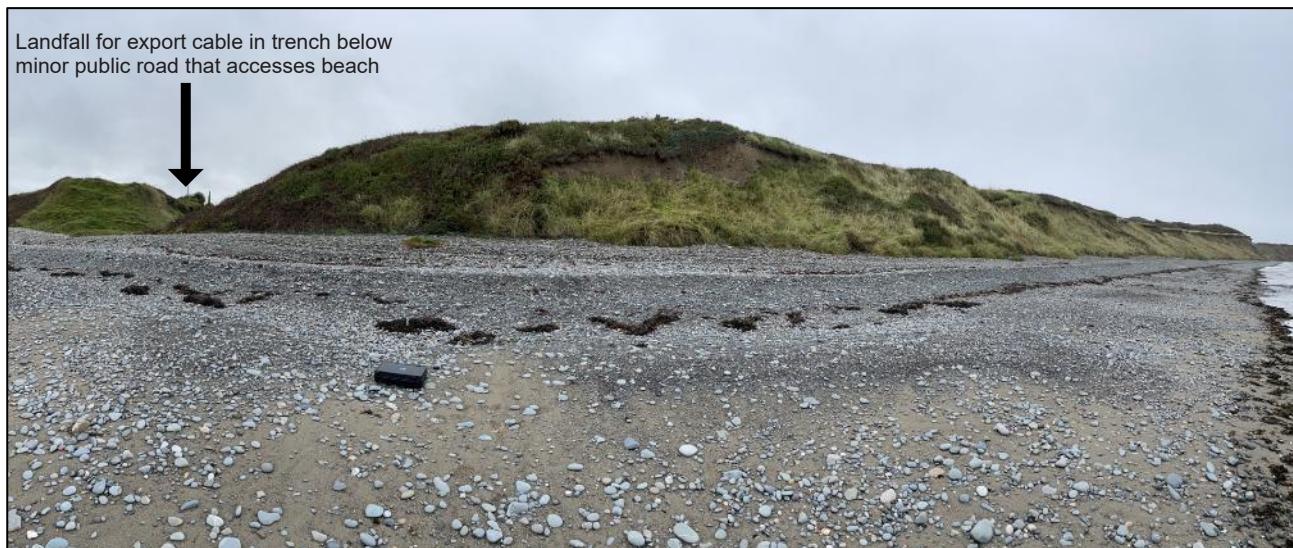
5. The cliffs to the south of the landfall are composed of dominantly sand and are 3 to 4 m high with a shallow and irregular vegetated morphology.
6. Inspection of the beach morphology shows a storm beach (berm) about 3 to 8 m from the cliff toe at the landfall location (Plate 1). The storm beach comprises beach material piled up by wave action during high water (storms). The berm divides the beach into backshore (upslope of berm) and a foreshore (downslope of the berm). The backshore and foreshore beach sections are inclined at about 5° with the separating berm inclined at about 25°.

Plate 1: General view of landfall location (opening in cliff on LHS) and cliff slopes to north of landfall.

1. At the landfall the export cable will be buried and come onshore within a trench. The buried cable will pass along a minor public road which is at the level of the back of the beach (Plate 1 and Plate 2).

1. As part of the Project, it is proposed to locate the landfall about 0.7 km to the southwest of Dunany Point, in County Louth.
2. At the landfall site the export (offshore) cable will be buried and come onshore within a trench. The buried cable within a trench will pass along a minor public road which is at the level of the back of the beach and represents a natural break in the cliffs (Plate 1 and Plate 2).

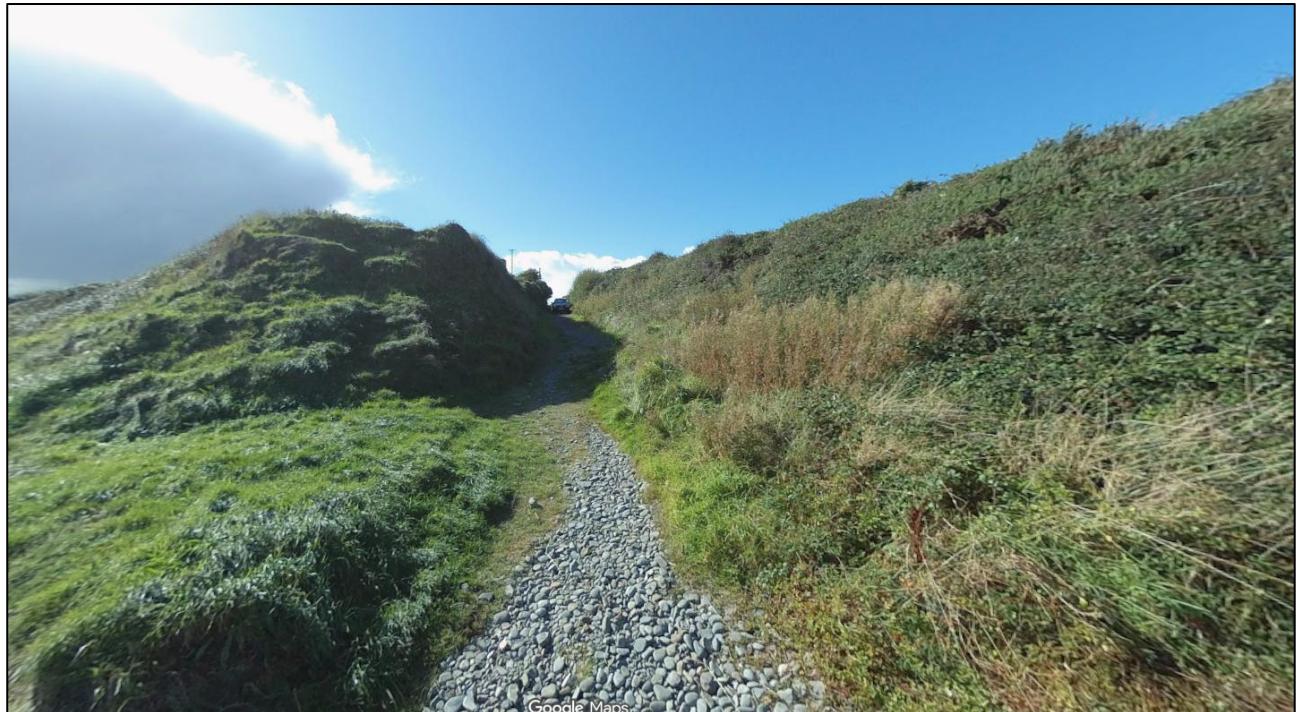
7. At the landfall location there is a natural break in the cliffs and there is little evidence of coastal retreat (Plate 2). To the north of the landfall, the glacial till cliffs have been affected by wave and scour erosion with associated landslipping which has resulted in coastal erosion with retreat of the cliffs. The cliffs to the south are not affected by landslipping and the rate of retreat appears less than the northern cliffs.

Plate 2: View of minor public road that accesses beach (image from Google Maps).

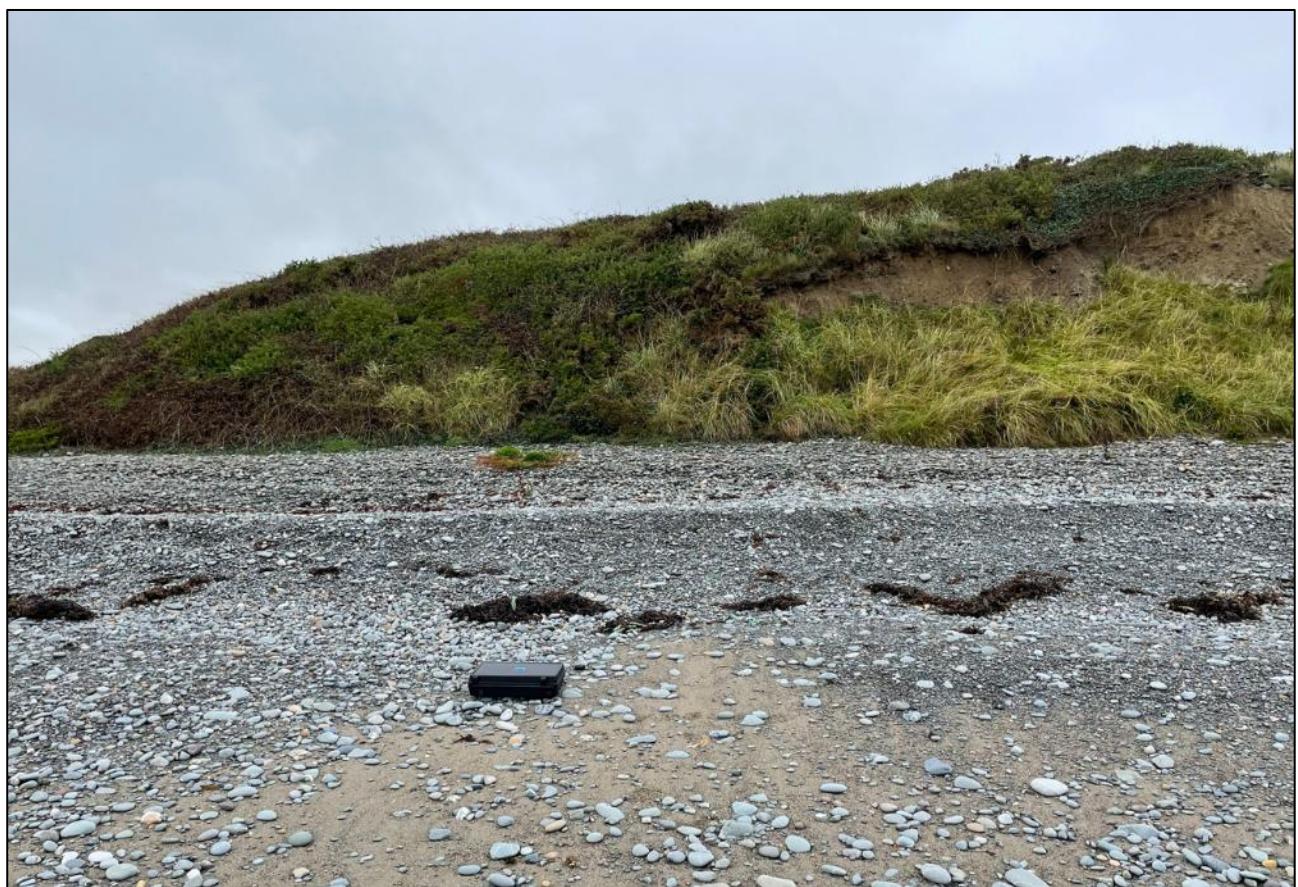
4. The route avoids the coastal cliffs to the north which are about 6 to 7 m high with an overall slope inclination of about 30° to 50°. These glacial till cliffs are in the CGS and are affected by landslipping (Plate 3: General view of cliff slope to north of landfall location. The glacial till within the cliff is the same material as identified in the boreholes.

Plate 3: General view of cliff slope to north of landfall location.

4. The landfall cable route avoids the coastal cliffs to the north which are about 6 to 7 m high. These glacial till cliffs are in the CGS and are affected by landslipping (Plate 3: General view of cliff slope to north of landfall location.). The previously proposed cable route was to pass through the coastal cliffs, however the route has been adjusted.

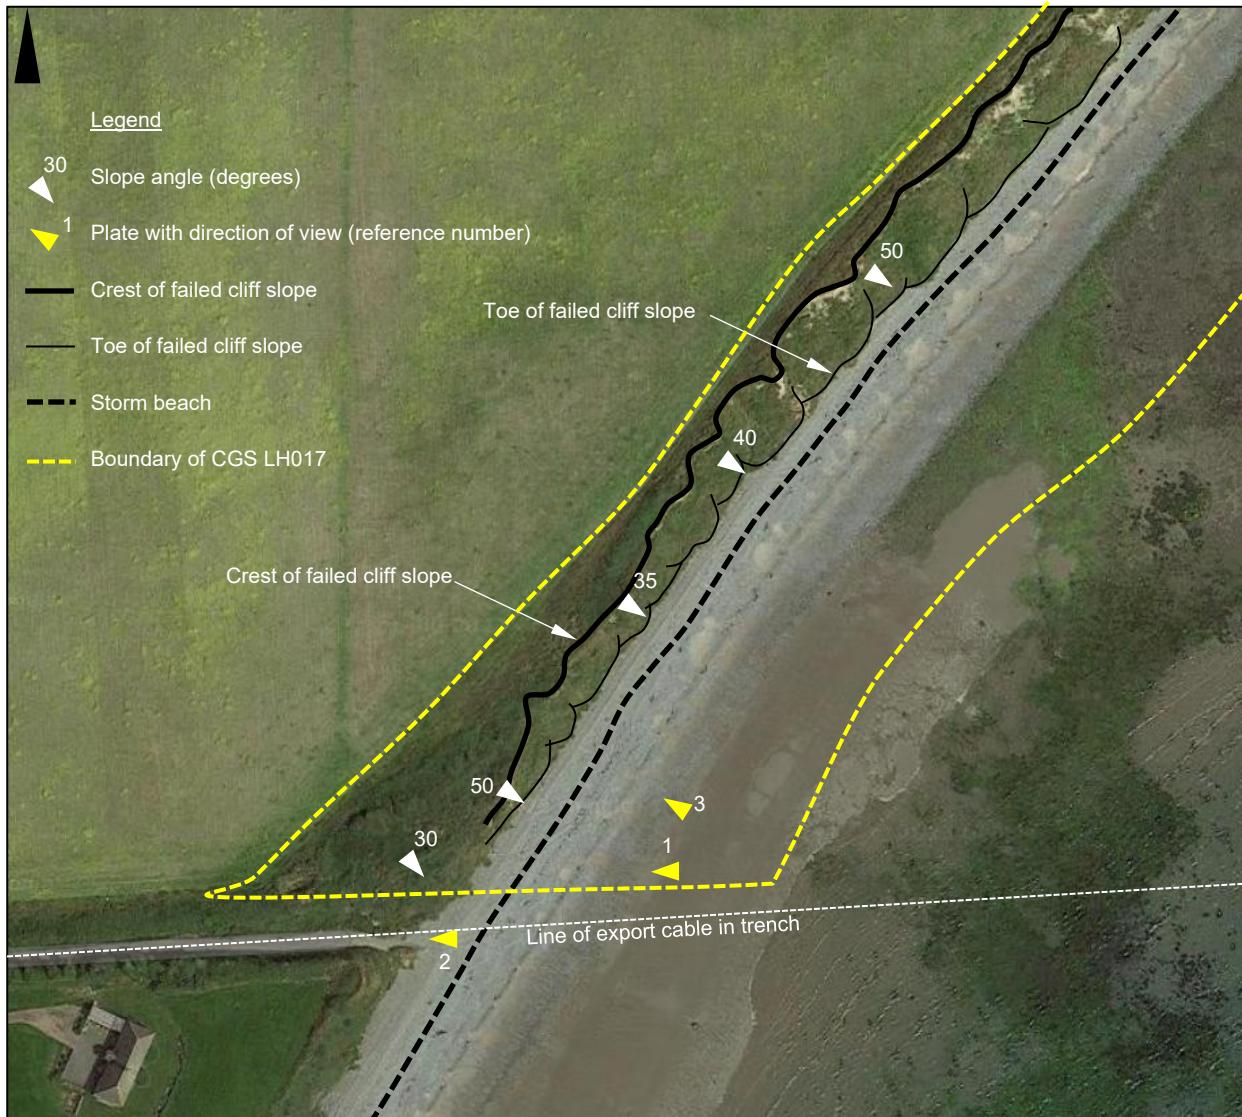
2. A transition joint bay (TJB) is required to connect the offshore cable with the onshore cable. The TJB will be either located within a field to the north about 150 m from the beach (Option 1), or within the road verge approximately 300 m from the beach (Option 2).

3. The export cable route above the HWM, TJB options and associated works are outside the footprint of the Dunany Point CGS, which comprises the exposed coastal cliff and part of the foreshore.

Figure 4A-1: Details of landfall location (image from Google Maps).

Findings of the site inspection are as follows (see Figure 4A-1 to Figure 4A-3):

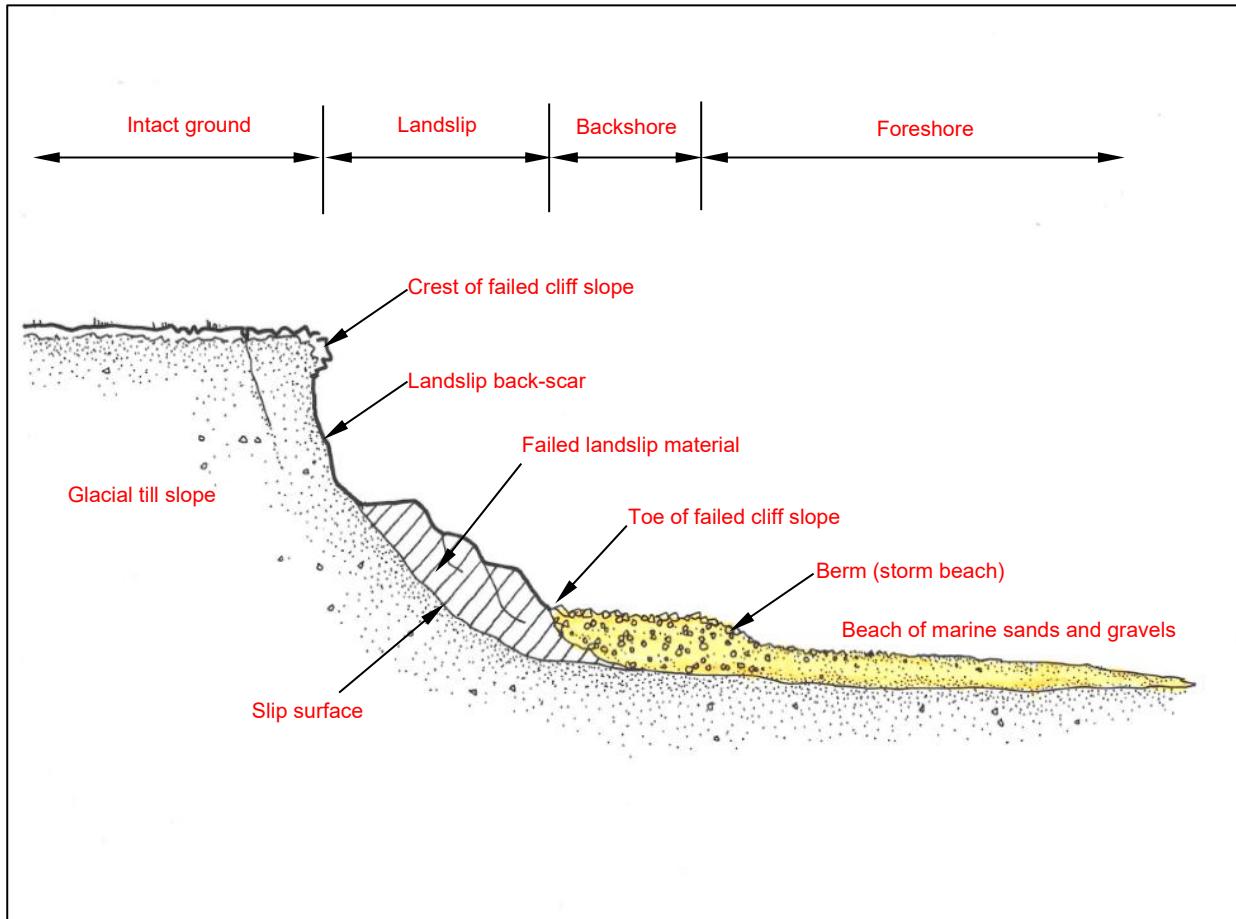
A schematic showing the details of landslipping along the cliffs to the north of the landfall is given in Figure 4A-2.

Figure 4A-2: Schematic section through cliffs north of landfall with details of landslipping.

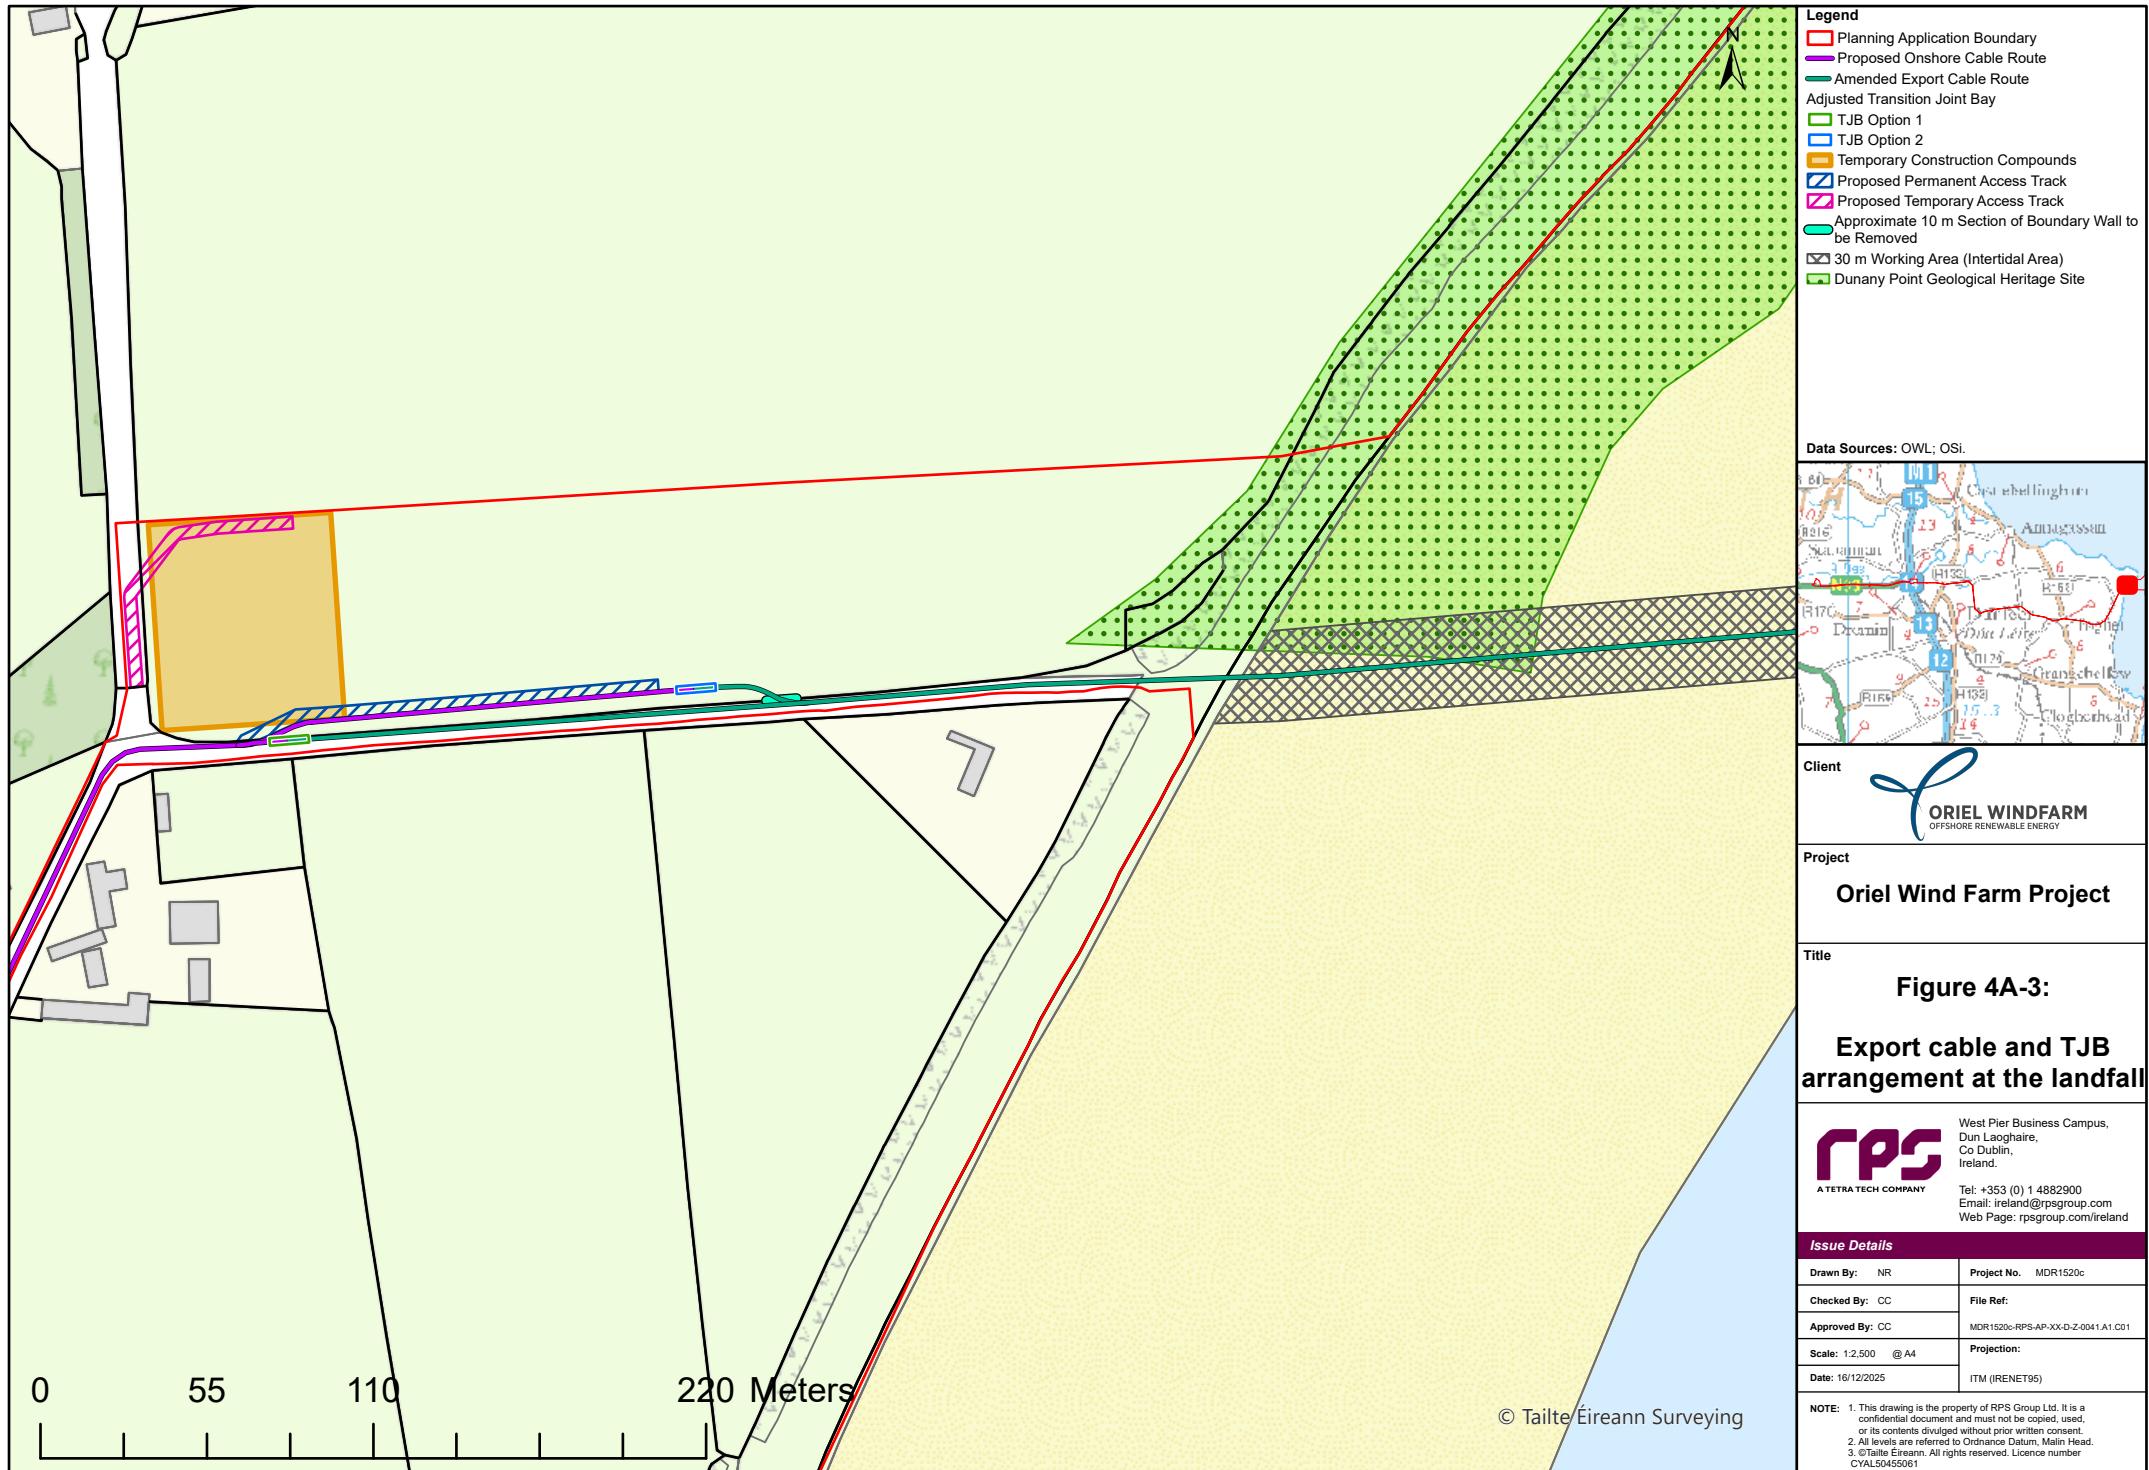
3. The export cable connects with the onshore cable within a TJB either located within a field to the north about 150 m from the beach (Option 1), or within the road verge 300 m from the beach (Option 2), see

5. The proposed revised export cable route and TJB options and associated works are outside the exposed coastal cliff (Figure 4A-3).
6. A review of TJB Option 1 and Option 2 shows with respect to stability and impact of the works:

See Figure 4A-3 provided in section 4 of this Addendum which replaces the figures showing the TJB options 1 and 2 in appendix 21-1: Coastal Erosion Assessment Report (EIAR volume 2C).
