# Marine Mammal Observer Report

Client	<b>Sure Partners Limited</b>
Document Ref.	23140-GDG-001-01
Project Title	Arklow Bank 2023 Offshore GI
Date	07/09/2023

Project Title:	Arklow Bank 2023 Offshore GI
Report Title:	Marine Mammal Observer Report
Document Reference:	23140-GDG-001-01

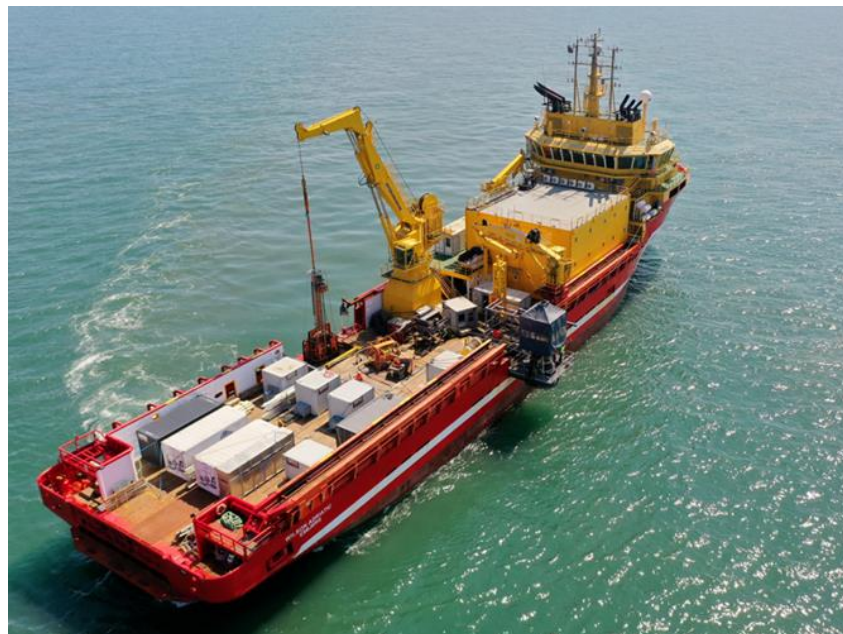
**Figure 2-1: Survey vessel, MV Connector**

General Information		Dimensions	
Vessel Name	MV Connector	Length (m)	90.2
Call Sign	OYOJ2	Breadth (m)	19
MMSI	219166000	Draft (m)	5.6
IMO	9244568	GRT	3524
Flag	Denmark (DK)	Accommodation	20 Berths
Class	Offshore Supply Ship	Deck Space (m <sup>2</sup> )	70
Built	2002	Endurance (Survey)	15 days

The Geotechnical Site Investigation work was completed on board the MV Connector (Summary details in can be found in the table below).

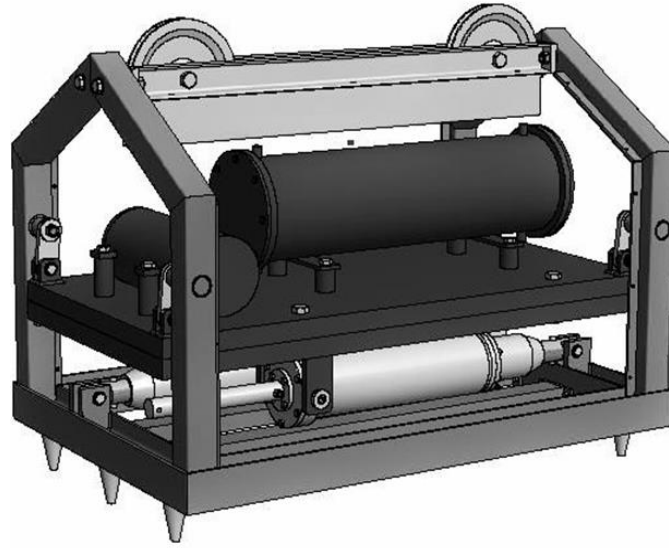
**Figure 2-2: Shear Wave Generator for Seismic Seabed CPT, Geo Thor.**

**Table 2-2: Specifications summary of Geo Thor unit**

<b>Geo Thor Data*</b>	
<b>Manufacture</b>	Geo.
<b>Dimensions, L/W/H (m)</b>	1.50/1.00/1.50 (hammer unit). 6.06/2.44/2.60 (Launch frame as 20' container frame).
<b>Weight in air (Kg)</b>	1600.
<b>Weight in water (Kg)</b>	1300.
<b>Subsea power system</b>	Electro powered hydraulic.
<b>Hammer system</b>	Spring loaded pistons for left/right strokes.
<b>Stroke energy (Joule)</b>	Configurable 10 – 400.
<b>Maximum operational water depth (m)</b>	100.
<b>Stroke rate (hits/min)</b>	3.
<b>Distance, Center hammer – Center CPT (m)</b>	2 – 5 (Depending on onboard equipment setup).
<b>Hydraulic oil type</b>	Hydro 32.
<b>Deck space requirements (m2)</b>	15

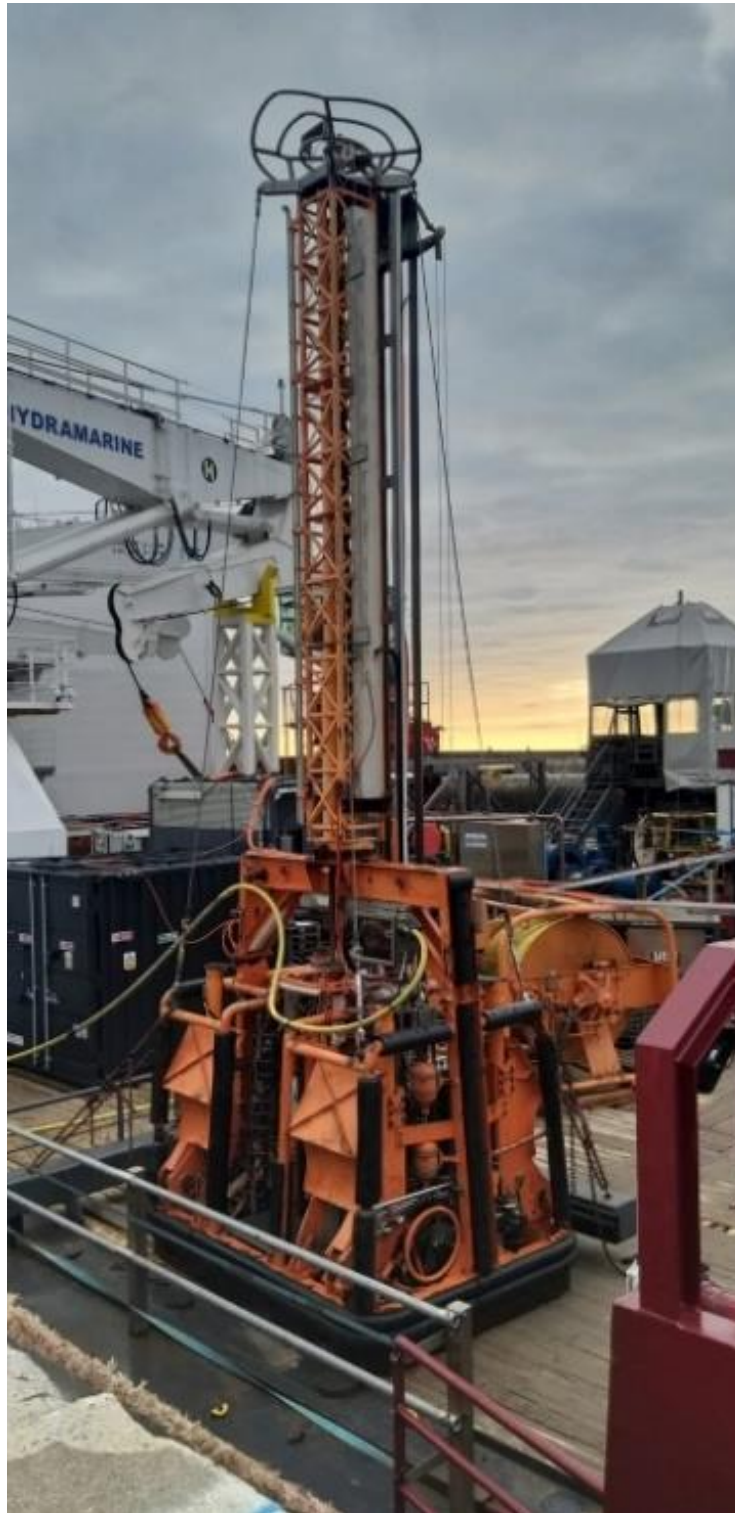
**Figure 2-3: Combined Seabed rig for CPT and Vibrocore, GeoCeptor.**

**Table 2-3: Specifications summary of GeoCeptor unit.**

<b>Manufacture</b>	Geo	
<b>Dimensions, L/W/H (m)</b>	3.2/2.4/2.2 (w. tower 8.2 m)	
<b>Weight in air (Kg)</b>	10.700 – 14.400	
<b>Weight in water (Kg)</b>	7.900 – 13.300	
<b>Hydraulic oil type</b>	Texaco Hydra 32	
<b>Launch options</b>	“over the side”, platform or through the moon pool	
<b>Deck space requirements</b>	Approx. 55 m including containers	
<b>Maximum operational water depth (m)</b>	3000 (Current operational limit 550 m)	
<b>Max operational seabed inclination (°)</b>	10	
<b>Power requirements</b>	<b>Rig</b>	690 VAC, 33 kW, supplied from 400 – 440 V
	<b>Operation container</b>	400 VAC/60 Hz or 380V AC/50 Hz, 40kW
		240 VAC, 5 kW
	<b>Storage/Workshop</b>	240 VAC, 5 kW
<b>Lifting system</b>	Single wire (optional double acting wire)	
<b>Umbilical</b>	Tension winch mounted MacArthney 58825 for 550 meters water depth	
<b>GeoCeptor – Vibrocore unit data</b>		
<b>Vibrocore system</b>	GeoCorer 3000/6000 w. 3 kN impulse at 28 Hz for fast penetration

<b>Core dimension (mm)</b>	106	
<b>Core catcher</b>	3 types of metal lamellae	
<b>Vacuum system</b>	Vacuum valve

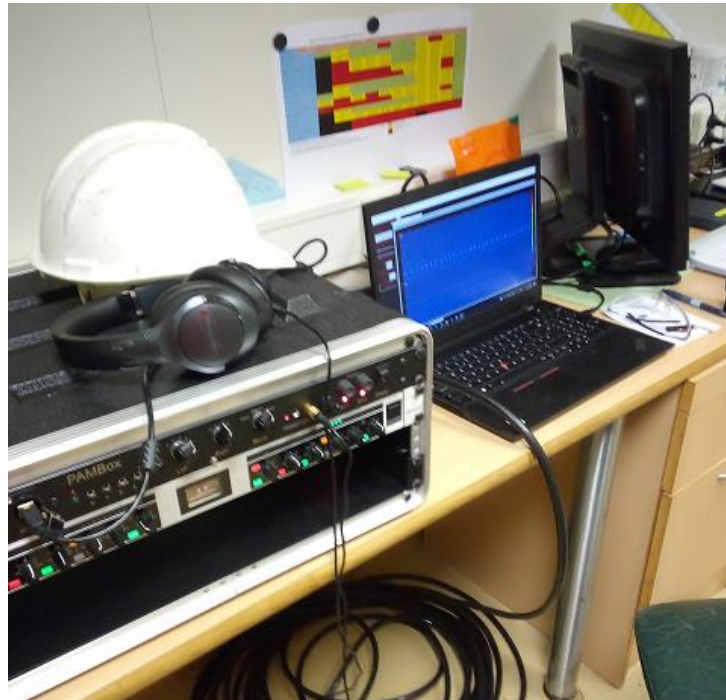
**Figure 3-1: PAM Station**

The PAM desk/station (Figure 3-1) was set up, within the MV Connectors client’s operations office, close to Geo Ops also located mid-rear, at the back deck of the vessel.

The analogue to digital data processing equipment comprised an amplifier/conditioner unit, (buffer box), Acquisition SD Sail DAQ /Sound card, Behringer audio processing, and a power supply, all contained within a Vanishing Point field instrument case.

The deck lead is connected to the rear of a conditioning unit, with outputs to a laptop running PAMGuard version 2.01.05 (open-source passive acoustic monitoring software), for visualisation and detection.

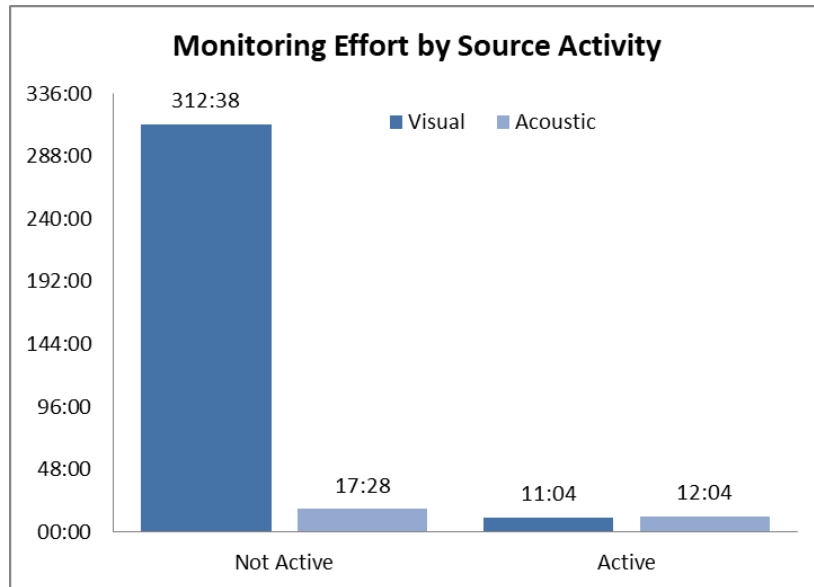
**Figure 4-2: Times of visual and acoustic monitoring effort by source activity**

Out of the total 353:14 hours of the monitoring effort, 23:08 hours (6,6%) were completed whilst the acoustic sources were active and 320:06 hours (93,4%) were completed whilst the acoustic sources were silent.
