Re: Ringsend to City Centre Core Bus Corridor Scheme.
Ringsend to City Centre, Co. Dublin.

Your Ref: **ABP-317679-23**
Our Ref: **SID-DCC-2023-027**

Grand Canal Basin Otter Survey and Otter Conservation Management Plan

October 2022

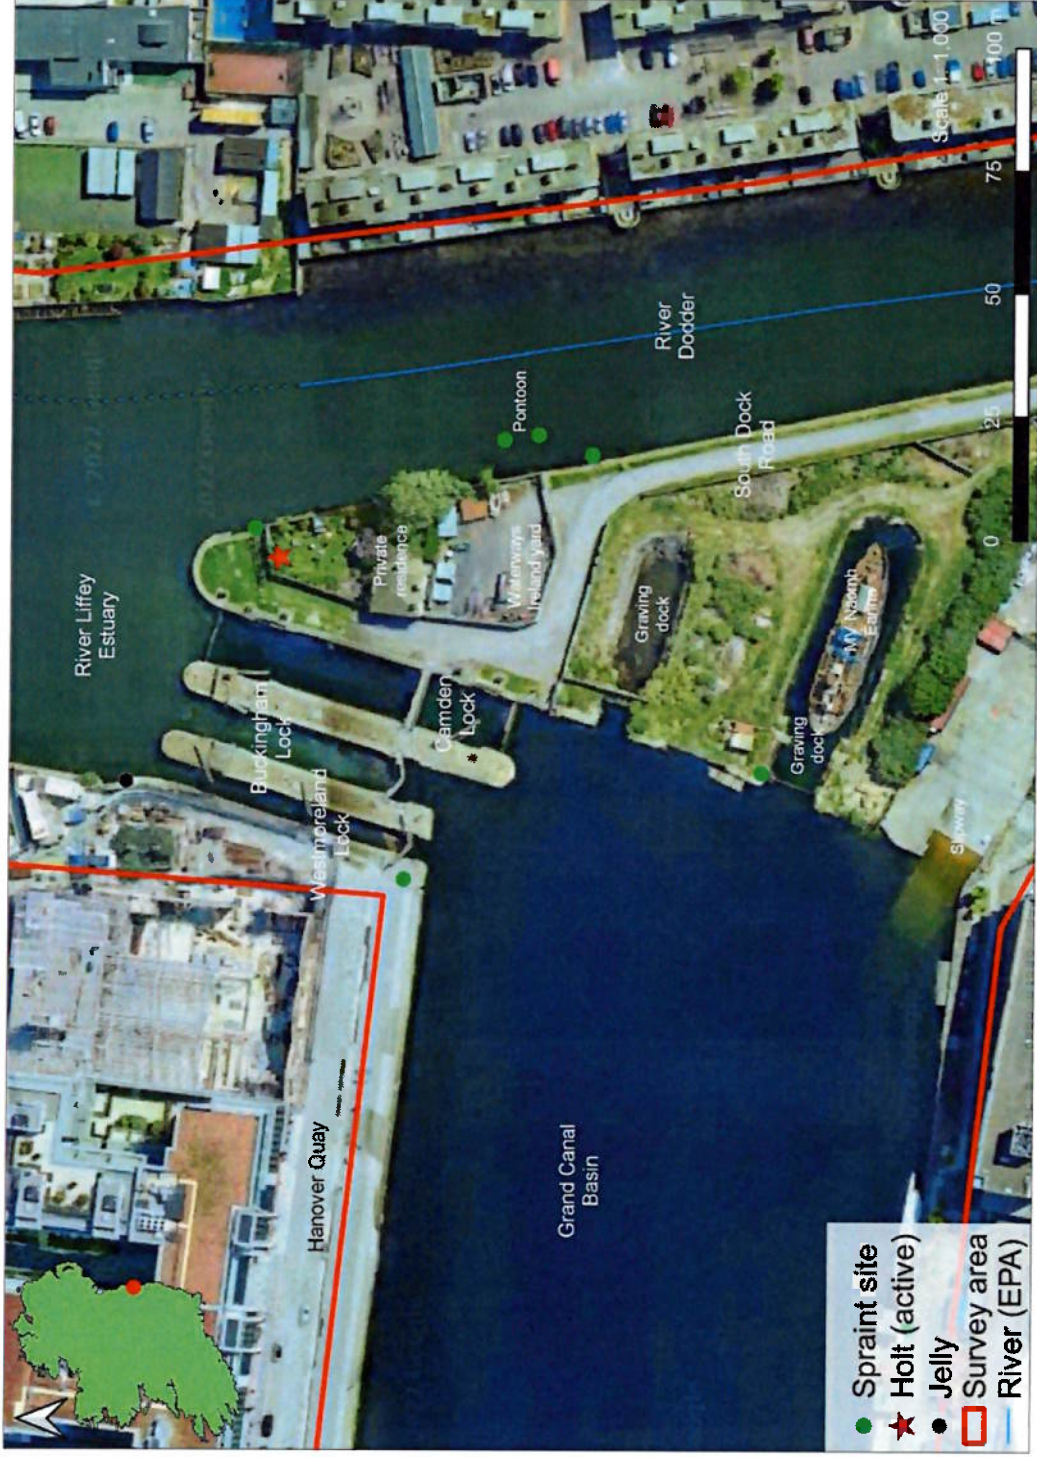
Figure 3.2 Location of otter signs in the immediate vicinity of the proposed Camden Lock works area, April 2022

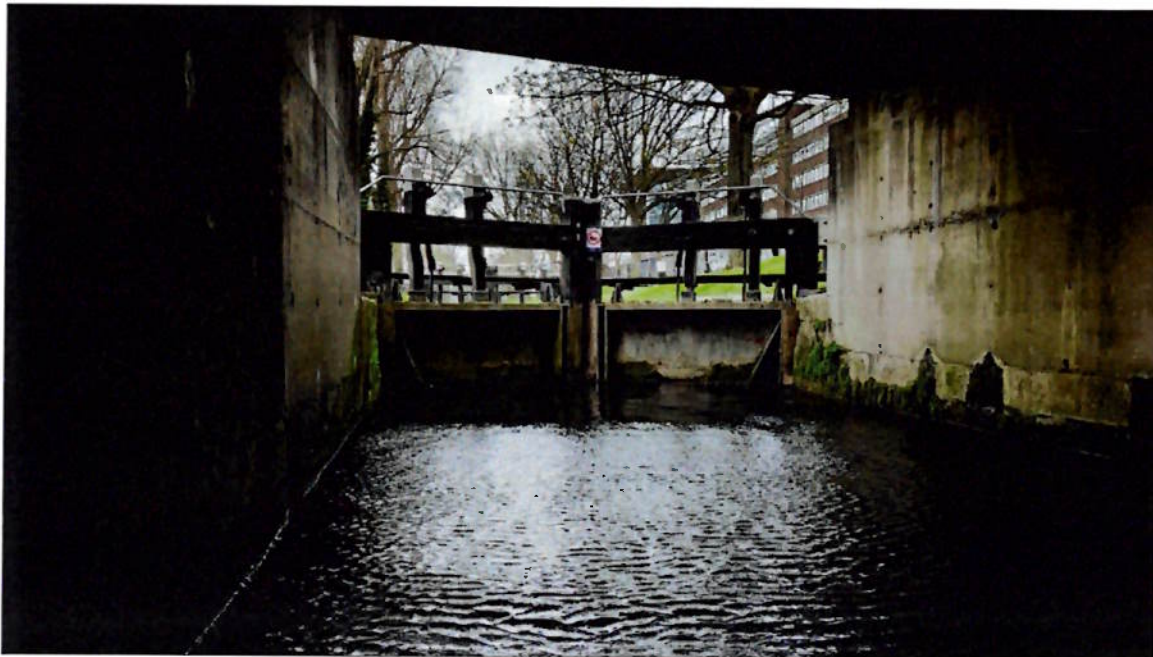
Plate 4.1 The Grand Canal at lock C1 (Macquay's Bridge) presents a significant barrier to otter movement given an absence of steps or ledges and a fall of approx. 1.8m

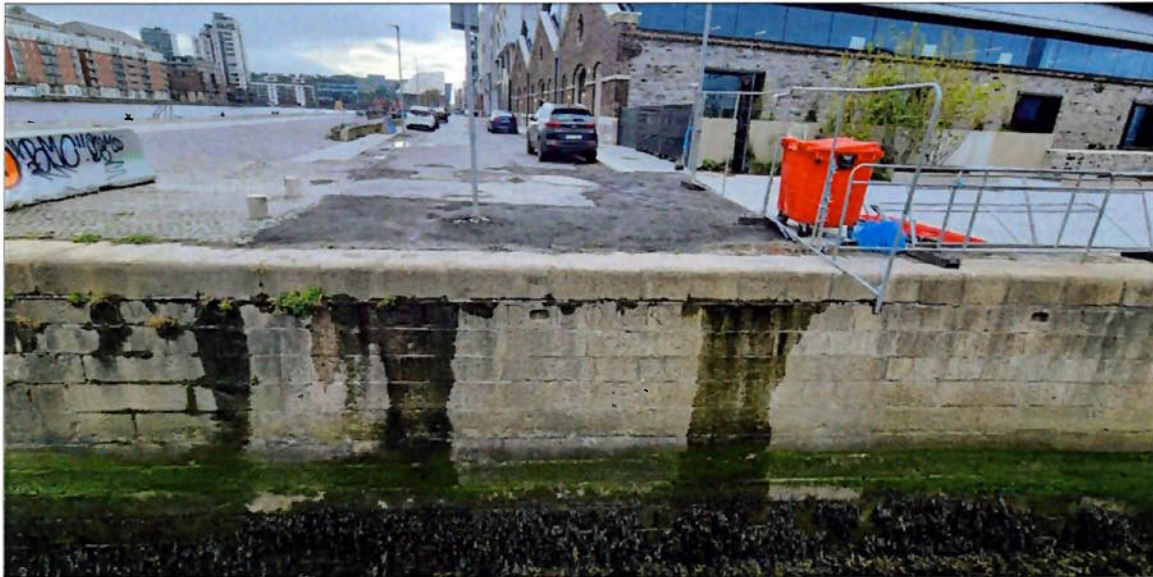
Plate 4.3 The potential otter commuting route along Westmoreland Lock/Hanover Quay was blocked via temporary construction fencing at the time of survey

Additionally, the triumvirate of canal locks at Westmoreland Lock, Buckingham Lock and Camden Lock (i.e. proposed works area) at the confluence of Grand Canal Basin and the River Liffey Estuary also present restrictions to otter movement (e.g. **Plate 4.2**). However, otter sign distribution in the vicinity would suggest that animals are able to move between Grand Canal Basin and estuarine habitat via a set of quay steps on the River Dodder (next to the old Grand Canal Docks sign) and traversing the open ground immediately east of Camden Lock (near Waterways Ireland yard). There is also opportunity for otters to move between the estuary and Grand Canal Basin via quay steps north of Westmoreland Lock (at Brewdog Outpost Dublin) along Hanover Quay. However, this access route was blocked to otters during the survey due to ongoing construction and associated temporary site fencing (**Plate 4.3**).

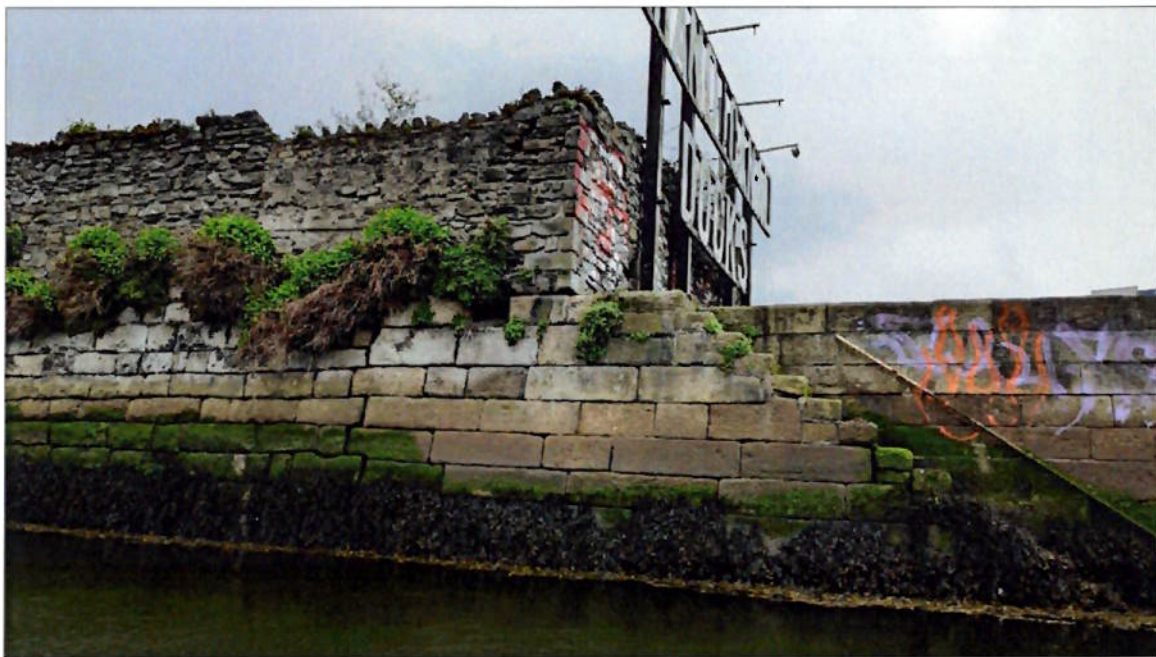
Plate 4.4 The quay steps on the River Dodder estuary which appear to be the main commuting/access route for otters moving between estuarine habitat and the Grand Canal Basin

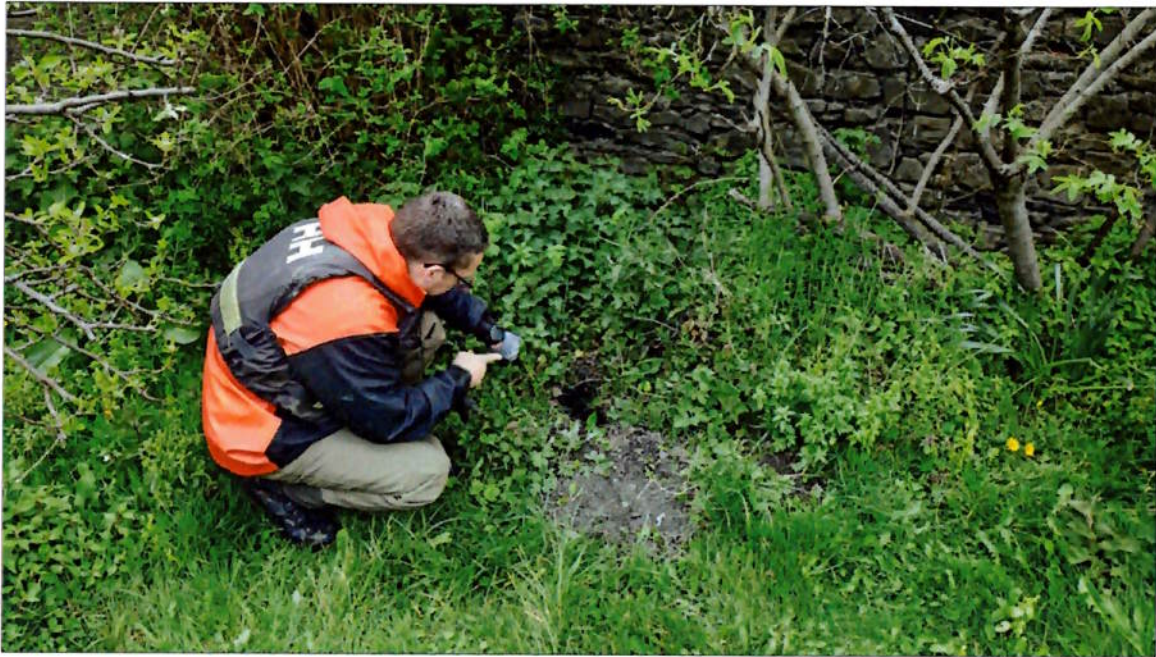
Plate 4.5 Active otter holt identified in private garden adjacent to Camden Lock (with trail leading to hole in the wall)

In this regard, temporary fencing of the area between the River Dodder quay steps and the hole in the wall providing access to the identified garden holt adjacent to Camden Lock should be adopted. Fencing should be solid galvanised steel fencing (i.e. not mesh) to ensure better disturbance shielding during works. Furthermore, a fenced-off pathway for otter between this location and Grand Canal Basin should be seriously considered during construction. The same recommendations would also apply to future works and future development plans for the Grand Canal Basin area. Future development and designs for the area should include for protection of this important otter habitat and passage route(s).

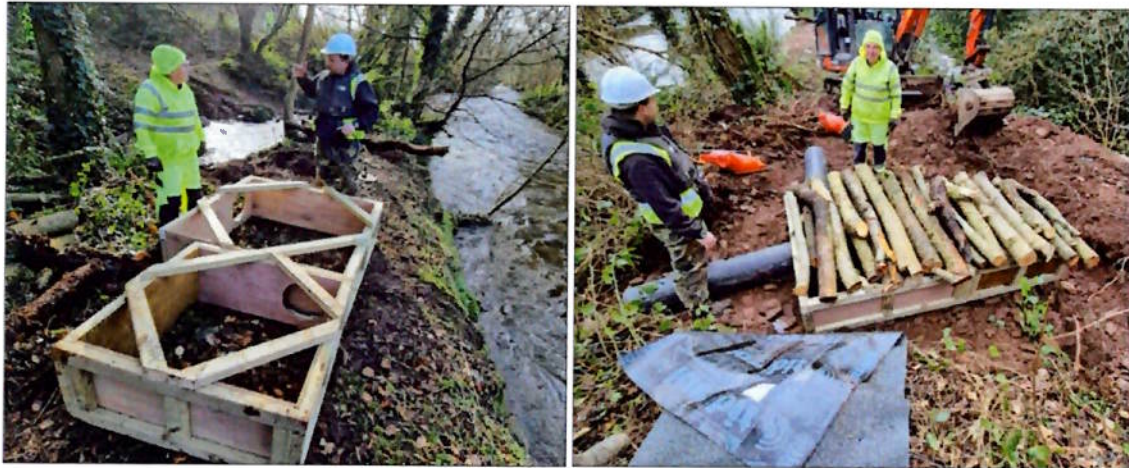
Plate 5.1 Example of a double-chambered artificial otter holt designed and installed by Triturus Environmental Ltd. on the Glashaboy River, Co. Cork in 2021 (left: box structure, right: natural log roof) Macklin, R. (2022)

The concrete platform at the Grand Canal Tunnel stormwater outfall (adjacent to Grand Canal Dock station within the inner Basin) would also be very suitable for artificial holt installation (**Figure 5.1**). On consultation with the NPWS (Terry Doherty, NPWS, pers. comm.) this area was agreed as a good prospective area for artificial holt construction. The area is evidently used as a highly regular sprainting site and, whilst located adjacent to high levels of human disturbance, is inaccessible to humans except via watercraft. Whilst the outfall has been targeted for removal under the proposed Grand Canal Storm Water Outfall Extension Project², part of the concrete wall/structure could be retained (**Plate 5.2**). This area could then serve as a sprainting site, a breeding site (artificial holt) and an area of enhanced biodiversity through aquatic planting (as proposed under the North Lotts and Grand Canal Dock SDZ Planning Scheme (Scott Cawley, 2015) (see below). Artificial otter holts should be constructed and installed in conjunction with suitably qualified otter specialists. These could be constructed using the double box structure design of Triturus Environmental Ltd. with natural wood limbs on the roof structure to improve naturalness (**Plate 5.1**) or by using a log holt structure (**Plate 5.3**).

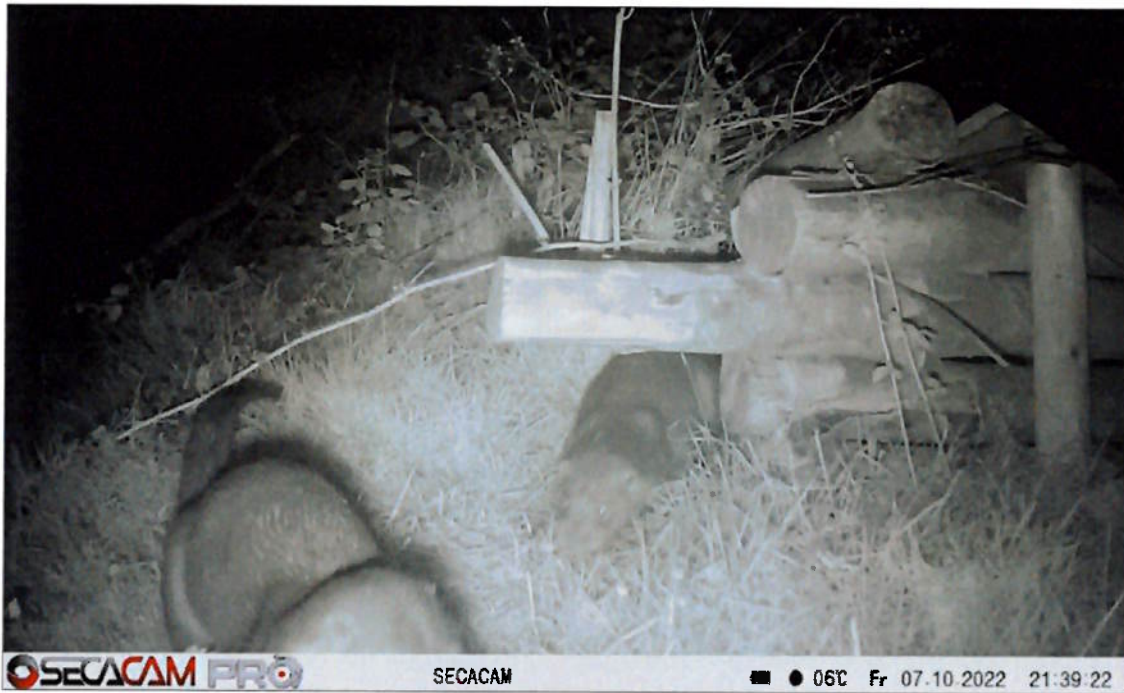
Plate 5.3 Example of a log holt structure that is used regularly by otter on the Glashaboy River, Macklin, R. (2022)

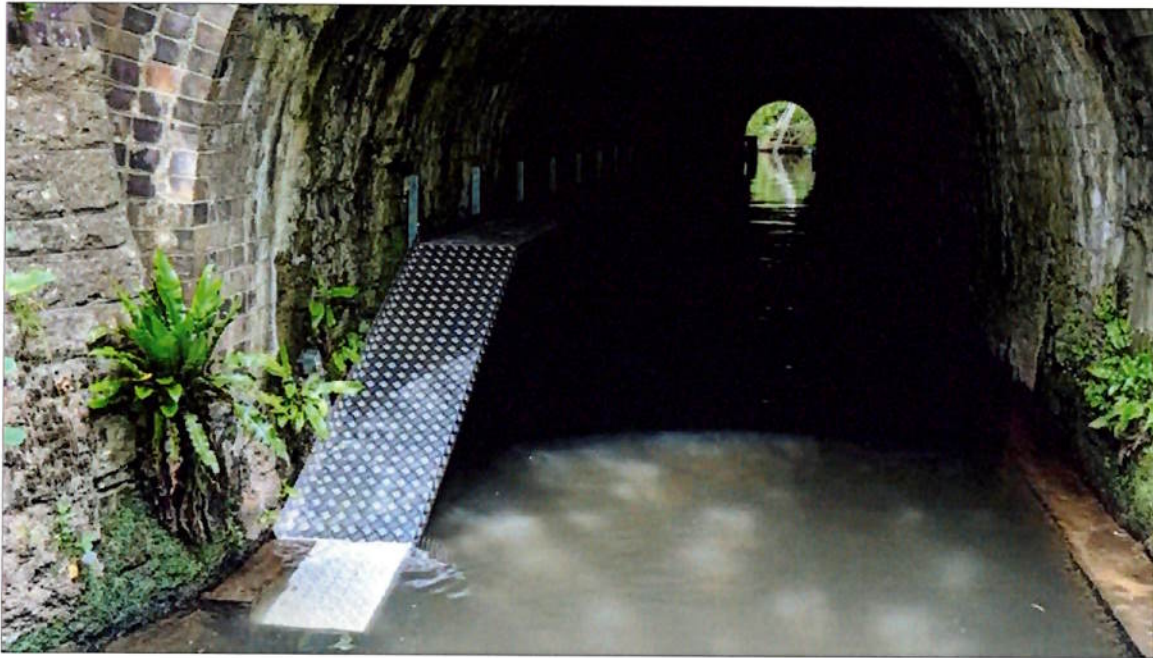
Plate 5.4 Example of best practice bolt-on steel mammal shelf/ledge for otter passage under culverts (source: Landmarc Environmental Engineering, UK)

the functionality of the lock. The design and installation of otter passage should be in consultation with otter specialists and follow best practice (e.g. TII, 2015; NIEA, 2011, NRA, 2006; OPW, 2006, Highways Agency, 1999). Channel width restrictions under the bridge(s) in this case may not allow for the installation of a 500m wide ledge as recommended for otter passage in Ireland (NRA, 2006), i.e. a narrower ledge would be required. Available Navigation width to be determined by Waterways Ireland, which will inform the suitability of installing Otter ledges at these locations.

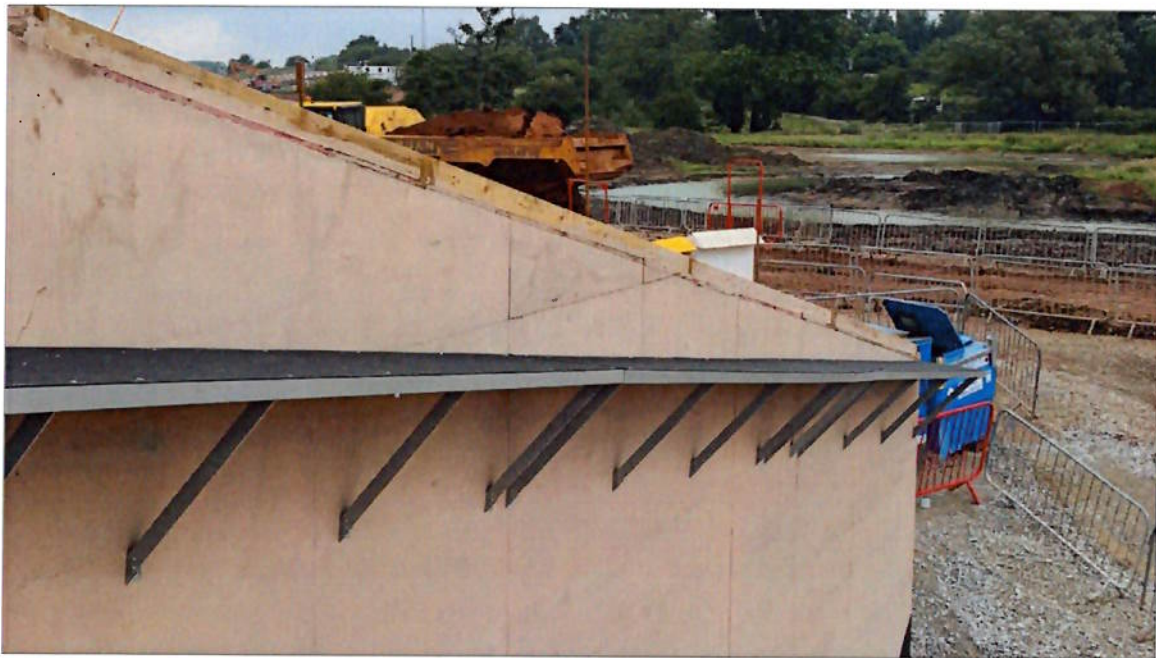
Plate 5.5 Another example of bolt-on mammal shelf/ledge for otter passage at a large road culvert (source: Althon, UK)

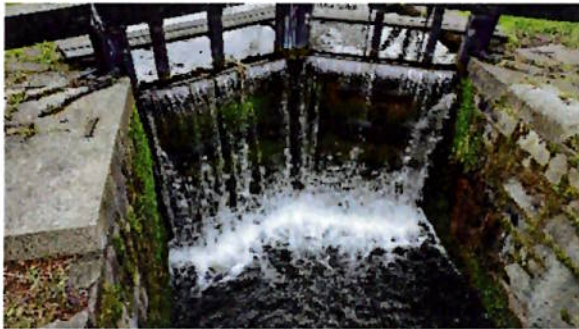
Plate 8.1 Lock C3 (McCartney Bridge) on the Grand Canal – a barrier to otter passage

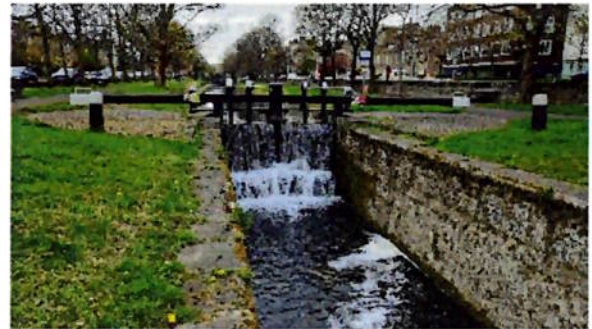
Plate 8.2 Lock C2 (Mount Street Bridge) – another barrier to linear otter passage along the Grand Canal

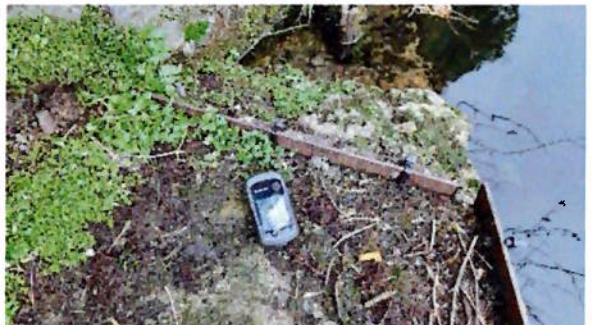
Plate 8.8 Regular spraint site on the concrete platform of the Grand Canal Tunnel outfall

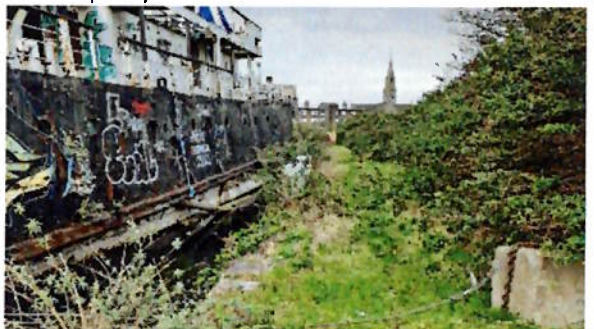
Plate 8.14 Low disturbance area of ground at the graving docks adjacent to the Naomh Éanna – an area with suitability for artificial otter holt installation
