Intervening Hedgerow Assessment

Trimming Impact under Proposed 400kV Transmission Line

September 2012

**North South 400kV Interconnection
Development**

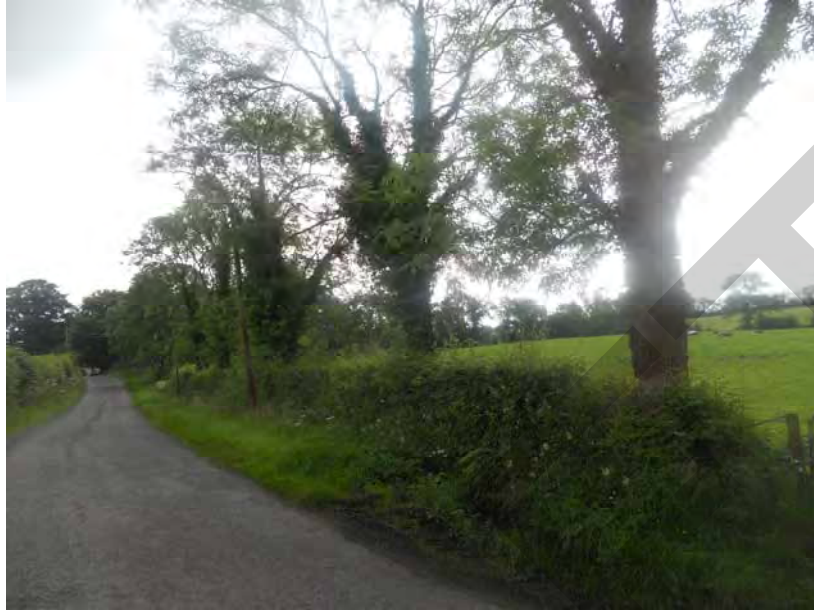
Type 2: Managed hedgerow and scattered mature ash tree which will require cutting within zone of impact. However given relatively scattered nature possibly only one or two trees will require cutting/ partial trimming.

- **Type 2:** This type is typically dominated by non mature trees or lower growing species but includes at least one (more typically several) identified mature tree specimen (typically >15m generally >20m) which will require cutting.
- **Type 3:** This type is dominated by mature trees which form a closed canopy treeline. Typical species include beech and oak tree lines are generally clustered around or in the vicinity of demesnes in Co. Meath.

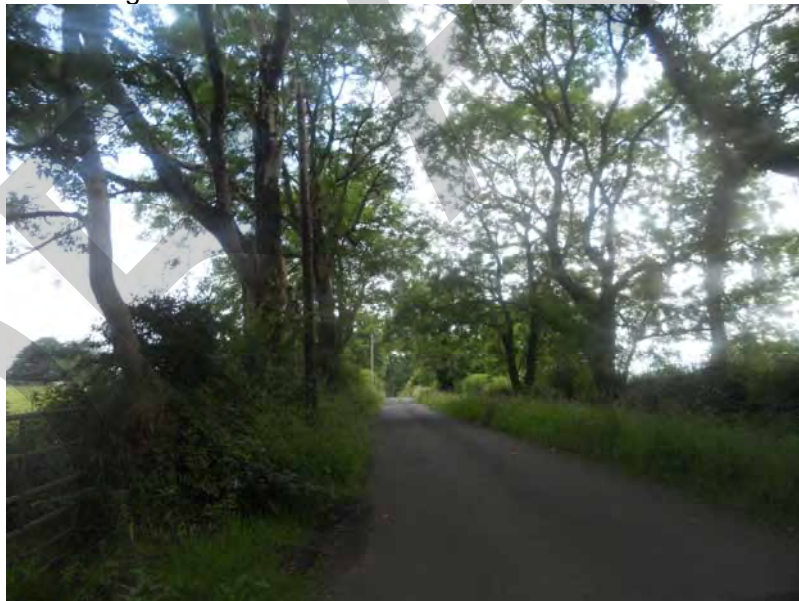
Type 2: Both sides of road. Note not closed canopy i.e. scattered but relatively dense mature trees at least 1 to 2 either side of road will require cutting/ significant trimming under the line.
